# **FULL-SCALE CRASH TESTS on PLASTIC DRUMS with TYPE III OBJECT MARKERS**

Missouri Highway and Transportation Commission  
Report No. 87-2

April 1988

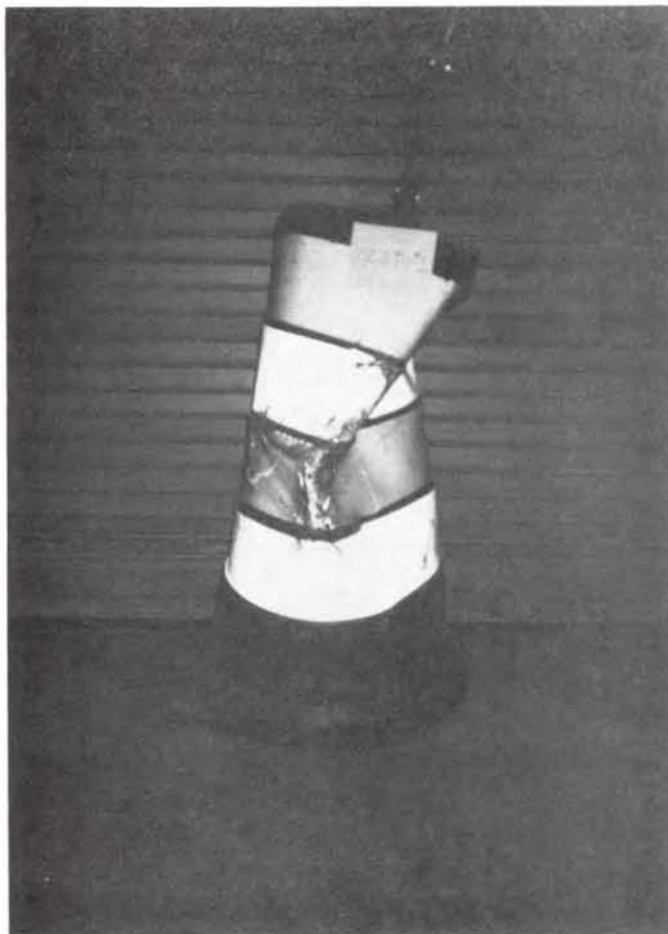
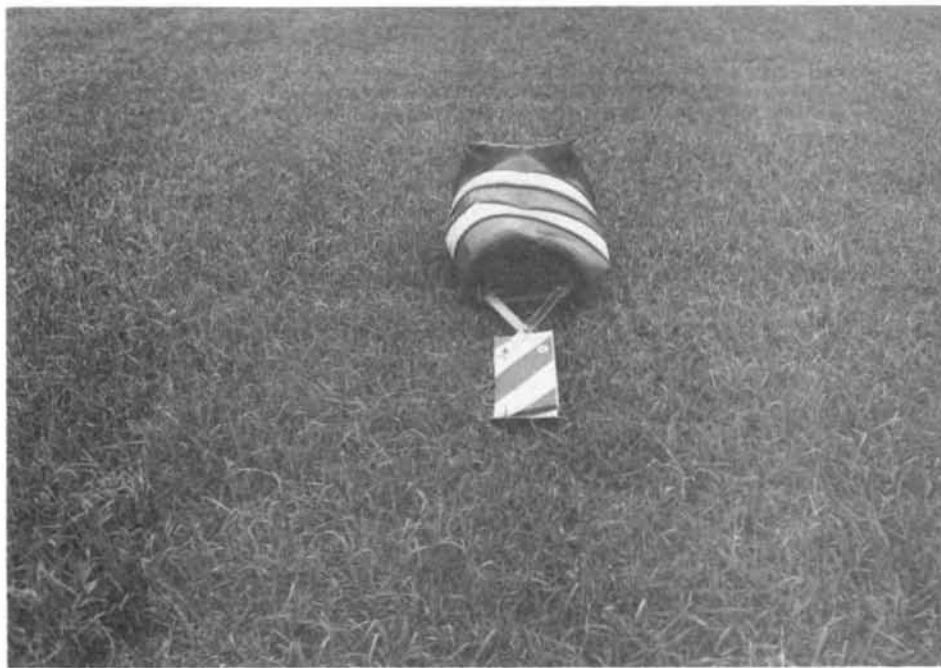
Figure 17. Damages to Plastic Drum Channelizer, Test No. 1

Upon impact, the channelizer buckled but remained upright and in front of the vehicle. When the channelizer buckled, the object marker deflected down touching the hood momentarily and then rebounded back to a position very close to its original position. After close examination, there was no visible evidence of fracture in the polycarbonate connectors. There was no damage done to the test vehicle and the only damage done to the flexible reflective sheeting was some tearing due to impact. The sheeting conformed with the deformation of the channelizer without any evidence of cracking or peeling. Figures 17-19 show photos of the channelizer, object marker, and test vehicle after the test.

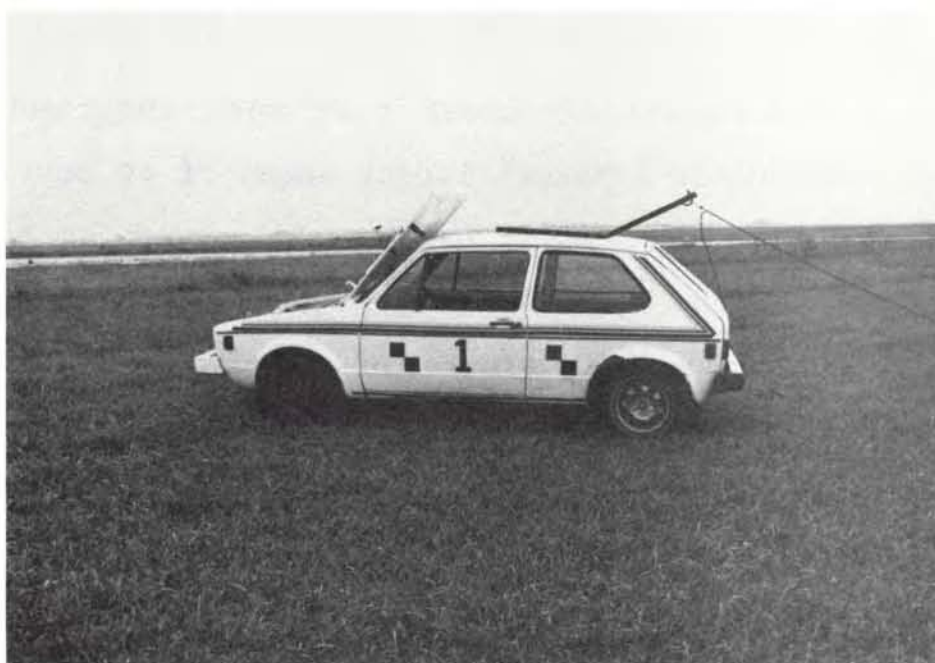
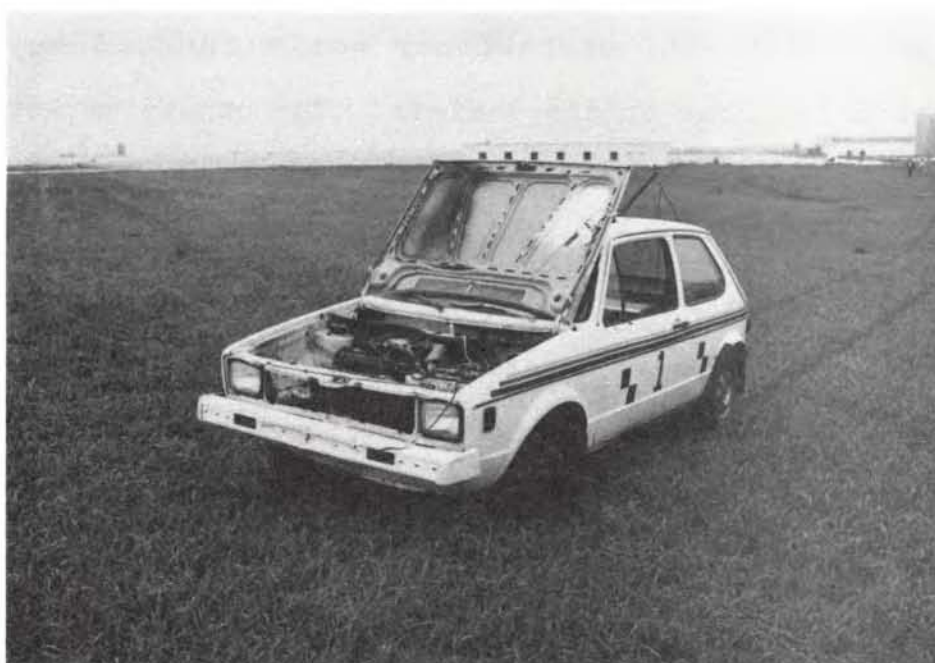
Figure 19. Damage to Test Vehicle, Test No. 1

During the test, at approximately 50 feet before impact, the hood of the test vehicle unlatched and flew up. After talking to the Missouri Highway and Transportation Commission about this incident, it was decided that the test was still good since this did not affect the results of the test in any way.

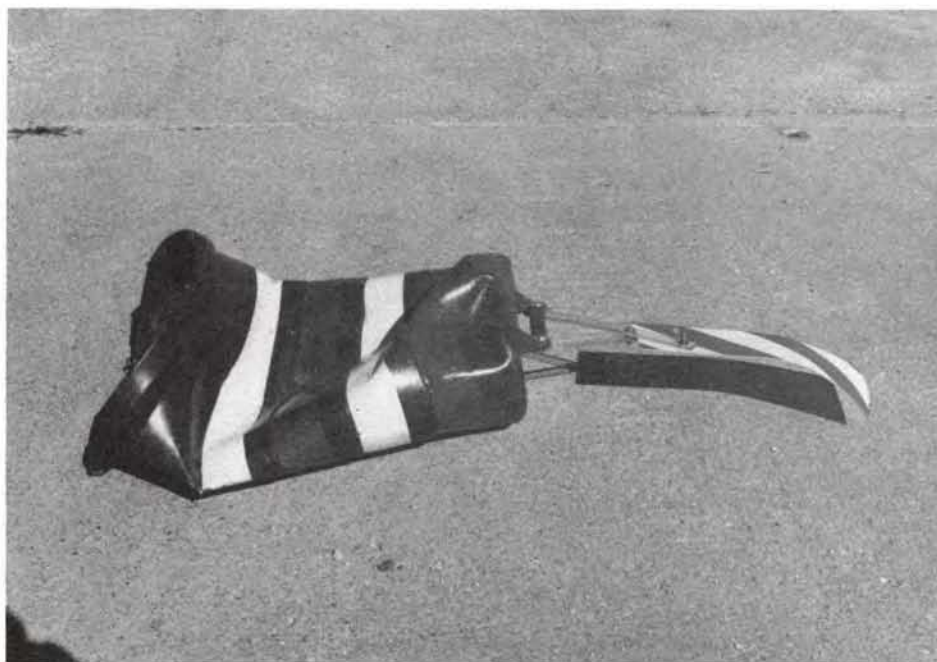
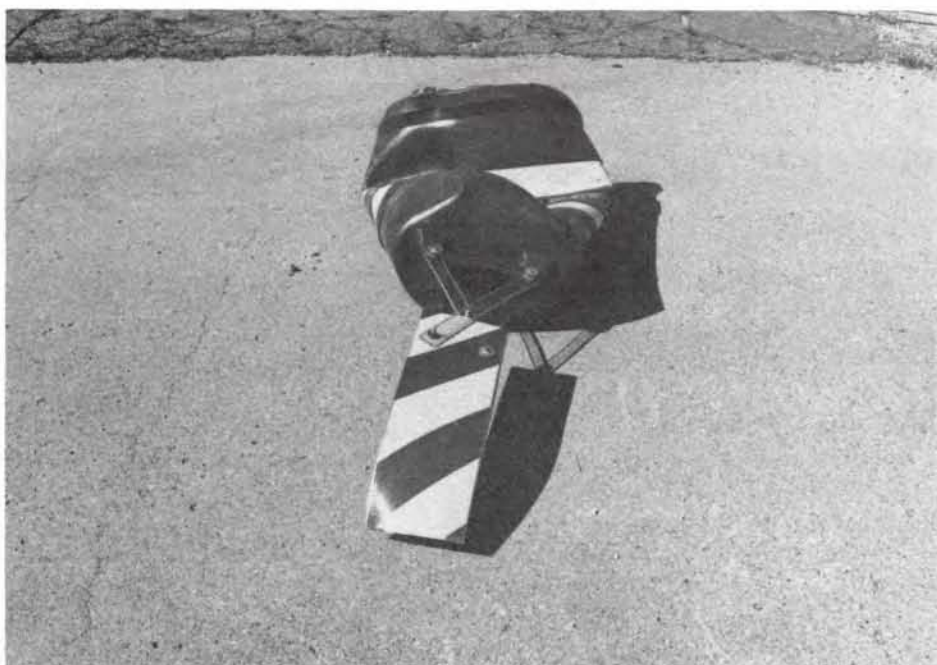
Figure 22. Damages to Plastic Drum Channelizer, Test No. 2

Upon impact, the channelizer again buckled but remained upright and in front of the vehicle. The object marker deflected but rebounded back to its original position and after examination, showed no evidence of fracture in the polycarbonate connectors. Unlike the first test, the reflective sheeting in the second test was a non-flexible engineering-grade reflective sheeting. Examination of the channelizer after the test showed that there was considerably more cracking and peeling of the reflective sheeting than in the first test. However, the sheeting in the second test was definitely reusable on the same channelizer. Figures 22-24 show photos of the channelizer, object marker and test vehicle after the test.
