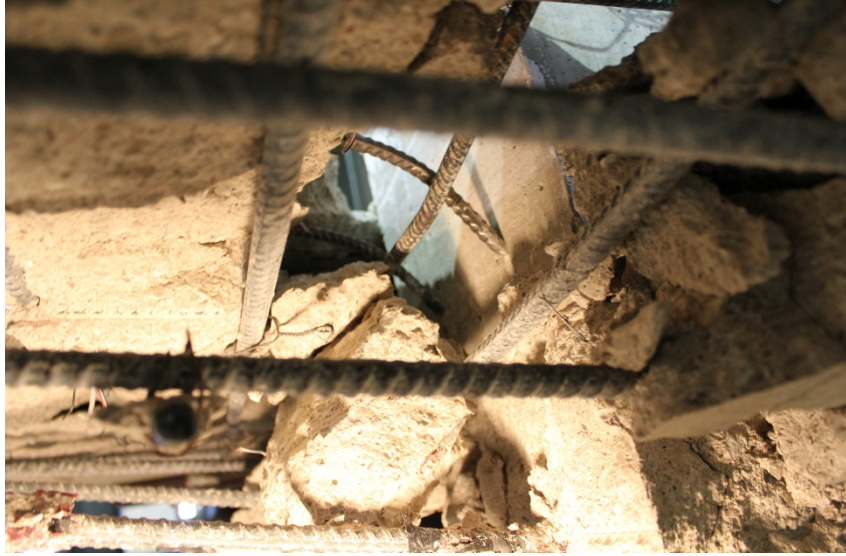
Figure A.11: Fracture #3 compression steel

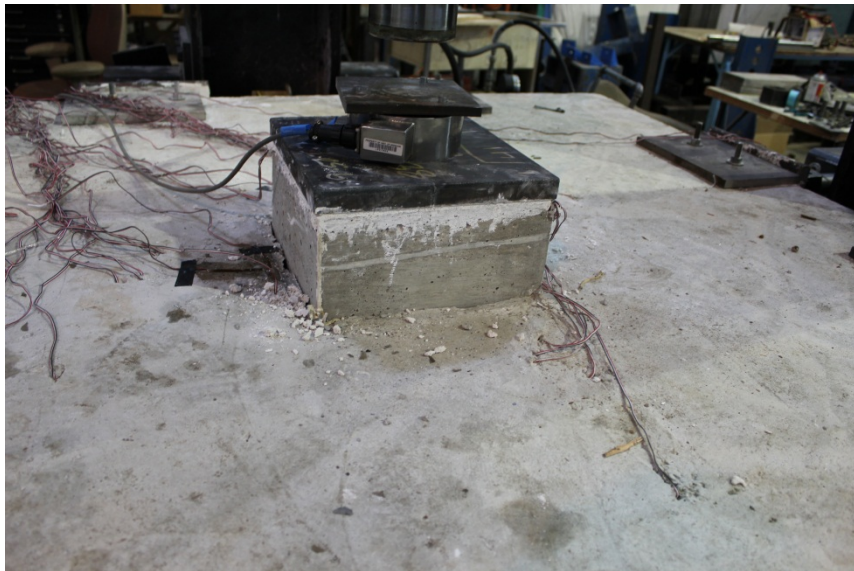
Figure A.12: Displaced top column stud after loading
