**VERIFICATION OF THERMOGRAPHIC BRIDGE
INSPECTION TECHNOLOGIES**

A Thesis presented to the Faculty of the Graduate School
at the University of Missouri - Columbia

Alan Michael Jungnitsch

MAY 2015

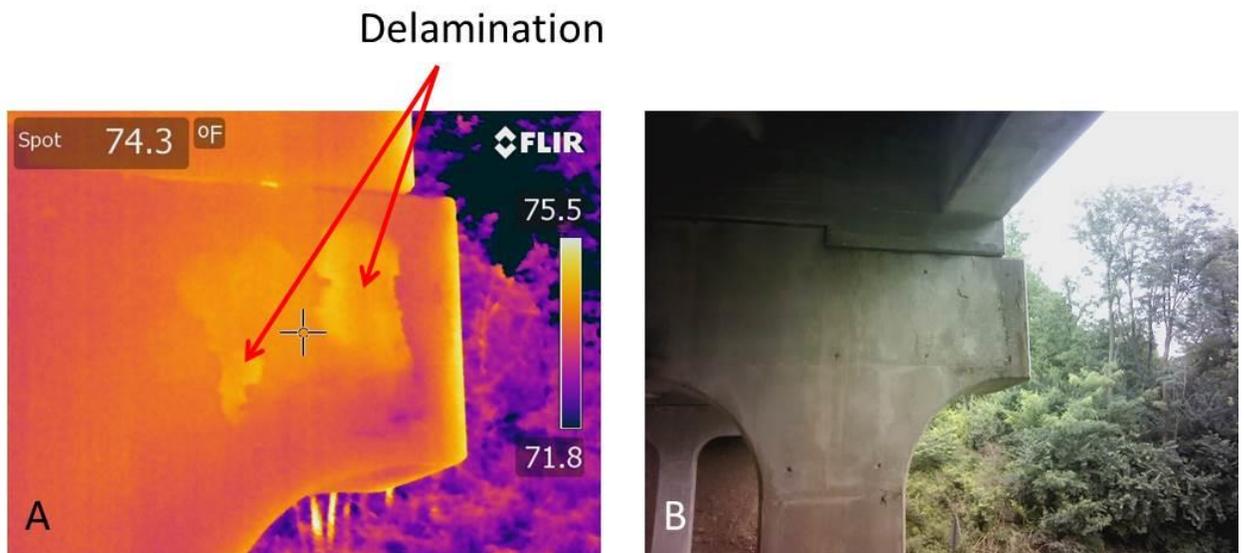
Figure 3-3: IR (A) and digital (B) images of a pier cap delamination captured during Kentucky training

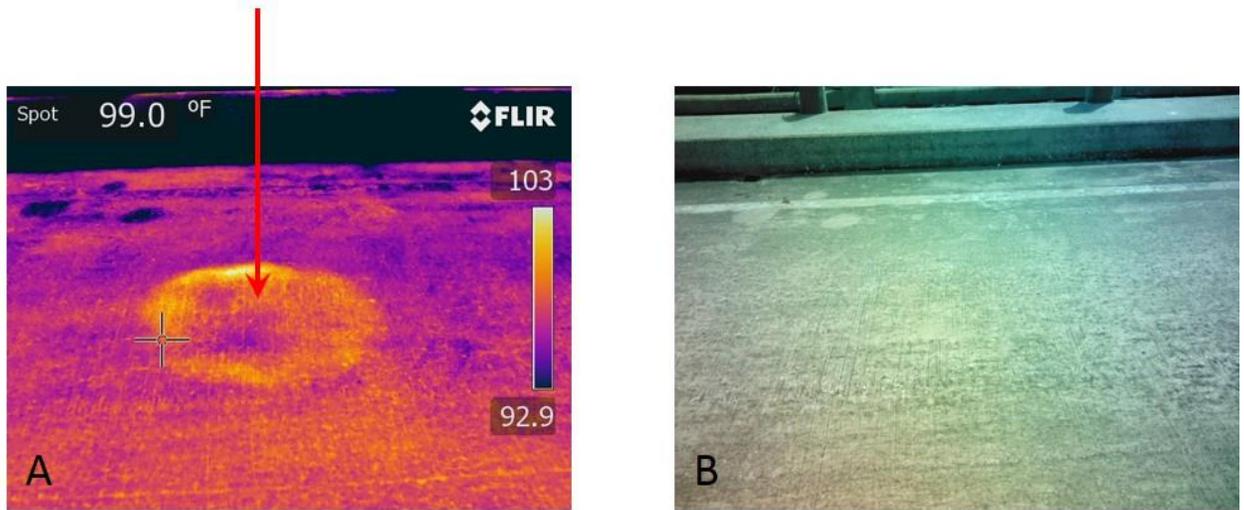
Figure 3-5: Infrared (A) and digital (B) images of a deck delamination in Florida

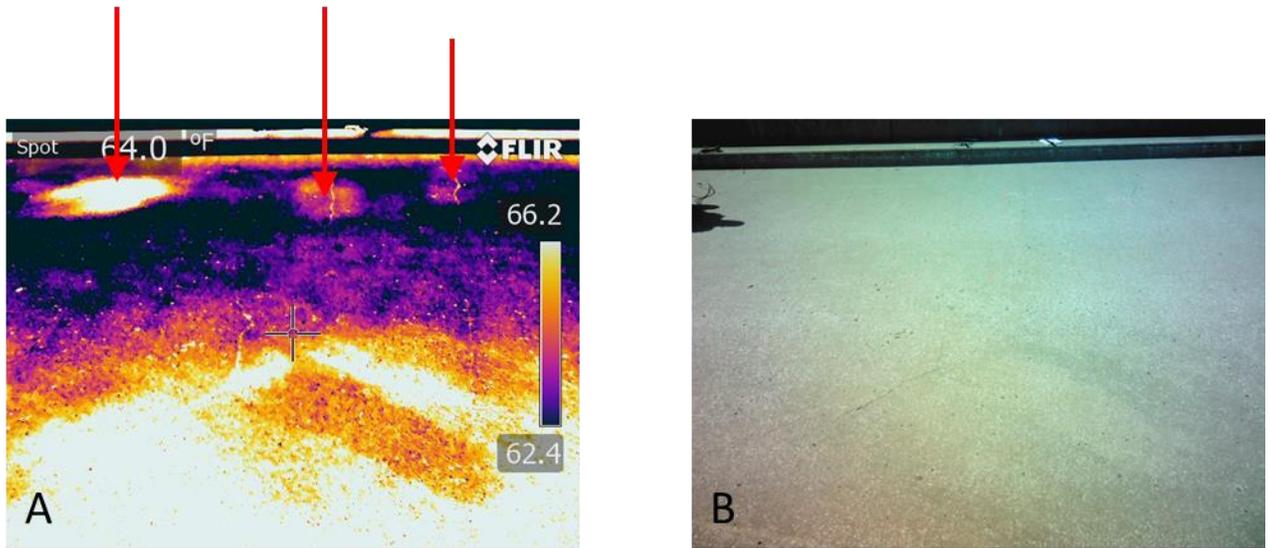
Figure 4-7: Infrared (A) and Digital (B) images of a group of delaminations in Kansas City

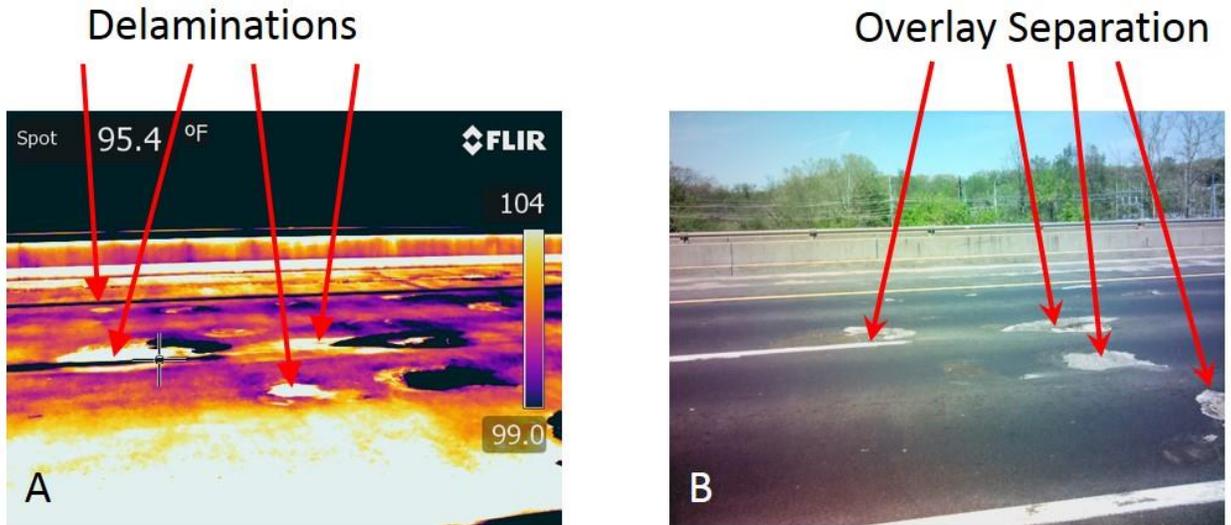
of the bridge. Soffit images are shown on the pooled fund website. Delaminated areas are shown as “hot spots” in Figure 4-9.

Figure 4-9: Infrared (A) and Digital (B) images of Providence Rd. Bridge (northbound) over Hinkson Creek

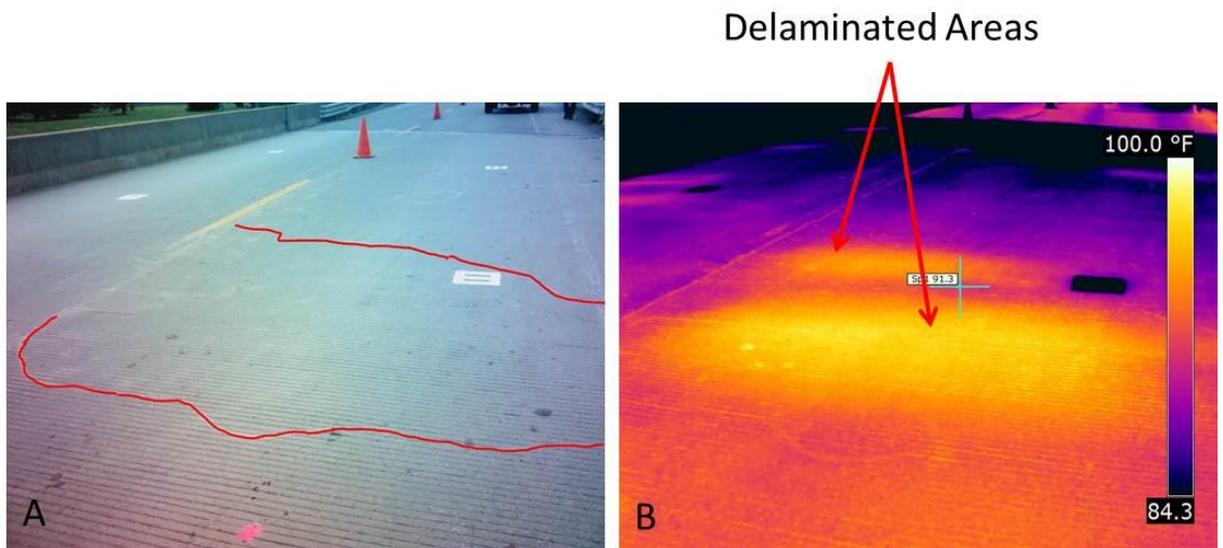
Figure 4-11: Hammer sound result (A) and Infrared (B) images of a deck delamination in Lamoni, IA

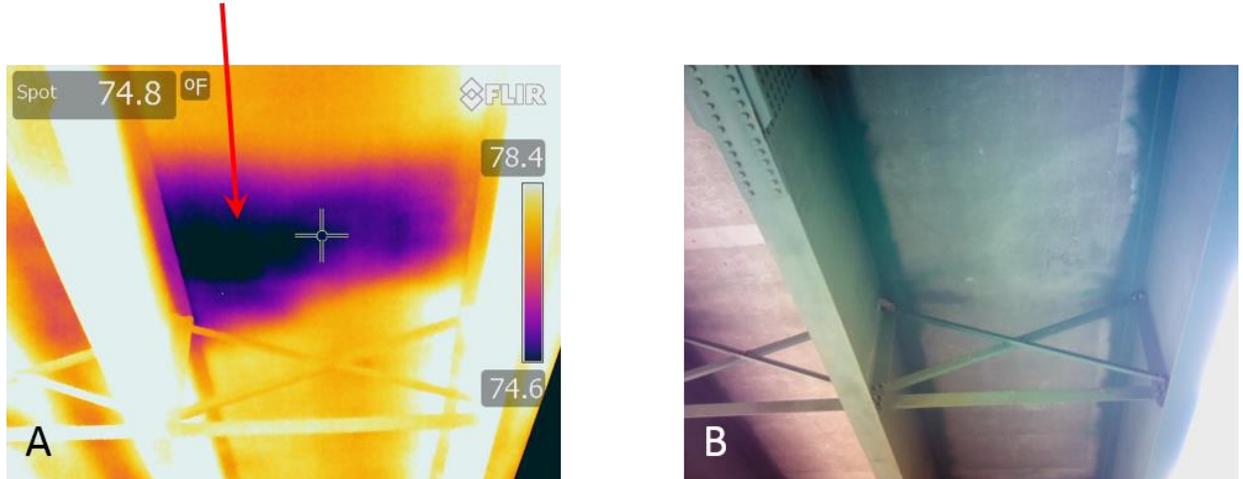
Figure 4-12: Infrared (A) and Digital (B) images from the soffit of the delamination in Figure 4-11

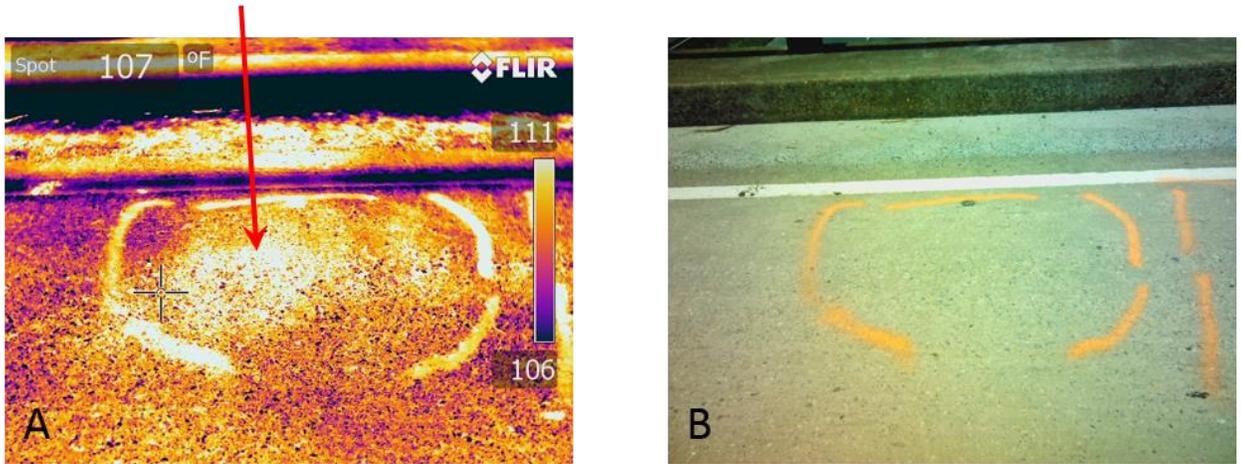
Figure 4-19: IR (A) and digital (B) images of a deck delamination on Johnstonville Rd.

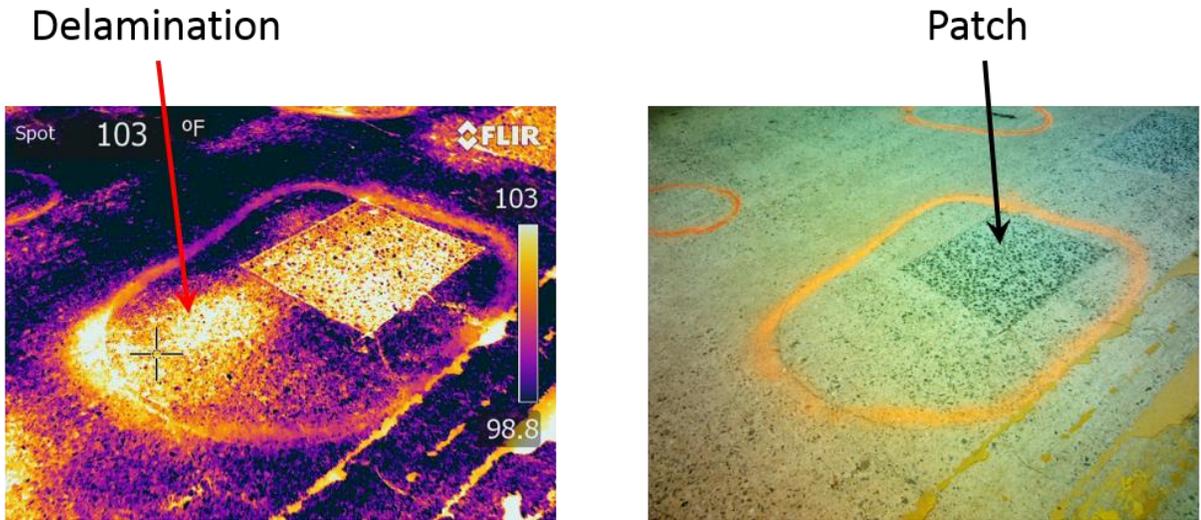
Figure 4-20: IR (A) and digital (B) images of a deck delamination over Ocmulgee River

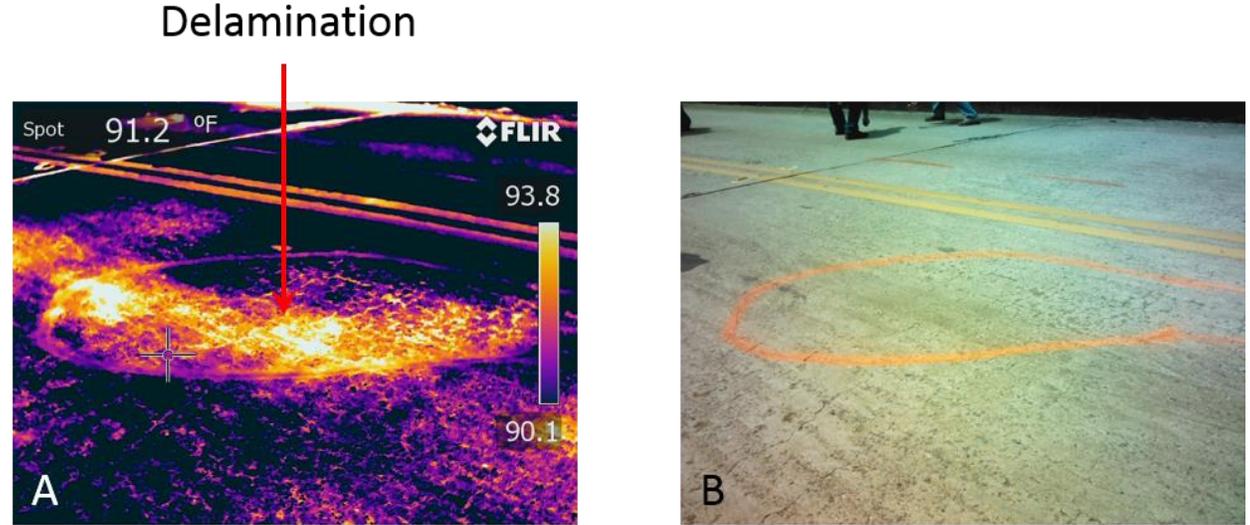
Figure 4-21: IR (A) and digital (B) images of a deck delamination over a railroad on Dames Ferry Rd.

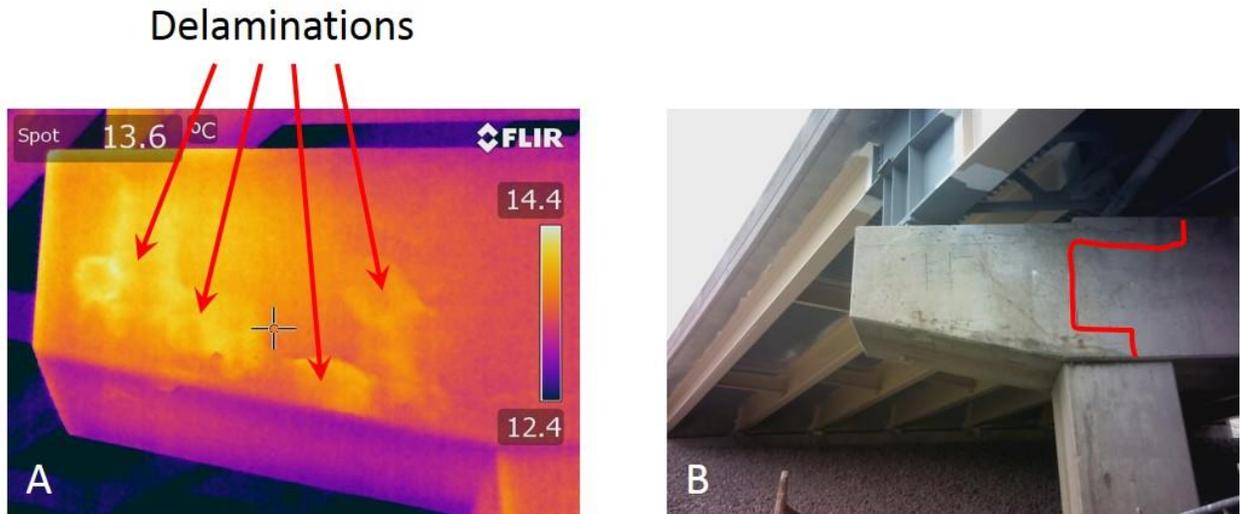
conditions were less than ideal, delaminated areas could still be seen in one of the pier caps. A thermal and digital image of the delaminations are shown in Figure 4-23 below.

Figure 4-23: Thermal image (A) and digital image (B) of a pier cap delamination

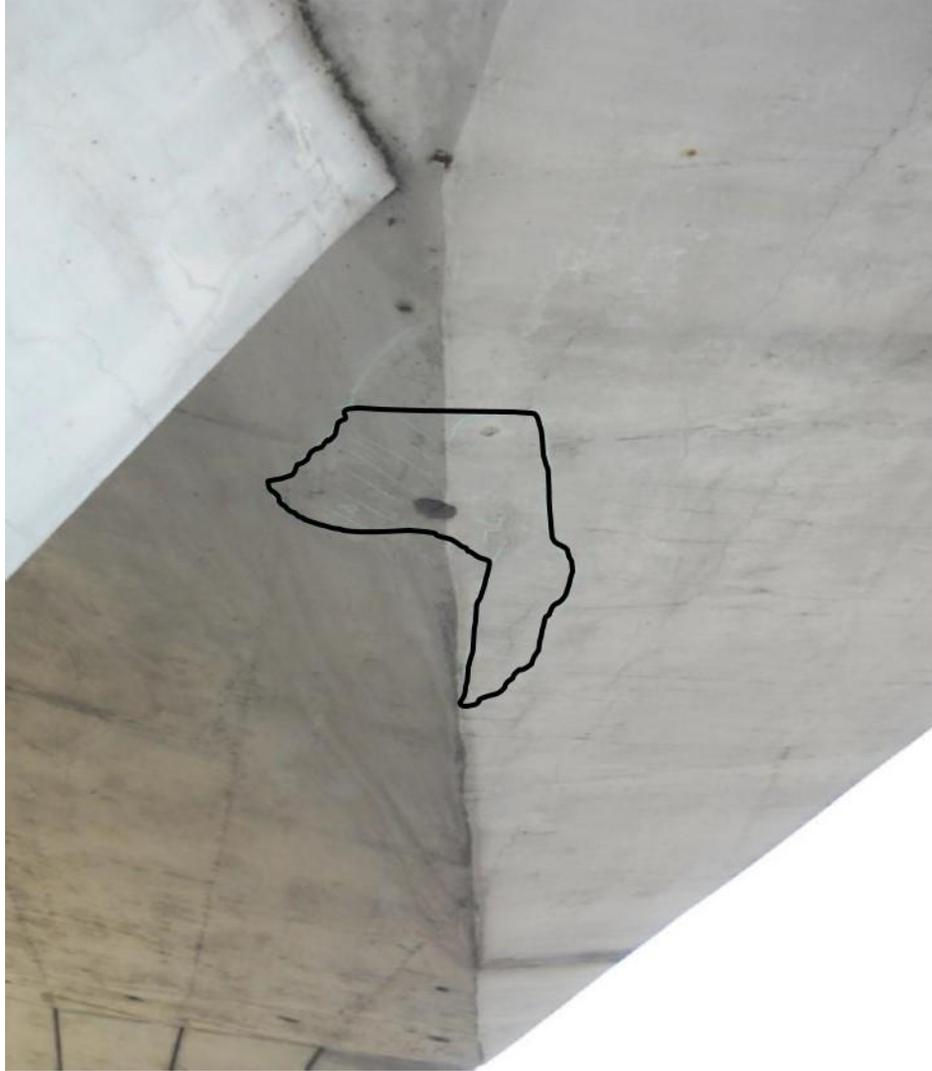
Figure 4-28: Hammer sounding results of a drain delamination from the WJE report

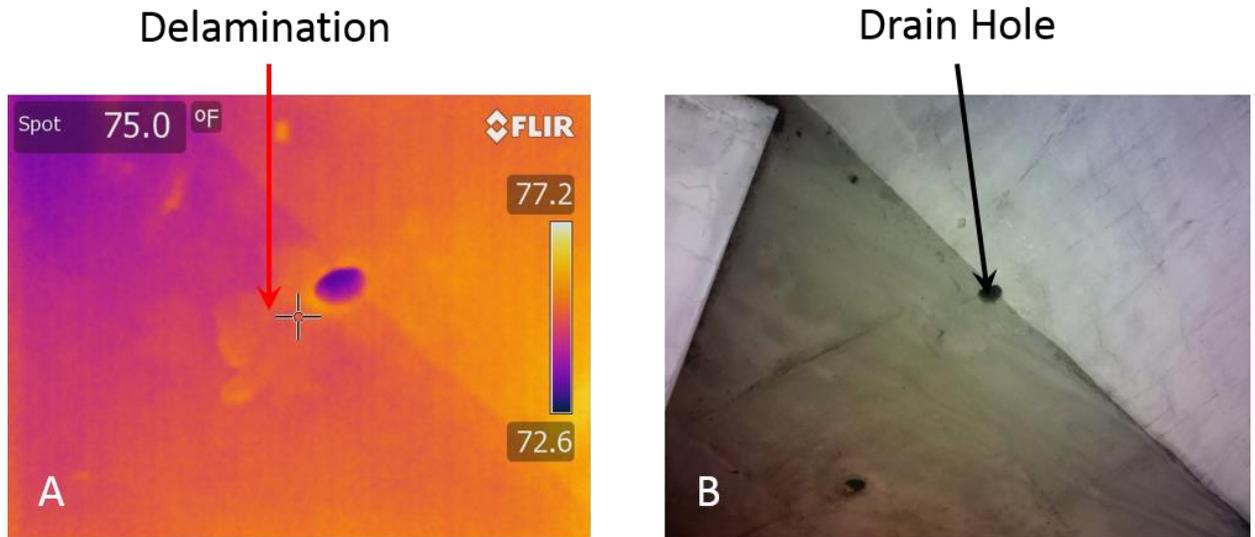
Figure 4-29: Thermal image (A) and digital image (B) of a drain delamination

Figure 4-29 was captured at approximately 2:30 in the afternoon when the temperature was approximately 77 °F (Wunderground 2013-2015). The temperature in the day had changed 20 degrees and should have been sufficient to capture a quality image. The image shows little thermal contrast between the delaminated area and the undamaged concrete with the smallest span possible for the camera. Higher thermal contrast between the delamination and sound concrete was expected with the weather conditions that were experienced.

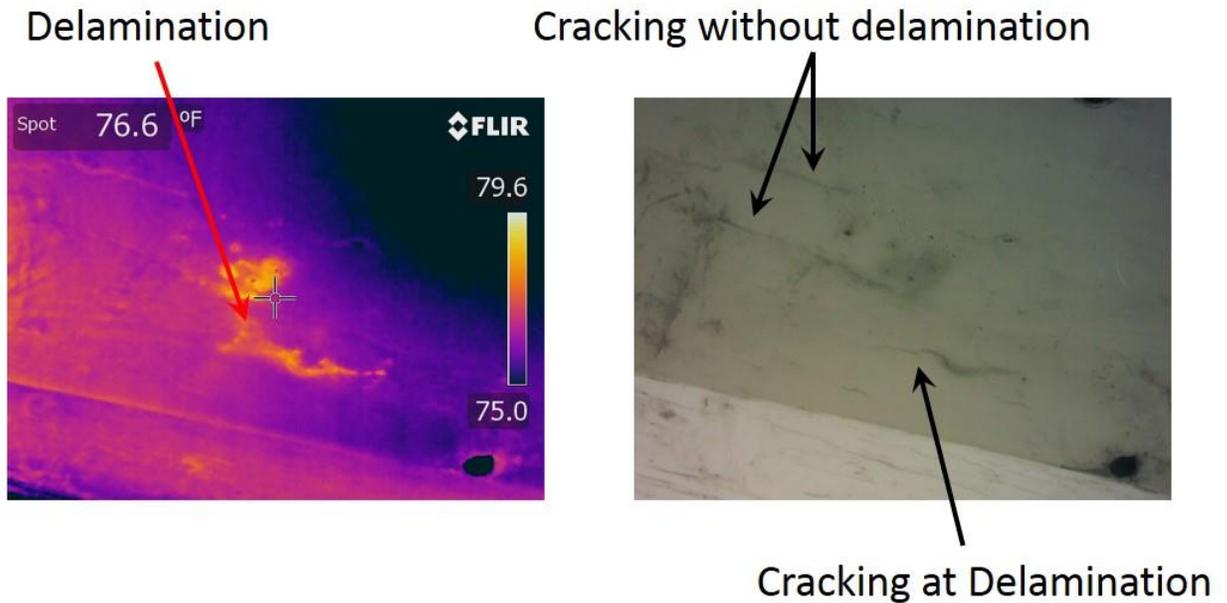
Figure 4-30: IR (A) and digital (B) image of a possible parge coat delamination

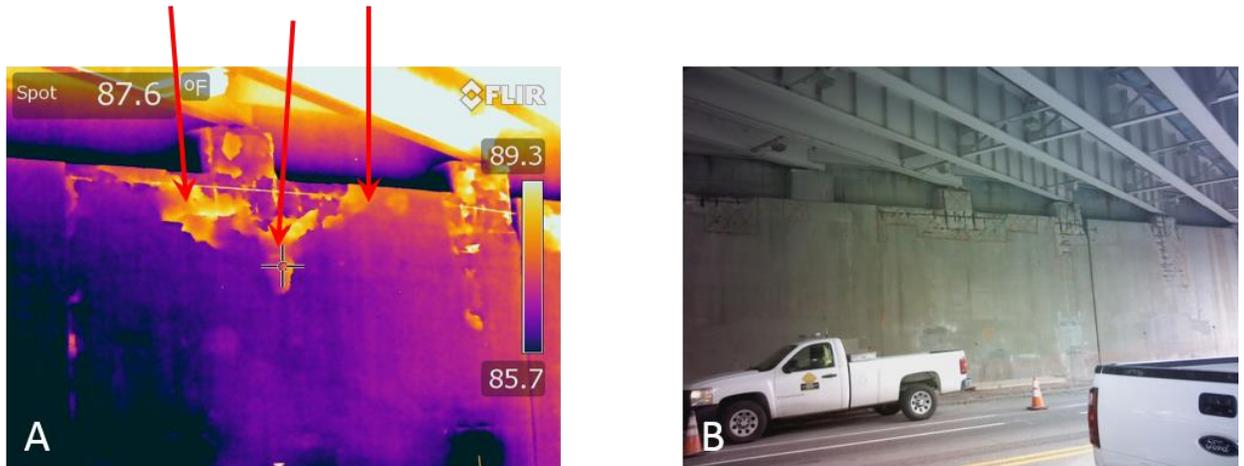
Figure 4-31: Thermal (A) and Digital (B) images of a delaminated abutment wall under I-265

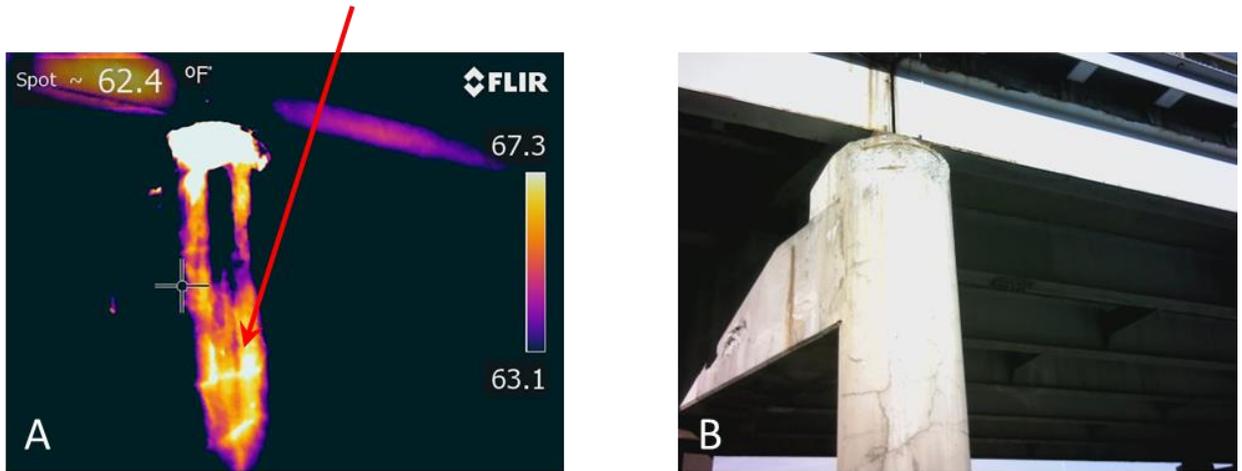
Figure 4-35: IR (A) and digital (B) images of a delaminated column on Pier 1 of South Bridge

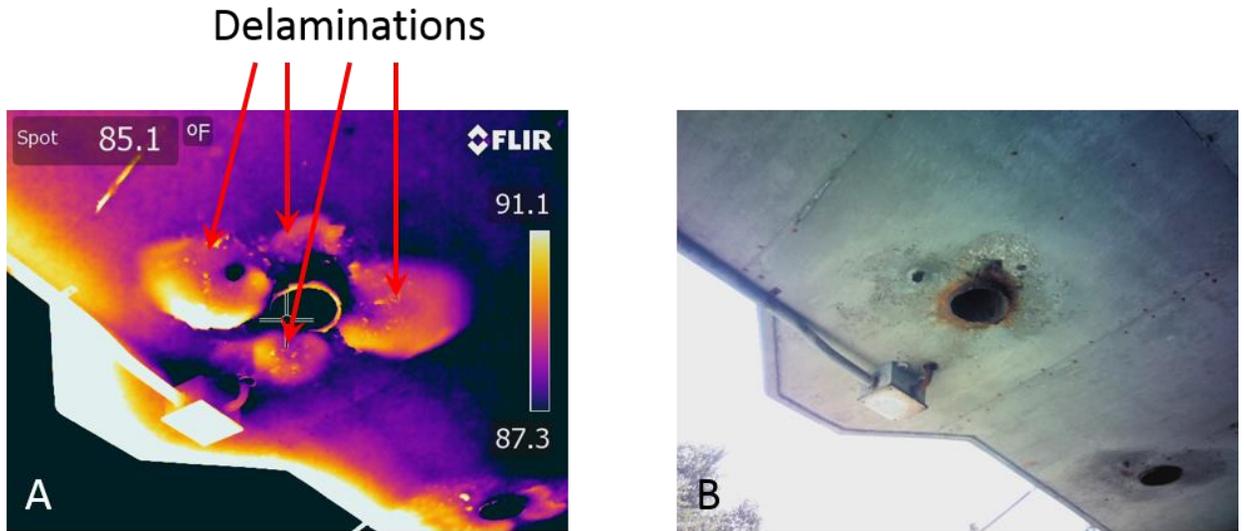
Figure 4-37: Afternoon infrared (A) and digital (B) images of a soffit delamination in Columbus, Ohio

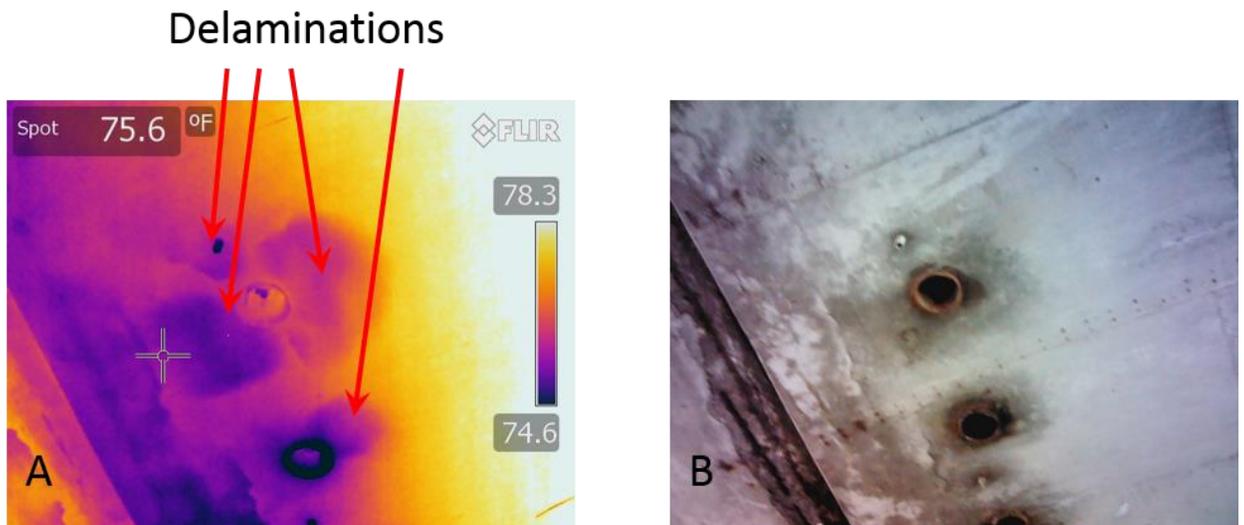
Figure 4-38: Morning infrared (A) and digital (B) images of a soffit delamination in Columbus, Ohio

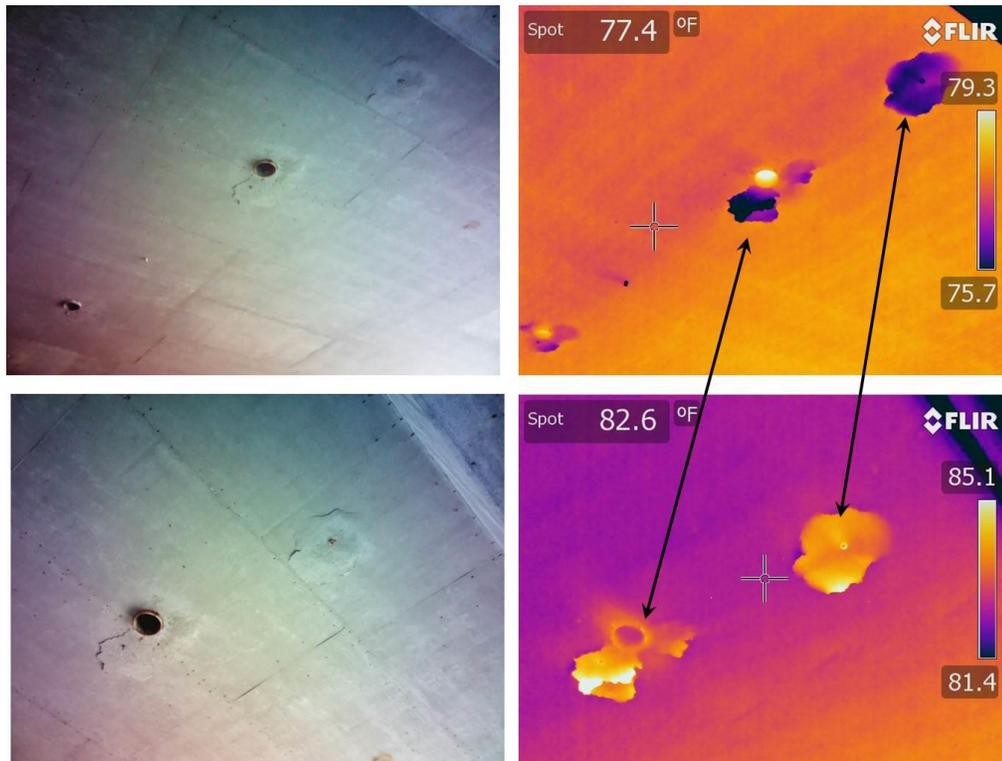
during the morning and afternoon. As shown in the images, the delaminations appear as cold spots during the morning hours and as hot spots during the afternoon.

Figure 4-39: Thermal images of delaminations in the soffit of a wide slab bridge, showing morning (top) and afternoon (bottom) results

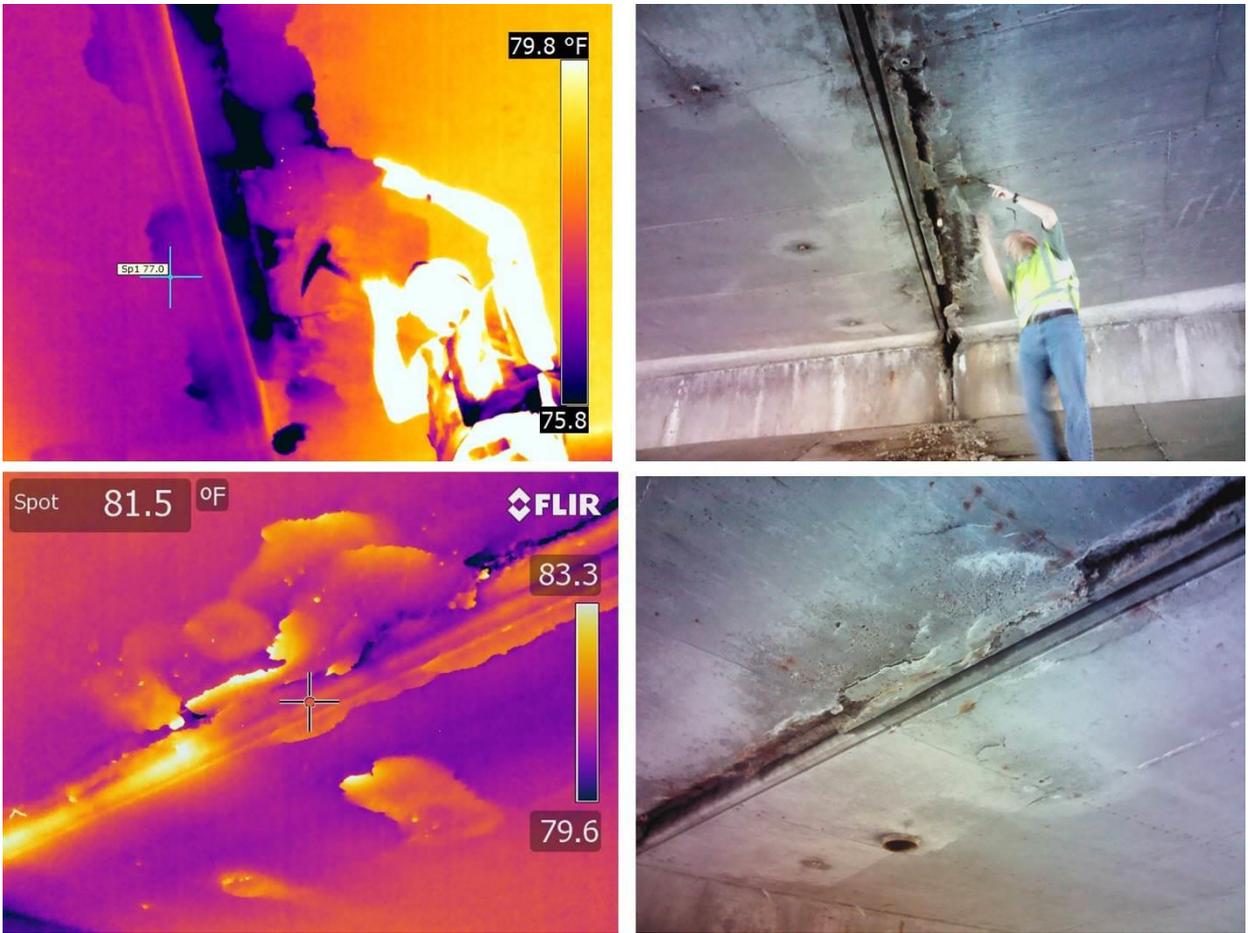
Figure 4-40: Thermal images showing damage along a longitudinal joint in a 159 ft wide slab bridge
