University of Missouri-Columbia

RDT 03-010

University of Missouri-Rolla

Signal Mast Arm Failure Investigation

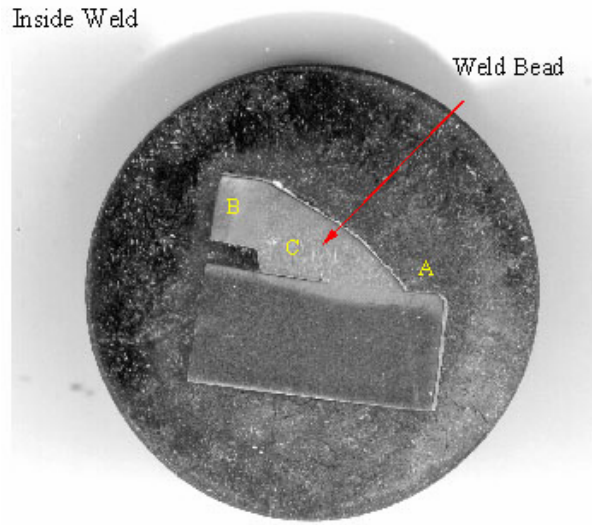
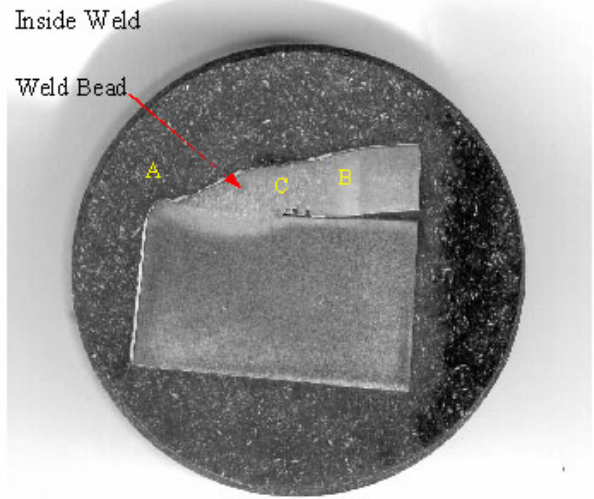
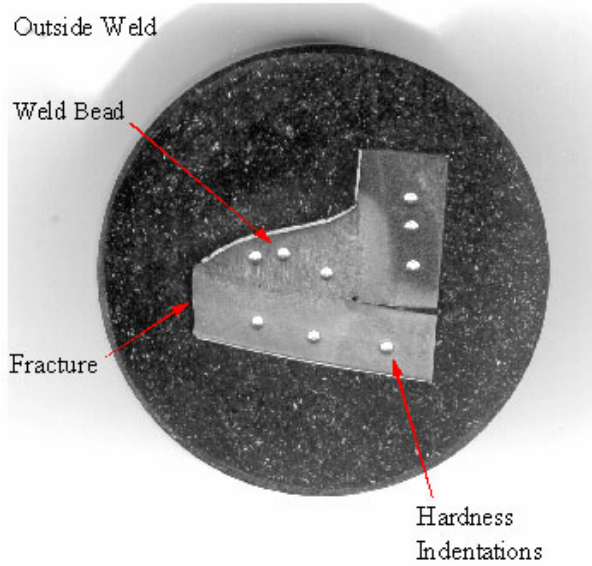
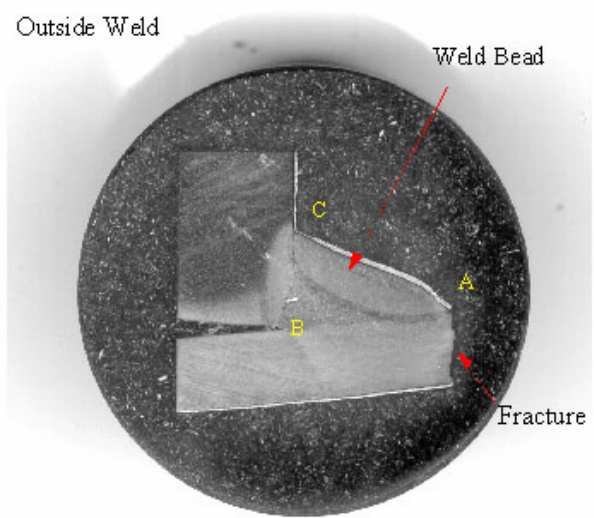
e Figure 2.5 Metallographic specimens examined, showing locations of photomicrographs

Four metallographic specimens were taken from a variety of locations in the mast arm assembly shown in Figure 2.2. Specifically, two specimens were cut from the outside weld in cracked and uncracked regions, which are respectively designated “CT” and “ET”. The other two specimens were cut from the inside weld in cracked and uncracked regions, respectively denoted as “BC” and “BE”. The metallographic sections were polished to remove any oxidation and were then etched using 2% Nital (2ml HNO₃, 98 ml CH₃OH). The resulting sections are shown in Figure 2.5.

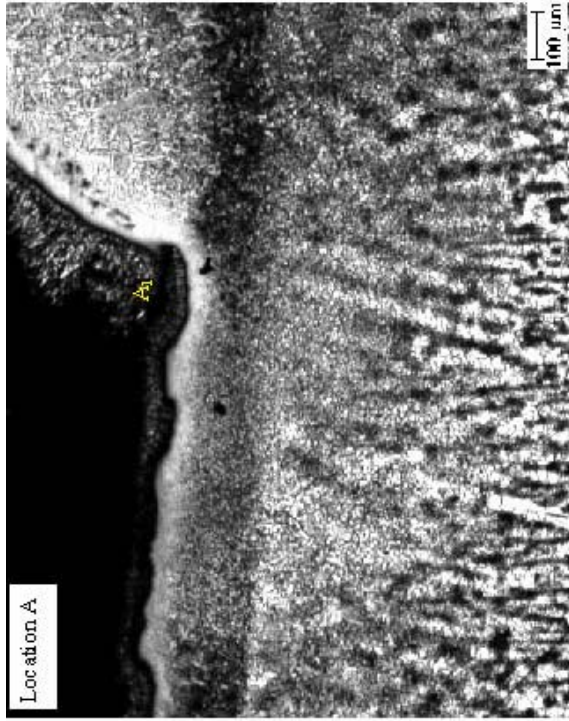
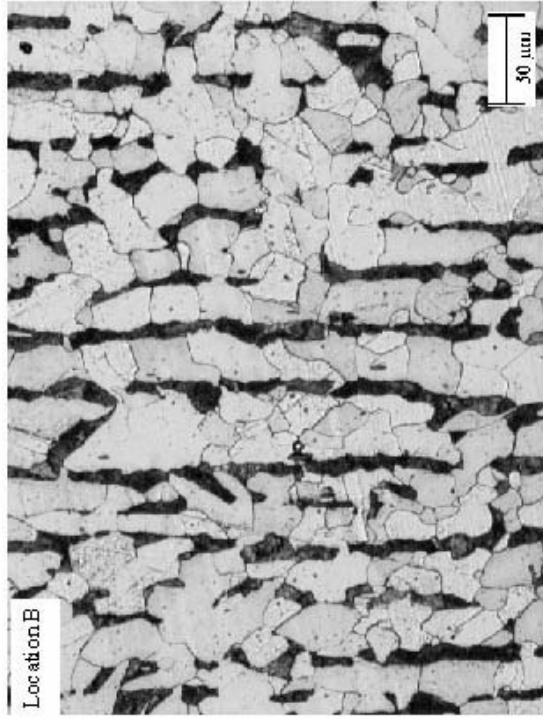
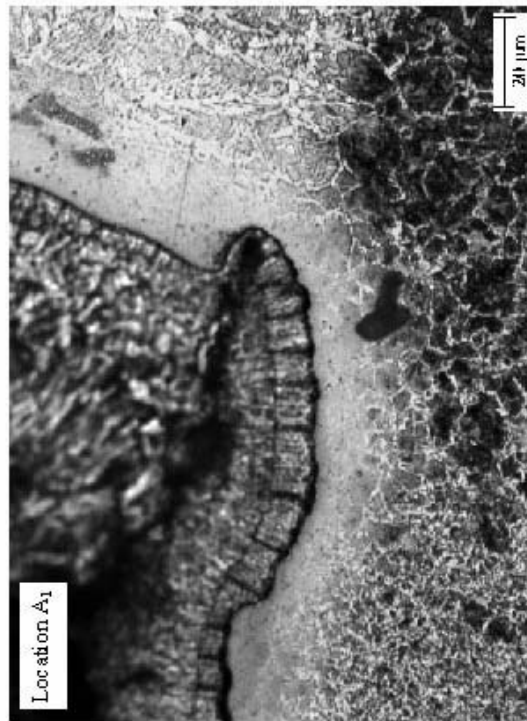
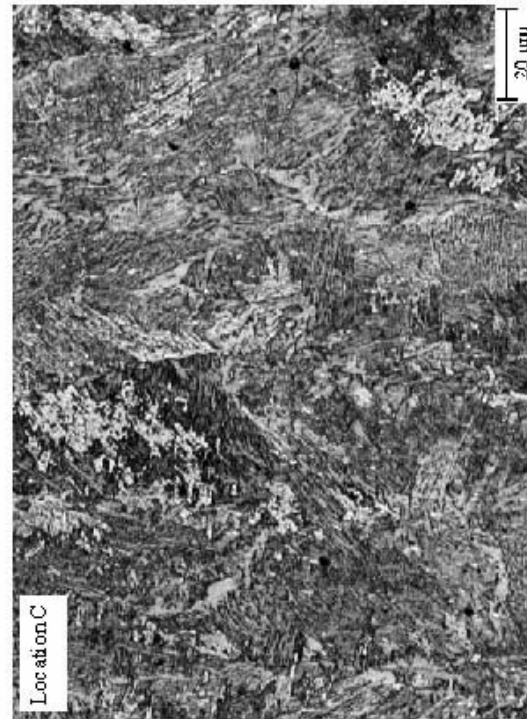
Figure 2.6 Selected photomicrographs from Specimen BC

Examination of these sections showed a lack of fusion in any of the metallographic sections. There is no evidence of any weld preparation. On the inside welds, the weld bead in Figures 2.6 and 2.7 showed a typical microstructure of acicular ferrite. The heat affected zone (HAZ) showed evidence of banded spheroidized pearlite. The base material was also banded, and exhibited distinct regions of very fine pearlite. This structure is not unusual for A36 steel that has been hot rolled. The radius at the toe of the weld is sharp. A sharp undercut of the weld is also evident. The undercut is approximately 50 to 100 μ m deep, and 200 μ m wide. This is a very sharp notch, and occurs where the base material is the softest, and least resistant to fatigue.

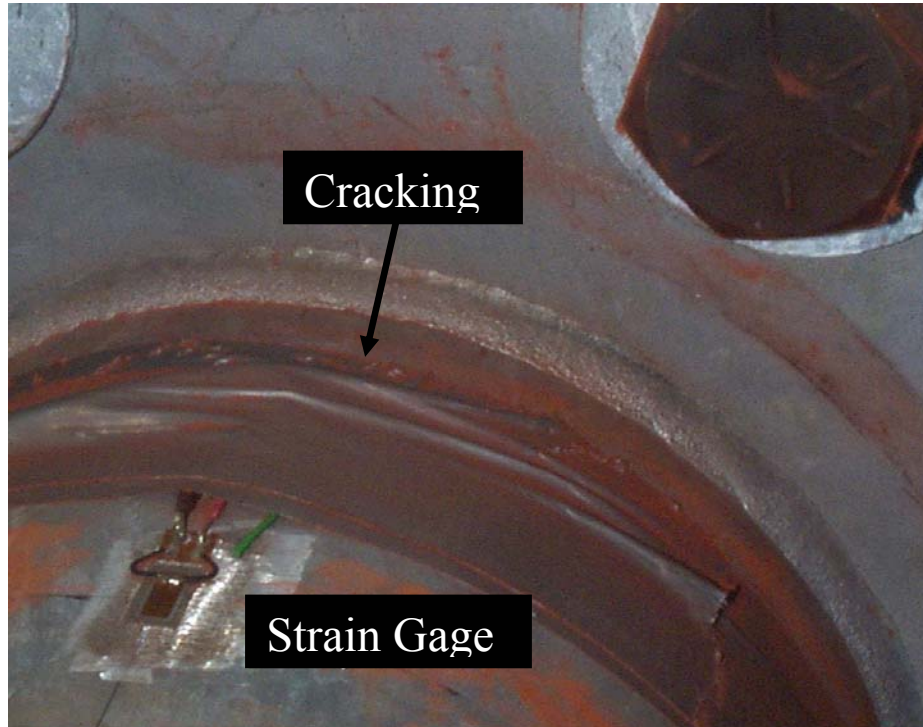
Figure 2.12 Valmont Mast Arm 254682 Cracking and Strain Gage
