VARIABILITY OF THE HORIZONTAL -TO-VERTICAL
SPECTRAL RATIO (HVSR) METHOD IN URBAN AREAS

A Thesis

In Partial Fulfillment
of the Requirements for the Degree
Master of Science in Civil Engineering

Braydon Smith

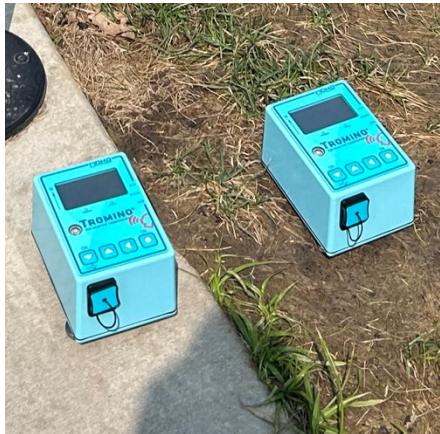
Figure 7: Tromino device used in data acquisition. Image of Tromino devices acquiring data on concrete and grass simultaneously at MIZ Quad Site 4.

HVSR measurements were recorded using a Tromino device produced by MoHo S.R.L. The Tromino is a compact device measuring 10 x 14 x 8 cm and weighing 1.1 kg (Figure 7), with an internal memory storage system. The internal system allows the Tromino to collect and store ambient noise data wirelessly, eliminating the need for external power or storage. These features make the Tromino highly portable, allowing a single operator to gather a substantial amount of data in a relatively short time.

The instrument is equipped with three orthogonal electrodynamic velocimeters and three orthogonal digital accelerometers, enabling it to record both ambient and induced vibrations. To acquire ambient noise data for this study, the Tromino was positioned on the

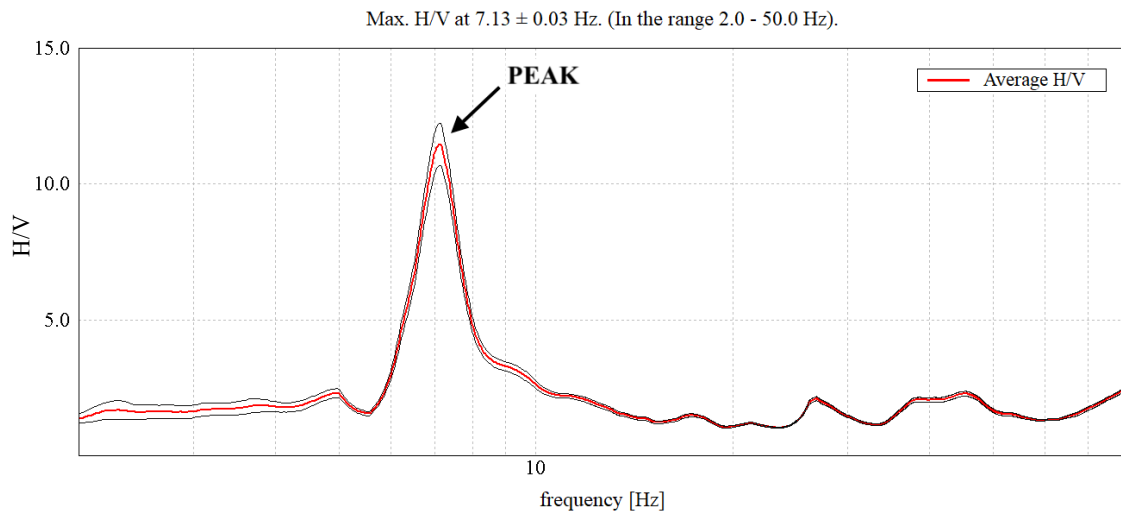
Figure 13: HVSR_{Res} example from MIZ MiddleQuad Test 5 on Grass

In some cases, the natural HVSR_{Res} can be clearly observed, as shown in Figure 13. The peak was chosen at the maximum value observed in the HVSR plot that is within the range of analysis (2 - 50 Hz). When the HVSR produced a clear HVSR_{Res}, the HVSR peak indicates that a change occurred in the subsurface stratum. In most cases, the HVSR_{Res} indicates that a "hard" layer, such as rock, was encountered. The single peak in the HVSR plot can be correlated with the "eye-shape" seen in the amplitude spectra plot (Figure 14) which typically indicates that the peak was produced by stratigraphic origin (Castellaro and Mulargia, 2009). The "eye-shape" in the amplitude spectra plot occurs when the vertical amplitude spectra drop off while the horizontal spectra remain constant or increases.

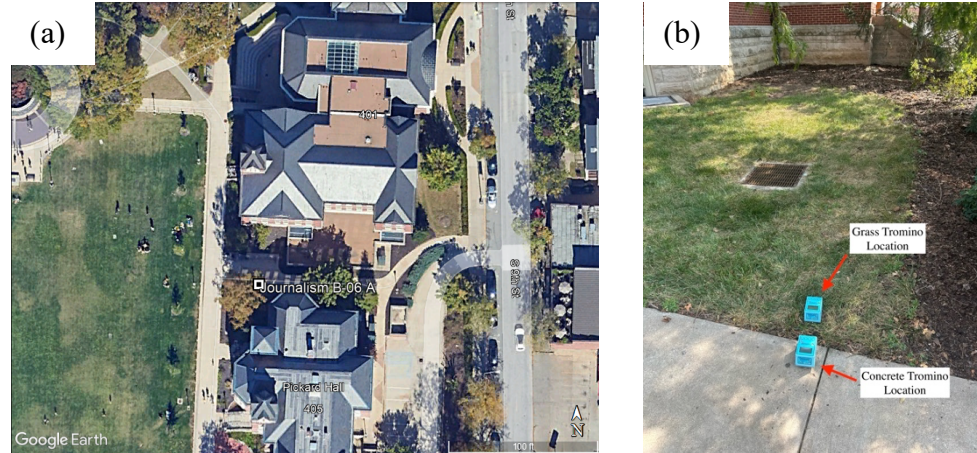
Figure 23: (a) An aerial photo of Journalism BH-06 A site location, and (b) is a photo of the Tromino set up before data acquisition.

Twelve data acquisitions conducted at Journalism B-06 A were used to examine HVSR variability due to different instrumentation coupling conditions (concrete versus grass), proximity to a building (near versus far), time of day building influence (occupancy status), proximity to strong construction noise (near versus far). It was also used in an attempt to replicate variability presented by Chi (2022). This site was chosen because the Tromino sensors could be used on concrete and grass simultaneously, ensuring that the same wavefield was recorded during data acquisition. The Journalism B-06 A site was located 15 ft (4.6 m) from the nearest building, Pickard Hall, and approximately 432 ft (132 m) from an active construction site. The construction site included an excavation, heavy machinery (e.g., excavator, forklift), and generators. Chi (2022) observed variability of the maximum peak frequency of approximately 18%. The coordinates of Journalism B-06 A are found in Table 3 and can be observed in Figure 23, along with an image of test set up. Boring logs from this site indicate 15 ft (4.6 m) layer of clay underlain by a 4 ft (1.2 m) layer of sand and an 8 ft (2.4 m) layer of clay. Shale was first encountered at a depth of 27 ft (8.2 m) and limestone was encountered at 43 ft (13.1 m) below the ground surface.

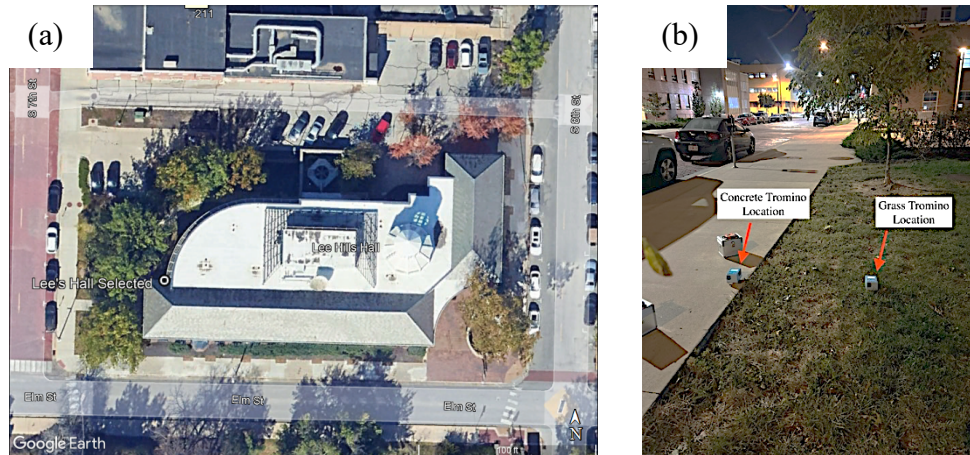
Figure 25: (a) An aerial photo of Lee's Hall BH-08 site location, and (b) is a photo of the Tromino set up before data acquisition.

Eight data acquisitions conducted at Lee's Hall BH-08 were used to examine HVSR variability due to different instrumentation coupling conditions (concrete versus grass) and used in an attempt to replicate variability presented by Chi (2022). This site was chosen because the Tromino sensors could be used on concrete and grass simultaneously, ensuring that the same wavefield was recorded during data acquisition. Chi (2022) observed variability of the maximum peak frequency of approximately 17%. The Lee's Hall BH-08 site was located approximately 45 ft (13.7 m) from the Lee's Hall structure, 4 ft (1.2 m) from a sidewalk, and 10 ft (3 m) from a roadway. Wavefields were variable at this location due to fluctuating vehicle and foot traffic which was related to the time of day. The coordinates of Lee's Hall BH-08 are found in Table 3 and can be observed in Figure 25 along with an image of test set up. Boring logs from this site indicate an 8 ft (2.4 m) layer of clay, with weathered shale first encountered at a depth of 8 ft (2.4 m). This was followed by thin layers of weathered shale and weathered limestone, with auger refusal in limestone at a depth of 16.7 feet (5.1 m) below the ground surface.

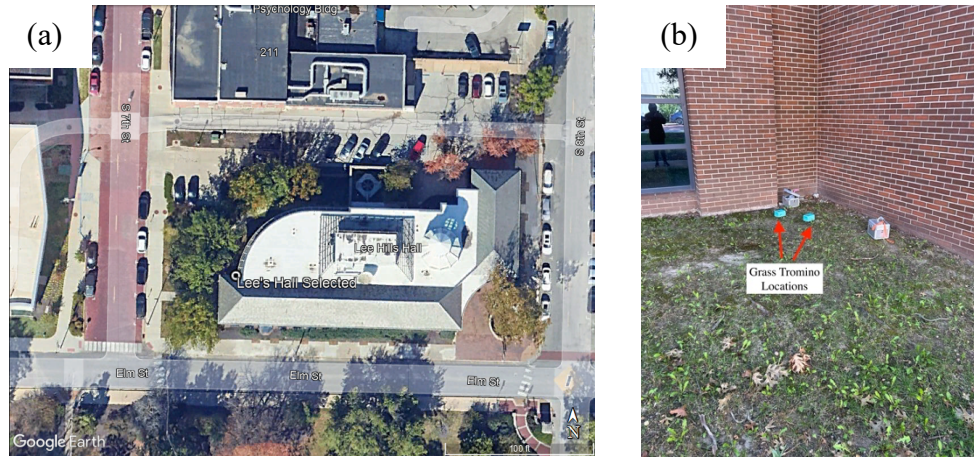
Figure 27: (a) An aerial photo of Lee's Hall Selected site location, and (b) is a photo of the Tromino set up before data acquisition.

Five data acquisitions conducted at Lee's Hall Selected were used to examine HVSR variability due to the proximity to a building (near to far) and time of day building influence (occupancy status). The Lee's Hall Selected site was approximately 3 ft (0.9 m) away from the southwest corner of the Lee's Hall structure. Data acquisition at Lee's Hall Selected was conducted exclusively on grass, due to the absence of concrete. The coordinates of Lee's Hall Selected are found in Table 3 and can be observed in Figure 27, along with an image of test set up. Boring logs were not available for this selected site.

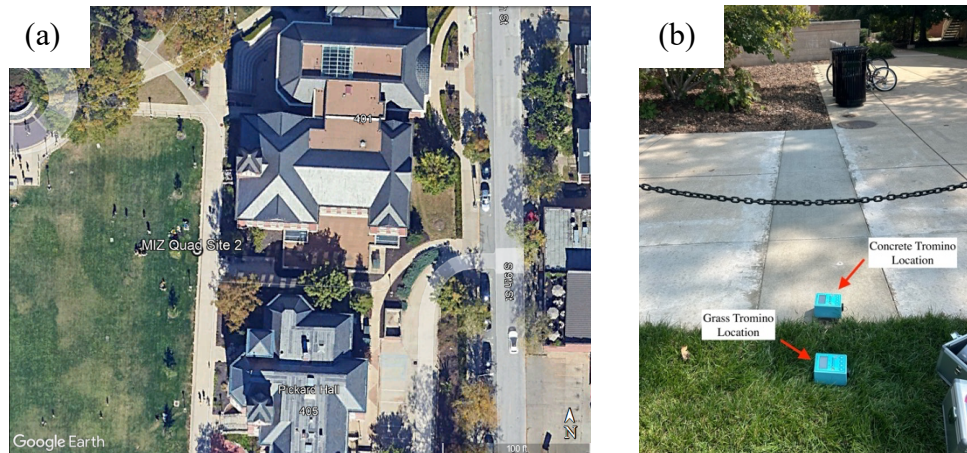
Figure 29: (a) An aerial photo of MIZ Quad Site 2 site location, and (b) is a photo of the Tromino set up before data acquisition.

Four data acquisitions conducted at MIZ Quad Site 2 were used to examine HVSR variability due to different instrumentation coupling conditions (concrete versus grass). This site was chosen because the Tromino sensors could be used on concrete and grass simultaneously, ensuring that the same wavefield was recorded during data acquisition. The MIZ Quad Site 2 was located 30 ft (9.1 m) from the Reynolds Journalism structure. The coordinates of MIZ Quad Site 2 are found in Table 3 and can be observed in Figure 29, along with an image of test set up. Boring logs were not available for this selected site.

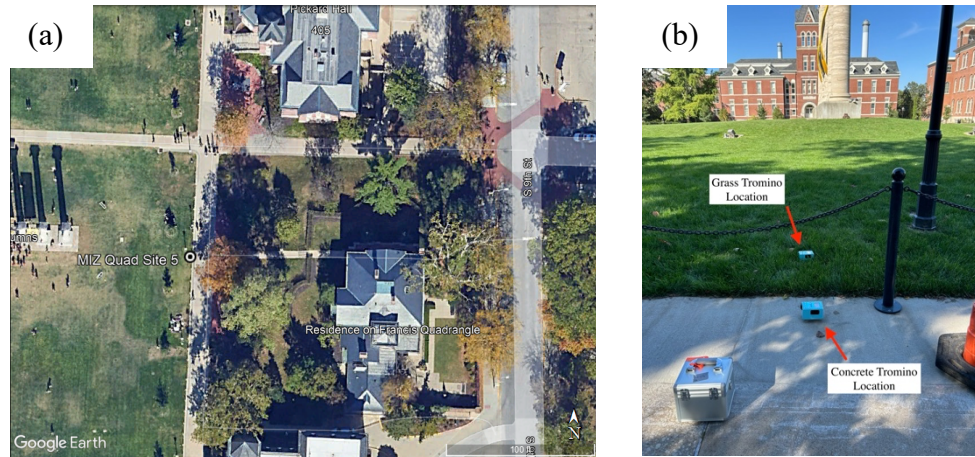
Figure 32: (a) An aerial photo of MIZ Quad Site 5 site location, and (b) is a photo of the Tromino set up before data acquisition.

Six data acquisitions conducted at MIZ Quad Site 5 were used to examine HVSR variability due to different instrumentation coupling conditions (concrete versus grass) and proximity to strong construction noise (near versus far). This site was chosen because the Tromino sensors could be used on concrete and grass simultaneously, ensuring that the same wavefield was recorded during data acquisition. The MIZ Quad Site 5 was located 100 ft (30.5 m) from the Residence on Francis Quadrangle, and approximately 225 ft (68.6 m) from an active construction site. The construction site included an excavation, heavy machinery (e.g., excavator, forklift), and generators. The coordinates of MIZ Quad Site 5 are found in Table 3 and can be observed in Figure 32, along with an image of test set up. Boring logs were not available for this selected site.

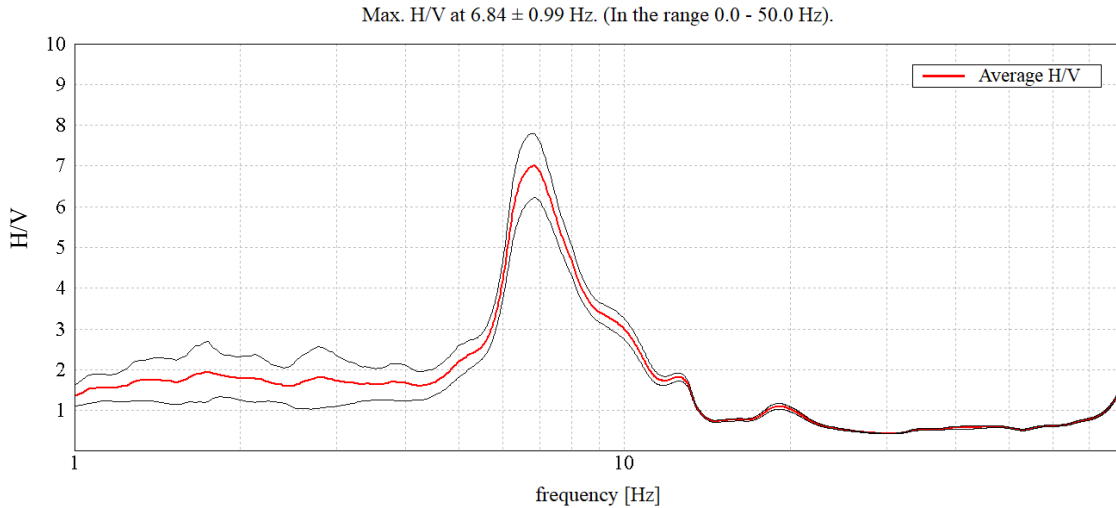
Figure 34: Example of HVSR data categorized as Category 1 (MIZ Quad Site 1, Test 6 on Concrete site).

Category 1 - High Quality: assigned to HVSR curves that had one clear, single peak with few (or no) secondary peaks that were far from the frequency of interest. Figure 34 shows an example of a Category 1 site.

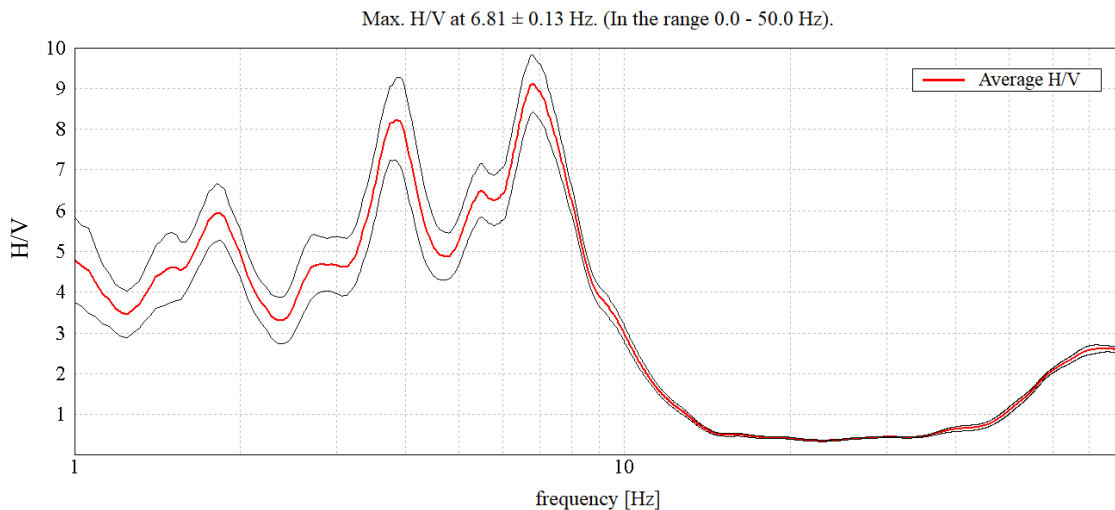
Figure 36: Example HVSR data categorized as Category 3 (MIZ Quad Site 1, Test 1 on Grass site).

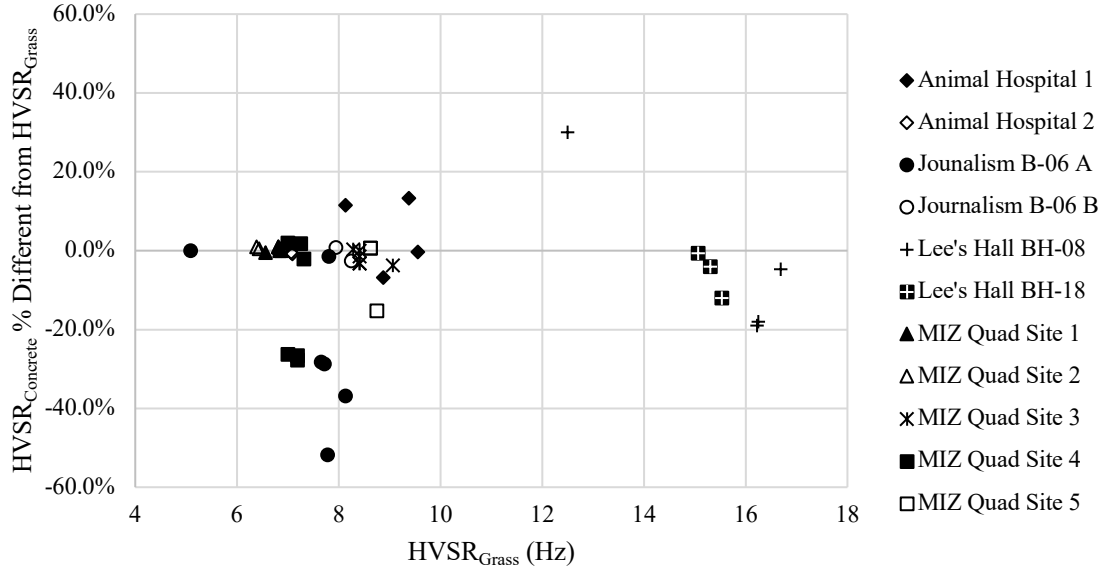
Figure 39: $HVSR_{Grass}$ versus percent difference of $HVSR_{Concrete}$ to $HVSR_{Grass}$.
