DYNAMIC CAPACITY OF
ISOLATED SLAB COLUMN SPECIMENS

A Thesis

at the University of Missouri-Columbia

MAY 2015

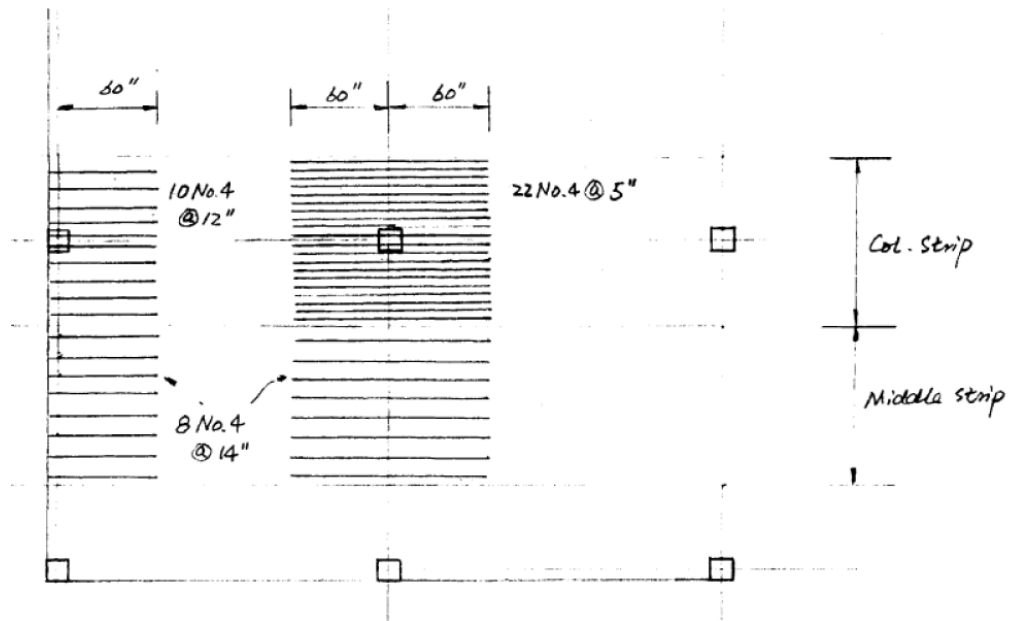
In a continuous framing system, large negative moments develop near the column and large positive moments are seen at the mid-span locations. Due to this moment distribution, the bottom slab reinforcing bars are not needed to resist the negative moments and are discontinuous through the column. Figures 3.1.2 and 3.1.3 provide sketched of the top and bottom reinforcing bar layouts, respectively. The bottom bar discontinuity seen in the prototype design is acceptable according to procedures in the ACI 1971 design code. If this structure were to be designed with a post 1971 ACI code, the slab bottom bars would need to be continuous through the column to provide structural integrity reinforcement.

Figure 3.1.2 – Initial sketch of top reinforcement in the prototype structure

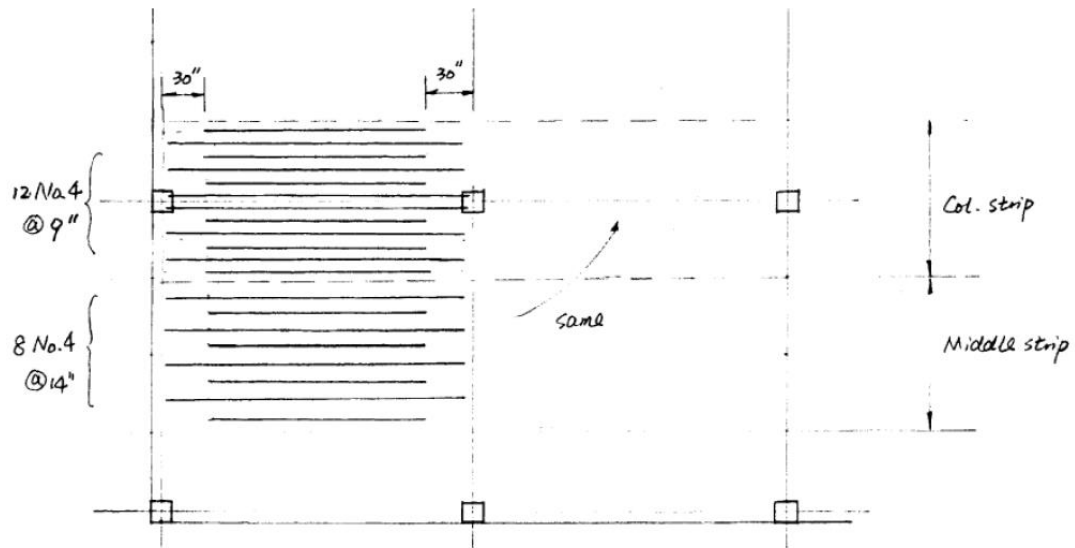
Figure 3.1.3 – Initial sketch of bottom reinforcement in the prototype structure

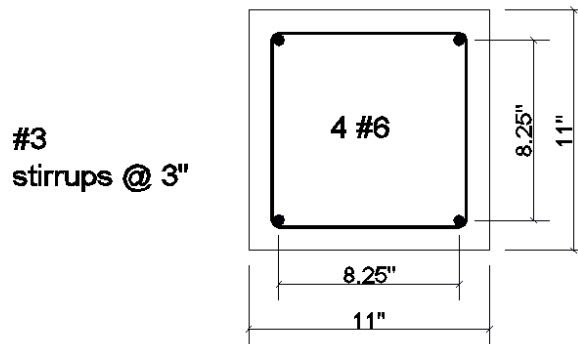
Figure 3.2.7 – Cross section view of column section

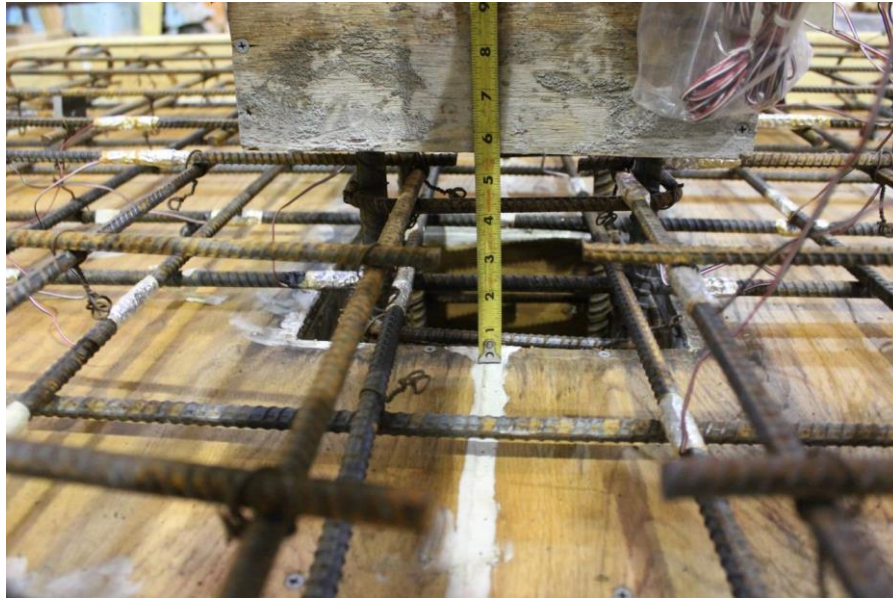
photo of the slab and column reinforcement, along with a final measurement ensuring proper slab depth can be seen in Figure 3.3.2.

Figure 3.3.2 – Picture of formwork with rebar placed and top column form in place

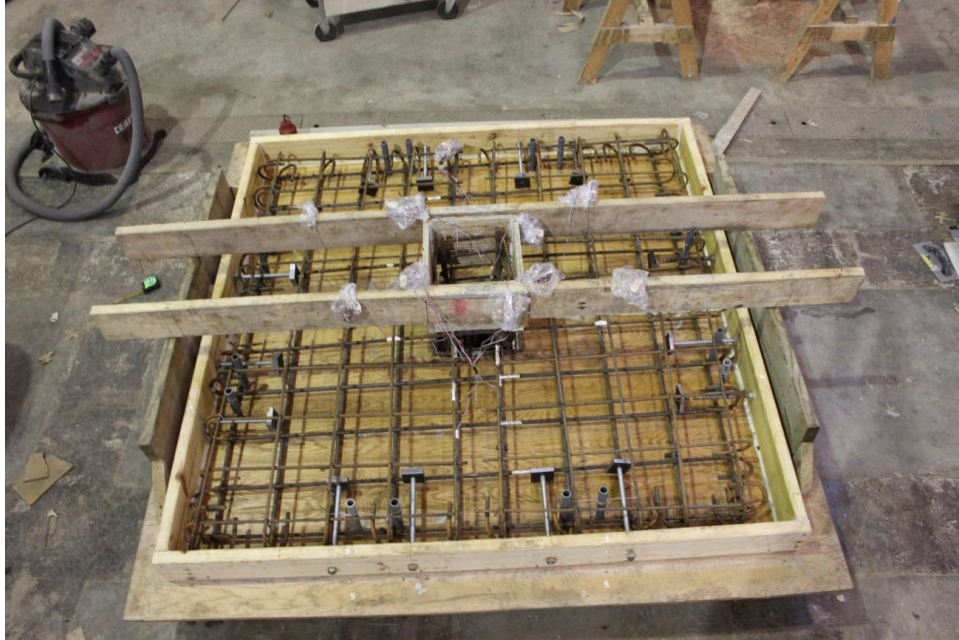
Once the slab reinforcement was in place and properly tied, the remaining vertical stirrups were installed and tied to the vertical reinforcement. The top column formwork could then be slid over the column reinforcement and final measurements were taken to ensure column alignment, slab thickness, and reinforcement spacing. The next step was to install the PVC pipes that had been previously cut to length. The PVC pipes were inserted vertically into the proper locations in the base of the formwork. Steel wire was used to secure the PVC pipes and free ends of the anchor rods to help keep them in place during the concrete pour. An example of completed formwork ready for concrete pour can be seen in Figure 3.3.3.

Figure 3.3.3 – Completed slab formwork prior to concrete pour

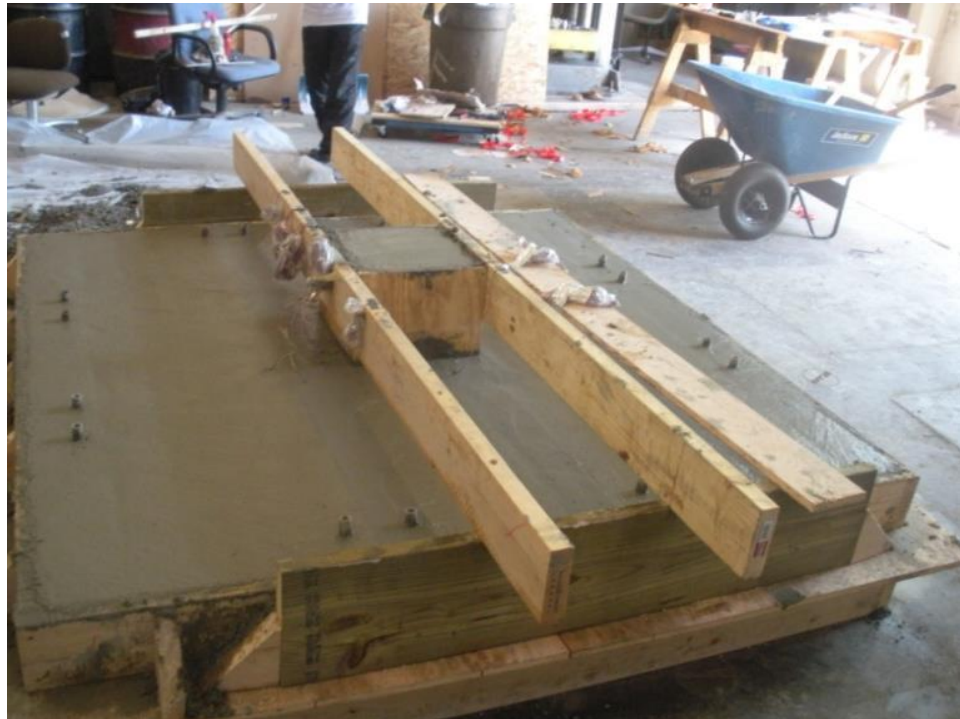
smoothed, dampened canvas or plastic sheets were placed over the top. These sheets helped prevent shrinkage of the slab by reducing evaporation; the slabs were monitored closely and kept hydrated for the first week of curing. A picture of a finished slab just after pouring can be seen in Figure 3.3.4.

Figure 3.3.4 – Slab after pouring and surface finishing was complete

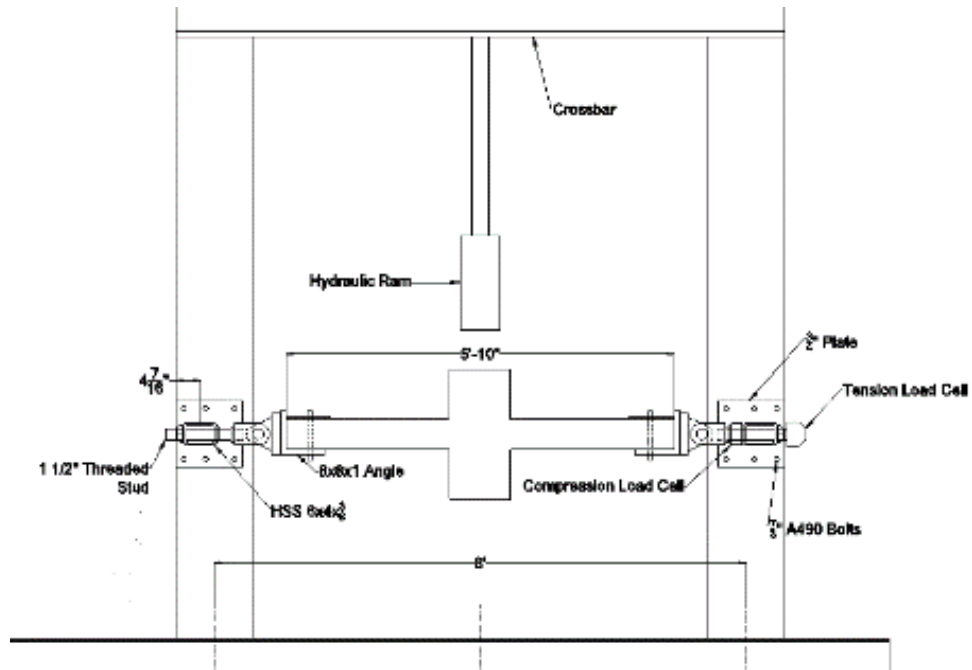
restrained test setup created in-plane forces, these forces resemble what would be seen in an actual flat plate structure. The use of dynamic loading also allowed us to take another step in replicating a progressive collapse scenario to replicate the accurate load rate. Figures 3.4.1 and 3.4.2 show 2D and 3D renderings of the test setup, respectively.

Figure 3.4.1 – 2D view of test setup with slab installed

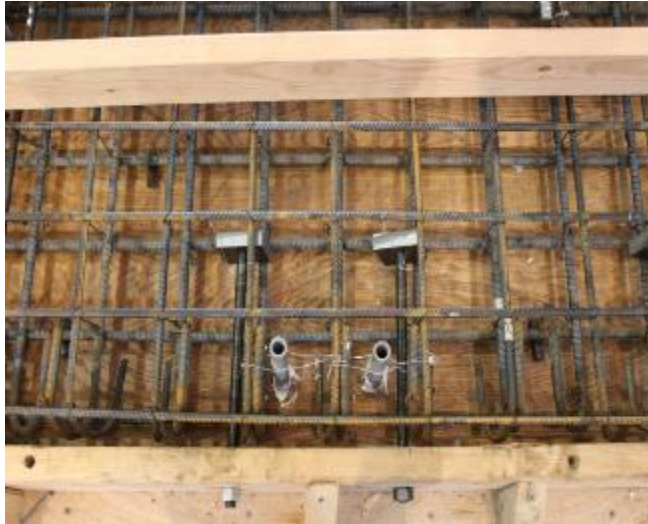
Figure 3.4.6 – Anchorage assembly and vertical PVC to be cast into slab

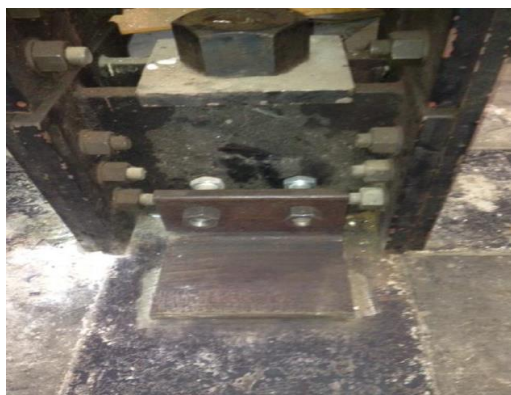
The goal of the test setup was to provide lateral restraint while vertically loading the slab. Although the large W sections seemed to provide the necessary lateral restraint, preliminary testing showed outward movement of the columns when testing specimens were loaded. To prevent movement of the columns, angles were welded to the lab floor at the base of the columns. Two bolts were threaded through the welded angle to rest against the base of the column and prevent the outward movement being observed. The angle and bolt setup can be seen in Figure 3.4.7.

Figure 3.4.7 – Angle stops welded at the base of each vertical column

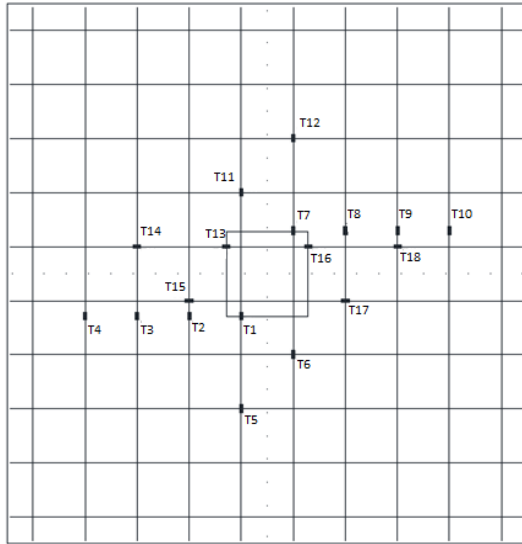
Figure 3.5.2 – Tension reinforcement strain gage layout for 0.64% reinforcement ratio

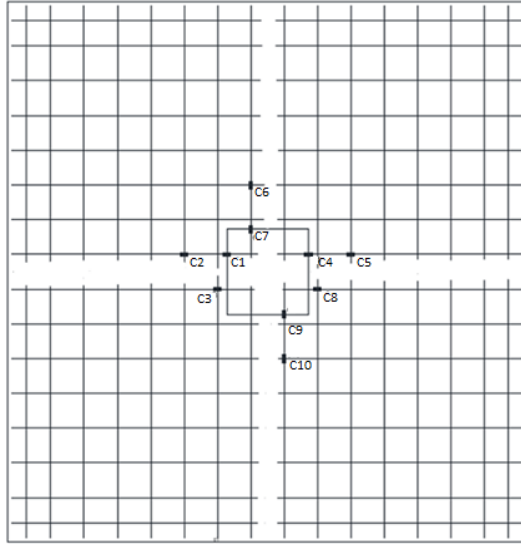
As previously mentioned, the layout for the 1.0% reinforcement ratio slabs had a slightly altered strain gage layout in comparison to the 0.64% reinforcement ratio slabs. The 1.0% reinforcement ratio slabs had 31 applied gages, 21 for the tension reinforcement and 10 applied to the compressive reinforcement. The gages were positioned to gather data from the same general locations, but a higher reinforcement ratio led to more reinforcing bar available for applying gages. The compressive and tensile strain gage layout for the 1.0% reinforcement ratio test specimens can be found in Figures 3.5.3 and 3.5.4, respectively.

Figure 3.5.3 - Compression reinforcement strain gage layout for 1.0% reinforcement ratio

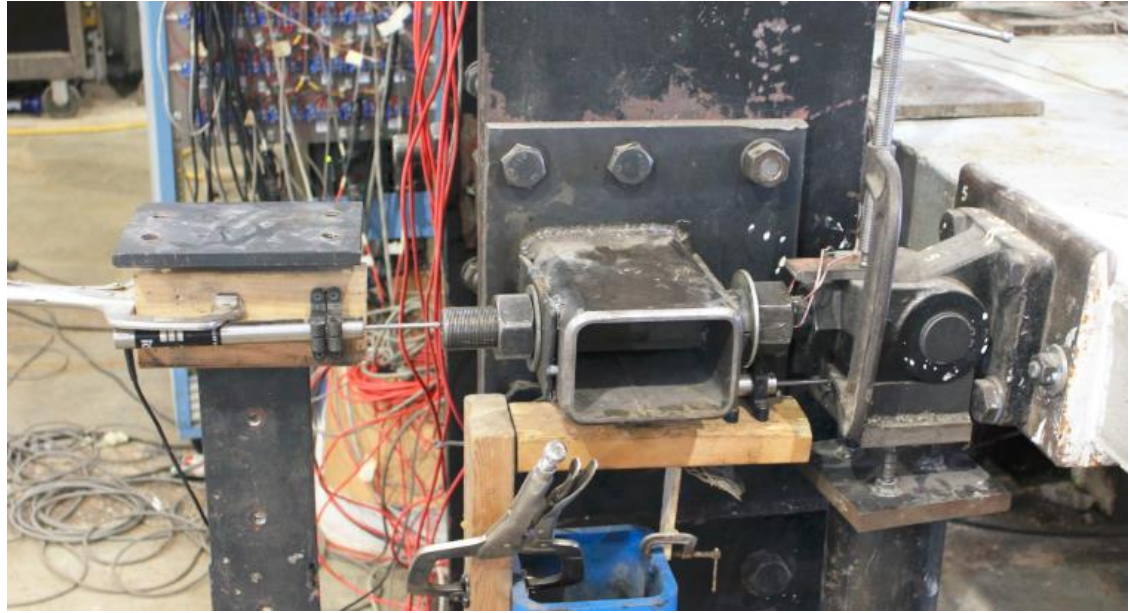
Figure 3.5.6 – lateral LVDTs placed against threaded rod and beneath pin connection

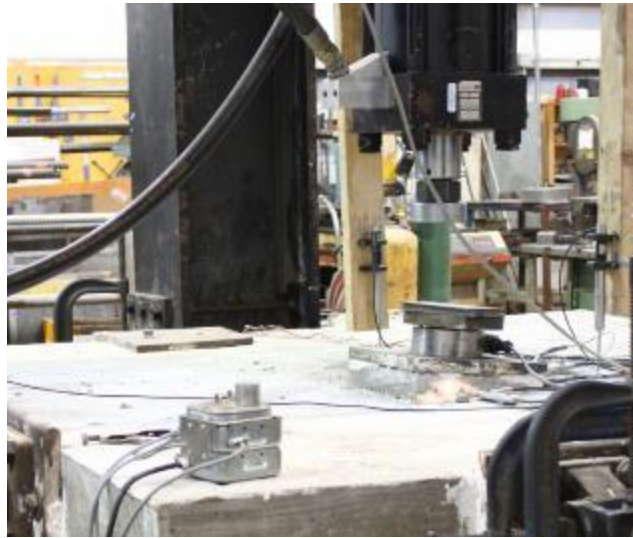
Figure 3.5.8 – Dynamically loaded test specimen after failure has occurred

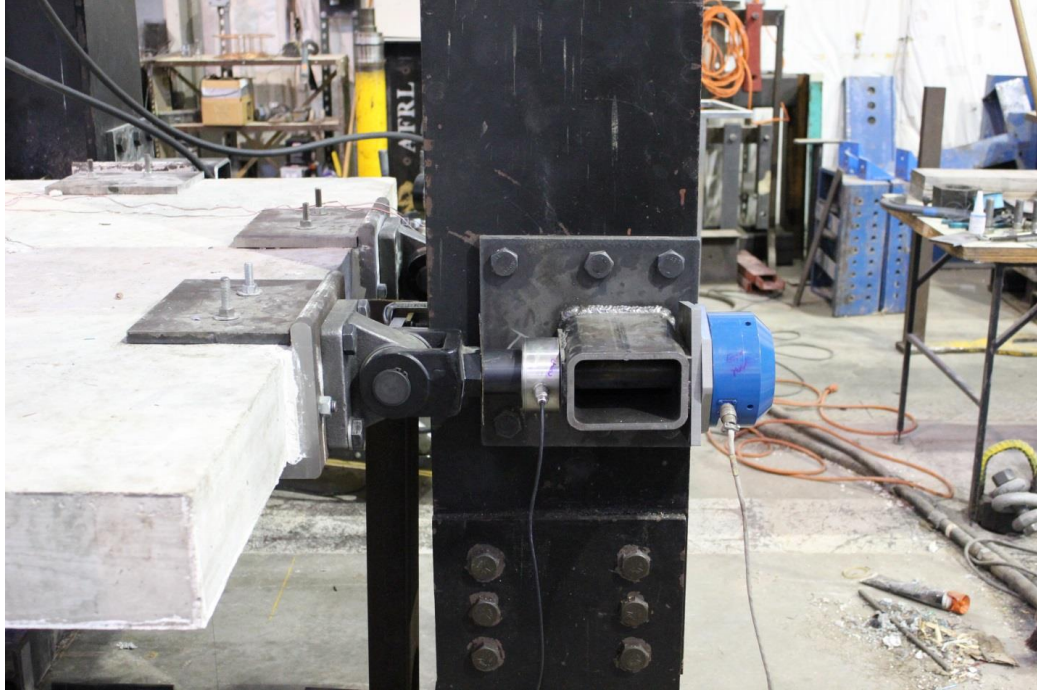
Two additional compression and two tension load cells were also used to measure the in-plane lateral forces for the restrained tests. The load cells were utilized by attaching them to the 1.5 inch threaded rods extending from clevis in the support assembly. The location of the compression and tension load cells in the test assembly can be seen in Figure 3.5.9.

Figure 3.5.9 – Location of tension (blue) and compression (silver) load cells to measure lateral forces

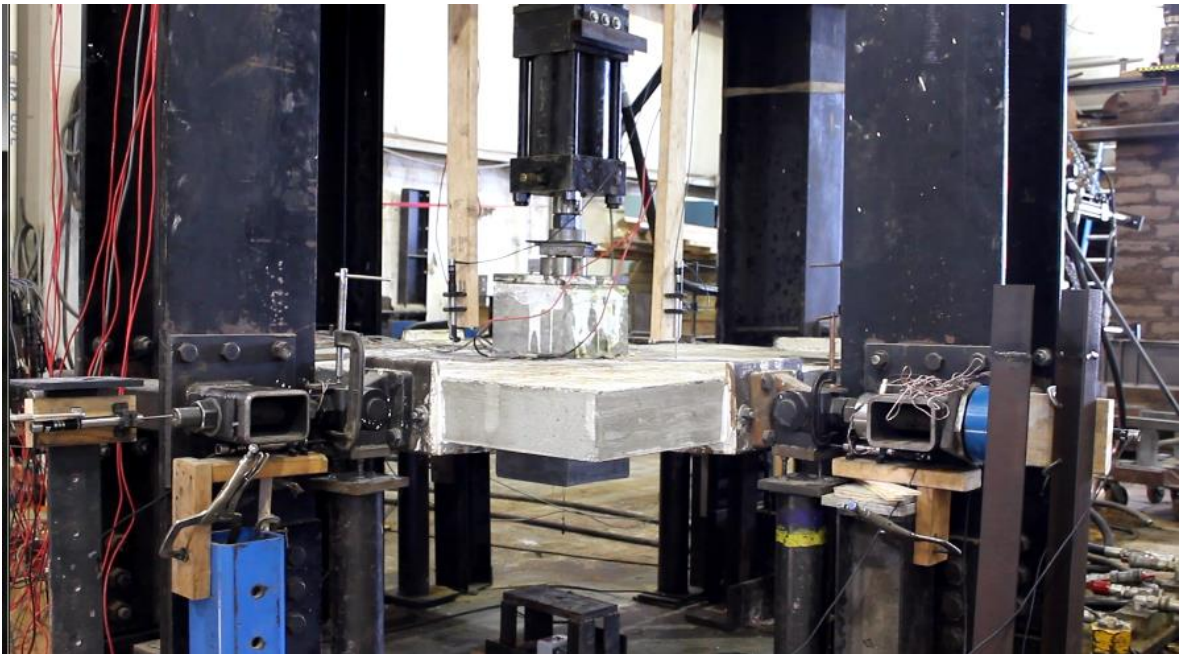
Following this will be a discussion and presentation of results between different tests; this will include data from each of the dynamic tests as well as data from previous static tests. Comparisons were made between tests with similar parameters, such as loading rate, reinforcement ratio, lateral restraint and measured concrete strength. A photo of a slab column specimen just prior to dynamic load testing can be seen in Figure 4.1.

Figure 4.1 – Overall view of test setup and slab specimen

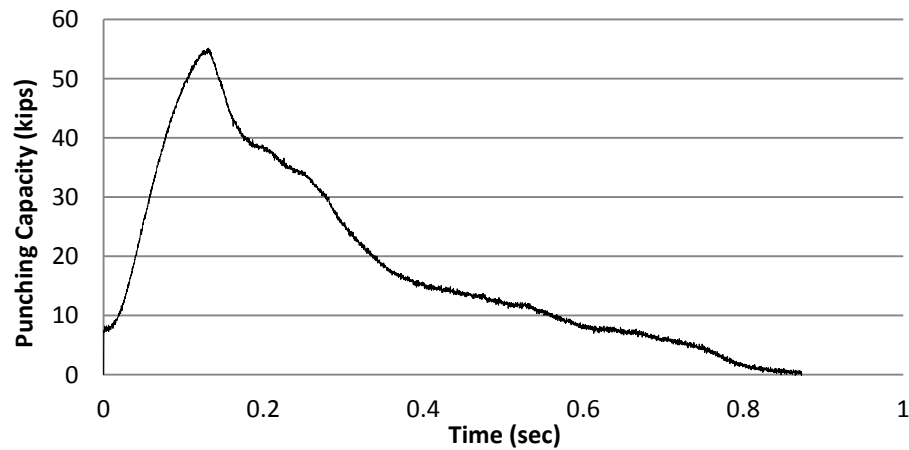
One full second after the initial loading, the slab reached zero capacity at a center column deflection of 7.5 inches. The load response of the slab specimen vs. the time can be seen in Figure 4.1.1. After punching occurs in the slab column specimen, the load capacity of the connection steadily decreases with increased deflection.

Figure 4.1.1 – Punching capacity vs. time for Dynamic 1 test

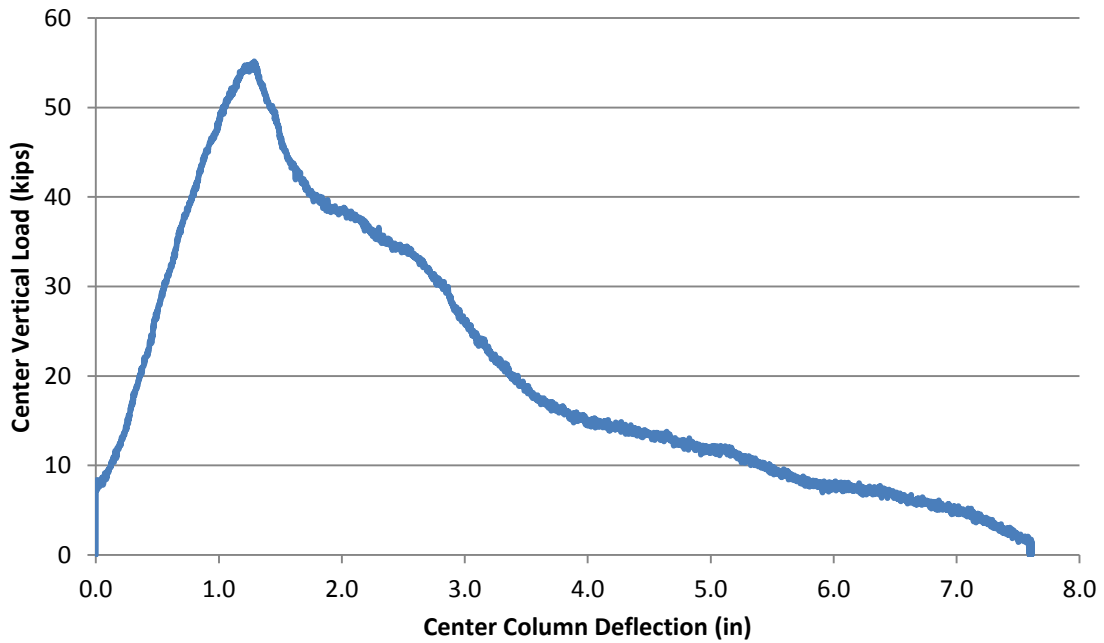
Unfortunately an error in the data acquisition system caused a delay in the reading of the load data. This delay was present on all tests. The delay caused a change in shape of the load deflection graph, but not a change in the peak load. Two additional tests will be conducted to determine the effect of the delay. Therefore, this thesis will focus on the only on the peak value of the load and the measured strain and displacement data.

Figure 4.1.2 – Vertical load vs. center column displacement for Dynamic 1 test

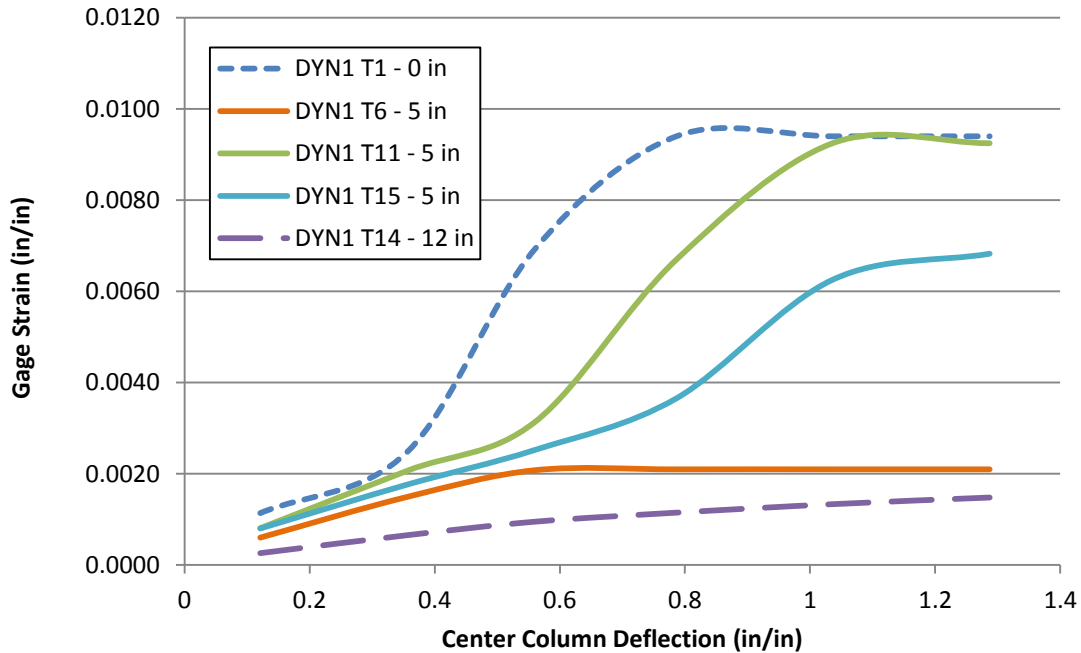
The profile in the given plot focuses on the region prior to punching failure; this provides a more in-depth analysis of the strain gage behavior.

Figure 4.1.5 – 0.64% Dynamic 1 tension gages vs. column displacement pre-punching

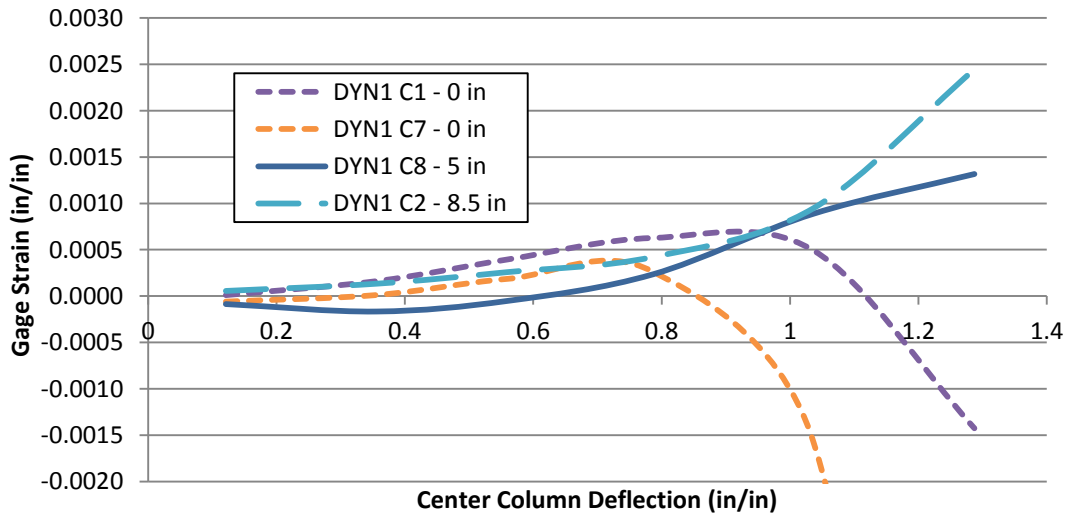
The Dynamic 1 test included five strain gages applied to the compressive reinforcement. The plot of center column displacement vs. compression gage strains can be seen in Figure 4.1.6. This plot also displays the behavior of each strain gage up until punching failure occurred.

Figure 4.1.6 – 0.64% Dynamic 1 compression gages vs. column displacement pre-punching

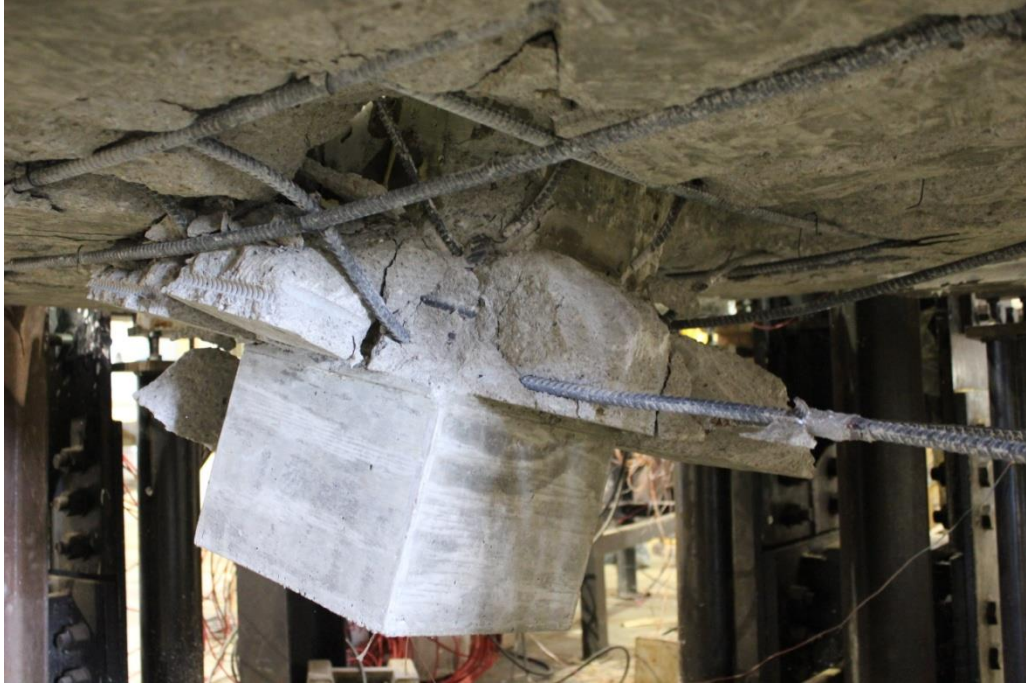
Figure 4.1.7 – Dynamic test 1 after failure of the connection

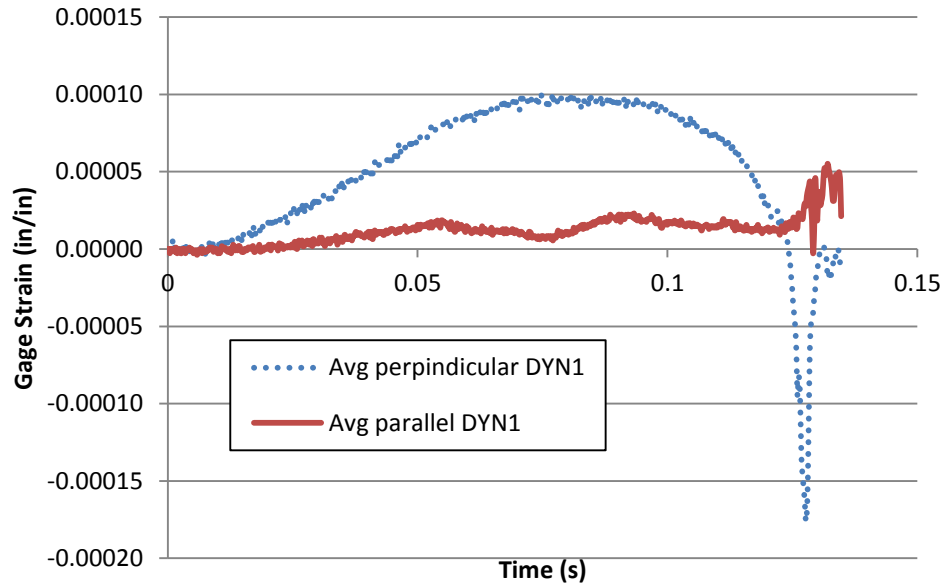
Figure 4.1.8 - Concrete strain parallel and perpendicular vs. time

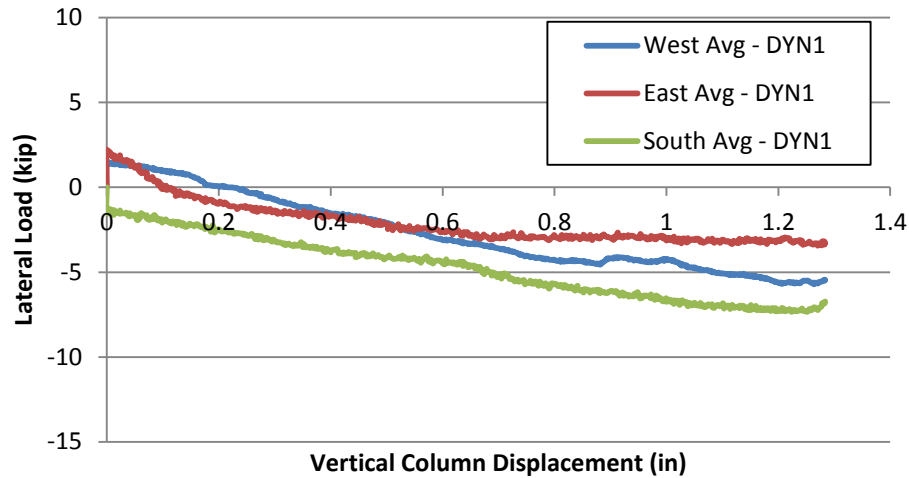
Figure 4.1.9 – Lateral load measured from threaded rod restraints

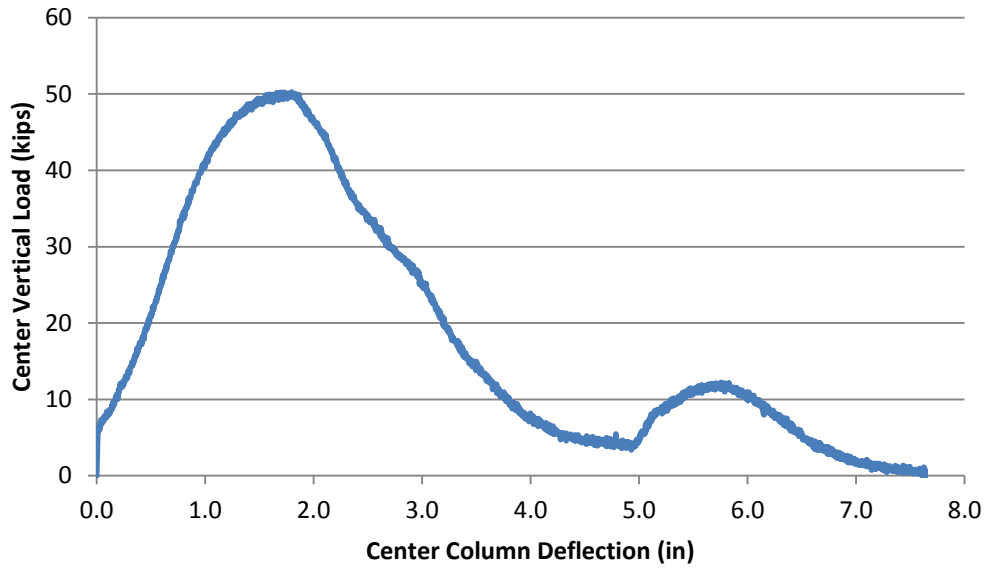
Figure 4.2.1 – Vertical load vs center column displacement for Dynamic 2 test

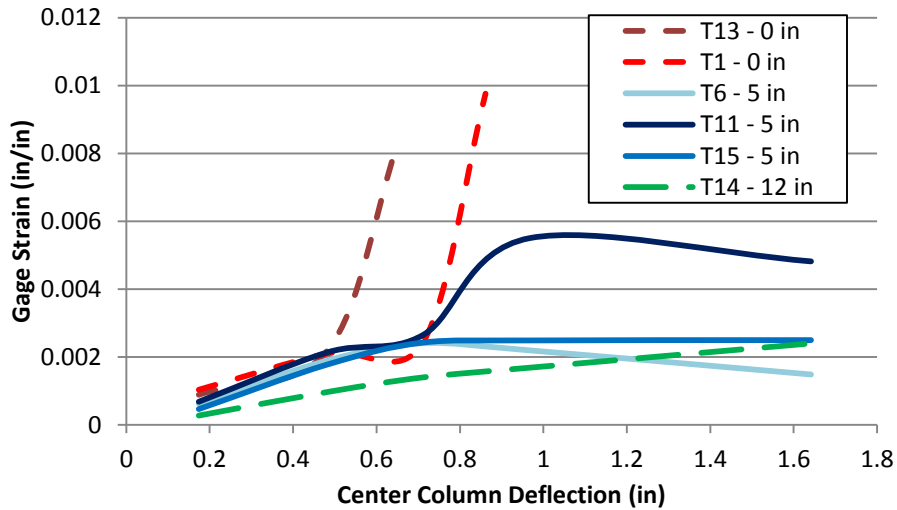
Figure 4.2.3 - 0.64% Dynamic 2 tension gages vs. column displacement pre-punching

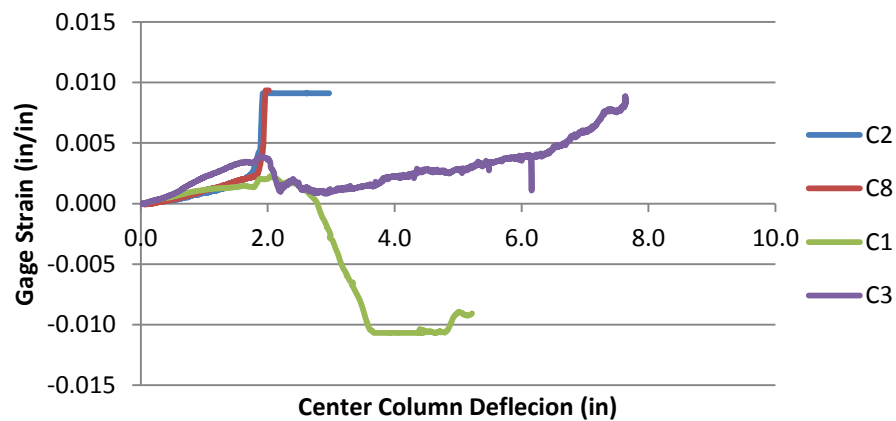
Figure 4.2.4 - Compression gage strain vs center deflection for Dynamic 2 test

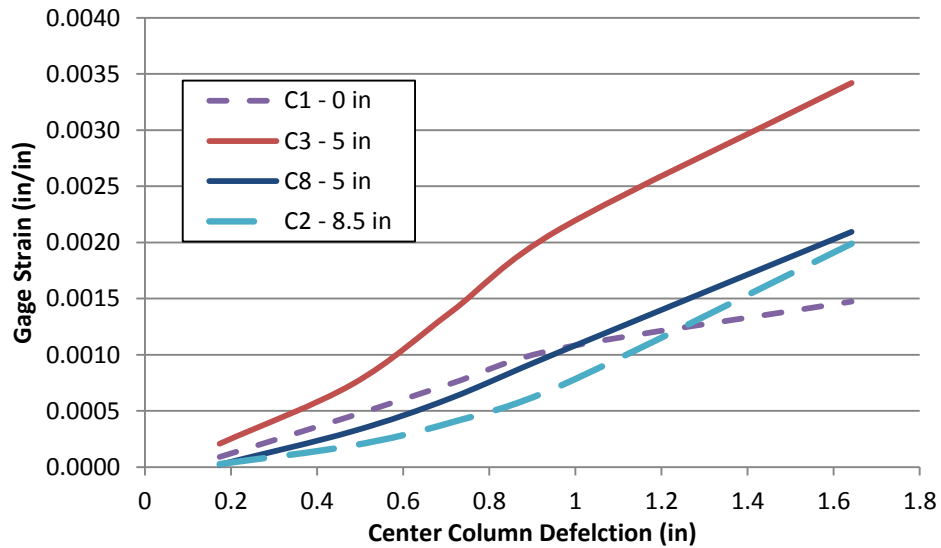
Figure 4.2.5 - 0.64% Dynamic 2 compression gages vs. column displacement pre-punching

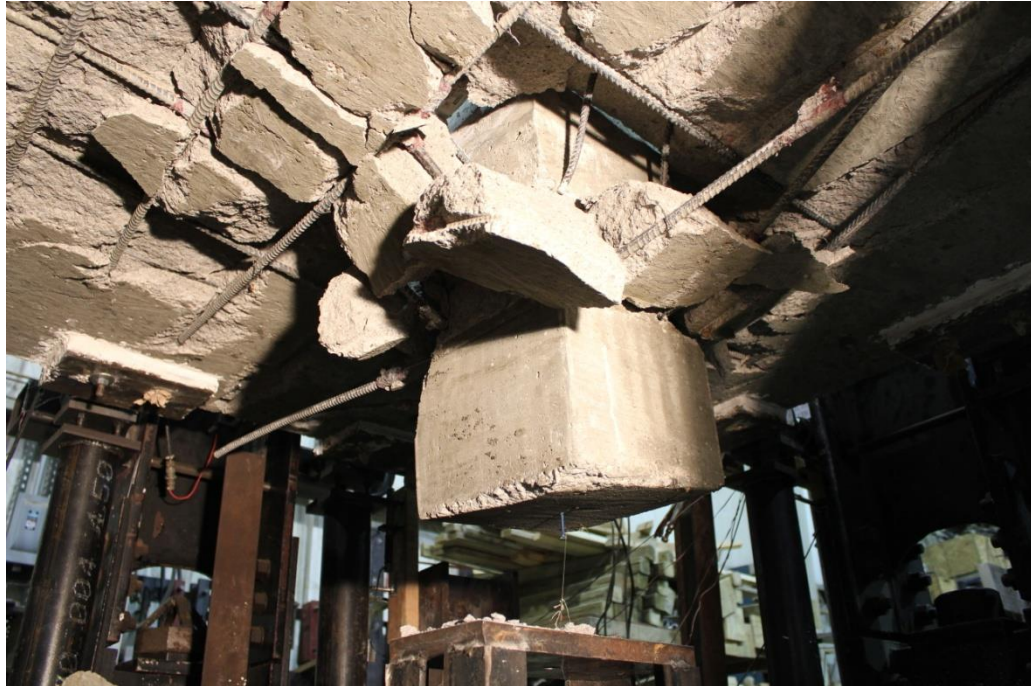
A picture of the failure region after the test completed can be seen in Figure 4.2.6.

Figure 4.2.6 – Failed Dynamic 2 specimen

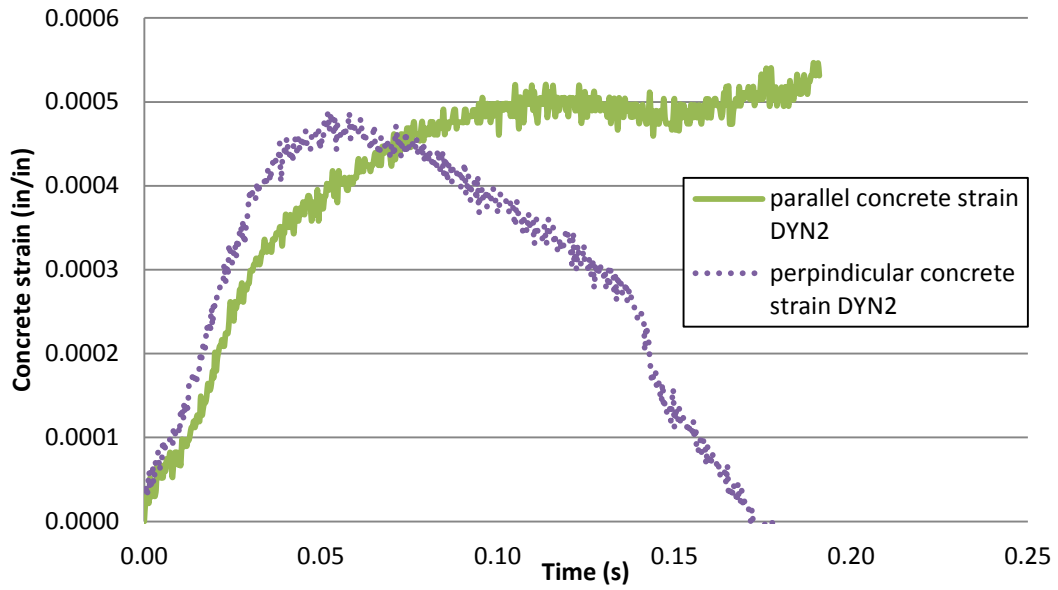
Figure 4.2.7 – Concrete parallel and perpendicular vs. time for Dynamic 2 test

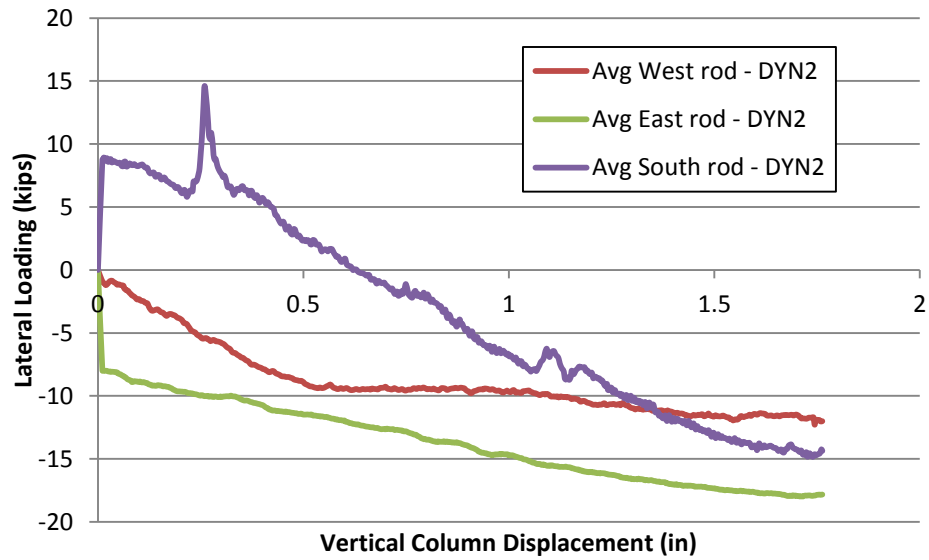
Figure 4.2.8 – Lateral load measured from threaded rod restraints

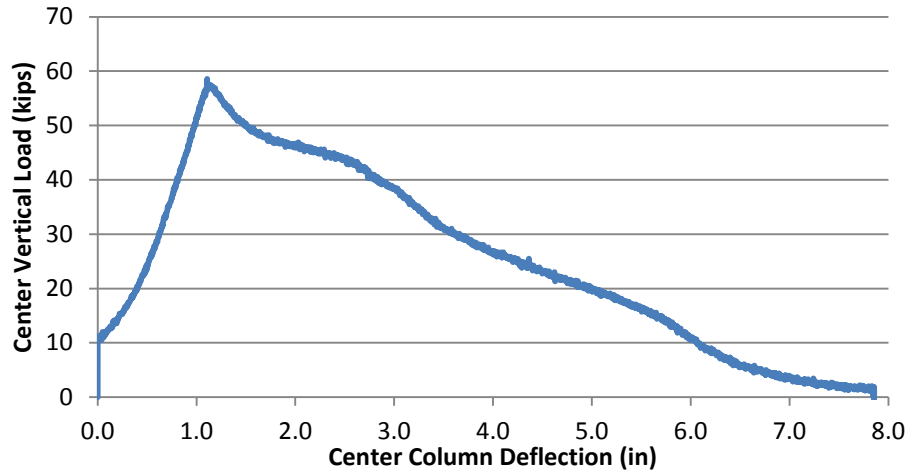
Figure 4.3.1 – Vertical load vs. center column displacement for Dynamic 3 test

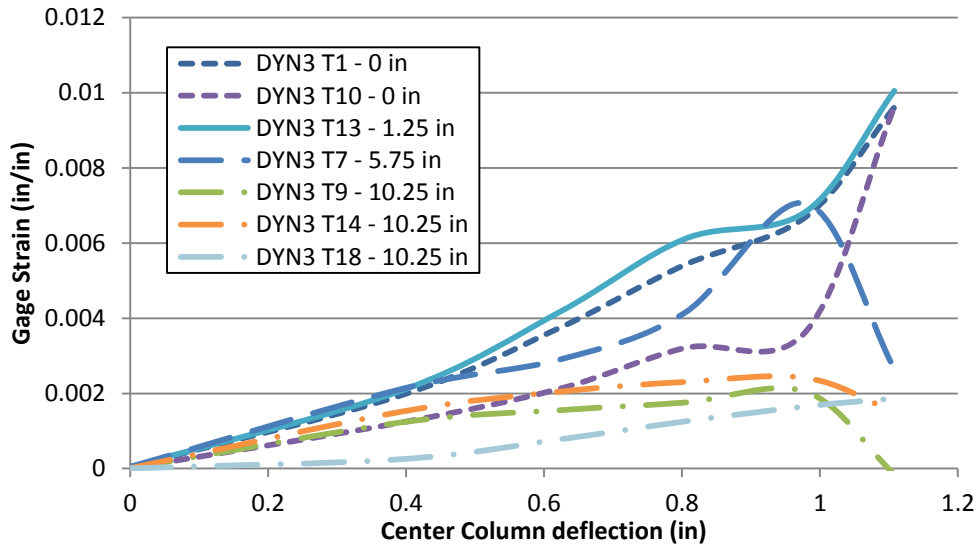
Figure 4.3.3 – 1.0% Dynamic 3 tension gages vs center column deflection pre-punching

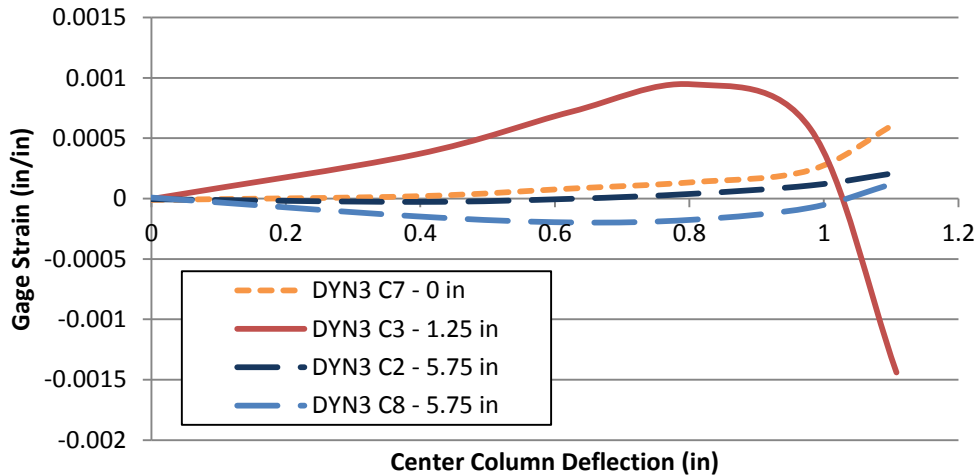
inches. The strain gage values up until punching failure occurred can be seen in Figure 4.3.5.

Figure 4.3.5 – 1.0% Dynamic 3 compression gages vs. column displacement pre-punching

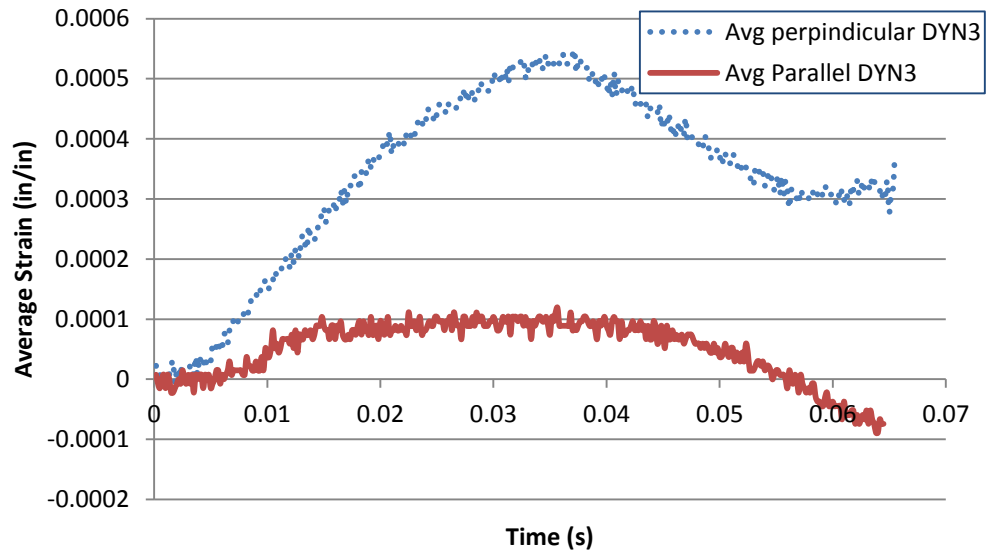
Figure 4.3.6 – Concrete parallel and perpendicular vs. time

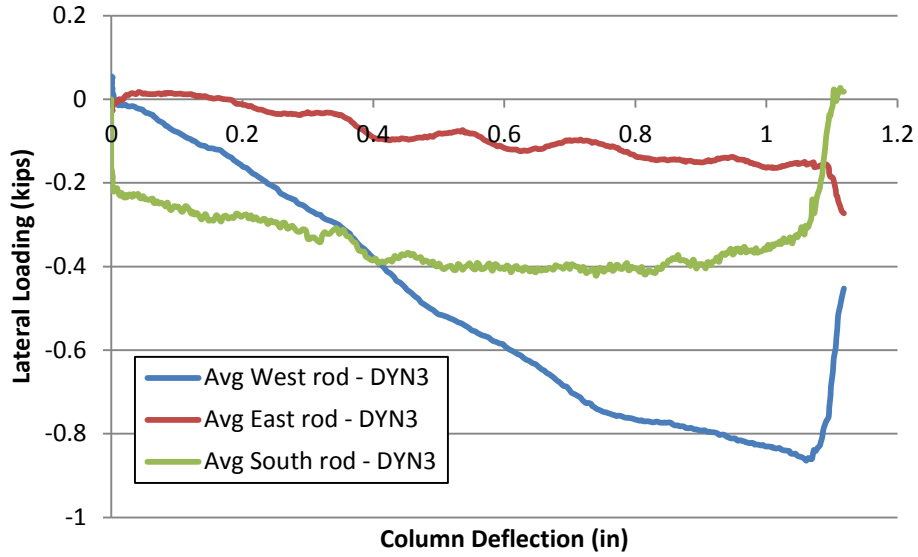
Figure 4.3.7 – Lateral loads calculated from threaded rods in support connection

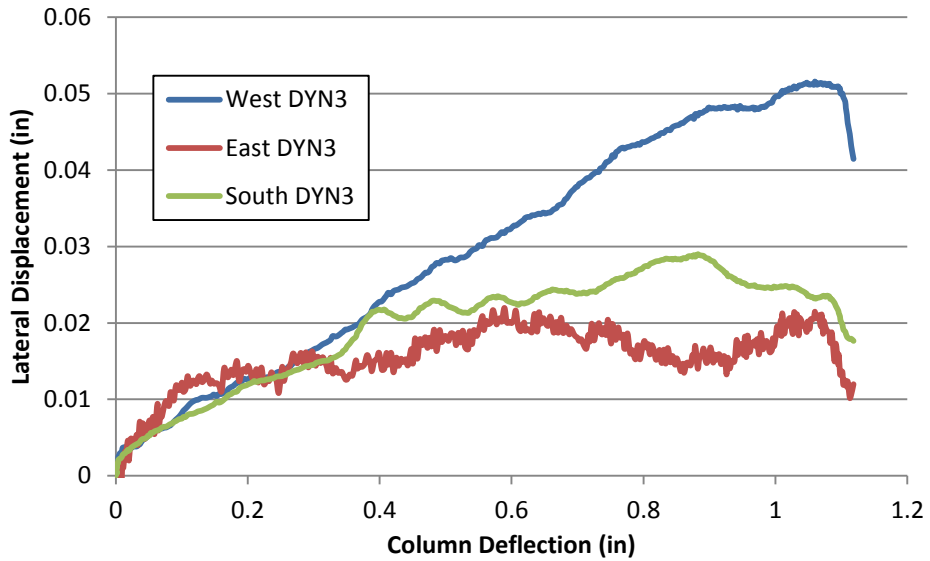
Figure 4.3.8 – Lateral displacements recorded from exterior LVDTs

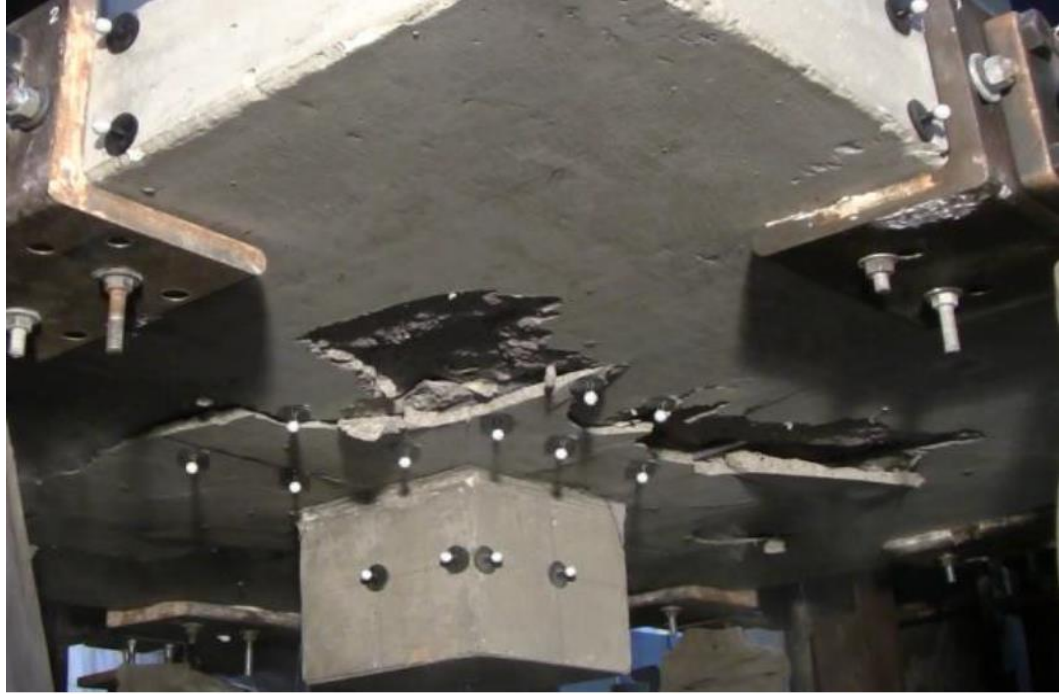
Figure 4.4.1.1 – Underside of 0.64% static test at punching failure of testing

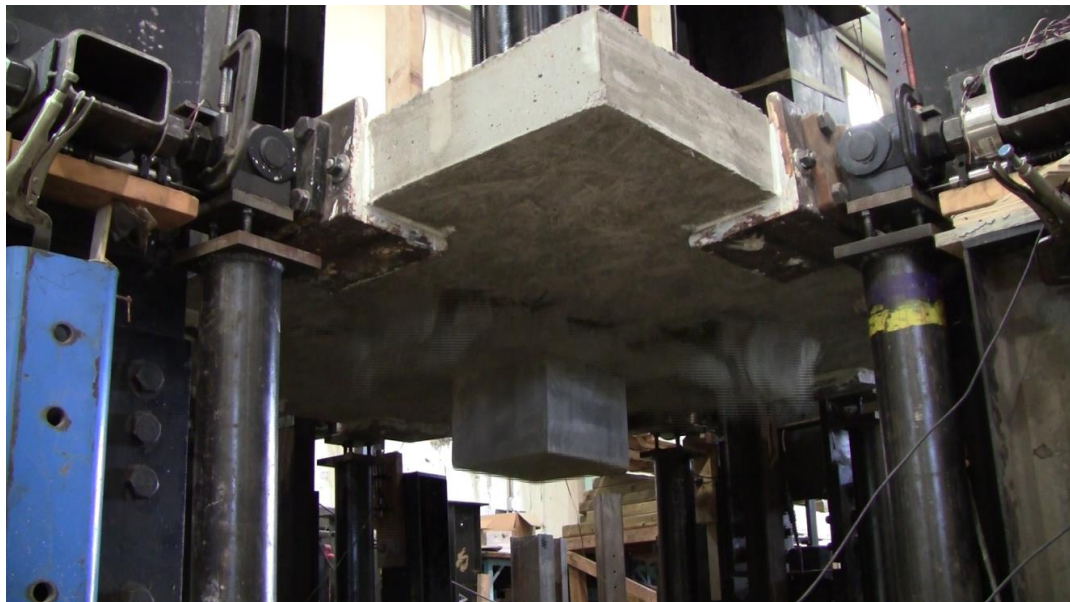
Figure 4.4.1.2 – Underside of the Dynamic 1 test at punching failure

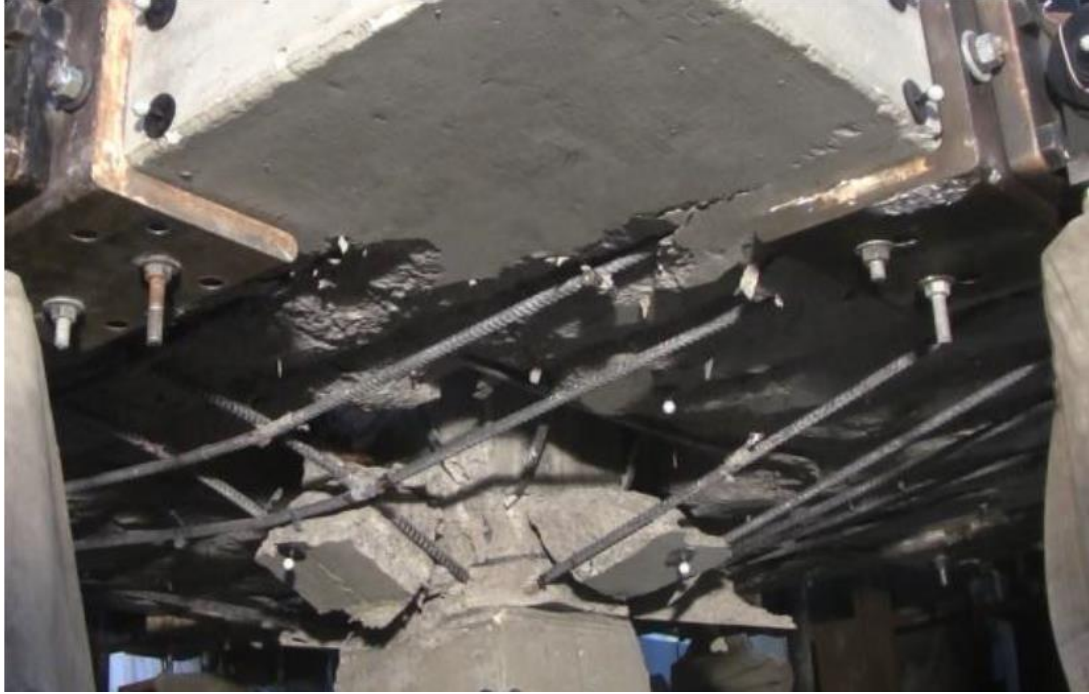
Figure 4.4.1.3 – Underside of the static 0.64% test at conclusion of testing
