DYNAMIC CAPACITY OF
ISOLATED SLAB COLUMN SPECIMENS

A Thesis

at the University of Missouri-Columbia

MAY 2015

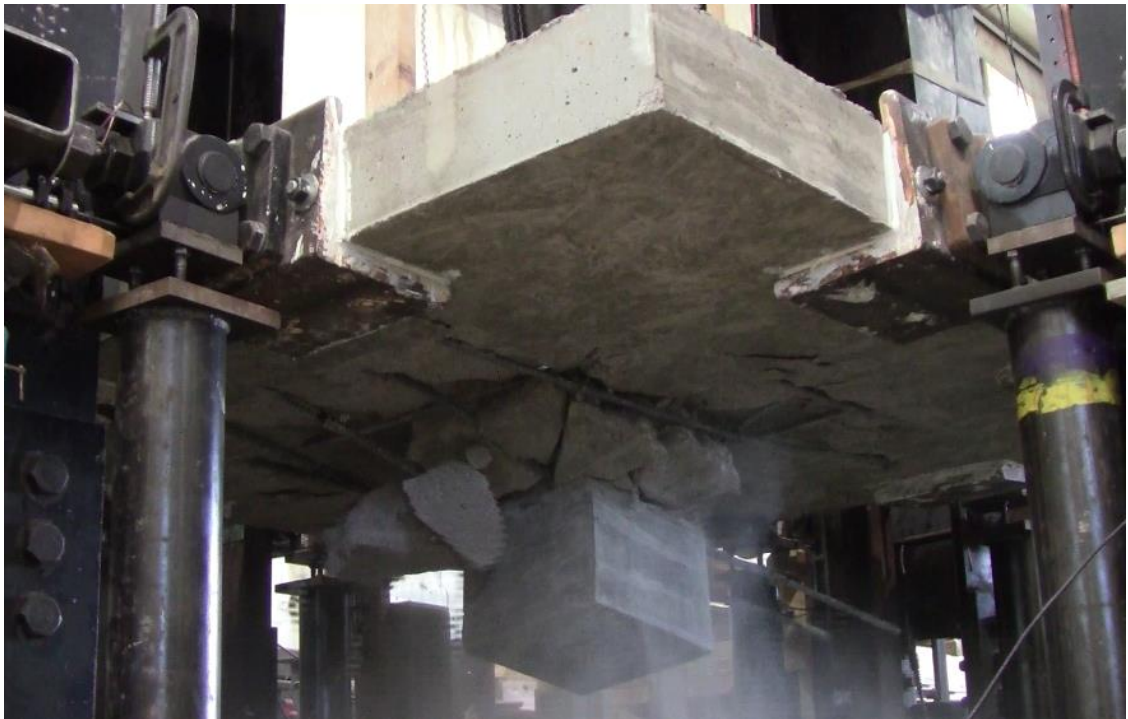
Figure 4.4.1.4 – Underside of the Dynamic 1 test at the conclusion of testing

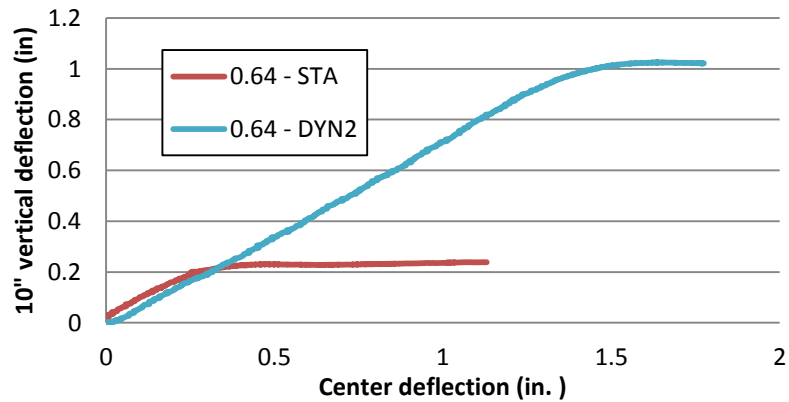
Figure 4.4.1.6 – Center and mid-span deflections prior to punching failure

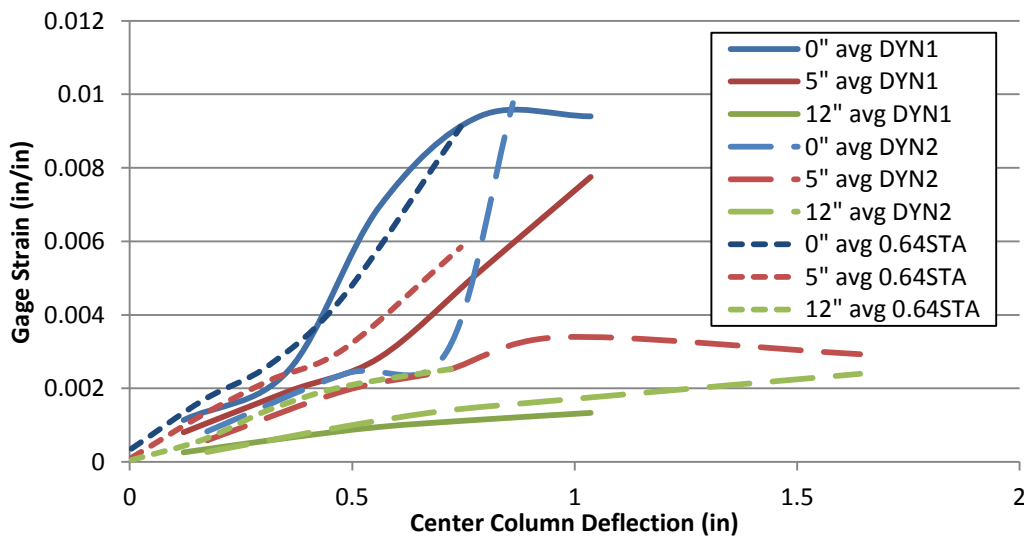
Figure 4.4.1.7 – Average Gage Strain vs. Center Deflection for 0.64% Tests

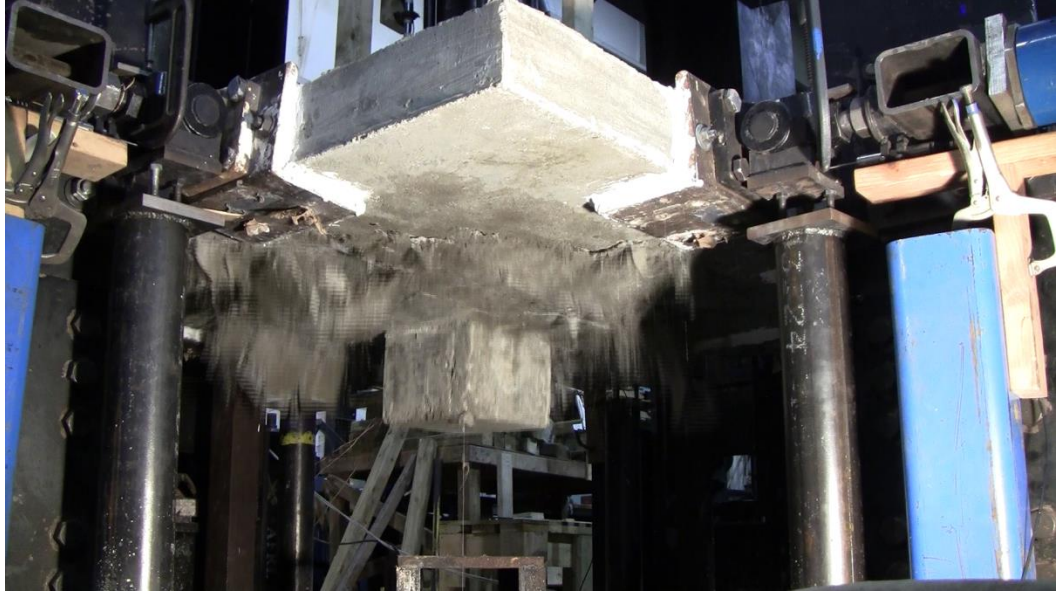
Figure 4.4.2.1 – Dynamic 3 test just after punching failure

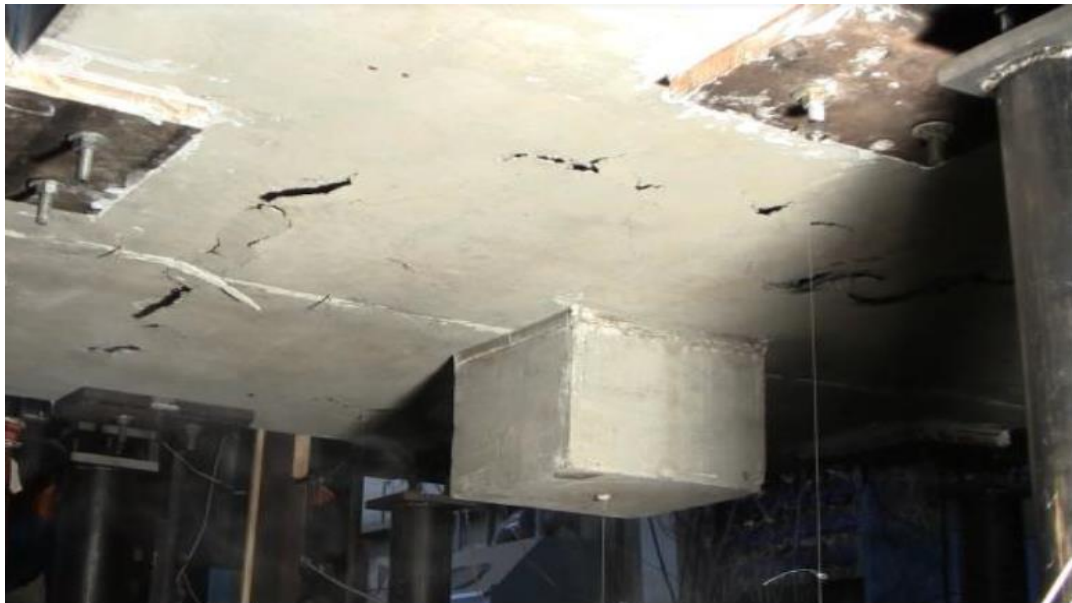
Figure 4.4.2.2 – Static 1.0% test just after punching failure

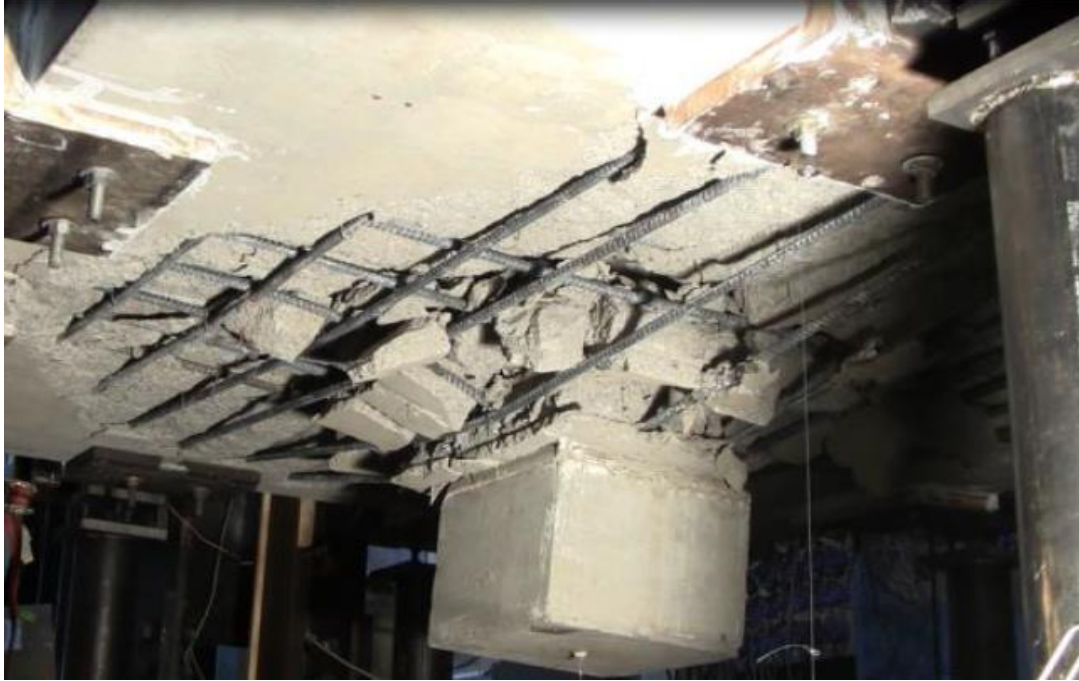
Figure 4.4.2.3 – Underside of 1.0% static test at the conclusion of testing

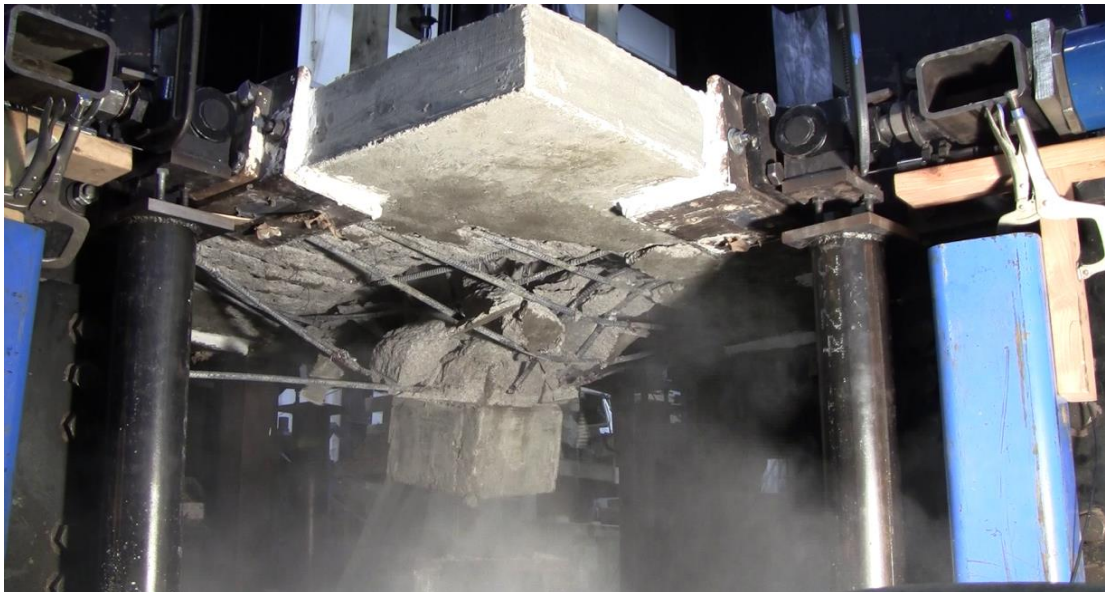
Figure 4.4.2.4 – Underside of the Dynamic 3 test at the conclusion of testing

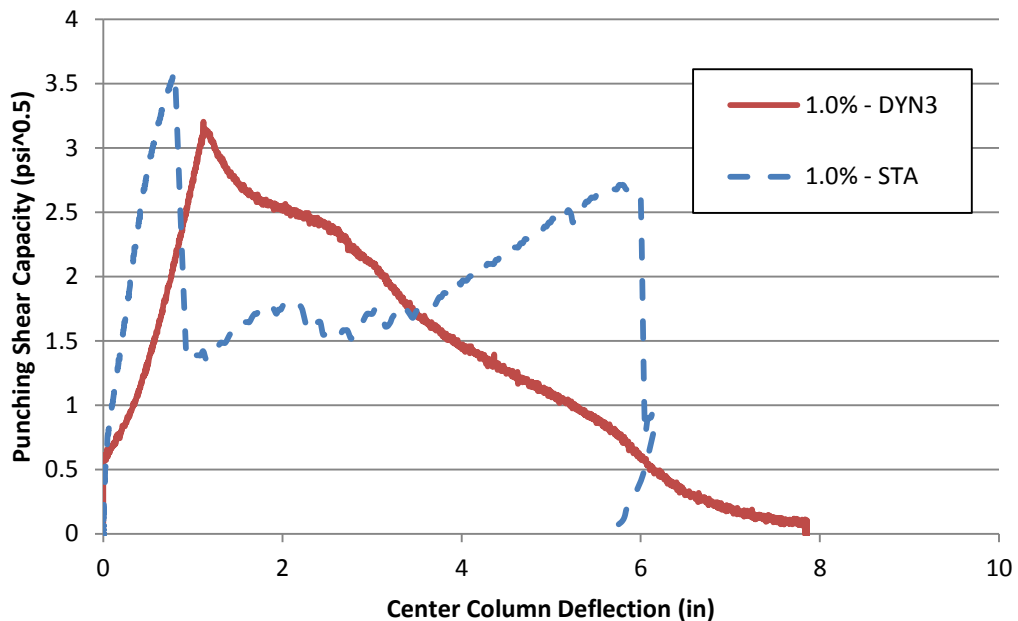
Figure 4.4.2.5 – Normalized capacity vs. Deflection for 1.0% test specimens

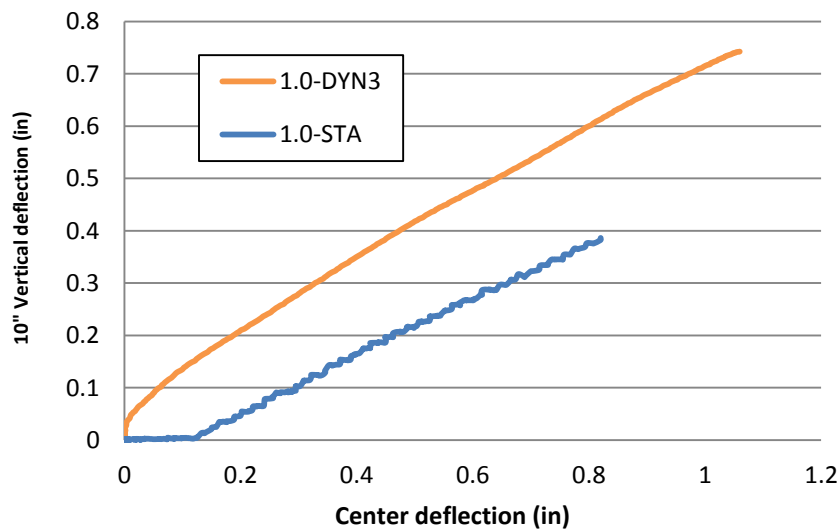
Figure 4.4.2.6 – Center and mid-span deflections prior to punching failure

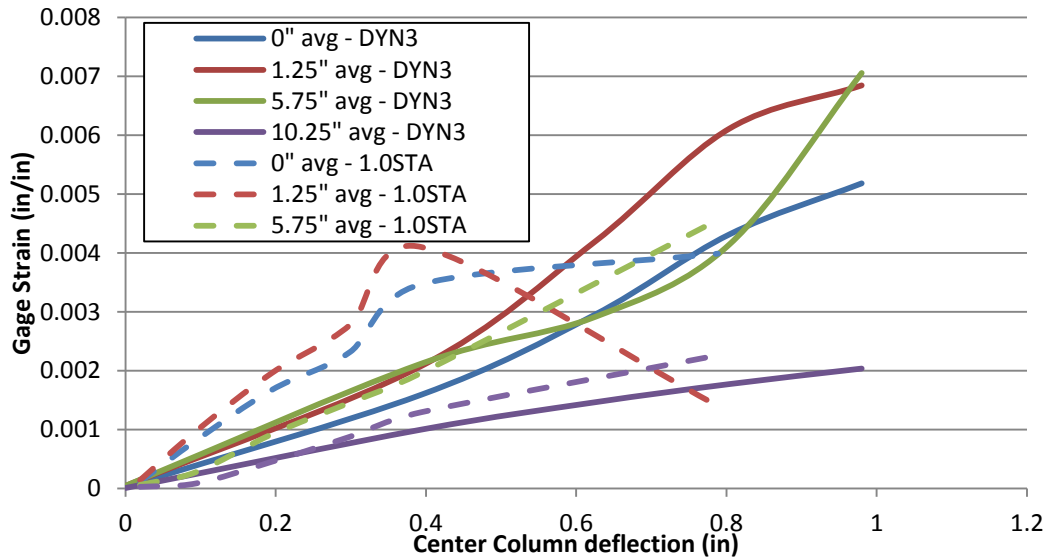
Figure 4.4.2.7 – Average tension strains for 1.0% reinforced specimens

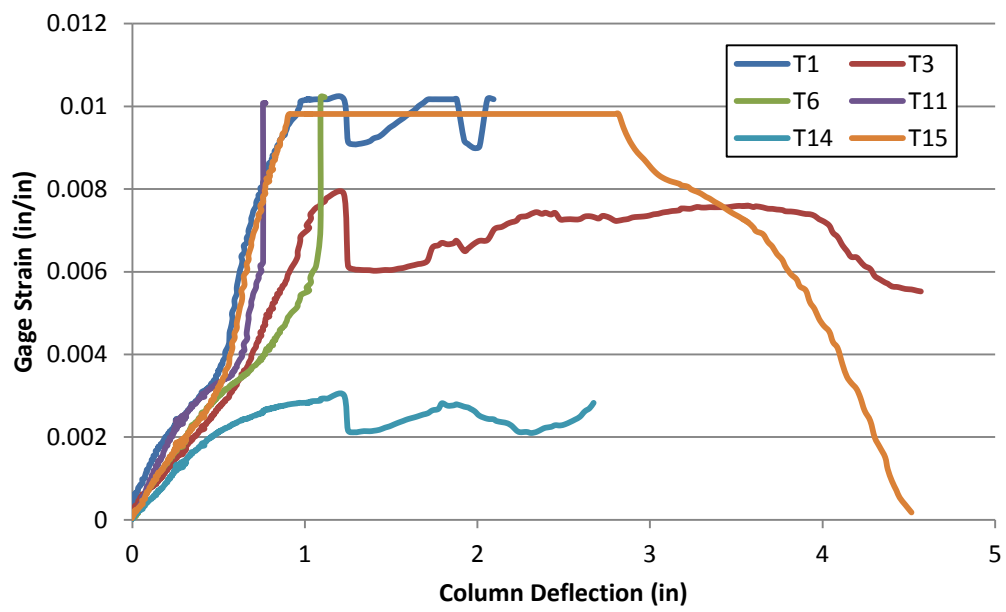
Tension strain gages for static 0.64% RE test

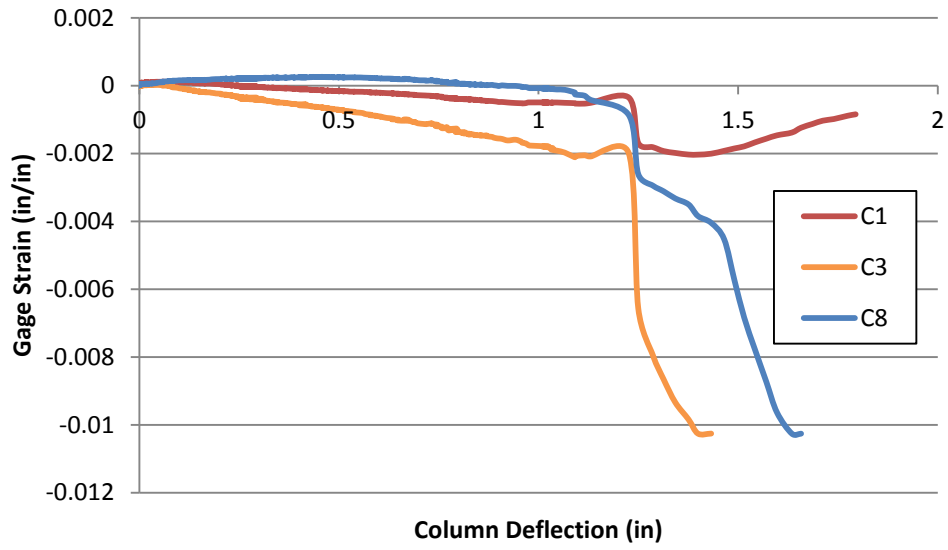
Compression strain gages for static 0.64%RE test

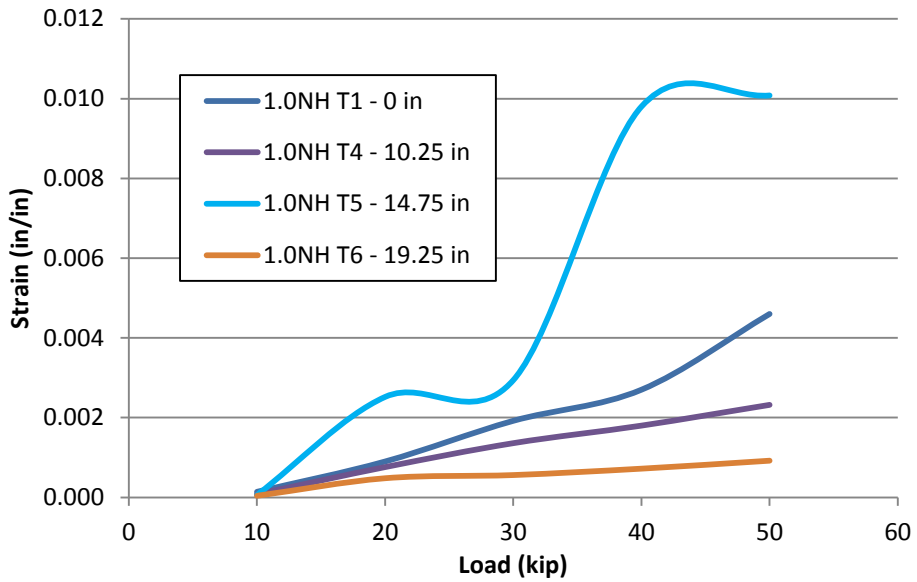
Strain gage profile on parallel reinforcement 1.0STA

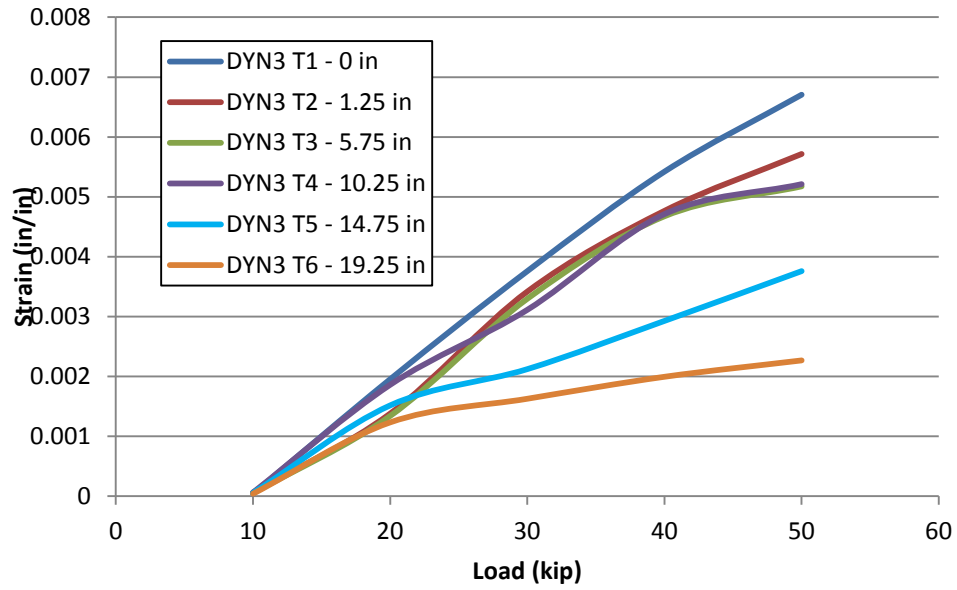
Strain gage profile on parallel reinforcement DYN3

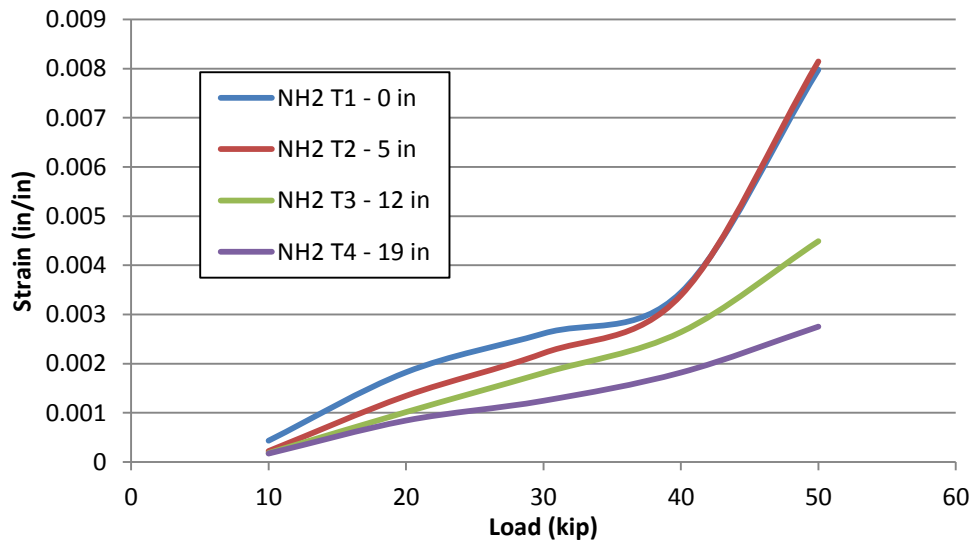
Strain gage profile on parallel reinforcement 0.64STA

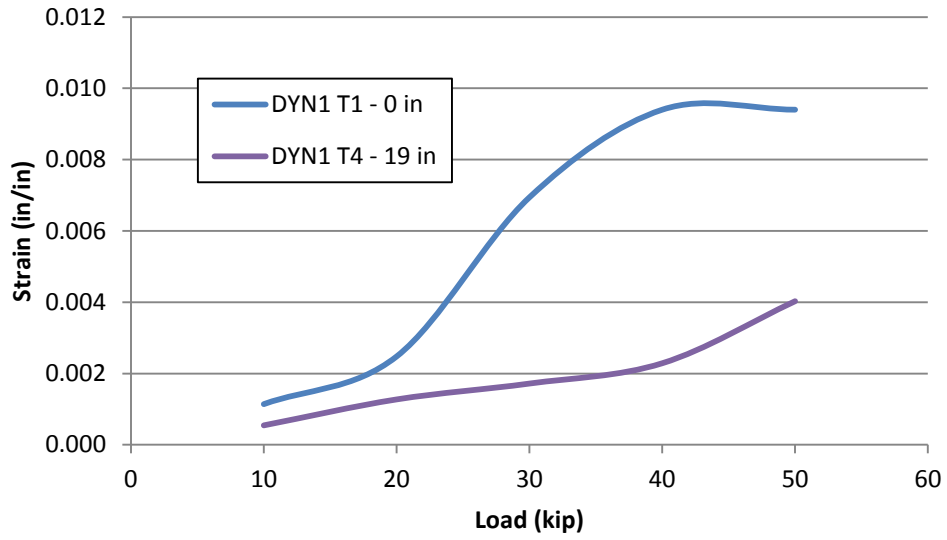
Strain gage profile on parallel reinforcement DYN1

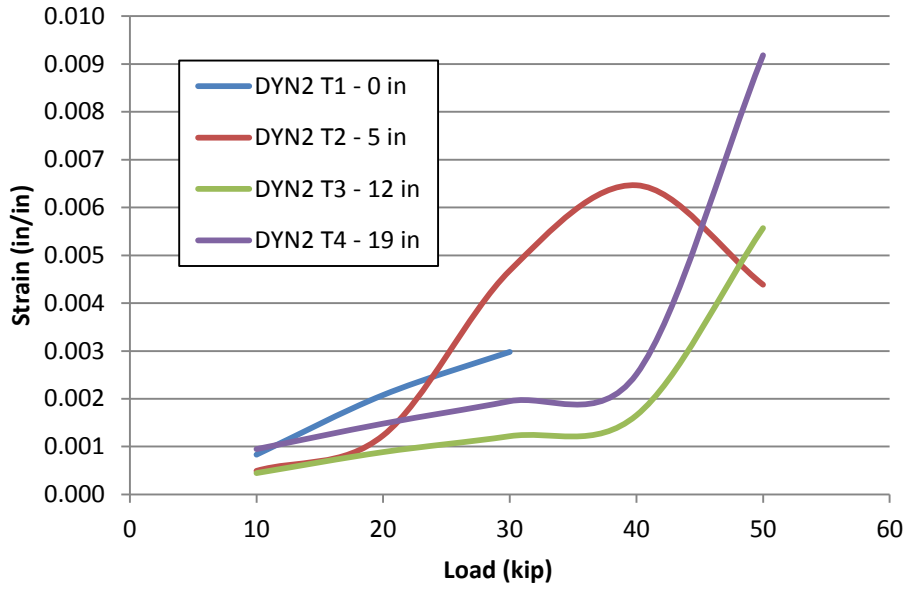
Strain gage profile on parallel reinforcement DYN2

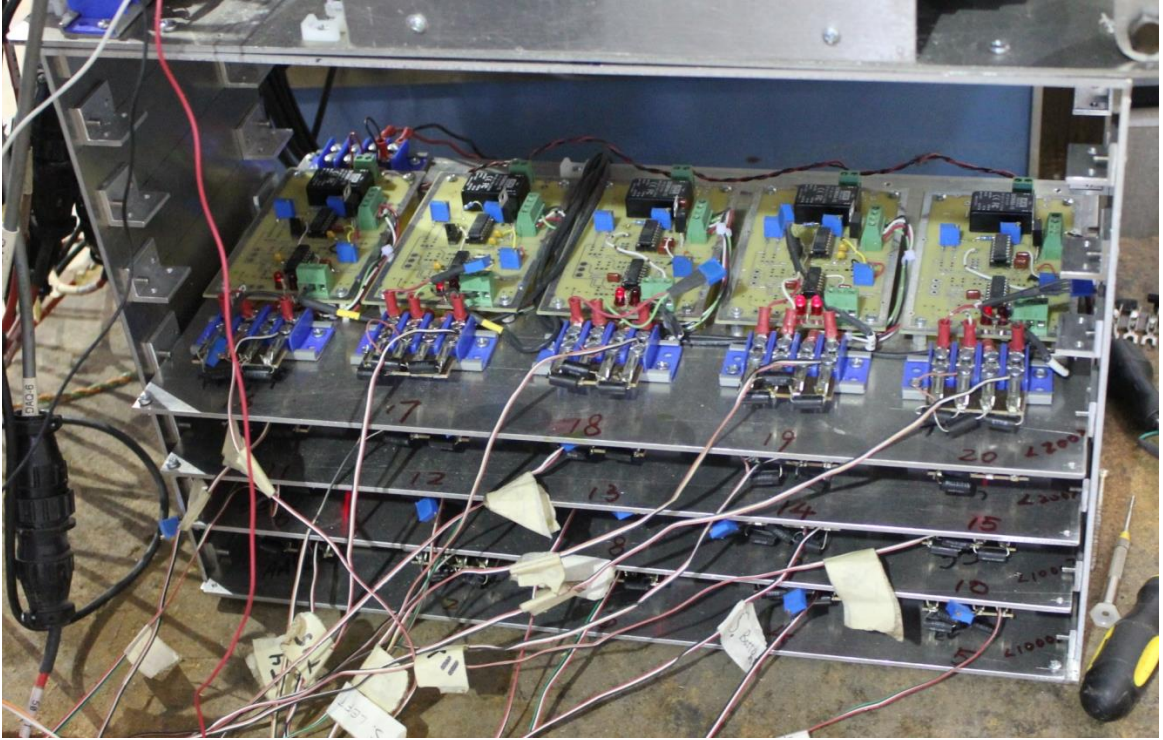
Fast data acquisition system (DAQ)

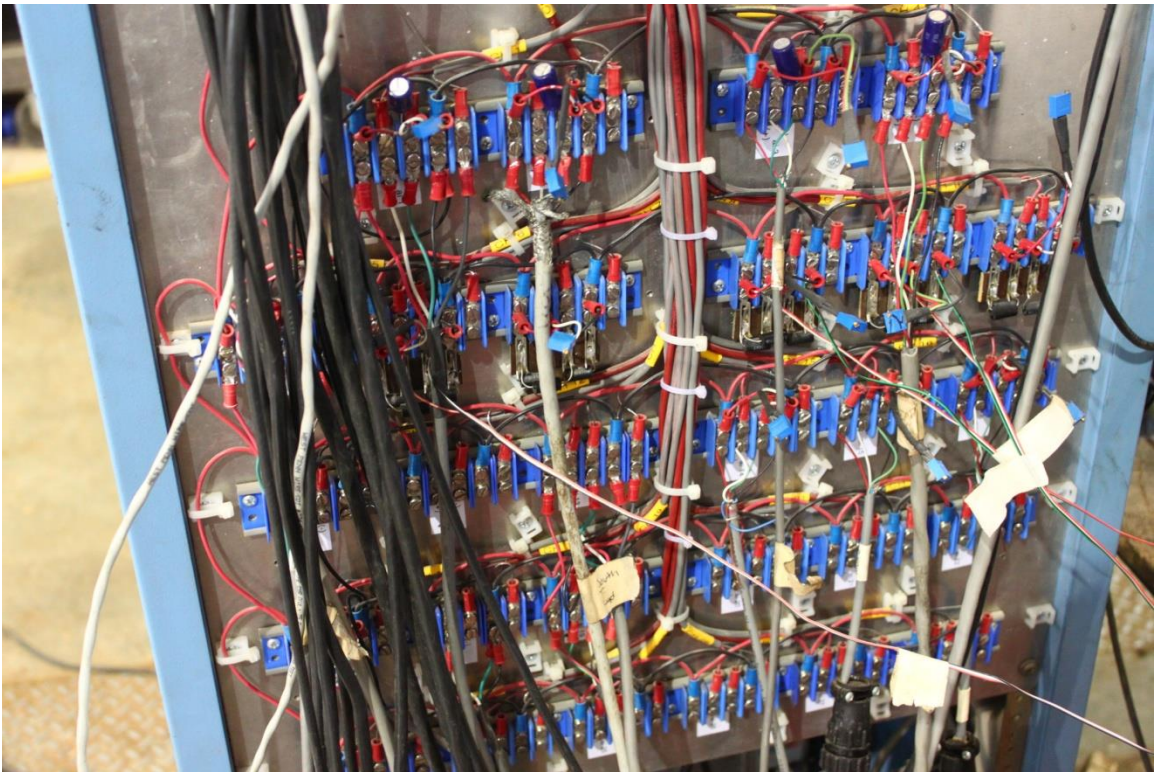
Original DAQ system used in static and dynamic tests

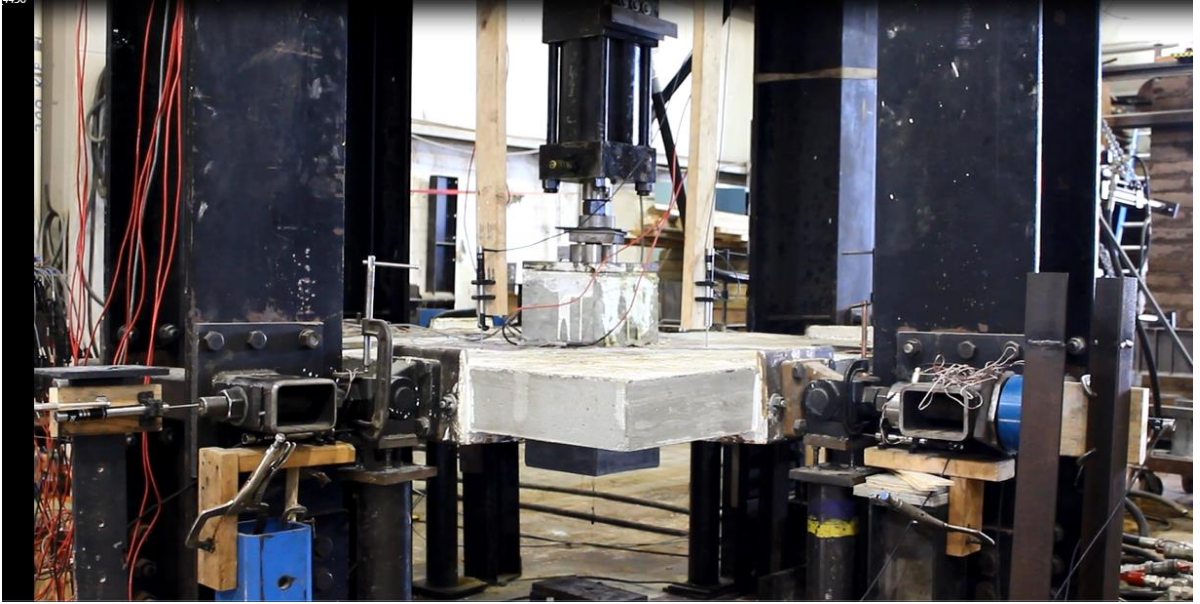
Overall view of dynamic test setup
