EVALUATION OF ALTERNATIVE RESISTANCE  
MECHANISMS FOR  
PROGRESSIVE COLLAPSE

A Thesis  
presented to  
the Faculty of the Graduate School  
at the University of Missouri-Columbia

by  
STEPHEN MARTIN STINGER  
Dr. Sarah Orton, Thesis Supervisor

MAY 2011

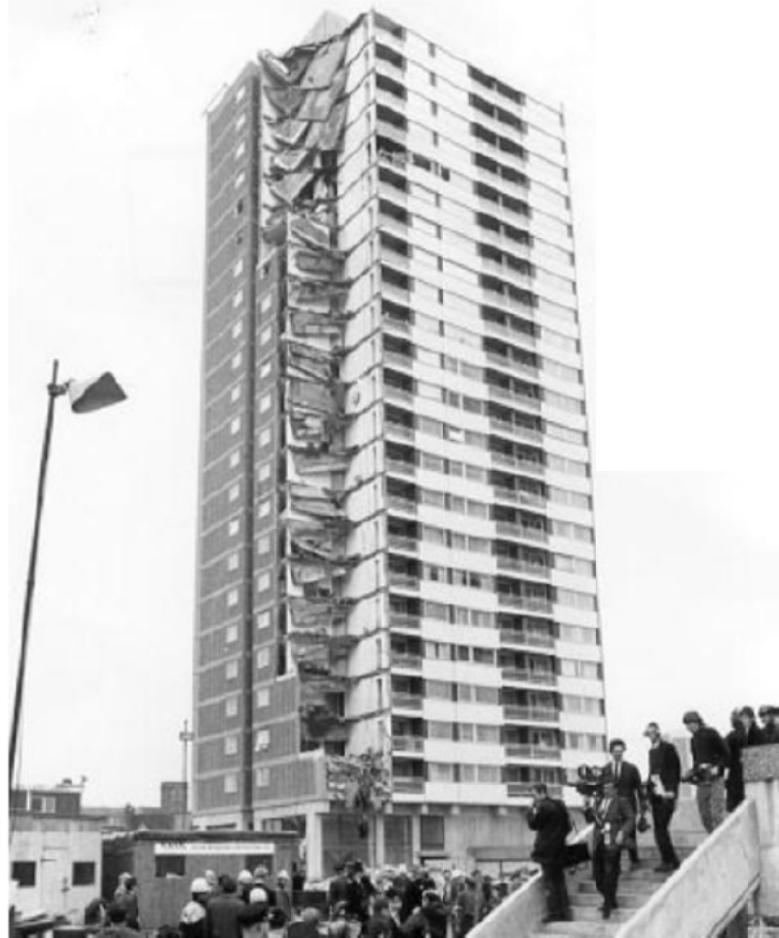
Figure 2.1.1: Ronan Point Tower after collapse (Nair, 2004)

A number of reinforced concrete structures have suffered from progressive collapse in recent history. The collapse of the Ronan Point Tower in 1968 in the Canning Town area of London, England is probably one of the most famous cases. This accident was started by a gas stove leak in apartment 90 on the 18<sup>th</sup> floor. The end result was a collapse of the southeast corner bay of the building from top to bottom as shown in Figure 2.1.1. The Ronan Point Tower was a 22-story residential apartment building that consisted of precast panels joined together without a structural frame. Due to poorly designed connections between the walls and floor, there were no alternate load paths to redistribute the forces in the event of a partial collapse. Since the collapse of the southeast corner of the Ronan Point Tower, there have been changes to building codes of the United Kingdom and other parts of the world to help prevent such tragedies from happening again (Pearson and Delatte, 2005). An example of these changes is that precast concrete structures in the United Kingdom are required to be tied together so that they can either

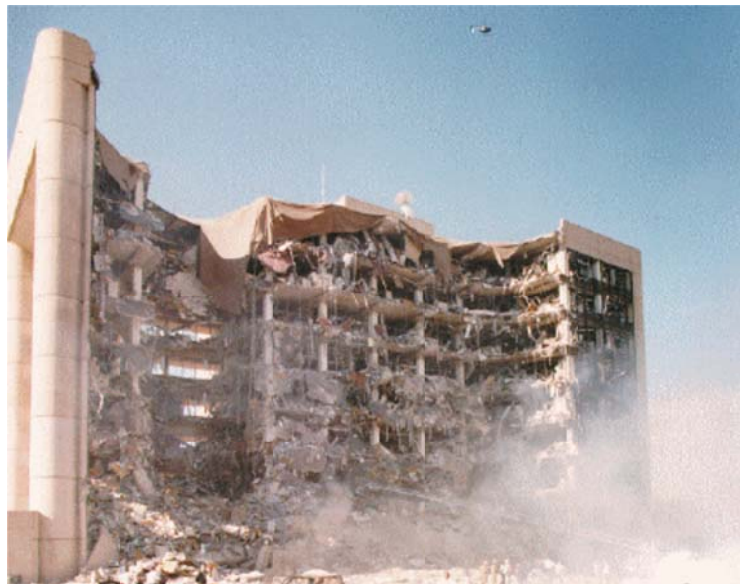
Figure 2.1.2: Murrah Building after explosion (Crawford, 2002)

Another example of progressive collapse was the Alfred P. Murrah Building in Oklahoma City, Oklahoma. The Murrah building was destroyed by a bomb in a truck at the base of the building on April 19, 1995. The bomb destroyed or severely damaged three columns. The loss of support from these columns led to a failure of the transfer girder. This failure of the transfer girder caused the collapse of the above columns and floor areas (Nair, 2004). The result was a collapse of one side of the building as shown in

Figure 2.1.2. The Murrah building was designed with discontinuous reinforcement for both the positive and negative moment regions of the beams. If the building had been detailed as a special moment frame (with continuous reinforcement), the collapsed area of the structure could have been reduced 50% to 80% (Corley, 2004). The extent of the damage prompted studies of progressive collapse and the development of new design guidelines for important buildings (Nair, 2004).

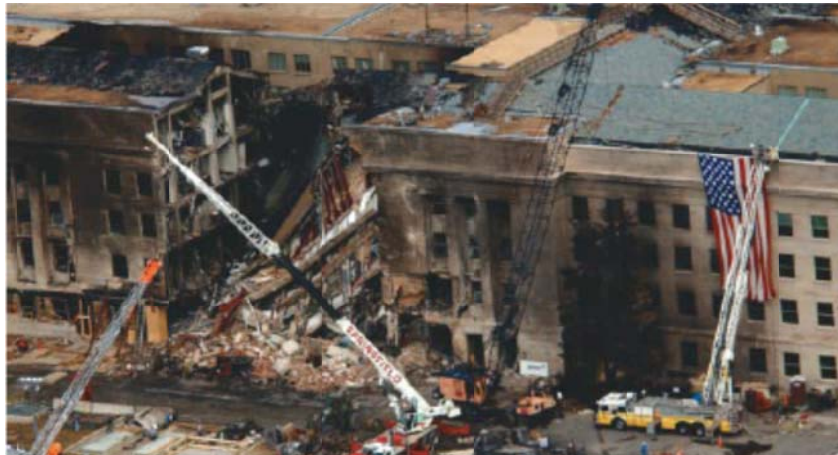
Figure 2.2.1: Pentagon Building after the crash (Mlakar et al., 2003)

floor of the building destroying 30 of the first-floor columns and damaging 20 others along a path that encompassed a 75 ft. wide by 230 ft. long section (Mlakar et al., 2003). Despite extensive damage to many of the columns on the first floor, the upper stories remained intact for more than 20 minutes before they collapsed due to fire as shown in Figure 2.2.1. According to the Pentagon Building Performance Report (Mlakar et al., 2003), the reasons for the performance of the building are “redundant and alternative load paths of the beam and girder framing system, short spans between columns, substantial continuity of beam and girder bottom reinforcement through the supports, design for 150 psf warehouse live load in excess of service load, significant residual load capacity of damaged spirally reinforced columns.”

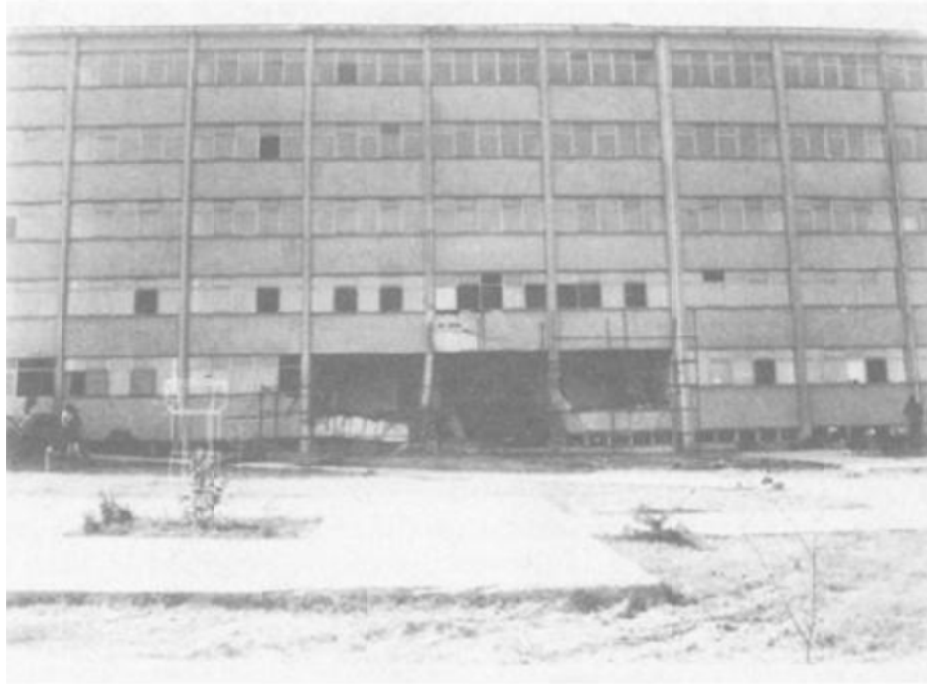
Figure 2.2.2: Office building damaged by system boiler explosion (Sucuoglu et al., 1994)

Another example was a typical reinforced concrete six-story office building (Figure 2.2.2) that was damaged by a steam boiler explosion (Sucuoglu et al., 1994). Sucuoglu et al. investigated the redistribution paths of forces resulting from a column failure and identified the basic structural defense mechanisms developed in the damaged building

frame. One of the findings of the study showed that non-load-bearing infill walls provide can reserve strength and help prevent the progressive failure of the structure.

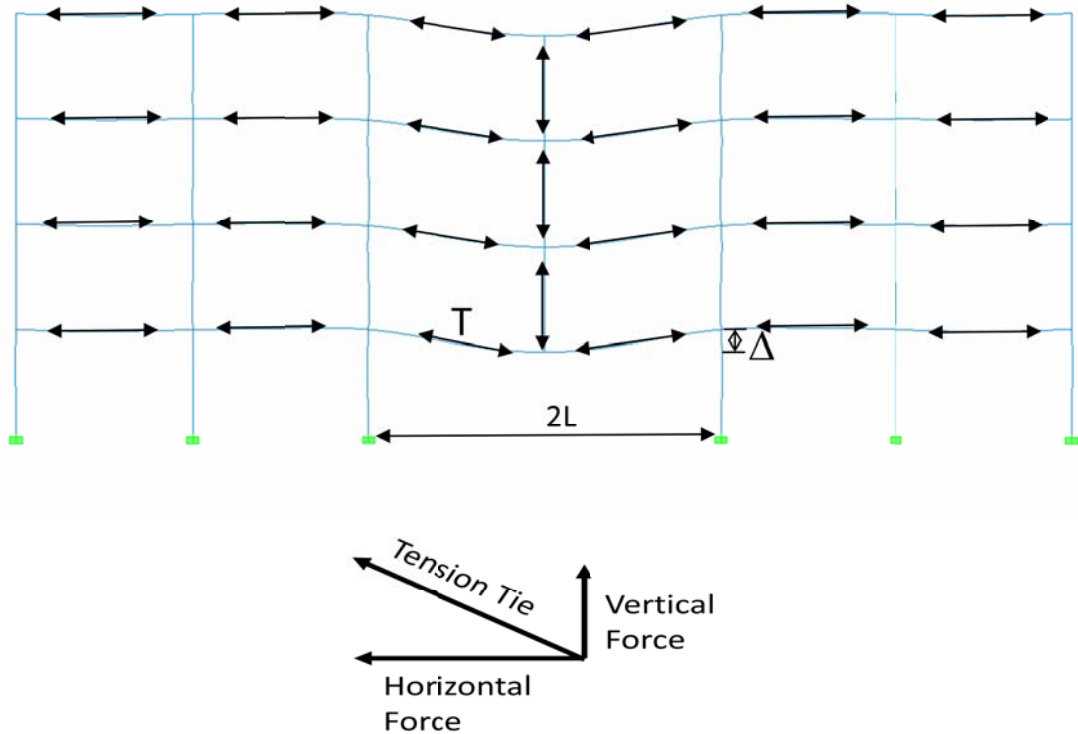
Figure 2.3.1.1: Catenary tension forces throughout a building (Orton, 2007)

However, the catenary tension only becomes effective at large levels of displacement, usually around 7 to 10% of the span length (Wong, 2002). Based on a typical 20 ft span, the deflection could be as much as 3 to 4 feet. Even though this is a rather large deflection for a floor, the catenary action prevents a complete collapse of the floor.

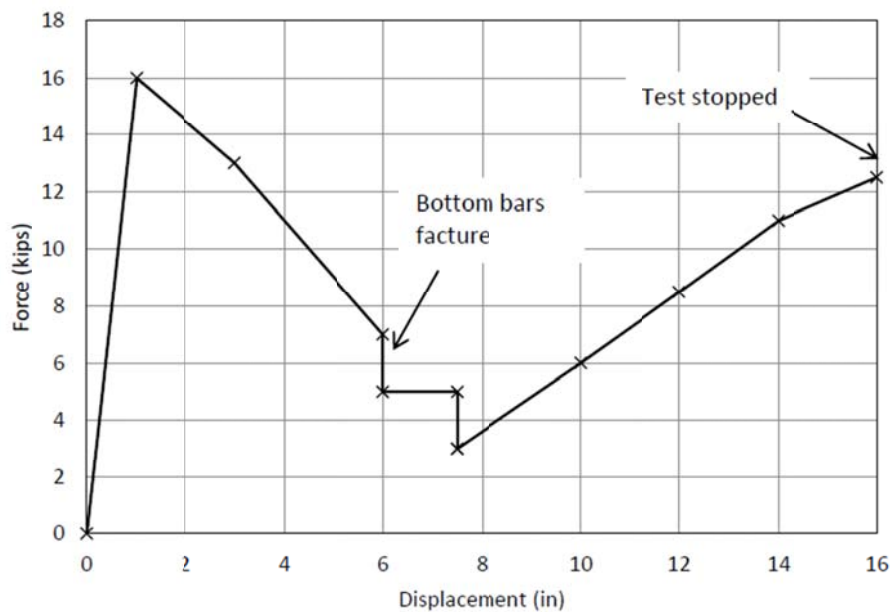
Figure 2.4.3: Force vs. displacement graph (Sasani and Kropelnicki, 2007)

As shown in Figure 2.4.3, the two bottom bars fractured at vertical displacements of about 6.0 in. and 7.5 in. They also found that catenary action developed in the top bars following the bottom bar fractures. Finally, the end of the beam rotated to about 11 degrees (Sasani and Kropelnicki, 2007).

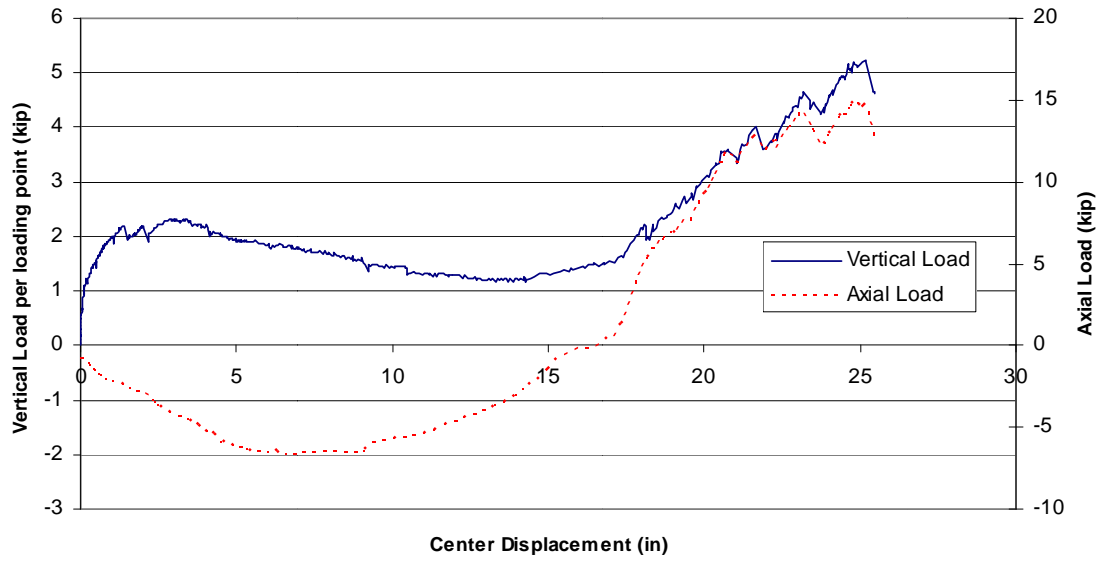
Figure 2.4.4: Vertical and axial loads vs. center displacement for beams with discontinuous reinforcement (Orton, 2007).

The axial load and vertical load vs. displacement response (Figure 2.4.4) shows a compressive arch phase until about 14 in. of deflection followed by a catenary tension phase. Although with discontinuous reinforcement the beam would have little or no flexural capacity, it was able to reach a load of 2.3 kips per loading point in compressive arch action and 5.2 kips in catenary action. The test was then stopped at 25 in. of deflection due to limitations in the test setup (Figure 2.4.5).

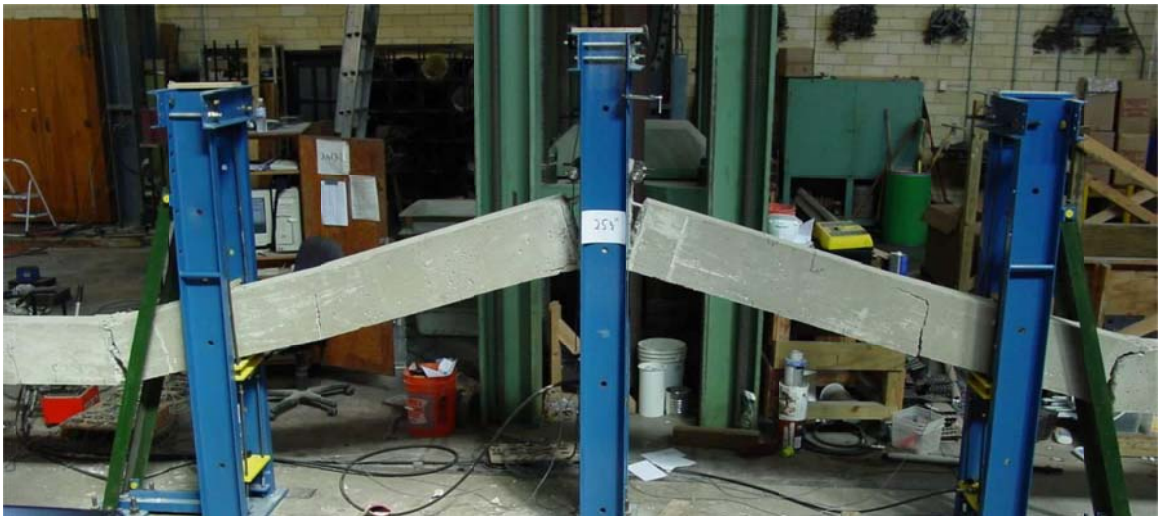
Figure 2.4.5: Photo of test NR-2 under catenary action (Orton, 2007)

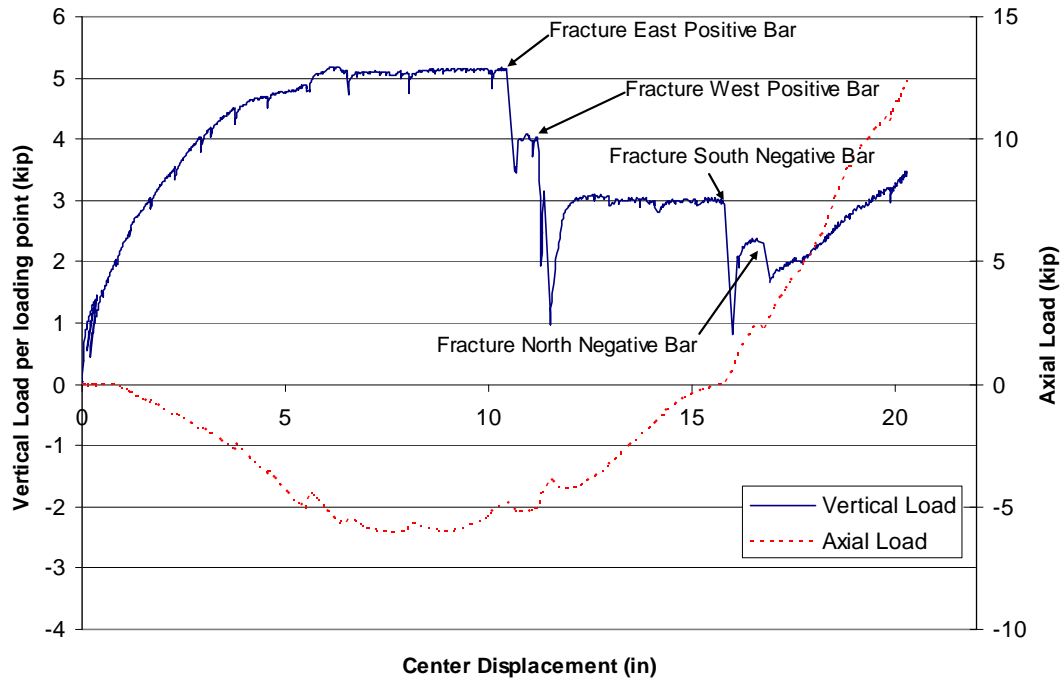
Figure 2.4.6: Vertical and axial loads vs. center displacement for beams with continuous reinforcement (Orton, 2007).

Another test found that a beam with continuous reinforcement was not able to carry a tension force before the bars fractured due to limited ductility in the beam in the positive hinge region. After fracture of the positive moment bars, the negative moment bars

fractured as well. After the loss of continuity, the beam was still able to carry increasing load through catenary tension.

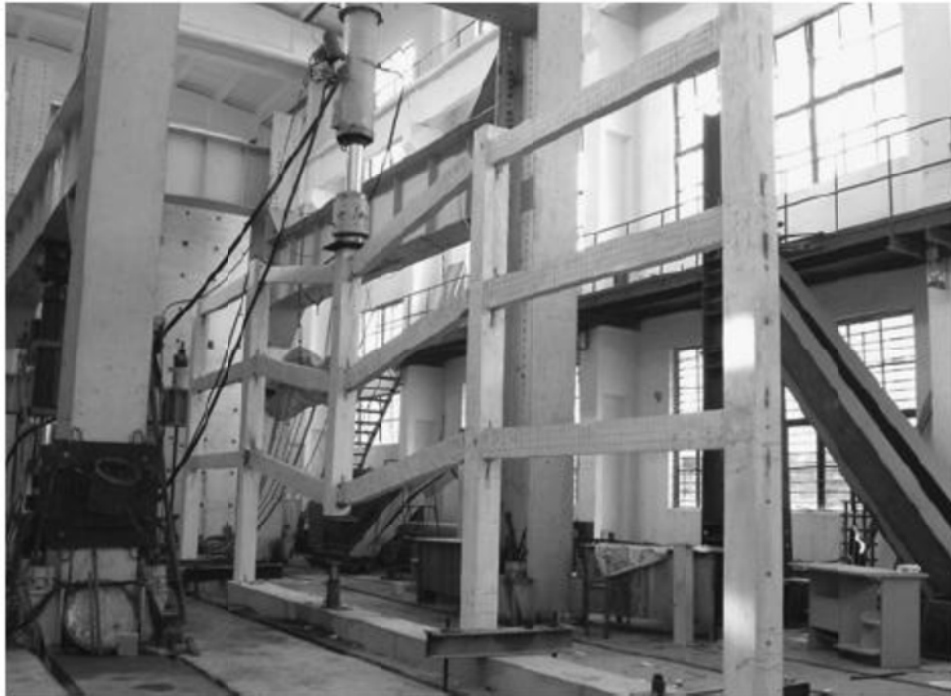
Figure 2.4.7: A reinforced concrete four-bay by three-story one-third scale model frame (Yi and Kunnath, 2008)

In other research, Yi and Kunnath (2008) conducted a static experiment to study the progressive collapse of a reinforced concrete frame due to the loss of a bottom story column. They tested a one-third scale model of a four-bay by three-story frame with continuous positive reinforcement as shown in Figure 2.4.7.

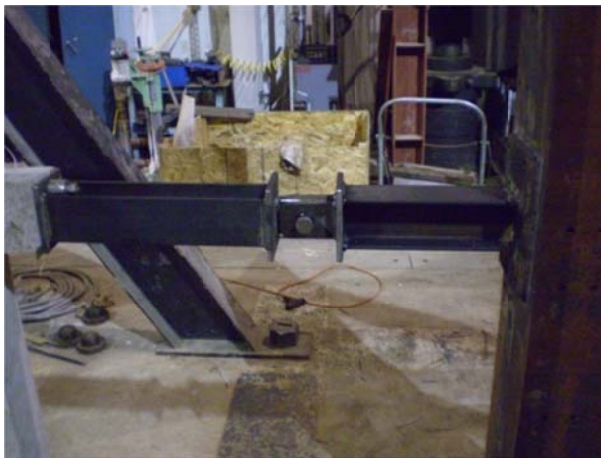
Figure 3.6.6: Reaction frame tied into the concrete frame

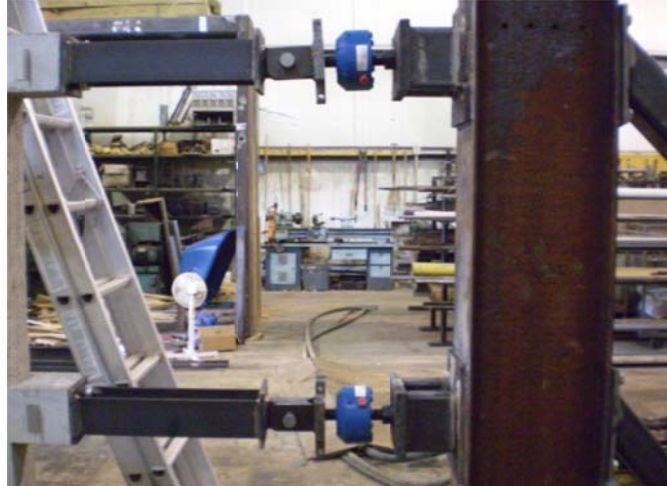
Figure 3.7.4: Load cells

Two Interface 1200 Standard Load Cells were connected to one side of the reaction frame using threaded rods as shown in Figure 3.7.4 and Figure 3.7.5. The load cells were connected to the concrete frame by an extension made of W4x13's. At the end of these extensions were welded plates that were bolted to the concrete through the #4 end-threaded bars sticking. These load cells would measure the horizontal reaction force caused by compressive arch and catenary tension.

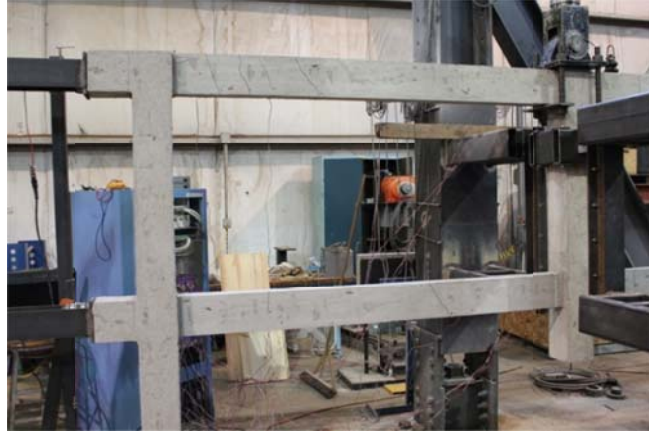
Figure 4.1.1: Discontinuous frame before loading

Upon loading, the frame initially responded in an elastic manner. At a load of around 200 to 250 lbs, cracks began to form at the locations of discontinuous reinforcement (Figure 4.1.2). As the load increased, the cracks widened and hinges began to form as shown in Figure 4.1.3. The ultimate failure point was when the negative moment bars tore out of the last stirrup as shown in Figure 4.1.4.

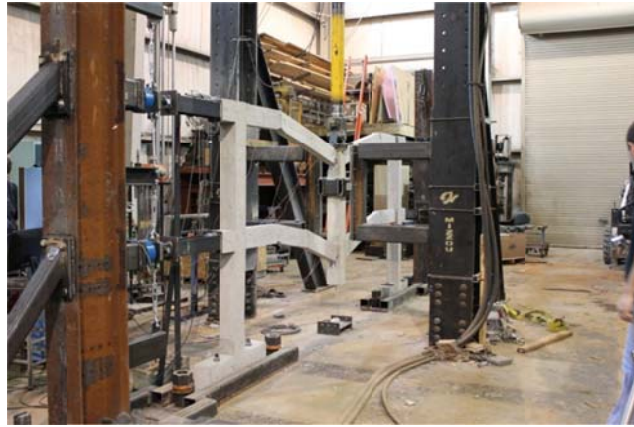
Figure 4.1.2: Discontinuous frame forming cracks

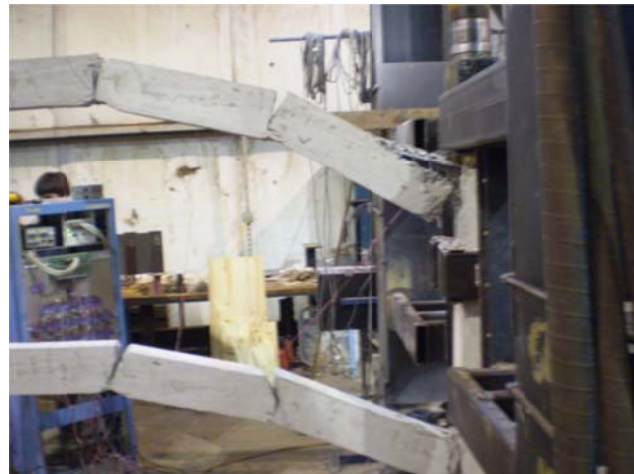
Figure 4.1.3: Discontinuous frame forming hinges

A closer look at a particular beam will show details of the cracking and hinge formations. At a about a load of 200 to 250 lbs, cracks formed at the discontinuous ends of the reinforcement (Figure 4.1.5). This correlated well to the predicted cracking moment of the beams (8.532 kip-in) which translated to a load of 237 lbs. These cracks occurred at the discontinuous ends of the negative reinforcement which ended 21.5 in. from the face of the outer columns. On this particular beam, the crack started 22.5 in. from the column as shown in Figure 4.1.6. This was similar to all four beams. Because no reinforcement crossed these cracks, they continued to open widely and formed hinges (Figure 4.1.7) with little further cracking in the rest of the beam. The only other significant cracking in the beams took place at the discontinuous ends of the negative moment reinforcement coming from the center column (21.5 in. from the face). These cracks formed secondary hinges as shown in Figure 4.1.3.

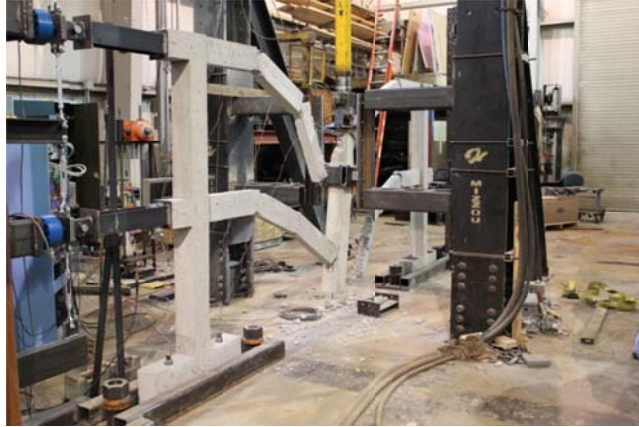
Figure 4.1.4: Discontinuous frame at failure

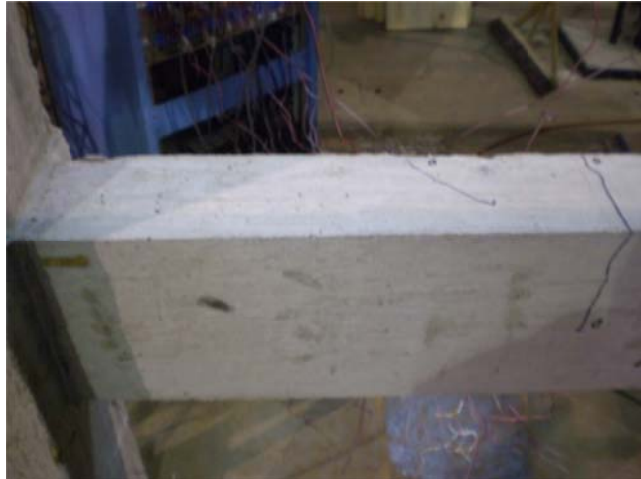
Figure 4.1.5: Initial cracking

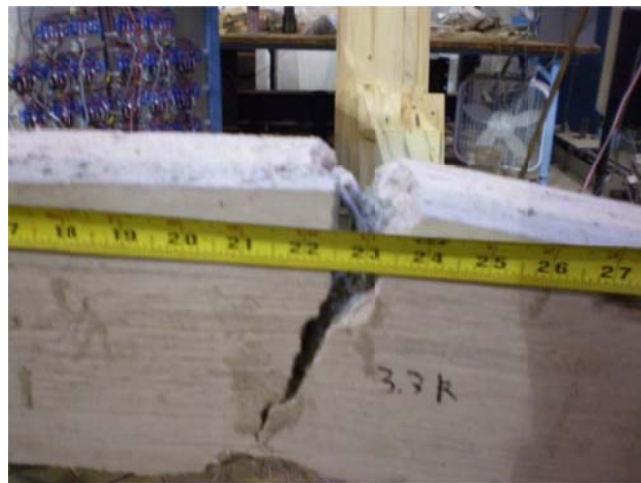
Figure 4.1.6: Crack at end of negative reinforcement

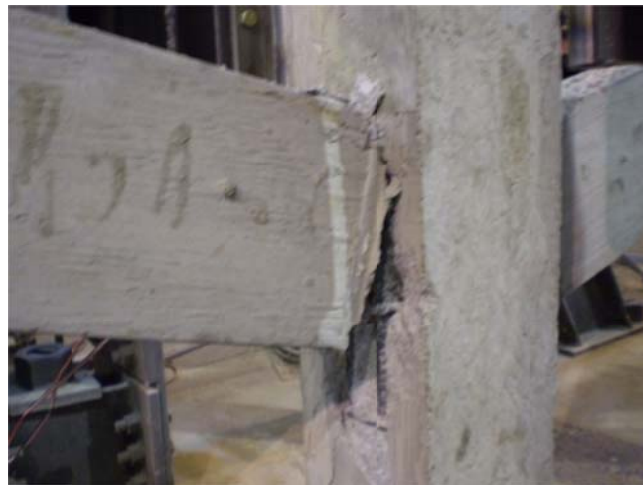
Figure 4.1.8: Formation of cracks at the center column

In addition to the hinges within the beams, there was damage where the beams connected with the center column. This was especially true for the bottom beams (Figure 4.1.8). These cracks occurred because the discontinuous positive reinforcement only extended 1.5 in. into the columns. These cracks widened and formed hinges as shown in Figure 4.1.9. At failure, the negative moment bars tore out of the stirrups as shown in Figure 4.1.10.

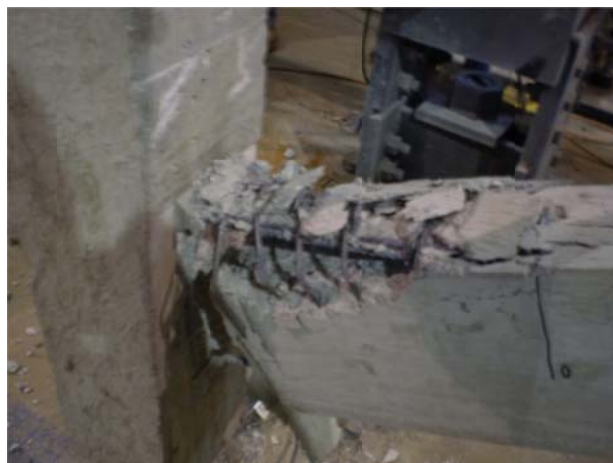
Figure 4.1.9: Formation of hinges at the center column

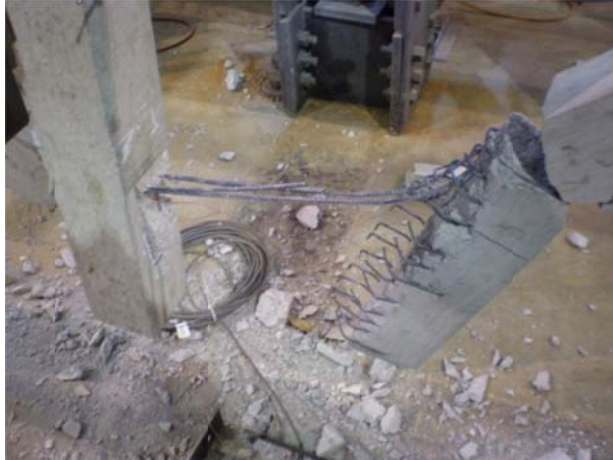
Figure 4.1.10: Longitudinal bars breaking out of the stirrups

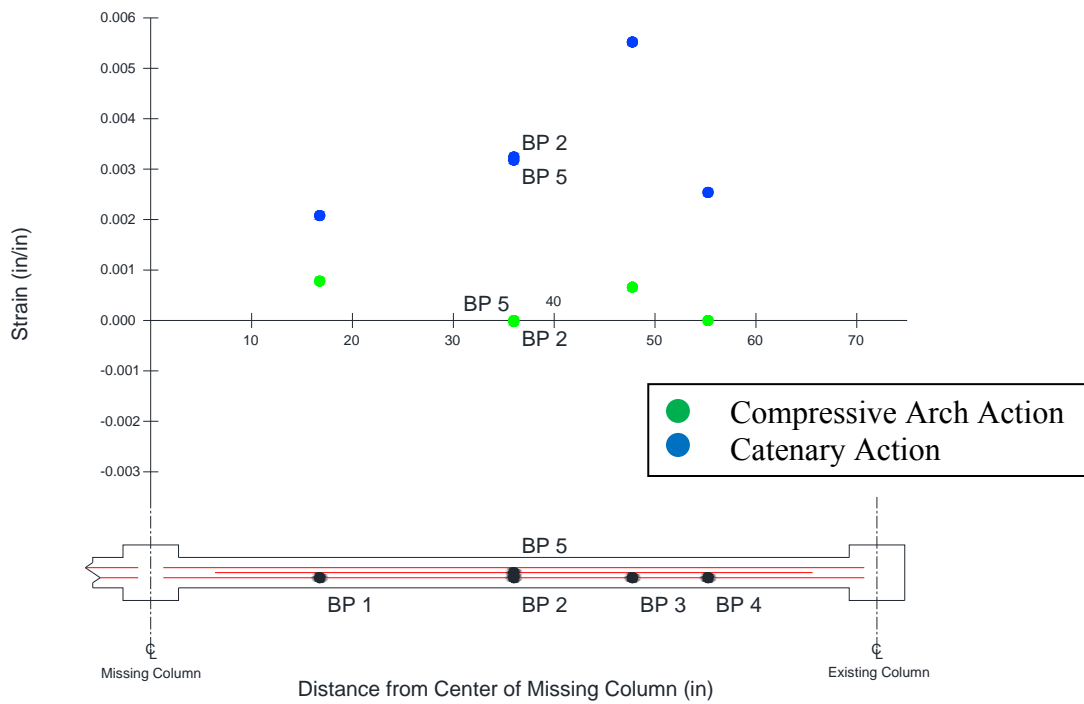
Figure 4.1.18: Strain gages in positive moment region of bottom beam

Besides the previous data, there was data from the 16 strain gages throughout two of the beams. The following graphs (Figure 4.1.15 through Figure 4.1.18) have strain points for each gage that didn't malfunction. The green dots represent the strain at the peak compressive arch action load (2.34 kips). The blue dots represent the strain at the peak catenary action or ultimate load (8.19 kips). At the peak compressive arch load, the strain in the positive moment bars increased towards the middle column while the strain in the negative moment bars increased towards the outer column which was expected. At the peak catenary action load, the highest strains for the negative moment bars were at the ends of the beams and the highest for the positive moment bars were at the middle of the beams which was also expected. The middle of the positive moment bars reached a stress of 56.7 ksi (BP2) which translated to 8.5 kips of load as compared to the 7.64 kips felt by the bottom load cell. The ends of the negative moment bars reached a stress of 33.3 ksi (TN2) which translated to 6.7 kips of load as compared to the 9.23 kips felt by the top load cell.

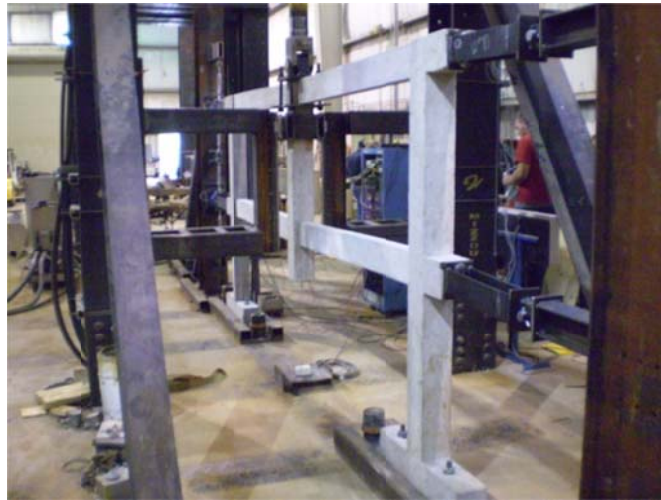
Figure 4.2.1: Continuous frame before loading

This frame was designed according to the 2008 ACI code which called for continuous reinforcement throughout beams. As with the discontinuous frame test, the actuator applied load to the center of the frame over the location of the lost column. Upon loading, the frame initially responded in an elastic manner. At a load of around 200 to 250 lbs, cracks began to form at the locations where the shorter bars of the negative moment reinforcement ended (Figure 4.2.2). As the load increased, the cracks widened and hinges began to form as shown in Figure 4.2.3. The ultimate failure point was when all the longitudinal bars in one area completely fractured as shown in Figure 4.2.4.

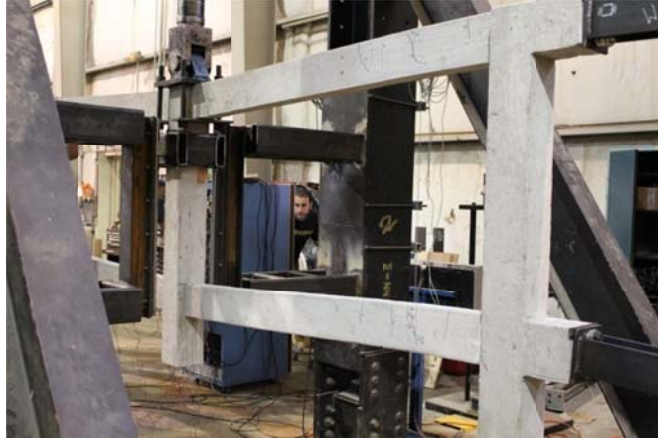
Figure 4.2.2: Continuous frame forming cracks

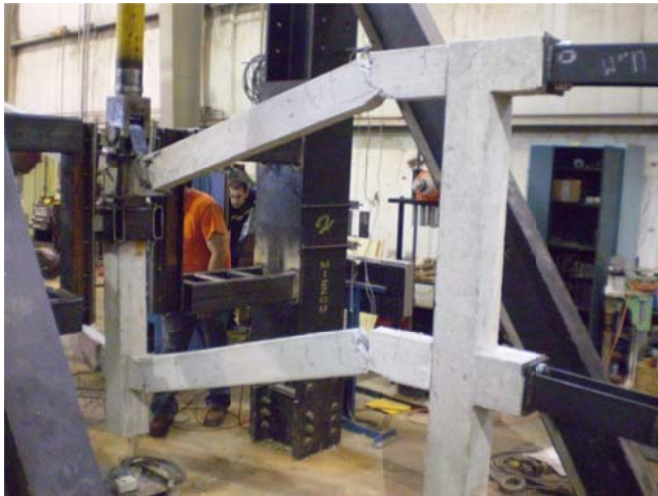
Figure 4.2.3: Continuous frame forming hinges

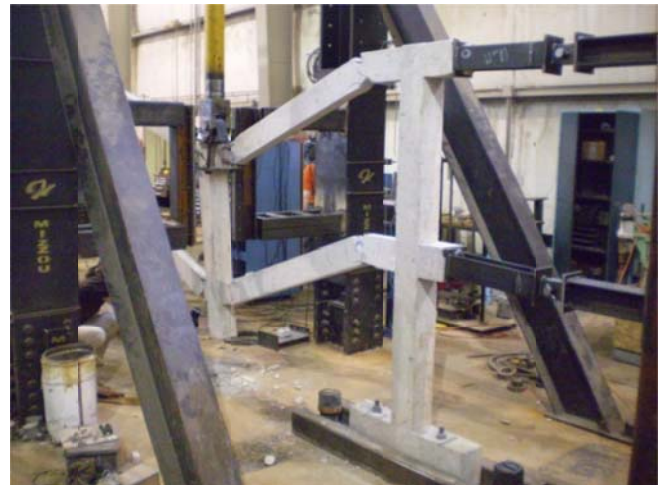
Figure 4.2.4: Continuous frame at failure

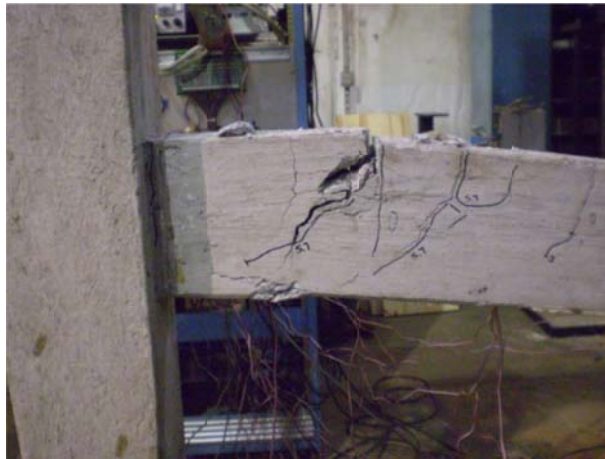
Figure 4.2.7: Formation of hinge

A closer look at a particular beam will show details of the cracking and hinge formations. At a about a load of 200 to 250 lbs, cracks formed at the ends of the shorter two bars of the negative moment reinforcement (Figure 4.2.5). This correlated well to the predicted cracking moment of the beams (8.532 kip-in) which translated to a load of 237 lbs. These cracks occurred at the ends of the shorter negative reinforcement bars which ended 12 in. from the face of the outer columns. On this particular beam, the crack started 11.5 in. from the column as shown in Figure 4.2.6. This was similar to all four beams. These cracks continued to open widely and formed hinges (Figure 4.2.7) with little further cracking in the rest of the beam. Next, the concrete near the hinge broke and fell off (Figure 4.2.8). At this point, all that was holding up the beam was the two longer negative moment bars until they fractured (Figure 4.2.9).

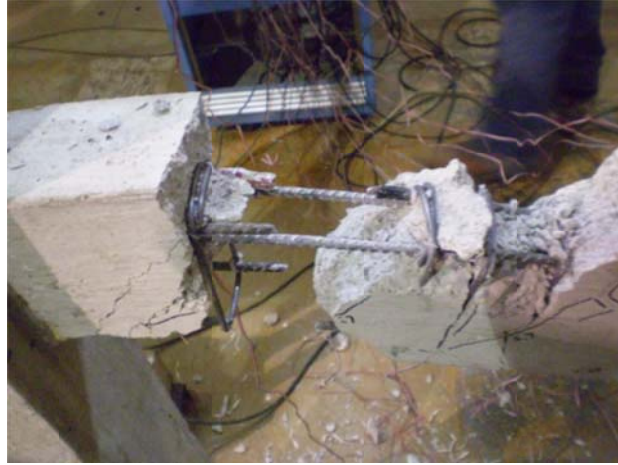
Figure 4.2.9: Failure of beam

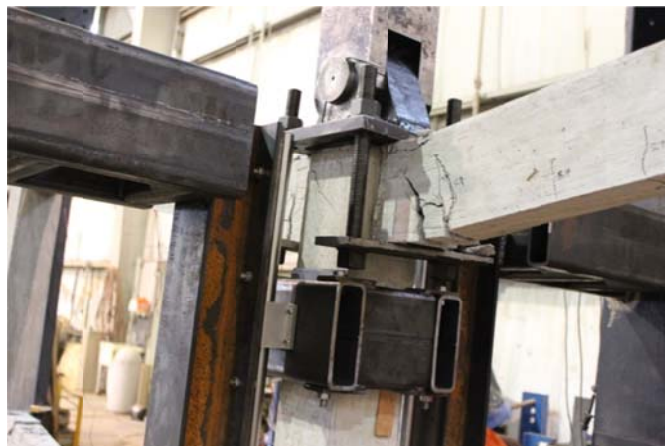
Figure 4.2.10: Crack forming near center column

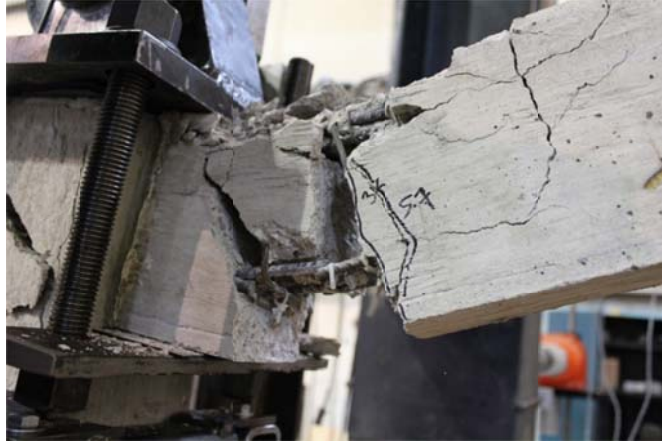
Figure 4.2.11: Hinge forming near center column

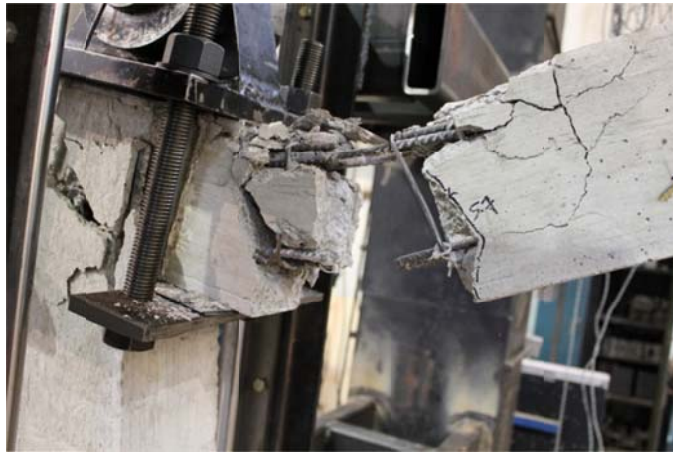
Figure 4.2.12: Bars fracturing near center column

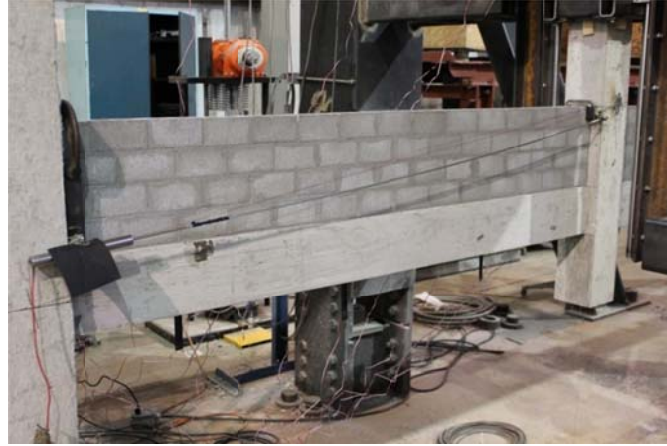
Figure 4.3.3: Diagonal LVDT

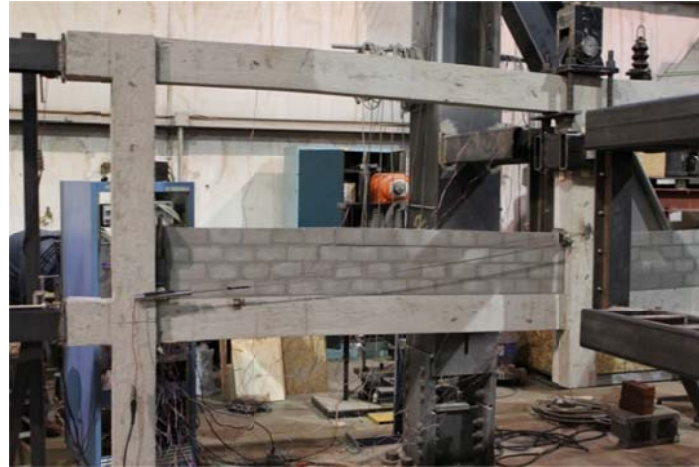
Figure 4.3.4: Infill wall frame forming cracks

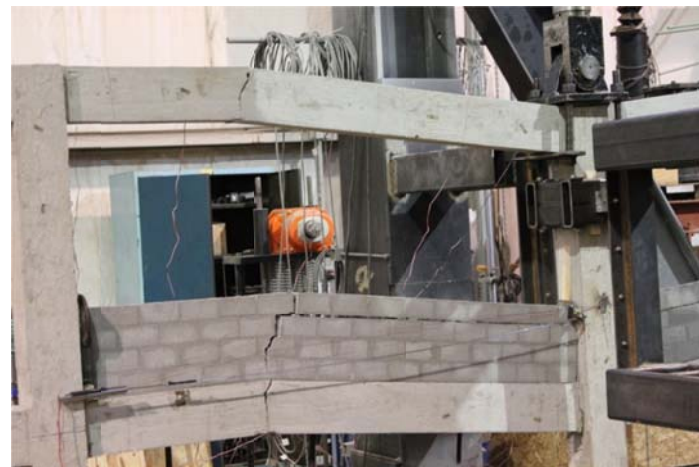
Figure 4.3.5: Infill wall frame cracks widening

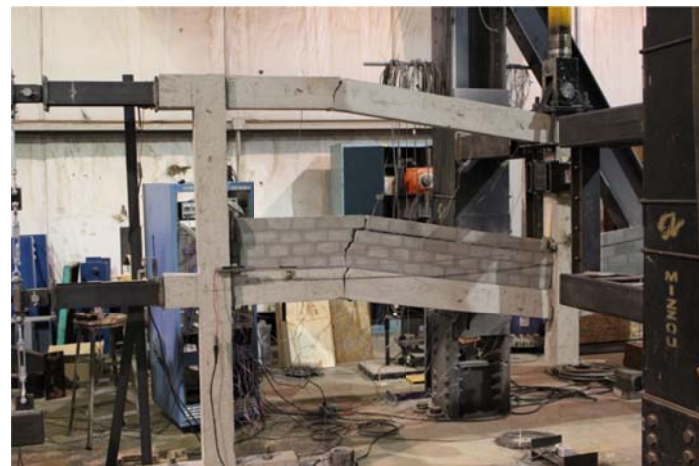
Figure 4.3.6: Infill wall frame forming hinges

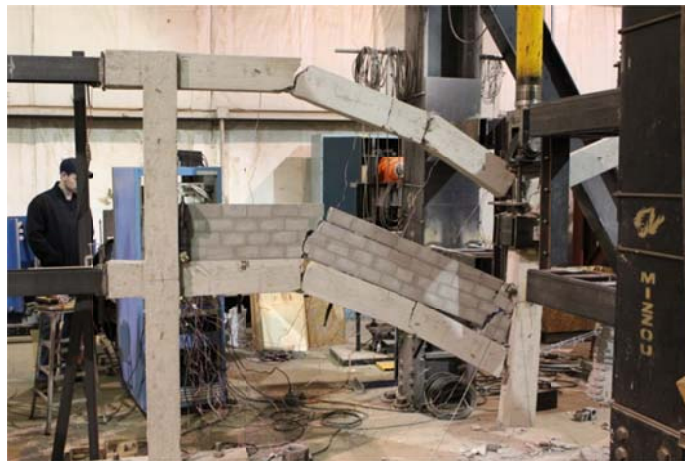
Figure 4.3.8: Infill wall frame at failure

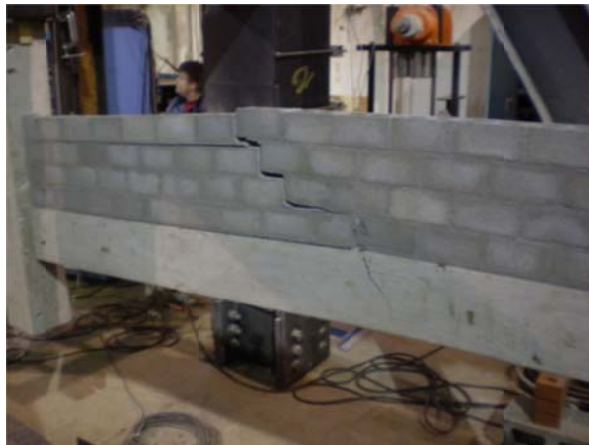
Figure 4.3.9: Crack forms in infill wall

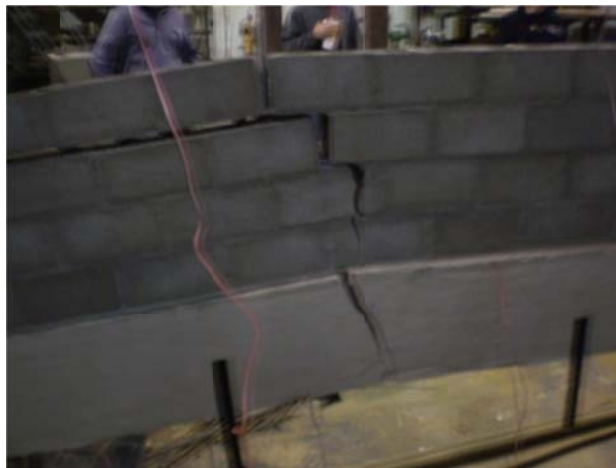
Figure 4.3.10: Crack propagates through beam

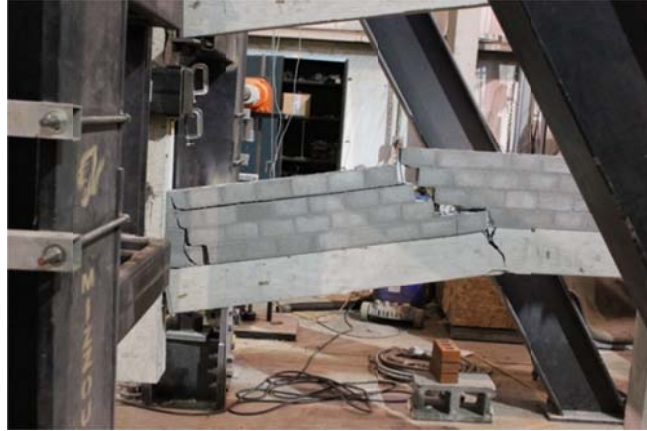
Figure 4.3.11: Crack widens and forms hinge

4.3.11) with little further cracking in the rest of the beam. As the load increased, the infill wall separated from the beam (Figure 4.3.12) and fell off. The frame reached ultimate failure when the negative moment bars tore through the stirrups (Figure 4.3.14).

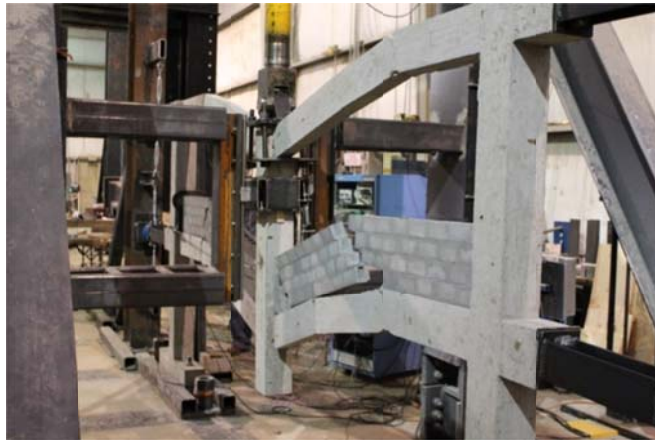
Figure 4.3.12: Infill wall is separated from beam

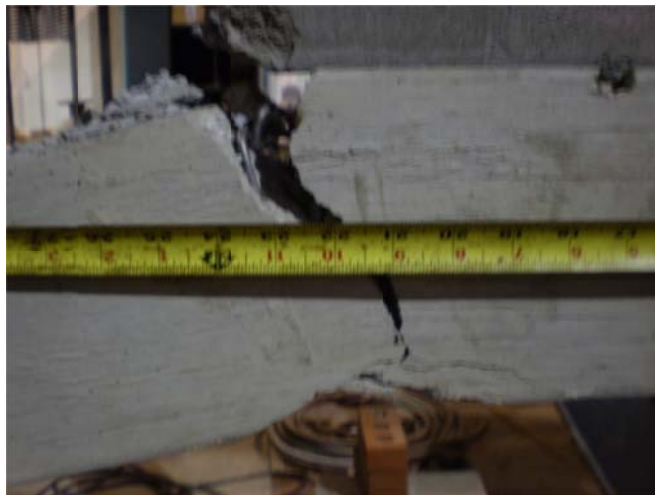
Figure 4.3.13: Crack formed where negative moment bars end

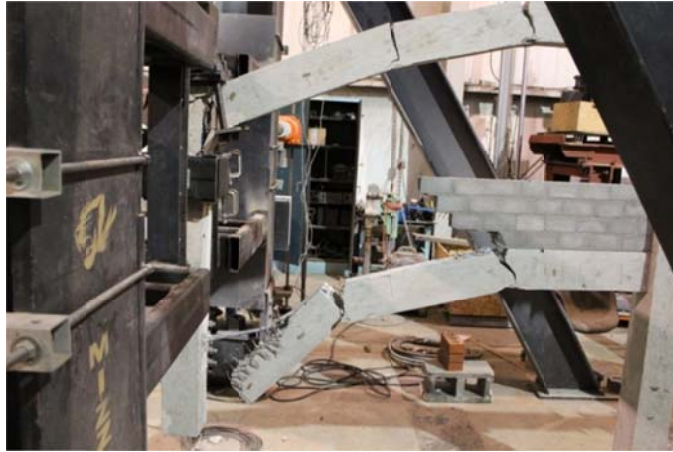
Figure 4.3.14: Negative moment bars have break through stirrups

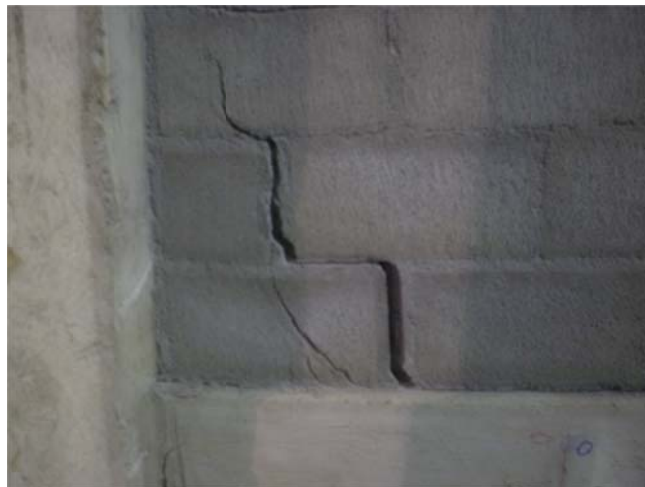
Figure 4.3.15: Initial crack near the center column

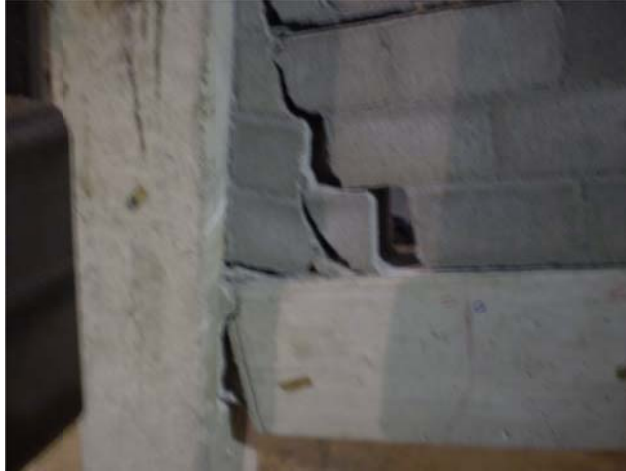
Figure 4.3.16: Crack propagates through beam and forms a hinge
