IMPROVING URBAN AIR AND STORMWATER QUALITY USING
PHOTOCATALYTIC HIGHWAY PAVEMENT AND
PHOTOCATALYTIC PERVIOUS
CONCRETE SHOULDERS

A THESIS IN
Civil Engineering

MASTER OF SCIENCE

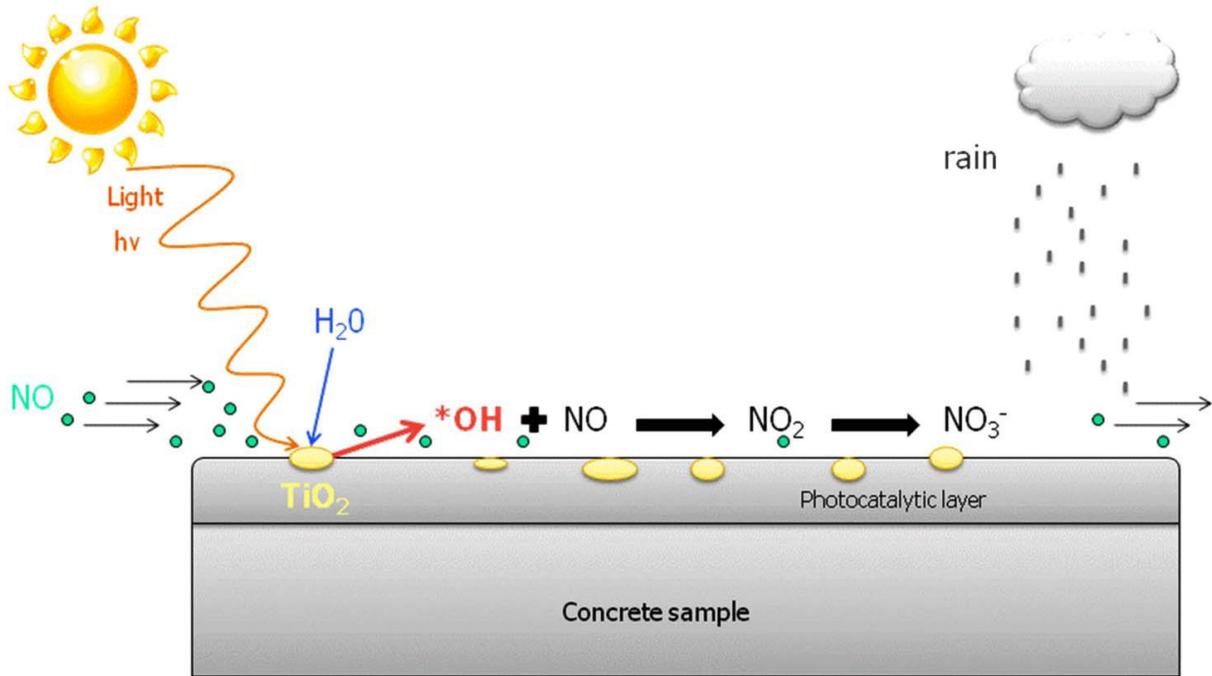
Figure 1. Photocatalytic oxidation of NO and NO₂ by concrete pavement containing TiO₂ (Dylla et al. 2011)

Research has shown that using the photocatalytic agents can reduce the levels of nitrogen oxides (NO_x) in the ambient environment, and with over half of NO_x being produced by mobile sources such as traffic emissions, efforts have been made to mitigate these emissions using TiO_2 (Dylla et al. 2011). In the presence of TiO_2 , the NO_x gasses, nitric oxide (NO) and nitrogen dioxide (NO_2) react to produce nitrate ions (NO_3^-), which washes away in the presence of water, as shown in Figure 1 (Dylla et al. 2011).

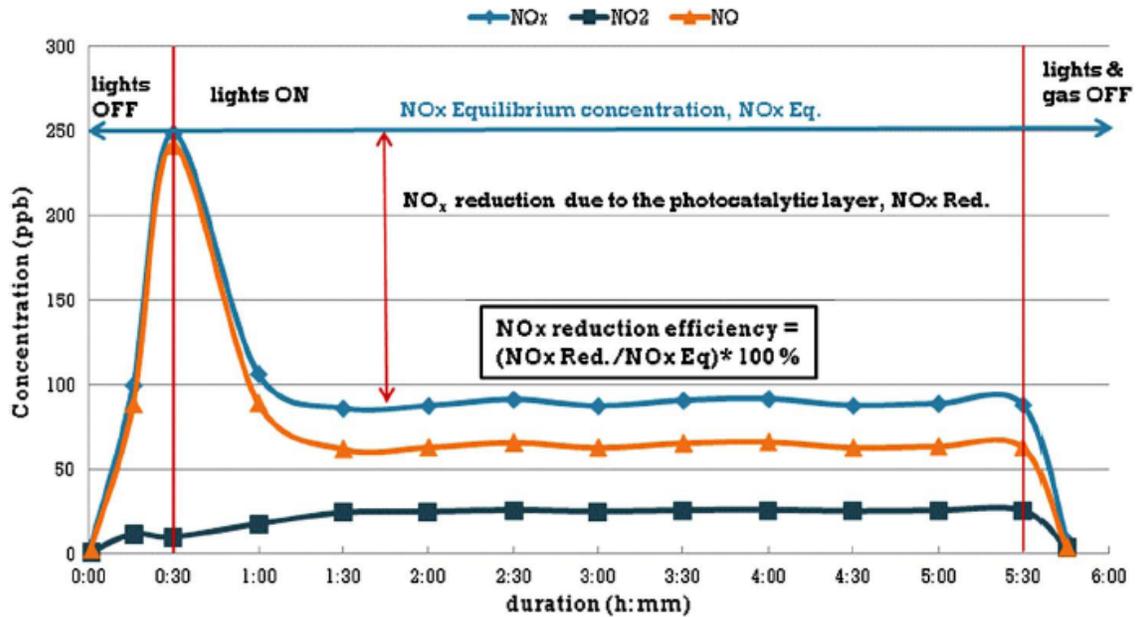
Figure 2. Reduction in NO_x due to TX Active Concrete (Dylla et al. 2011)

By knowing the total amount of NO_x within the atmosphere and the total NO_x after the ambient conditions have reached equilibrium, the total efficacy of the TX Active cements can be determined (Hasan et al. 2010). Figure 2 shows the reduction of NO_x due to the TX Active cements in a laboratory test (Dylla et al. 2011).

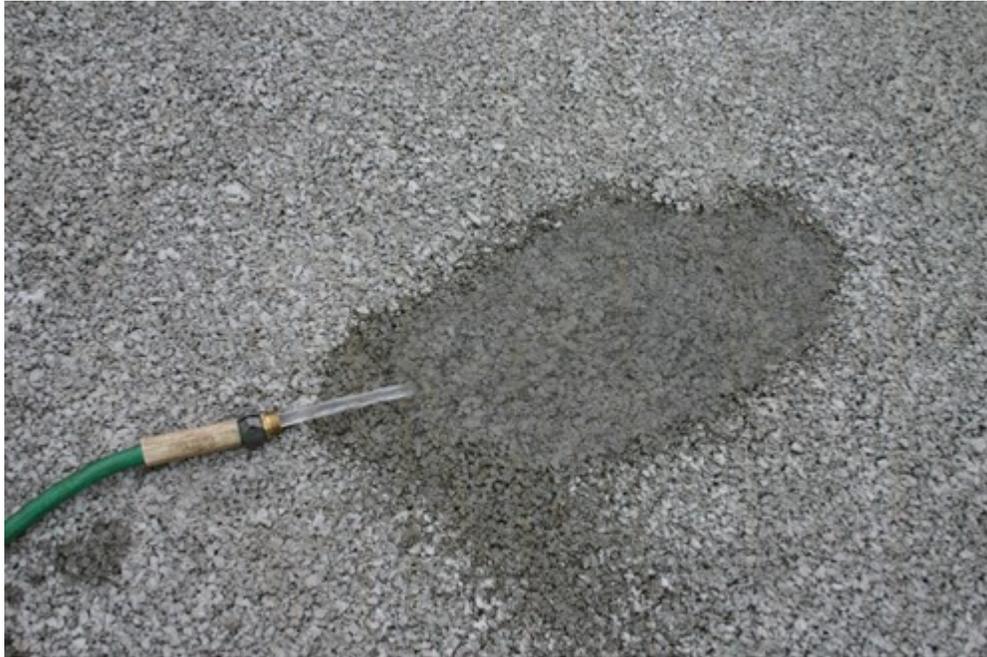
Figure 3. Water infiltration into a pervious concrete surface (Purinton Builders 2010)

Pervious concrete allows for water infiltration as shown in Figure 3 (Purinton Builders 2010). Similar to conventional concrete pavements, Portland cement pervious concrete (PCPC) is a concrete composed of cement, water, and aggregate, and is typically placed on an aggregate subbase; however, PCPC has little to no fine aggregate, and has a

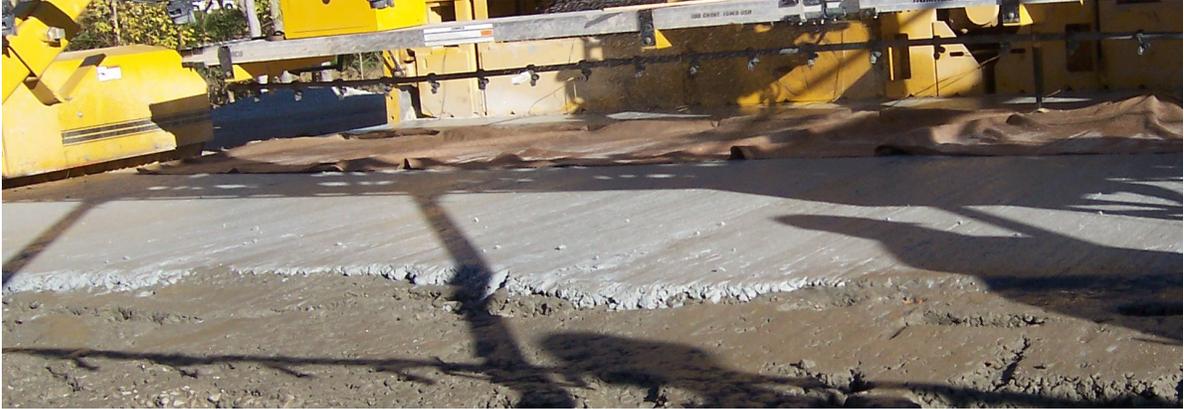
Figure 4. Two-lift pavement and the distinct top and bottom lifts

Two-lift paving is accomplished by paving a bottom lift of a thickness greater than two inches, consisting of a lower quality concrete and containing less cementitious material. The aggregate in the bottom lift is not required to have a high durability, and thus maybe recycled, low quality, and/or cheaper aggregate. Atop of the bottom lift is the premium concrete surface exposed to vehicle traffic and environmental loading, which is placed immediately after the bottom lift is placed and before the bottom lift sets. The top lift typically is approximately two inches thick, contains a high quality aggregate, and has a high durability and a high cementitious material content (Hall, 2007). By using less cement and recycled aggregate in the bottom lift, cost reductions could potentially justify the use of two-lift pavement, while the top lift maintains durability and pavement performance (Cable et al. 2004). An example of two lift pavement is provided in Figure 4, from the construction of this project.

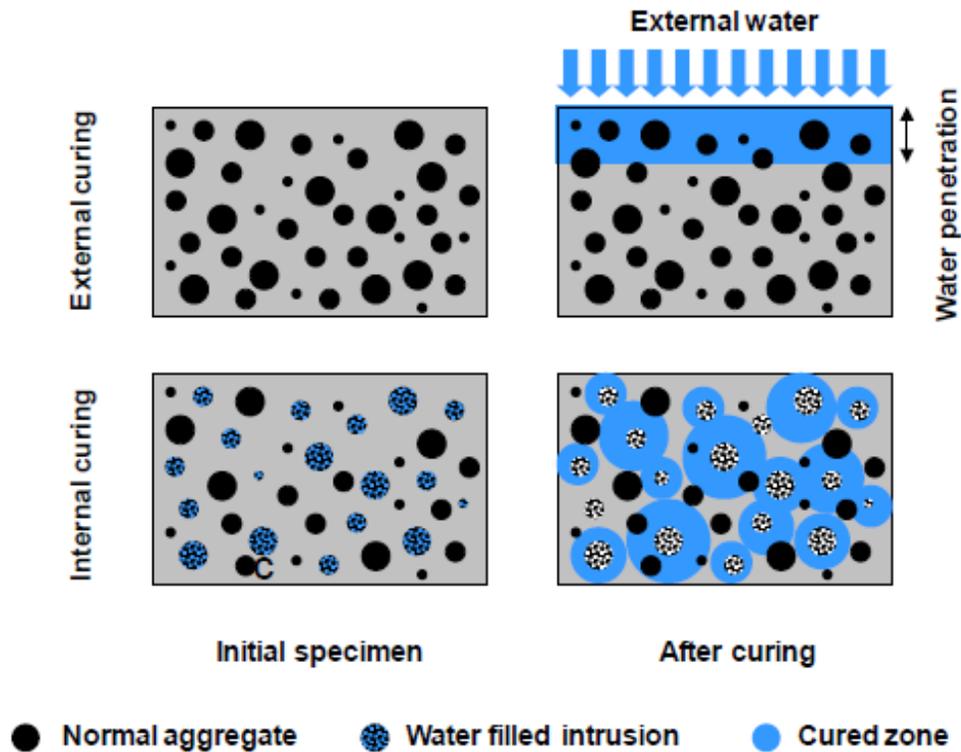
Figure 5. Internal VS. external curing in concrete and the effective area of each (Bentz et al. 2010)

EC introduces water to the surface to cure the concrete, and though this water may penetrate a few millimeters of the surface, the bulk of the material has lower moisture than required for curing. IC, on the other hand, disperses water throughout the concrete. From this, it is apparent that IC is more inclusive than EC. Furthermore, IC is not meant to replace EC, it is meant to work alongside it for the most adequate curing possible.

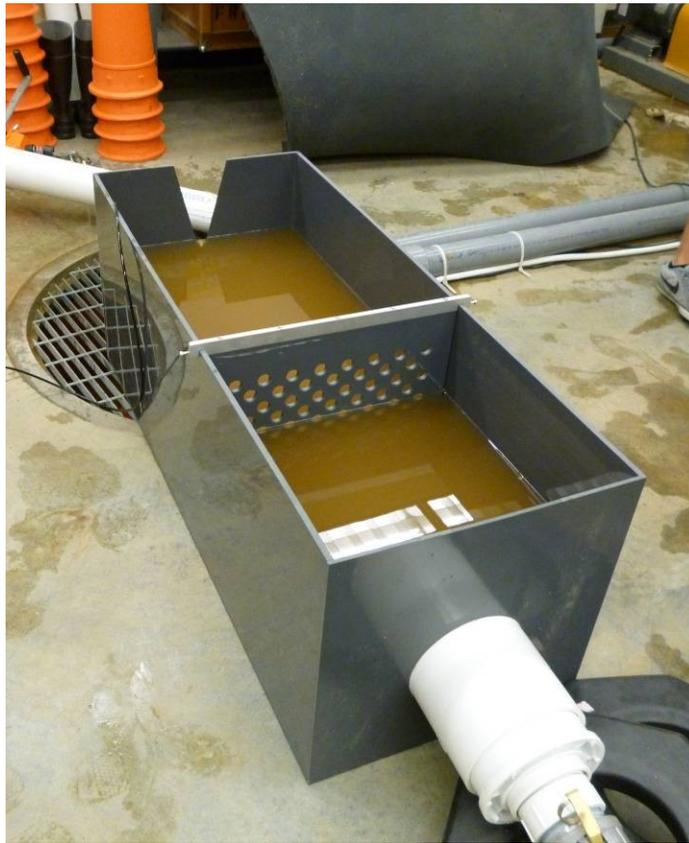
Figure 7. Lab calibration of weir box

The weir boxes were completed and then calibrated in a laboratory as shown in Figure 7. The results from this calibration are provided in Appendix A. The boxes were covered in the field, but opened during calibration for purpose of illustration.

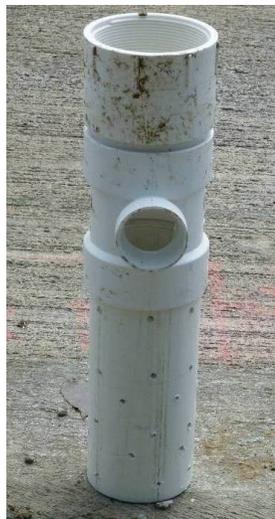
Figure 8. PVC perforated standpipe for instrument housing and water seepage

The depth of the water in the subbase/pervious concrete was also determined in order to compute the water storage capacity of the system as well as the water retention time of the pavement. The pressure transducers used were the same as those used in the weir boxes, and were calibrated similarly and set to collect data every five minutes as well. The pressure transducer was placed in a standpipe, shown in Figure 8; the purpose of the standpipe was to house the instruments and to allow water percolation into the pipe to obtain accurate readings of water depth and retention time. ASTM test standard C1701 “Standard Test Method for Infiltration Rate of in Place Pervious Concrete” was used to determine the infiltration rate of the pervious concrete.

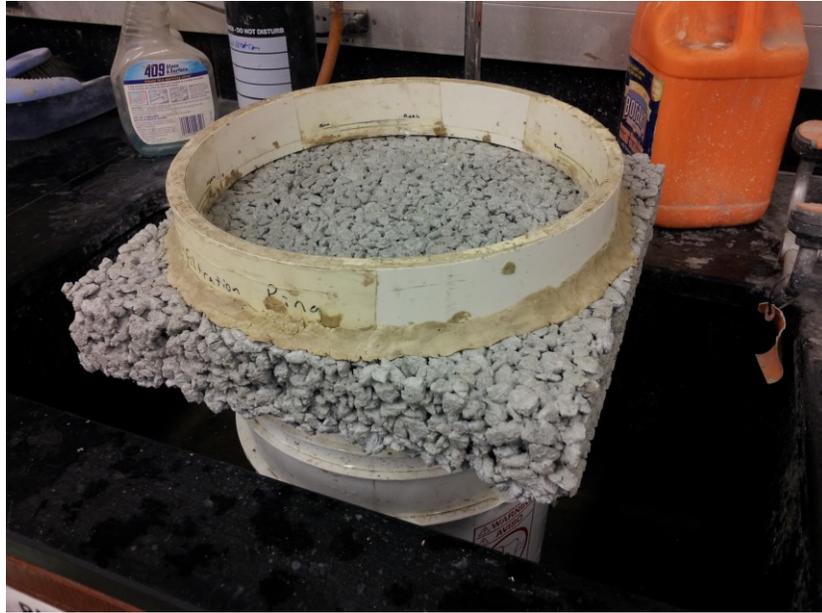
Figure 9. Infiltration ring to determine the rate of infiltration in pervious lab samples

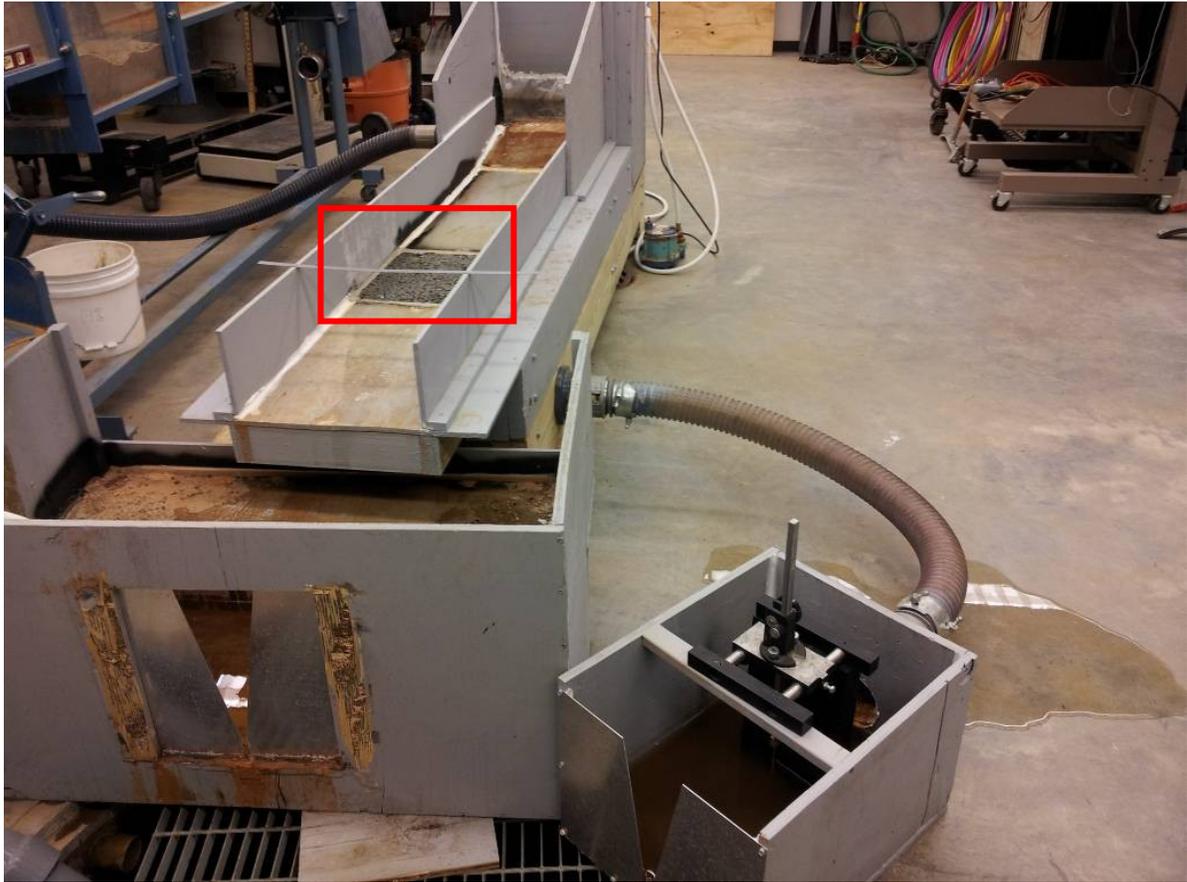
Figure 10. Flume used determine the infiltration rate of the samples (highlighted)

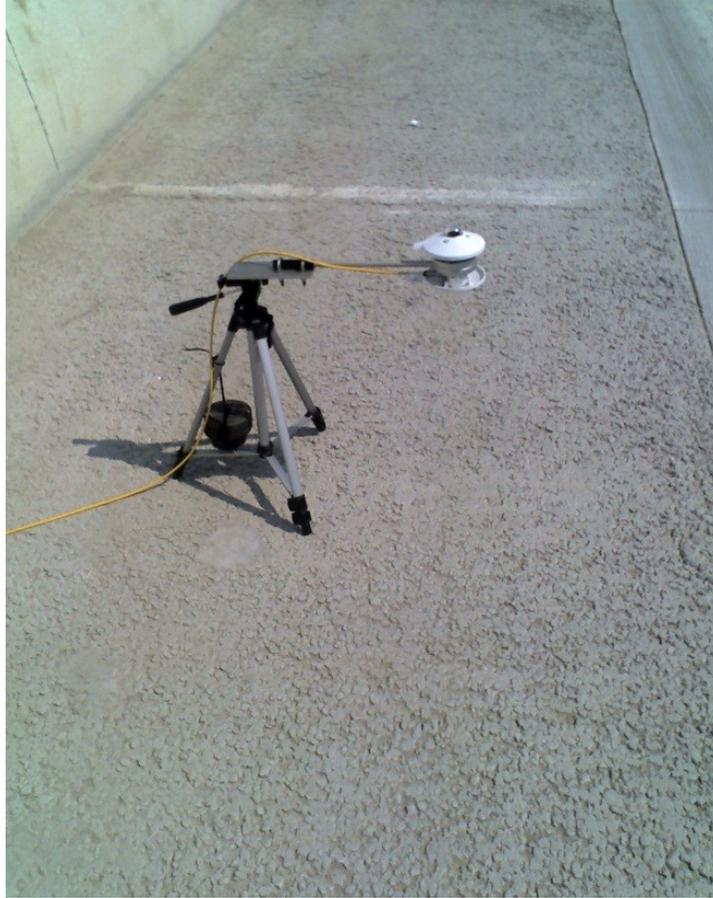
Figure 12. Albedometer composed of two pyrometers measuring initial reflectance of the pervious concrete pavement.

To determine the effect of the pavement profiles on the highway, T-wire thermocouples were installed into the pavements at differing depths to determine the temperature differences of the pavement due to the interaction of the differing layers. The T-wire sensors were connected to the CR1000 data logger, and the data collection rate was set to five-minutes. The pavements albedo was measured using an albedometer, composed of two Campbell Scientific CMP3 pyranometers, in order to determine the ratio of solar radiation reflected from the pavement with respect to the global solar radiation at the construction of the pavement. One of the two pyranometers measured the reflection of the pavement, while the other one measured the ambient ultraviolet radiation, as shown in Figure 12. This test was in accordance with ASTM E1918 “Standard Test Method for Measuring Solar Reflectance of Horizontal and Low Sloped Surfaces in the Field” (2006).

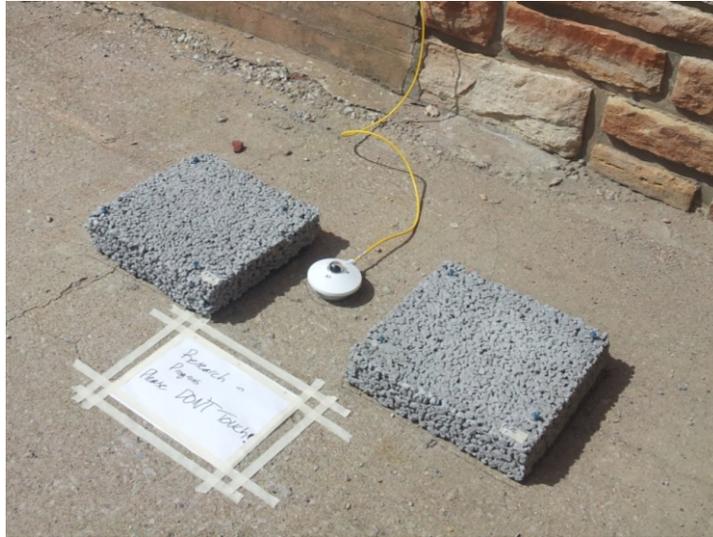
Figure 13. Samples placed outdoors with pyrometer recording solar radiation

The lab samples were placed outdoors for 6 days with a CMP3 pyranometer nearby to determine the solar intensity for the duration of the solar exposure of the samples, as shown in Figure 13. The samples were placed so as to absorb uninterrupted ultraviolet radiation, near a minor source of vehicle traffic to determine the air quality benefits of the photocatalytic sample.

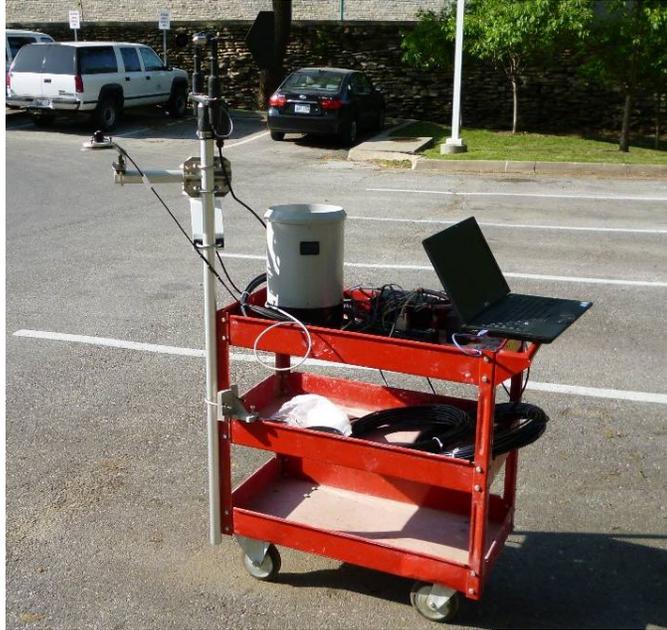
Figure 14. Weather station calibration prior to field installation

Weather data was collected for temperature, humidity, wind speed and direction, solar radiation, and rain intensity and duration. All of the equipment was manufactured by Campbell Scientific and was meant to work and be programmed with the CR1000 data logger to collect data every five-minutes. The temperature and humidity was determined using a CS215 temperature and humidity probe; wind speed and direction was determined using a RM Young 03002 wind sentry; solar radiation was determined using a CS300 pyronometer; and rain intensity and duration was determined using a TB4 tipping bucket rain gauge. Prior to installation, the equipment was verified to ensure proper operation. A figure of the lab verification is provided below in Figure 14.

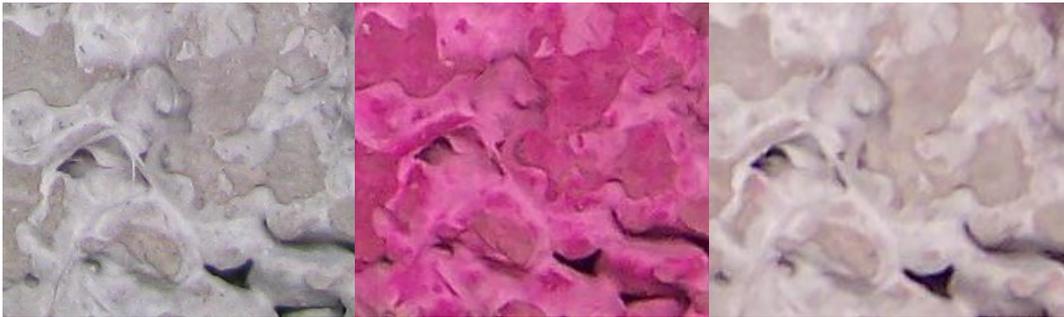
Figure 15. TX Active sample after placing (left), after painting with rhodamine dye (center), and after placing in sunlight and washing (right)

Color analysis was performed on TX Active pervious concrete cured with the same curing compound used in the field and colored with a rhodamine dye. The results of this test are provided in Figures 15 and 16.

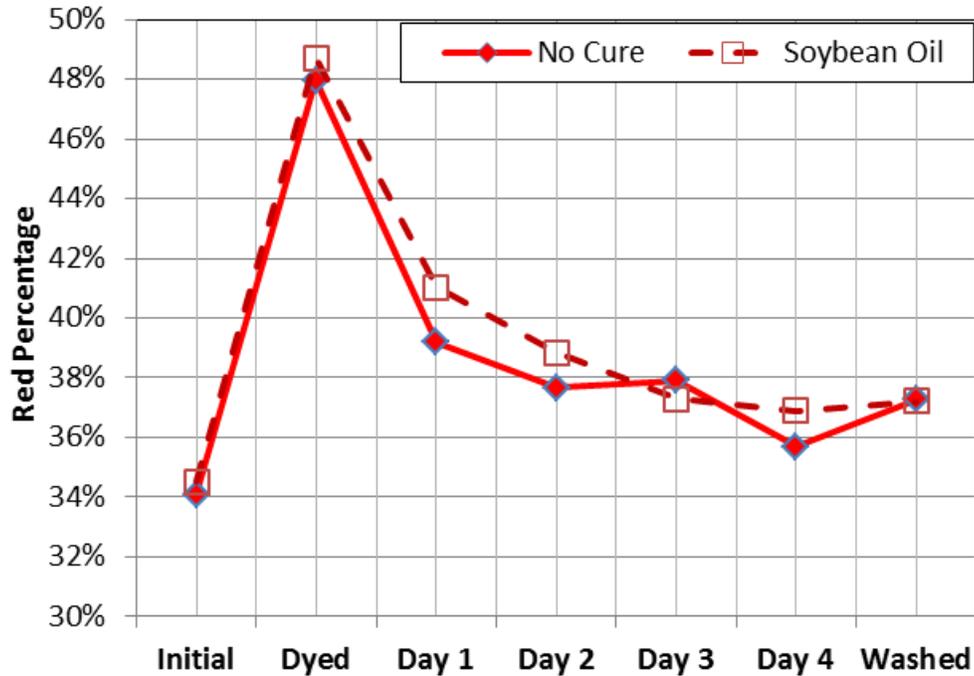
Figure 16. Color analysis of the rhodamine dye on TX Active pervious concrete

Color analysis was performed on a TX Active pervious concrete sample colored with rhodamine dye and cured with soy bean oil, similar to what was used in the field. The samples were placed outside for five days, and were photographed under the same condition after each day. The pictures were then analyzed using image analysis software.

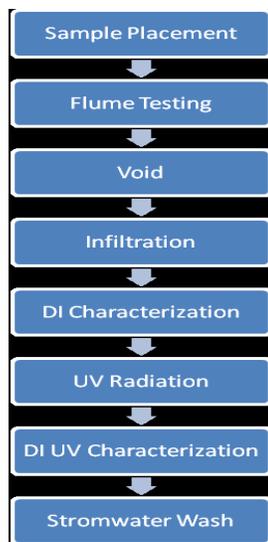
Figure 17. Flowchart of testing procedure

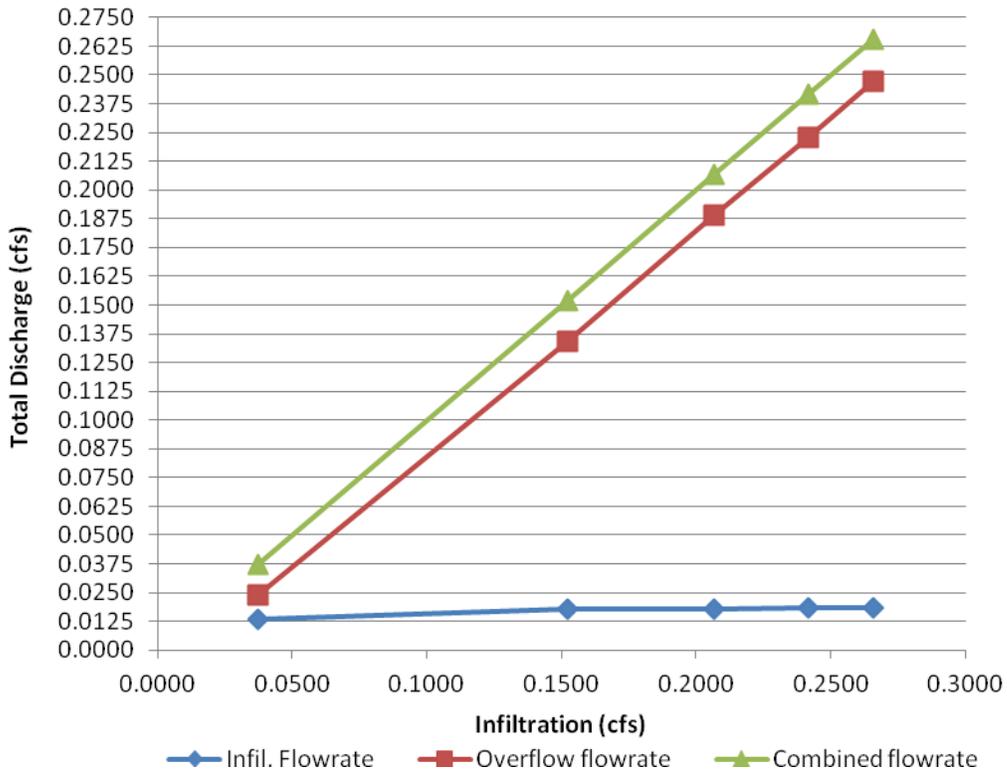
Figure 18. Infiltration rate of the Portland cement pervious concrete sample.

The infiltration rate diagrams show that the Portland cement pervious concrete sample had an infiltration rate that topped out at approximately 0.018 cubic feet while the rest of the water ran off the surface of the sample. The TX Active concrete sample diagram shows that the sample had allowed the infiltration of approximately 0.0400 cubic feet of water per second before any water ran off the sample. The infiltration rate then topped out at approximately 0.075 cubic feet of water per second.

The flume results are provided in Figure 18 for the PCPC and Figure 19 for the TXPC. The data associated with the flume is provided in Appendix B.

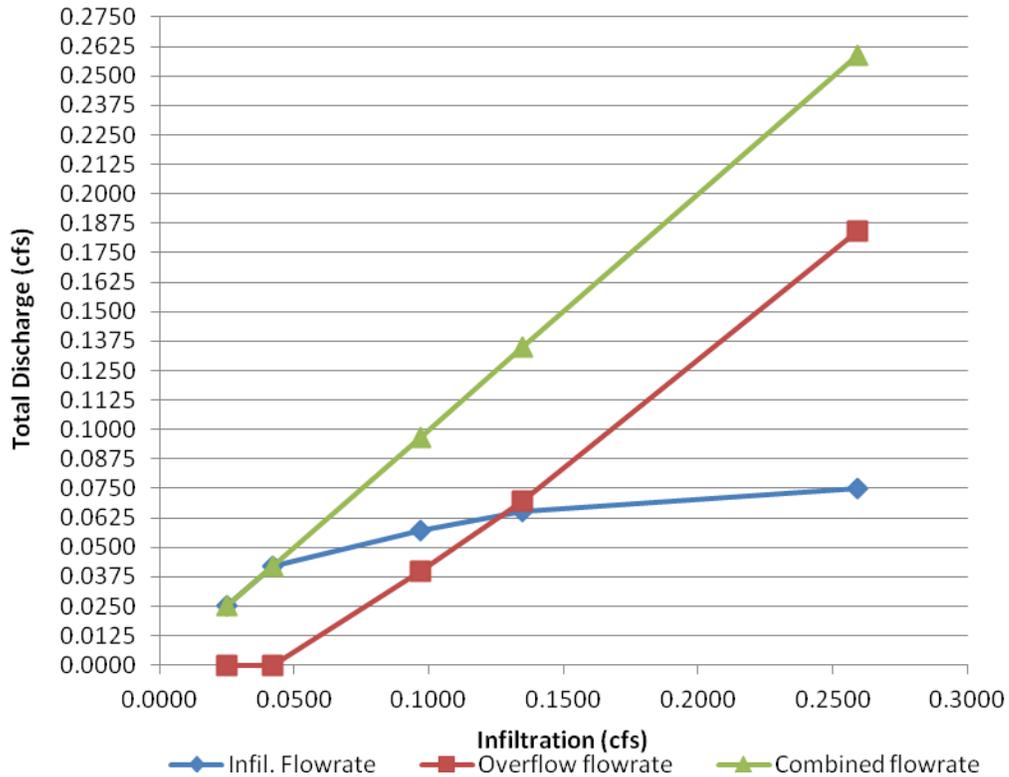
Figure 19. Infiltration rate of the TX Active pervious concrete sample

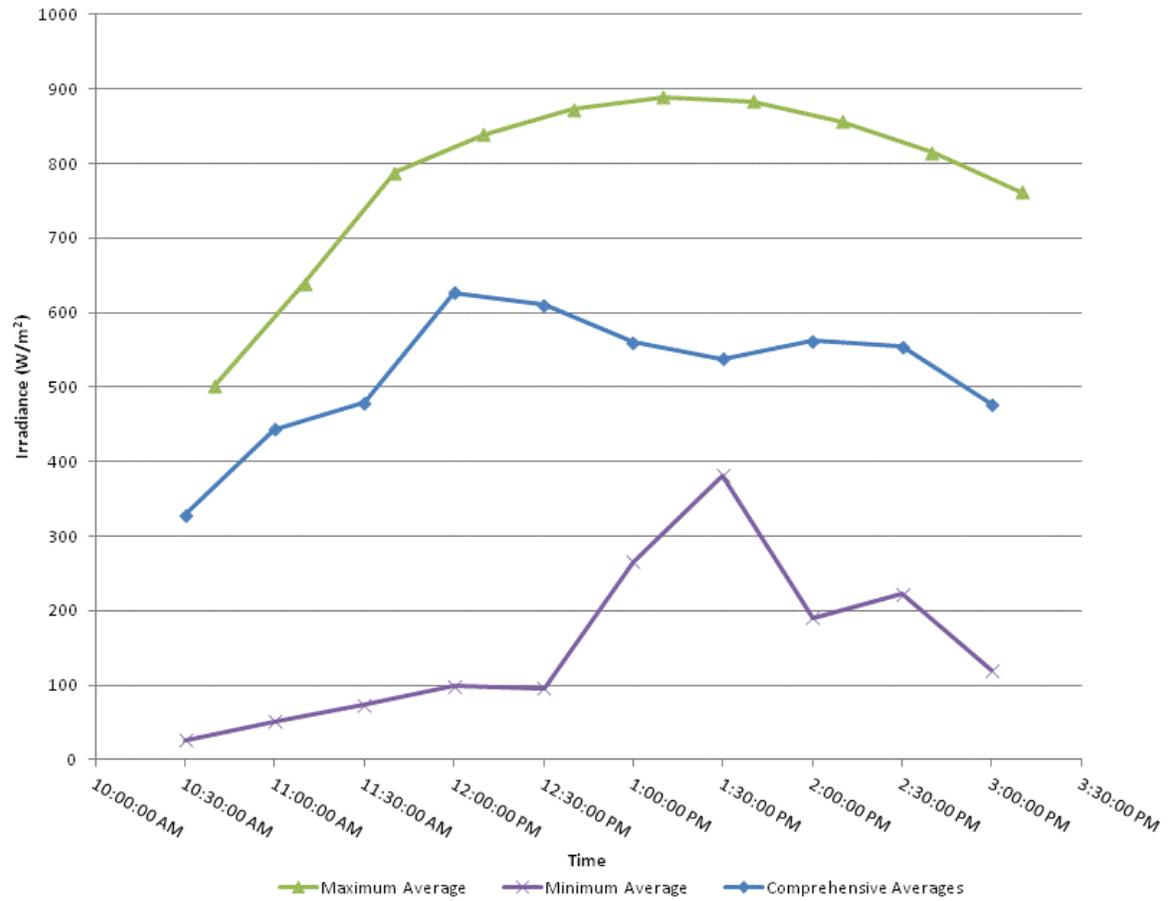
Figure 20. Solar radiation while the samples were placed outside

Figure 20 below presents the solar radiation of the days that the samples were placed outside. The results show the maximum radiation in one day, the minimum radiation in one day, and the average radiation amongst the six days.

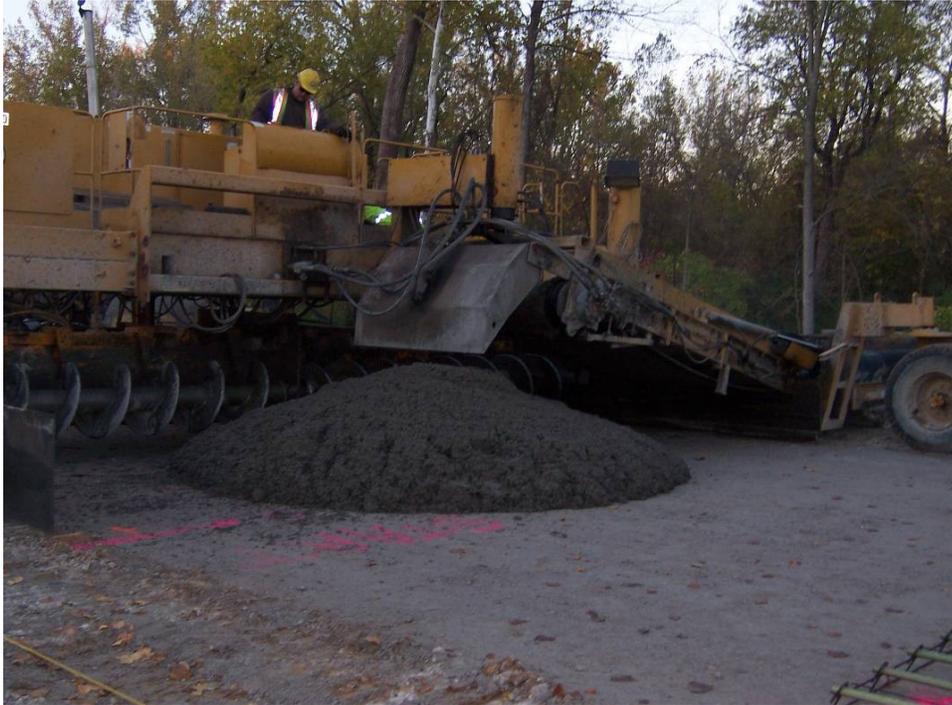
Figure 21. Concrete hauled in and placed with a belt placer

then placed on the base by means of a belt placer as shown in Figure 21, where it then passed a slipform paver, Figure 22. The bottom lift paving train was controlled and aligned using string line wire controls.

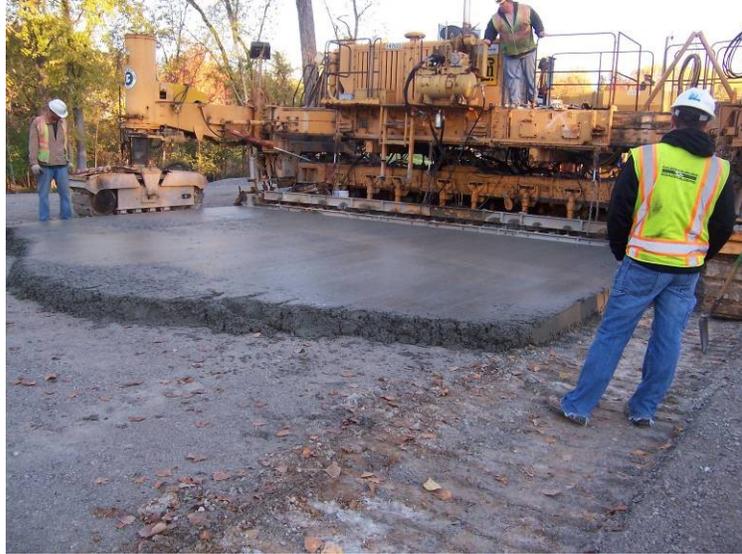
Figure 22. Slipformed bottom lift

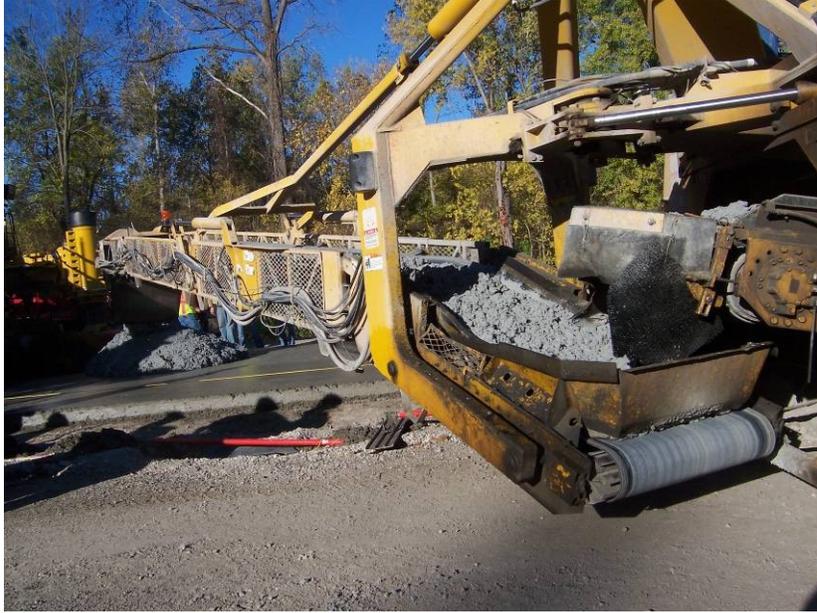
Figure 23. Top lift placed in an asphalt placer and spread using a conveyor system

The photocatalytically active top lift was placed using an asphalt materials placer as shown in Figure 23. The material was placed directly on top of the still fresh bottom lift where a second slipform paver processed the top concrete as shown in Figures 24 and 25. The top lift paver was controlled using a stringless guided system; the robotic total stations are shown in Figure 26. To minimize confusion of materials since both paving trains were operating simultaneously; trucks were unloaded on differing sides of the highway. The final stage of the paving train after mechanical and manual screeding of the top lift was the application of a curing compound with a cure cart.

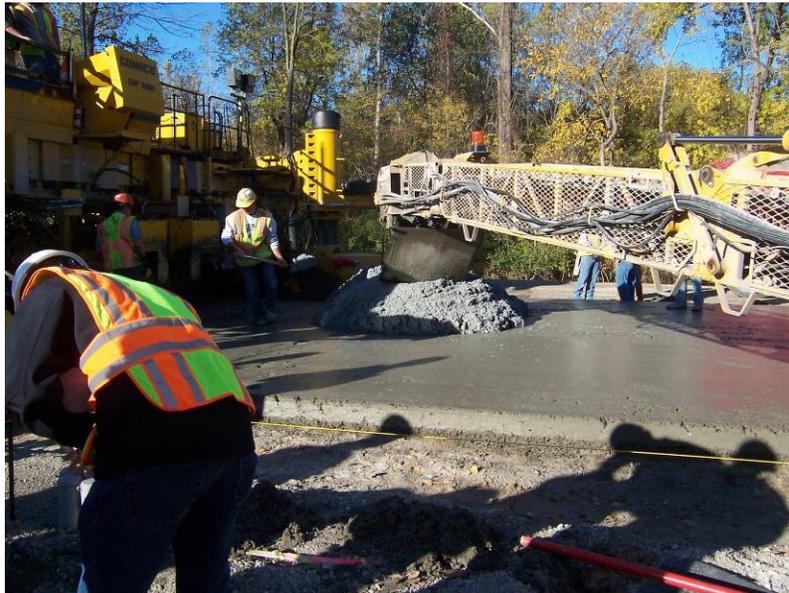
Figure 24. Top lift to be processed by slipform paver

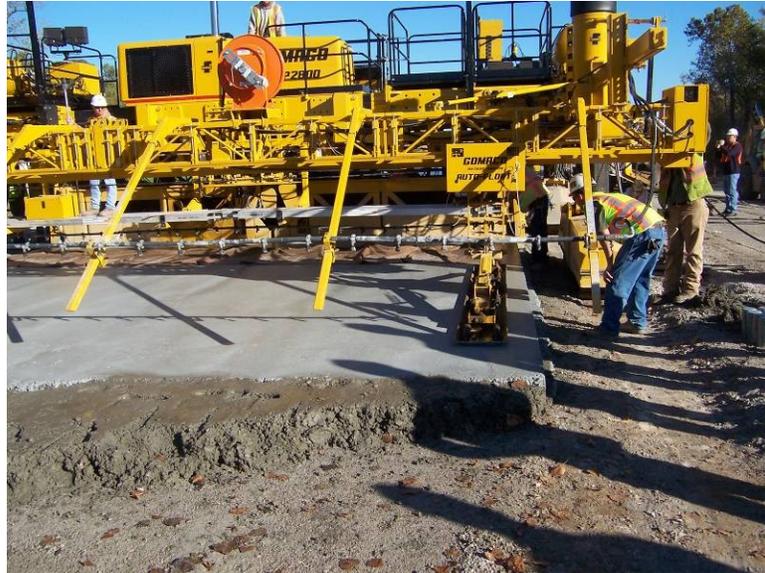
Figure 25. Top lift after paver operation

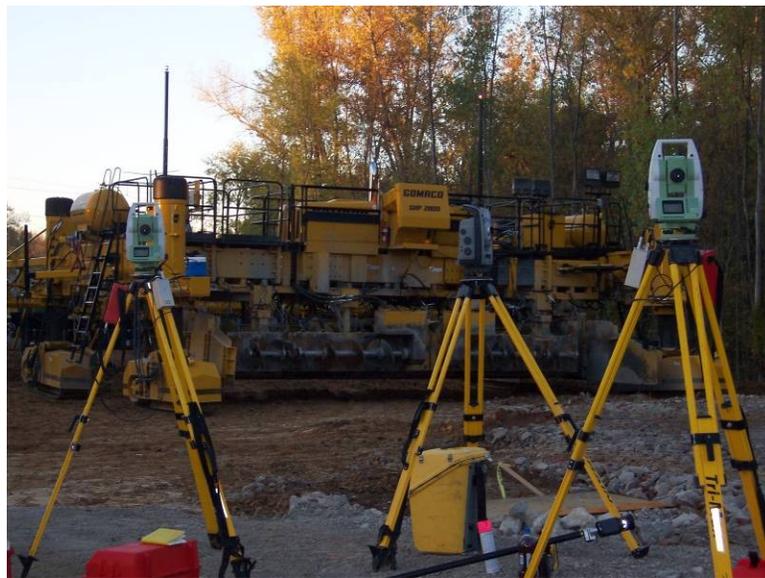
Figure 26. Robotic total stations controlling stringless paver

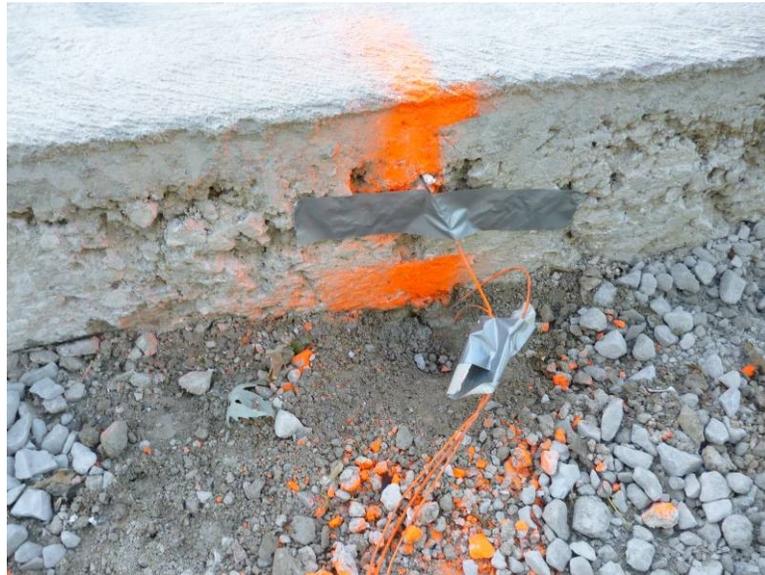
Figure 27. T-wire thermocouples placed in the mainline pavement

After the initial two lift paving construction and other construction efforts such as grading the base, placing conventional shoulders, paving the northbound lanes, and placing Jersey barriers between the lanes were completed, the next phase of the UMKC research team was to begin placing instruments for data collection. This included placing instruments in the mainline and in the base beneath the pervious concrete. The instruments placed in the mainline were T-wire thermocouple wires, Figure 27. The instruments placed in the base include a perforated polyvinyl chloride (PVC) standpipe previously shown in Figure 8, and Figure 28 shows the field placement of the pipe. The standpipe housed a pressure transducer and T-wire thermocouples as shown in Figure 29.

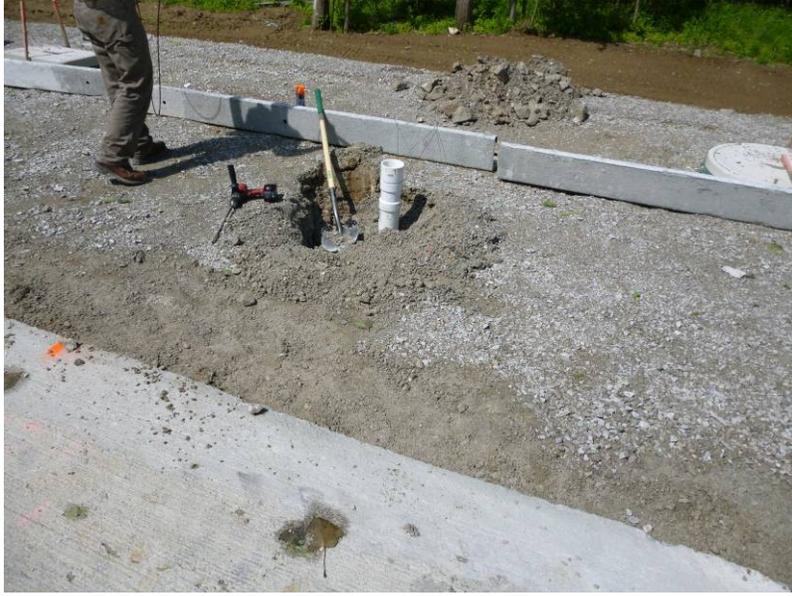
Figure 28. Standpipes final placement

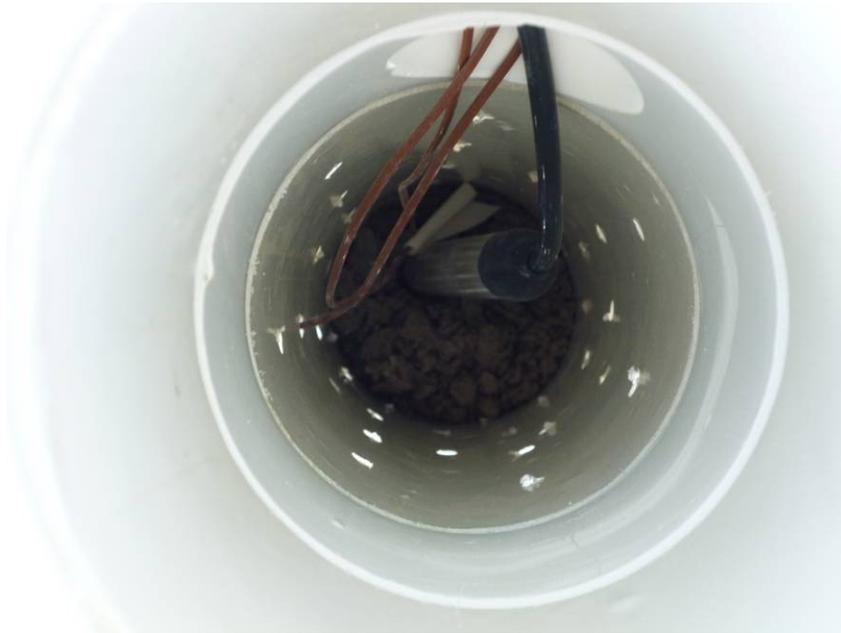
Figure 29. Standpipe in place and housing instruments

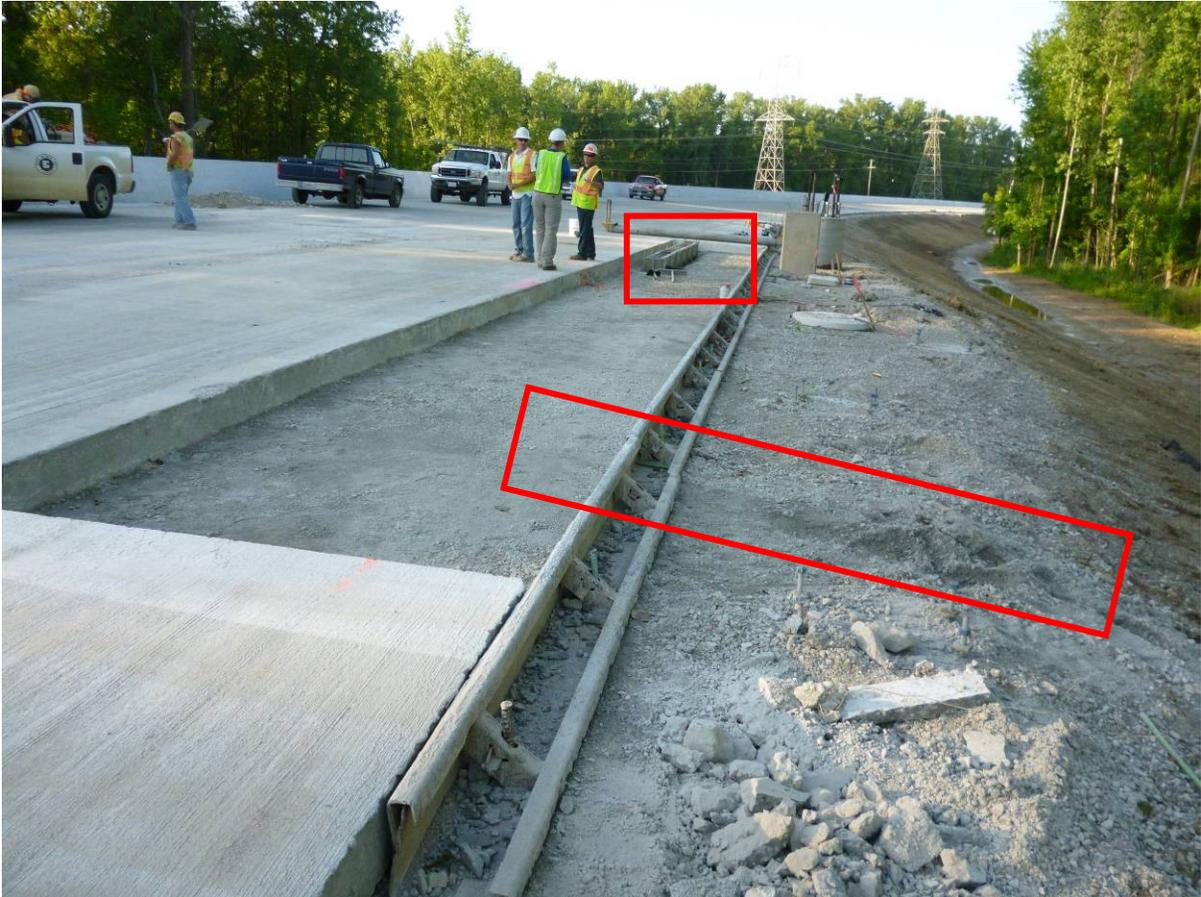
Figure 30. Completed formwork and the (highlighted) drainage systems.

After placing the instruments, and completing the drainage systems and placing the formwork for the shoulders as shown in Figure 30, the following step in the procedure was the paving of the pervious shoulders.

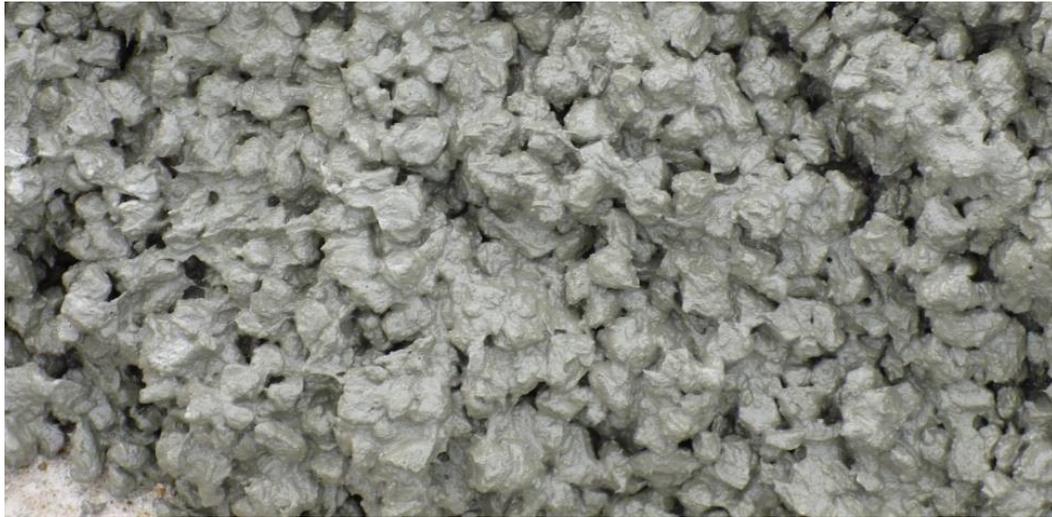
Figure 31. Final pervious concrete mix during test trial

In order for the final placement of the pervious concrete shoulders to take place, a trial placement was needed, as shown in Figure 31.

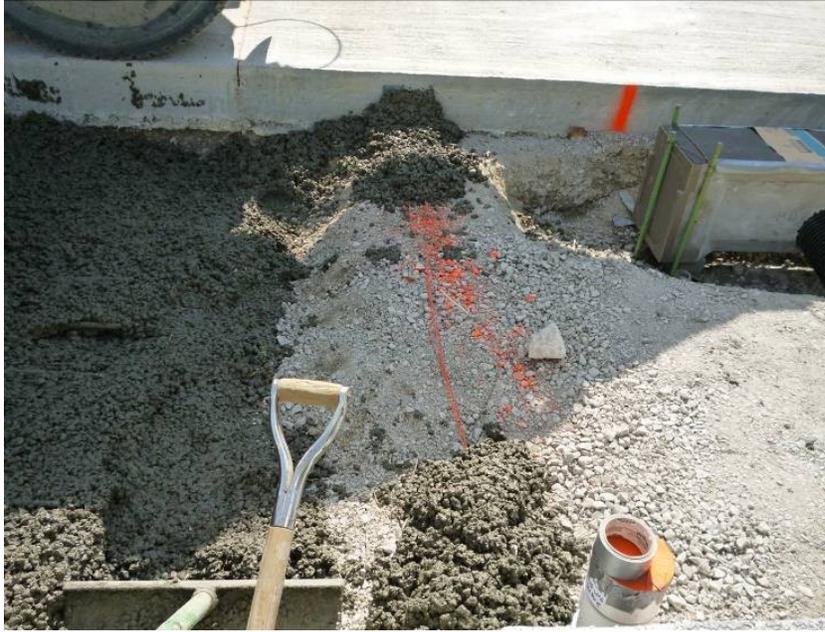
Figure 32. Protecting wires and filling in low spots with material

The pervious concrete shoulders were paved on the 3rd of May, 2012. The pervious concrete was hauled on site using agitator trucks, at approximately 10 cubic yards per load. The conventional pervious concrete was the first to be placed, followed by the photocatalytic pervious concrete. To protect the equipment and wires, concrete was placed so as to cover the delicate items and to fill in gaps and holes prior to placing as shown in Figure 32. The material was spread using the agitator truck chute and hand tools, Figure 33, and was finished using a roller screed, Figure 34. Finishing around the tile drain and other difficult to reach areas was completed by hand as shown in Figure 35. After paving over the standpipe, the concrete was removed from the surface exposing the pipe as shown in Figure 36. After finishing, the shoulders were sprayed with a curing compound using a small pump sprayer as depicted in Figure 37.

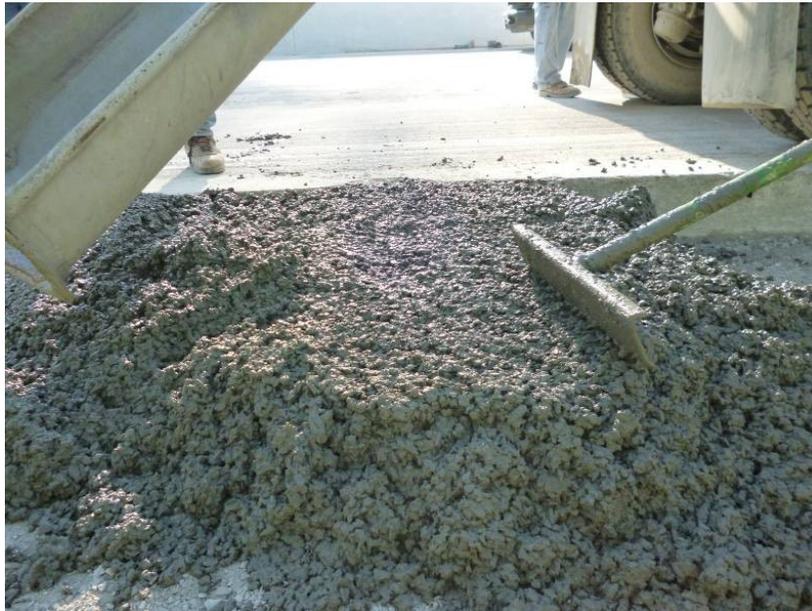
Figure 33. Placing concrete using truck chute and hand tools

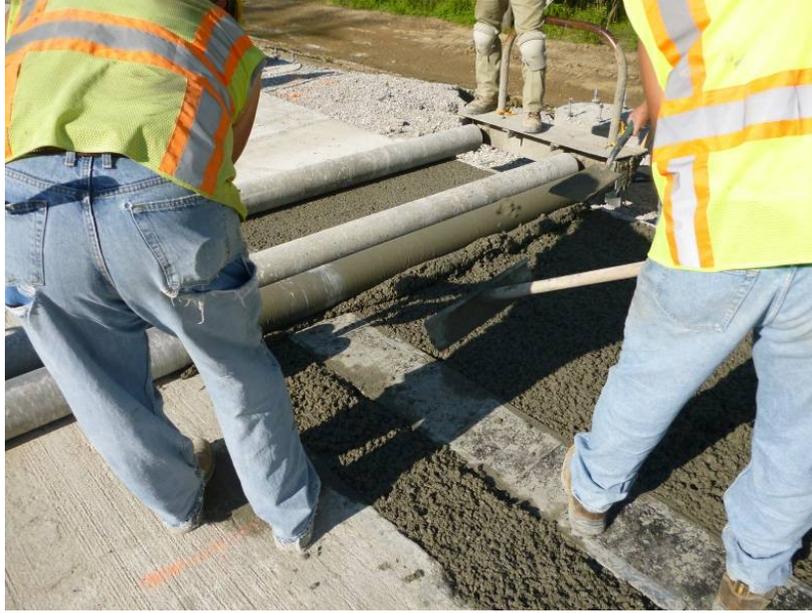
Figure 34. Roller screed finishing

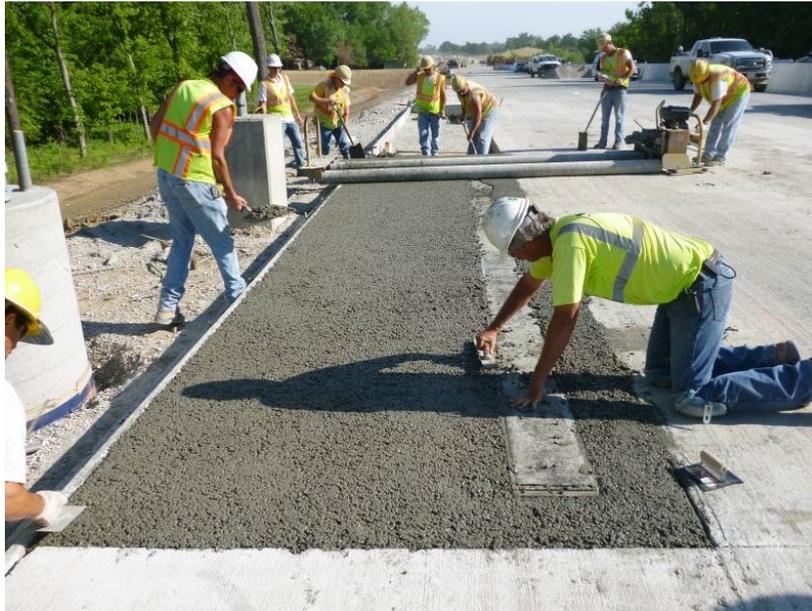
Figure 35. Hand finishing around tile drain
