IMPROVING URBAN AIR AND STORMWATER QUALITY USING
PHOTOCATALYTIC HIGHWAY PAVEMENT AND
PHOTOCATALYTIC PERVIOUS
CONCRETE SHOULDERS

A THESIS IN
Civil Engineering

MASTER OF SCIENCE

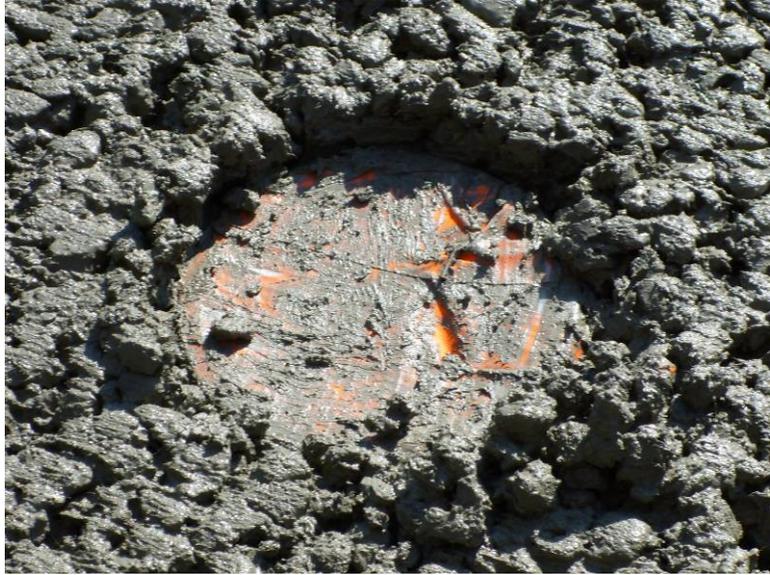
Figure 36. Uncovering standpipe

The pervious concrete shoulders were paved on the 3rd of May, 2012. The pervious concrete was hauled on site using agitator trucks, at approximately 10 cubic yards per load. The conventional pervious concrete was the first to be placed, followed by the photocatalytic pervious concrete. To protect the equipment and wires, concrete was placed so as to cover the delicate items and to fill in gaps and holes prior to placing as shown in Figure 32. The material was spread using the agitator truck chute and hand tools, Figure 33, and was finished using a roller screed, Figure 34. Finishing around the tile drain and other difficult to reach areas was completed by hand as shown in Figure 35. After paving over the standpipe, the concrete was removed from the surface exposing the pipe as shown in Figure 36. After finishing, the shoulders were sprayed with a curing compound using a small pump sprayer as depicted in Figure 37.

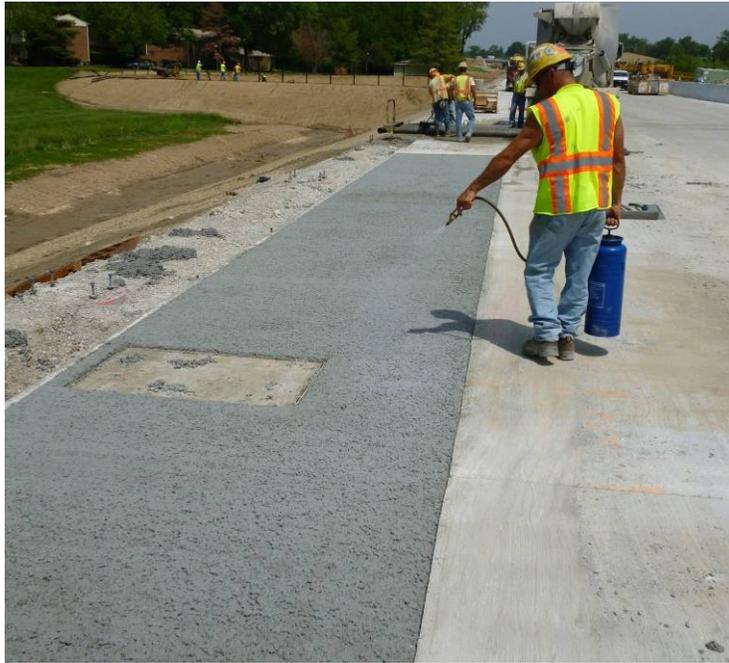
Figure 37. Hand pressurized cure spray

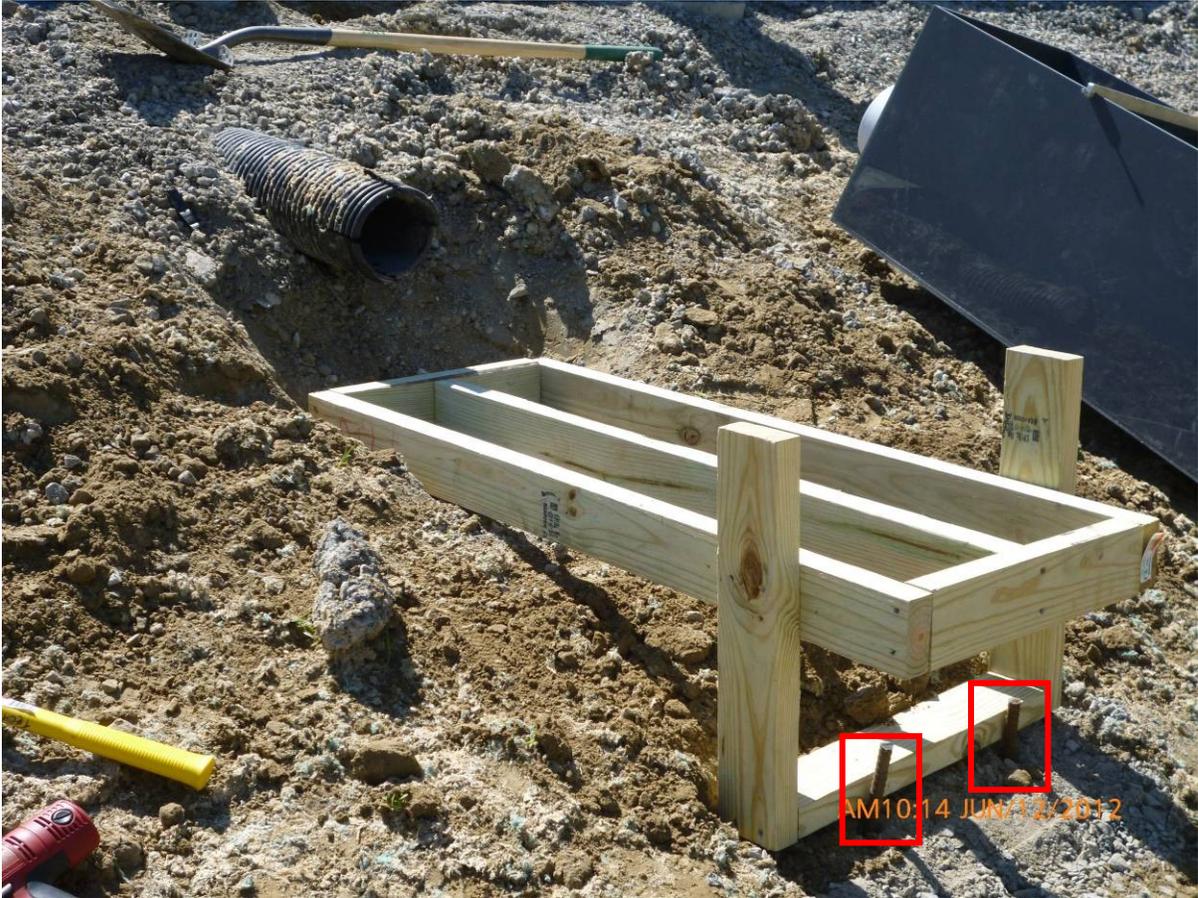
Figure 38. Wooden weir box support and reinforcing steel

The weir boxes were connected to the pipes daylighted from the pervious concrete sections, and were installed on wooden foundations to protect and level the boxes as shown in Figure 38. Steel reinforcing bars (rebar) were placed in front of the wooden foundations to prevent sliding, highlighted in Figure 38, and steel shelf brackets were attached onto the boxes and placed in the ground, as shown in Figure 39. The rebar pieces used were 18-inches long and the steel brackets were approximately 3-feet long. The PVC weir boxes originally were covered with PVC lids; however, due to climatic conditions including excessive heat and sunlight, the PVC lids were replaced with wooden lids at the presence of warping, as represented in Figures 40. The lids, along with the wooden foundations, also served the purpose of supporting the box from bulging when filled with water.

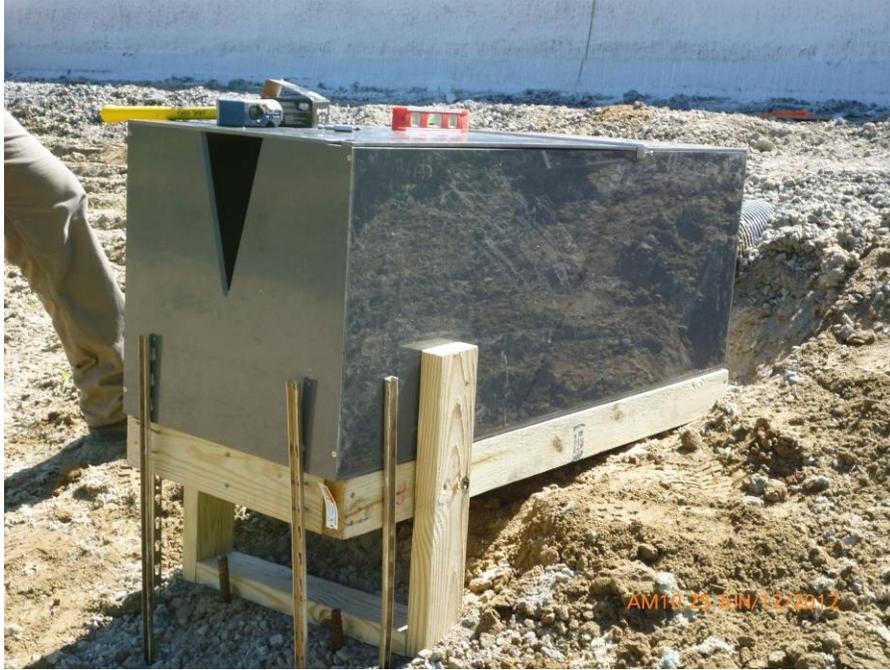
Figure 39. Steel shelf brackets attached to the weir boxes to prevent slippage.

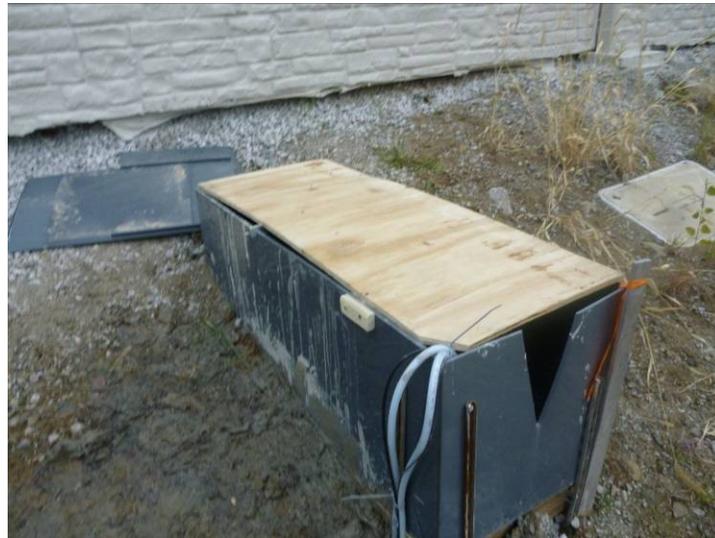
Figure 40. Wooden lid protecting the weir box from the elements

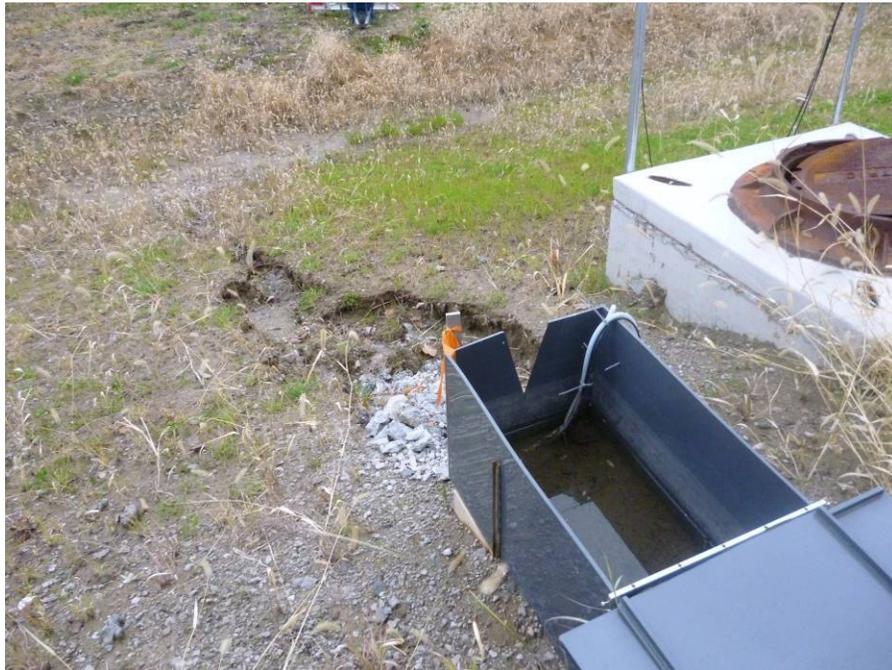
Figure 41. Rearview of aggressive erosion due to water discharge from weir box

In order to further protect the weir boxes and the drainage ditches slope, riprap was placed beneath the boxes and at the base of the water discharge. This was repeated multiple times as the water flanked the slope differently each time that riprap was applied. Figure 41 and 42 below represent the finalized slope stabilization executed for one of the more aggressively eroded weir box locations.

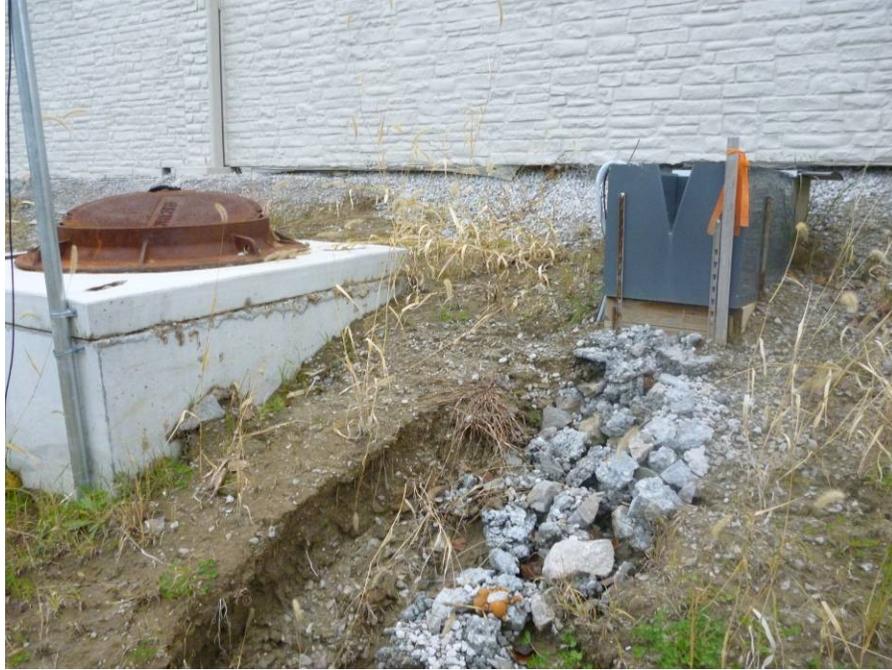
Figure 42. Riprap placement to protect drainage ditch slope from erosion

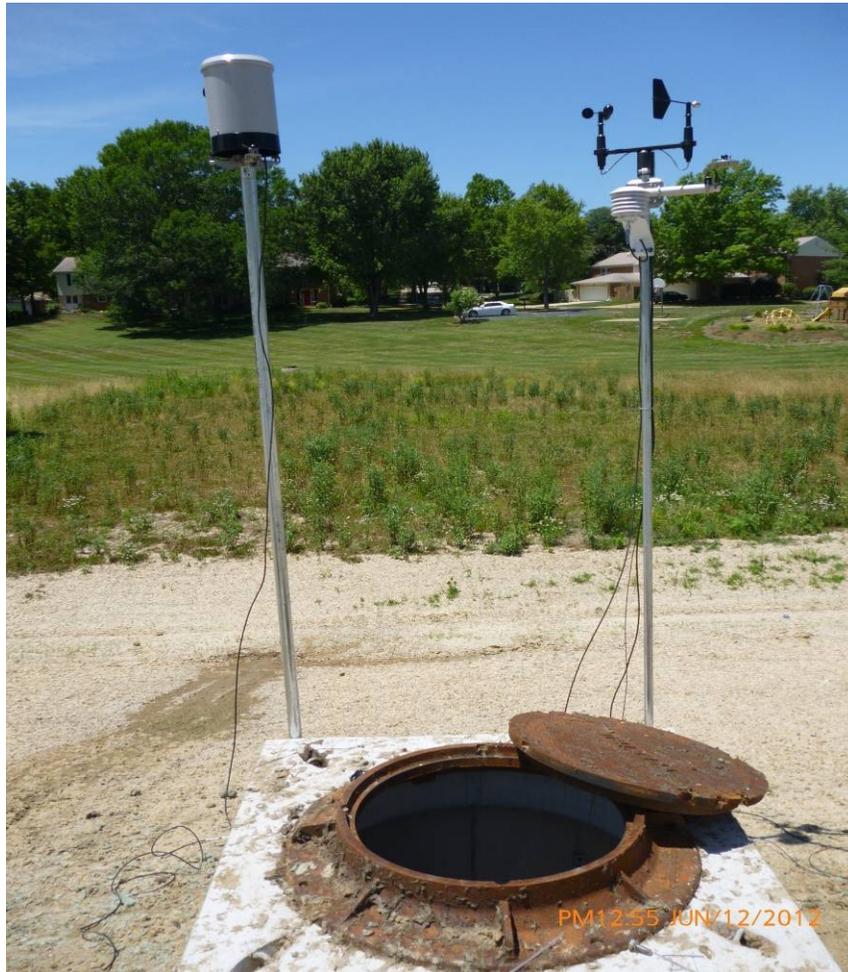
Figure 43. Weather station mounted directly to the vault, prior to moving the wind sentry

reason for the move was the fact that the sound wall was not constructed as of the initial instrument placement.

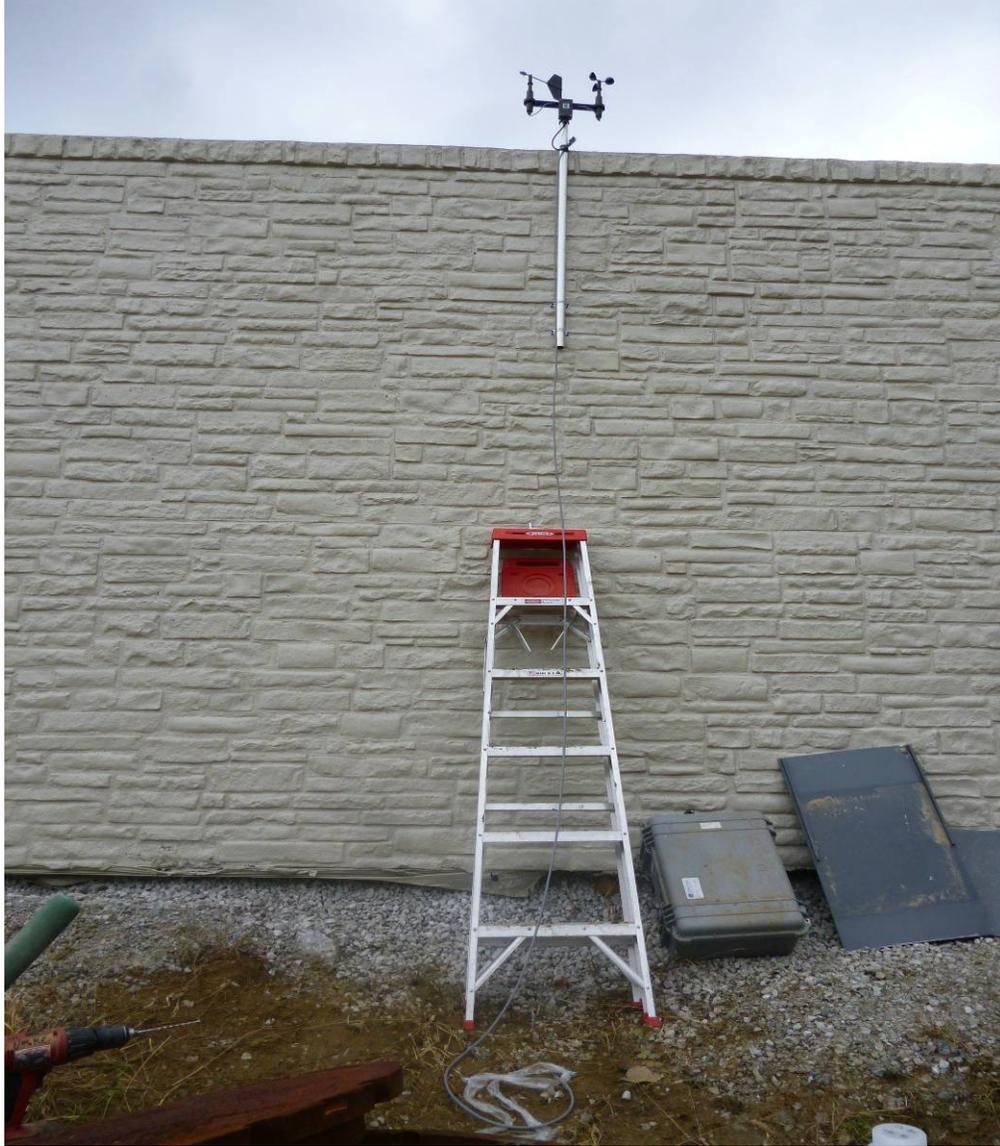
Figure 44. Wind sentry moved directly to the sound wall

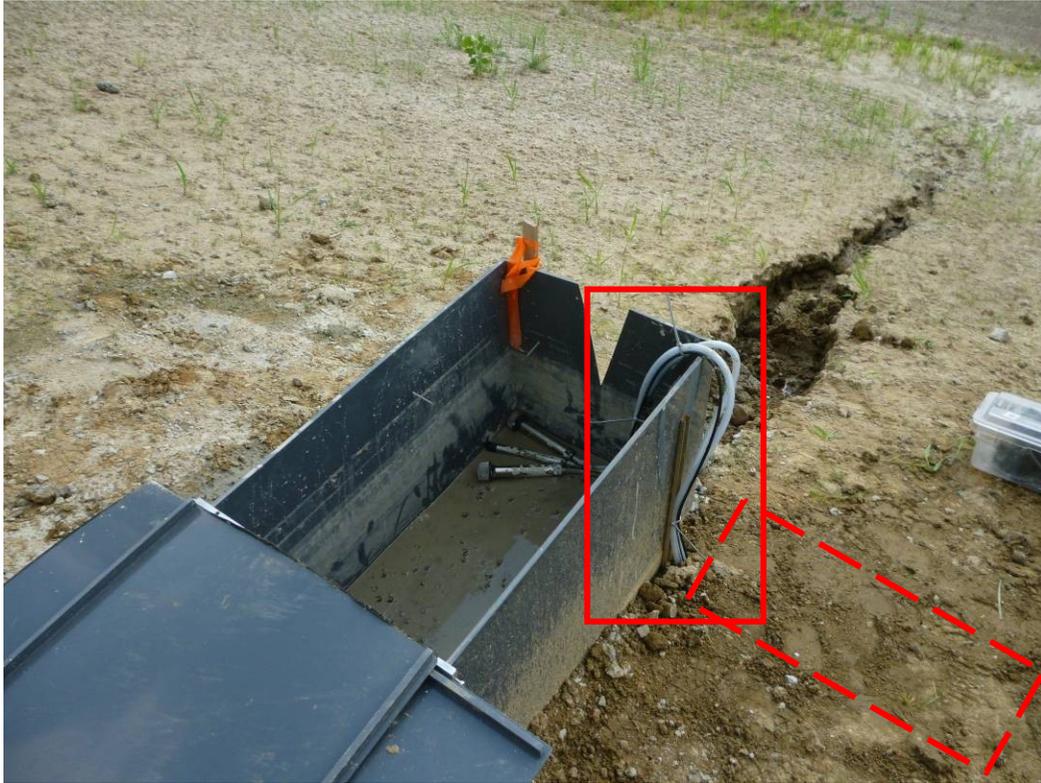
Figure 45. Wires and hoses buried and trenched to the concrete vault

The water sampler hose was trenched from the weir boxes to the appropriate vaults, as were all of the T-wire thermocouples, pressure transducer wires, and moisture sensor wires for the water samplers. The hoses and wires from the weir boxes are shown in Figure

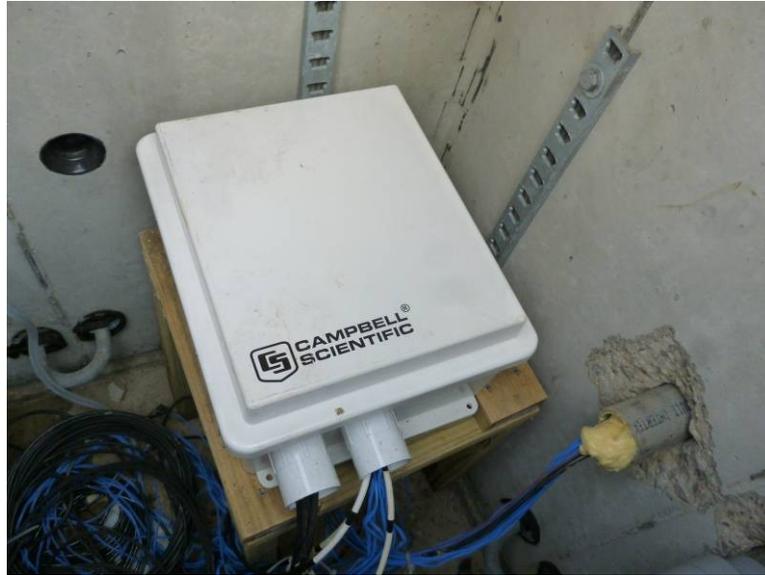
Figure 46. Slot for wire and hose insertion within the concrete vault

45. All of the wires were inserted into the vaults from slots installed into the concrete prior to installation, as shown in Figure 46. Also depicted in the figure is the fact that the slots were sealed using spray foam insulation to prevent moisture intrusion.

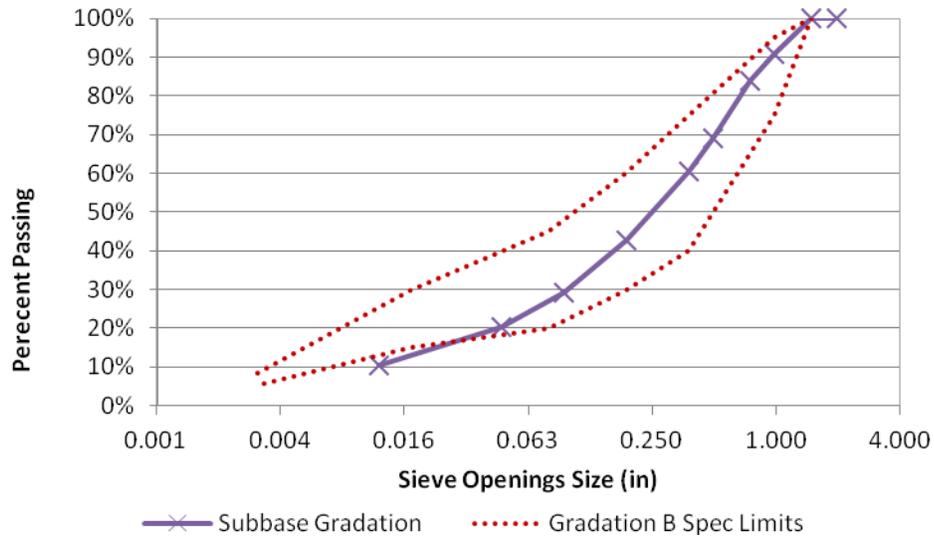
Figure 49. Subbase Gradation

The characteristics of the limestone subbase beneath the pervious concrete were determined to verify the water storage and infiltration capabilities. The dry rodded unit weight, the bulk specific gravity, the specific gravity at saturated surface dry conditions, and the absorption of the subbase material are provided in Table 11 below. The gradation curve for this material is provided in Figure 49.

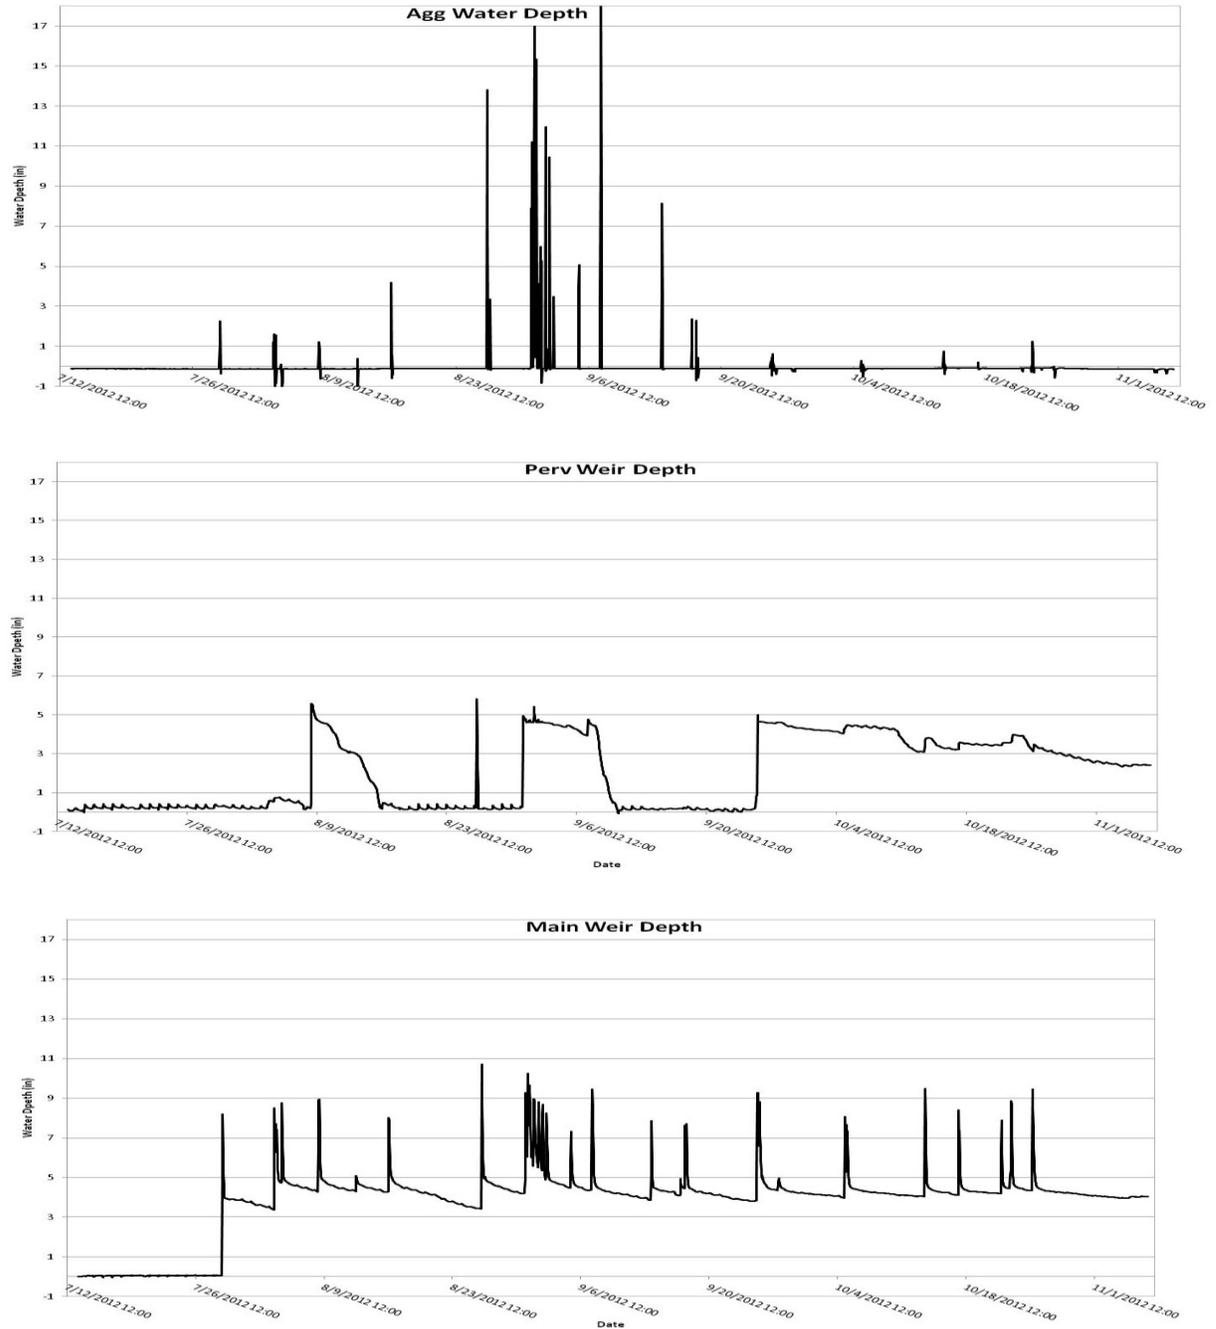
Figure 50. Depth of water within control section weirs from initial placement until the battery died, hourly averages

The data logger from the control section was retrieved and the data was downloaded and processed for clarity. Figure 50 depicts the water depths throughout the time period of data collection of the mainline weir, the pervious shoulder weir, and the aggregate subbase. Figure 51 provides the temperature of the weir box and the water.

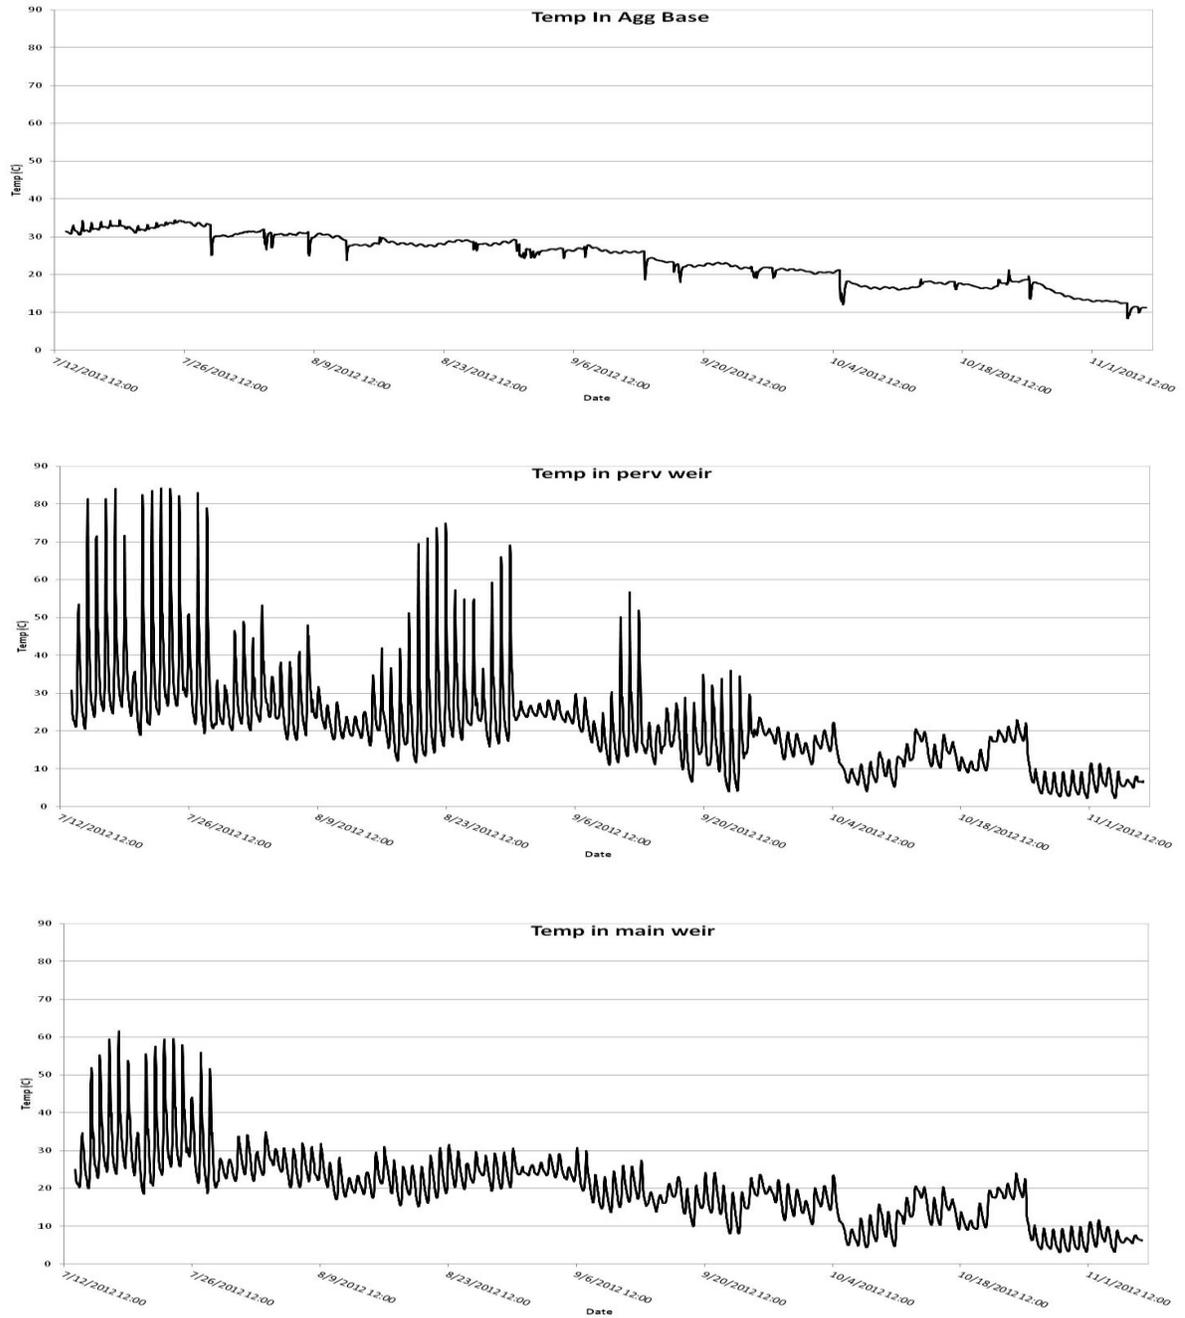
Figure 51. Temperature of water within control section weirs from initial placement until the battery died, hourly averages

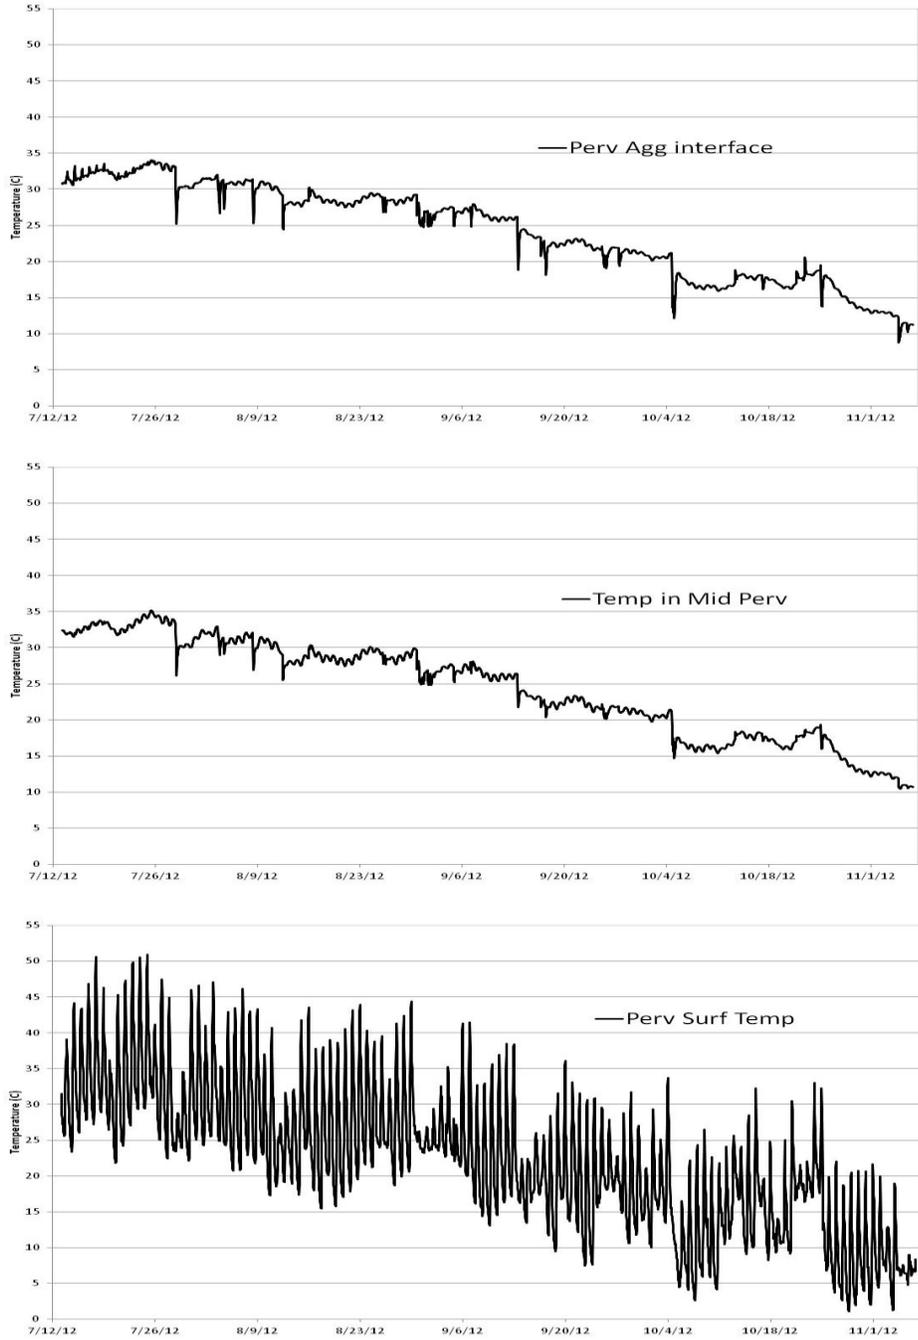
Figure 52. Pervious pavement profile temperatures

The temperature profiles of the concrete are provided in Figure 52-55.

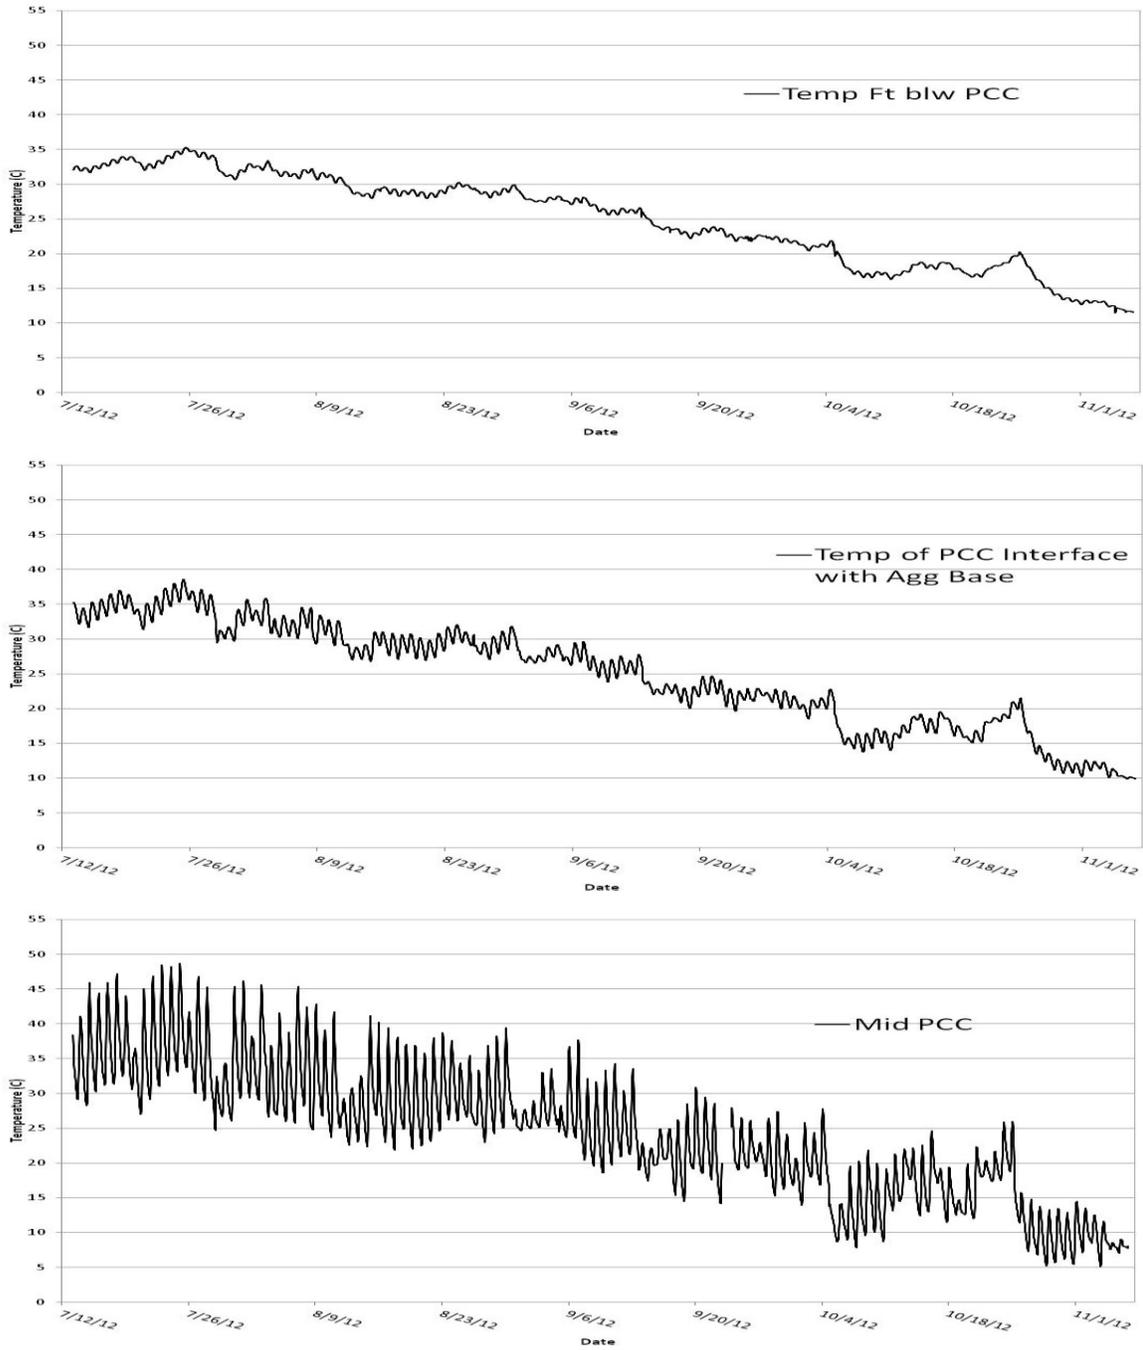
Figure 53. Mainline pavement profile temperatures

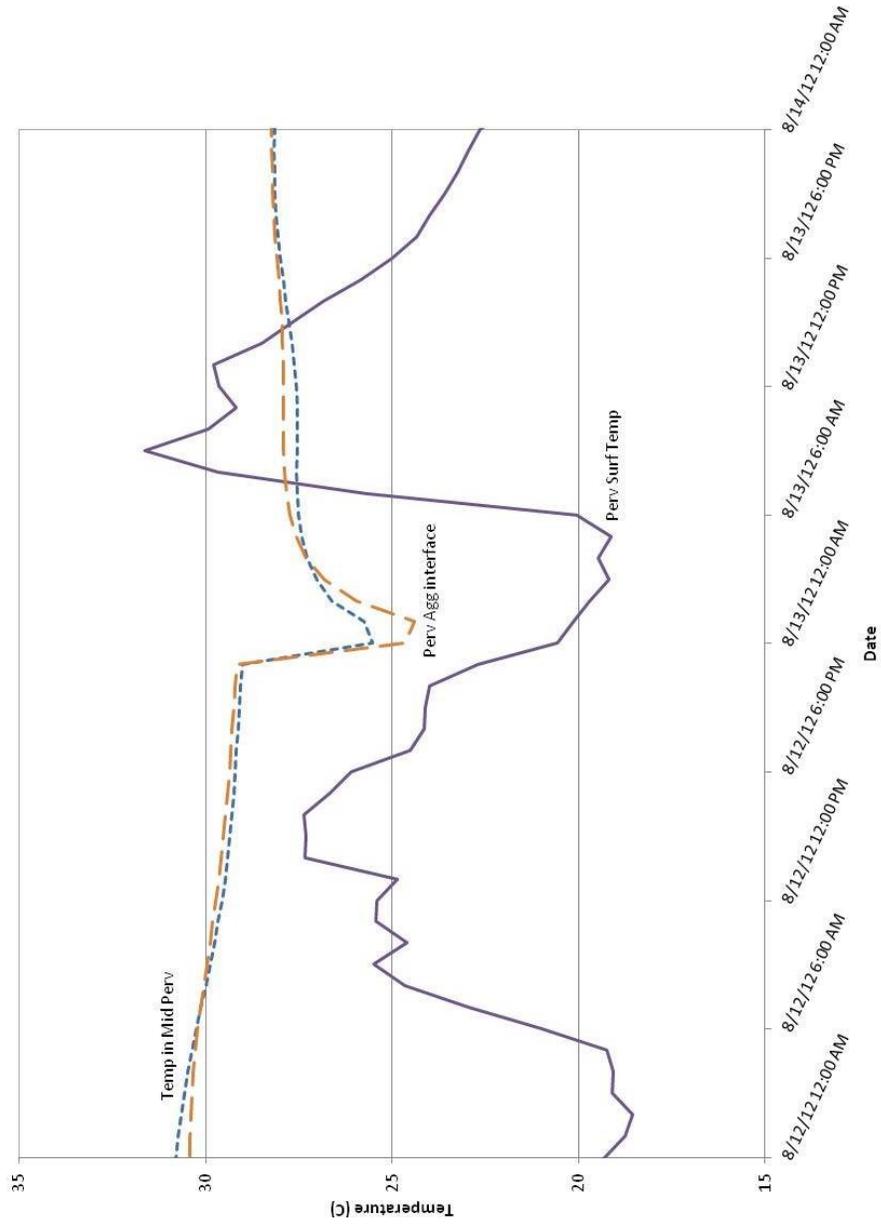
Figure 54. Pervious concrete temperature response to rain infiltration, approximately 24hours before and after rain event

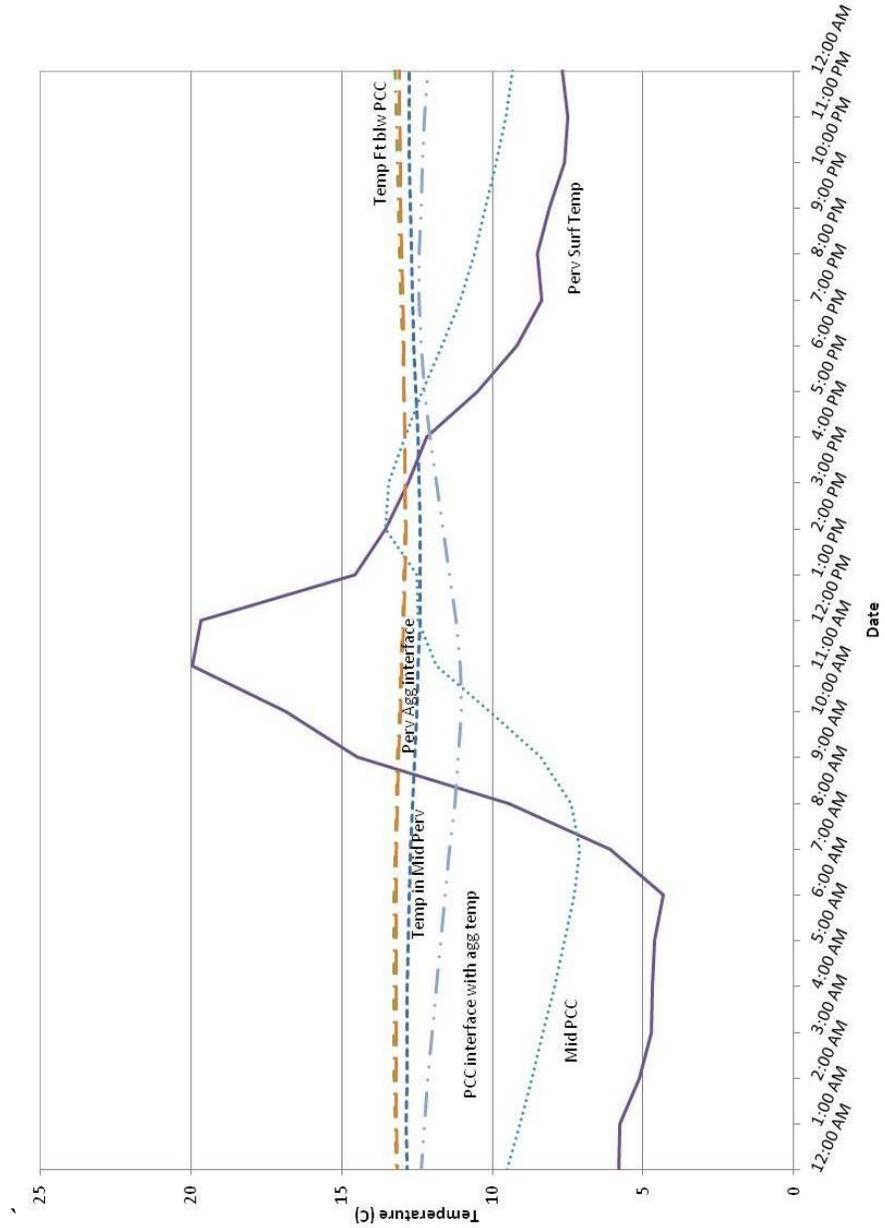
Figure 55. One day comparison of all temperature sensors, on 11/02/2013

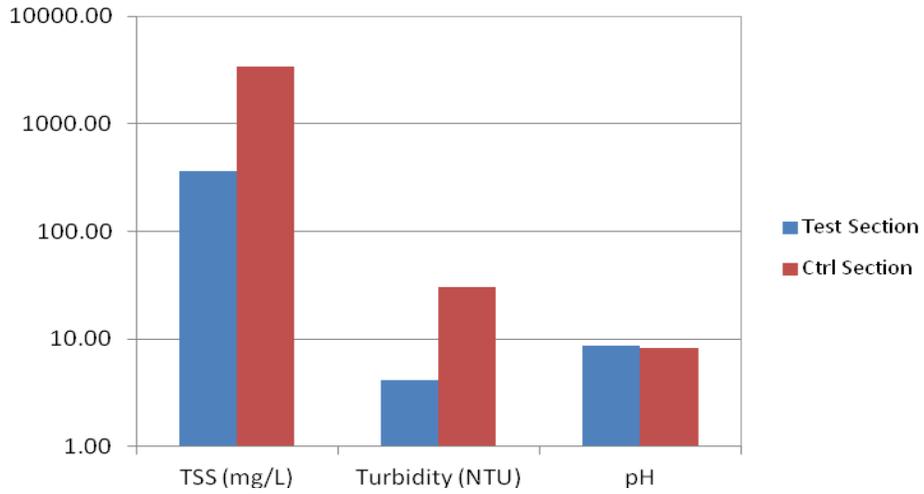
Figure 56. Construction water quality results

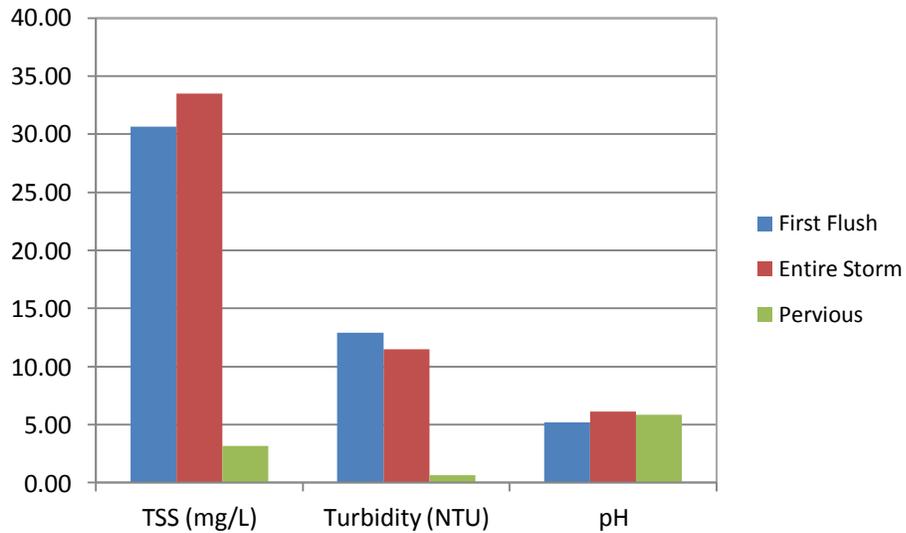
Figure 57. Control section weirs; water quality results of water sample collected on

07/29/2012

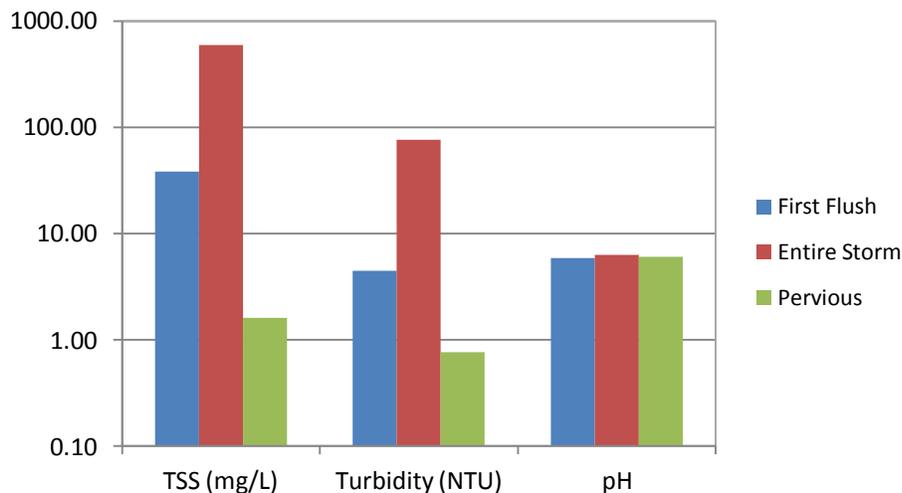
Figure 58. TX active weirs; water quality results of water sample collected on 07/29/2012

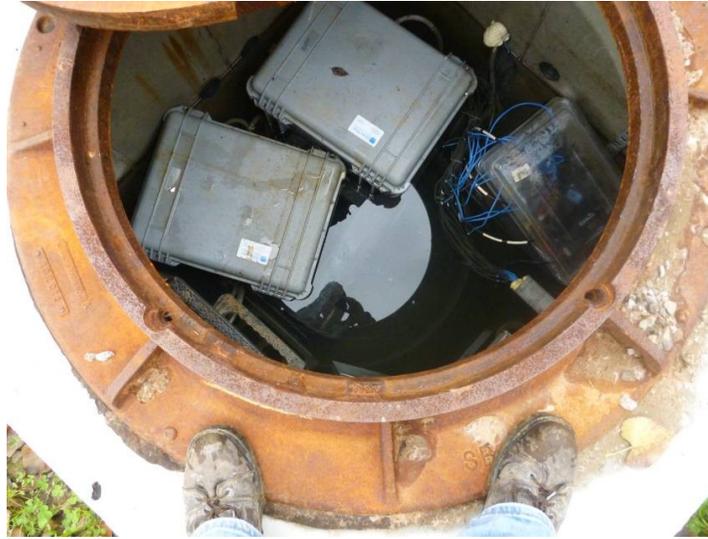
The vaults used for protecting the instruments and the power supply were much more heavy duty than required. The problem associated with the heavy duty vaults was the susceptibility for water infiltration, and the consequential water that was retained. Figure 60 depicts one of the two vaults used that was entirely flooded and the equipment floating

within it since there was no way to purge the water. The data logger was saved because of the container it was in which was floating and protected from the water infiltration. The other vault similarly did flood, however the water was expelled which introduced the rusting and corrosion of all of the equipment, as shown in Figure 61 and 62. The rust progressed to the point that the screws used to hold up the water sampler stand sheared off breaking off one of the legs and knocking down the equipment, Figure 63. As a comparison, an image of the equipment stand is provided in Figure 64, showing the water samplers standing upright. The vault that was rusted was the one housing the weather station, and the data logger was so severely damaged that the data could not be downloaded on to a computer. Thus this data is incomplete and insufficient to provide an adequate comparison between rainfall and the discharge of water from the pervious concrete shoulders. Furthermore, the water samplers which were meant to be installed upright, leaked battery fluid, possibly contaminating the water samples, as shown in Figure 62 previously. Along with the heavy duty vaults, the lids that were used were far too heavy to be easily managed by one individual, which presented a danger to anyone opening the vaults.

Figure 60. Instruments floating within vault due to flooding

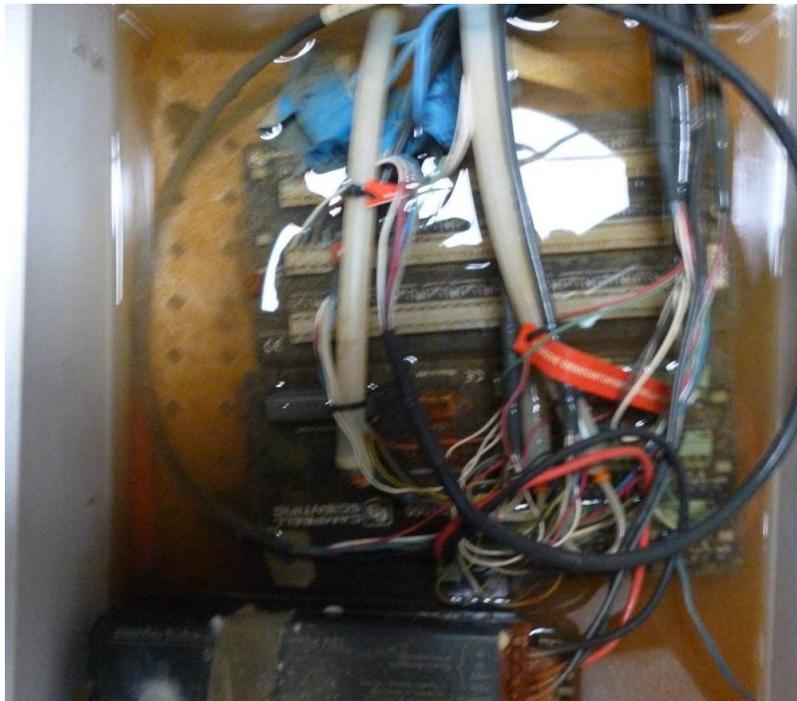
Figure 61. Instrument corrosion and battery leak due to flooding

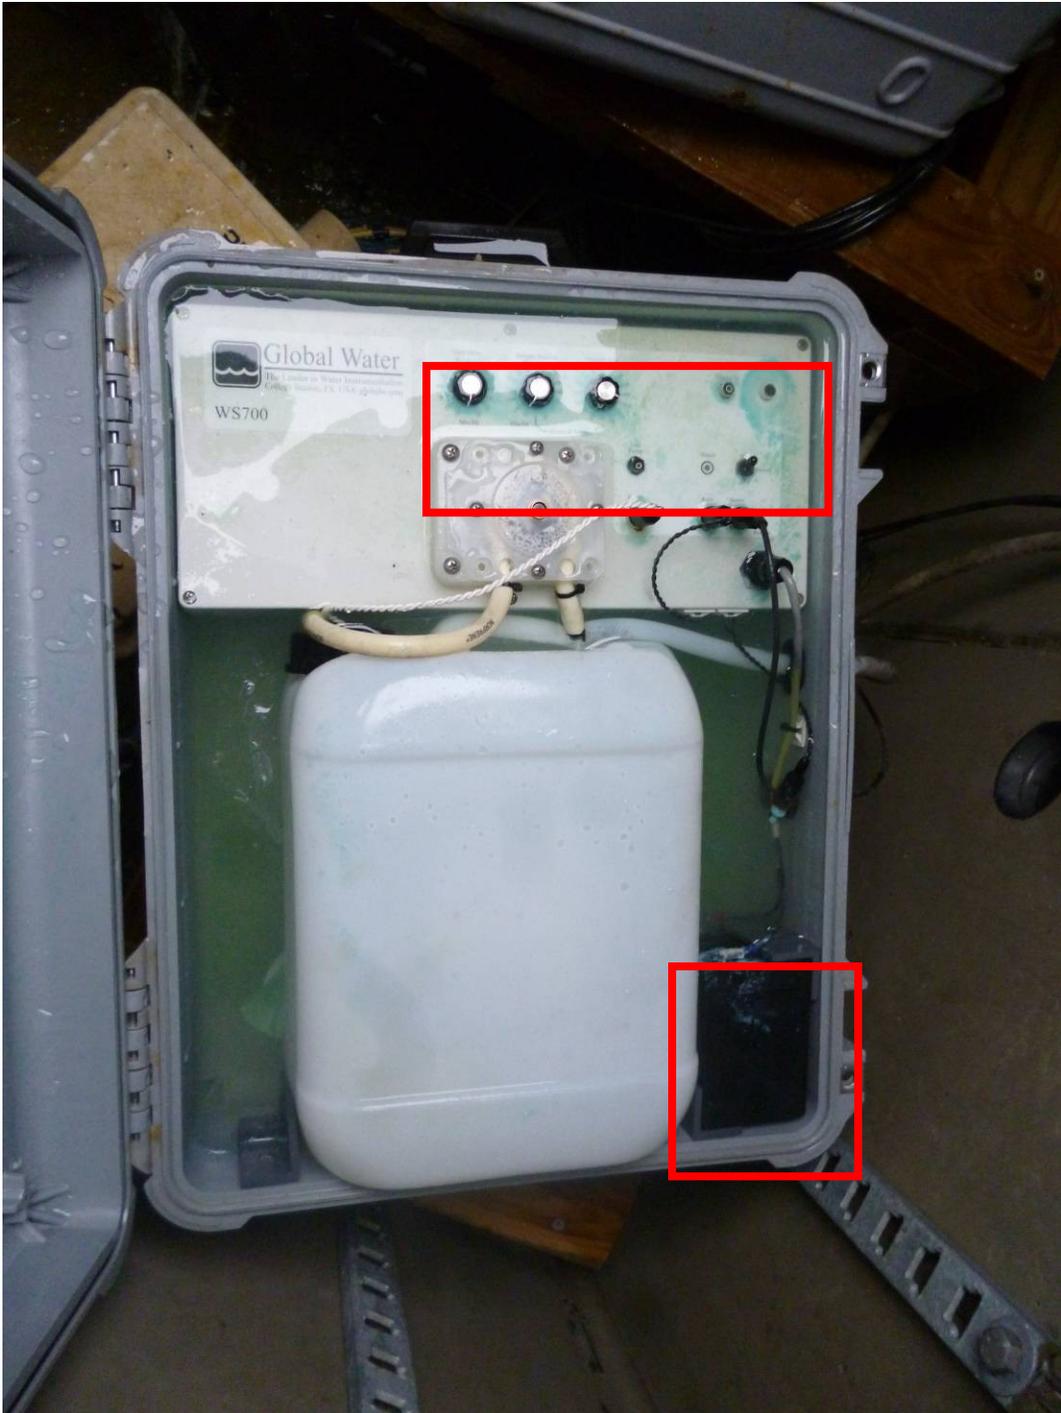
Figure 62. Flooding induced damage and battery corrosion to water samplers

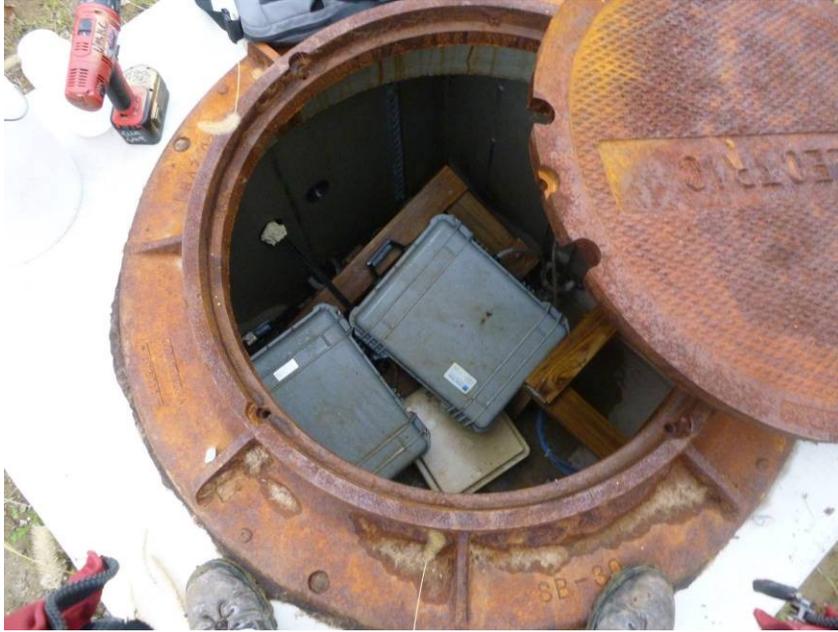
Figure 63. Equipment knocked down due to the rusting of the mount screws.

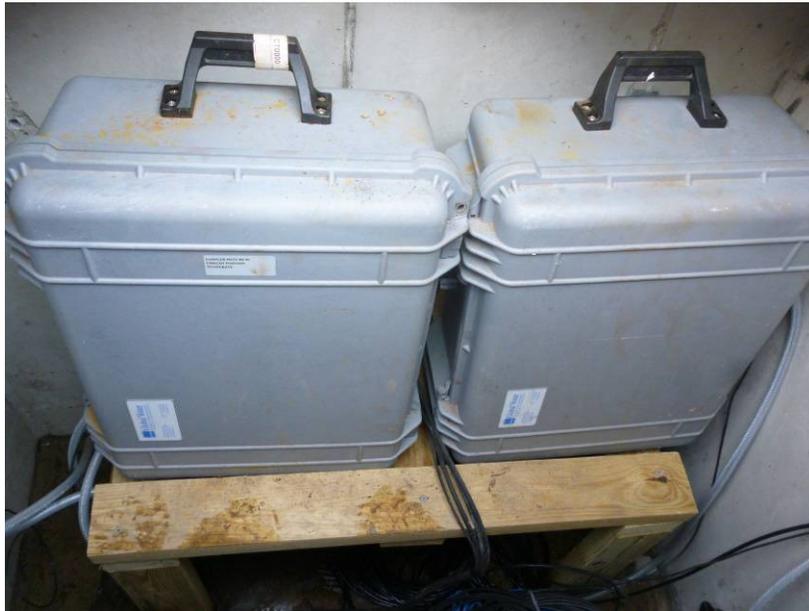
Figure 64. Water sampler stand prior to rusting of mount screws
