IMPROVING URBAN AIR AND STORMWATER QUALITY USING
PHOTOCATALYTIC HIGHWAY PAVEMENT AND
PHOTOCATALYTIC PERVIOUS
CONCRETE SHOULDERS

A THESIS IN
Civil Engineering

MASTER OF SCIENCE

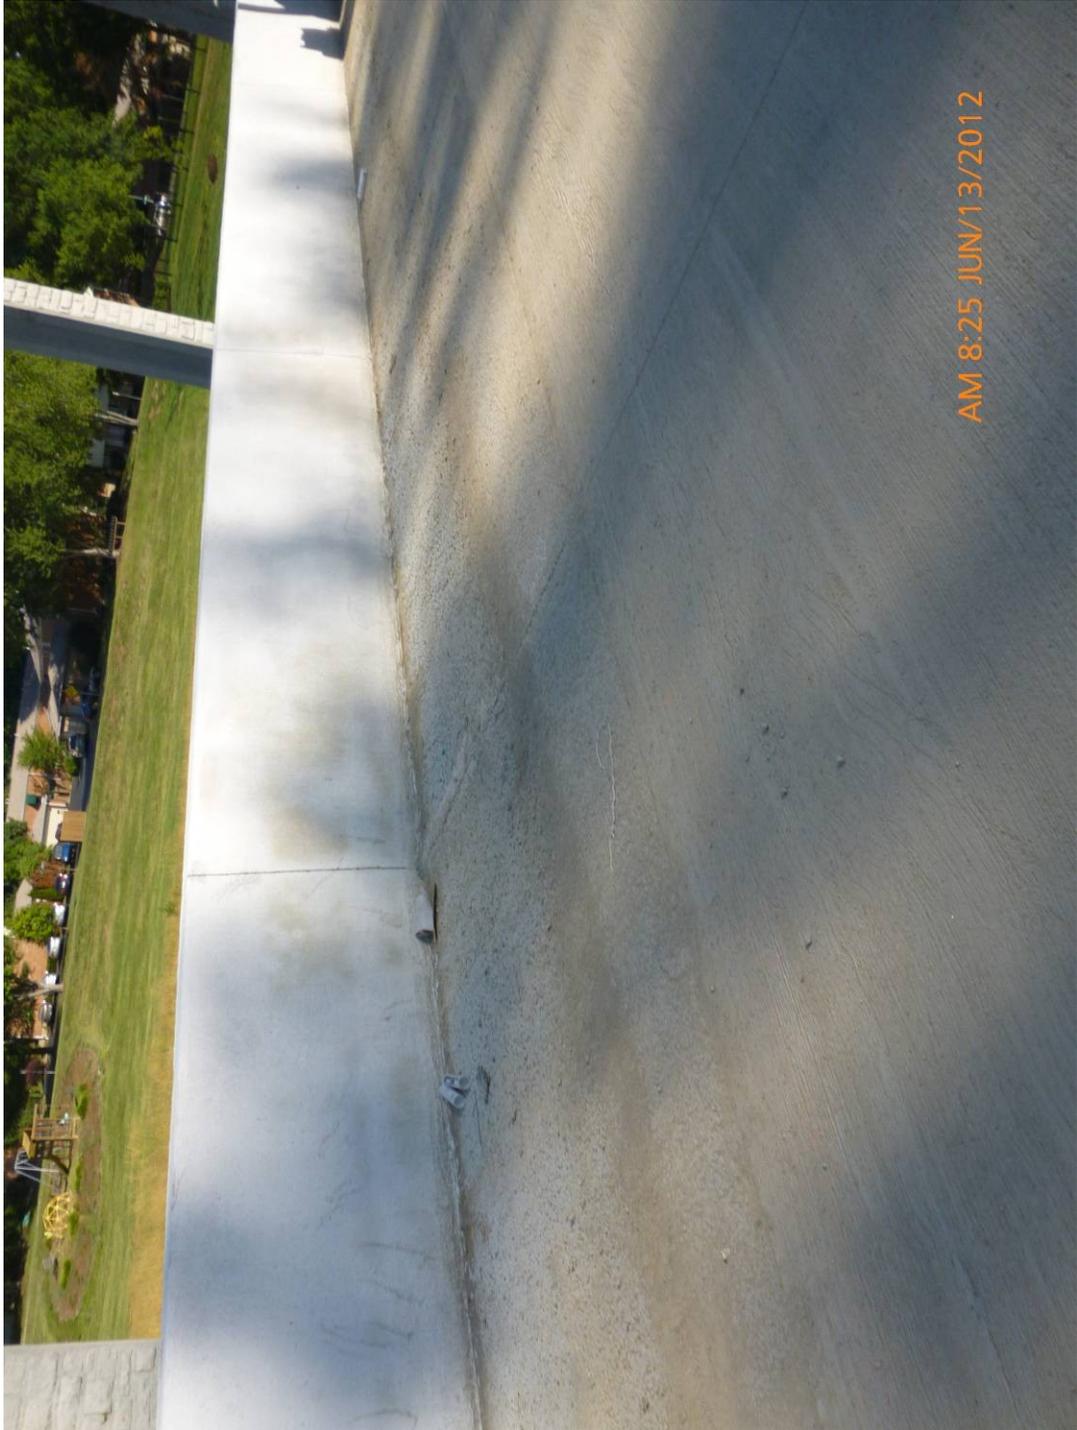
Figure 65. Clogged pervious concrete shoulders prior to vacuuming

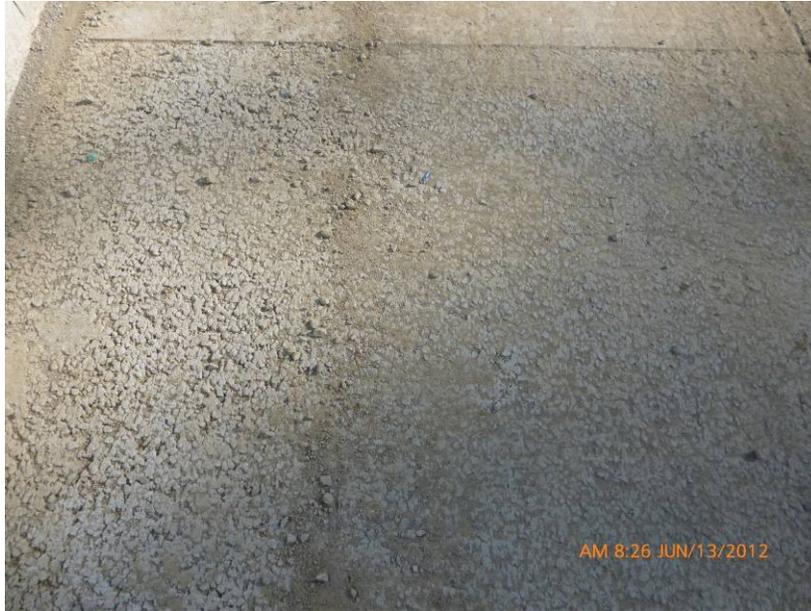
Figure 66. Close-up of clogged pervious concrete shoulders

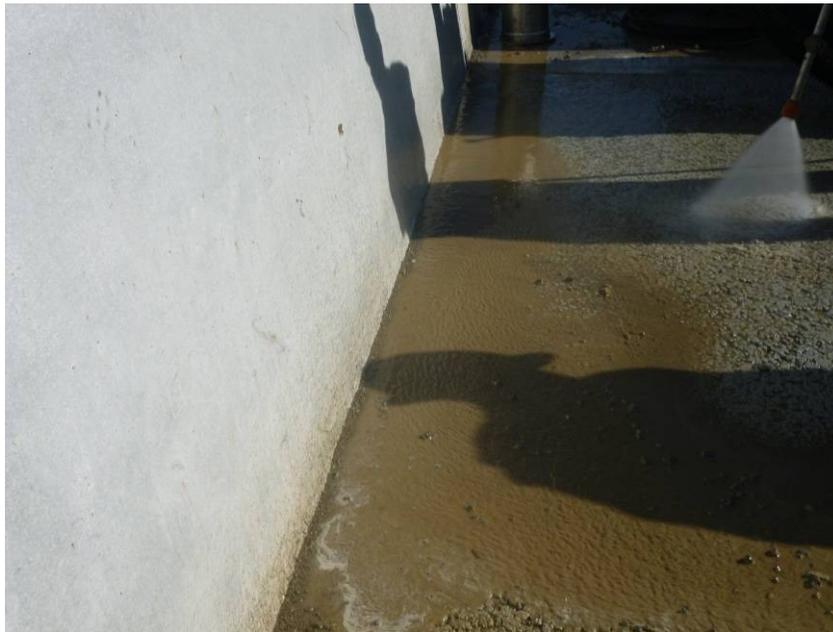
Figure 67. Water pooling on the pervious concrete pavement

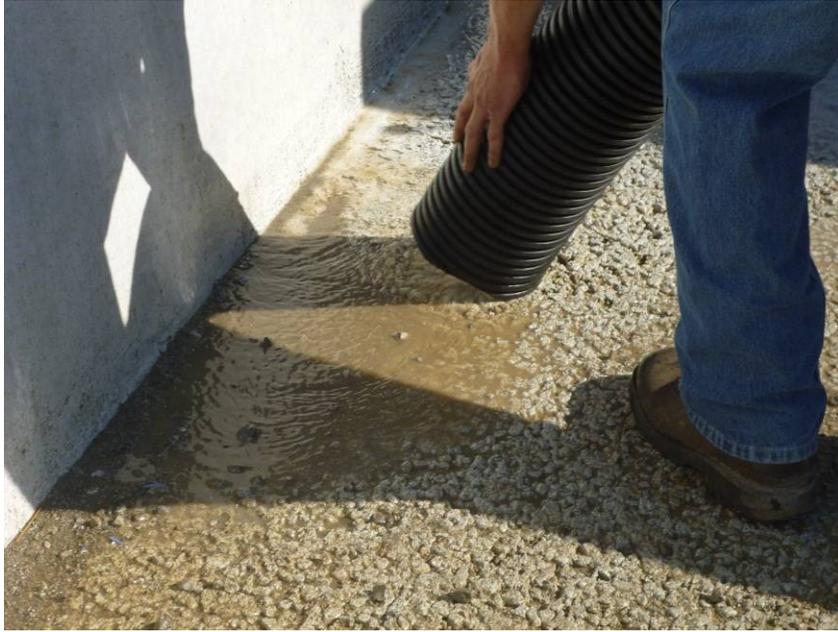
Figure 68. Vacuuming pervious concrete shoulders

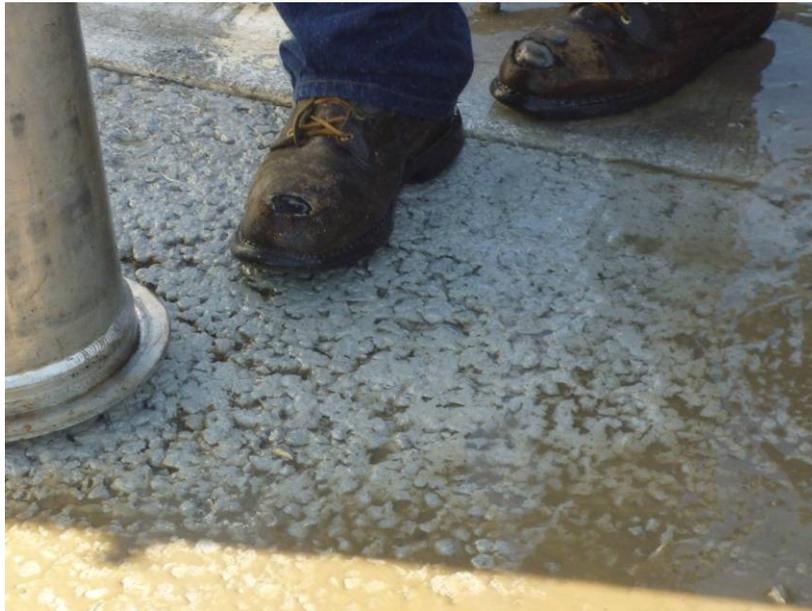
Figure 69. Close-up of vacuuming/washing operation

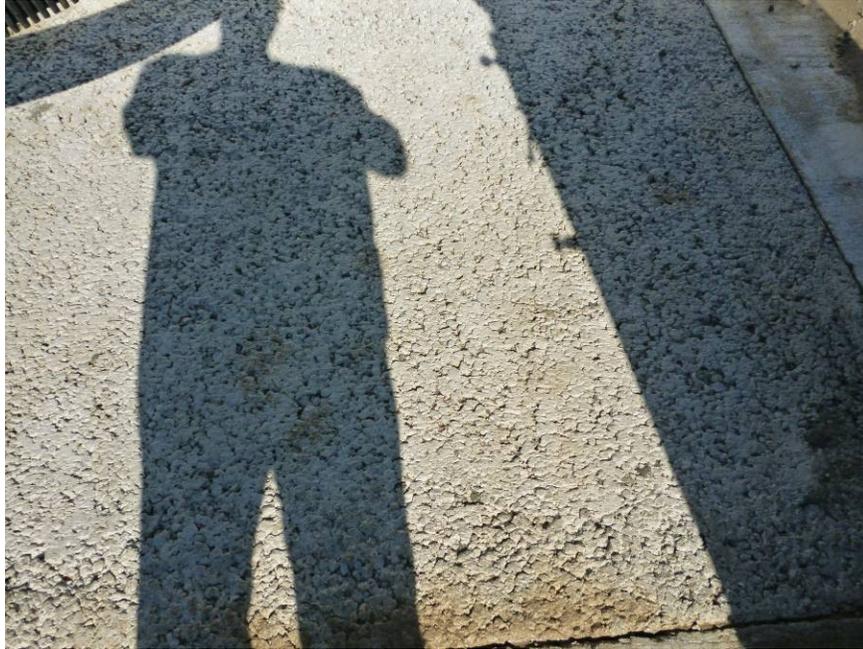
Figure 70. Pervious concrete shoulders after vacuuming

Upon the completion of the vacuuming operation, the rate of infiltration was being determined as described in the “Methods and Instrumentation Process” chapter above. However, the rate of infiltration was very low, and further possibilities were being discussed as to what the issue might be. The MoDOT office had sent to obtain core samples of the concrete and sent them for analysis by the research team. The percent voids of the core samples were determined, as were the ratio of materials used using image analysis, Figure 71 and 72. It was determined from this that the concrete mix design was not appropriate as the concrete had a high cementitious material ratio, as indicated by the results provided in Table 19. This adversely affected the porosity of the concrete, as the cementitious material simply filled in the voids, causing the concrete to be impermeable. This meant that that the pervious

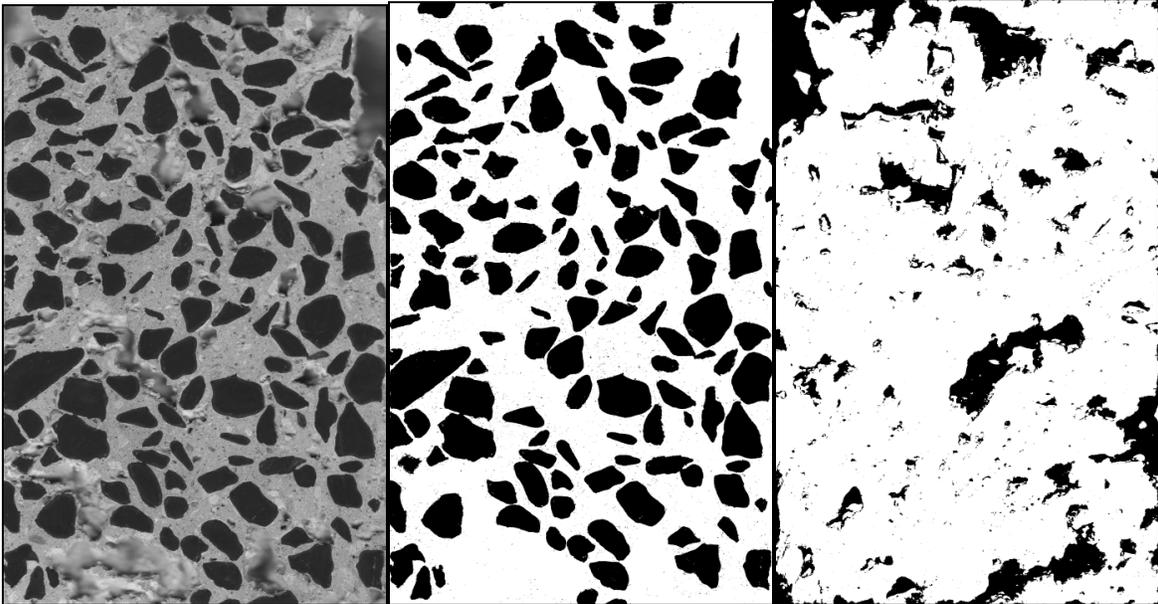
Figure 71. TX Active Image analysis of cored samples, cross-section of sample with aggregates black (left), aggregate volume (middle), voids black on mirrored surface (right)

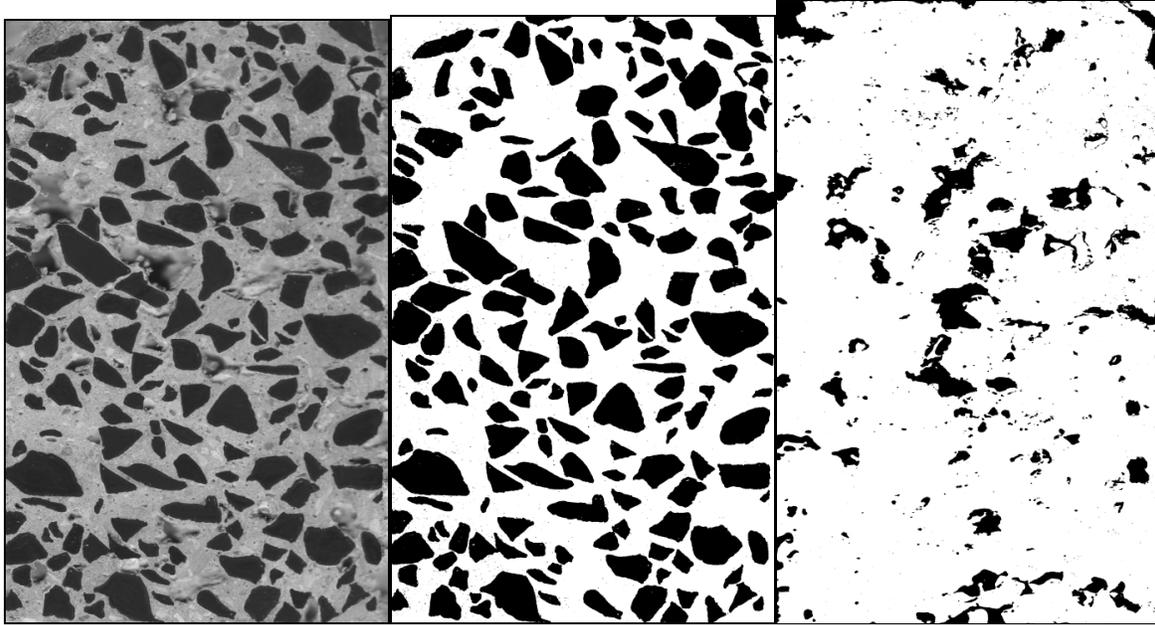
Figure 72. PCPC image analysis of cored samples, cross-section of sample with aggregates black (left), aggregate volume (middle), voids black on mirrored surface (right)
