EVALUATION OF THE EFFECTS OF IN-PLANE LATERAL RESTRAINT  
AND REINFORCEMENT RATIO ON THE PUNCHING  
CAPACITY OF FLAT SLAB COLUMN SPECIMENS

A Thesis presented  
To the Faculty of  
The Graduate School of the  
University of Missouri – Columbia

By  
CHRISTOPHER ROBERT HENQUINET  
Dr. Sarah L. Orton, Thesis Supervisor

July 2013

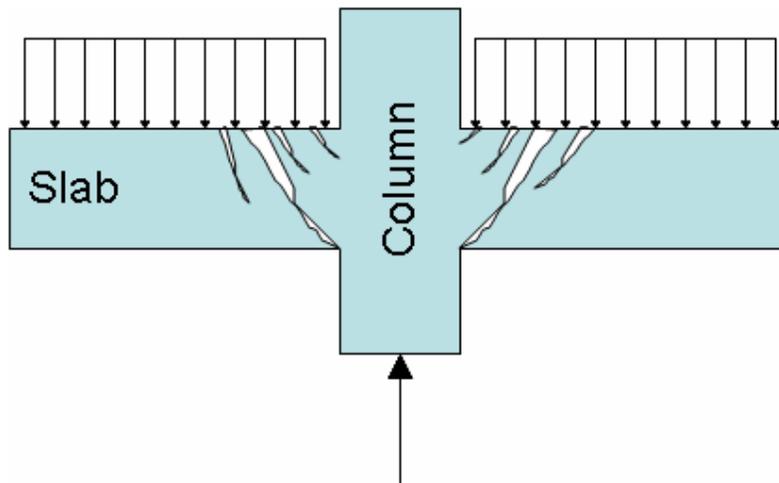
Figure 2.1.1 – Diagonal cracks resulting from shear (Harris 2004 ).

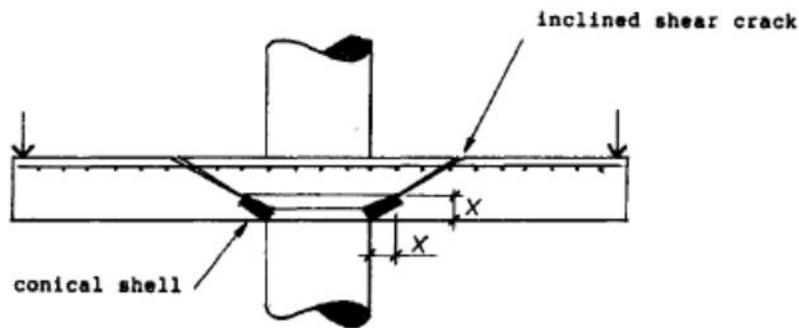
Figure 2.1.2 – Illustration of moment couple resisting shear forces (Broms 1990).

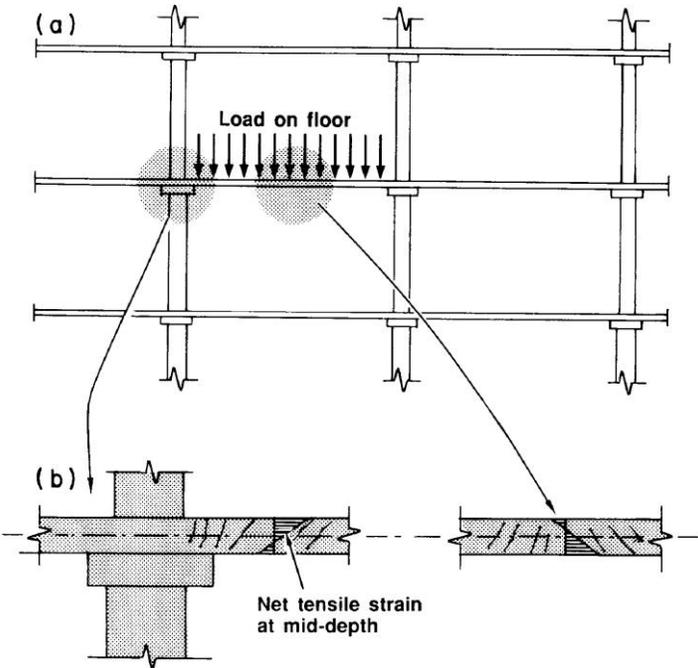
Figure 2.1.1.1 – Picture demonstrating the net tensile stress at the center of the slab (Vecchio and Tang, 1989).

Compressive membrane action can lead to increased flexural capacity of slabs due to in-plane lateral compressive forces. When reinforced concrete slabs are subjected to gravity loads the extreme tensile fiber of the concrete cracks as it reaches its modulus of rupture ( $f_r$ ). After the concrete cracks the bottom reinforcement goes into tension because it is now required to carry the load that the cracked concrete cannot. As the loading increases the overall tensile stress at the bottom face of the slab is greater than the compressive stress at the top of the slab which results in a net tensile stress at the centerline of the slab (Vecchio and Tang 1989). These effects are illustrated in Figure 2.1.1.1.

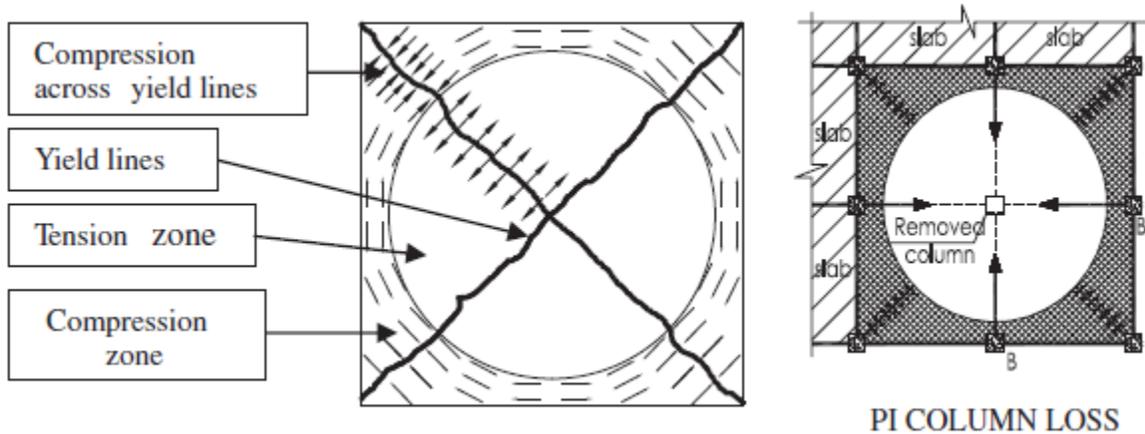
Figure 2.1.2.1 – Tensile membrane in a simply supported slab (Dat and Hai 2011).

of the slab develops, this compression zone provides restraint for the tensile forces in the center of the slab. The restrained tensile forces acting at large deflections work like a catenary and are able to support the vertical loads. Therefore the overall capacity of the slab is a combination of the tensile membrane action in the center of the slab and the increased flexural capacity in the exterior of the slab due to the in-plane compressive forces that are present (Dat and Hai 2011). This is illustrated in Figure 2.1.2.1 (Dat and Hai 2011).

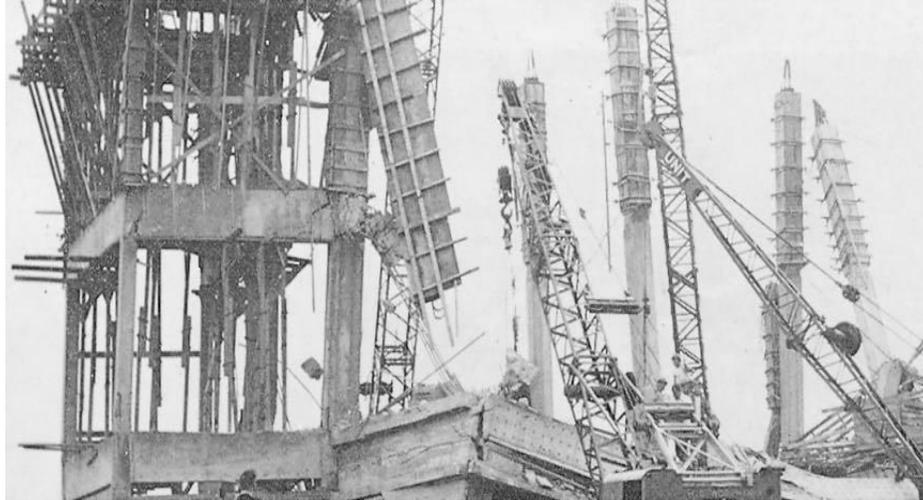
Figure 2.3.1 – Photo of collapsed structure in Jackson, Michigan (Aberdeen Group 1956).

One structural failure attributed to punching shear occurred in an office building in Jackson, Michigan in 1956. The structure was still under construction when the flat plate slabs failed due to shear at the column connections. It was speculated that the failure occurred because the area of the slab around some of the interior columns was reduced by the addition of holes to allow the instillation of pipes and duct work (Aberdeen Group 1956). It can be seen in Figure

2.3.1 that most of the structure that had already been constructed collapsed as a result of the punching failures at the connections.

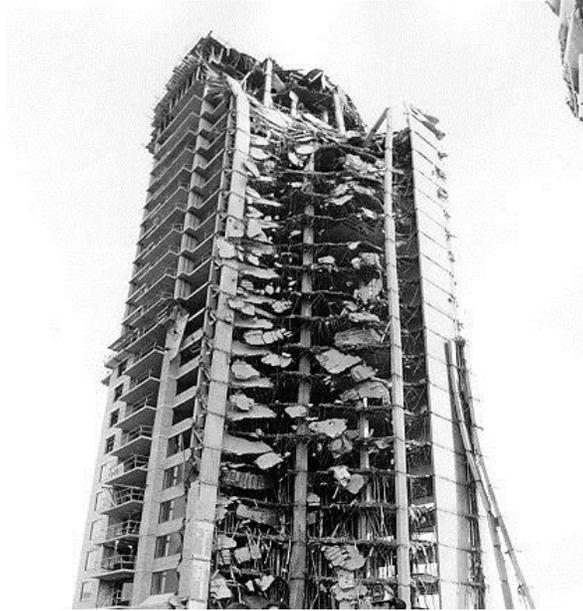
Figure 2.3.2 – Photo of the results of the progressive collapse of a portion of the Skyline Tower  
(Crowder 2005).

Another instance of failure during construction occurred in Boston, Massachusetts in 1971, this failure resulted in the deaths of four men. The structure was nearing completion when a slab connection at the roof failed, this initial failure caused a progressive collapse in the structure that propagated all the way down to the ground level. The root cause of this failure was inadequate concrete strength that resulted from poor protection from cold weather during the curing process (King and Delatte, 2004). A third case where a punching shear failure has occurred in a structure during construction happened in 1973, the Skyline Plaza Tower collapsed resulting in 48 casualties. After the completion of one of the stories in the tower the construction shoring below was removed prior to the scheduled date which resulted in punching shear failures around multiple slab column connections above (Crowder, 2005). These failures resulted in the slabs below being overloaded which caused them to fail as well, this progressive collapse propagated all the way down to the ground as can be seen in Figure 2.3.2.

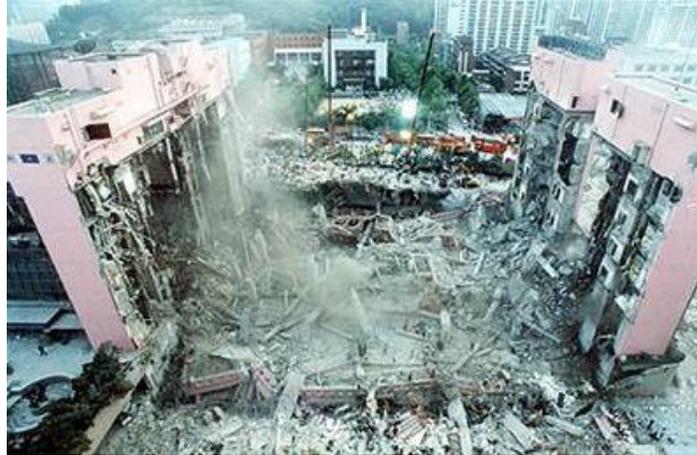
Figure 2.3.3 – Photo of the collapsed Sampoong Department Store Building (Gardner et al 2002).

A fourth example of structural failure due to punching shear occurred in South Korea in 1995, a five story department store collapsed while it was in use resulting in the deaths of 501 people. The structure was not initially a department store, in order to convert the existing structure columns were removed to provide space for escalators to be installed. However this was not the only issue, the fifth floor was also renovated to accommodate a restaurant which increased the dead load on that floor by over 30% (Gardner et al, 2002). The remaining slab column connections were not adequate to resist the increased loading, this ultimately resulted in a punching shear driven progressive collapse of a large portion of the structure. The loss of life associated with this collapse increased the need for research in the area of punching shear failures as well as progressive collapse. The collapsed structure can be seen in Figure 2.3.3.

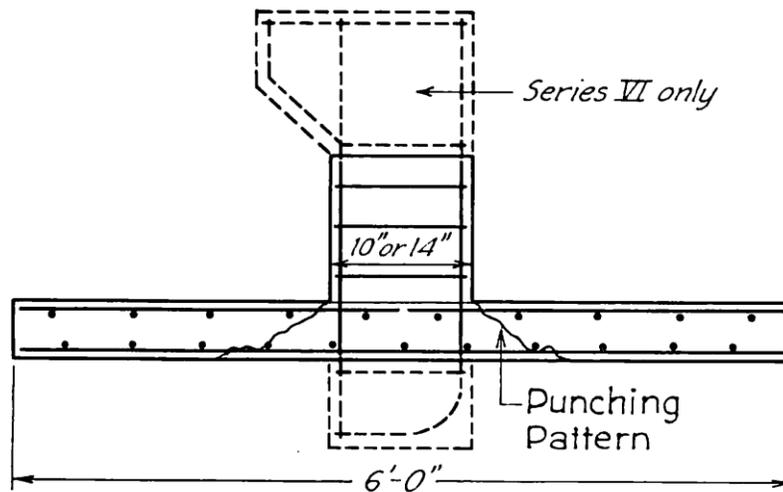
Figure 2.4.1 – Sketch of slab specimens tested by Elstner and Hognestad (1956).

compressive strength, volume of tension and or compression reinforcement, addition of shear reinforcement as well as the boundary support conditions. At the conclusion of the testing it was determined that 85% of the slabs tested failed in shear due to punching. Also, it was determined that the ultimate failure of the slab occurred after yielding of the reinforcement in the vicinity of the column, thus yielding of reinforcement can be used as an obvious indicator of the presence of punching shear (Elstner and Hognestad, 1956). The tested slab specimens were loaded from a top column stud however no bottom column stud was present which may have prevented the researchers from obtaining a completely accurate stress distribution within the specimens. A sketch of the test specimens can be seen in Figure 2.4.1.

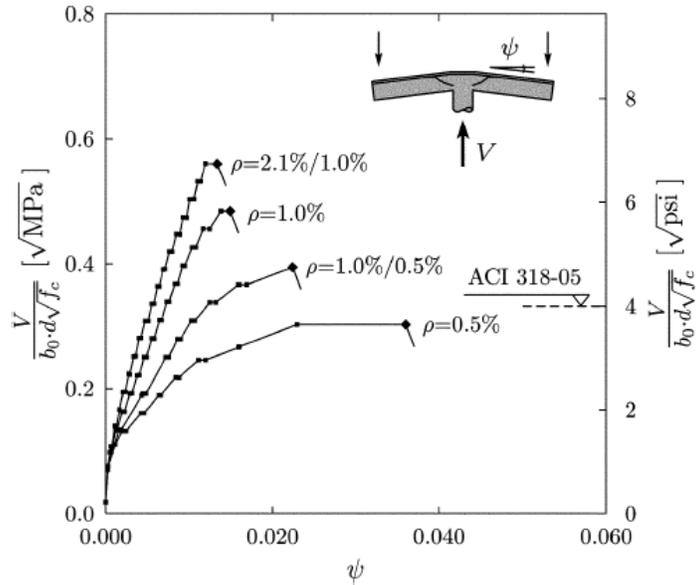
Figure 2.4.2 – Plot of load vs. slab rotation for slabs tested at various reinforcement ratios (Kinnunen and Nylander 1960).

Their testing was designed to determine the effects of the reinforcement ratio on the punching shear capacity of the slabs. Their findings showed that slabs tested with low reinforcement ratios (around 0.5%) failed in a significantly more ductile manner in comparison to slabs tested with a high reinforcement ratio (about 2%) which failed in a brittle manner. The ultimate capacity of the slabs tested with the lower reinforcement ratio was dependent on the flexural strength of the slabs thus the punching failure did not occur until after large plastic deformations. However the slabs with higher reinforcement ratios which failed in a brittle manner failed before yielding of the reinforcement. Kinnunen and Nylander were able to conclude that the failure of the slabs was related to not only the reinforcement ratio but also the angle of rotation of the slab (Kinnunen and Nylander, 1960). A plot displaying results can be seen in Figure 2.4.2. Overall, the slabs with lower reinforcement ratios failed at lower ultimate loads but were much more ductile than the slabs with higher reinforcement ratios which failed at higher loads.

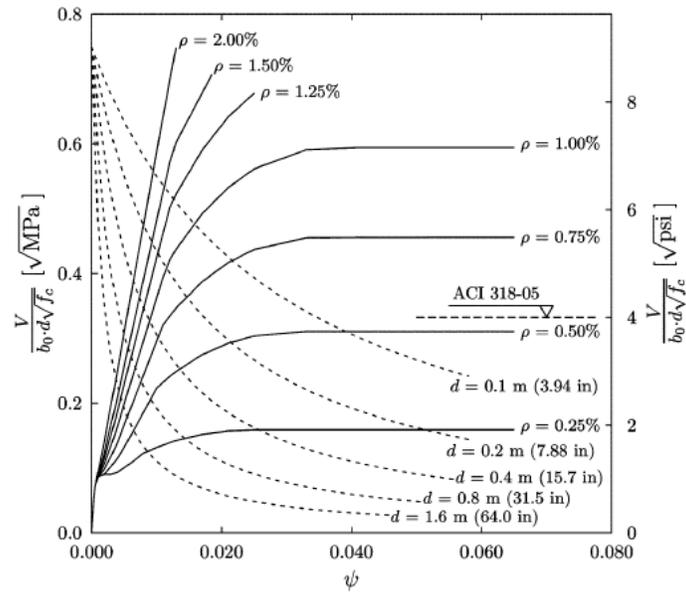
Figure 2.4.3 – Plot displaying relationship between slab thickness, strength and ductility (Muttoni 2008).

Muttoni’s (2008) research focused on testing slab specimens of different thicknesses as opposed to the work done by Kinnunen and Nylander (1960) as well as Elstner and Hogenstad (1956). Overall it was determined that there were large differences in the performance of the slabs based on size. Muttoni determined that punching capacity for thick slabs with low reinforcement ratios were lower than may have been anticipated in comparison to thinner slabs with similar reinforcement. Also, the thick slabs did not show much ductility prior to failure which Muttoni (2008) determined was undesirable. A plot comparing the thickness, strength and ductility of slabs tested can be seen in Figure 2.4.3.

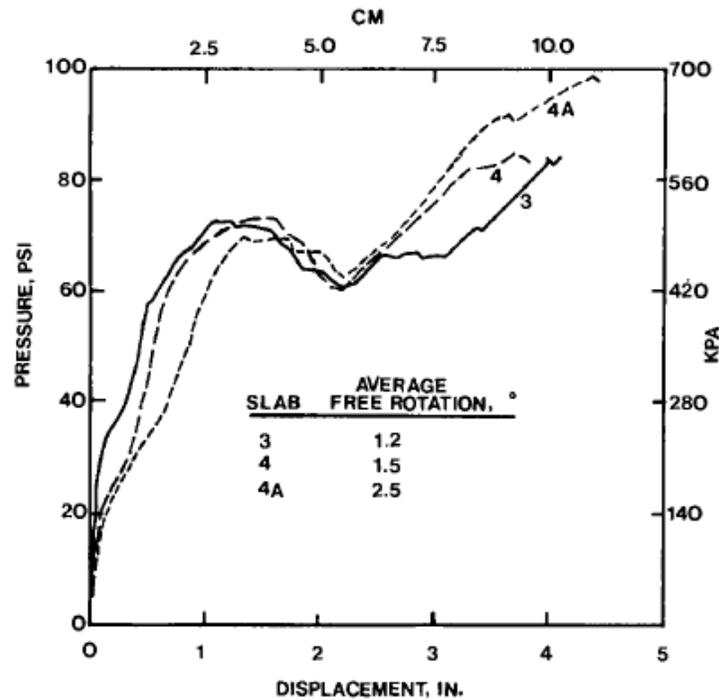
Figure 2.4.4 – Plot of load vs. displacement for slabs with various restraints (Guice and Rhomberg 1988).

benefit of compressive membrane action. Small rotational freedoms also increased the effects of tensile membrane action after the punching failure had occurred. Figure 2.4.4 shows that the slabs with lesser rotational freedoms benefited more from compressive membrane action while the slabs with greater rotational freedoms saw greater benefits once tensile membrane action took over after the punching failure occurred.

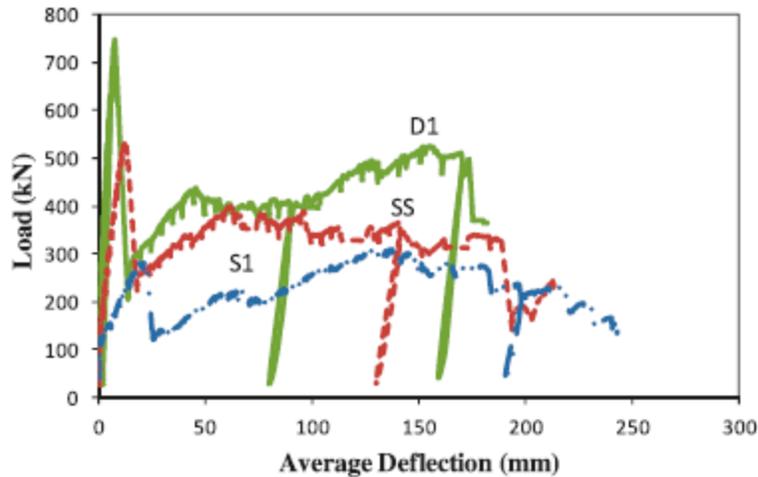
Figure 2.4.6.2 – Plot showing the effects of increased slab thickness and reinforcement depth on the pre and post punching capacity of flat slabs (Habibi et al. 2012).

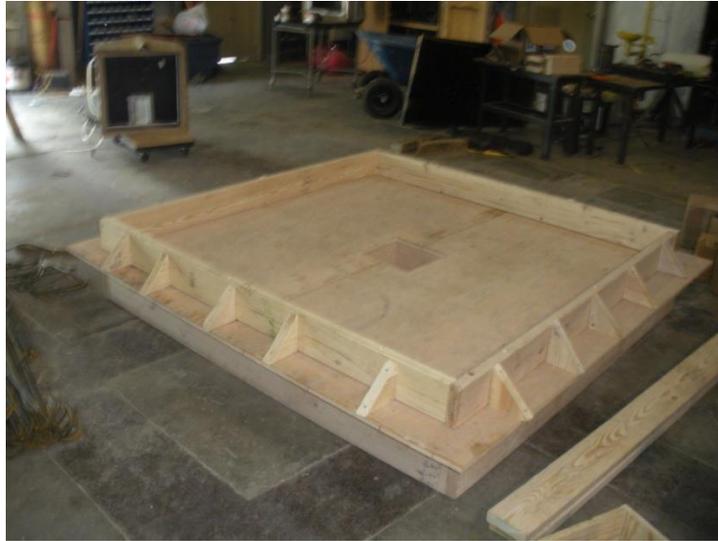
Figure 3.3.1 – Formwork for the slab specimens without top column stub formwork in place.

The slab specimen construction made up the majority of the man-hour work for this research. First the formwork for the concrete was constructed. In order to accommodate to column stub underneath the slab the formwork needed to be raised at least eight inches off of the ground. This was accomplished by creating a grid of 2 x 4's and 2 x 6's stacked on top of each other to create a solid base for the slab formwork. To create a flat bottom of the slab the formwork base was leveled and then  $\frac{3}{4}$  inch plywood was screwed down to the base with a hole cut in the plywood to allow for the column stub to be cast. The sides of the slab formwork were created using 2 x 6's standing on edge. This worked perfectly for our slab since the 2 x 6's actually have a width of 5.5 inches and the design thickness of the slab was 5.5 inches. The vertical 2 x 6's were braced to avoid bending under the weight of the wet concrete. In order to cast the column stub pieces we created two plywood boxes one of which fit underneath the slab formwork and the other was suspended above the slab at the proper height using boards that ran from one side of the form to the other. The completed formwork can be seen in Figure 3.3.1.

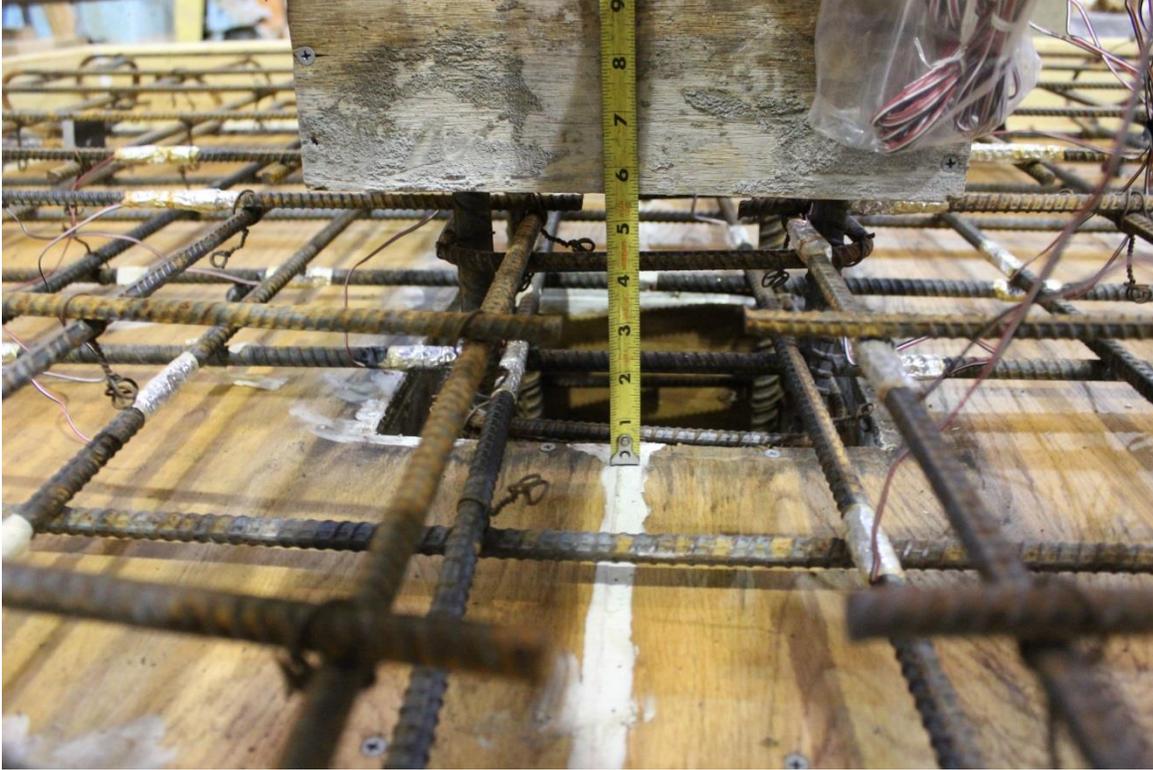
Figure 3.3.2 – Picture of slab formwork showing slab depth and reinforcement depths.

Prior to pouring the slab the reinforcing cages were placed into the formwork along with the column reinforcement and the anchors. Measurements were made to ensure that the correct concrete cover would be provided. The spacing between the tension and compression reinforcement was also measured to ensure accuracy. A photo showing reinforcement spacing and slab depth can be seen in Figure 3.3.2.

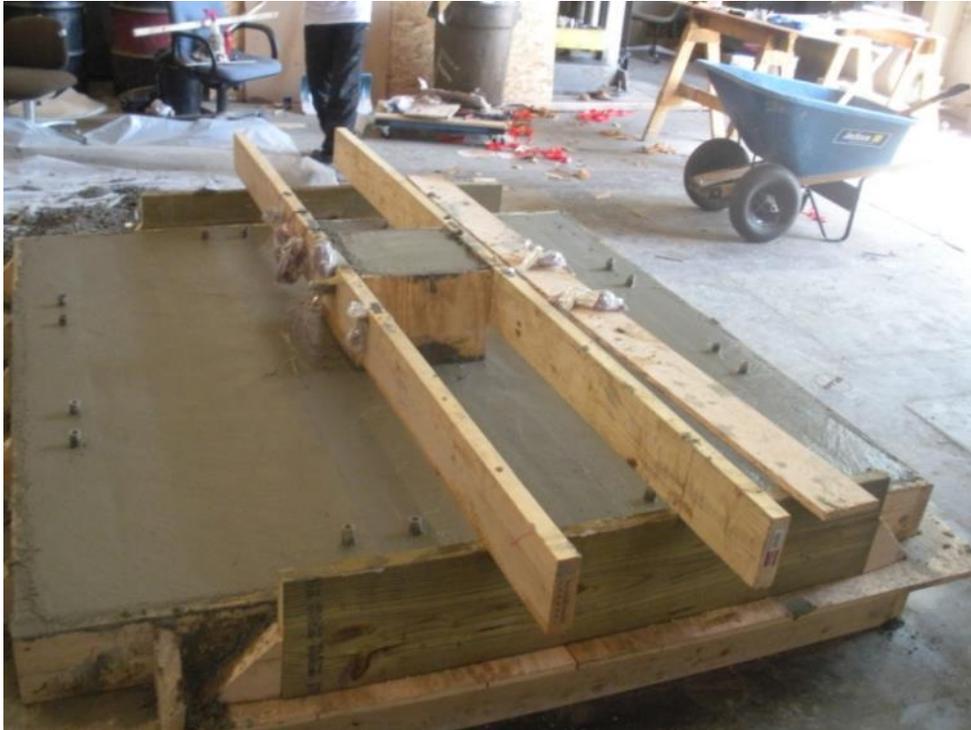
Figure 3.3.4 – Slab specimen just after pouring was completed.

Once the formwork and the reinforcement was in place we were ready to pour the slab. We moved concrete into the form using shovels as opposed to dumping it directly from the truck to avoid damaging any of the instrumentation or losing wires in the concrete. As the form was filled we used a concrete vibrator to help consolidate the concrete and remove unwanted voids. Care was taken to ensure that the concrete was not over vibrated such that it began to segregate. While pouring the slab we made efforts to ensure that the slab thickness was maintained at 5.5 inches especially in the area where the punching failure would occur as the slab thickness in this region directly affects the punching strength. Once the slab was poured we placed wet canvas over the slab followed by a plastic sheet to help prevent shrinkage due to evaporation during the curing process, the canvas was kept wet for the first week of curing. The slab just after pouring was completed can be seen in Figure 3.3.4.

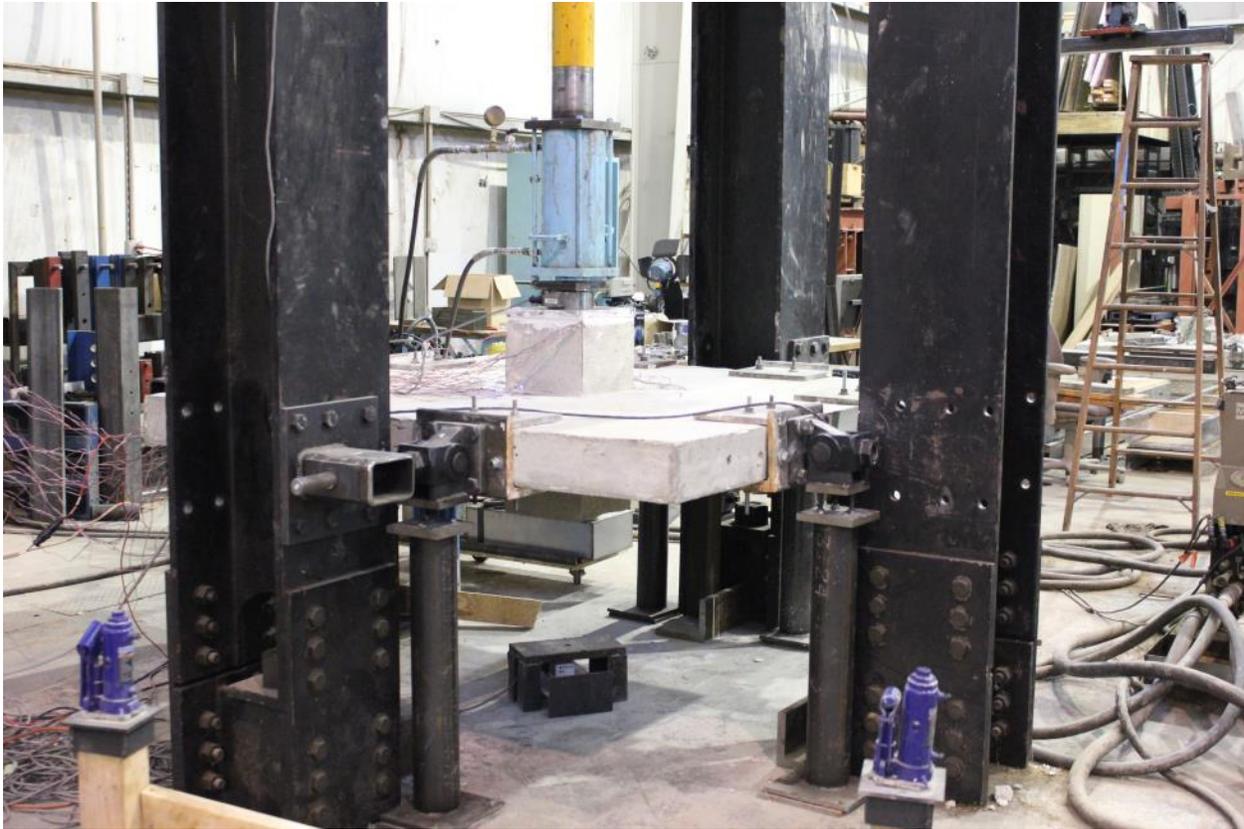
Figure 3.4.1 – Unrestrained test setup with slab specimen ready for testing.

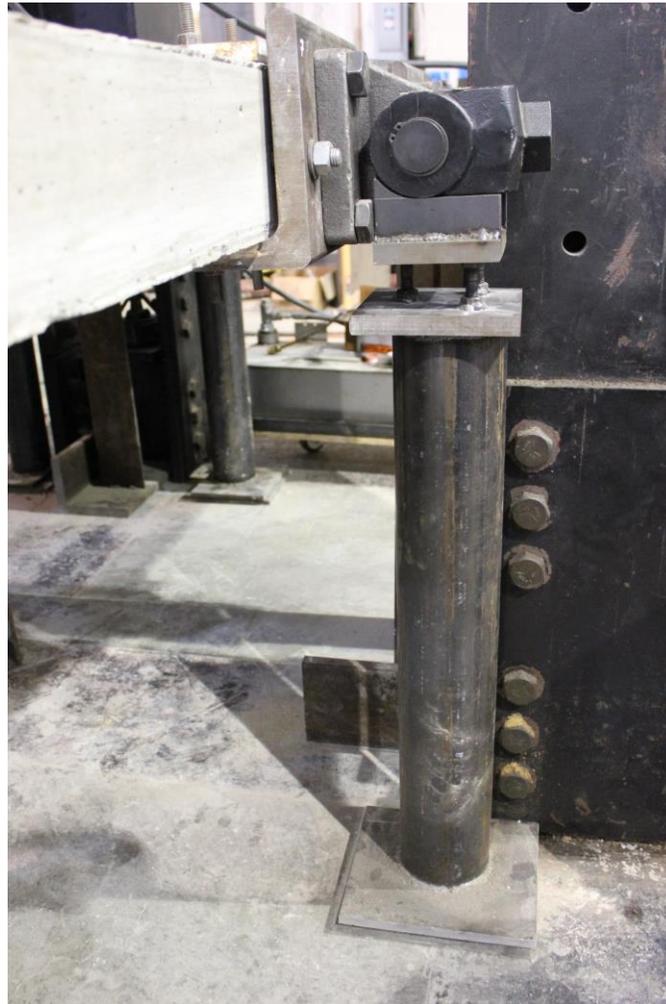
Figure 3.4.2 – Picture of one of the eight adjustable vertical supports.

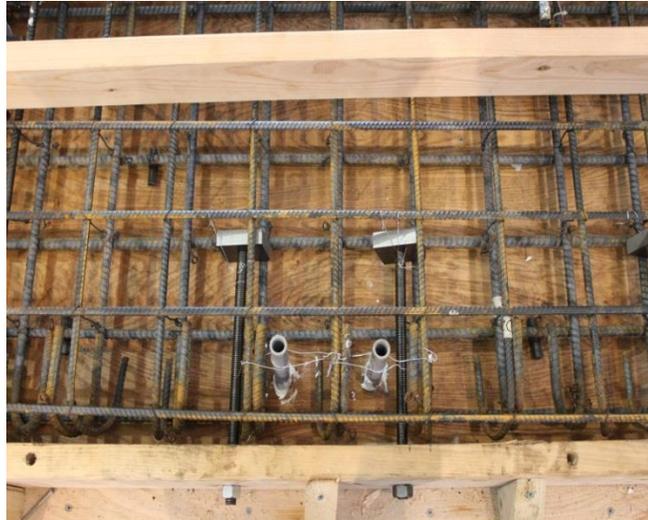
Figure 3.4.4 – Anchorage area prior to casting slab.

connected to the test setup support column using bolted steel parts. The part that actually connects to the slab its self is an 8x8x1 inch angle section. The angle has been cut down to a length of 12inches so that it can be moved and connected to the slabs without too much difficulty. Both legs of the angle have holes drilled in them to allow for connection to the slab. This is accomplished by connecting to the 5/8 inch anchor rods that were cast in the slab such that they extend out of the sides and the 1/2 inch threaded rods were run through the vertical holes that we cast into the slab around the anchor locations. Both were secured with nuts and washers against the angle. Also, a 1/2 inch steel plate positioned on the top of the slab to provide confinement around the anchor areas was put in place and secured with the vertical threaded rods. A schematic of the anchorage as well as a picture of the anchorage area prior to casting the slab can be seen in Figures 3.4.3 and 3.4.4 respectively.

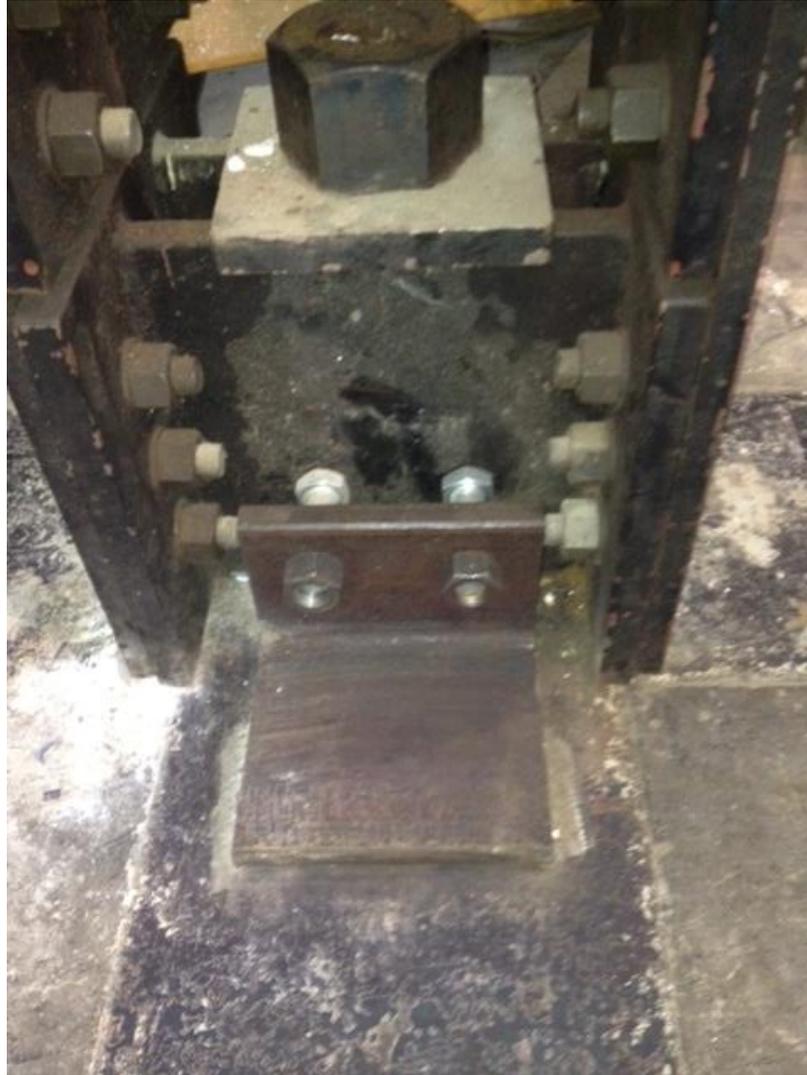
Figure 3.4.5 – Added bracing to prevent the support columns from sliding during restrained testing.

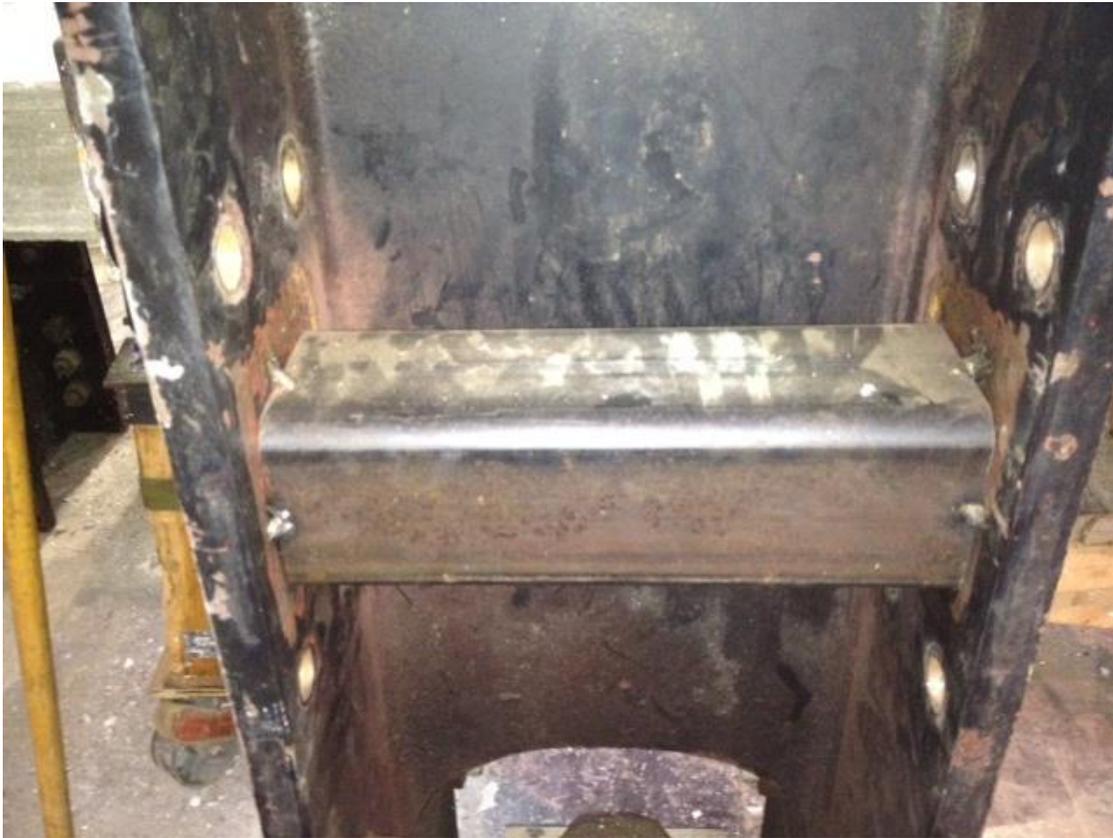
Figure 3.4.6 – Welded compression brace to stiffen the flanges of the support columns for the restrained test setup.

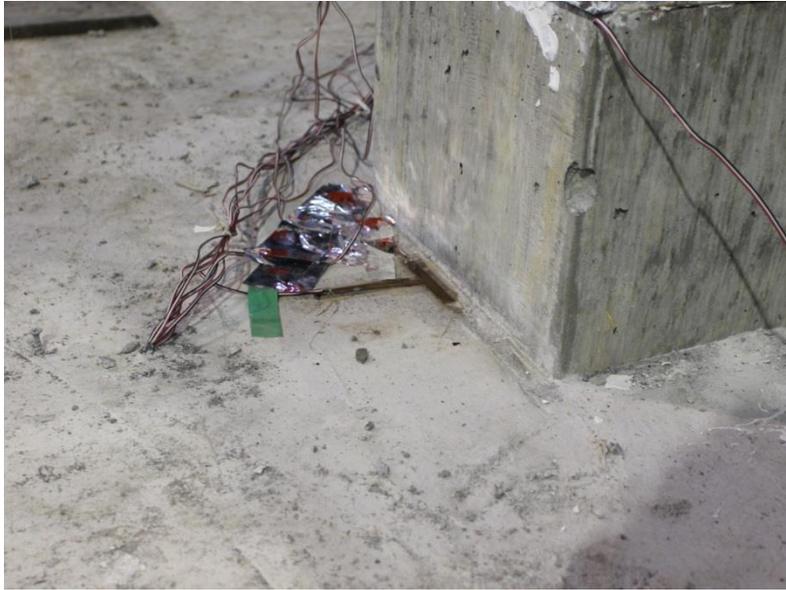
Figure 3.5.5 – Picture of concrete gages in position on the slab against the face of the column.

Strain gages were also applied to the concrete slabs surface against the center of the faces of the column. These gages allowed us to record the strain in the concrete itself during the testing. For each test there were four concrete gages placed around the column two each on two adjacent sides of the column. On each of the two sides one of the gages was placed such that it was measuring the strain parallel to the face of the column and one gage was placed such that it was measuring the strain perpendicular to the face of the column. There was no difference in the placement of the concrete strain gages between the various test setups. The concrete gage positions on one face of the column can be seen in Figure 3.5.5.

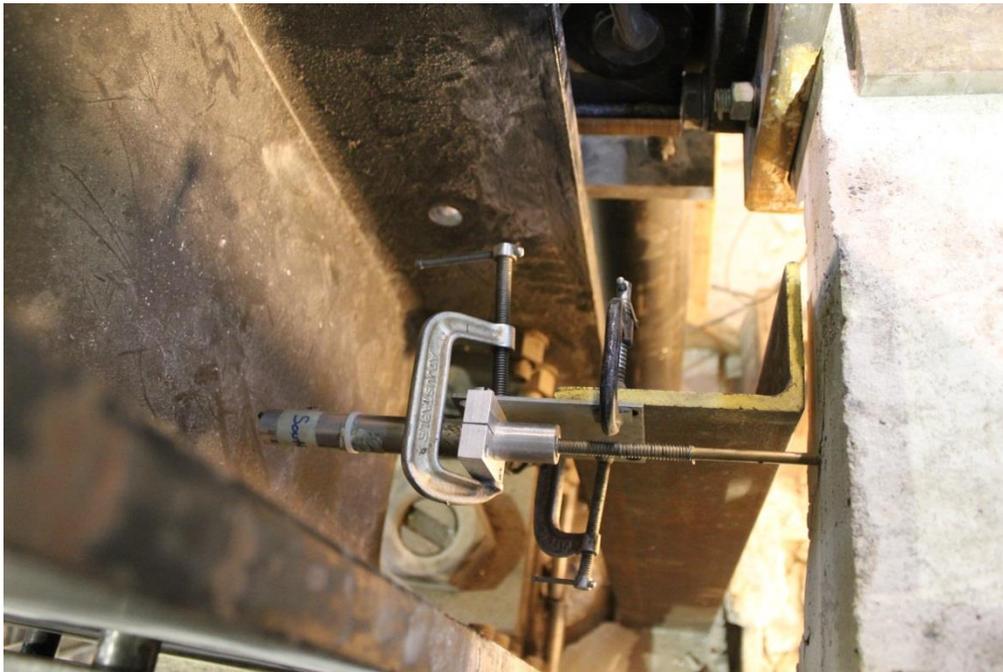
Figure 3.5.7 – Picture from above showing an LVDT positioned along the outer edge of the slab in order to measure the horizontal displacements.

The LVDT's were measuring from the vertical outer edge of the slab, they were placed along the edge in the center of the slab measured from top to bottom as well as end to end. Measurements were made in all four directions to determine if the slab was translating in any direction as well as expanding or contracting. There was no difference in the setup of the LVDT's that were measuring lateral movements between the different test setups. A photo of one of the LVDT's used to measure lateral movements can be seen in Figure 3.5.7.

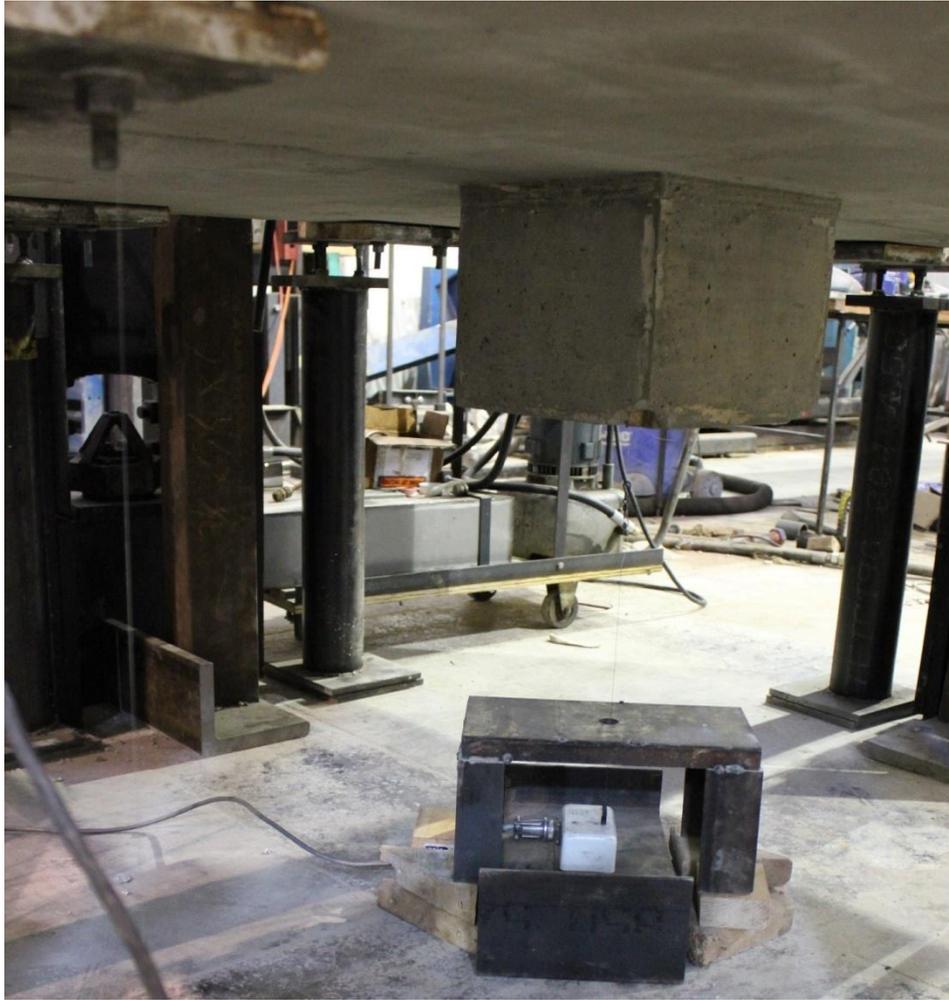
Figure 3.5.8 – Picture of center vertical string pot positioned directly under the bottom column stub (the string pot is covered to prevent damage from falling concrete).

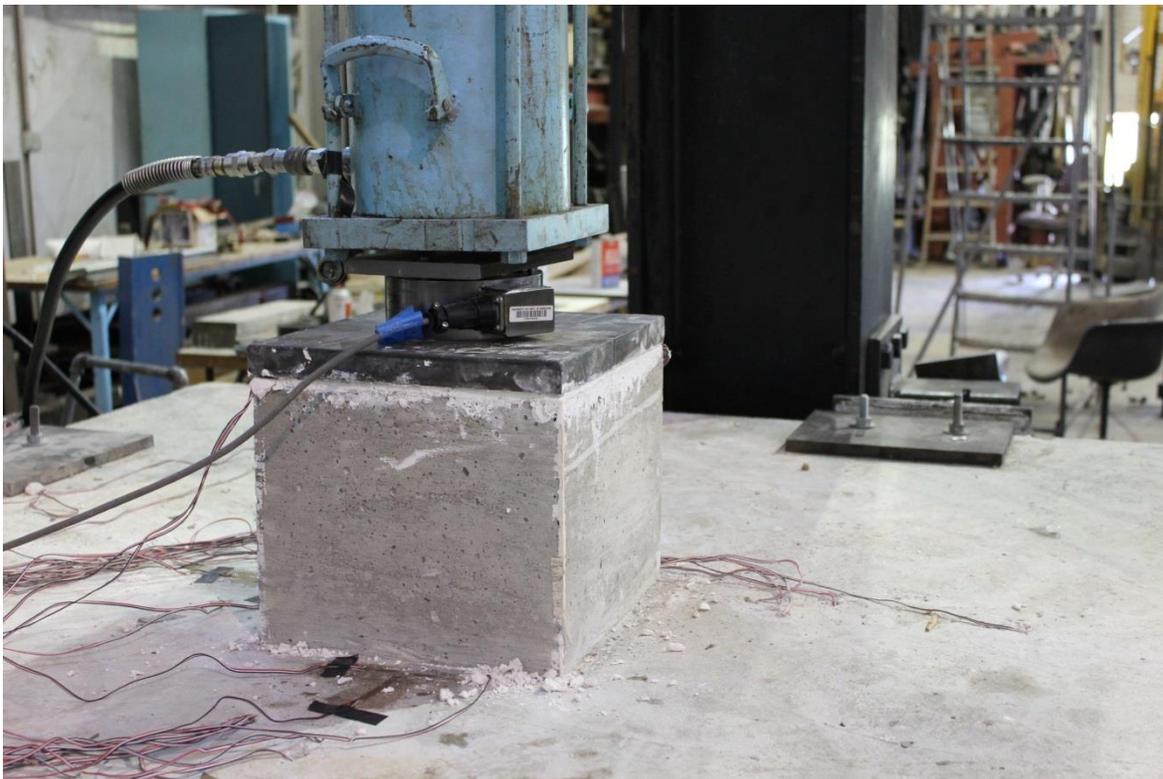
Figure 3.5.10 – Picture of center compression load cell in position on top column stub.

During each of the test a load cell was used to record forces that were applied on the column. The center load cell was a 200 kip compression load cell that was positioned directly under the hydraulic jack. This provided the ability to record the load applied to the slab during the test. This center load cell can be seen in Figure 3.5.10.

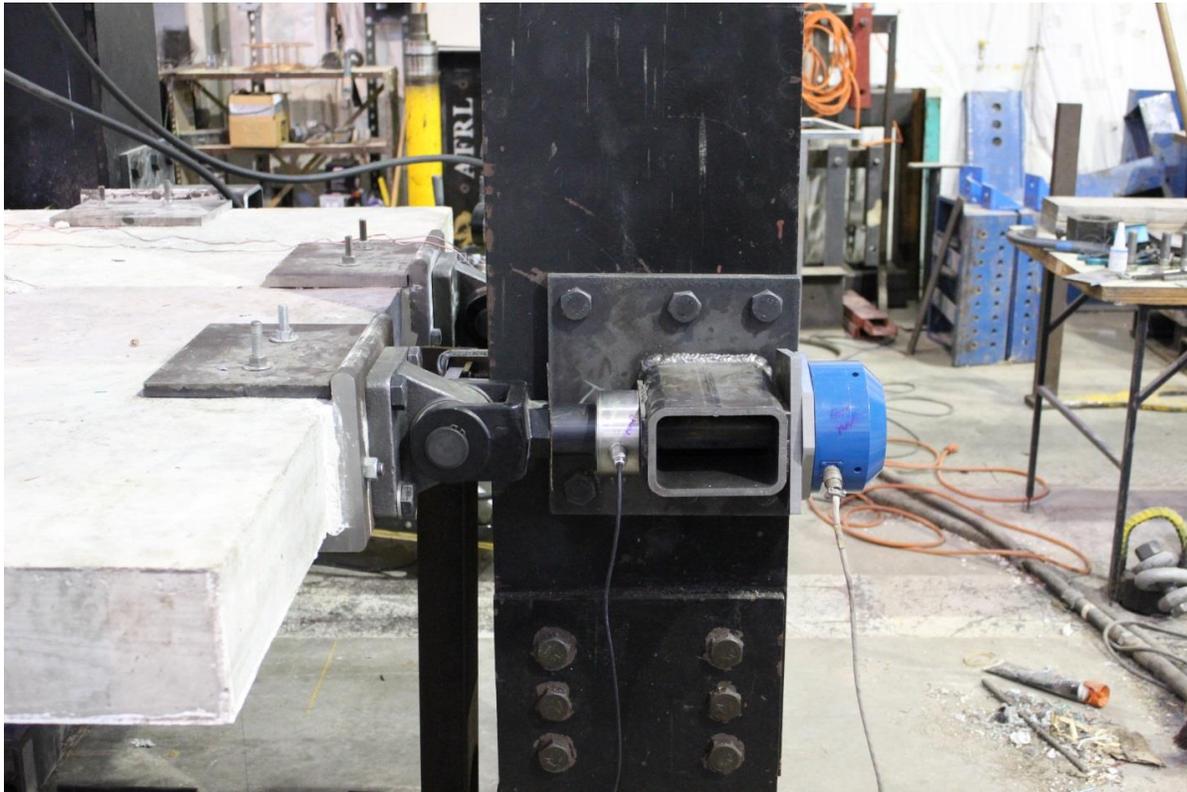
Figure 3.5.11 – Picture of tension (blue) and compression (silver) load cells in position for the restrained test setup.

For the unrestrained test the center load cell is the only load cell used. When testing specimens in the restrained setup the center load cell as well as four other load cells were used. There were two tension load cells and two compression load cells. The additional load cells

were placed on the 1.5 inch threaded rods that extended from the clevis, these load cells provided the ability to record any lateral forces that developed as the slab was loaded. An example of the locations of the additional load cells can be seen in Figure 3.5.11.

The compression load cells were slid over the end of the rod prior to placing the rod through HSS that is attached to the column. The compression load cell is held in place by a washer and nut that forces it against the HSS. The tension load cells threaded on the ends of the same rods that the compression cells were on and were tightened down such that there was no slack in the system. The load cells were placed on rods that were on adjacent columns such that they were not measuring directly across from each other.

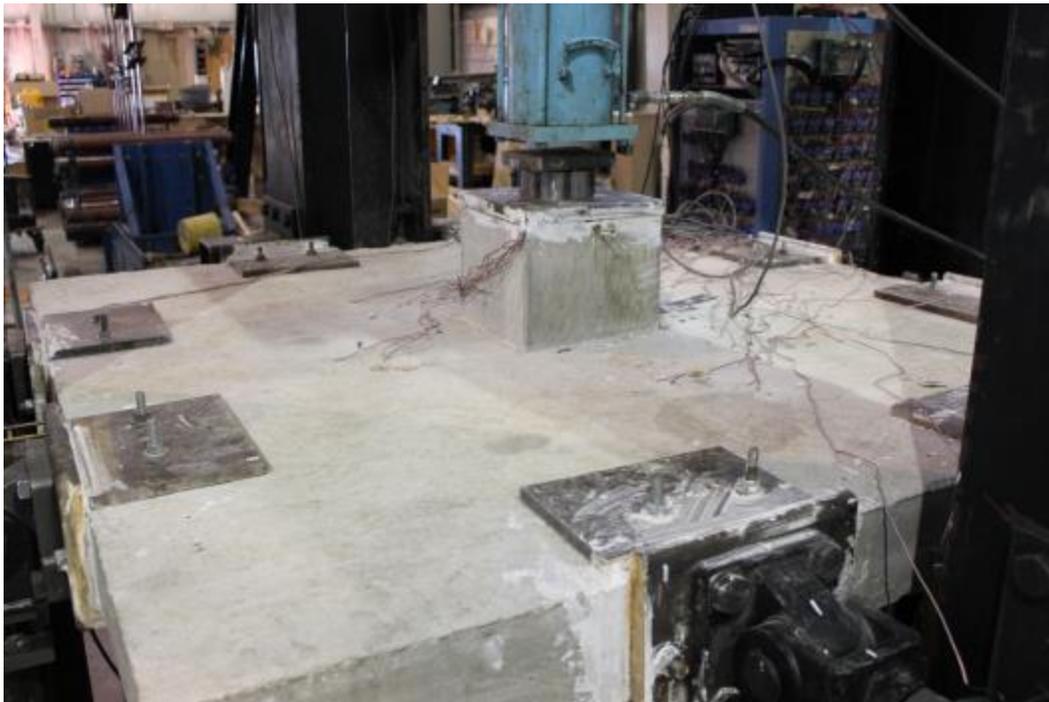
Figure 4.1 – Top view of slab specimen prior to testing.

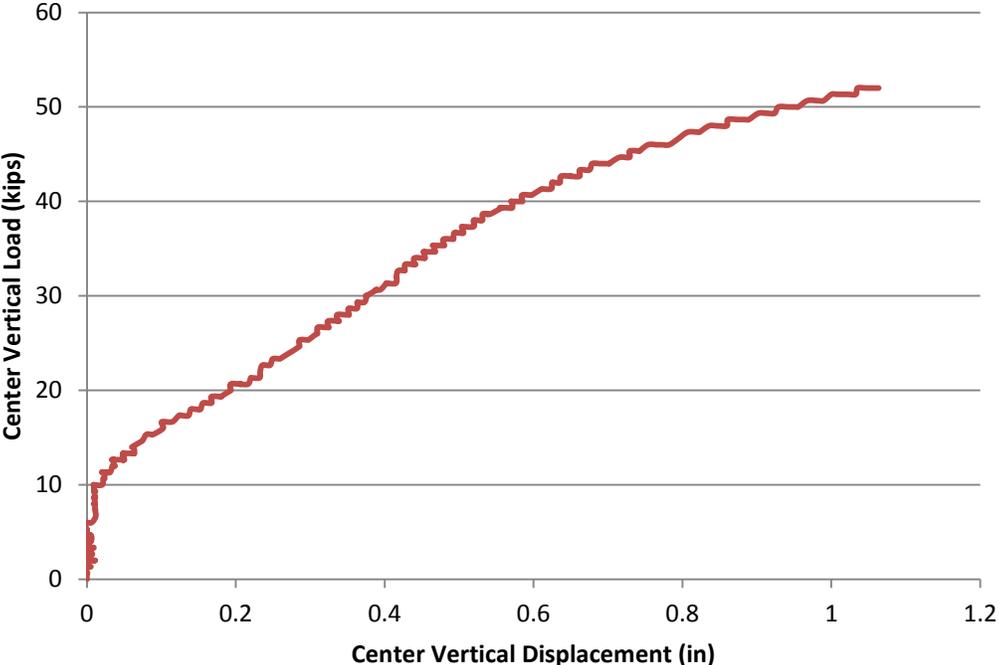
Figure 4.1.1.1 – Pre-punching vertical load vs. center vertical displacement for the 0.5% unrestrained specimen.

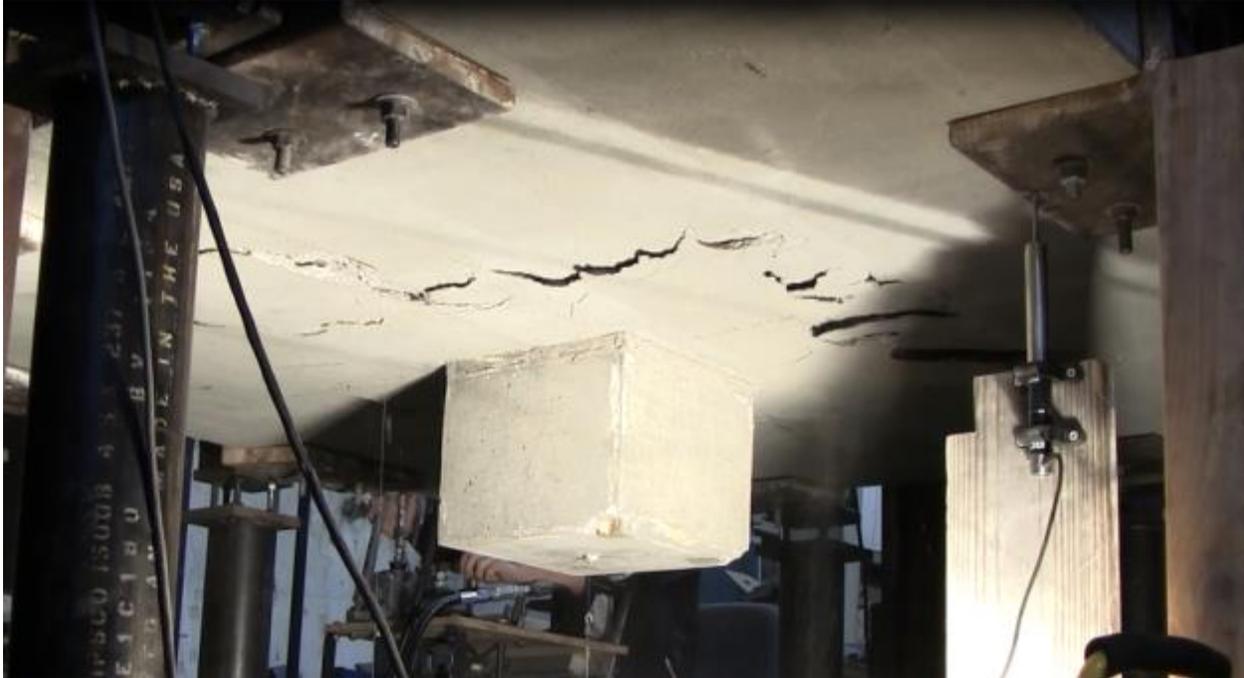
Figure 4.1.1.2 – Underside of the 0.5% unrestrained slab just after the punching failure.

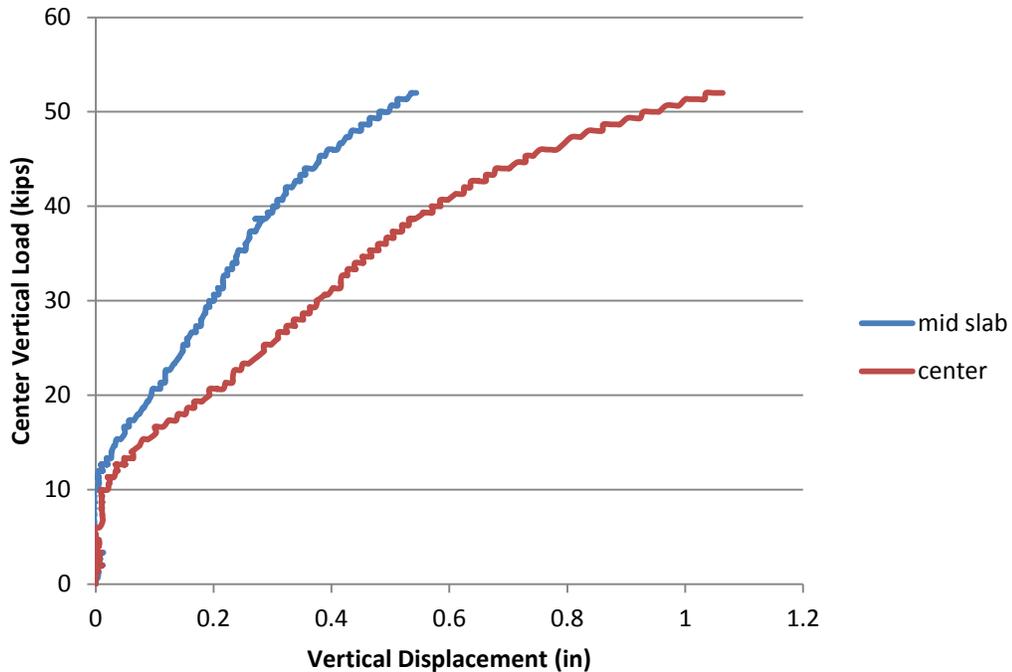
Figure 4.1.1.3 – Vertical displacements measured relative to the displacements of the supports 0.5% unrestrained slab specimen.

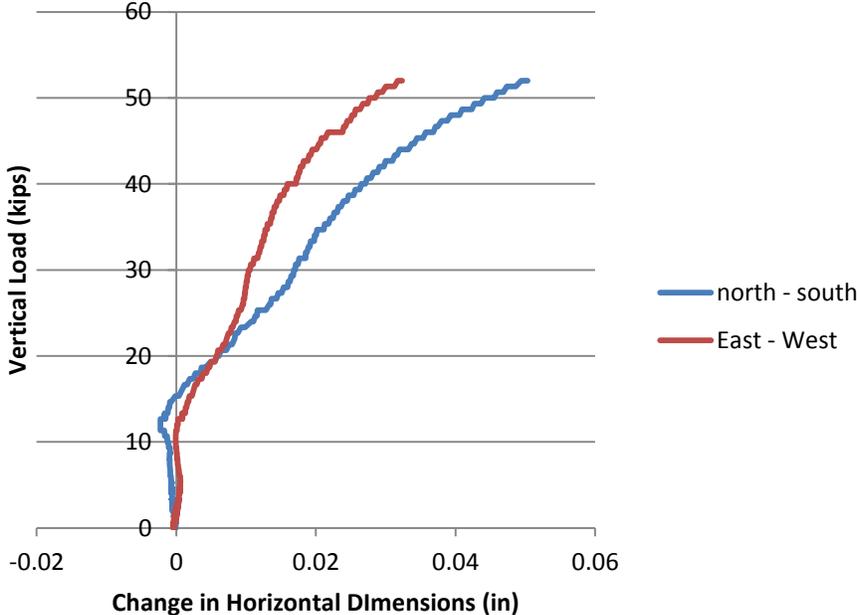
Figure 4.1.1.4 - Horizontal expansions of the 0.5% unrestrained slab as it relates to the applied loading prior to the punching failure.
