EVALUATION OF THE EFFECTS OF IN-PLANE LATERAL RESTRAINT  
AND REINFORCEMENT RATIO ON THE PUNCHING  
CAPACITY OF FLAT SLAB COLUMN SPECIMENS

A Thesis presented  
To the Faculty of  
The Graduate School of the  
University of Missouri – Columbia

By  
CHRISTOPHER ROBERT HENQUINET  
Dr. Sarah L. Orton, Thesis Supervisor

July 2013

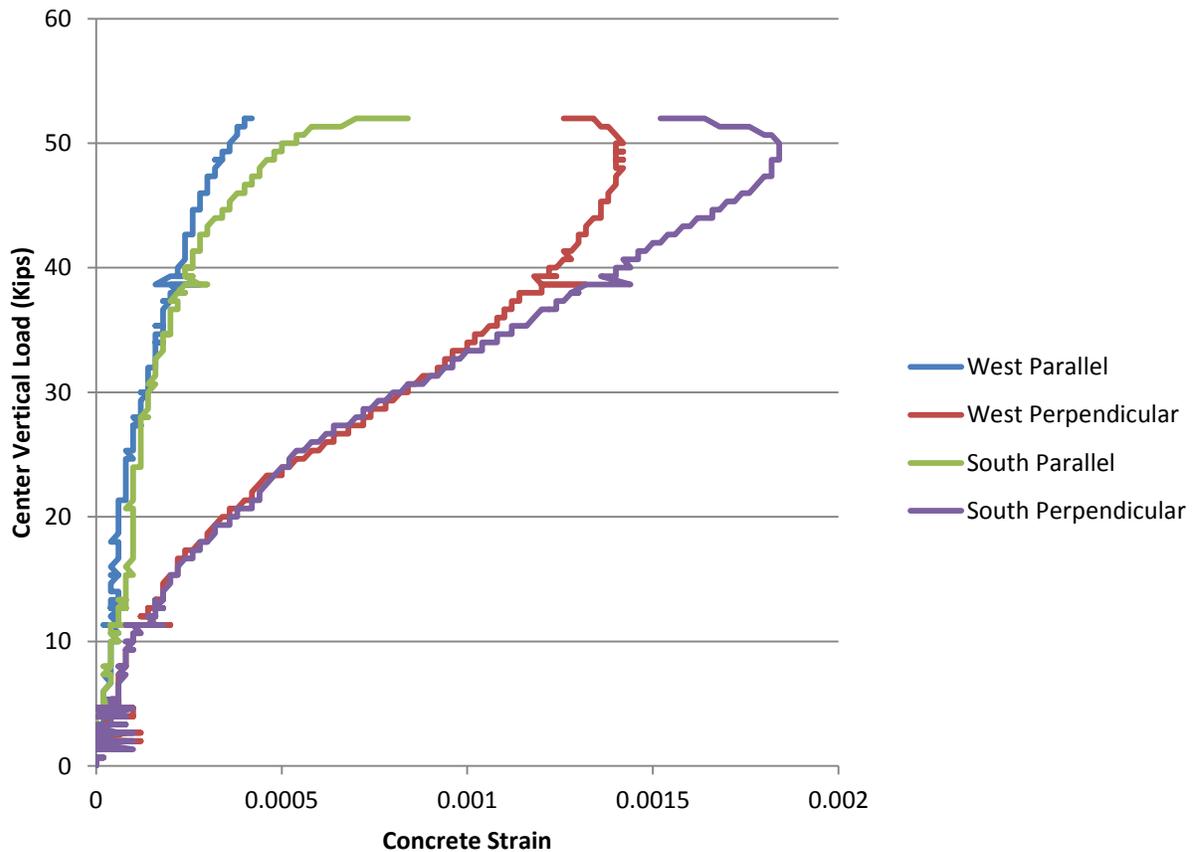
Figure 4.1.1.5 – Applied vertical load vs. concrete compressive strains measured along two of the faces of the column of the 0.5% unrestrained slab prior to the punching failure.

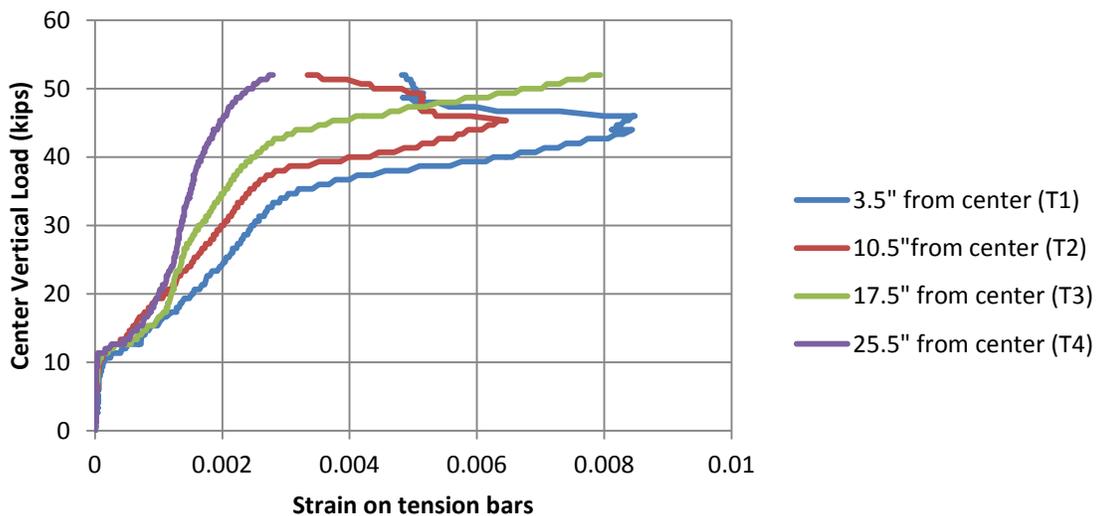
Figure 4.1.1.6 –Strain on the tension reinforcement vs. applied vertical load on the 0.5% unrestrained slab as you move away from the center of the slab specimen.

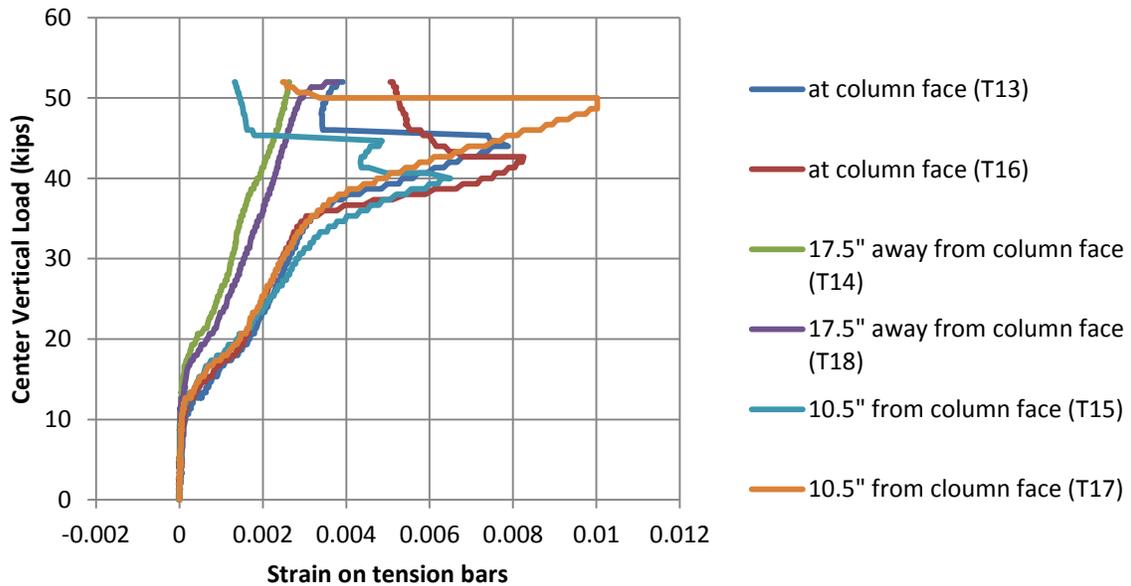
Figure 4.1.1.7 – Applied load on the 0.5% unrestrained slab vs. strain on the tension reinforcing cage as the bars pass through the column and punching cone.

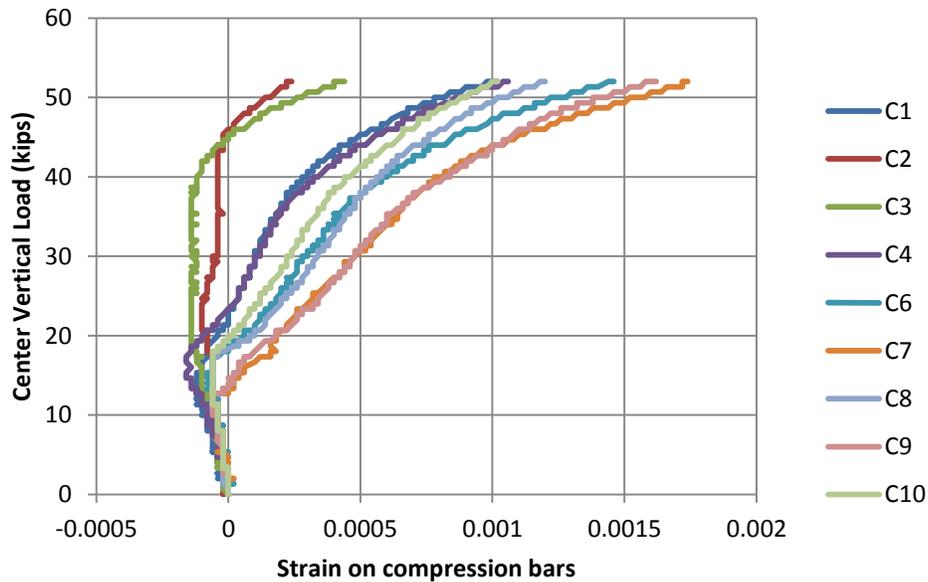
Figure 4.1.1.8 – Applied vertical load on the 0.5% unrestrained slab vs. strain on compression bars prior to the punching failure occurring. Compressive strains are shown as negative and tensile strains are shown as positive.

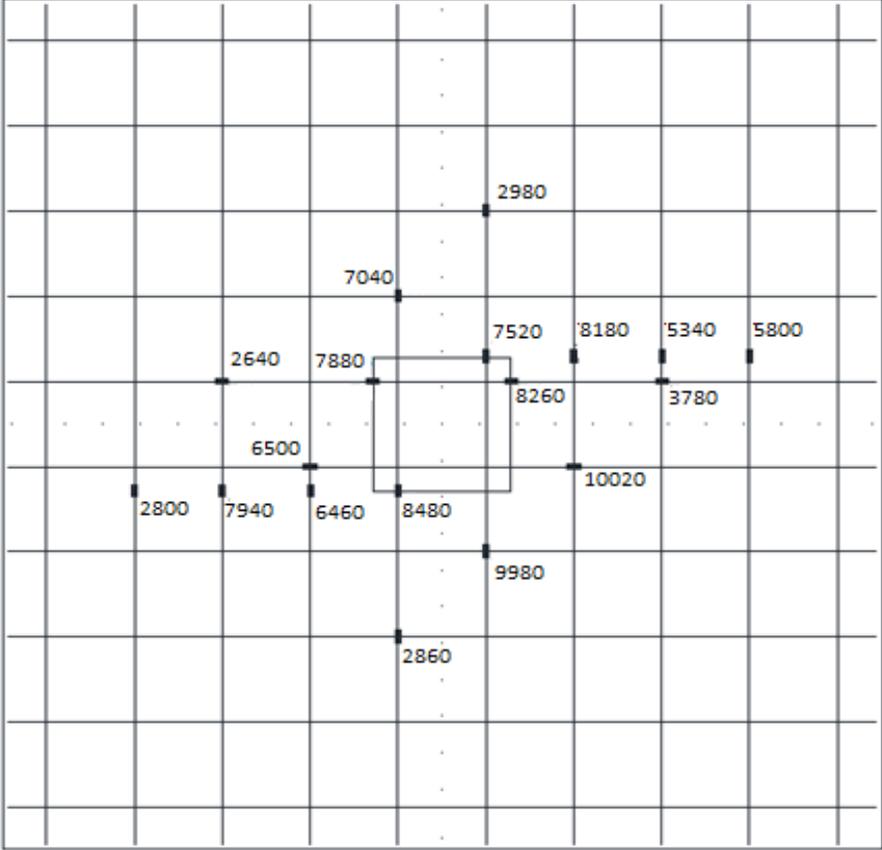
Figure 4.1.1.9 – Maximum strain values on the tension reinforcement prior to failure for the 0.5% unrestrained slab (strain values listed in microstrains).

strain values prior to failure listed at their corresponding locations within the slab. The gage locations can be referenced in Figures 3.5.1 and 3.5.2.

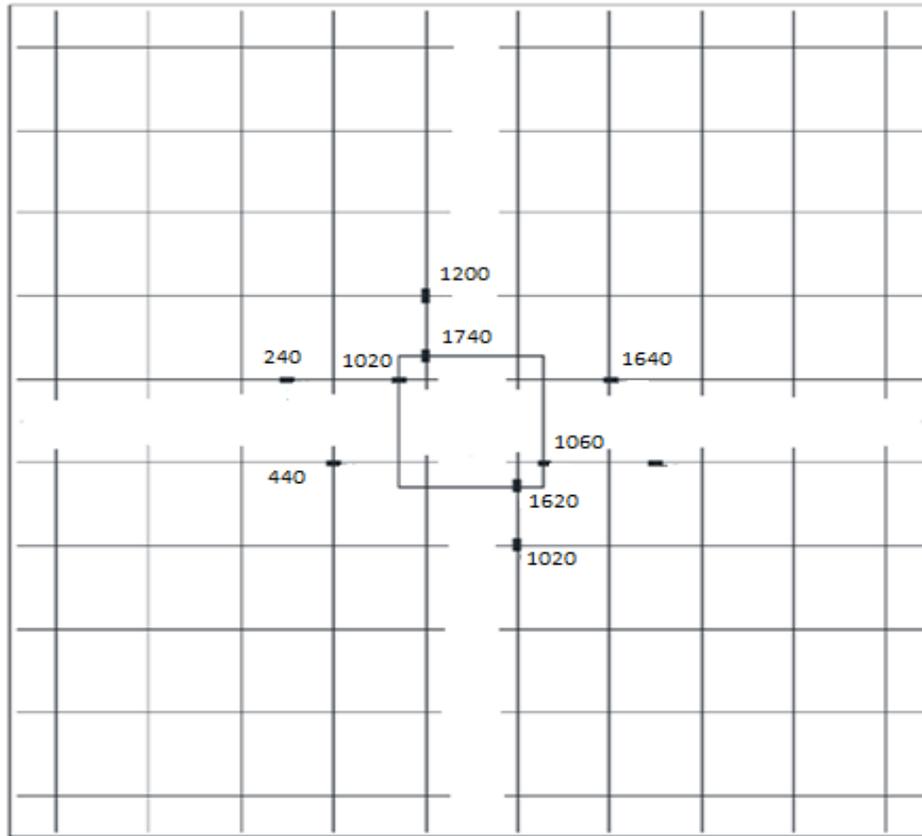
Figure 4.1.1.10 – Maximum tensile strain values on the discontinuous reinforcement prior to failure for the 0.5% unrestrained slab (strain values are listed in microstrains).

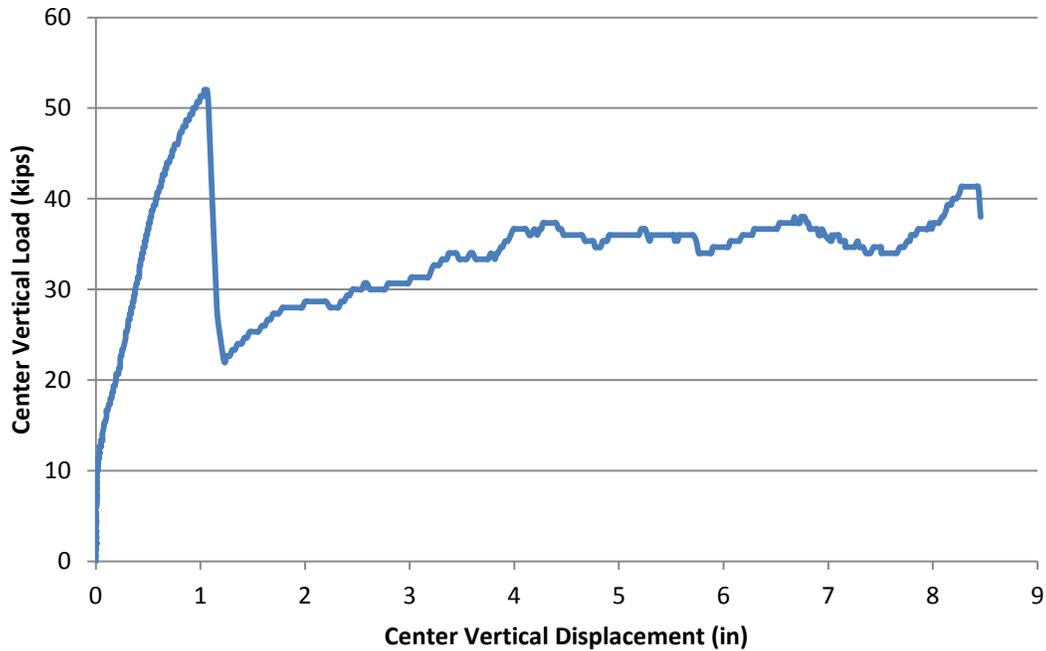
Figure 4.1.2.1 – Load Deflection plot including post punching response of the 0.5% unrestrained slab.

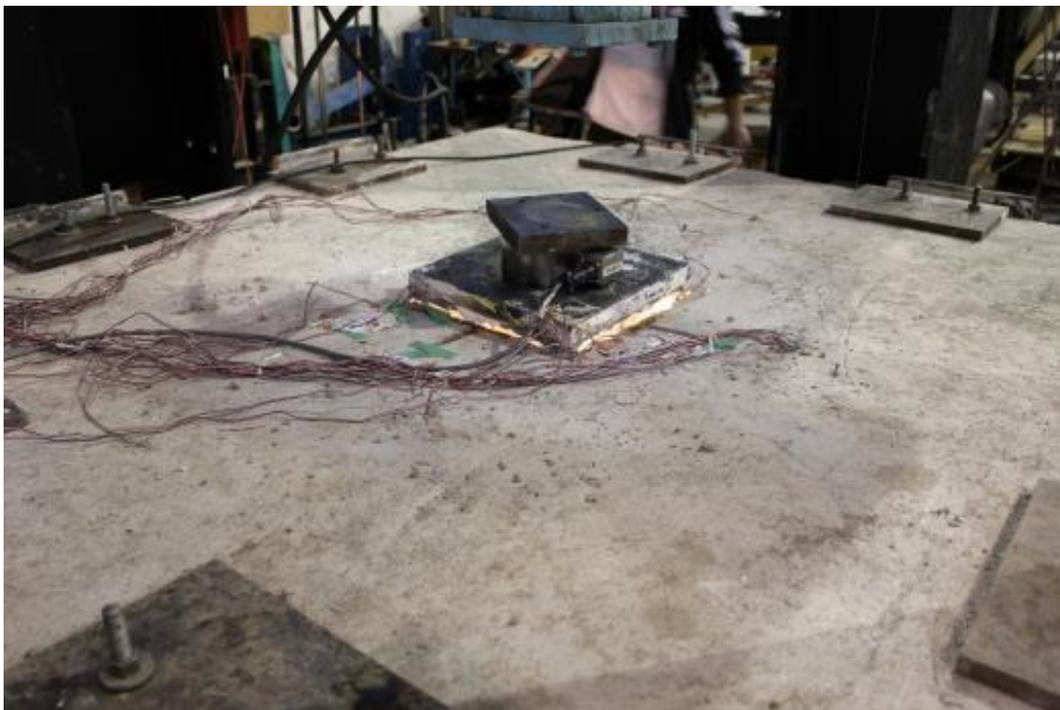
Figure 4.1.2.2 – 0.5% unrestrained slab from above at the conclusion of the test.

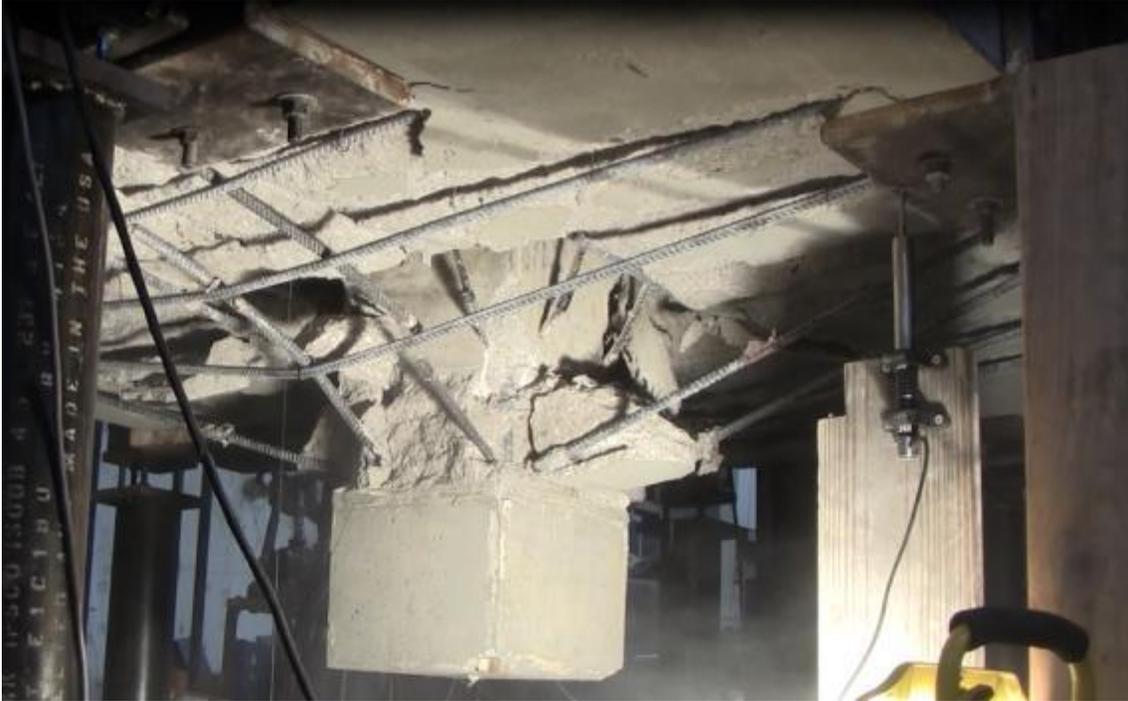
Figure 4.1.2.3 – Underside of the 0.5% unrestrained slab at the conclusion of the test.

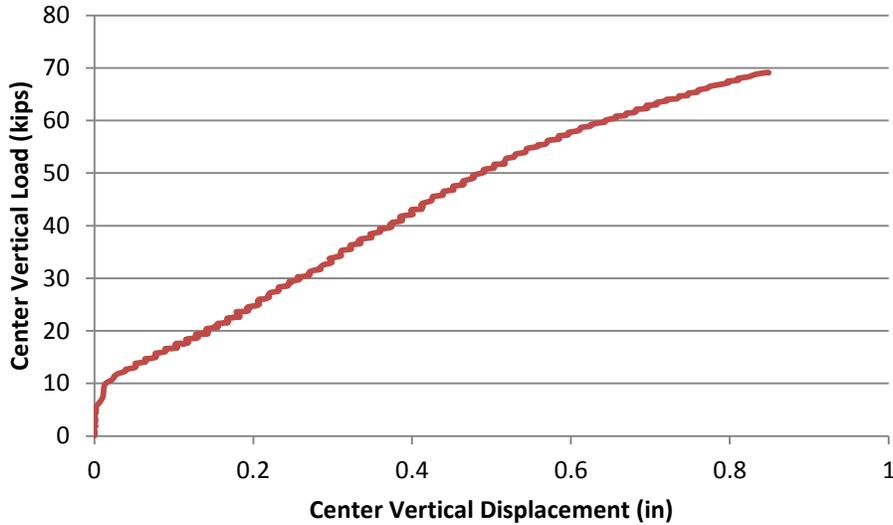
Figure 4.1.3.1 – Center load deflection response of the 1% reinforcement unrestrained slab specimen prior to the punching failure occurring.

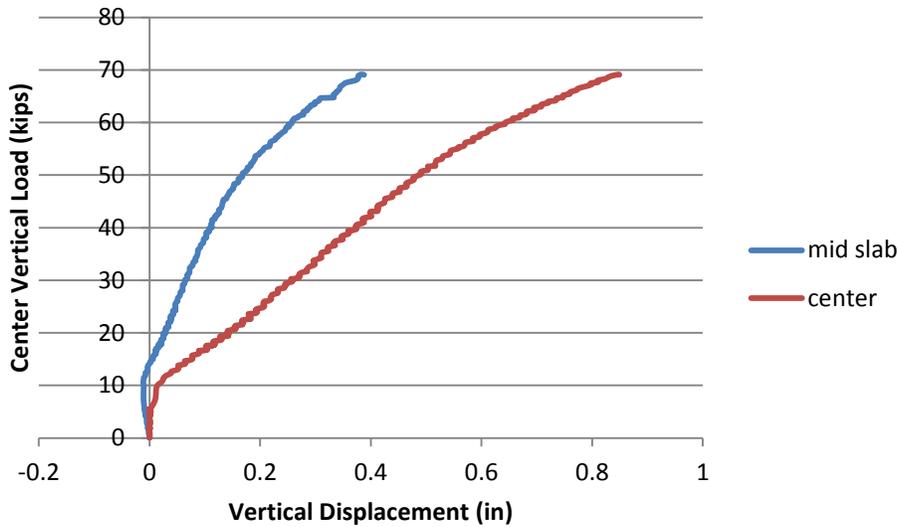
Figure 4.1.3.2 – Load displacement response for the center location as well as the mid slab location relative to the supports for the 1.0% unrestrained slab.

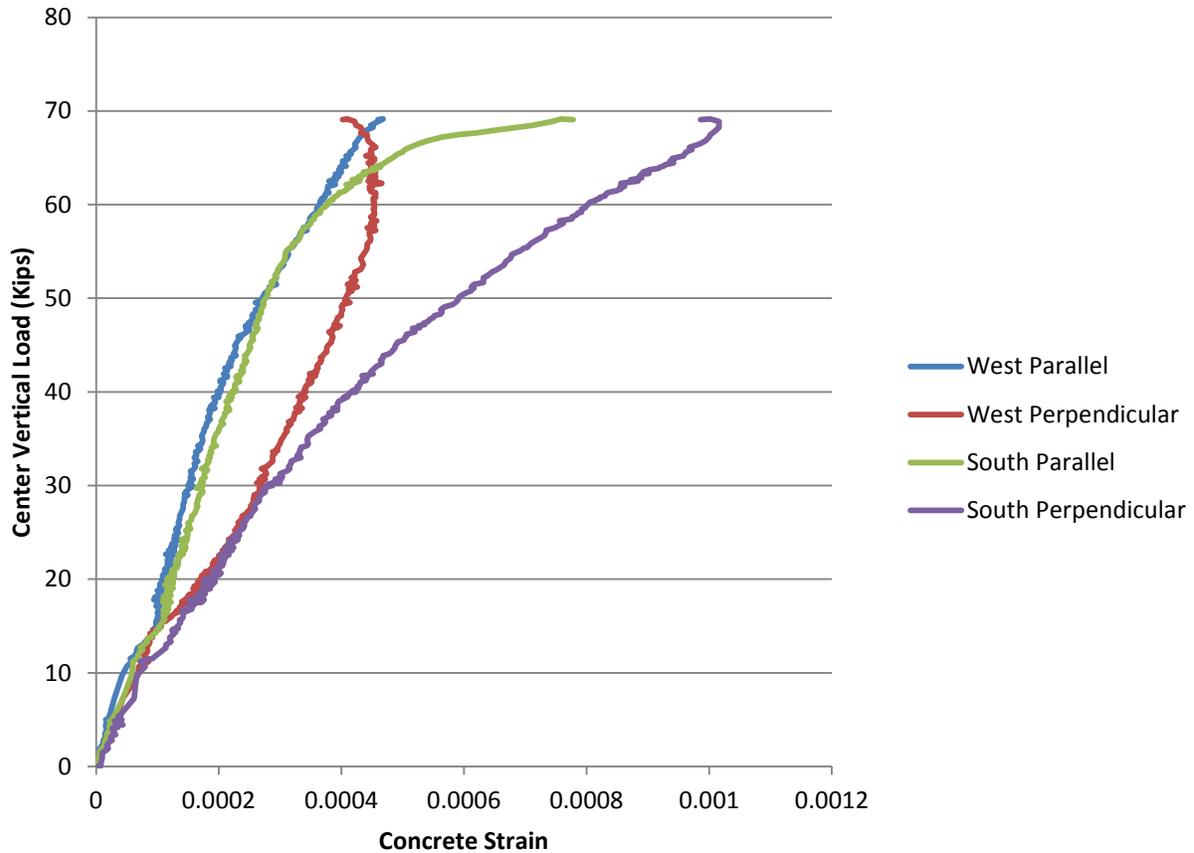
Figure 4.1.3.3 – Applied vertical load vs. compressive concrete strains for the 1% unrestrained slab specimen.

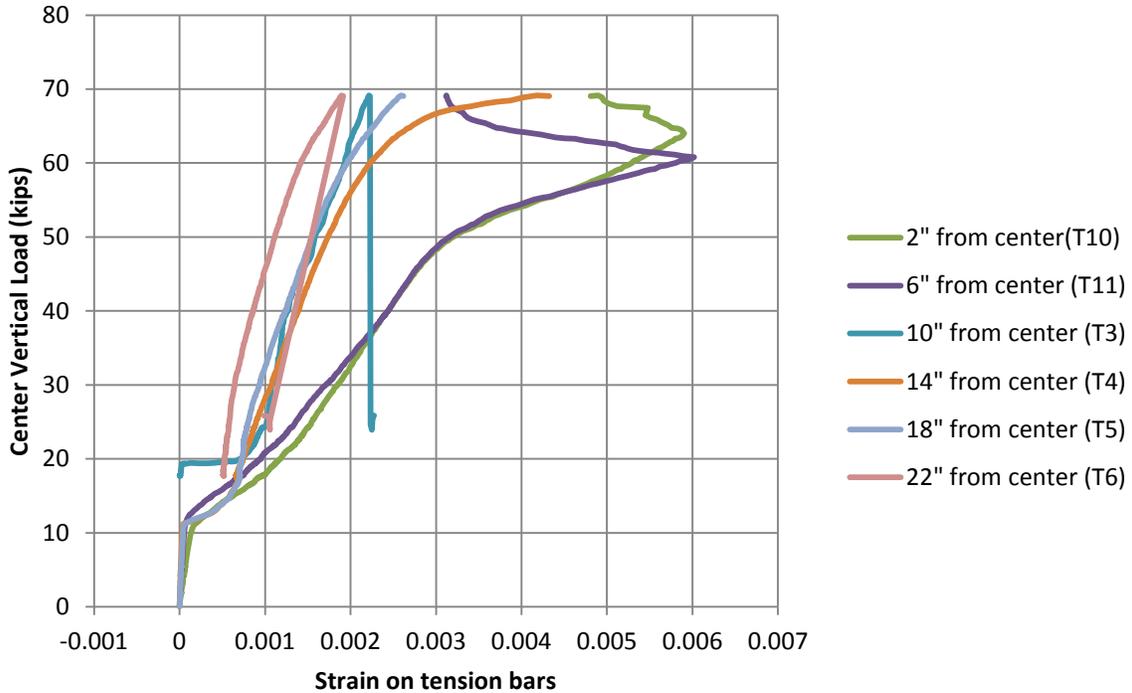
Figure 4.1.3.4 – Applied load on the 1.0% unrestrained slab vs. tension reinforcement strains as measurement locations moved away from the center of the slab.

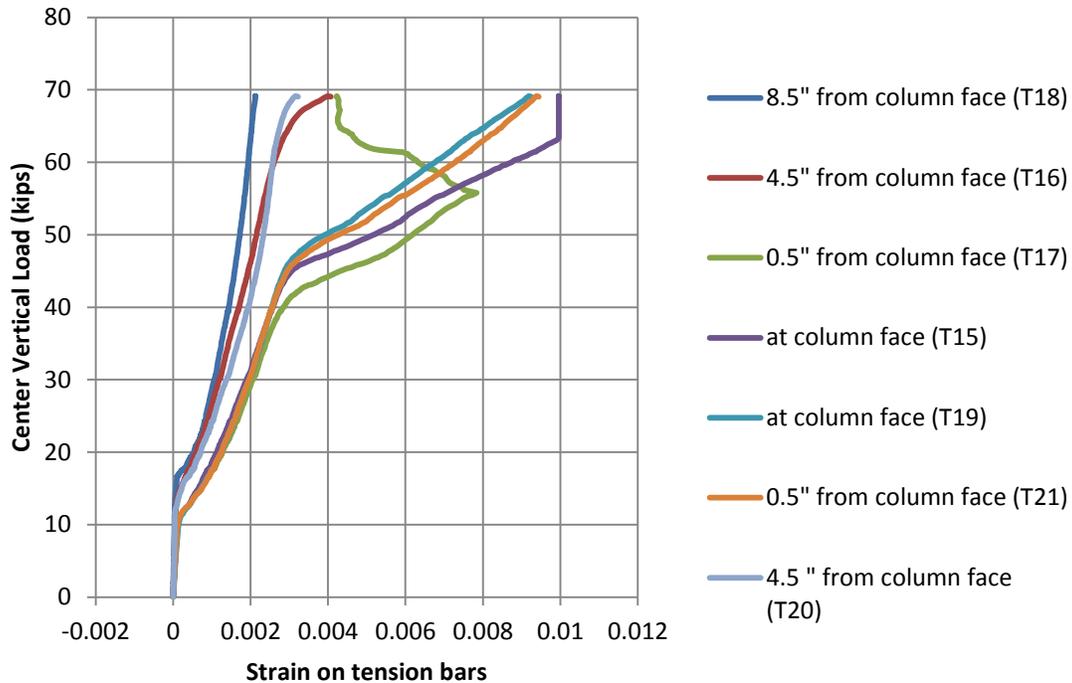
Figure 4.1.3.5 – Relationship between applied load on the 1.0% unrestrained slab and measured strains on tension reinforcement as measuring locations moved through the column.

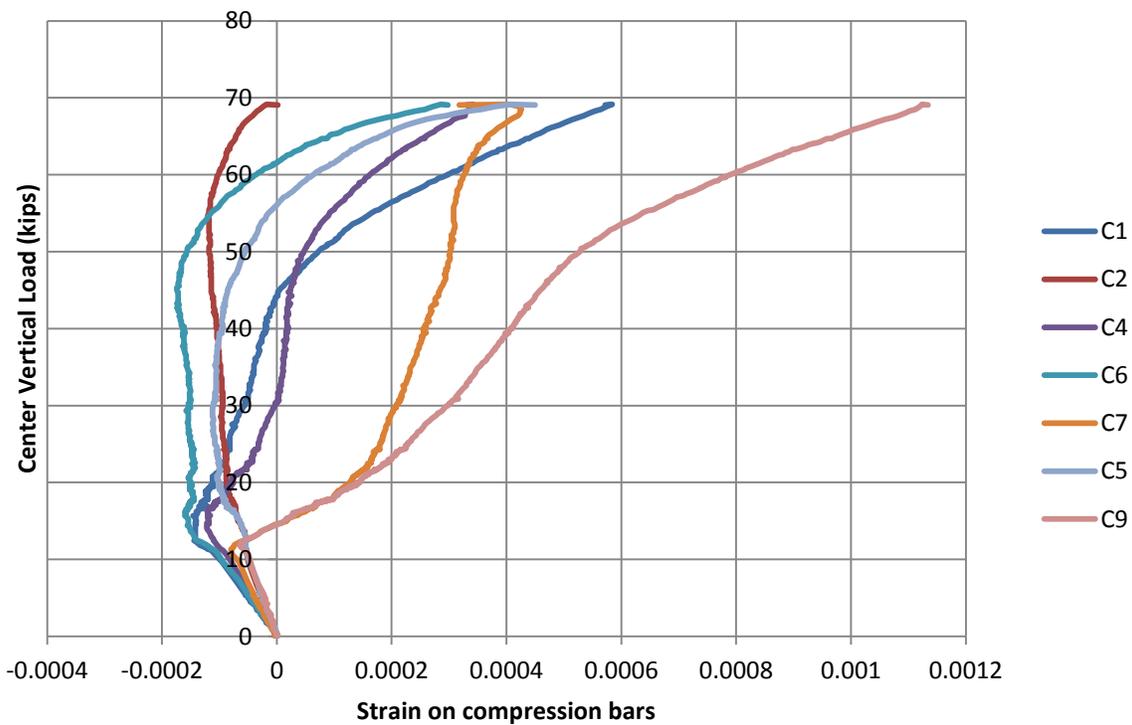
Figure 4.1.3.6 – Relationship between applied load on the 1.0% unrestrained slab and measured strain on the compression reinforcing cage. Compressive strains are shown as negative while tensile strains are shown as positive.

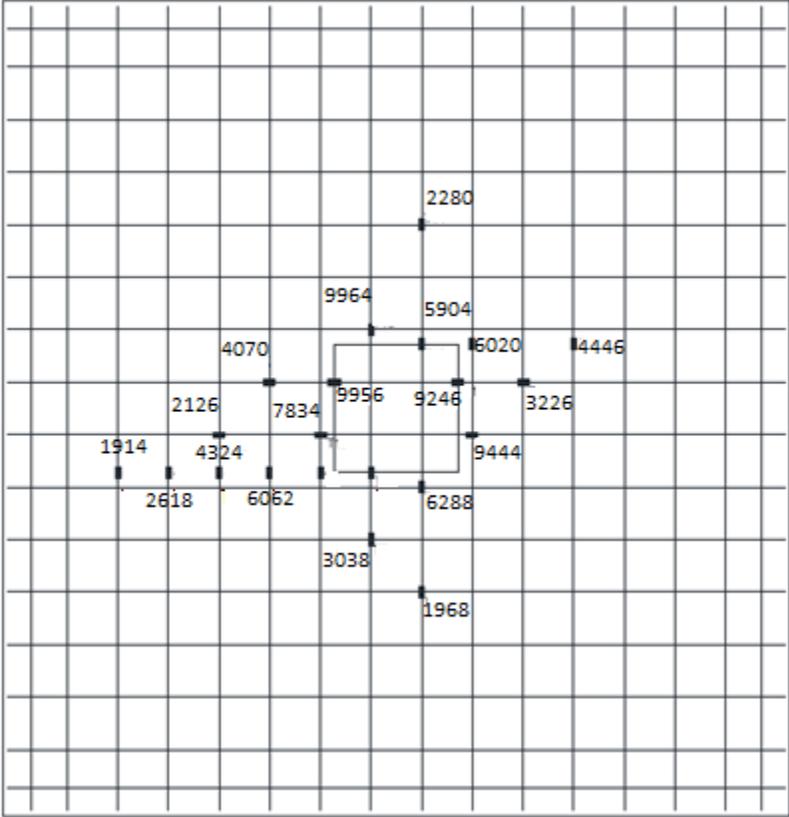
Figure 4.1.3.7 – Maximum strains on the tension reinforcement prior to the punching failure for the 1.0% unrestrained slab (strain values listed in microstrains).

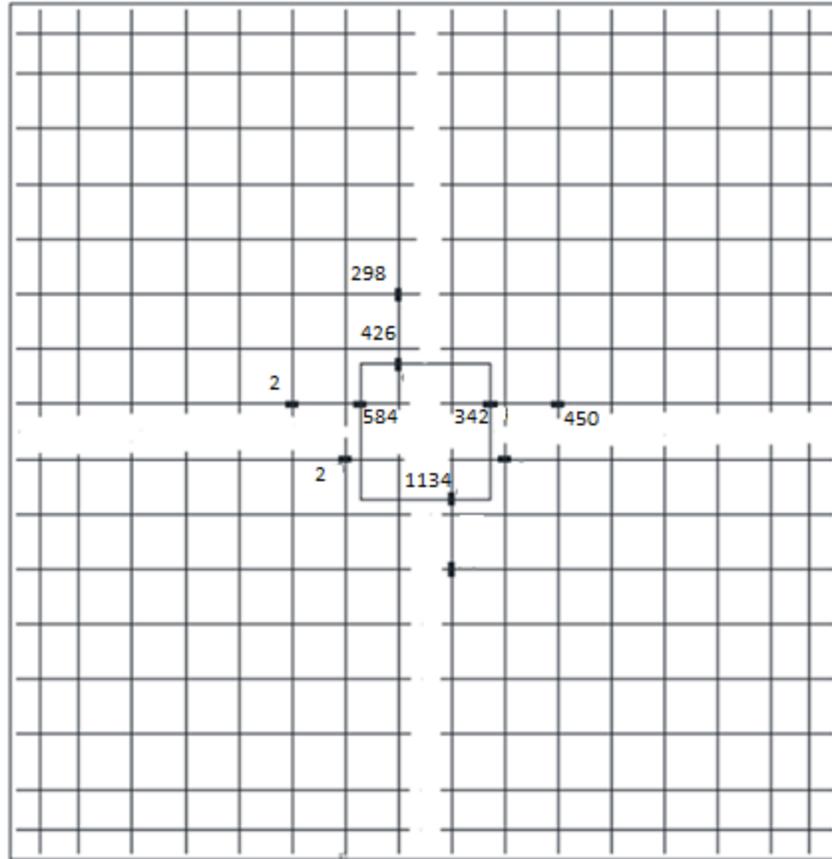
Figure 4.1.3.8 – Maximum strains on the discontinuous reinforcement prior to failure for the 1.0% unrestrained slab (strain values listed in microstrains).

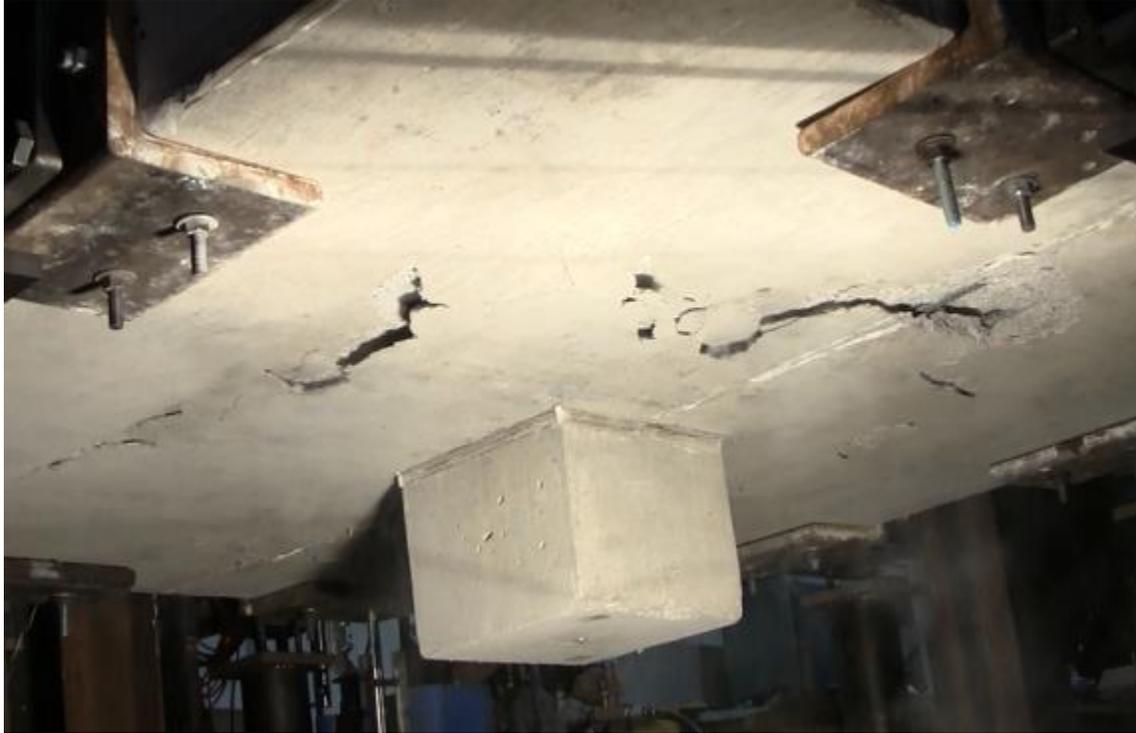
Figure 4.1.3.9 – Underside of the 1.0% unrestrained slab just after the punching failure.

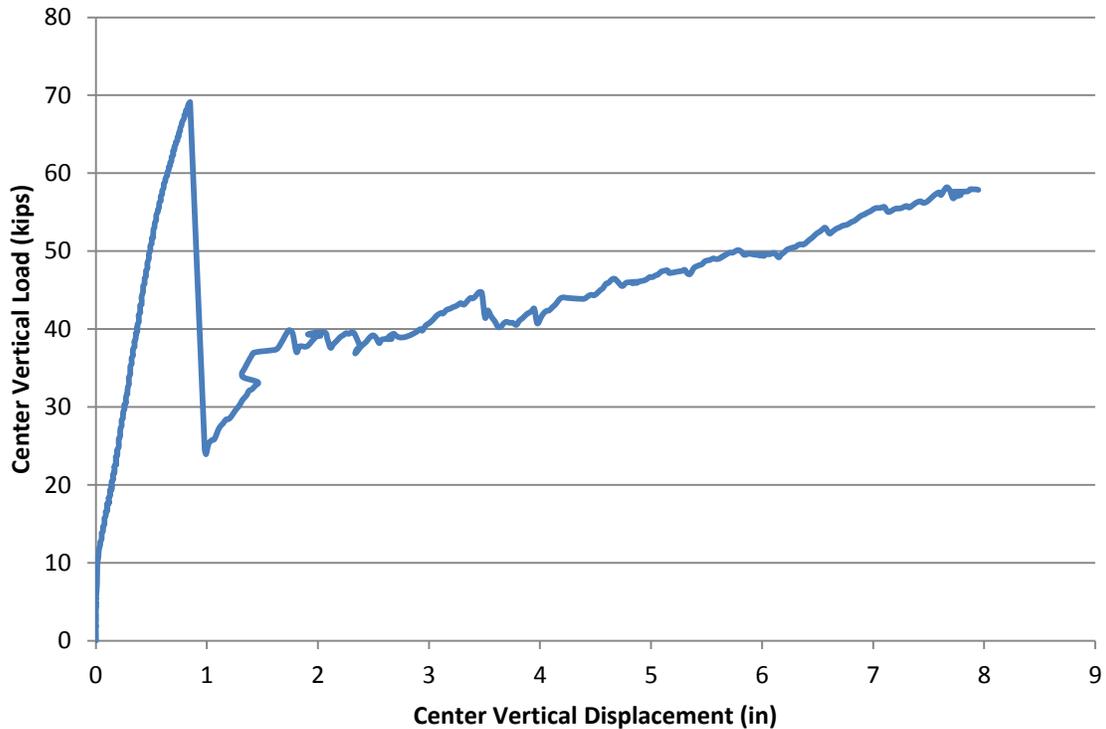
Figure 4.1.4.1 – Load Deflection plot including post punching behavior for the 1.0% unrestrained slab.

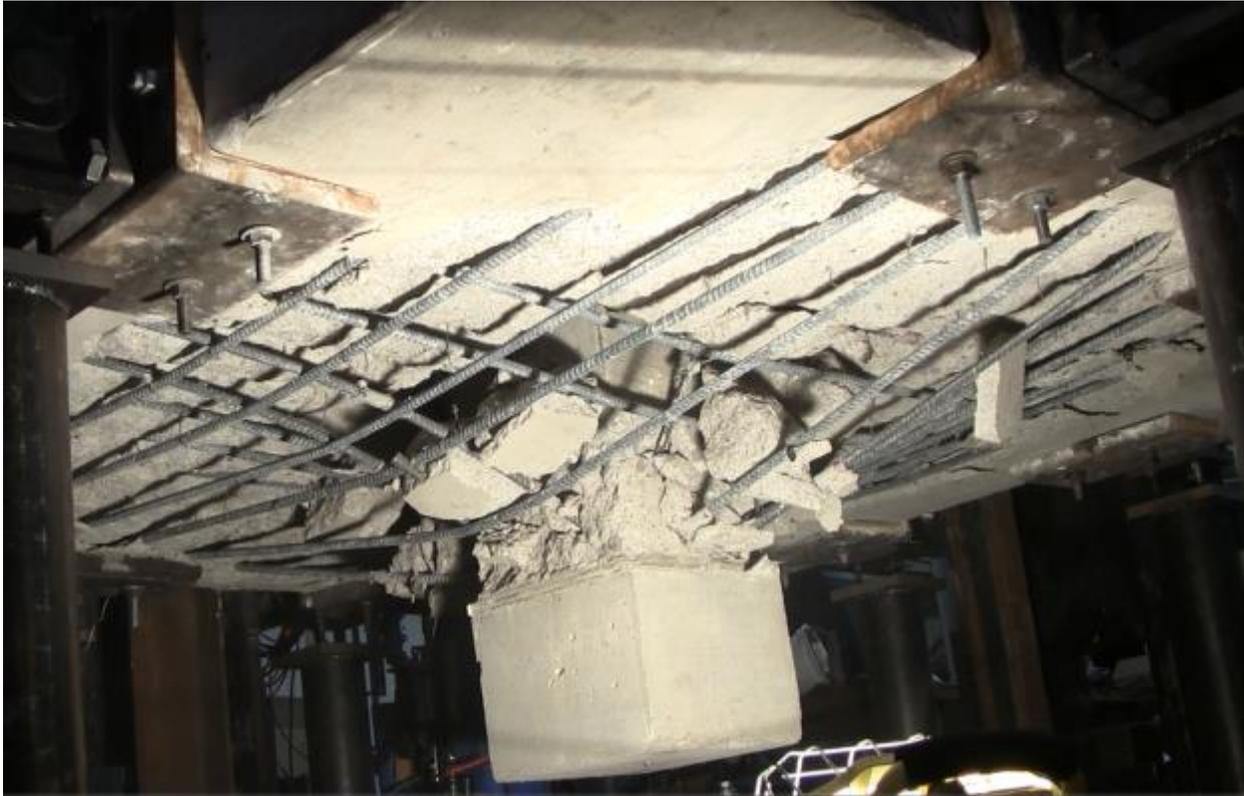
Figure 4.1.4.2 – Underside of the 1.0% unrestrained slab at the conclusion of the testing.

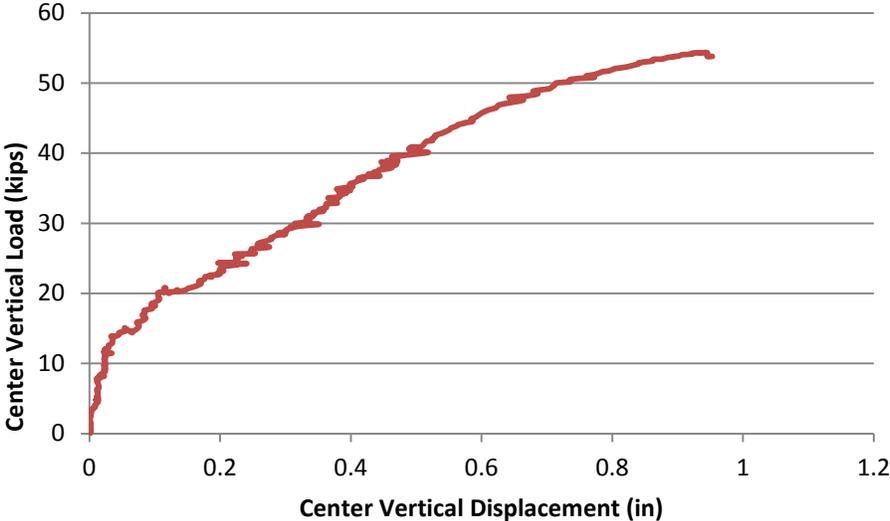
Figure 4.2.1.1 – Center load-deflection plot for the 0.5% restrained slab prior to the punching failure.

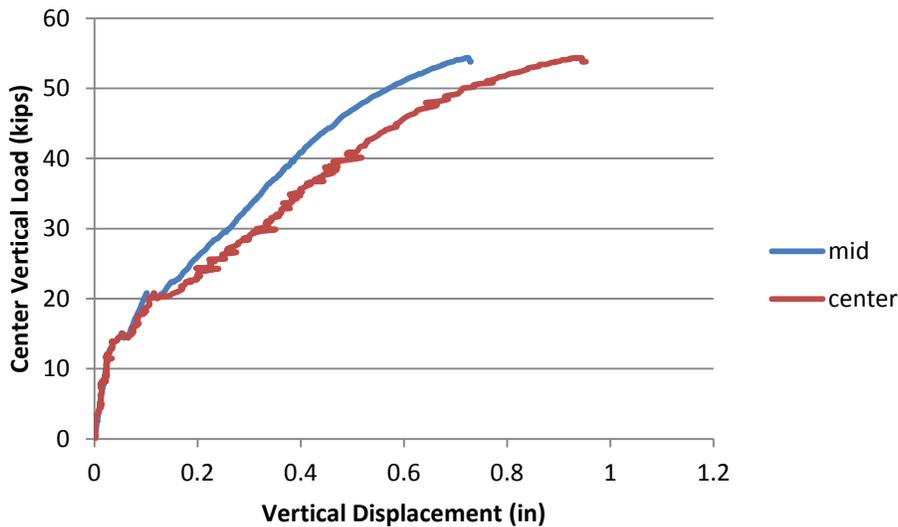
Figure 4.2.1.2 – Load displacement plot for the 0.5% restrained slab prior to the punching failure.

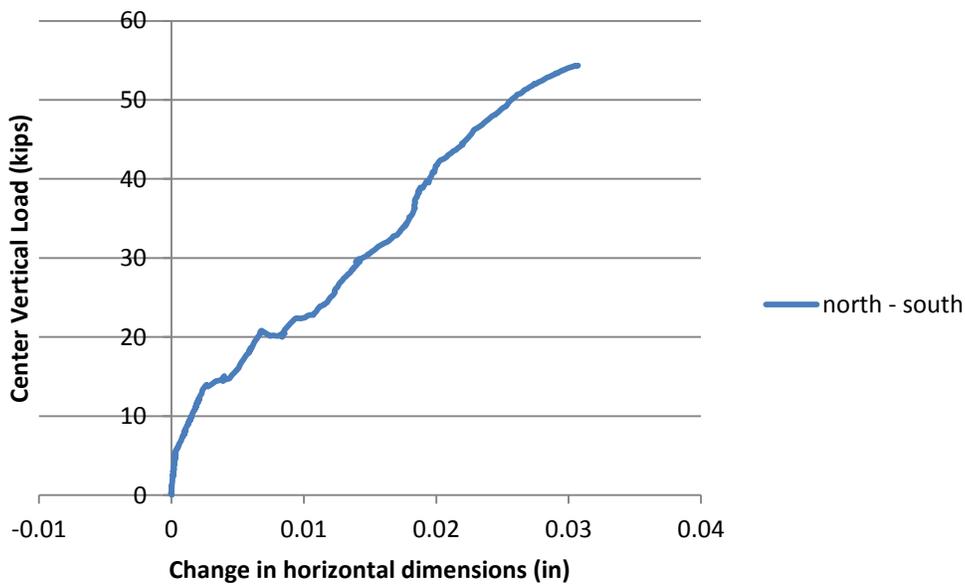
Figure 4.2.1.3 – Change in horizontal dimensions of the 0.5% restrained slab and the corresponding applied vertical load.

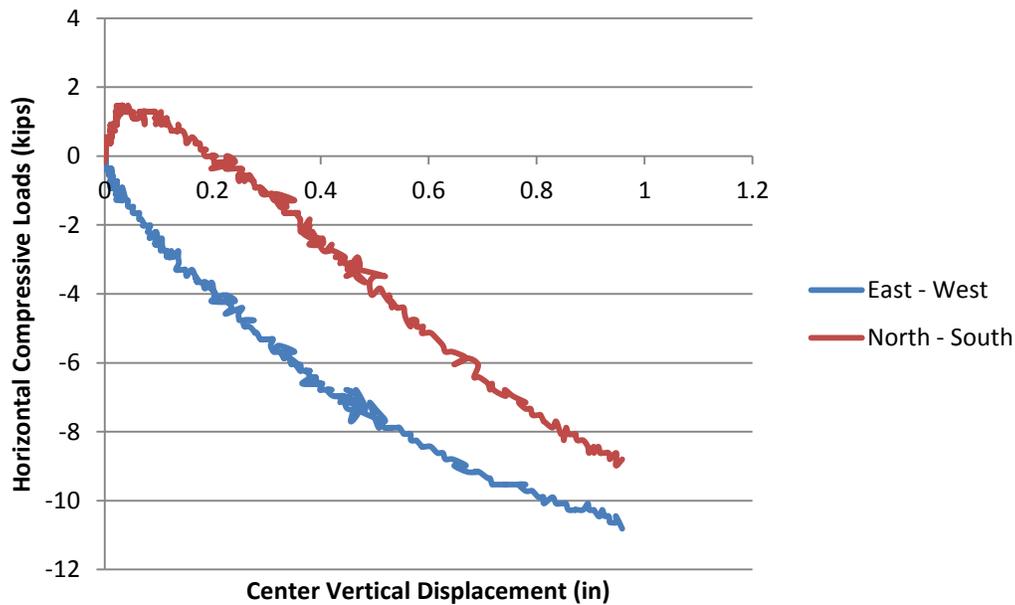
Figure 4.2.1.4 – Horizontal compressive loads measured by load cells in relation to the center vertical displacement for the 0.5% restrained slab.

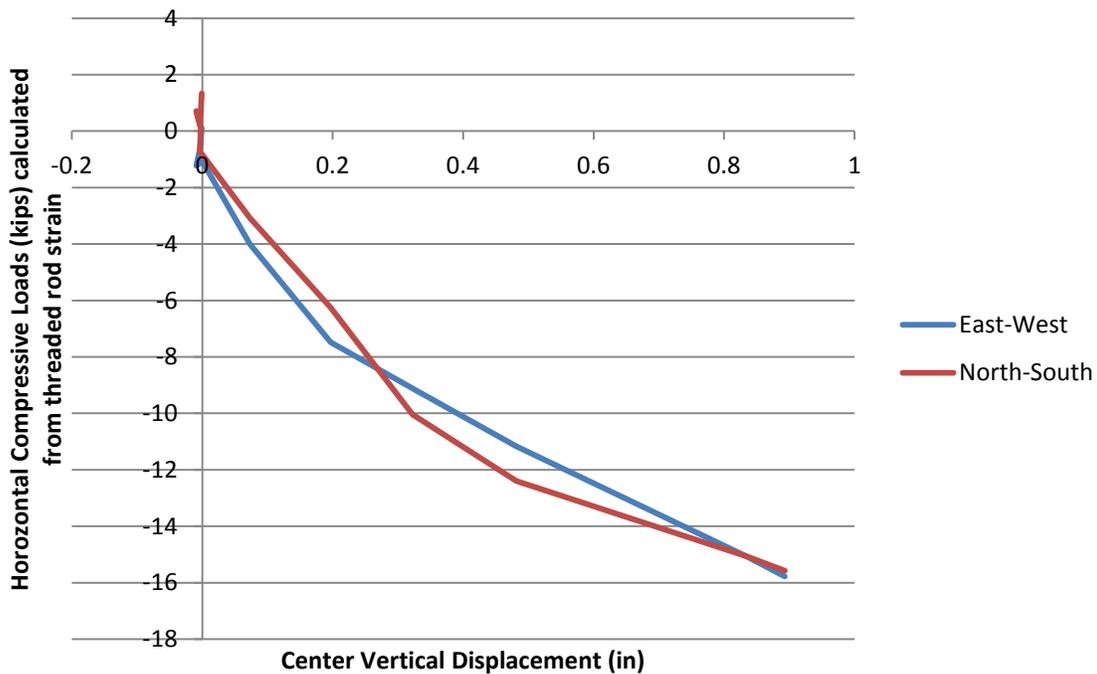
Figure 4.2.1.5 – Horizontal compressive loads calculated from threaded rod strains for the 0.5% restrained slab.

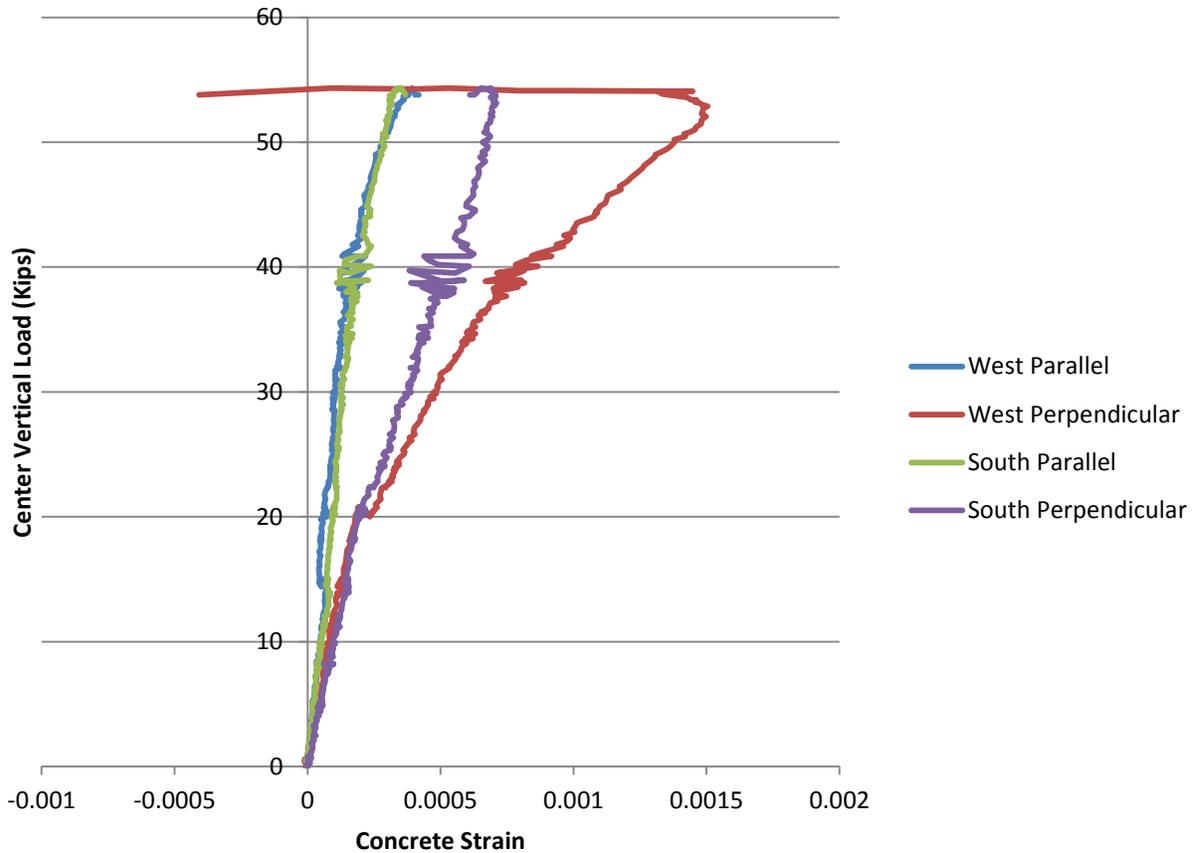
Figure 4.2.1.6 – Applied vertical load and strain in the concrete measured on the slab at the face of the column for the 0.5% restrained slab.

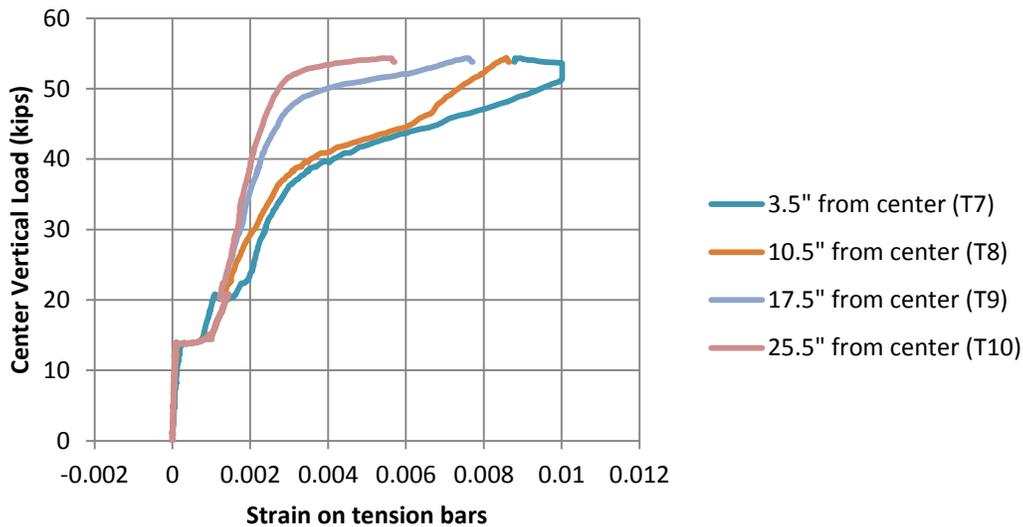
Figure 4.2.1.7 – Applied load and resulting strain on tension reinforcement as measurements were made farther from the center of the 0.5% restrained slab.

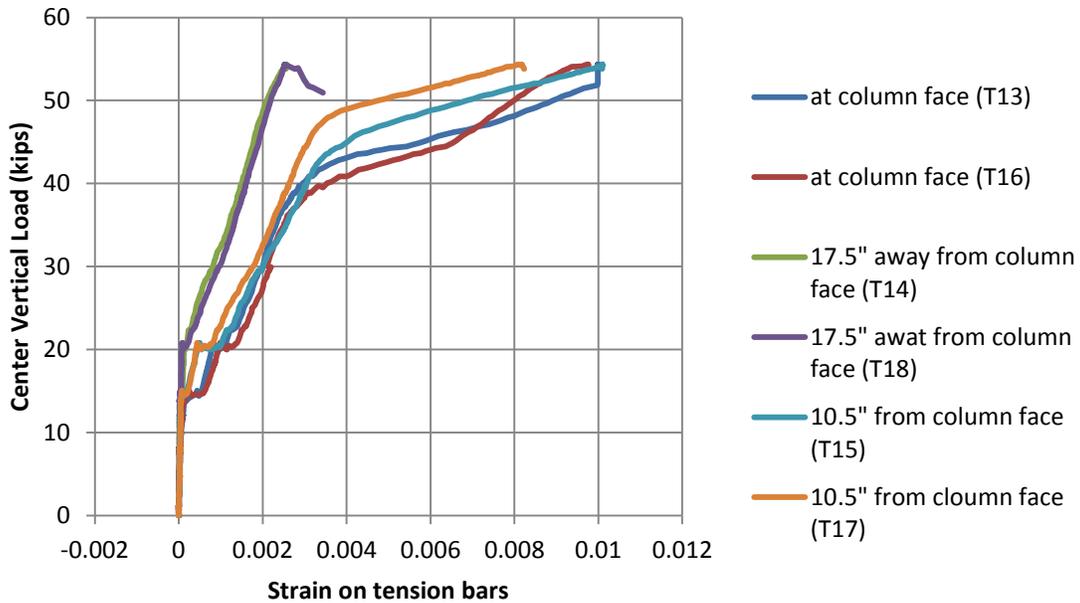
Figure 4.2.1.8 – Applied load and resulting tensile strains on the reinforcement that is continuous through the column of the 0.5% restrained slab.

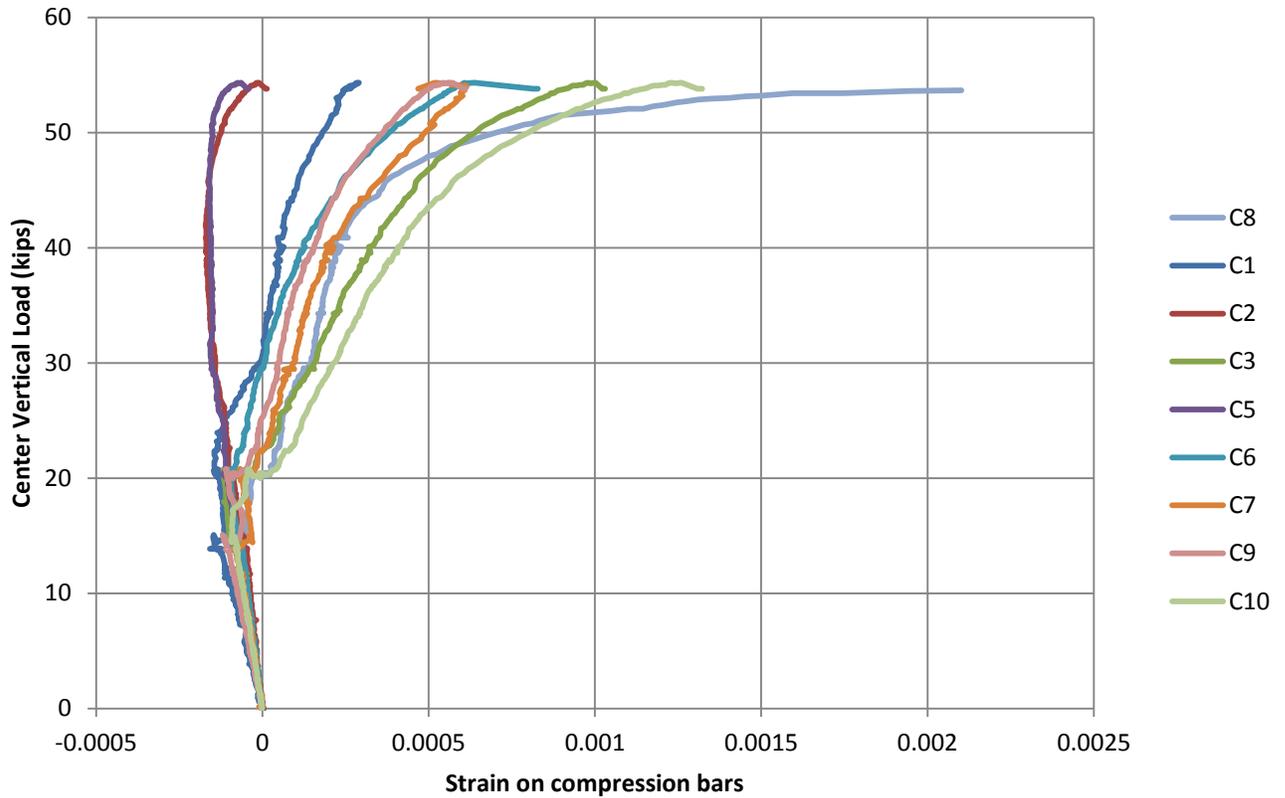
4.2.1.9 – Applied load and resulting strain on the compression reinforcement prior to the punching failure for the 0.5% restrained slab. Compressive strains are shown as negative and tensile strains are shown as positive.

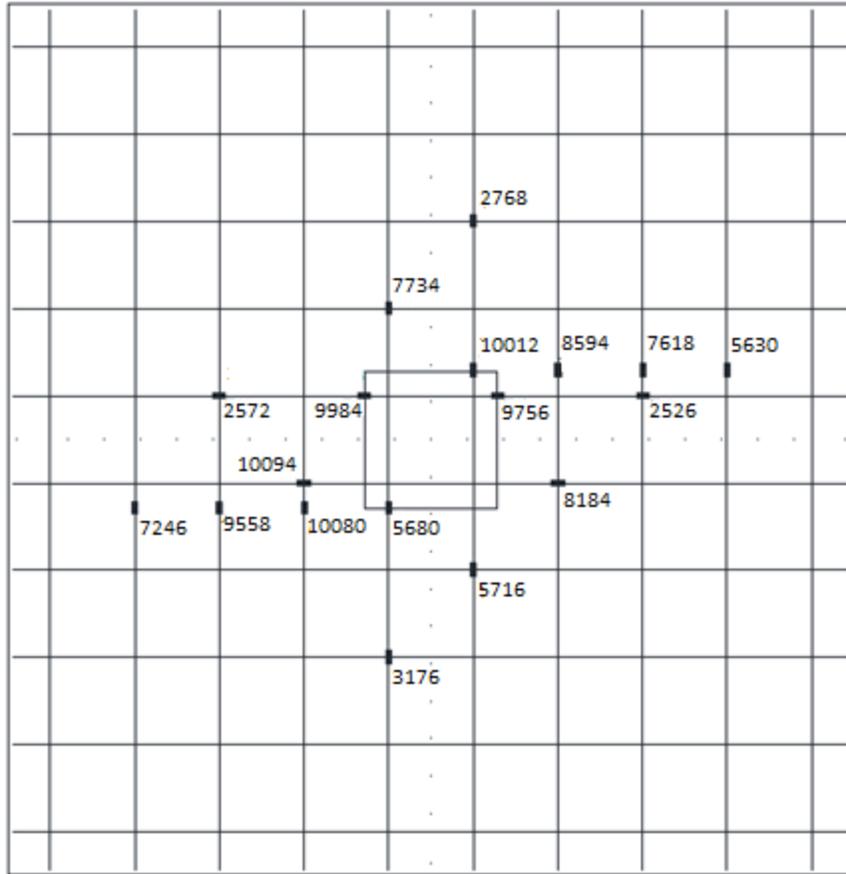
Figure 4.2.1.10 – Maximum strains on the tension reinforcement prior to failure for the 0.5% restrained slab (strain values listed in microstrains).
