EVALUATION OF THE EFFECTS OF IN-PLANE LATERAL RESTRAINT  
AND REINFORCEMENT RATIO ON THE PUNCHING  
CAPACITY OF FLAT SLAB COLUMN SPECIMENS

A Thesis presented  
To the Faculty of  
The Graduate School of the  
University of Missouri – Columbia

By  
CHRISTOPHER ROBERT HENQUINET  
Dr. Sarah L. Orton, Thesis Supervisor

July 2013

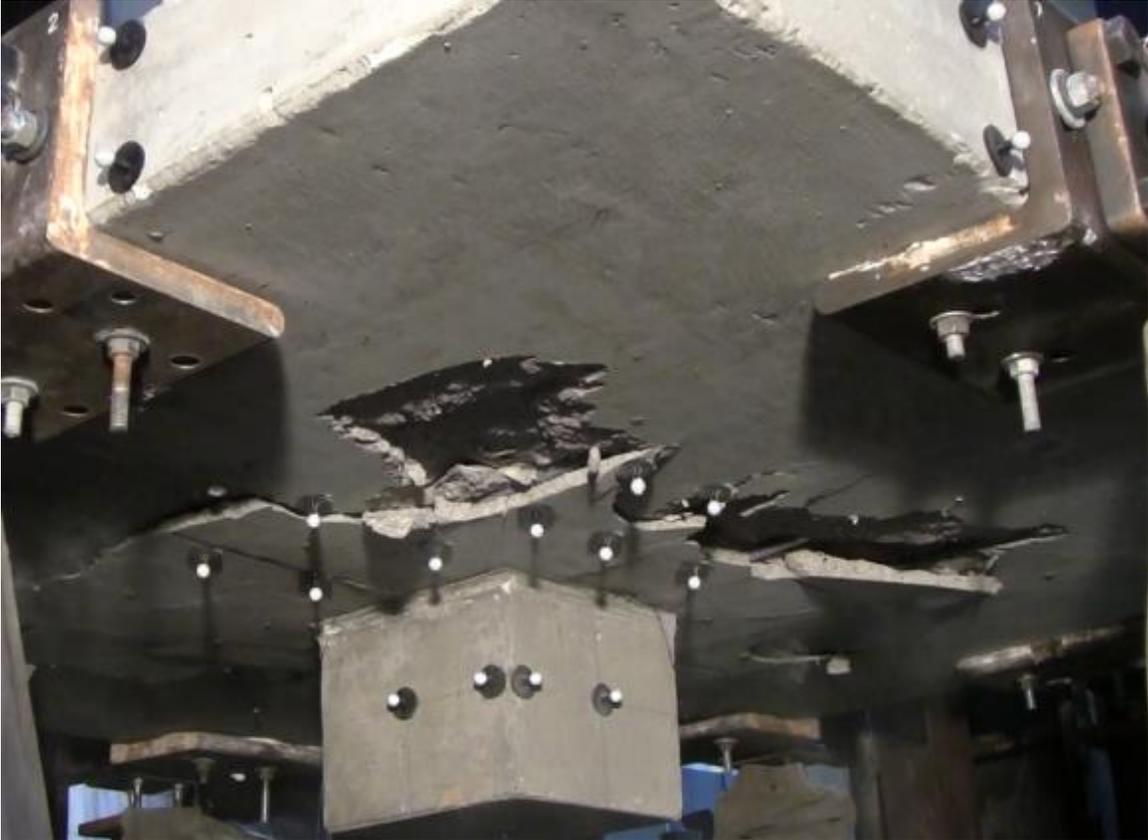
Figure 4.2.1.12 – Underside of the 0.5% restrained slab just after the punching failure. The slab bottom was instrumented with markers to record displacements via video.

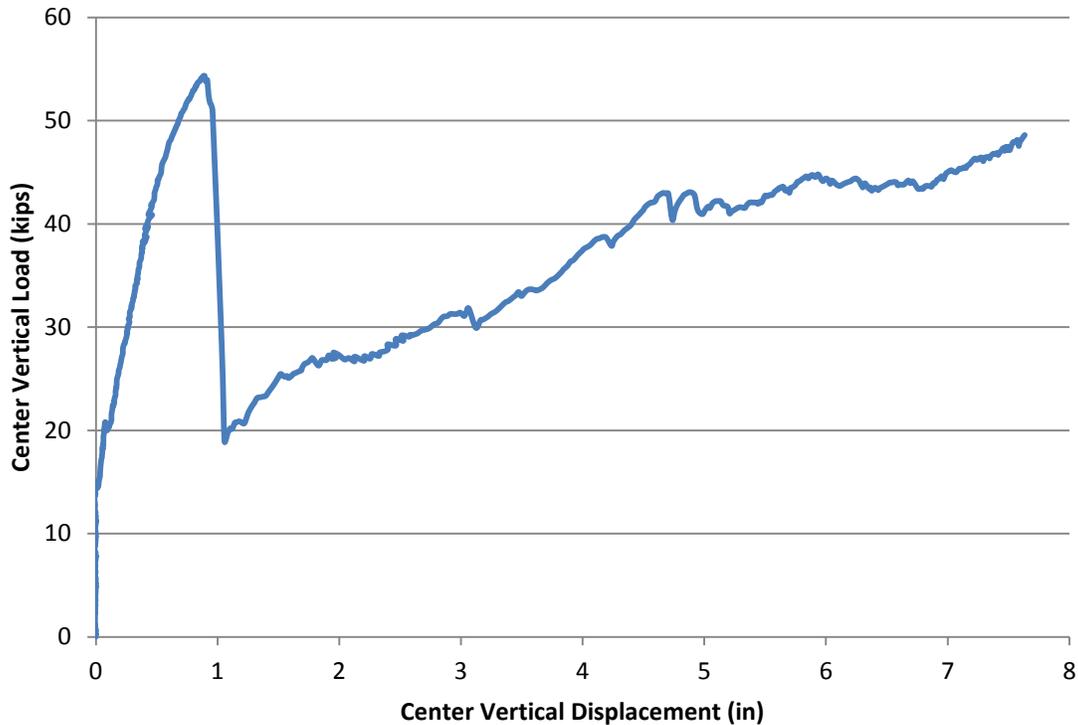
Figure 4.2.2.1 – Load Deflection plot including post punching response for the 0.5% restrained slab.

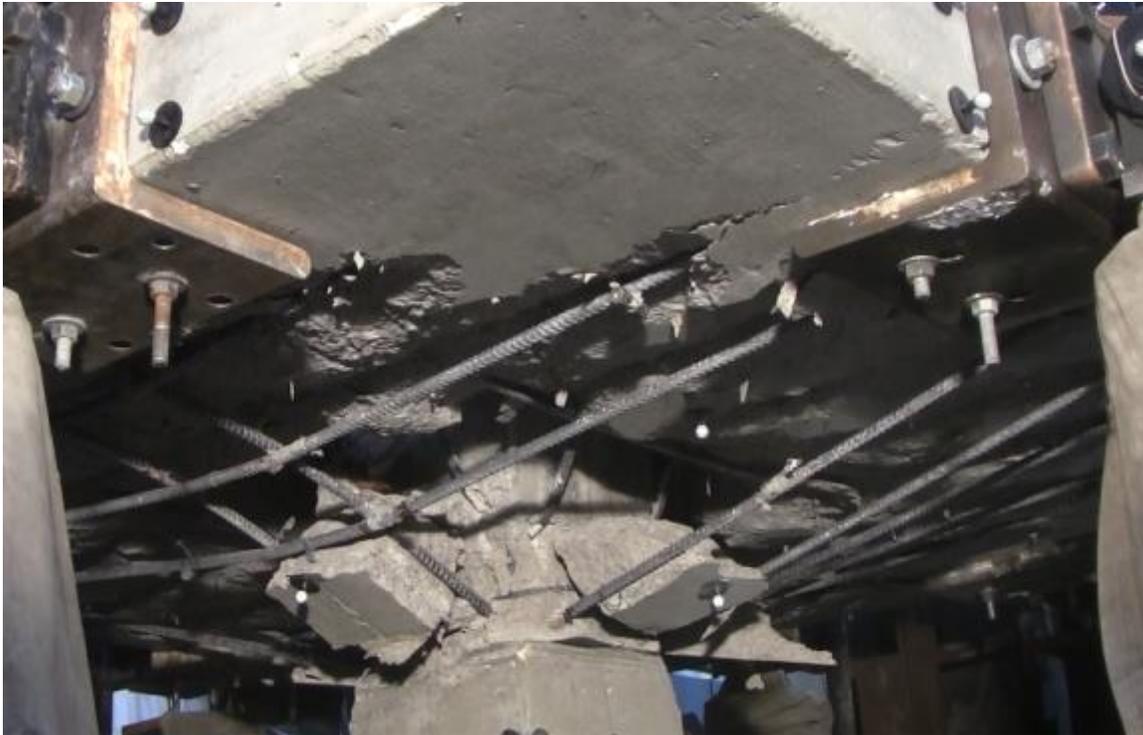
Figure 4.2.2.2 – Underside of the 0.5% restrained slab at the conclusion of the testing.

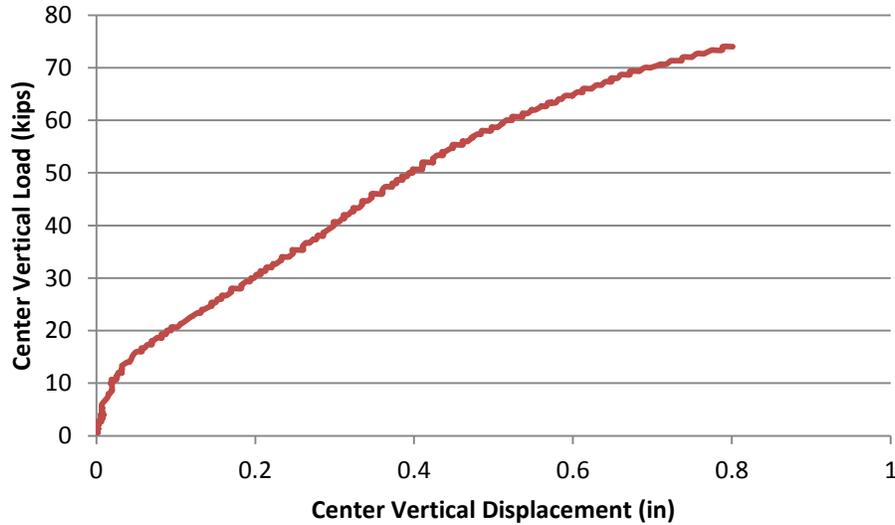
Figure 4.2.3.1 – Center load deflection plot for the 1% restrained slab prior to the punching failure.

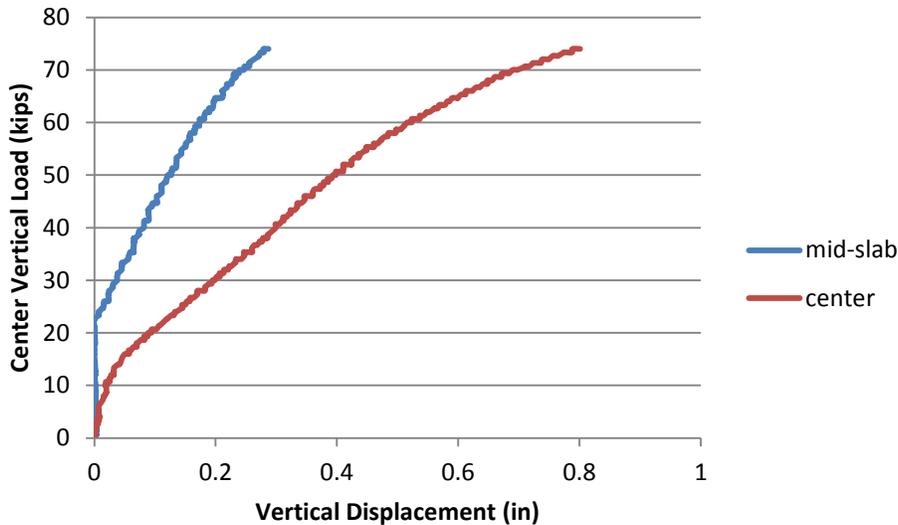
Figure 4.2.3.2 – Load deflection plot showing displacements relative to the supports prior to the punching failure for the 1.0% restrained slab.

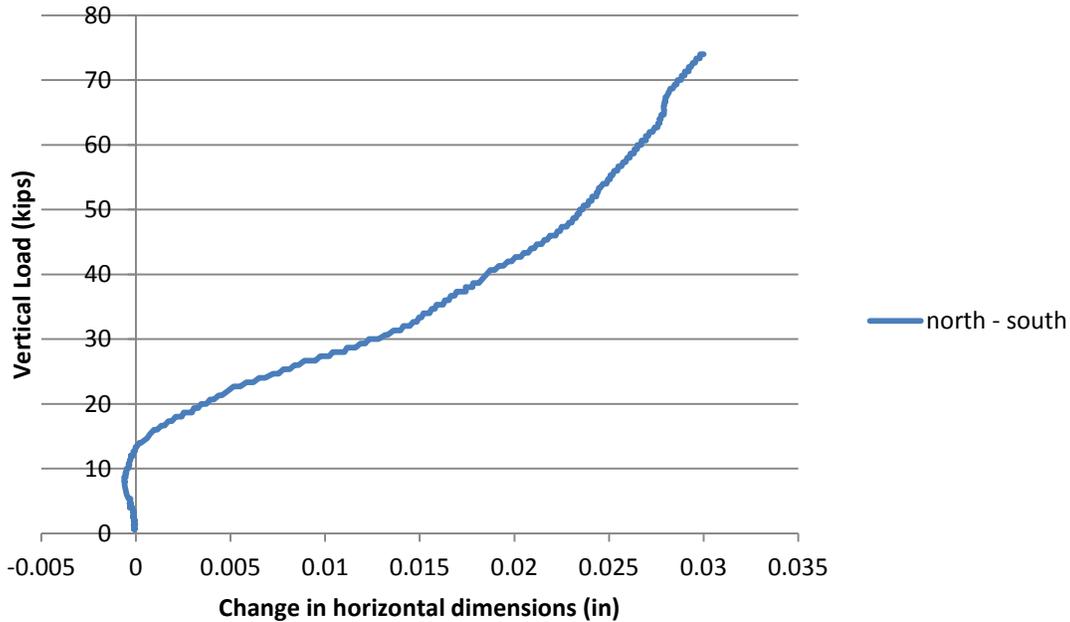
Figure 4.2.3.3 – Applied vertical load and resulting change in horizontal dimensions of the 1.0% restrained slab specimen.

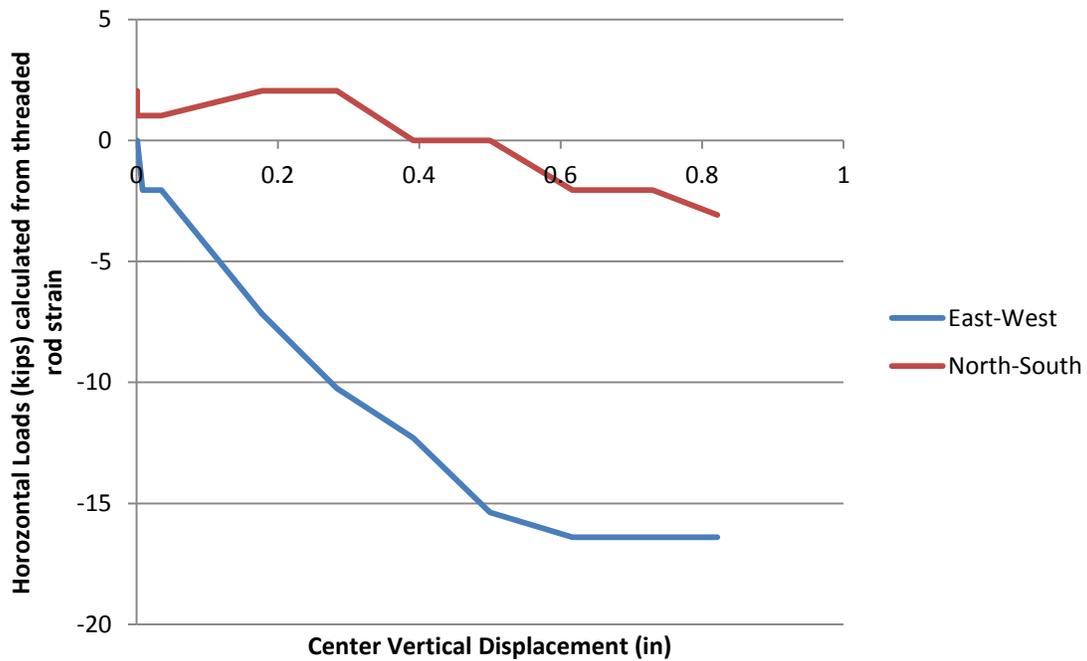
Figure 4.2.3.5 – Total lateral compressive loads calculated from the strain in the threaded rods used to connect the 1.0% restrained slab to the reaction frame.

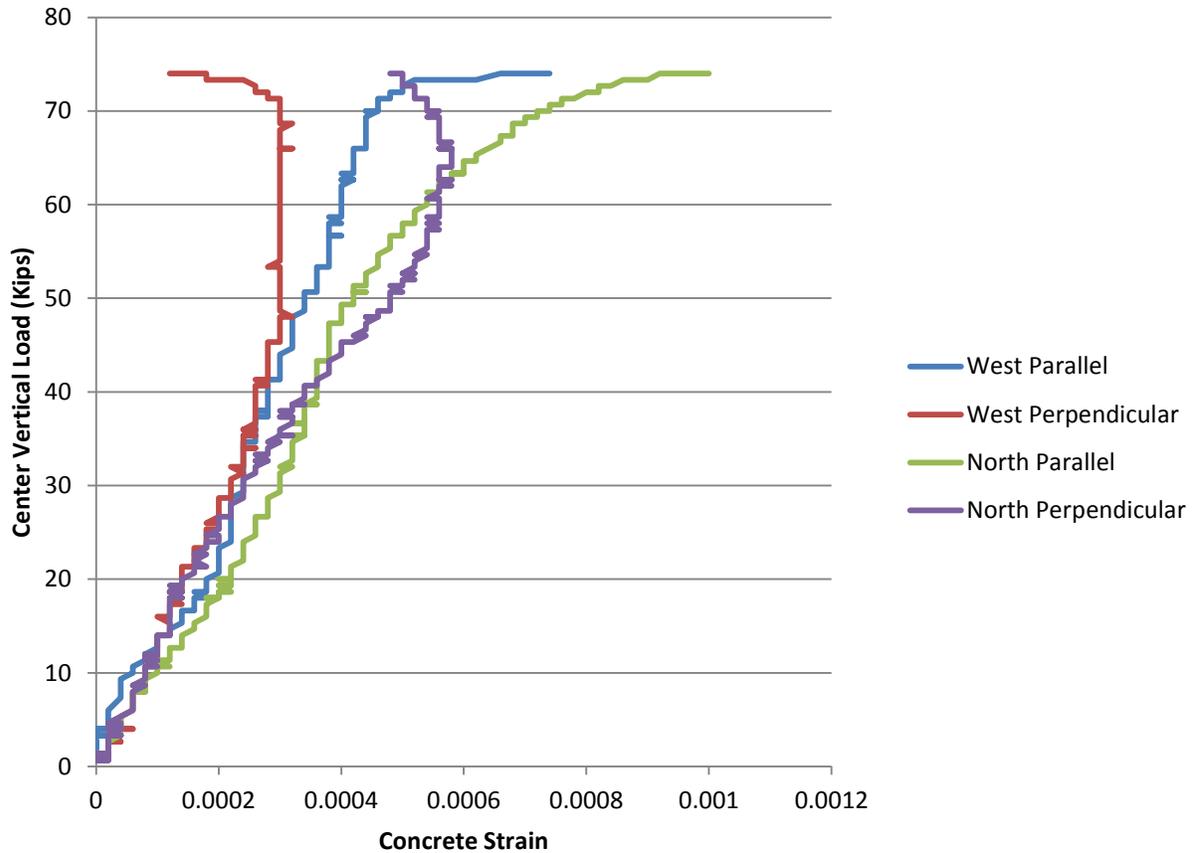
Figure 4.2.3.6 – Applied load and corresponding compressive strain in the concrete prior to the punching failure for the 1.0% restrained slab.

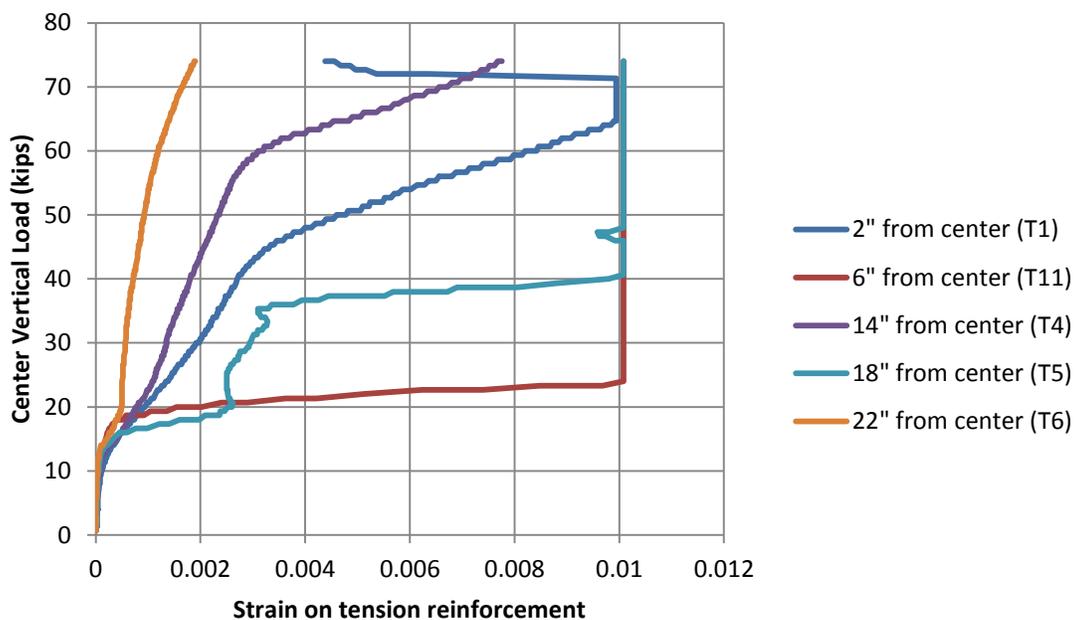
Figure 4.2.3.7 – Applied load and the corresponding tensile strains on the reinforcement for the 1.0% restrained slab.

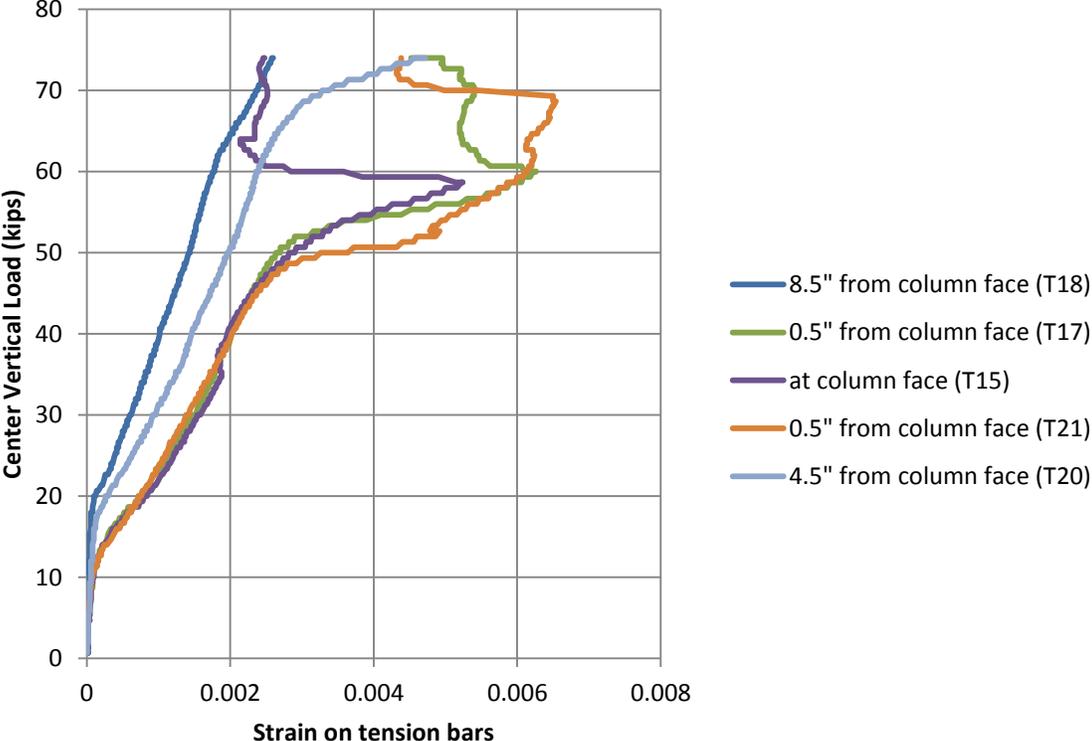
Figure 4.2.3.8 – Applied vertical load and the corresponding tensile strains on the bars continuous through the column for the 1.0% restrained slab.

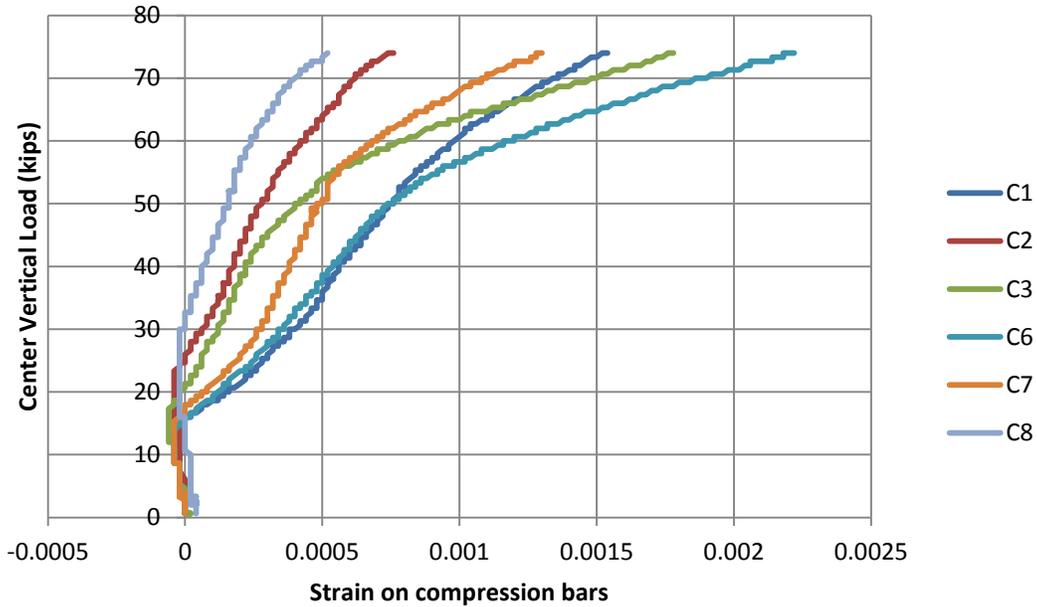
Figure 4.2.3.9 – Applied load and the resulting strain on the compression reinforcement prior to the punching failure for the 1.0% restrained slab. Compressive strains are shown as negative and tensile strains are shown as positive.

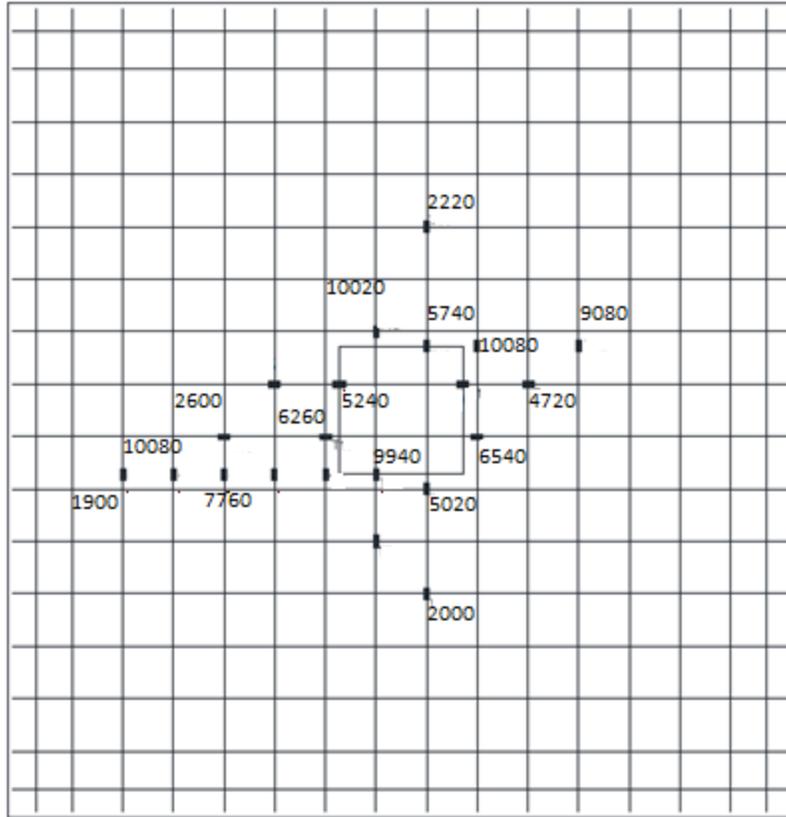
Figure 4.2.3.10 – Maximum strains on the tension reinforcement prior to failure for the 1.0% restrained slab (strain values listed in microstrains).

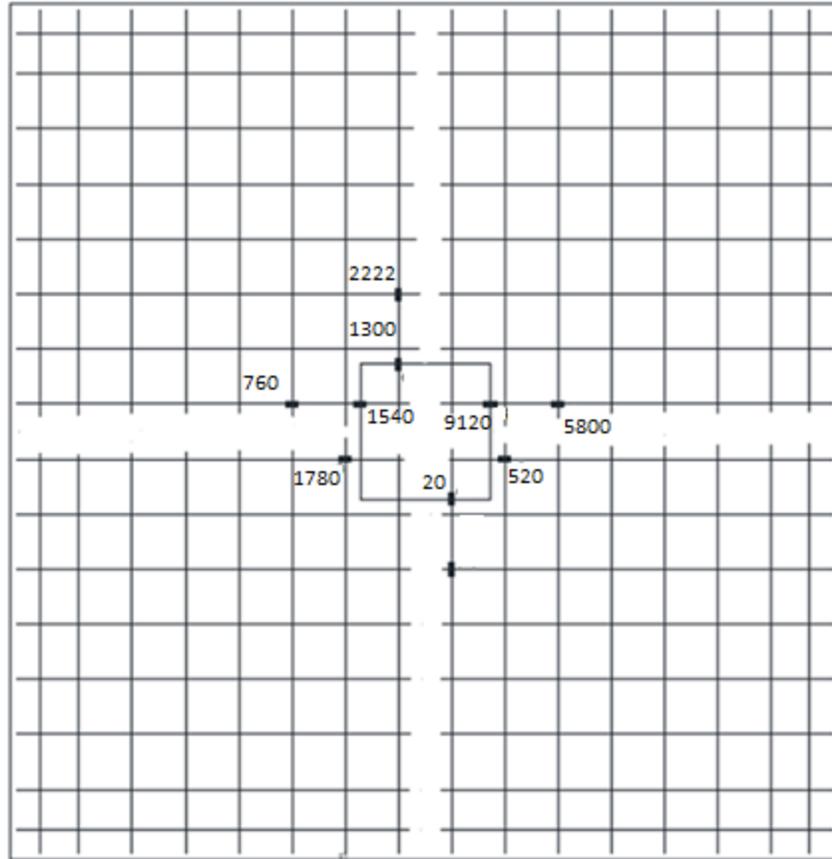
Figure 4.2.3.11 – Maximum strain values on the discontinuous reinforcement prior to failure for the 1.0% restrained slab (strain values listed in microstrains).

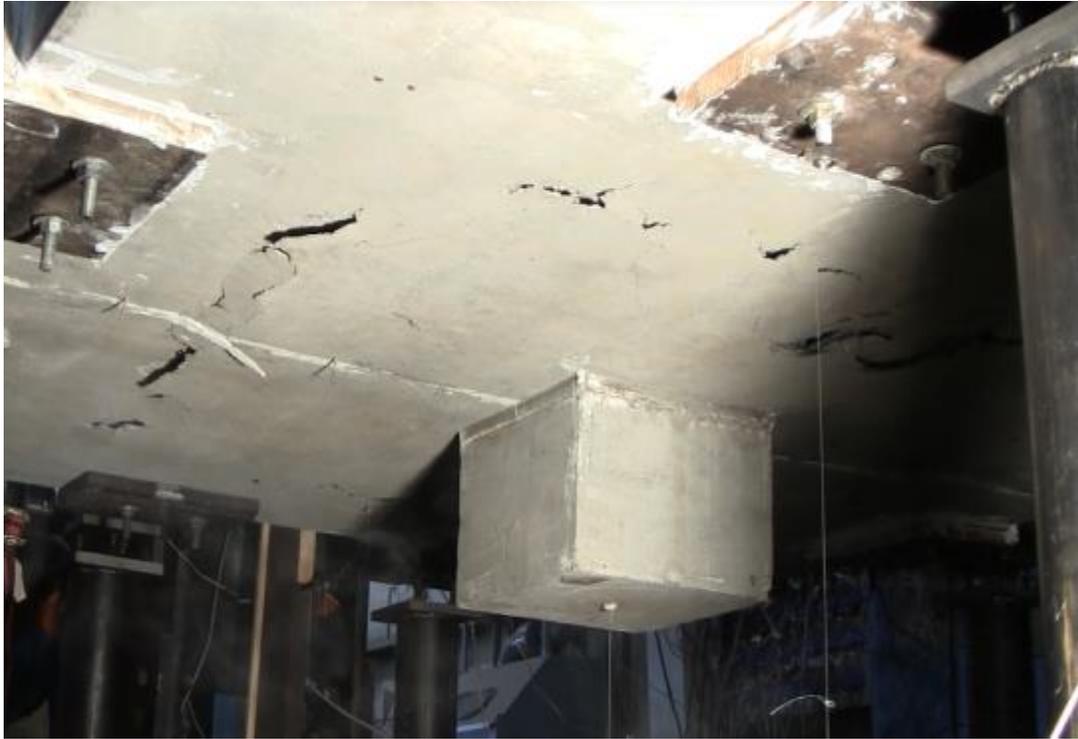
Figure 4.2.3.12 – Underside of the 1.0% restrained slab just after the punching failure occurred.

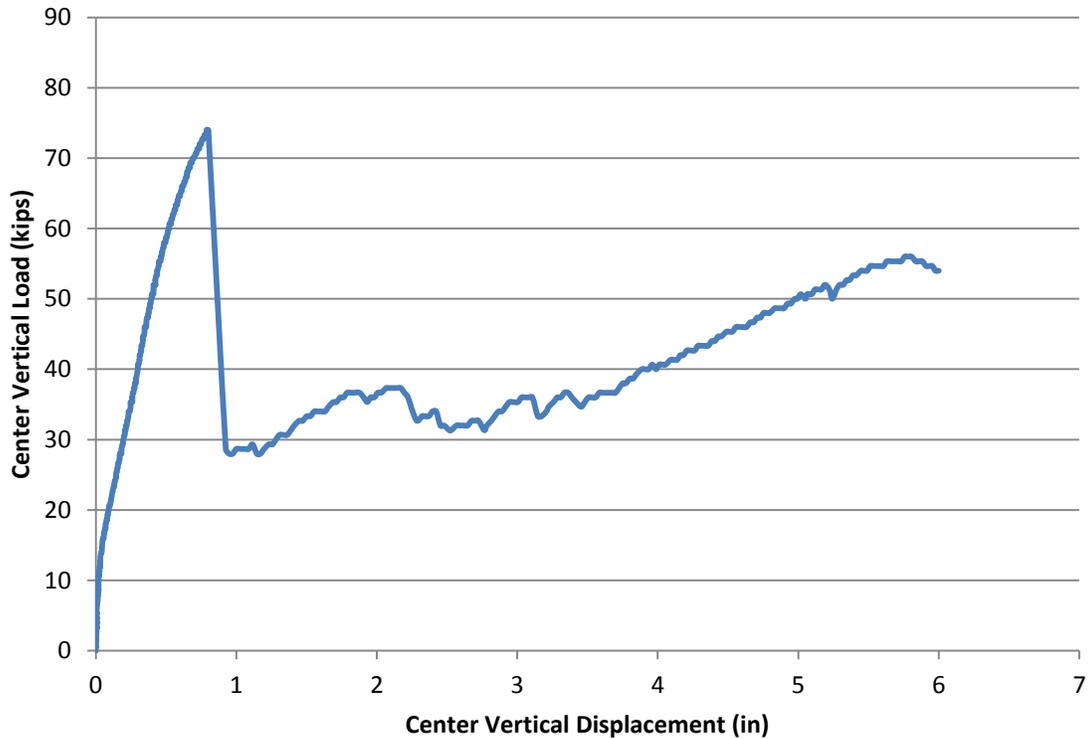
Figure 4.2.4.1 – Load deflection plot including post punching response for the 1.0% restrained slab.

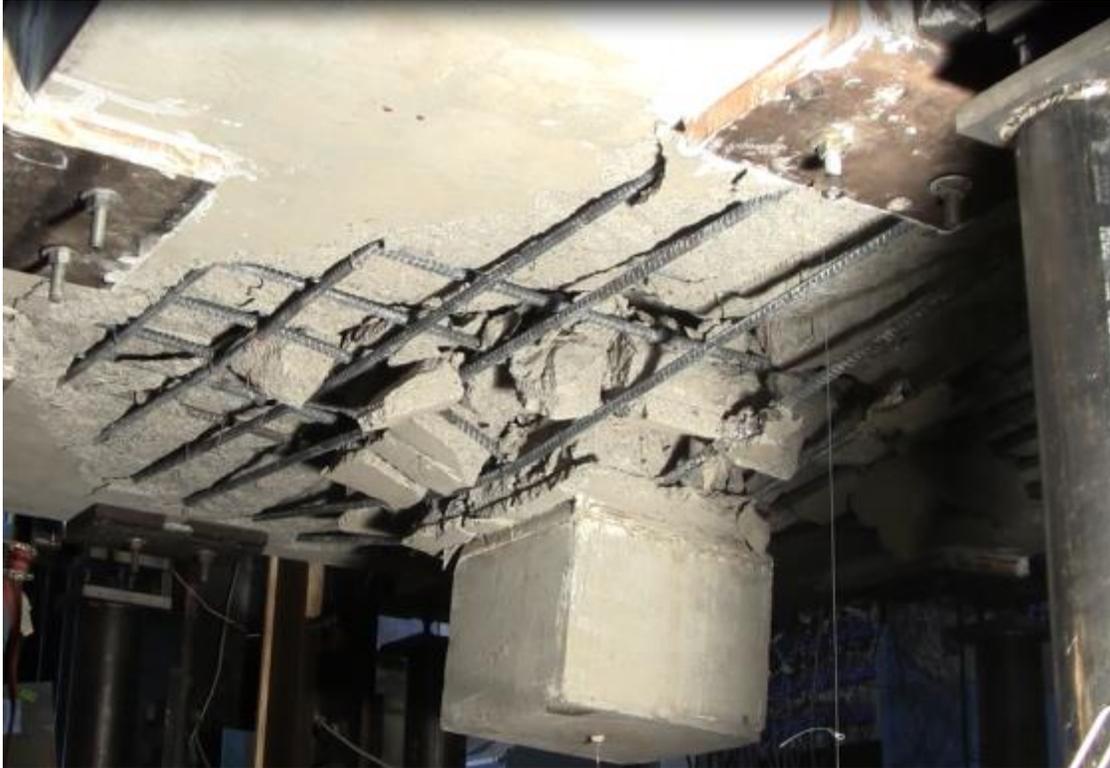
Figure 4.2.4.2 – Underside of the 1.0% restrained slab at the conclusion of the testing.

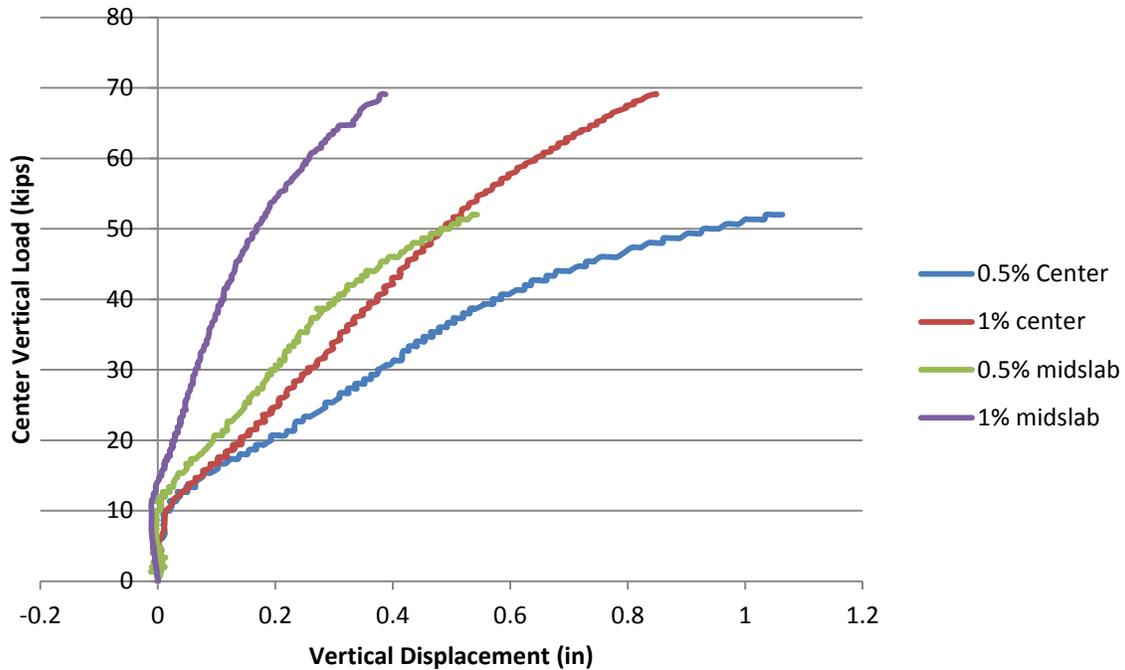
Figure 4.3.1.1 – Load Deflection plot showing center and mid-slab deflections for the 0.5% and 1.0% reinforced slabs tested in the unrestrained configuration.

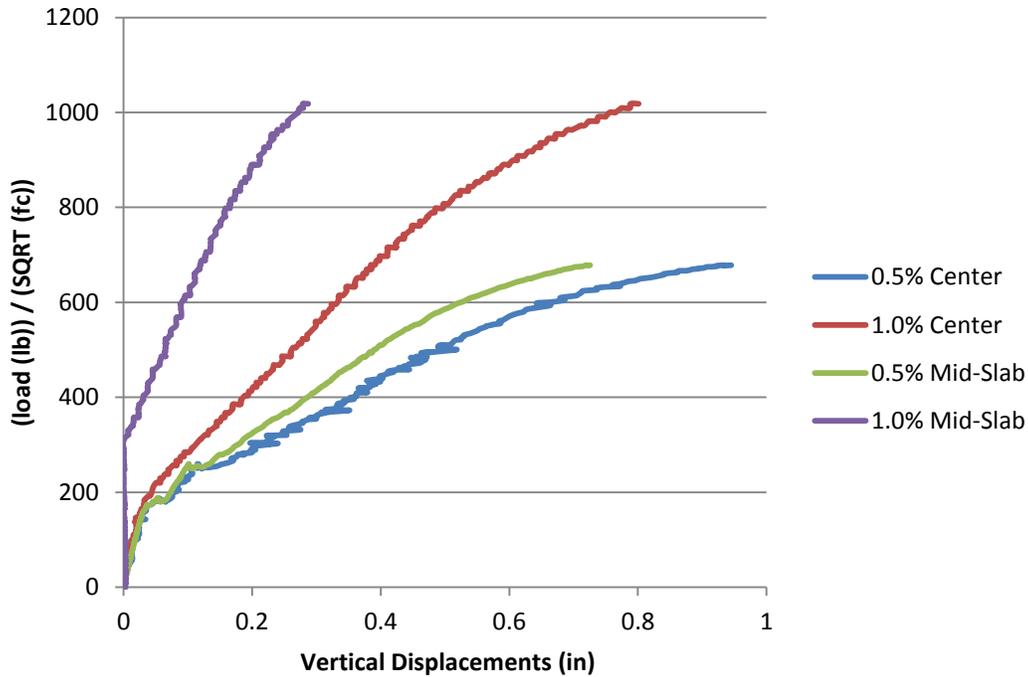
Figure 4.3.2.1 – Load deflection plot for the slabs tested in the restrained test setup with load values normalized to the concrete compressive strength.

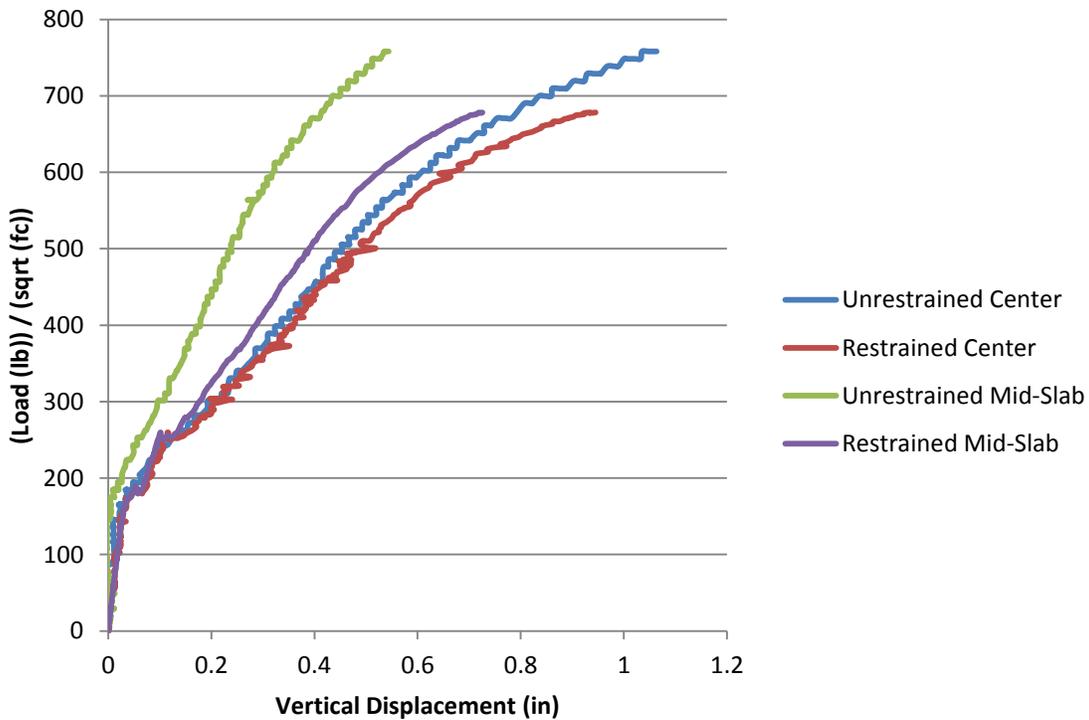
Figure 4.3.3.1 – Load deflection plot for the 0.5% reinforcement slabs with the applied load normalized to the concrete compressive strength.

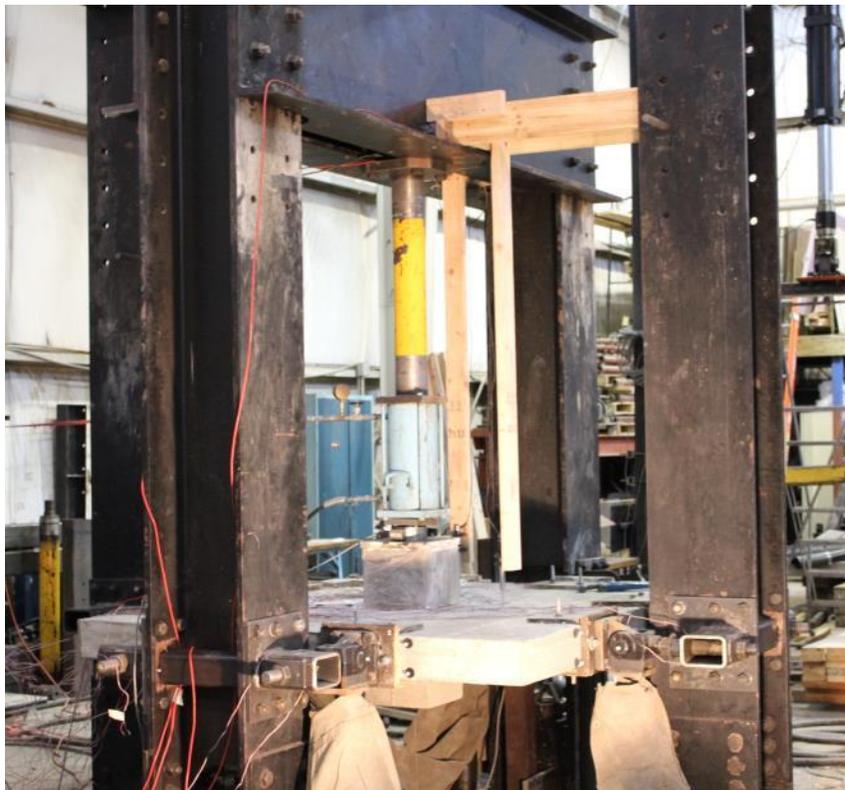
Photo of overall test setup
