SENSOR CHARACTERIZATION FOR LONG- TERM REMOTE MONITORING OF BRIDGE PIERS

A Thesis presented to the Faculty of the Graduate School of the
University of Missouri – Columbia

Master of Science

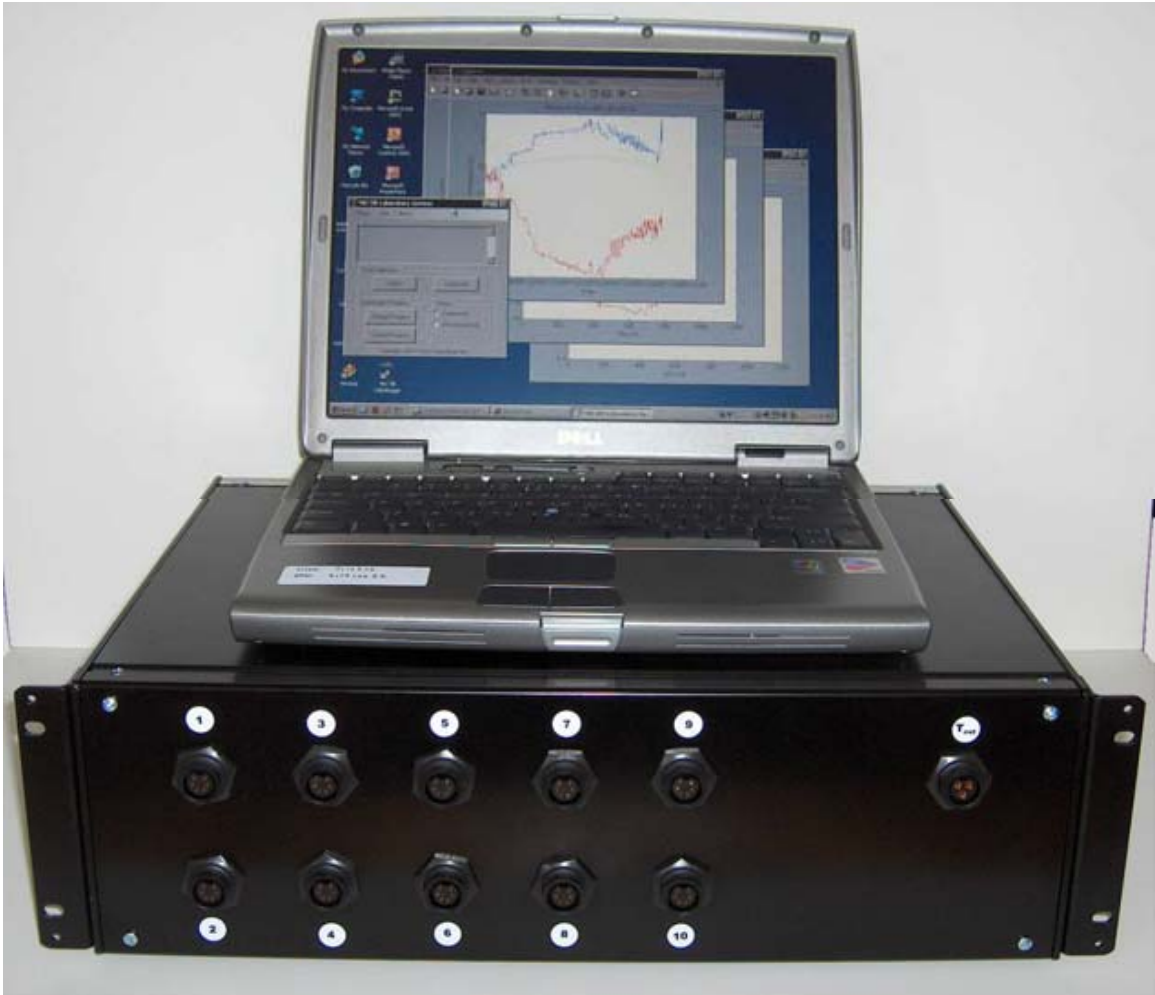
Figure 2-3: Photograph of data acquisition system designed and manufactured by Fuchs Consulting, Inc.

Task 2 consisted of the manufacturing and construction of the sensor system and laboratory test fixtures. The manufacturing of the on-site data acquisition system was completed by Fuchs Consulting, Inc. (FCI). This system was used in the majority of the laboratory testing. It can collect data from two axes of ten sensors simultaneously. A photograph of the system can be seen in Figure 2-3.

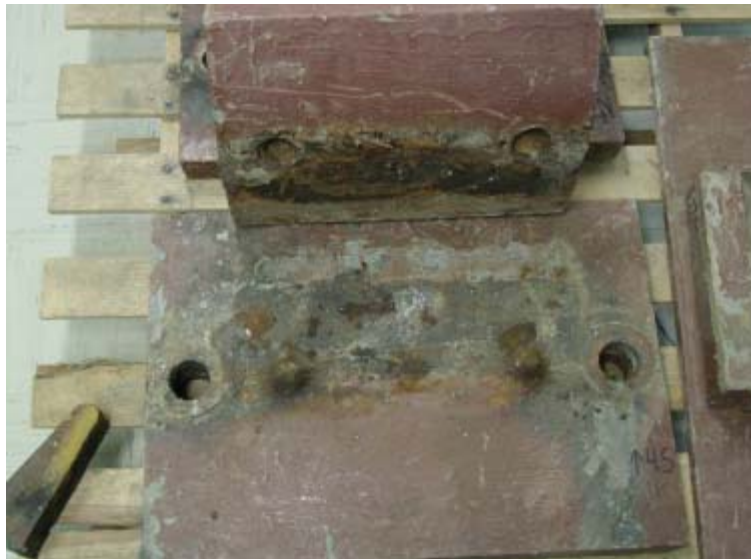
Figure 3-5: Photograph of the corrosion in the rocker bearings.

The rocker bearings were in the tilted position for at least the past 20 years, causing major corrosion buildup beneath them that can be seen in Figure 3-5. This corrosion prevented the rocker bearings from rotating back to their original position by forming a wedge beneath the rocker bearing. The corrosion also provided the proper amount of friction for the rocker bearings to exert large amounts of horizontal force onto

Pier 11. This force comes from the horizontal component of the vertical live and dead loads on the bridge. The transferred force made the pier susceptible to displacement rather than the bearings, thus causing a tilt of the pier originating from the applied force at its top surface.

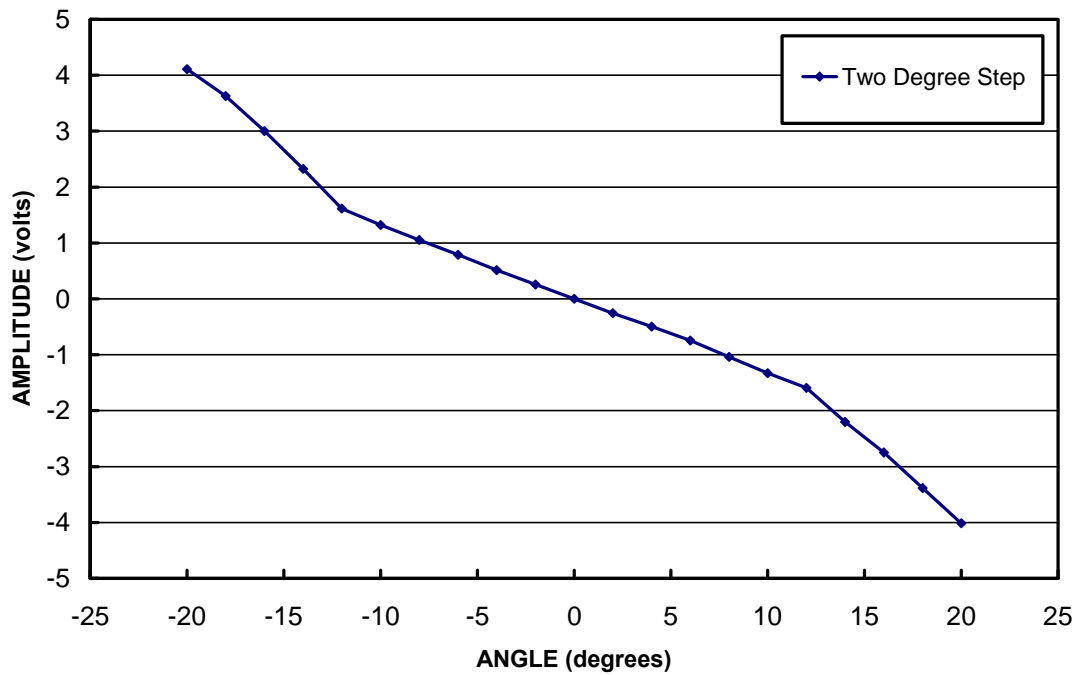
Figure 4-4: Graph showing the linear and the non-linear behavior of the DX-008 Sensors.

displaying actual readings that show the linear and non-linear behavior of these sensors can be seen in Figure 4-4. This data was collected from testing of the sensors through + - 20 arcdegrees using a stepped process.

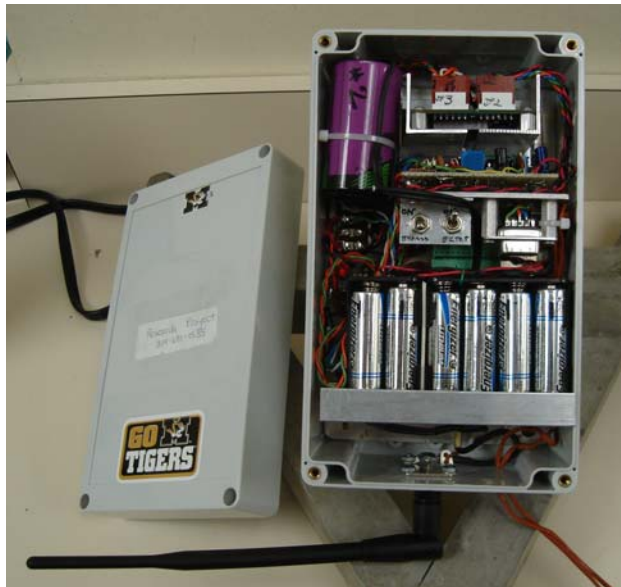
Figure 4-5: Photograph of the first wireless tilt monitoring system.

To begin the preliminary system development for the project, two wireless tilt monitoring devices were built. This gave the research group a better understanding of the EZ-TILT-2000-008-rev2 tilt sensors that were initially chosen and a representation of the problems that would be faced in creating the overall system. Wireless data acquisition was accomplished using a Microstrain™ V-Link 2.4 GHz Wireless Voltage Node.

The sensors were mounted in enclosures that provided appropriate leveling methods to accommodate for the narrow angular range of the sensors. The enclosures contained the necessary electrical system for both RS232 hard lines and wireless data transfer. One wireless system can be seen in Figure 4-5.

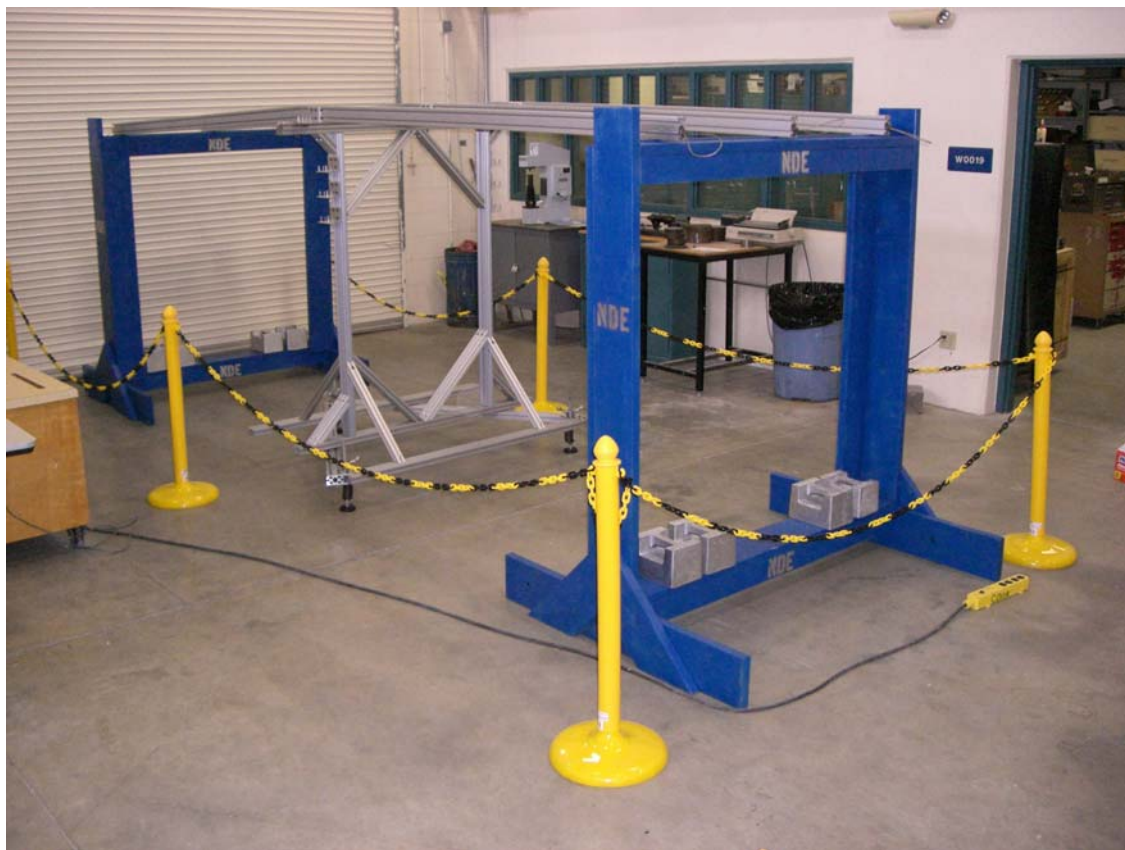
Figure 4-21: Photograph of the completed test bridge with girders and security chain.

In Figure 4-18, the construction process of both the central pier and the abutments can be seen. Figure 4-19 shows the assembled abutments and central pier. Figure 4-20 shows the abutments after being painted. Weights can be seen placed on the abutments and will be discussed along with the other additions. Figure 4-21 shows the completed test bridge with all modifications.

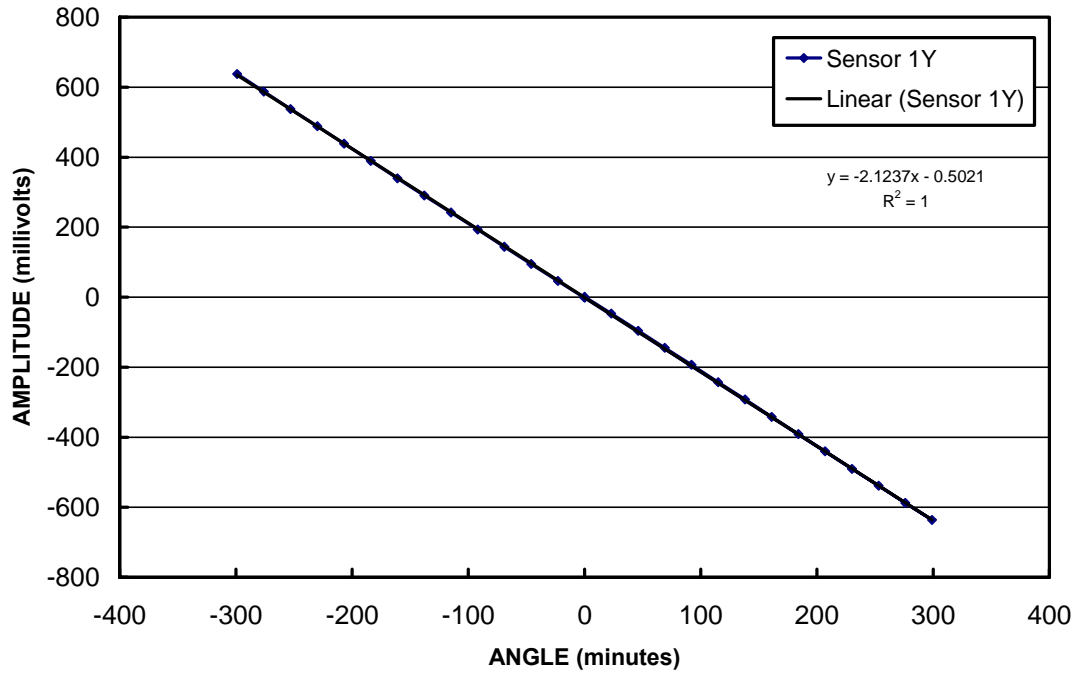
Figure 5-1: Graph showing multimeter results from Sensor #1, Y-Axis.

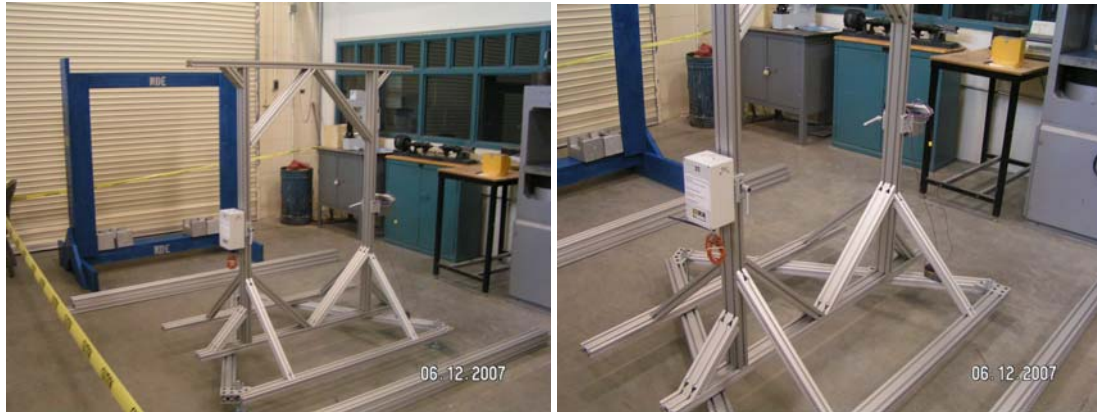
Figure 5-13: Photographs of the wireless tilt monitoring system on test bridge pier.

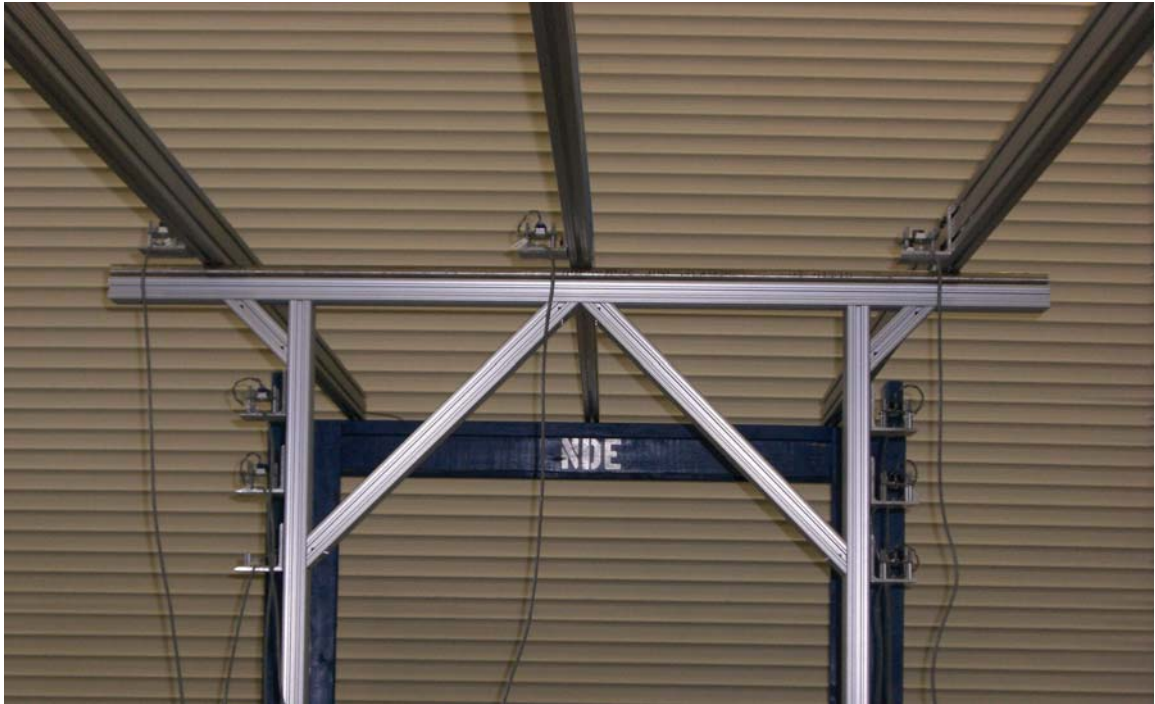
Figure 5-14: Photograph showing sensor placement on test bridge.

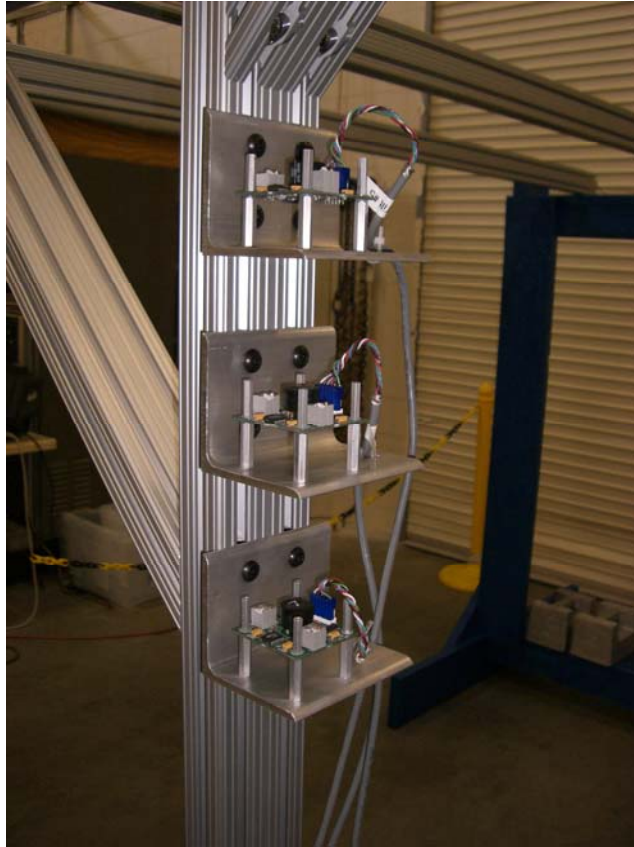
Figure 5-16: Photograph of sensors mounted on pier of test bridge.

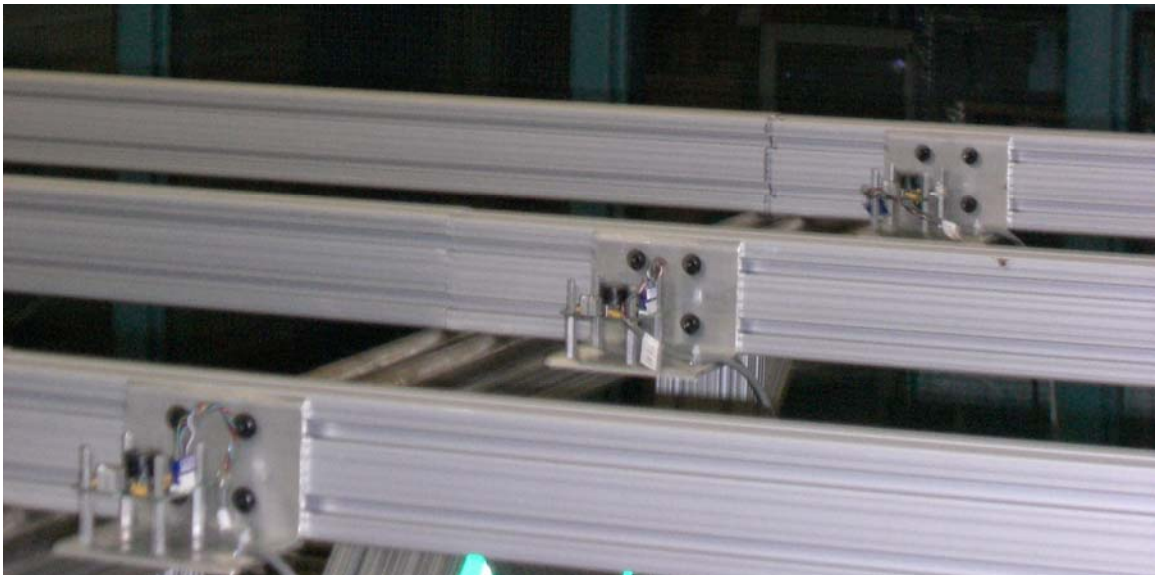
Figure 5-17: Photograph of sensors mounted on the girders of the test bridge
