**A STREAM PHYSICAL HABITAT ASSESSMENT  
IN AN URBANIZING WATERSHED OF  
THE CENTRAL U.S.A.**

A Thesis presented to the  
Faculty of the Graduate  
School at the University of  
Missouri-Columbia

JULY 2015

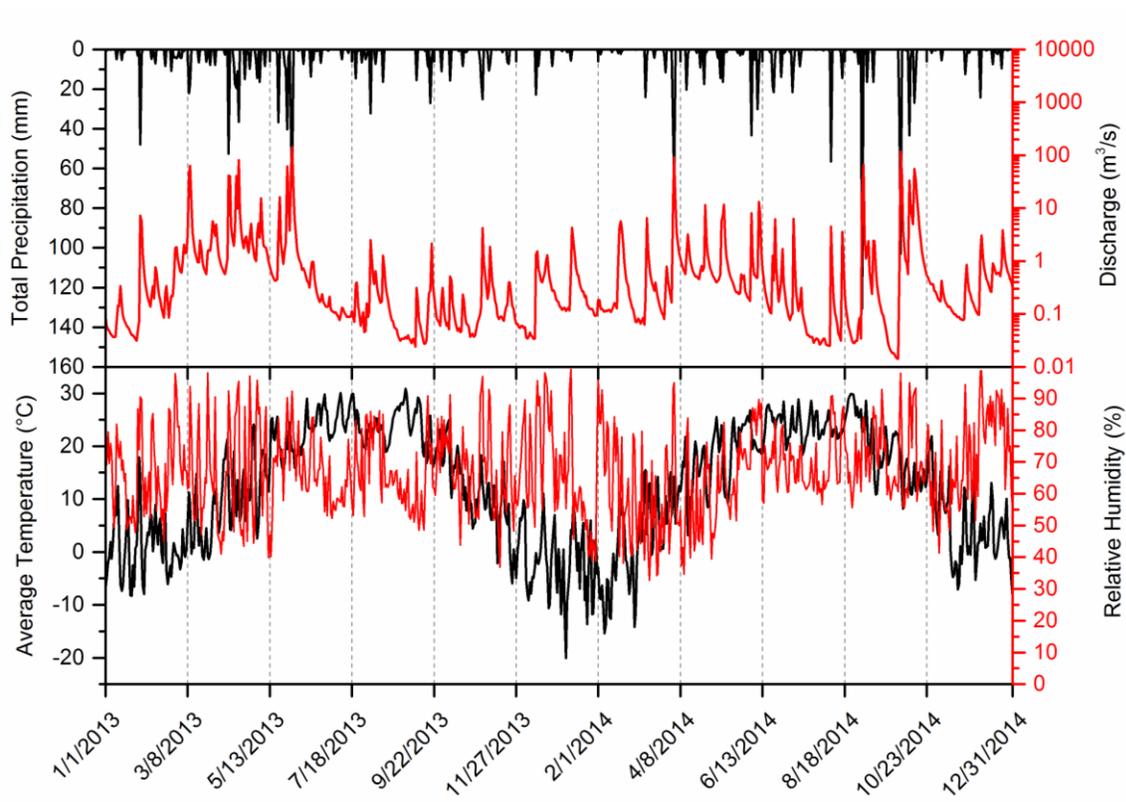
**Figure 2.** Total daily precipitation, average daily discharge rate in Hinkson Creek, average daily temperature, and daily relative humidity are presented for the period January 1, 2013 through December 31, 2014, and include the study period from July 18, 2013 through August 15, 2014.

Climate data for the study period (precipitation, discharge in Hinkson Creek, temperature, and relative humidity) are presented in Figure 2. Discharge data from Hinkson Creek are presented on a logarithmic scale for ease of comparison with precipitation. A negative relationship is observed between temperature and relative humidity.

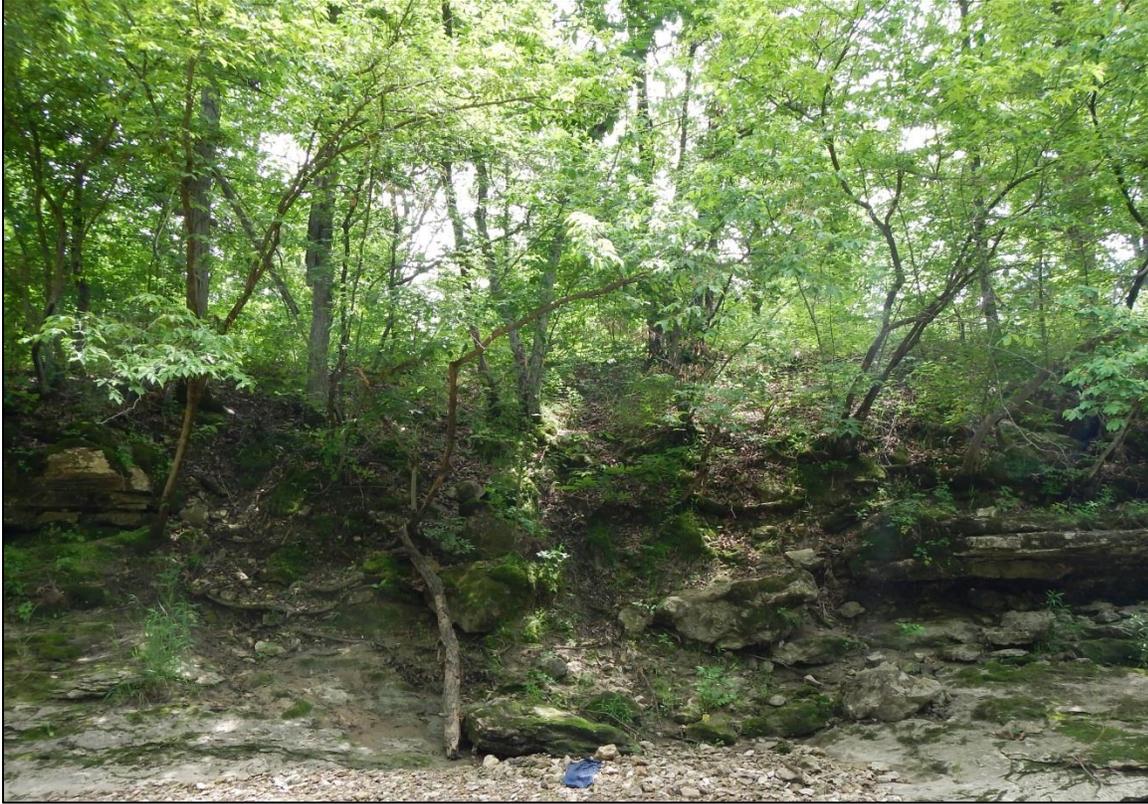
**Figure 4.** Karst (limestone) formation on left descending bank of Hinkson Creek approximately 1.4 km upstream of Rogers Road, 05-29-2014, 14:17 (lat. 39.023698, long. -92.240008).

as sandstone (Springer et al. 2003). Karst (Figure 4) and sandstone (Figure 5) formations were visible at various points along Hinkson Creek during the PHA.

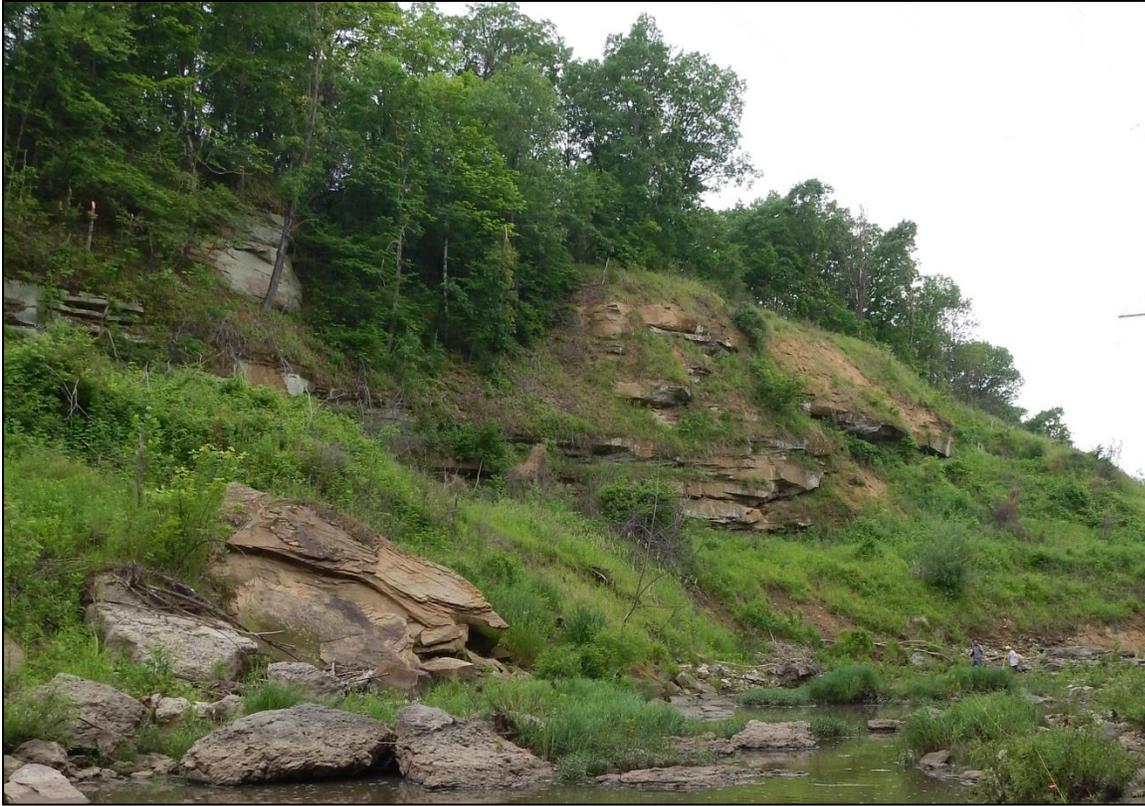
**Figure 5.** Sandstone bluff formation approximately 2.7 km upstream of Rogers Road on left descending bank of Hinkson Creek, 06-02-2014, 09:38 (lat. 39.02401, long. -92.232383). Field crew members at the lower right of the photograph give an idea of the scale of the formation.

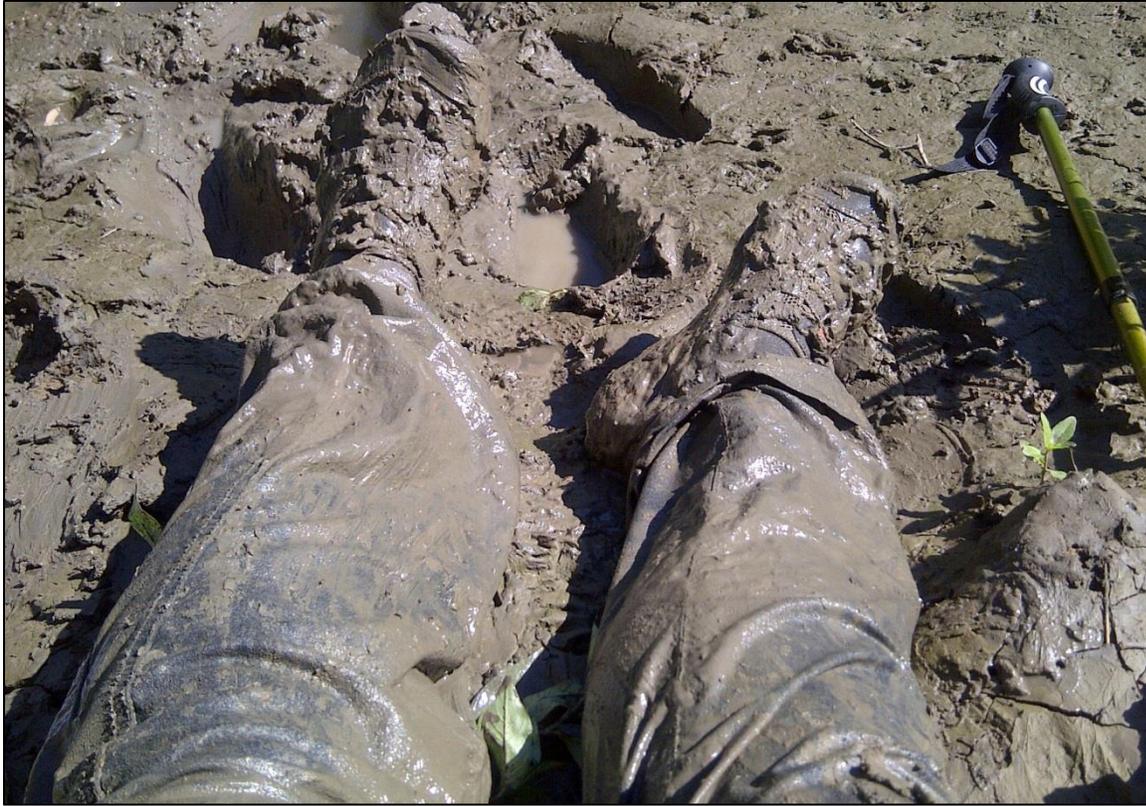
**Figure 7.** A view of the author's legs after walking through a deep clay substrate in Hinkson Creek 3 km downstream of Twin Lakes Recreation Area, 07-15-2014, 09:59 (coordinates not available).

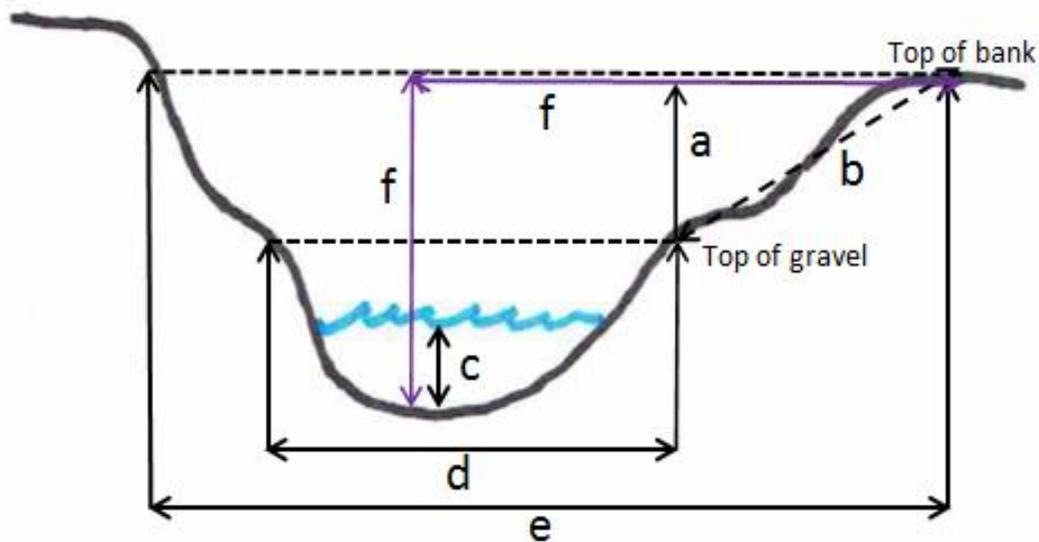
**Figure 15.** Cross-sectional view of channel and bank dimensions measured during PHA of Hinkson Creek: a) bank height, b) bank slope, c) thalweg depth, d) channel width, e) bankfull width, and f) relative thalweg depth (vertical) and thalweg position (horizontal). Wetted width is designated by the blue wavy line.

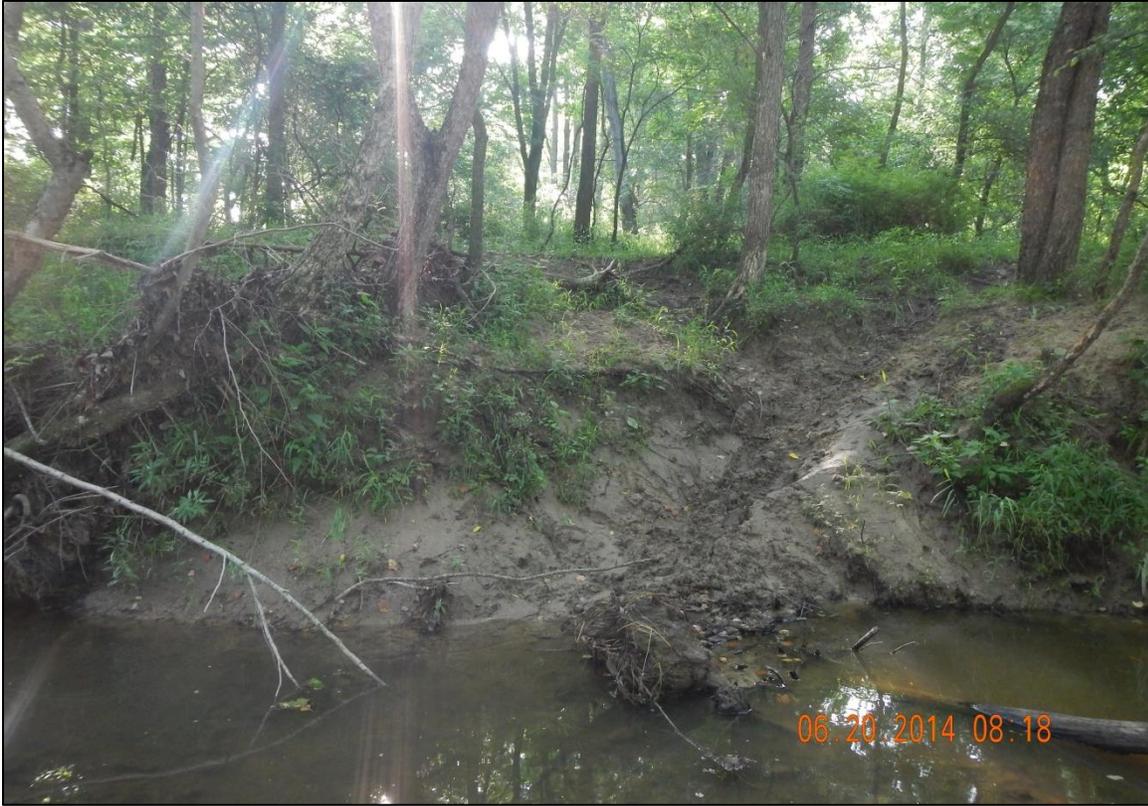
**Figure 16.** A cattle trail in a streambank of Hinkson Creek, 06-20-2014, 08:18 (lat. 39.069505, long. -92.215825).

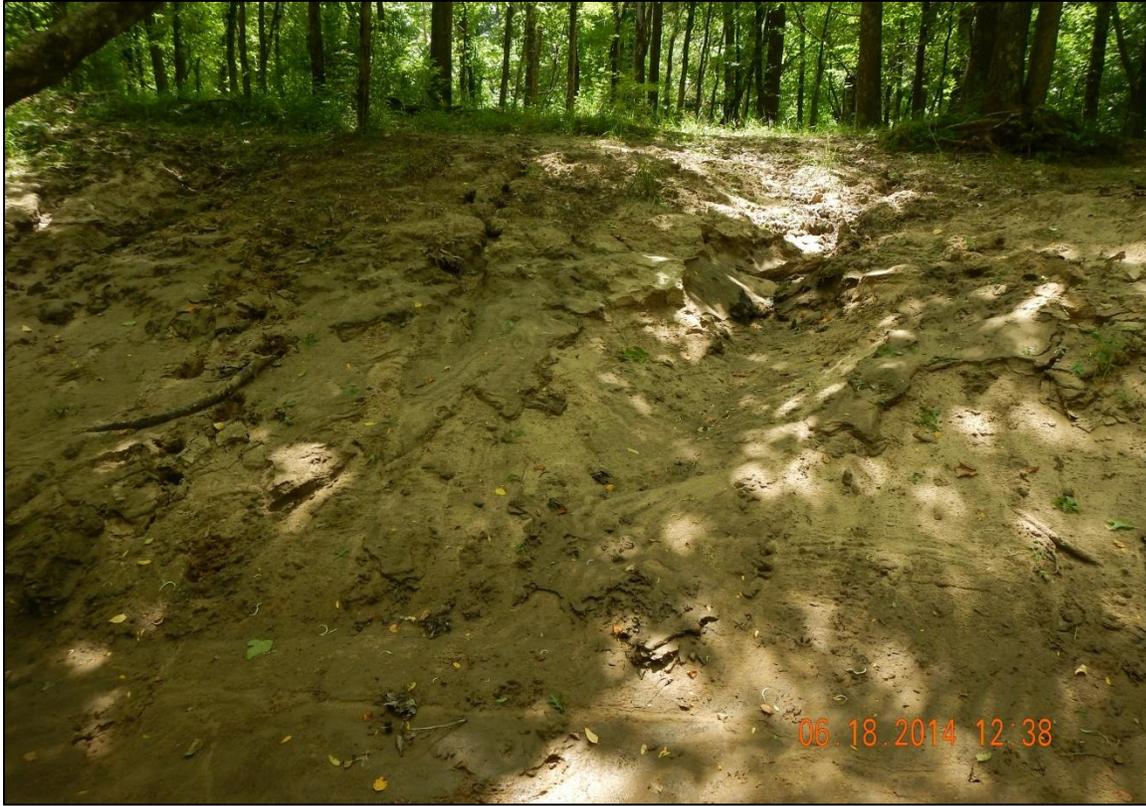
**Figure 17.** Cattle trail. Photograph taken approximately 1 km upstream of Spiva Crossing Road, 06-18-2014, 12:38 (lat. 39.062998, long. - 92.212955).

The final category of wildlife is cattle that were identified by tracks in the banks or streambed. Cattle tracks were observed within 19 100 m sections of Hinkson, and horse tracks were observed within 2 100 m sections. Damage to streambanks from cattle trails were observed (Figures 16 and 17), as were fecal deposits in or near the water.

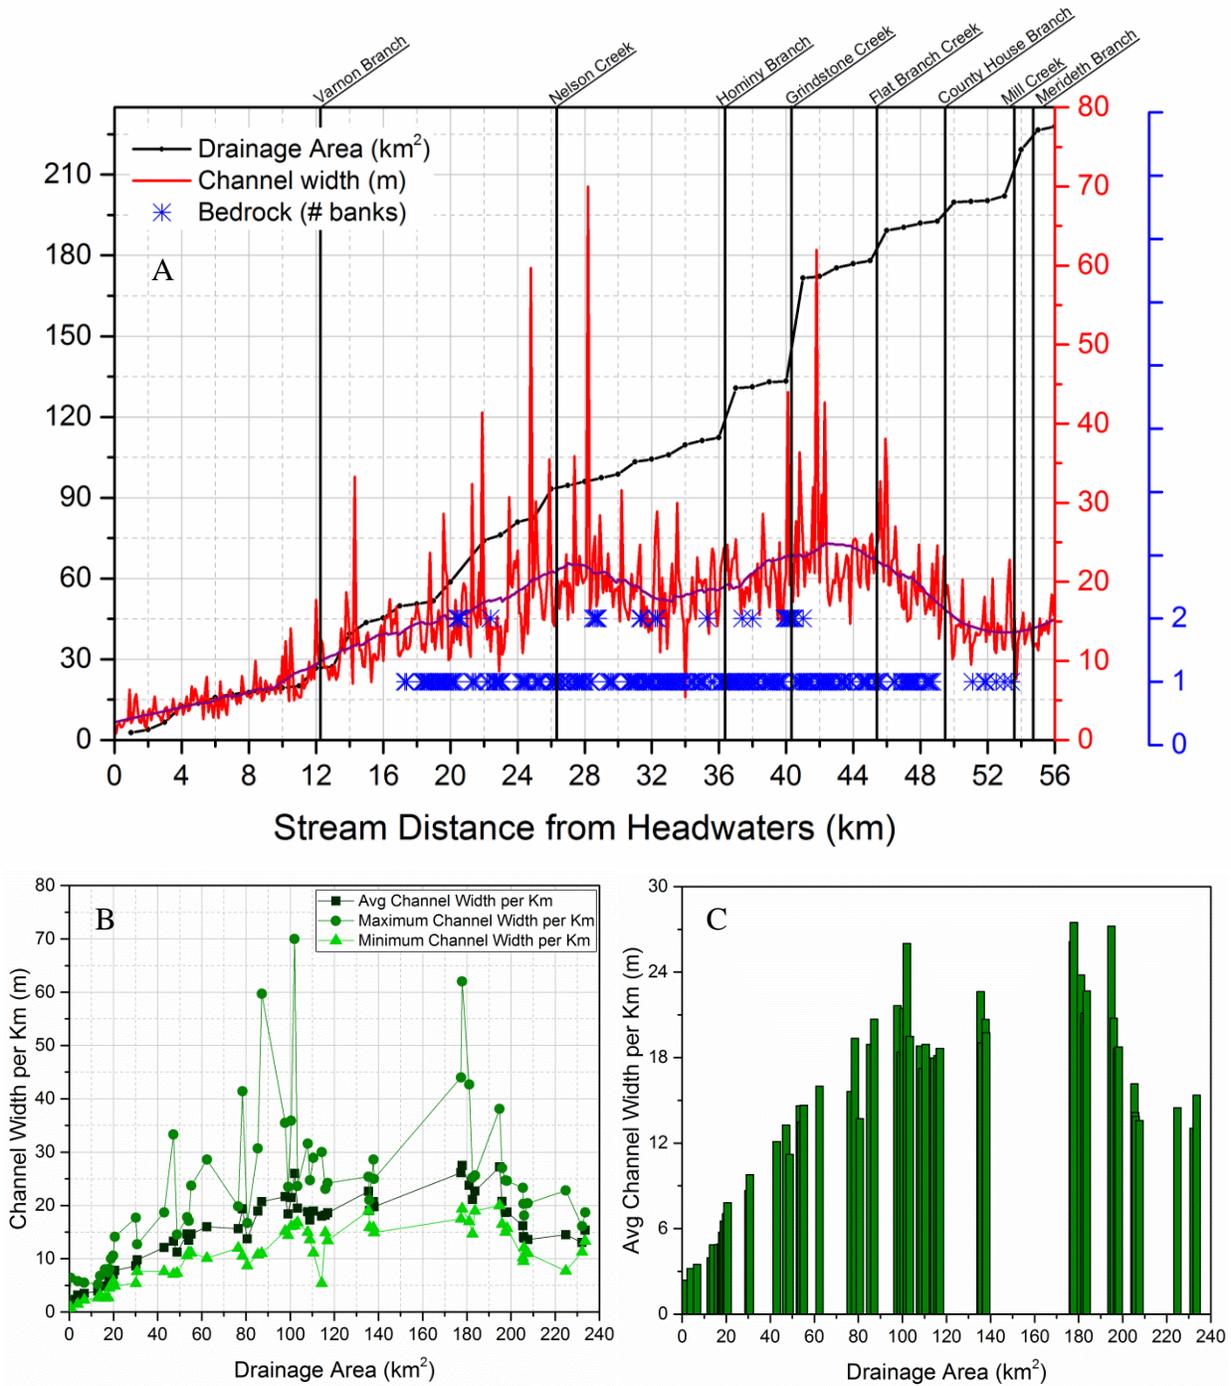
**Figure 18.** A. Channel width with stream distance from headwaters and drainage area in Hinkson Creek, with 100 pt moving average shown in dark gray, and major tributary confluences marked. Bedrock constraints are shown with blue asterisks; B. Average, maximum and minimum channel width per kilometer with drainage area in Hinkson Creek watershed to illustrate variability in measurements, and C. Average channel width per kilometer with drainage area in Hinkson Creek watershed.

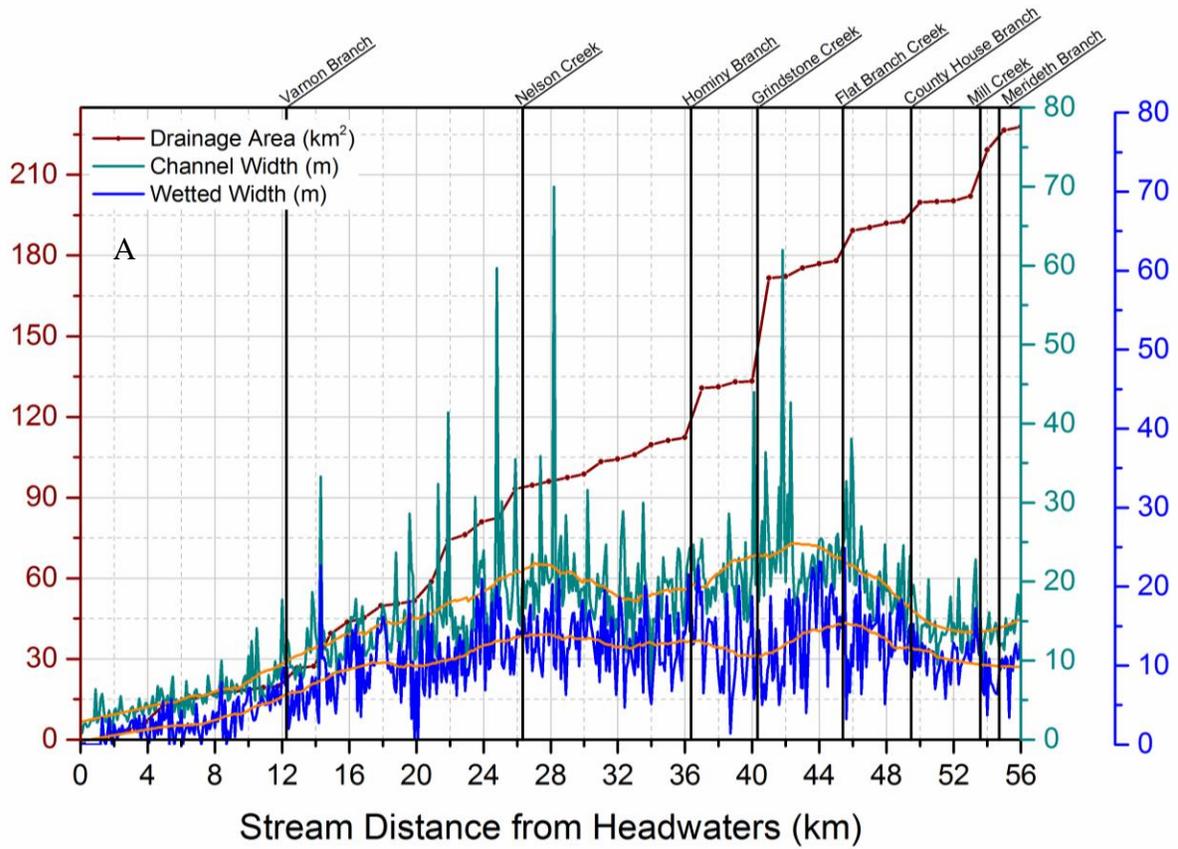
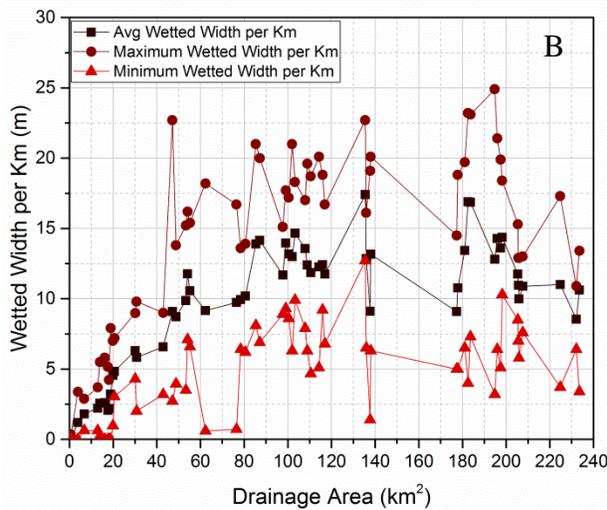
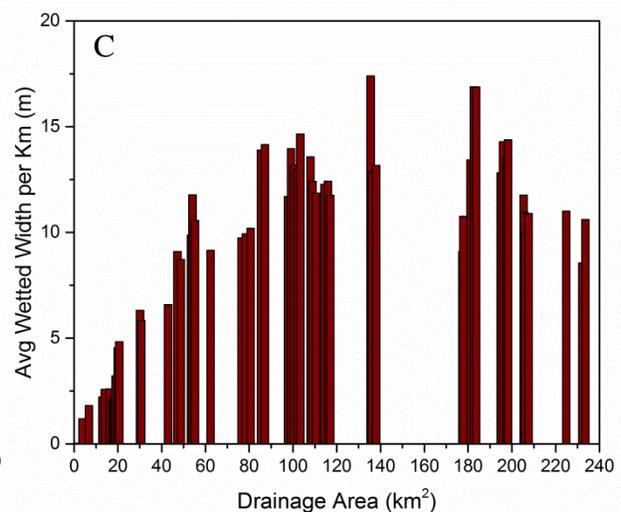
**Figure 19.** A. Channel width and wetted width with stream distance from headwaters and drainage area in Hinkson Creek, with 100 pt moving averages shown in orange, and major tributary confluences marked; B. Average, maximum and minimum wetted width per kilometer with drainage area in Hinkson Creek watershed to illustrate variability in measurements; and C. Average wetted width per kilometer with drainage area in Hinkson Creek watershed.

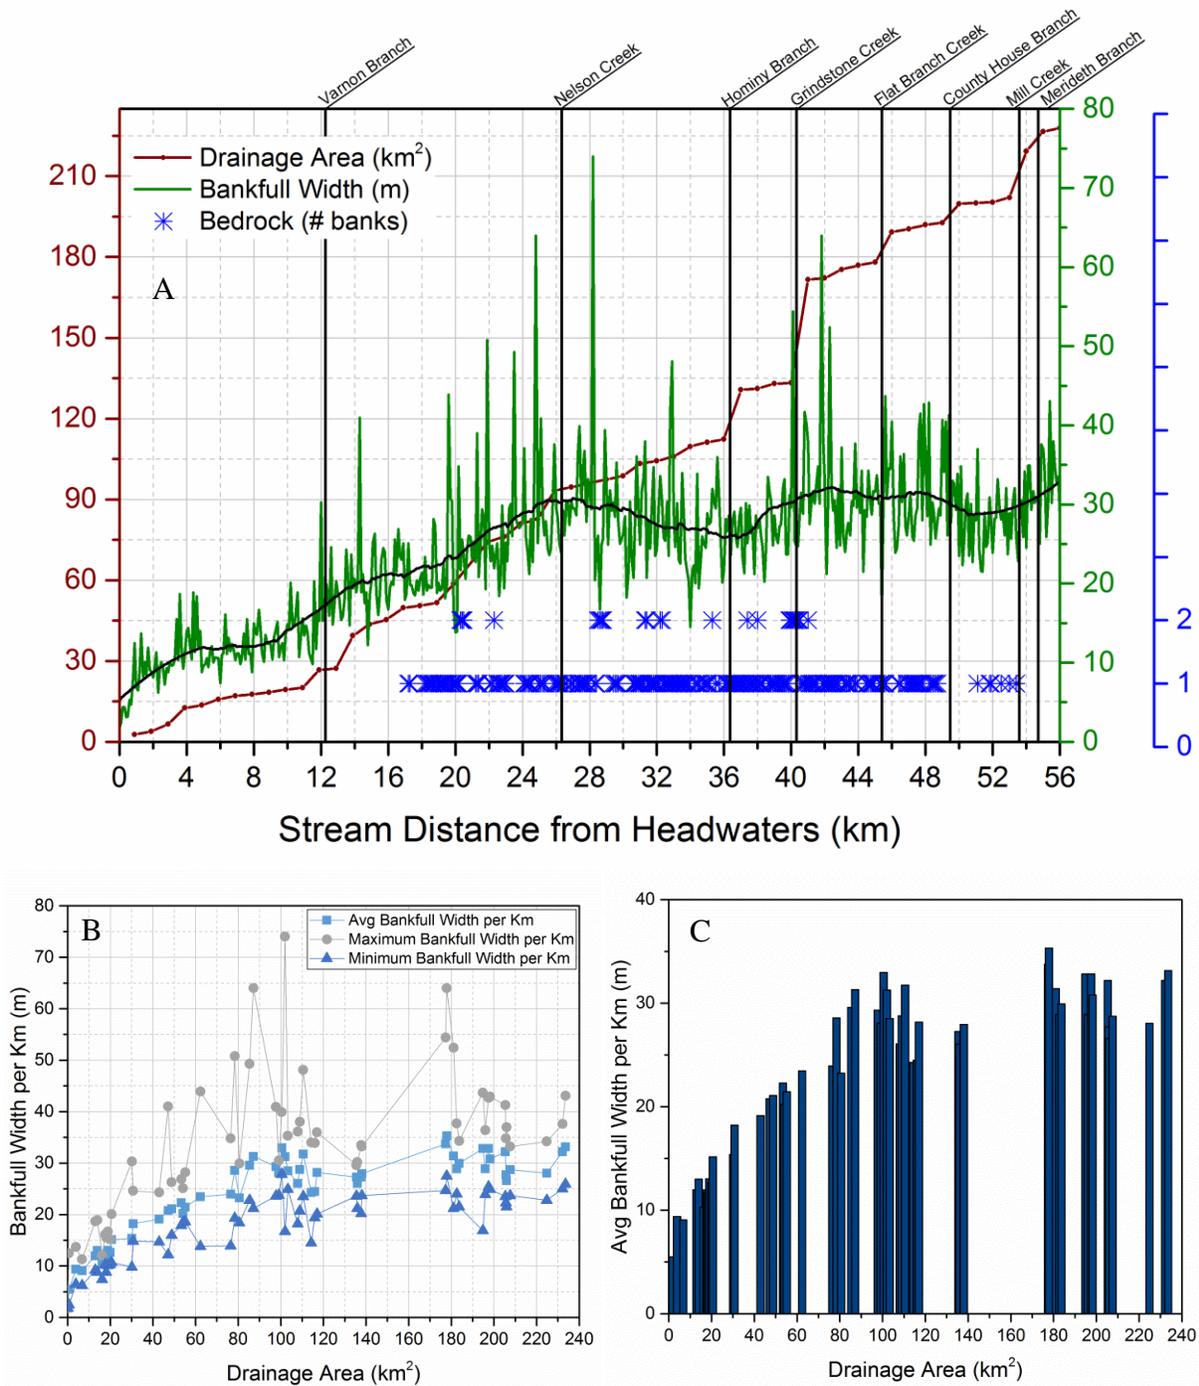
**Figure 20.** A. Bankfull width with stream distance from headwaters and drainage area in Hinkson Creek, with 100 pt moving average shown in black, and major tributary confluences marked. Bedrock constraints are shown with blue asterisks; B. Average, maximum and minimum bankfull width per kilometer with drainage area in Hinkson Creek watershed to illustrate variability in measurements; and C. Average bankfull width per kilometer with drainage area in Hinkson Creek watershed.

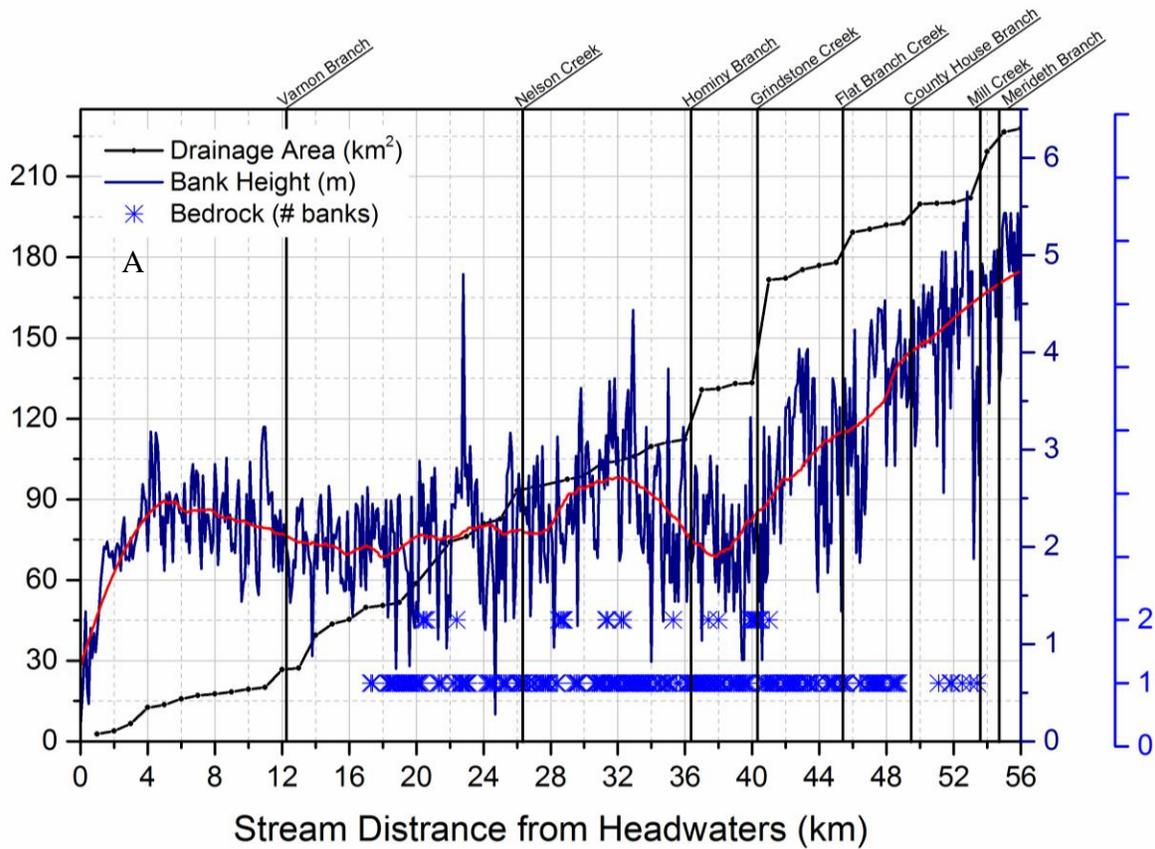
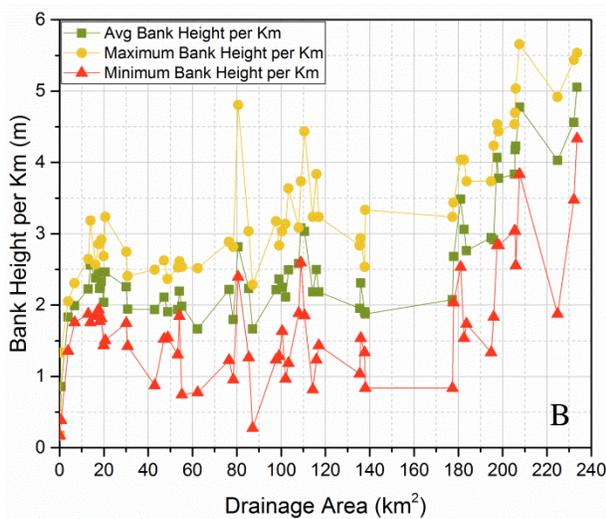
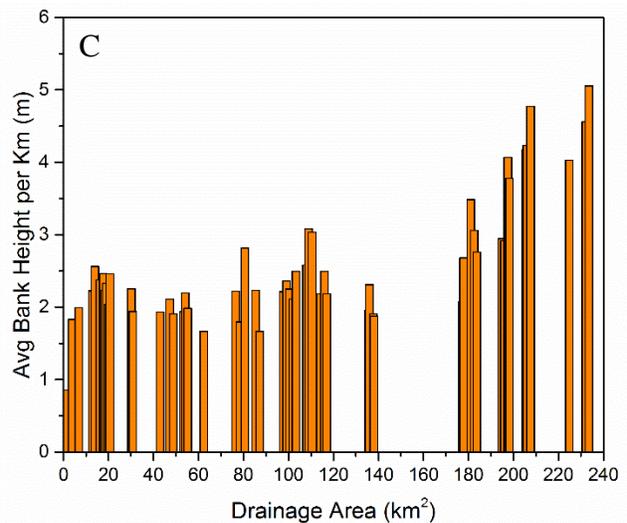
**Figure 21.** A. Bank height with stream distance from headwaters and drainage area in Hinkson Creek, with 100 pt moving average shown in red, and major tributary confluences marked. Bedrock constraints are shown with blue asterisks; B. Average, maximum and minimum bank height per kilometer with drainage area in Hinkson Creek watershed to illustrate variability in measurements; and C. Average bank height per kilometer with drainage area in Hinkson Creek watershed.

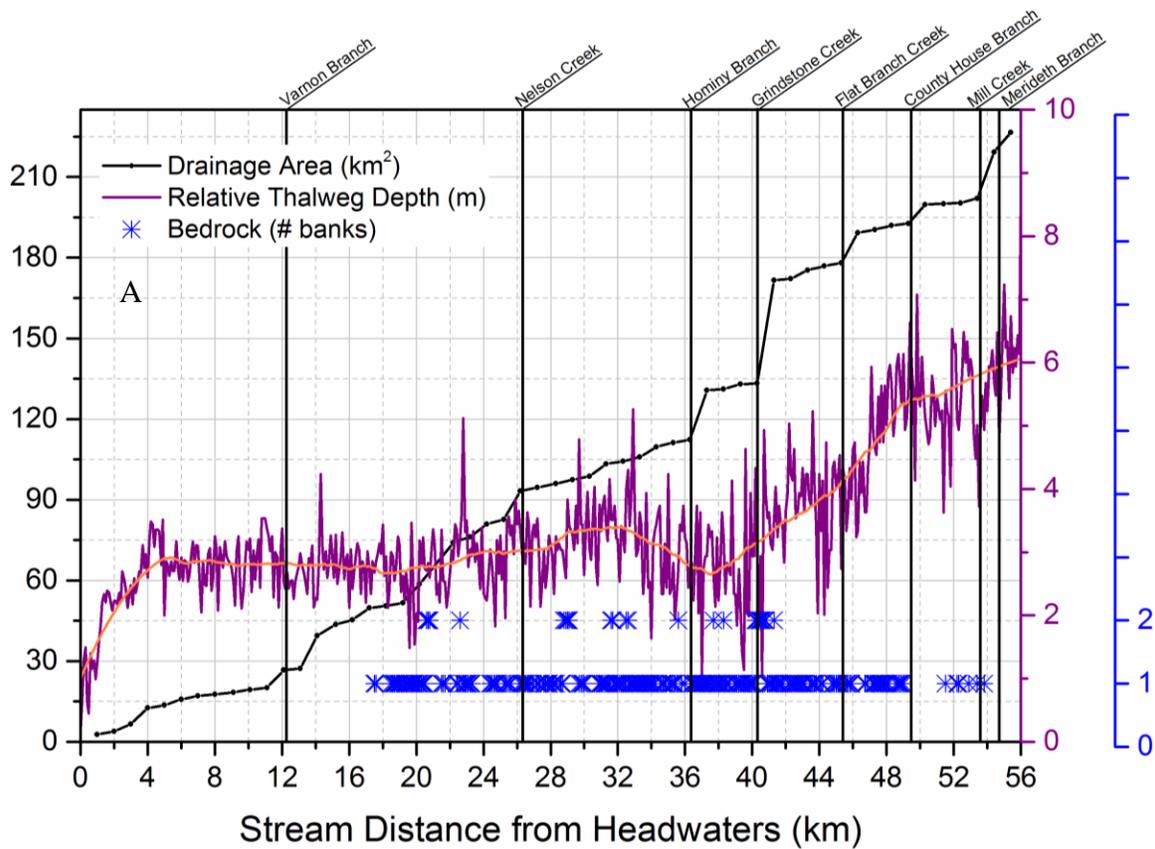
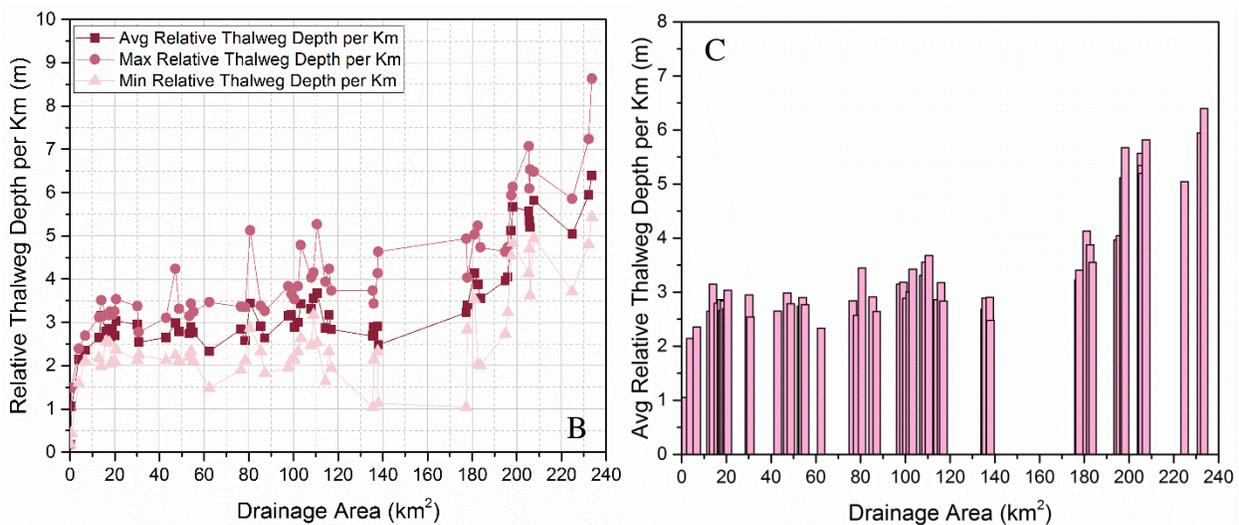
**Figure 22.** A. Relative thalweg depth with stream distance from headwaters and drainage area in Hinkson Creek, with 100 pt moving average shown in orange, and major tributary confluences marked. Bedrock constraints are shown with blue asterisks; B. Average, maximum and minimum relative thalweg depth per kilometer with drainage area in Hinkson Creek watershed to illustrate variability in measurements; and C. Average relative thalweg depth per kilometer with drainage area in Hinkson Creek watershed.

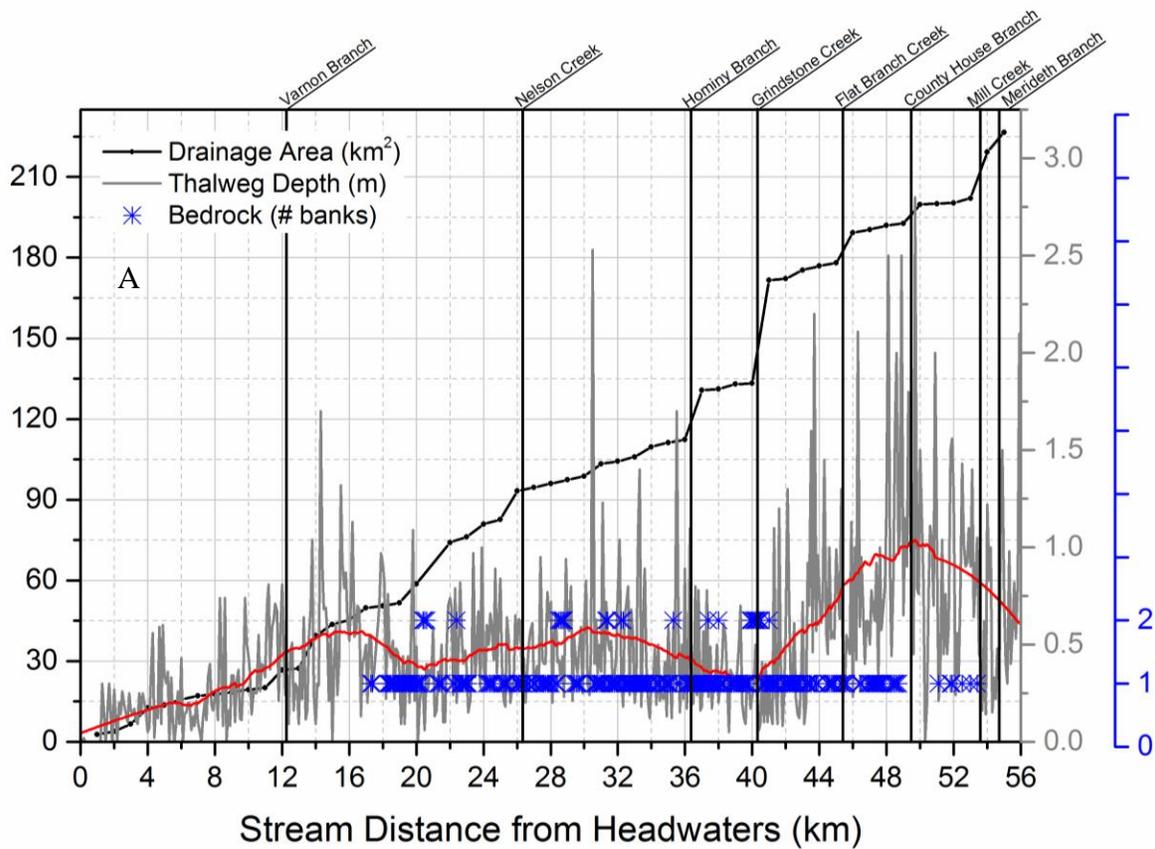
**Figure 23.** A. Thalweg depth with stream distance from headwaters and drainage area in Hinkson Creek, with 100 pt moving average shown in red, and major tributary confluences marked. Bedrock constraints are shown with blue asterisks; B. Average, maximum and minimum thalweg depth per kilometer with drainage area in Hinkson Creek watershed to illustrate variability in measurements; and C. Average thalweg depth per kilometer with drainage area in Hinkson Creek watershed.

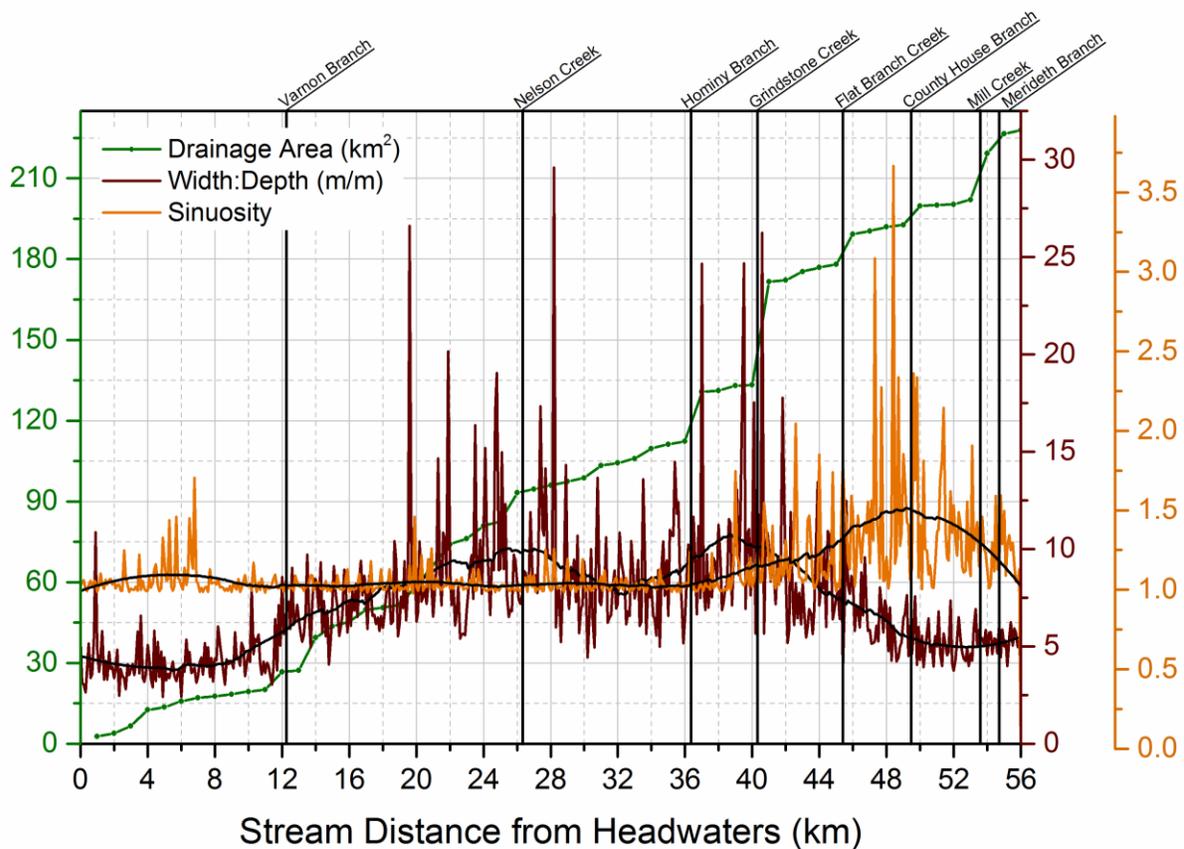
**Figure 24.** Width: depth ratio and sinuosity in Hinkson Creek with stream distance and drainage area. 100 pt moving averages are marked in black.

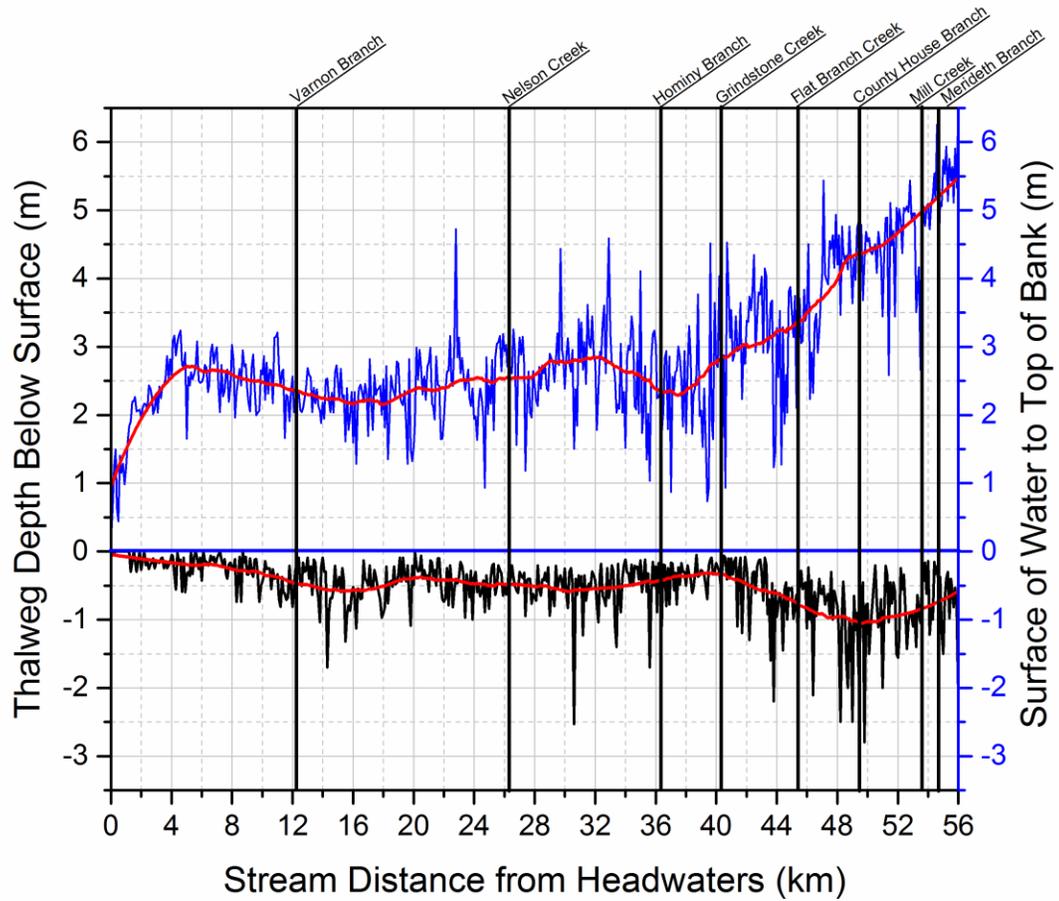
**Figure 25.** Thalweg depth (left y-axis, in black) and distance from surface of water to top of bank (right y-axis, in blue) with stream distance, with 100 pt moving averages in red. Confluences with the 8 major tributaries are marked.

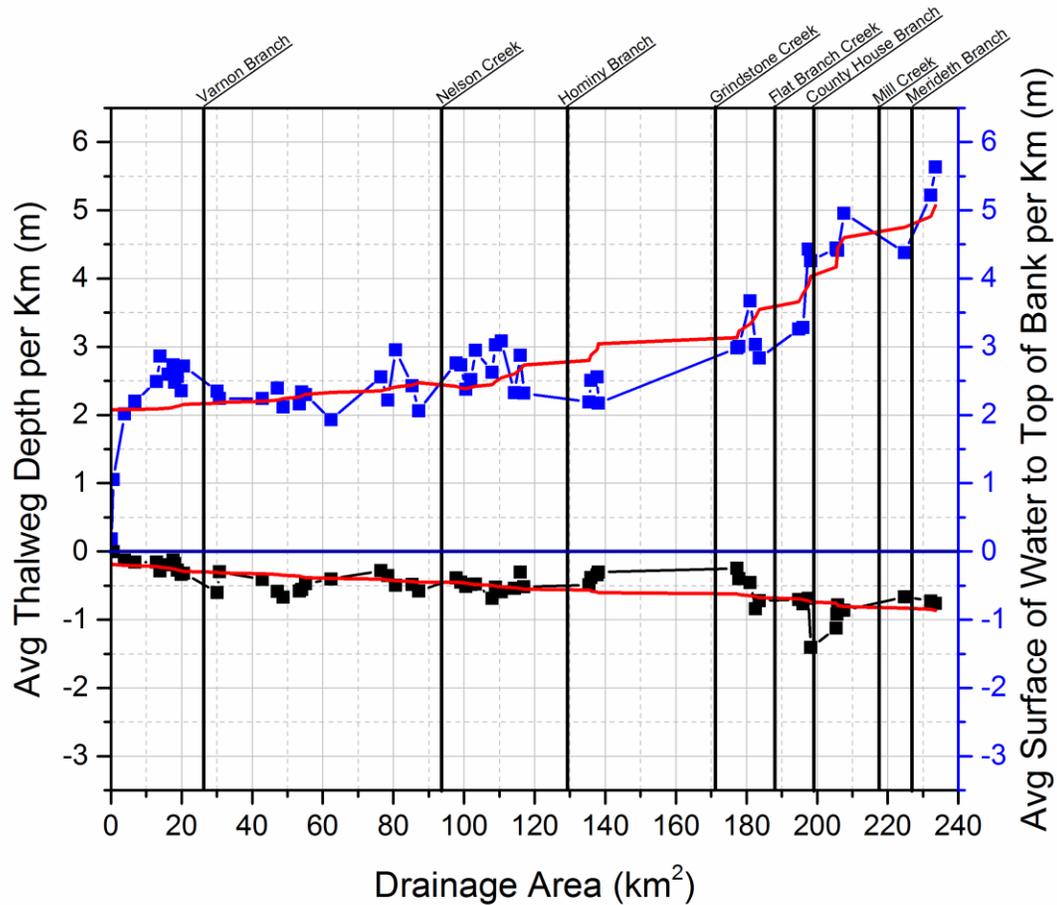
**Figure 26.** Average thalweg depth per km and average distance from surface of the water to the top of the bank per km with drainage area, 50 pt moving average in red. Confluences with the eight major tributaries are marked.

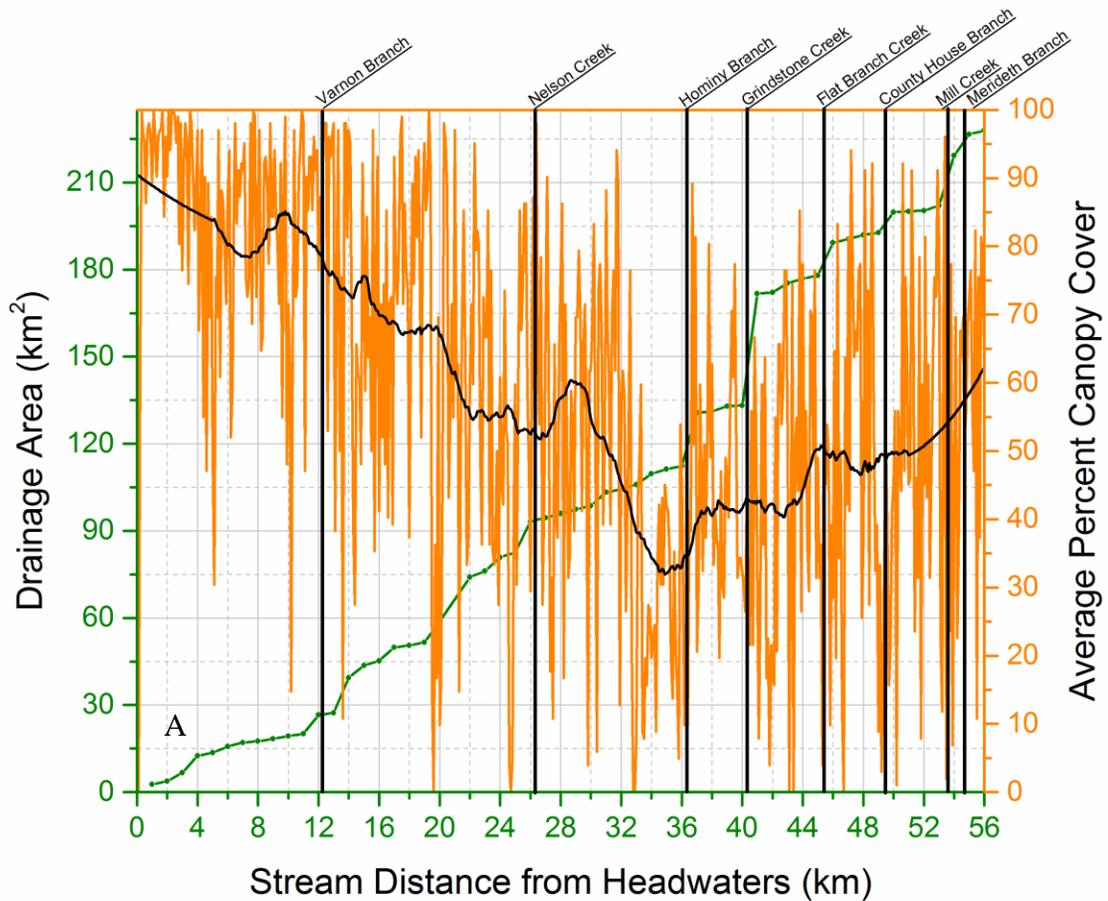
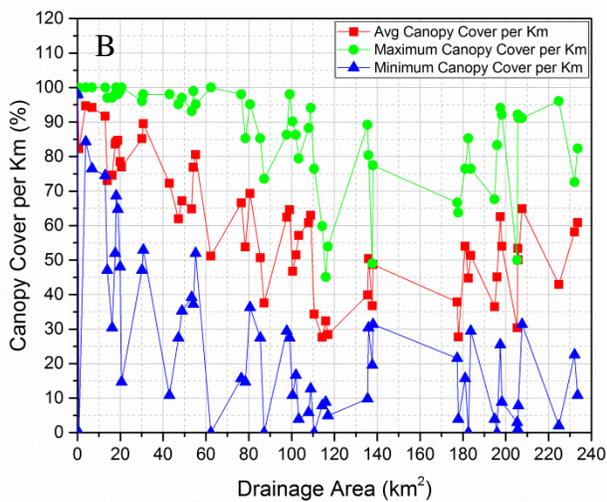
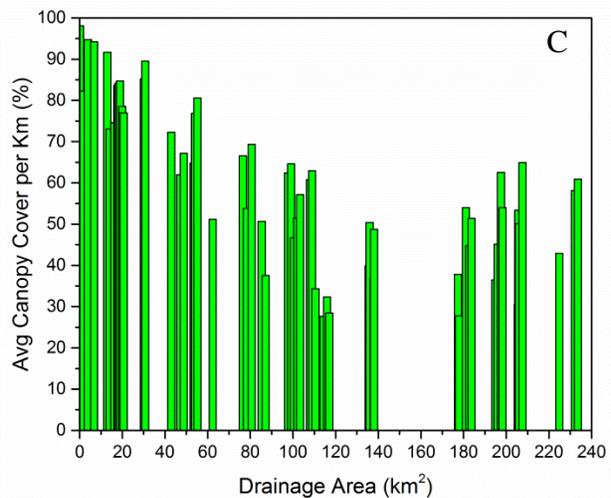
**Figure 27.** A. Average percent canopy cover with stream distance from headwaters in Hinkson Creek and drainage area, with 100 pt moving average shown in black, and confluences with the eight major tributaries marked; B. Average, maximum and minimum percent canopy cover per kilometer with drainage area in Hinkson Creek watershed to illustrate variability in measurements; and C. Average percent canopy cover per kilometer with drainage area in Hinkson Creek watershed.

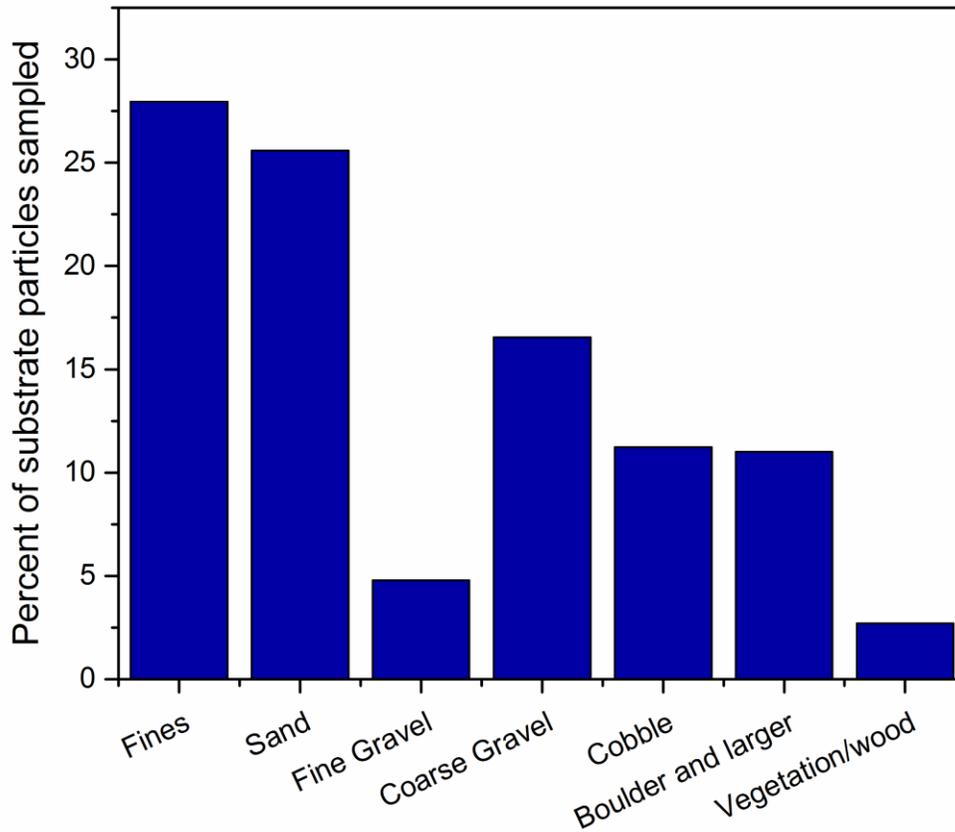
**Figure 28.** Percentage of substrate particle samples collected during the pebble count and thalweg profile of the PHA of Hinkson Creek, grouped by size class. Fines include both silt and clay particles.
