**A STREAM PHYSICAL HABITAT ASSESSMENT  
IN AN URBANIZING WATERSHED OF  
THE CENTRAL U.S.A.**

A Thesis presented to the  
Faculty of the Graduate  
School at the University of  
Missouri-Columbia

JULY 2015

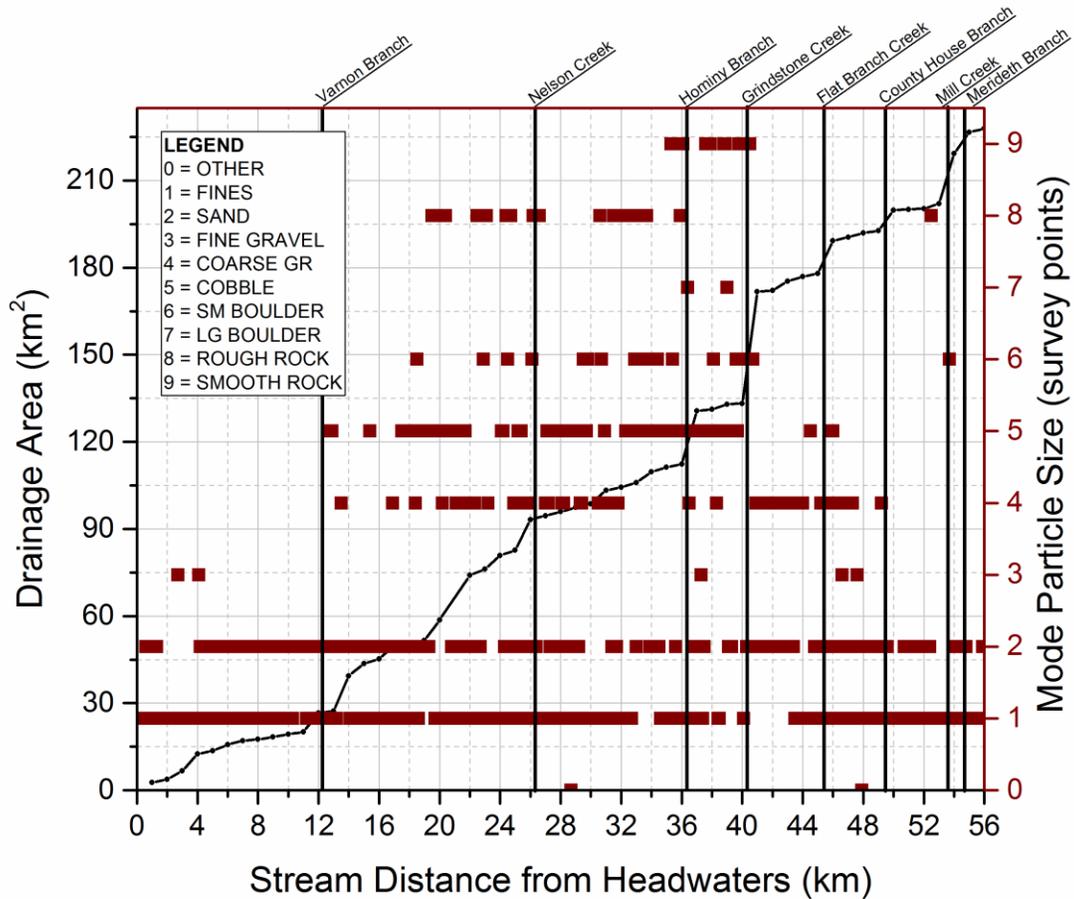
**Figure 29.** Mode particle size (of 15 particles per survey point) with stream distance and drainage area in Hinkson Creek during the PHA of Hinkson Creek (Phase II). Confluences with eight major tributaries are marked.

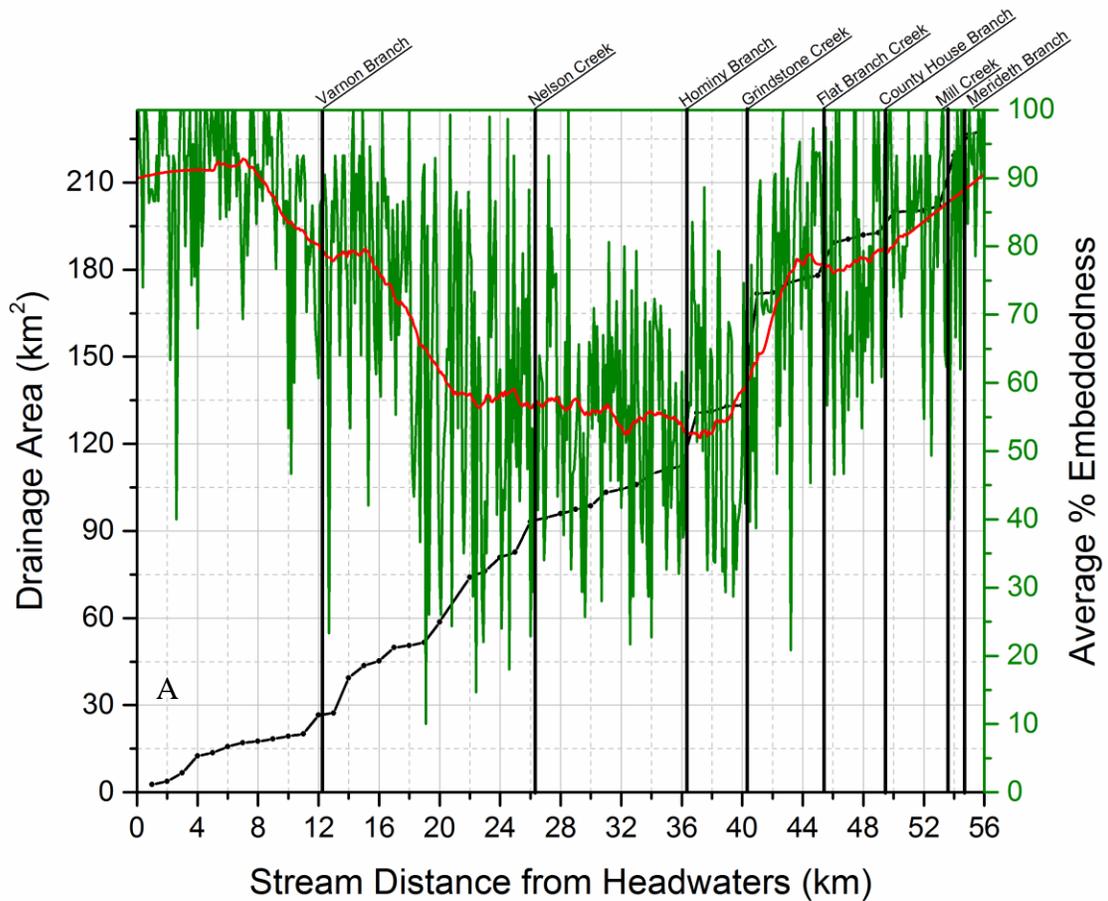
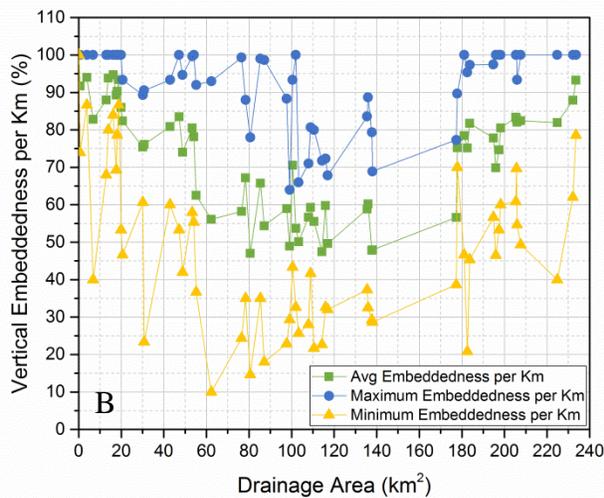
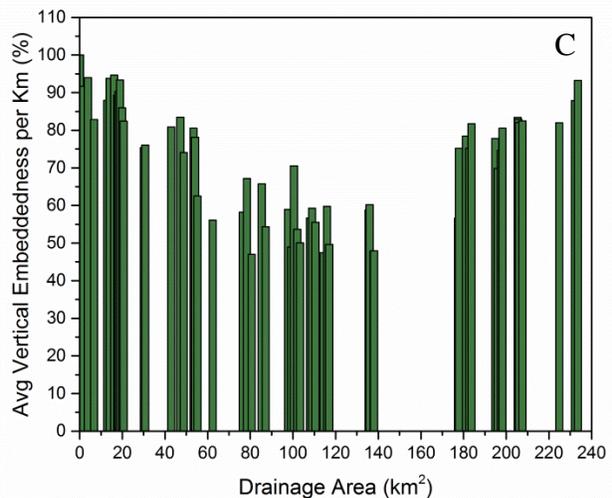
**Figure 30.** A. Average percent vertical embeddedness of sampled particles with stream distance from headwaters and drainage area in Hinkson Creek, with 100 pt moving average shown in red. Confluences with the eight major tributaries are marked; B. Average, maximum and minimum percent vertical embeddedness per kilometer with drainage area in Hinkson Creek watershed to illustrate variability in measurements; and C. Average percent vertical embeddedness per kilometer with drainage area in Hinkson Creek watershed.

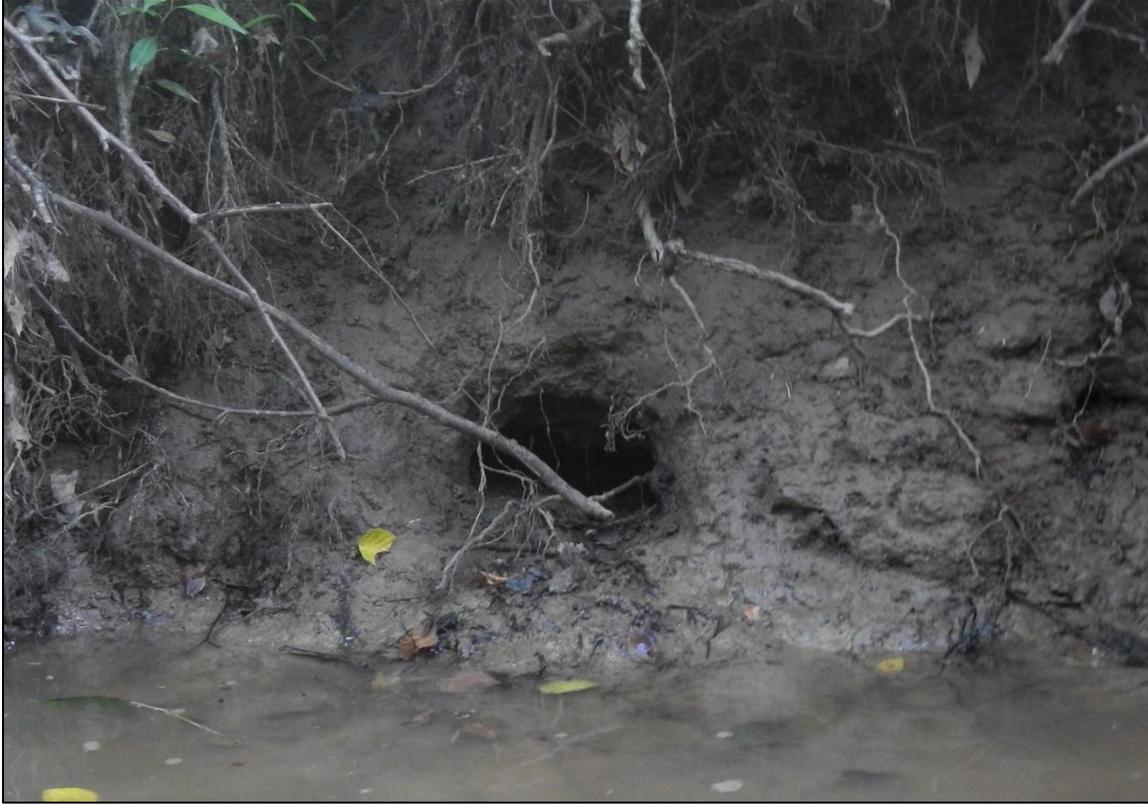
**Figure 31.** One of several muskrat dens found during the PHA of Hinkson Creek, 08-13-2014, 10:03 (lat. 39.115652, long. -92.19164).

The surficial geology of Hinkson Creek may be directly relevant to the availability of physical habitat available for aquatic biota. For example, Bucci (2009) showed that stable streambanks (corresponding to reduced sand content) provide burrow habitat for muskrats living in the riparian corridor (Illinois, USA). The dens observed on Hinkson Creek were constructed in streambanks near the level of the water surface at baseflow (example shown in Figure 31). Streambanks were used as habitat by wildlife in Hinkson Creek (Figures 32 and 33).

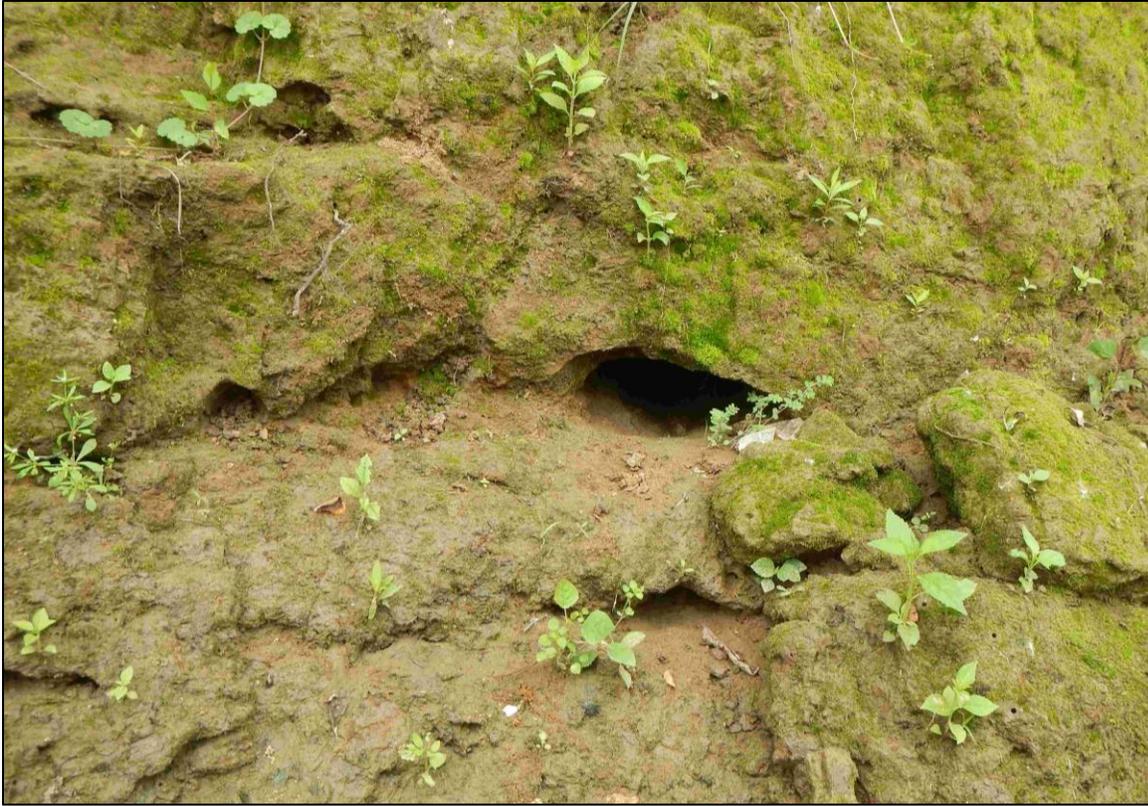
**Figure 32.** A burrow for a bird or small mammal in the streambank more than a meter above the surface of the water of Hinkson Creek, 08-08-2013, 12:39 (lat. 38.924095, long. - 92.326942).

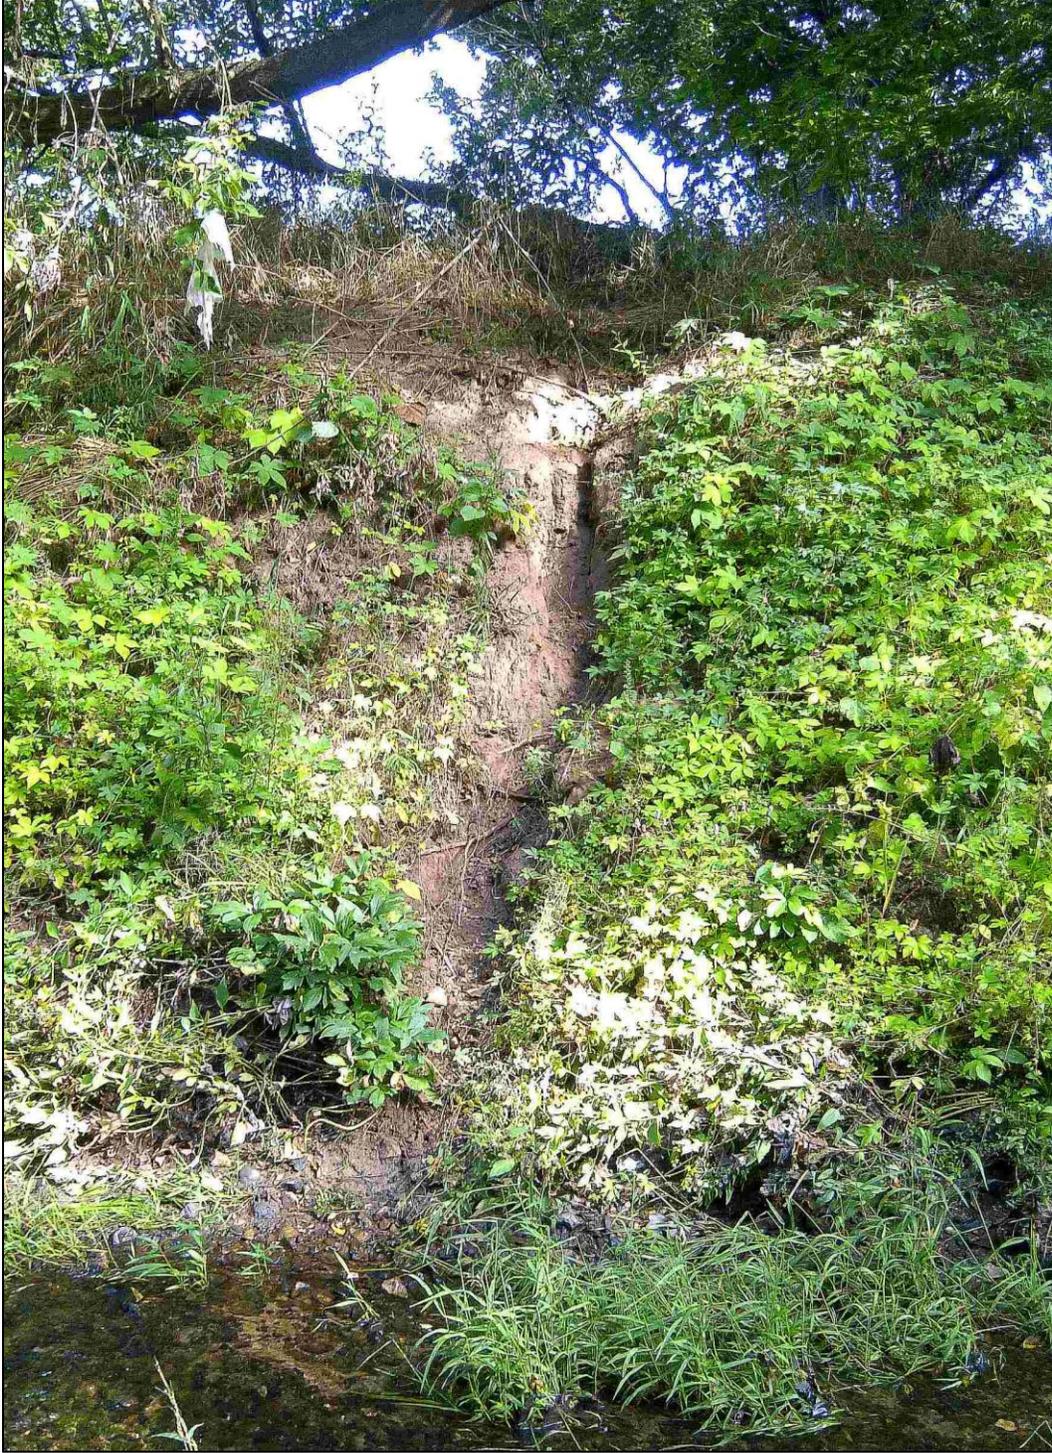
**Figure 33.** A river otter slide on a bank of Hinkson Creek, 10-01-2013, 10:35 (coordinates not available).

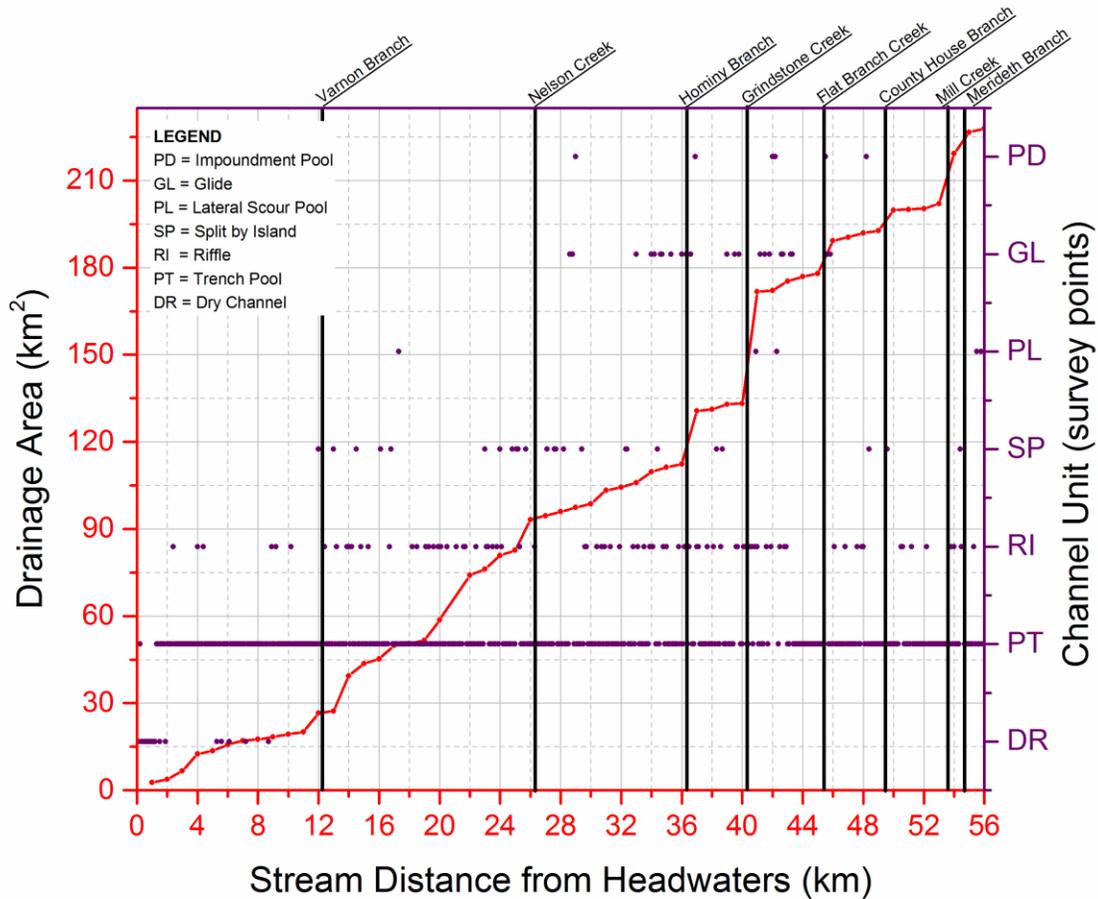
**Figure 35.** Channel unit types recorded during the PHA of Hinkson Creek, with stream distance and drainage area. Confluences with the eight major tributaries are marked.

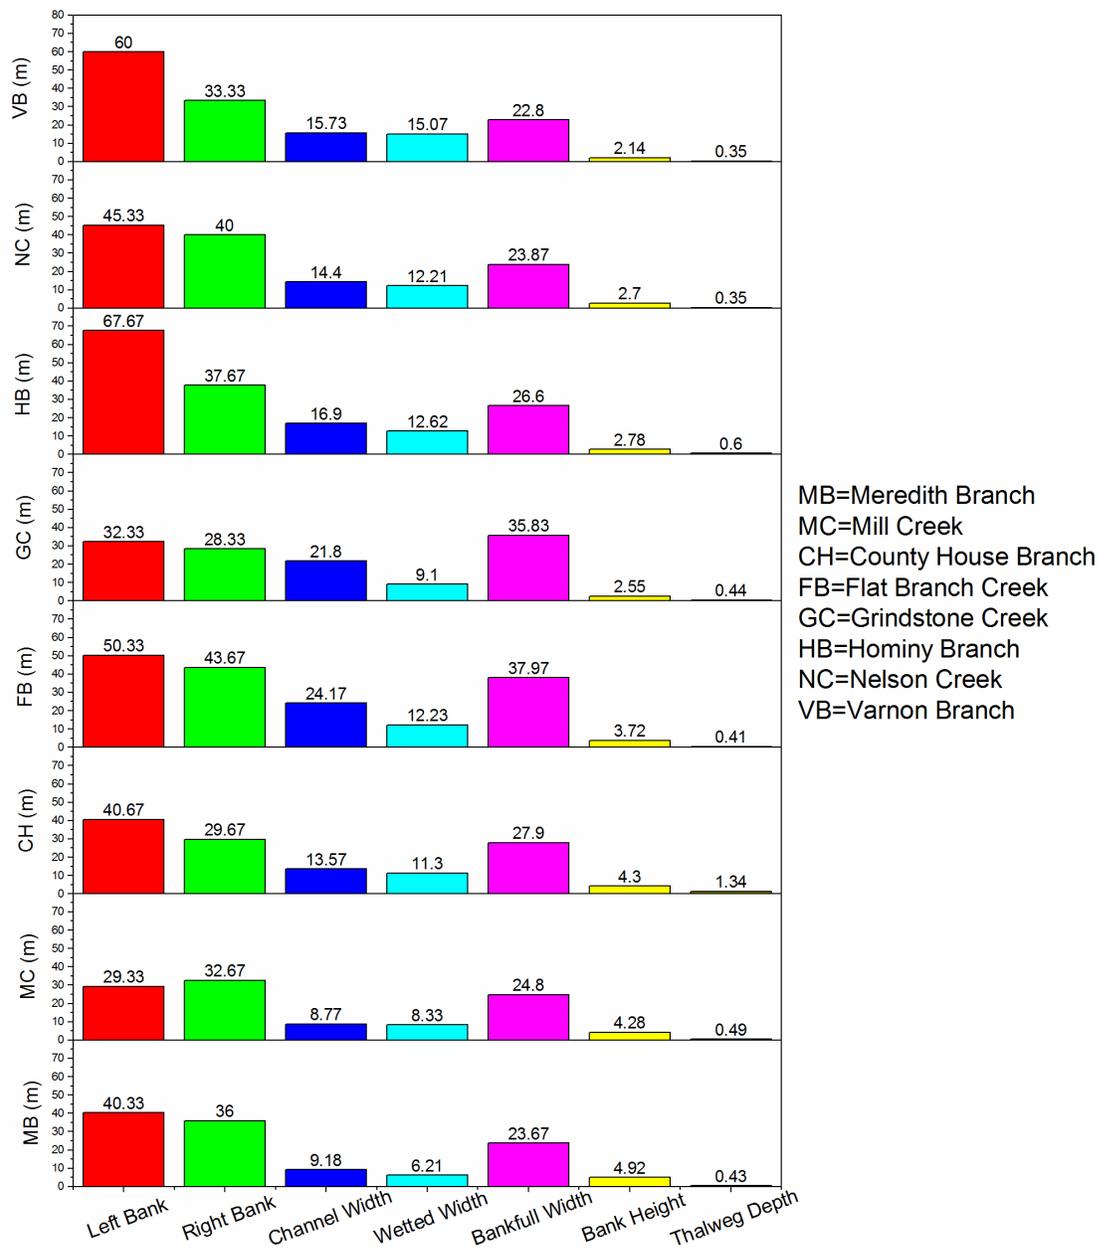
**Figure 36.** A comparison of averaged transect measurements (see section 2.2 *Physical Habitat Assessment Field Protocol* for how metrics are calculated) at the confluence of each of the eight major tributaries of Hinkson Creek. All measurements are in meters, with the exception of the left bank and right bank angles which are in degrees.

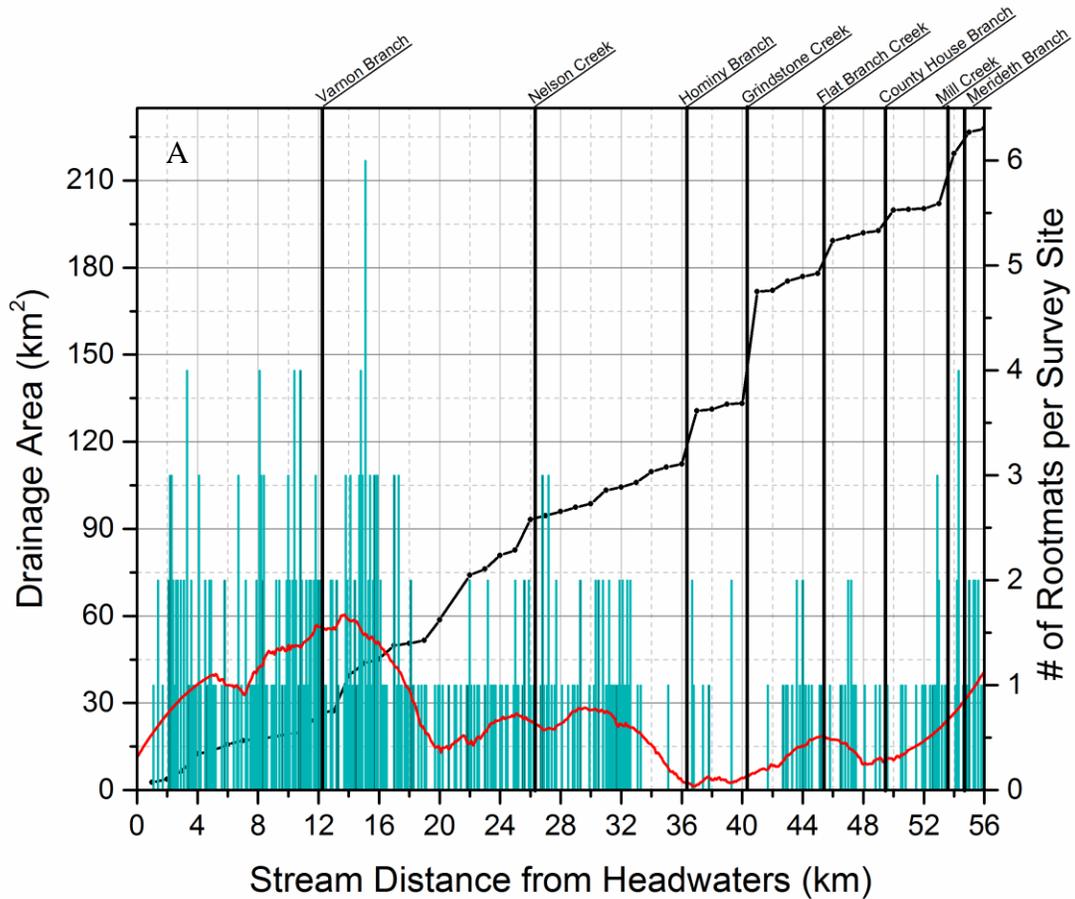
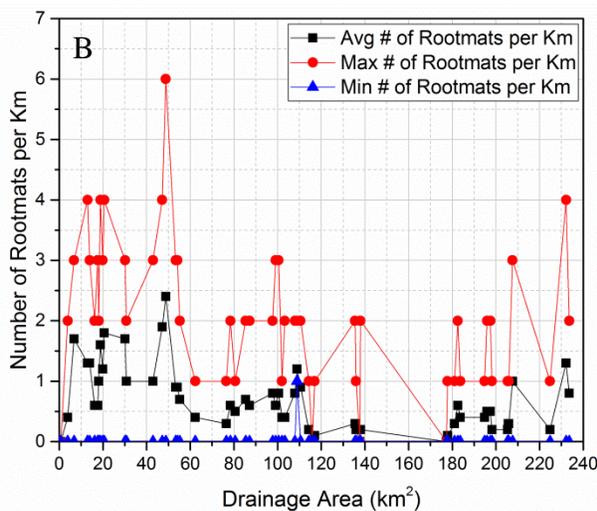
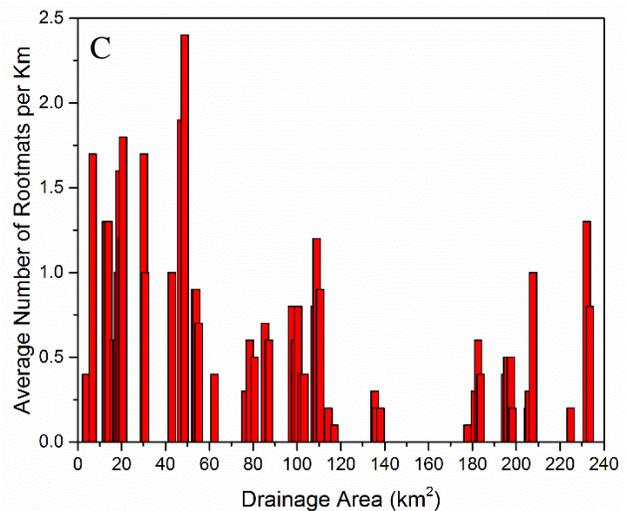
**Figure 37.** A. Number of rootmats per survey site with stream distance from headwaters and drainage area in Hinkson Creek, with 100 pt moving average shown in red. Confluences with eight major tributaries are marked; B. Average, maximum and minimum number of rootmats per kilometer with drainage area in Hinkson Creek watershed to illustrate variability in measurements; and C. Average number of rootmats per kilometer with drainage area in Hinkson Creek watershed.

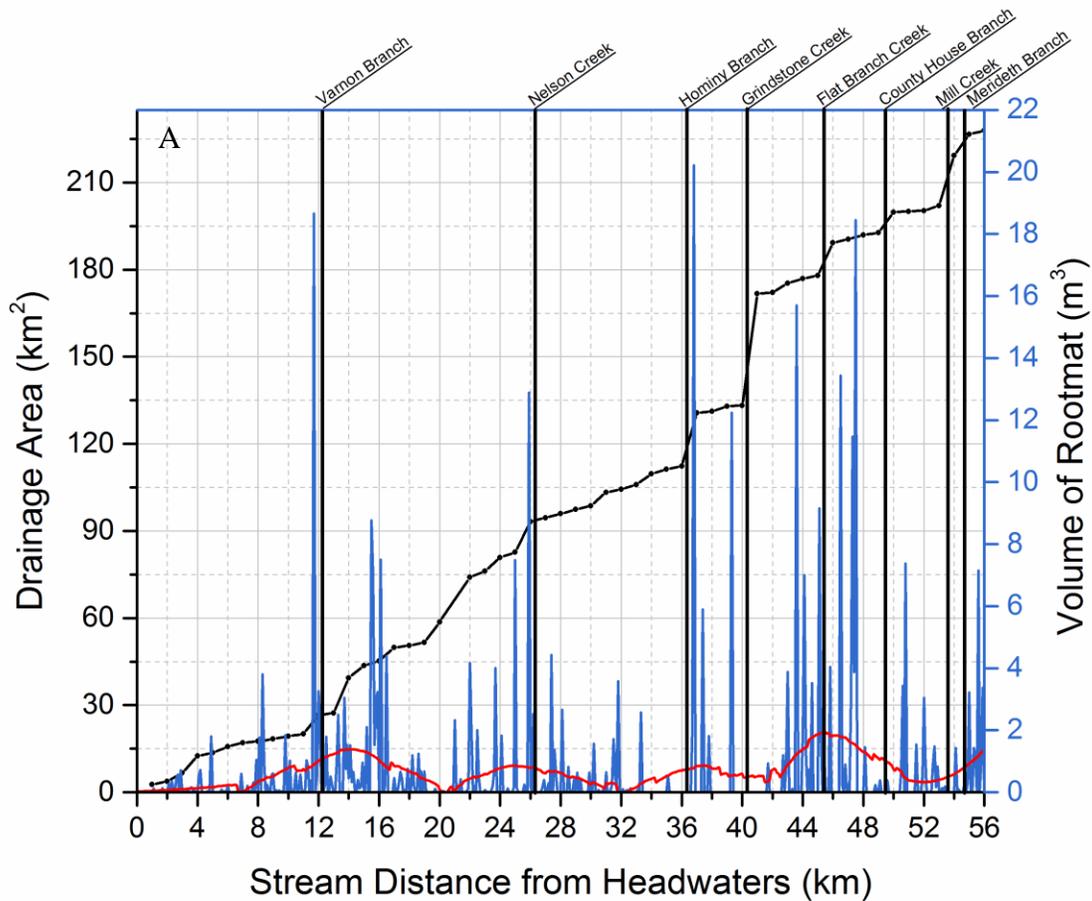
**Figure 38.** A. Rootmat volume at survey sites with stream distance from headwaters and drainage area in Hinkson Creek, with 100 pt moving average shown in red. Confluences with eight major tributaries are marked; B. Average, maximum and minimum rootmat volume per kilometer with drainage area in Hinkson Creek watershed to illustrate variability in measurements; and C. Average rootmat volume per kilometer with drainage area in Hinkson Creek watershed.

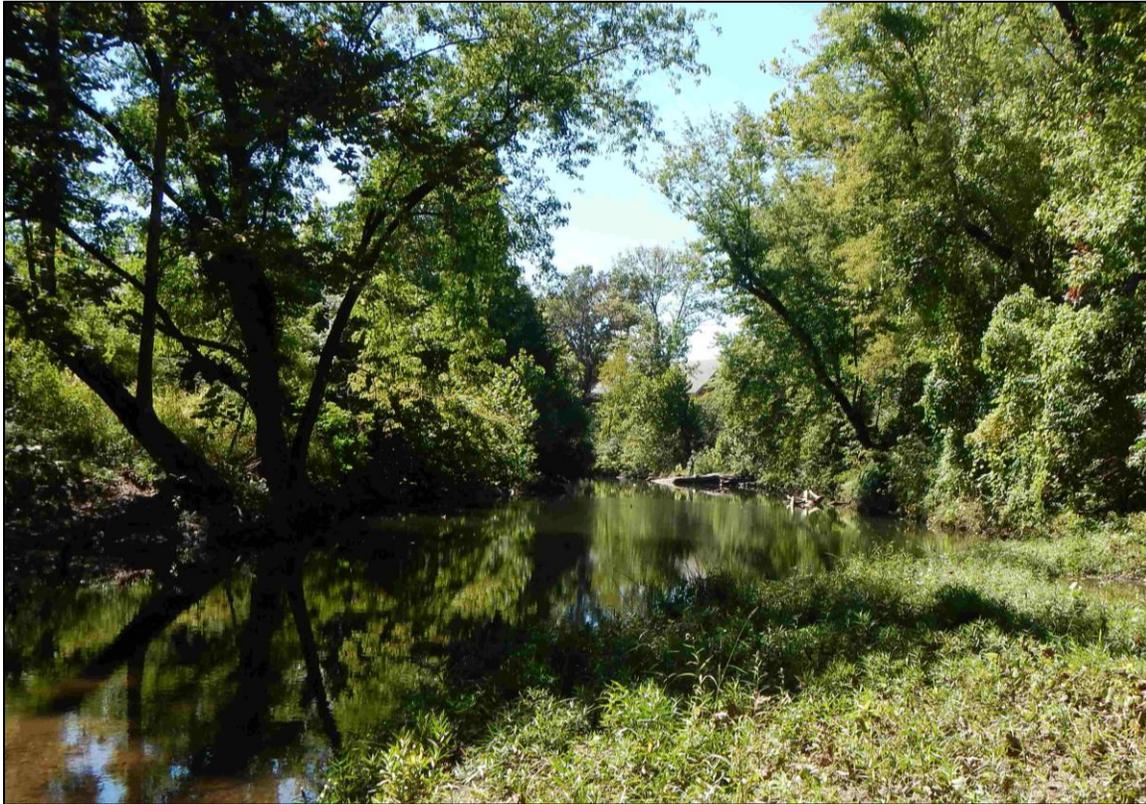
**Figure 40.** Riparian shading of Hinkson Creek a few hundred meters upstream of Forum Blvd. in the city of Columbia, September 29, 2013, 13:38 (lat. 38.924228, long. -92.362847).

The riparian corridor along the length of a stream serves a number of important functions with respect to aquatic biota. Stream temperature is often correlated to the condition and extent of nearby riparian corridor vegetation cover (Sponseller et al. 2001) (Figure 40). The riparian zone may provide habitat or a path for dispersal between water bodies for biota such as frogs that

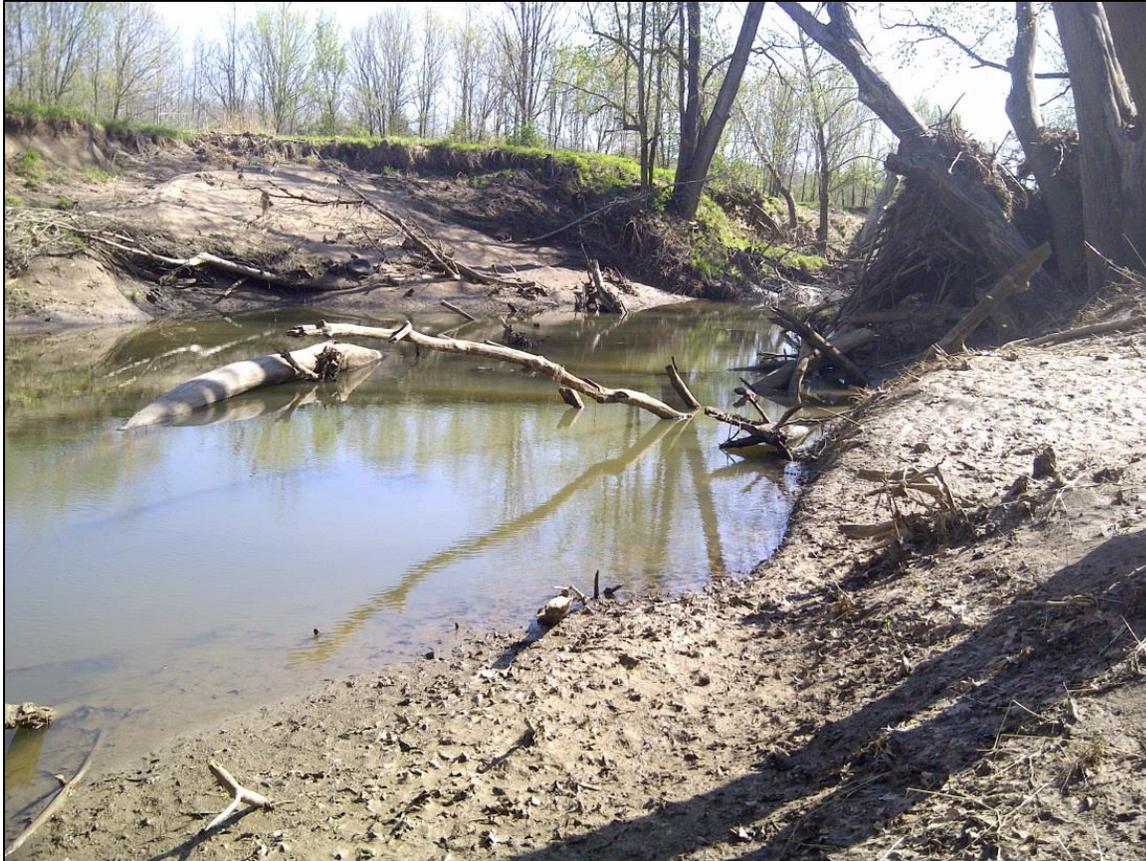
**Figure 46.** Large woody debris in stream has created deep pools and habitat for aquatic turtles just downstream of Forum Nature Area in Columbia (coordinates not available).

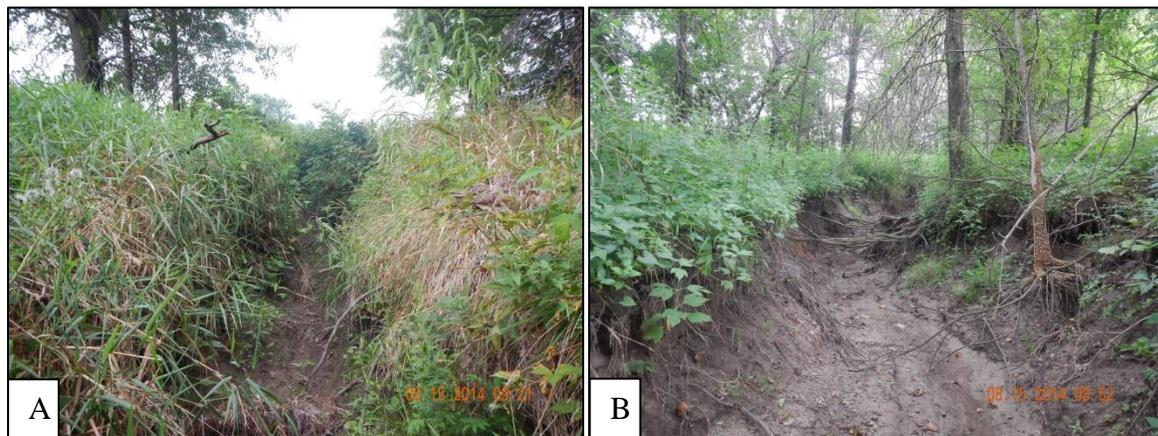
**Figure 48.** A. The view 200 m downstream of the headwaters, during the "drainage ditch" portion of the stream's beginnings, 08-15-2014, 09:21 (lat. 39.128743, long. -92.180752). B. Channel incision is evident 300 m downstream of the headwaters on the left descending bank where tree roots are visible, 08-15-2014, 08:52 (lat. 39.127875, long. -92.180977).

Hinkson Creek begins near a cornfield representative of the land-use in Varnon Branch tributary catchment (Figures 47A and 47B), and is barely more than a drainage ditch for the first few hundred meters. Channel incision and streambank erosion is observed 300 m downstream of

the headwaters (Figure 48B) suggesting potential land-use effects on stream physical habitat from deforestation and agricultural land-uses in the uppermost reaches of HCW.

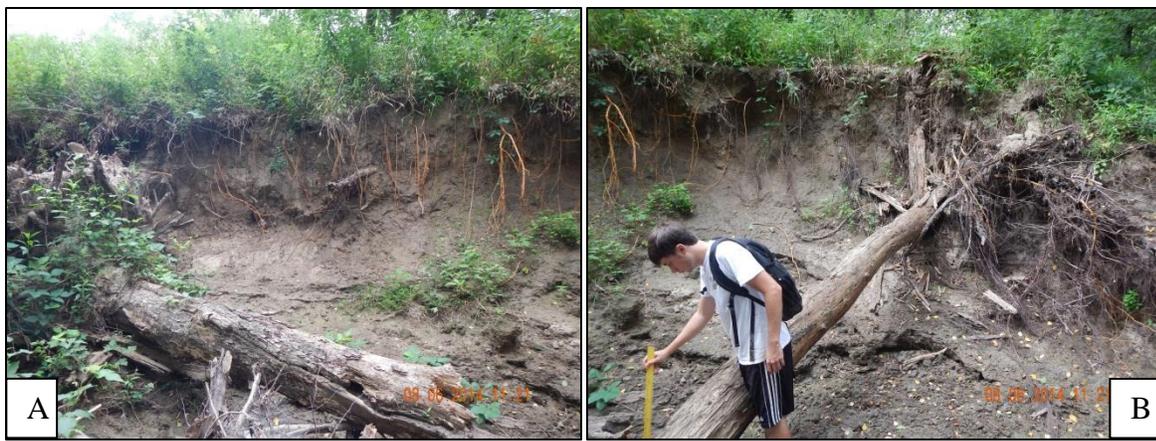
**Figure 49.** A and B. View of the right descending bank approximately 4.5 km downstream of the headwaters, where streambank erosion has caused riparian trees to fall in to the stream, 08-06-2014, 11:21 (lat. 39.106112, long. -92.19592).

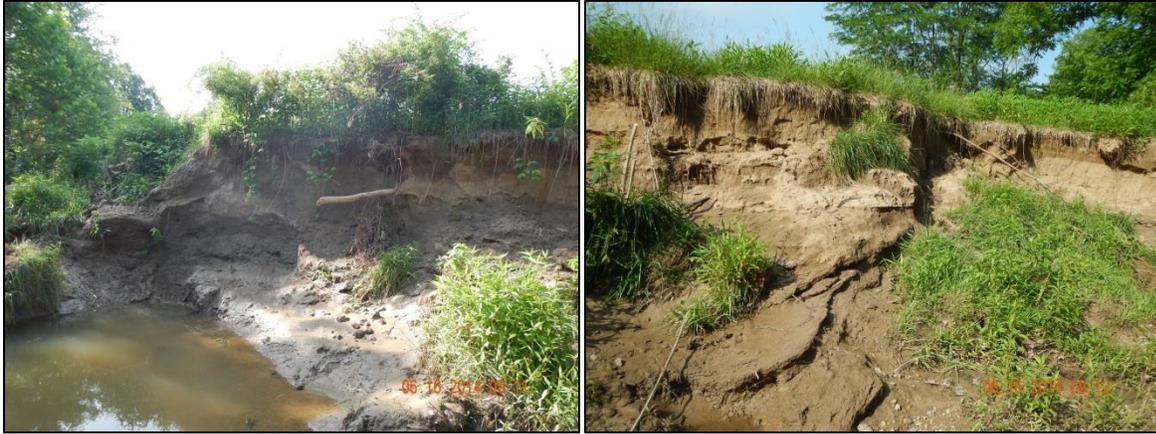
**Figure 50.** A view of the right descending bank adjacent to an agricultural field approximately 15 km downstream of the headwaters shows an incised streambank with ongoing mass wasting, 06-16-2014, 09:12 (lat. 39.055623, long. -92.218477).

At every 100 m survey point, measurements of bank and channel variables were collected including bank angle (left and right banks), channel width, wetted width, bankfull width, and bank height (bankfull bank only). Bank angle exhibited the greatest range of measurements, with a maximum of 100°, minimum of 0°, mean of 35.0°, median of 34.0°, and standard deviation of 16.1°. Mean bank angle was very similar for the left and right banks, measuring 34.6° and 35.5°, respectively. Channel width and bankfull width varied from a maximum of 70.0 m and 74.0 m respectively (both at a survey point approximately 3 km upstream of Mexico Gravel Road in northern Columbia, right descending bank pictured in Figure 50), to a minimum of 0.8 m and 1.8

At meanders in the stream, streamflow exerts more stress on streambanks (Azzola et al. 1986), and it is at the bends of Hinkson Creek that some of the most extensive and rapid change seems to be occurring. The next set of photographs was taken approximately 15 km downstream from the headwaters (drainage area between 43 and 44 km<sup>2</sup>), near the central point in an “S” meander in Hinkson Creek (Figure 50). The section of streambank pictured is immediately adjacent to an extensive agricultural field, so the streambank erosion shown here is potentially due to a combination of upstream and lateral effects of land-use changes. The composition of the streambank in this location is largely sand which would not offer much resistance (lack of cohesiveness) to the effects of altered hydrology from upstream deforestation and agricultural land-uses (Geyer et al. 2001).

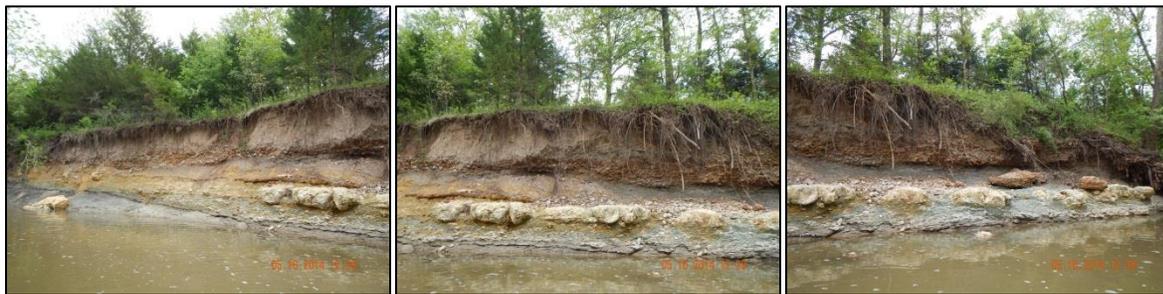
**Figure 51.** View of the left descending bank of Hinkson Creek 1 km upstream from the bridge over Hinkson Creek at Mexico Gravel Road in northern Columbia, 05-16-2014, 12:39 (lat. 38.969027, long. -92.278697).

Near the rural / urban interface at the northern edge of the city limits of the city of Columbia (drainage area between 102 and 103 km<sup>2</sup>), streamflow volume and velocity exerts

sufficient shear stress to incise banks not made of sand, but composed of clay, gravel, and roots from riparian vegetation (Figure 51). Moving downstream into the city of Columbia, the additional cumulative effects from land-use will include less crop (agricultural) influence, and an increasing percentage of impervious surface area drainage concurrent with urbanization in the watershed.

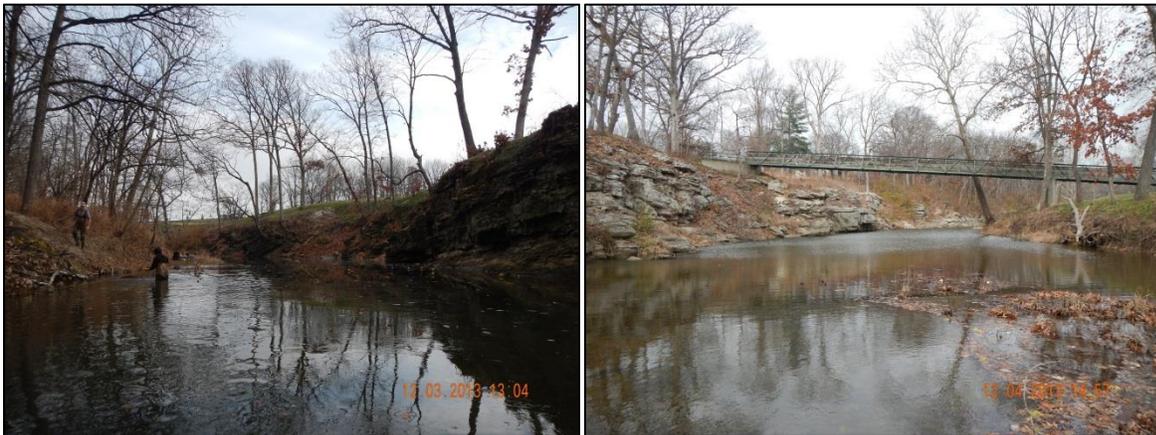
**Figure 52.** Just downstream of the I-70 and Hwy 63 interchange in Columbia, Missouri. These two photographs were taken approximately 300 m apart, and show the bedrock constraints on the left descending bank (12-03-2013, 13:04; lat. 38.960268, long. -92.298872), and right descending bank (12-04-2013, 14:57; lat. 38.959427, long. -92.300617), respectively.

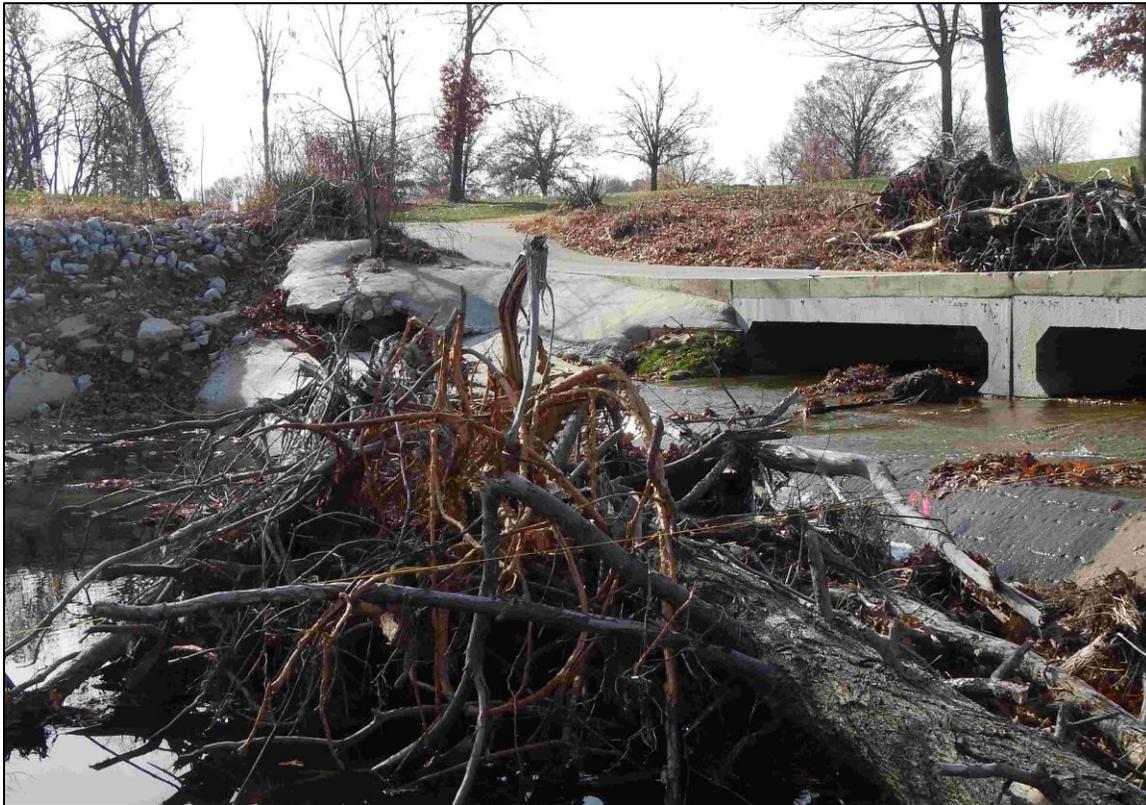
**Figure 54.** A bridge constructed by Columbia Country Club which owns the land on either side of Hinkson Creek approximately 300 m upstream of East Walnut Street in Columbia, Missouri, 11-24-2013, 14:06 (lat. 38.958472, long. -92.29949).

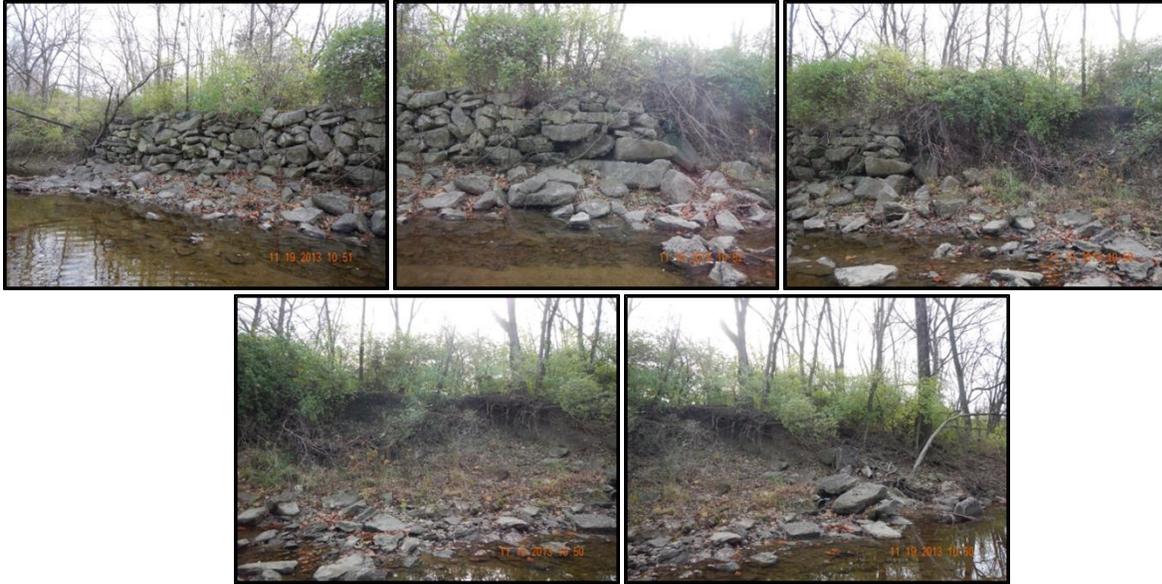
**Figure 55.** A manmade erosion control structure consisting of a rock wall on the left descending bank of Hinkson Creek, just upstream of East Walnut Street in Columbia, Missouri, and the streambank erosion and incision just downstream of the structure, 11-19-2013, 10:50 (lat. 38.953833, long. -92.300263).

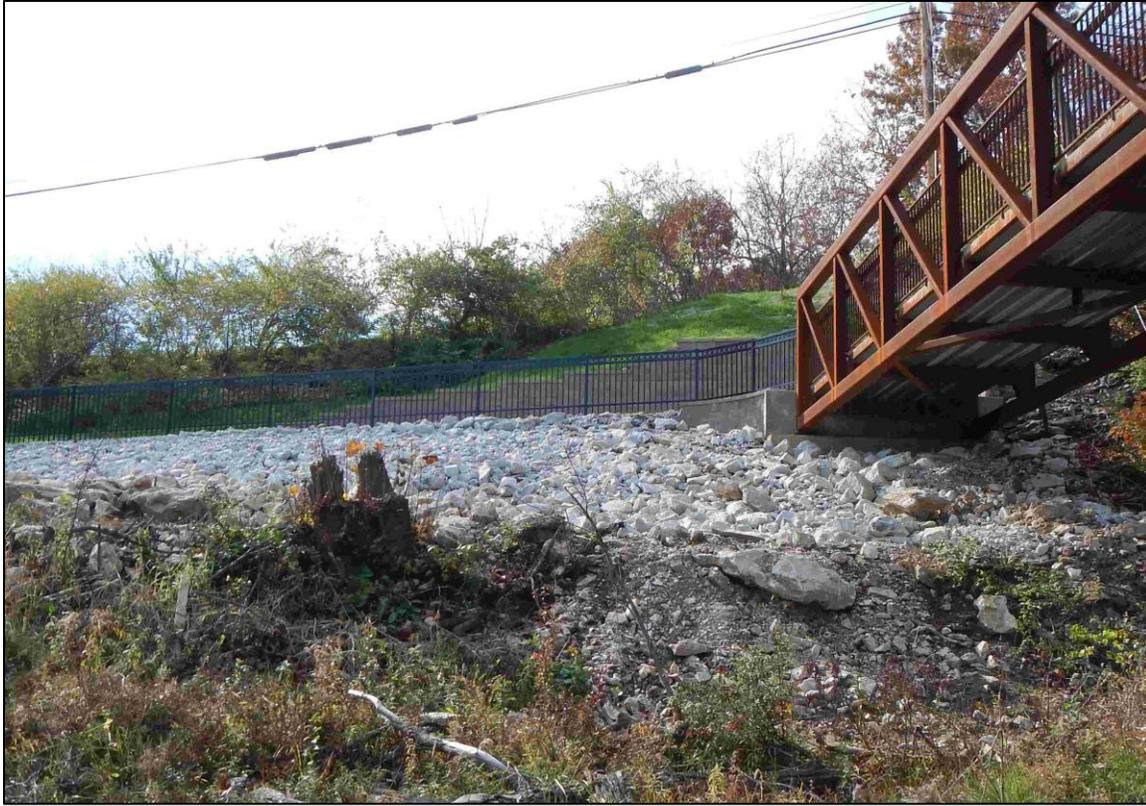
**Figure 56.** A footbridge across Hinkson Creek between E. Broadway Street and Old Highway 63 on the Hinkson Creek Trail, 11-10-2013, 13:41 (lat. 38.946007, long. -92.306657).

In addition to terrestrial land-use practices in HCW having effects on stream physical habitat, there are a number of manmade structures in/across the stream which have likely contributed to alteration of stream hydrologic processes and in-stream physical habitat (for a discussion of the effect of bridges, see Paul and Meyer 2001). Three examples are presented here as Figures 54, 55 and 56. The first example is a bridge constructed to provide access from one side of a private golf course to the other less than 500 m upstream of the area shown in Figure 53. The bridge has in effect created a low-water dam with a pool on the upstream side, and may impede flow of the stream during periods of low or baseflow conditions (Figure 54). A second example is a rock wall constructed by a landowner on the left descending bank just a few hundred meters upstream of the bridge over Hinkson Creek at E. Walnut St. The intention of the rock wall was presumably to reduce streambank erosion and prevent loss of the landowner's property. However, the photographs indicate the observed effect of streambank erosion just downstream of the rock wall (Figure 55). The final example shows the replacement of riparian vegetation with riprap near a footbridge on the Hinkson Creek Trail constructed by the City of

Columbia, located between Broadway Street and Old Highway 63 (Figure 56). Riprap is frequently used near bridges in Hinkson Creek presumably to prevent streambank erosion at the hillslopes enhanced during bridge construction.

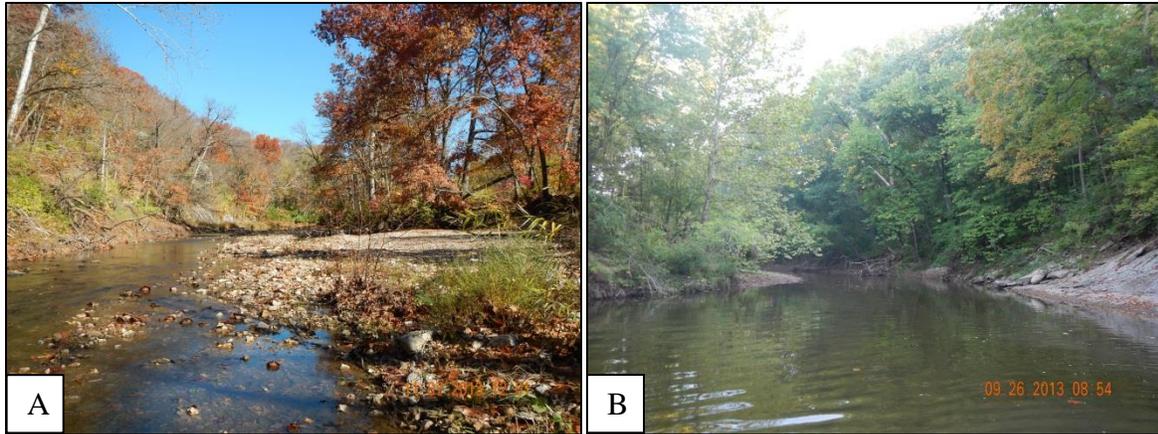
**Figure 57.** A. Looking upstream approximately 2 km downstream of E. Broadway St. in Columbia, with bedrock on the right descending bank, 11-07-2013, 12:01 (lat. 38.944068, long. -92.309618). B. Approximately 0.8 km upstream of Stadium Blvd. in Columbia, with bedrock on the left descending bank, 09-26-2013, 08:54 (lat. 38.935558, long. -92.308967).

Between E. Walnut Street (Hominy Branch tributary catchment) and the area just below the confluence with Grindstone Creek (Grindstone Creek tributary catchment), there are a number of bedrock constraints along Hinkson Creek which seem to mitigate the effects of land-use on some characteristics of in-stream physical habitat (Figures 57 and 58). The relative stability of some stream metrics in this section of Hinkson Creek may be attributable to the stabilizing effects of bedrock on the stream channel.
