**A STREAM PHYSICAL HABITAT ASSESSMENT  
IN AN URBANIZING WATERSHED OF  
THE CENTRAL U.S.A.**

A Thesis presented to the  
Faculty of the Graduate  
School at the University of  
Missouri-Columbia

JULY 2015

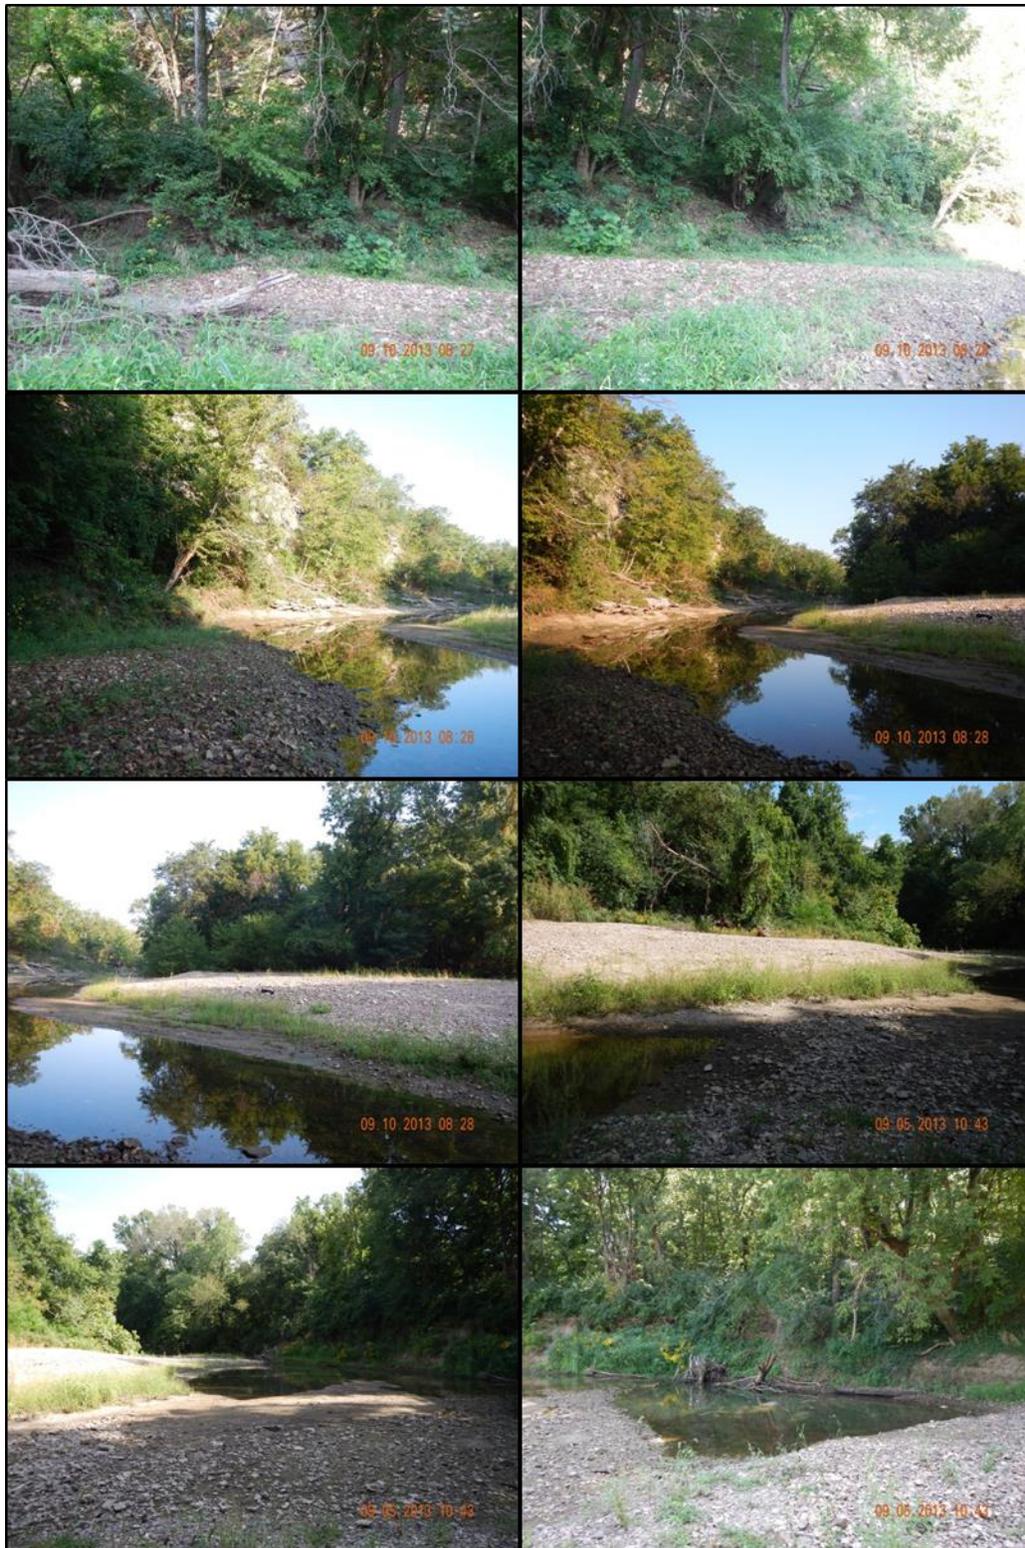
**Figure 59.** A panorama of the confluence of Grindstone Creek and Hinkson Creek beginning at left descending bank of Grindstone Creek and ending with the view upstream in Grindstone Creek, 09-05-2013, 10:43 and 09-10-13, 08:28 (lat. 38.927533, long. - 92.321808).

The confluence of Grindstone Creek and Hinkson Creek is an impressive expanse measuring almost 50 m across at the widest point on Hinkson Creek upstream of the confluence. A bedrock cliff forms the left descending streambank downstream of the confluence, and the bedrock continues across the stream as the substrate in some areas near the confluence (Figure 59). The biodiversity observed at this confluence placed it among one of the “hotspots of biodiversity” along Hinkson Creek. During the initial survey of this area in September of 2013, the field team observed signs of deer and raccoon, hundreds of tadpoles and minnows, as well as bullfrogs, American toads, and numerous plant species in bloom.

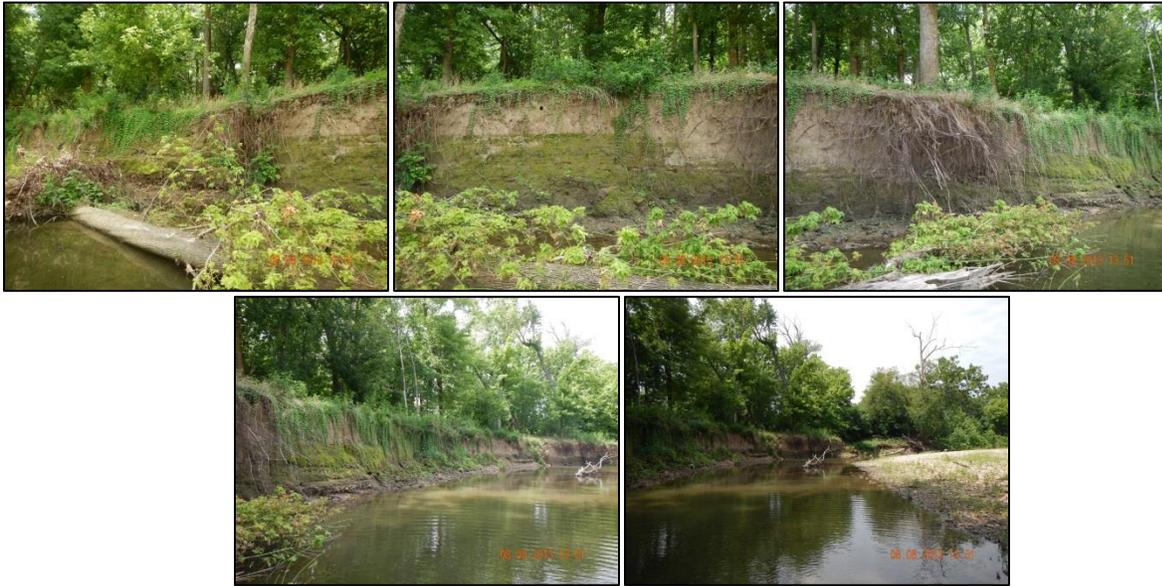
**Figure 60.** Photographs showing the extent of bank erosion of left descending bank around bend in Hinkson Creek approximately 3.4 km downstream of the Grindstone confluence, 08-08-2013, 13:51 (lat. 38.923943, long. -92.3269).

Although the photographic database contains many examples streambank erosion in Hinkson Creek, the photographs in Figure 60 are distinct in several ways. The bankfull width at the bend in these photographs is among the widest along the entire length of Hinkson Creek (maximum 74 m). At this point in the stream, the cumulative land-use effects include upstream rural land-use, some urban land-use runoff from urban development in the city of Columbia, some drainage from the University of Missouri – Columbia campus, and influx from the confluence of Hinkson Creek with Grindstone Creek approximately 3.4 km upstream. The bankfull width at this point in the stream is 64 m, and the cumulative drainage area is approximately 177.5 km<sup>2</sup>. An aerial view of this bend (Google Earth) is shown in Figure 61.

This bend of Hinkson Creek is not bedrock constrained, and there are no natural or manmade barriers to prevent the stream from continuing to widen at the bend as high flow velocities (shear stress) carve out the left descending stream bank and deposition on the point bar on the right bank continues.

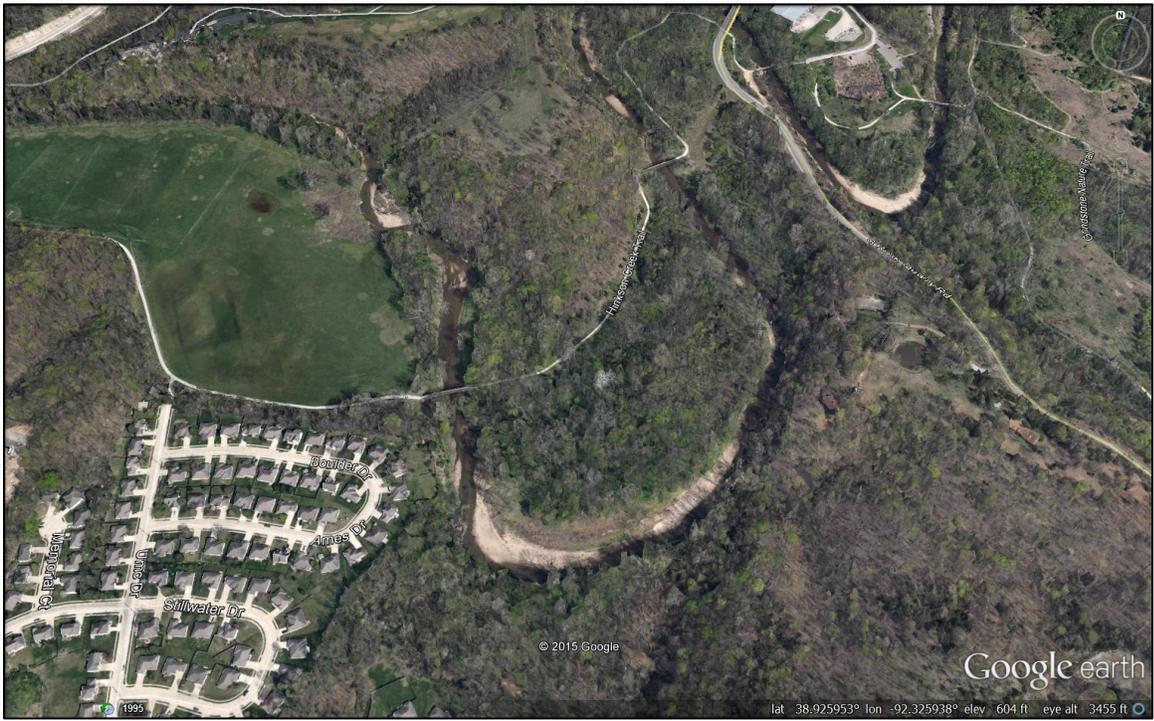
**Figure 61.** A wide bend in Hinkson Creek located 3 km upstream of Providence Road and 3.4 km downstream of the confluence with Grindstone Creek in Columbia, Missouri.

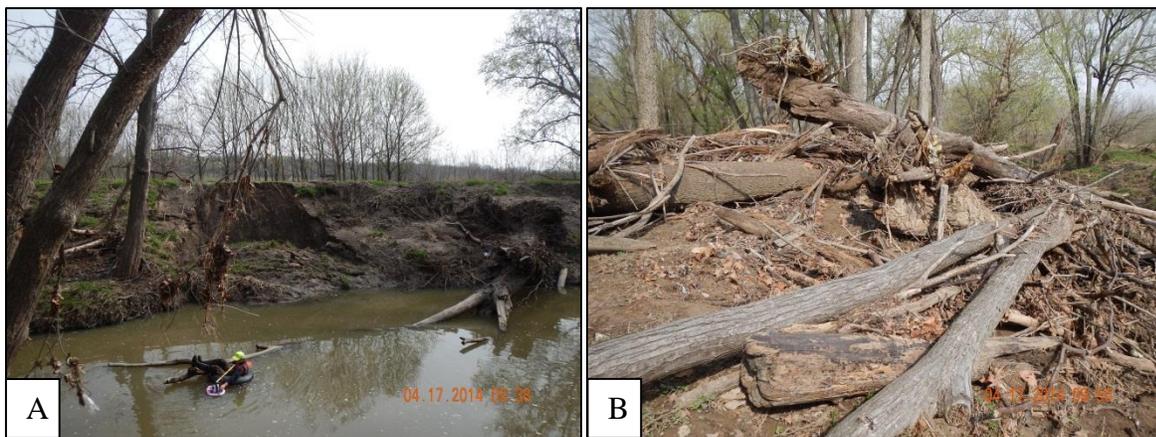
**Figure 62.** A. A view of the mass wasting on the right descending bank just downstream of Forum Nature Area in Columbia, 04-17-2014, 09:38 (lat. 38.922188, long. - 92.377815). B. A large woody debris pile on the left descending bank 20 m upstream from the bank failure in photograph A, 04-17-2014, 09:50 (lat. 38.921907, long. - 92.377642).

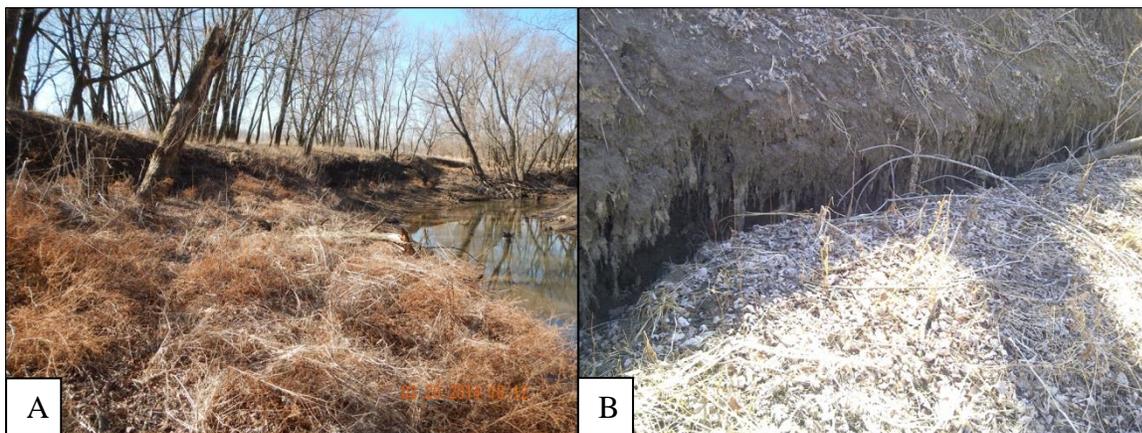
**Figure 64.** A. Looking downstream approximately 1 km upstream of the mouth of Hinkson Creek, 03-20-2014, 10:12 (lat. 38.9181, long. -92.408655). B. A crack at the top of the slumping bank shown in photograph A.

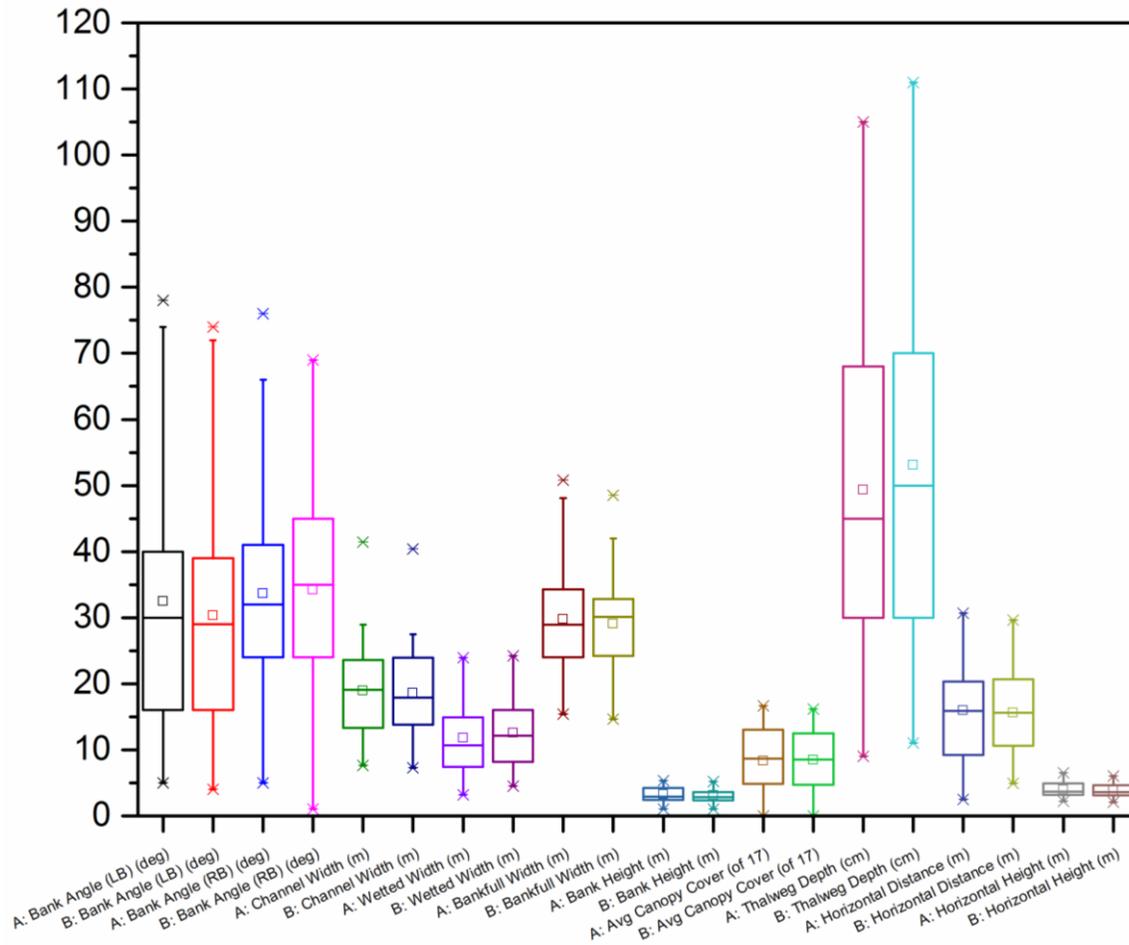
**Figure 65.** Box and whisker plot of comparison of initial survey metric (A) and resurveyed metric (B) at resurvey points of various measurements taken during PHA of Hinkson Creek.

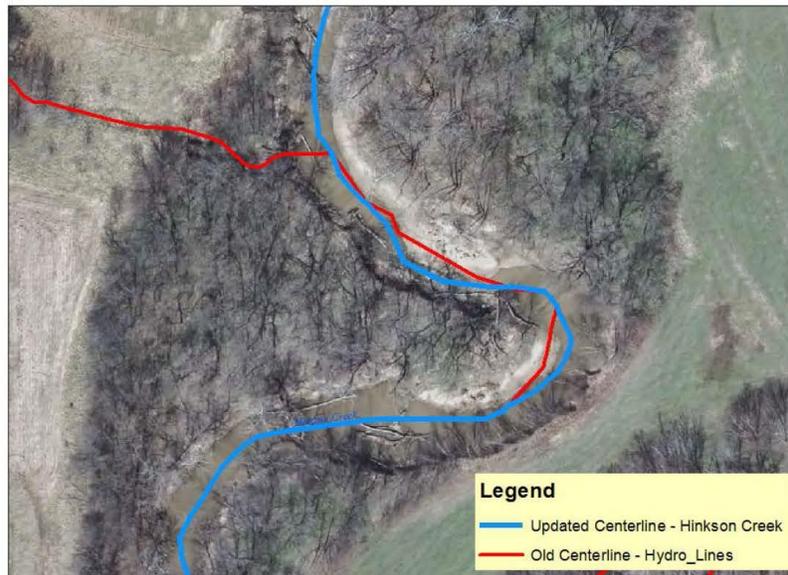
Figure 2. The centerline for Hinkson Creek was updated (blue) in places where old line work (red) did not reflect stream conditions in 2011.

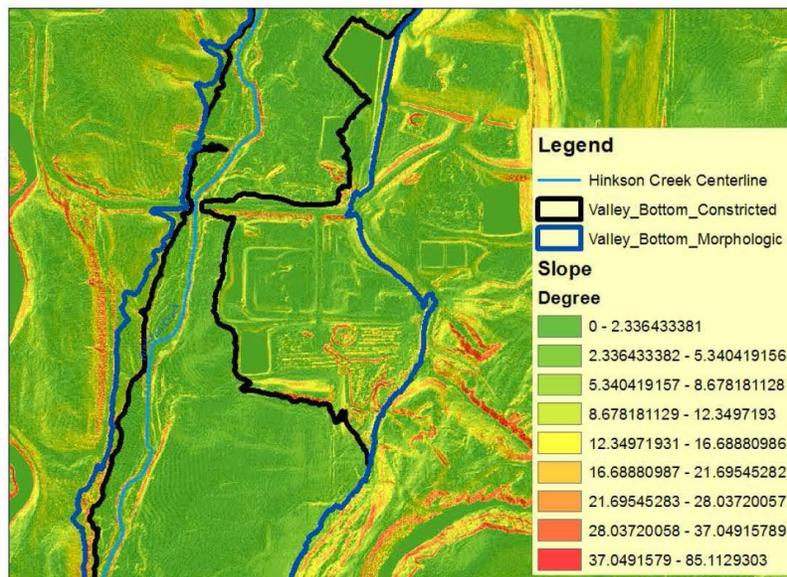
Figure 4. Location within the valley where constricted (black) valley is narrowed due to levee and road build. Morphological valley (blue) is considerably wider in some areas.

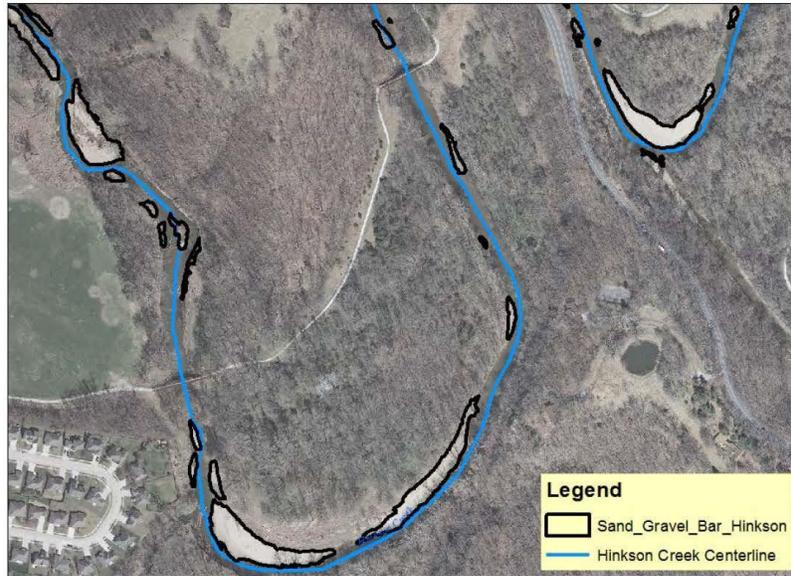
Figure 7. Sand and gravel bars were identified based on 2011 6" true color leaf-off imagery.

Sand and gravel bars within Hinkson Creek channel were delineated based on 2011 6 inch 3-band true color leaf off aerial photography, provided by Boone County (Figure 7). Image objects were generated based on the 2011 photography using Ecognition software. Due to file size restrictions, the imagery was divided into seven tiles and image objects/polygons were generated based on the textural and tonal homogeneity of the imagery. The image object tiles were merged into a single file for sand and gravel bar delineation. Polygons that circumscribed sand or gravel bars were manually selected and modified, at a scale of 1:1000, as needed by scanning the entire length of Hinkson Creek from the confluence to the headwaters. No distinction between sand versus gravel bars was possible due to limitations of the imagery. Accordingly, the resultant dataset is a record of sand or gravel bars that existed in the spring of 2011.

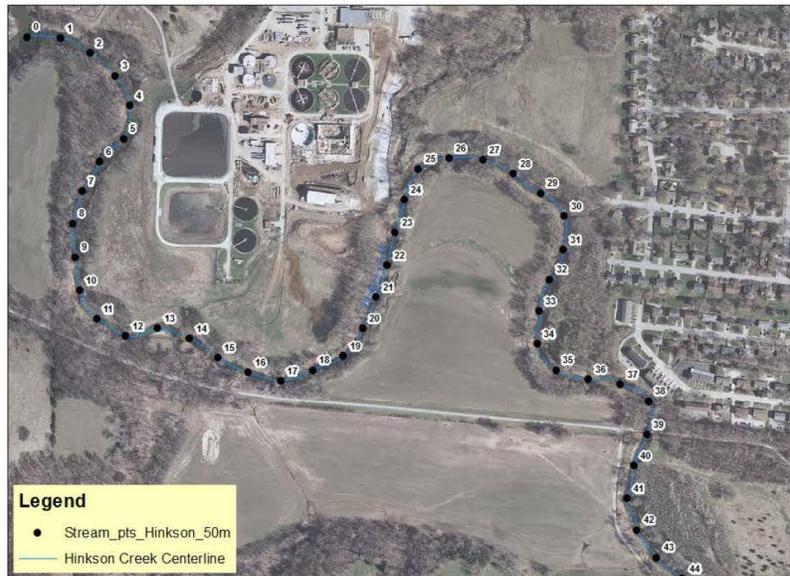
Figure 12. Shown are points at 50 meter intervals along the Hinkson Creek centerline, beginning at the confluence with Perched Creek, used to apply attributes of physical information (i.e. slope, sinuosity, bankfull width, valley width, etc.) to a specific point within the stream.

Points were generated along the Hinkson Creek centerline at various intervals to assist in selection of stream sampling locations and to apply physical attributes of the stream at given centerline intervals, so that field data could be compared to GIS data (Figure 12). Attributes applied to the points were % slope, sinuosity, bankfull width, morphological and constricted valley width, and distance to valley wall. Points were created at intervals of 50, 100, 250, 500, 1000, 2000, and 4000 meters. All points at an interval greater than 50 meters were based on the 50 meter points. Physical stream attributes at multiple scales allow fine and broad scale views of the stream. The unique identification number for each set of points begins at 0 at the confluence of Perche and Hinkson Creeks and increases chronological upstream to the headwaters.

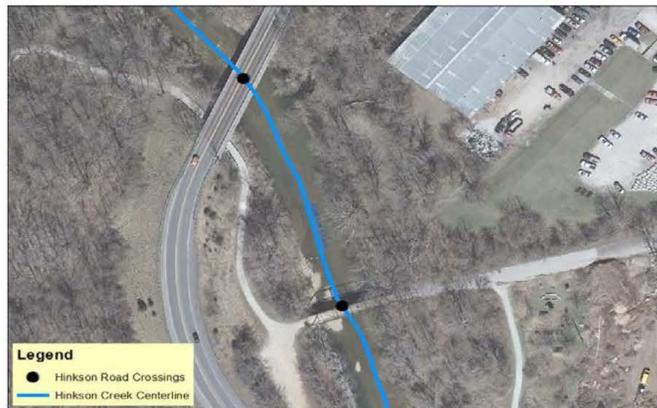
Figure 22. A point file of road crossings was manually created by marking any road, bridge, trail, or low water crossing along the stream centerline visible in Spring 2011.

A point file was created indicating where roads, bridges, trails, cart paths, etc. cross Hinkson Creek (Figure 16). A point was manually placed on the stream centerline at the location of a stream crossing based on visual inspection of the 2011 6" leaf off imagery provided by Boone County at a scale of 1:1000.

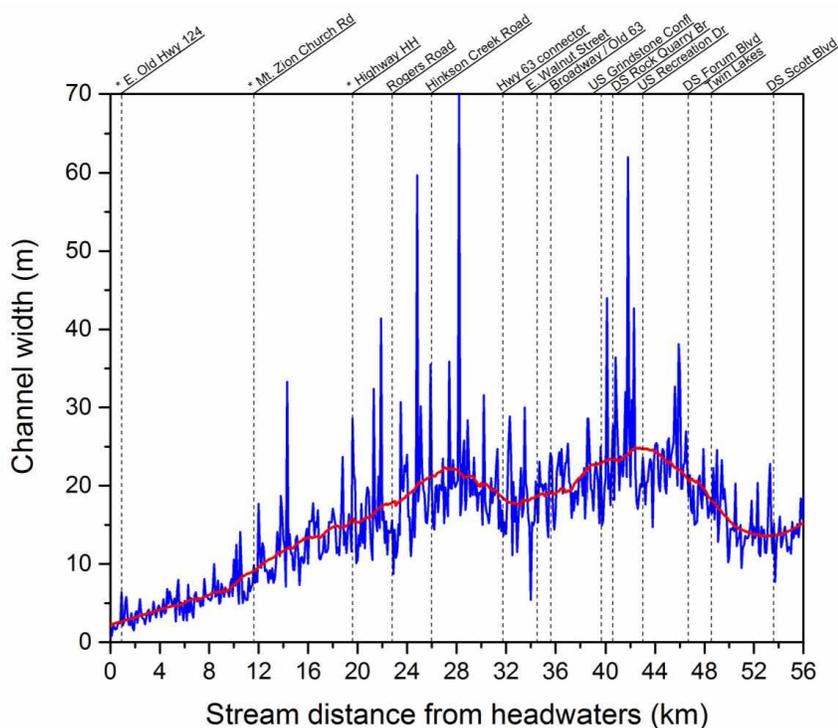
Figure 5. Channel width as a function of stream distance from the headwaters for the entire length of Hinkson Creek. 100pt moving average in red.
