OVERCOMING THE CHALLENGES OF USING UNMANNED AIRCRAFT FOR
BRIDGE INSPECTIONS

A THESIS IN
Mechanical Engineering

MASTER OF SCIENCE

by
IGNACIO HERNANDEZ

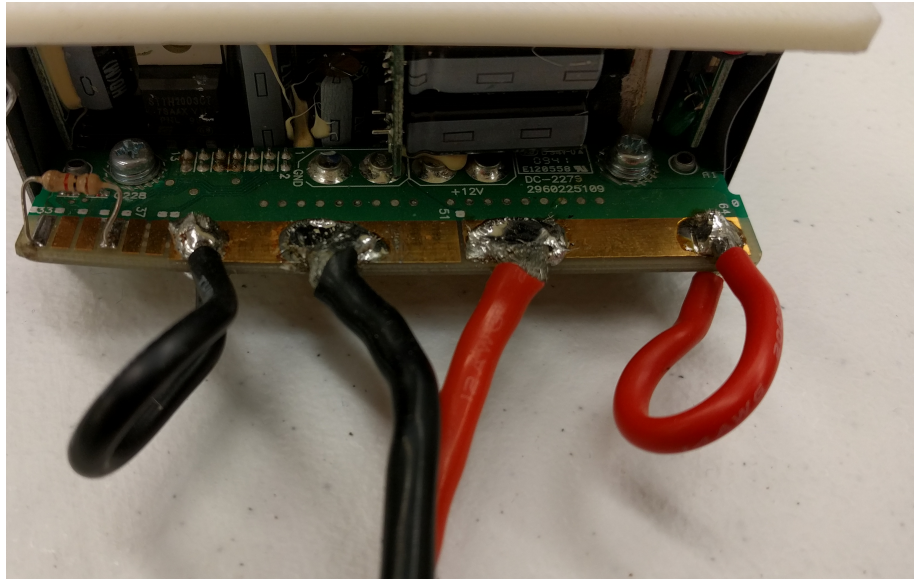
The power supply used to provide continuous power to the vehicle was selected based on the powering needs of the selected aircraft platform and hardware. The power converter was developed using an HP Switching Power Supply model DPS-1200FB A. The power supply is rated for an input voltage of 110-120VAC and 200-240VAC and an input current of 10A and 7.8A, respectively. With an input of 110-120VAC and 200-240VAC the power supply can output 12.0 VDC and a maximum current of 75A and 100A, respectively. The power supply is intended for use in computer server systems. To use as a lone power supply the effects of being connected to a server needed to be mimicked. By installing a 330 to 1000 Ω resistor between two of the terminals [41]. A 1000 Ω resistor was soldered between the terminals labeled 33 and 36 (Figure 1).

Figure 1: Server connections of HP DPS-1200FB-A switching power supply

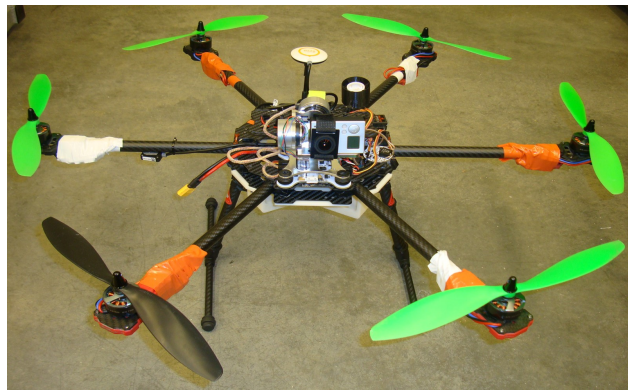
The second generation UAS prototype was built upon the Turnigy S1000 hex-copter frame (Figure 2). The aircraft was intended to also carry the same power supply, camera, LED light, tether, and power backup system from the first generation. Based on the failure of the power converter in the first generation prototype phase testing was conducted to ensure that the aircraft was capable of takeoff with all necessary hardware

Figure 2: Second generation UAS prototype

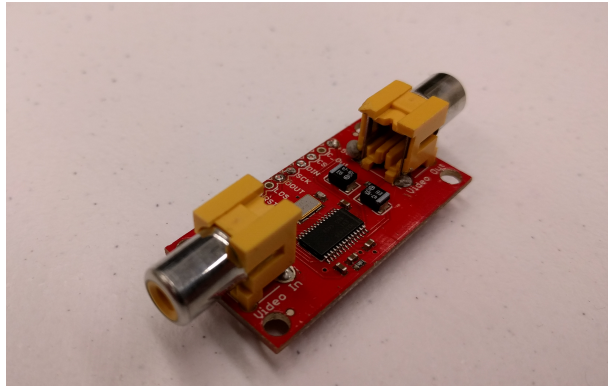
The OSD system overlays text over video transmitted to the grounded pilot and inspector. Since the same video feed to the ground monitor and goggles is used, it is convenient for both monitoring devices to have overlay sensor measurements. Both the voltage and distance measurements were monitored by an Arduino microcontroller. The microcontroller allows for simple integration of OSD hardware. For the OSD system, a Sparkfun MAX7456 breakout board was used (Figure 4). The breakout board consisted of two video connections, one for receiving and the other for transmitting. The received video was taken directly from the onboard video camera (GoPro Hero 3+). The breakout board was programmed to overlay certain information received from the microcontroller. Sensor information was then overlaid onto the live video feed and transmitted to the

Figure 4: SparkFun MAX7456 Breakout Board

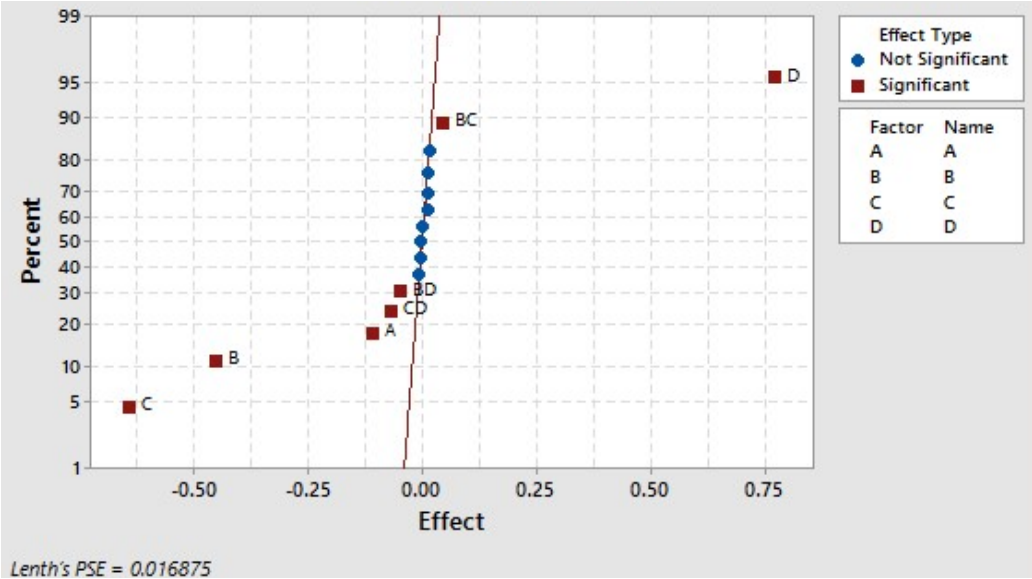
The statistics package Minitab was used to perform an analysis of variance (ANOVA) of the collected lift results for each factor combination to identify variations among generated lift. Before performing an ANOVA the test model was examined to identify the effect of the four different factors on the response (lift). The effect of a factor is the change in lift resulting from a change in the level of a factor. Analysis of a normal probability plot of these effects is required. Figure 5 shows both negligible and large effects. The negligible effects lie along the line of best fit while the large effects lie far away from the line. From the normal plot it is seen that main effects of A, B, C, and D along with interactions BC, BD, CD are significant effects. Another option in determining the significant effects comes from the Pareto chart shown in Figure 8. Based on the Pareto chart, effects of A, B, C, D, BC, BD, and CD are deemed significant. This is determined by the point of demarcation (0.0434) between significant and non-significant effects.

Figure 5: Normal plot of the effects

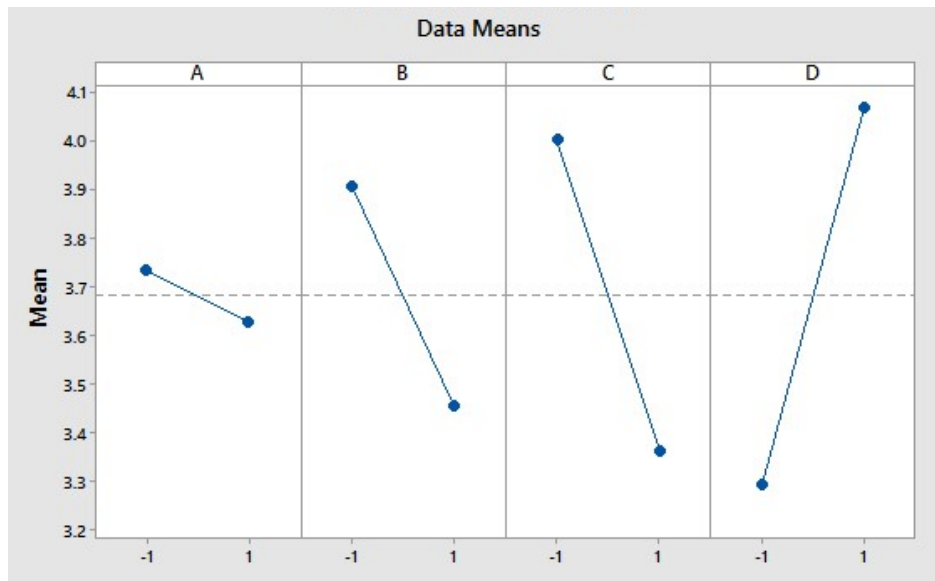
The main effects of A, B, C, and D are plotted in Figure 6. Effects of factors A, B, and C are negative indicating that to generate maximum lift, factors A, B, and C should be ran at low levels (11 in ABS props with DPS 1200 power supply). Main effect D is positive indicating that to generate maximum lift factor D should be ran at the high level (810 kv motors). Apart from effects it is necessary to examine important interactions. The BD, CD, and BC interactions from the normal plot are plotted in Figure 7. The BC interaction plot shows that the low level propeller size has greater effect on lift with the low level power supply. The BD interaction plot shows that the low level propeller size has greater effect on lift with the high level motor. The CD interaction plot shows that the low level power supply has greater effect on lift with the high level motor. Therefore, maximum lift is achieved when A, B, and C are at the low level and D is at the high level.

Figure 6: Main effects plot for lift

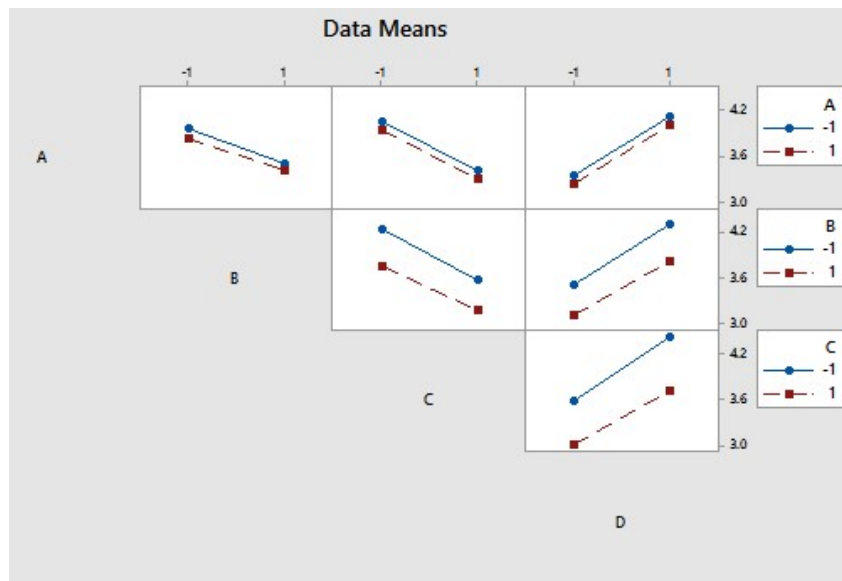
Figure 7: Interaction plot for lift

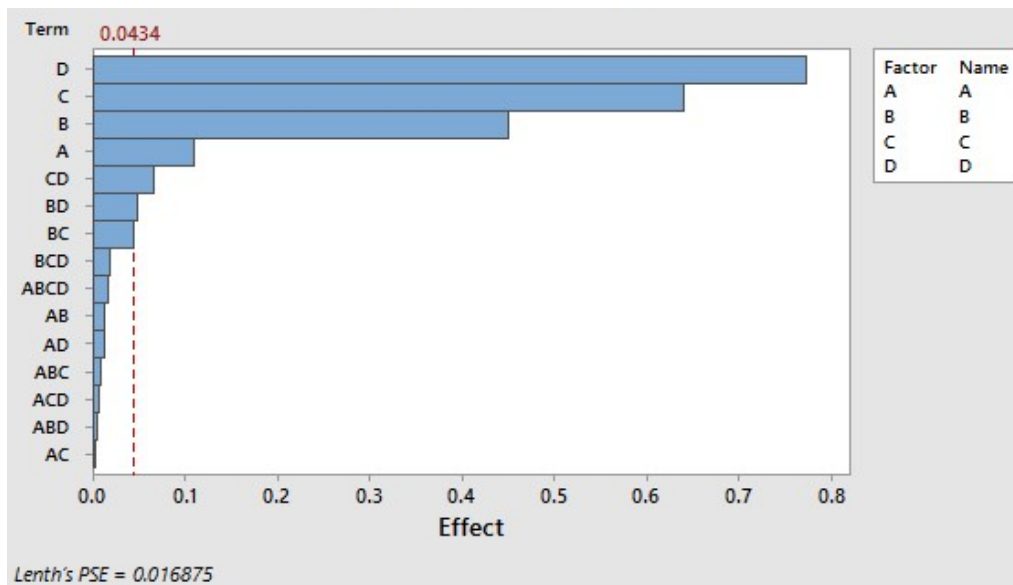
Figure 8: Pareto chart of the effects

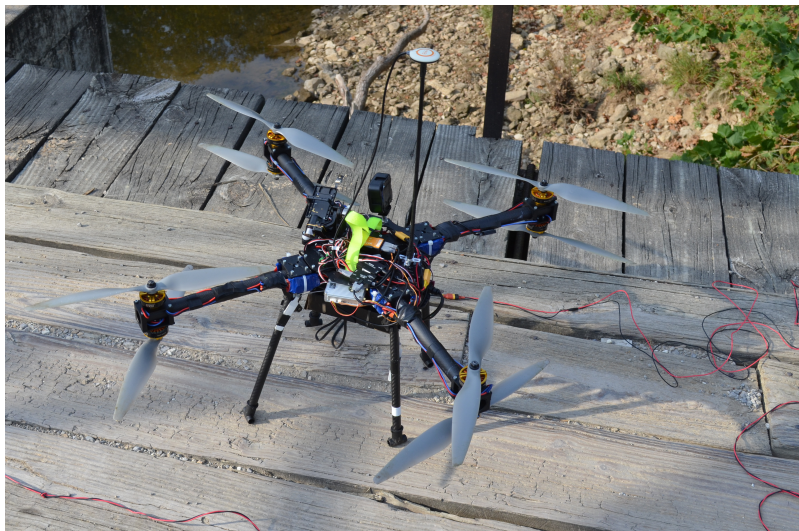
Flight stabilization is performed with the same DJI Naza m v2 autopilot. The gimbal and flight control commands are combined and transmitted over a wireless telemetry link (DJI Lightbridge™). Additionally, the telemetry link also transmits the onboard high-definition (HD) video to the operator(s). The camera platform consists of a 3-axis stabilization gimbal (DJI Zenmuse™) and a HD camera (GoPro Hero4™) mounted on top of the aircraft frame. Finally, the video data is viewed from both HD goggles (Cine-mizer) and on a high resolution computer monitor (ASUS).

Figure 9: Fully equipped Octocopter

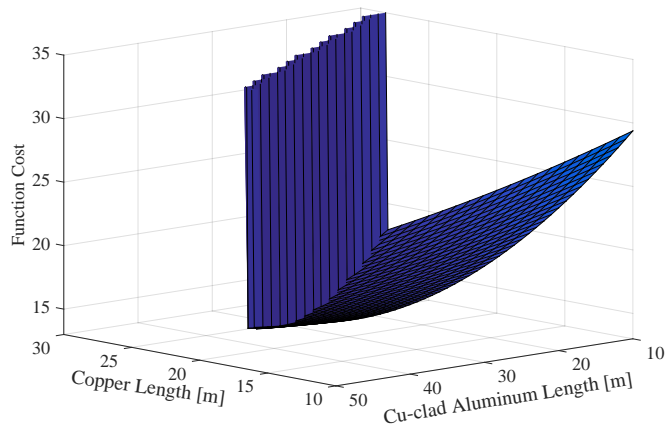
Based on available payload the maximum tether weight was not to exceed 1.5 kg (3.3 lb) and minimum power supply input voltage was set to 190VAC (per manufacturer supplied data). The penalty function was set to 100 for each constraint violated to ensure clear violation of the design constraints. The input variables of the multivariate optimization were copper-coated aluminum wire diameter and length, and copper wire diameter and length. Due to the relative simplicity of the equations, direct parameter space investigation was conducted. A representative surface plot for the relationship between the cost function and the two wire lengths is shown in Figure 11. For this surface the copper-coated aluminum wire has a diameter of 1.291 mm (0.0508 in.) and the copper wire also has a diameter of 1.291 mm. Within the constraints identified, a tether length of 55 m (180 ft.) was achieved. The final tether consists of 22 m of 16 AWG copper and 33 m of 16 AWG copper-coated aluminum wire.

Figure 11: Cost function results for copper (16 AWG) and copper-clad aluminum (16 AWG) wire.

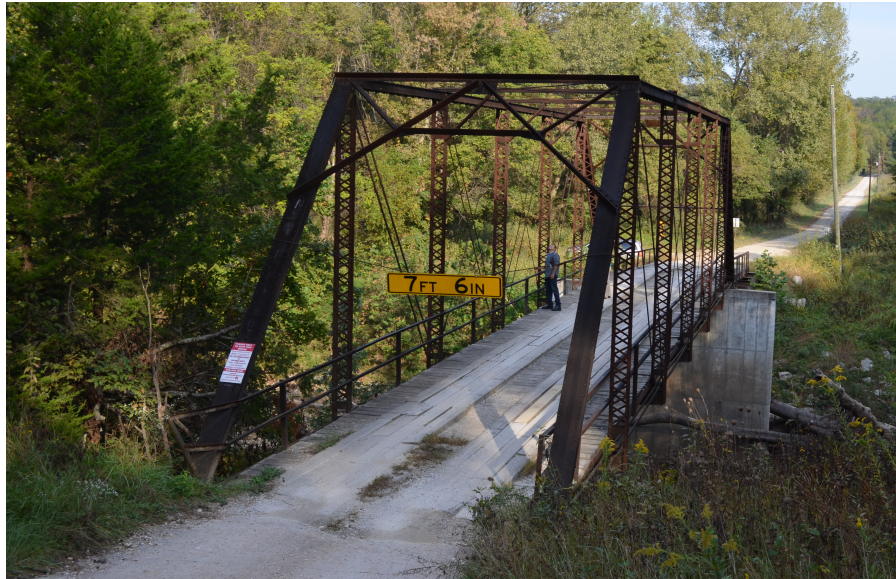
Figure 12: Fracture-critical, structurally deficient Boone County bridge.

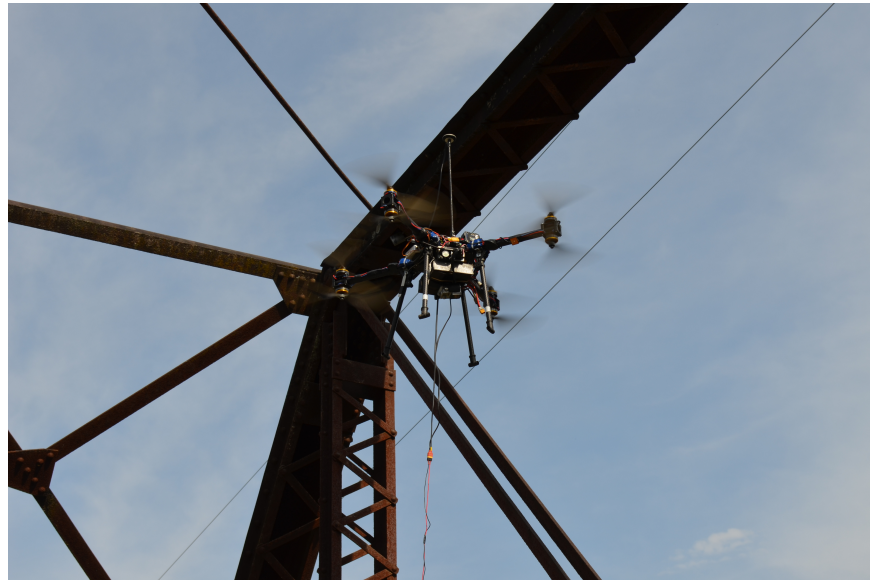
vehicle stable at close proximity to the bridge. Even though the truss structure presented some obstacles the pilot was able to maneuver around the complex structure and avoid contact with the structure (Figure 13). Overall, the bridge inspectors were extremely satisfied with the clarity and sharpness of the video transmitted to the goggles and ground monitor particularly, when underneath the deck. An example of the onboard recorded

Figure 13: Tethered aircraft during superstructure inspection.

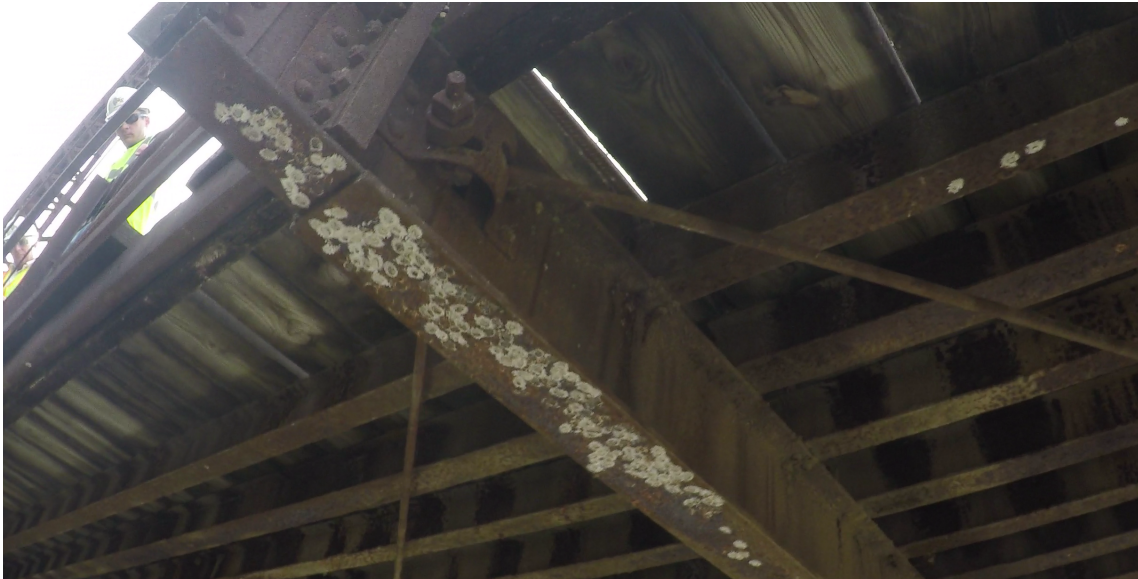
video collected during substructure inspection is shown in Figure 14. The screen capture highlights the clarity of the imagery captured by the aircraft, providing confidence in the inspector conclusions from the video data. From the collected video data, inspectors were able to determine that the substructure is in “better-than-expected” condition.

Figure 14: Camera footage from tethered aircraft during substructure inspection.

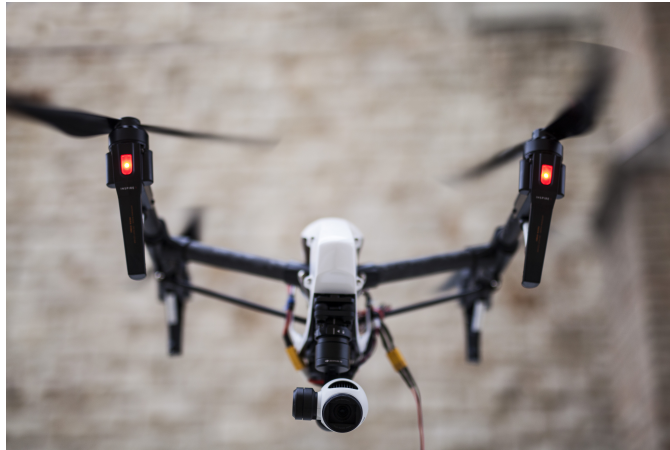
The flight system gives the option of operating in its Dual Remote Controllers Mode. The “Master” controller controls aircraft flight while the “Slave” controller controls gimbal movement and camera parameters. The dual controller mode no longer limits inspector and pilot mobility as experienced with the third generation aircraft. The remote control system used in the third generation required pilot and inspector to always be within

Figure 15: Commercial-off-the-shelf DJI Inspire 1 aircraft during hovering flight operations.

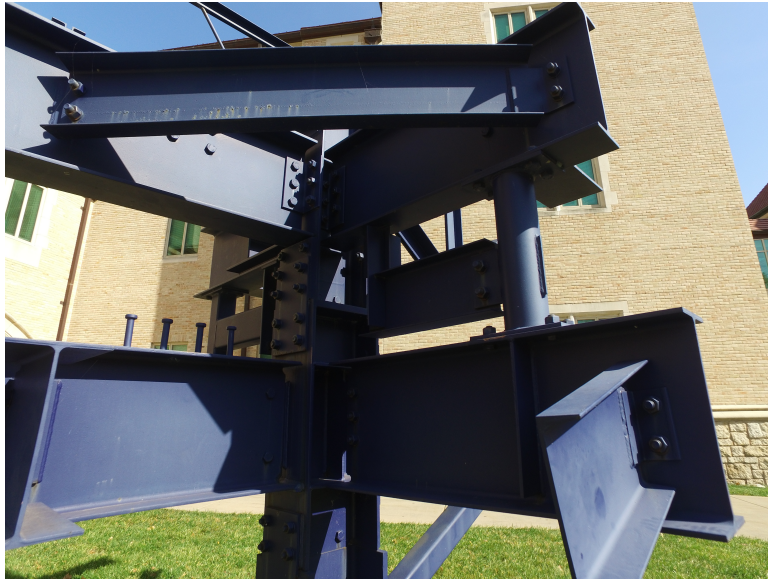
Figure 16: Steel construction with manual underexposure.

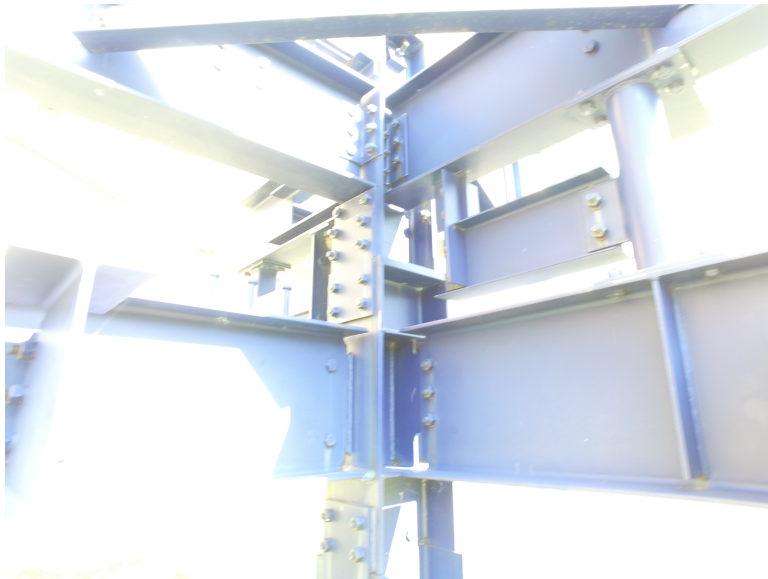
Figure 17: Steel construction with manual overexposure.

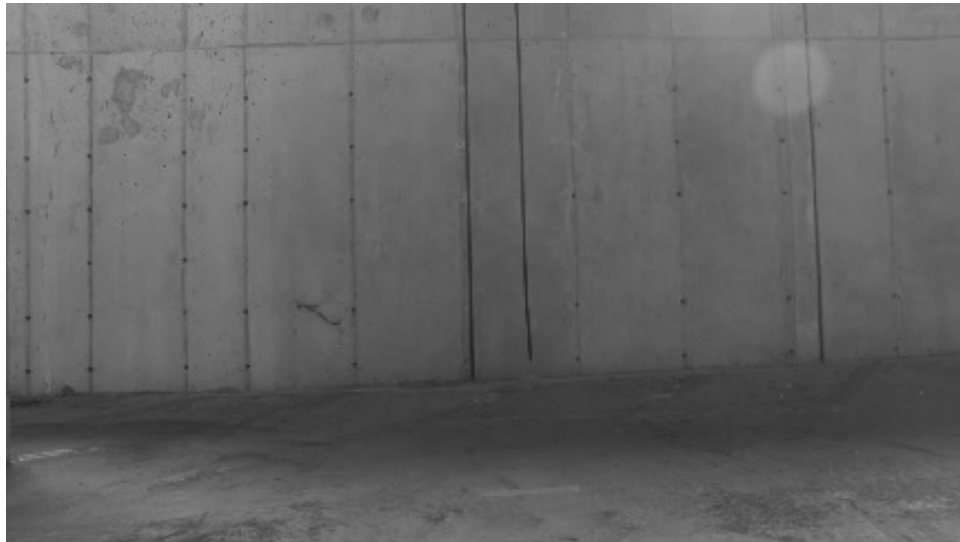
the aircraft needs to fly vertically while maintaining a constant horizontal position in order to avoid hitting neighboring steel supports. To assess the aircraft's ability to maintain constant vertical and horizontal positioning, the strip's midpoint relative to the camera's midpoint was measured. The video processing software arranges pixels in an x-y grid as shown in Figure 21. During horizontal flight the strip's y midpoint coordinates are expected to remain fairly constant. During vertical flight the strip's x midpoint coordinates are expected to remain relatively constant.

Figure 19: Vertical 28 cm strip used for flight quality testing.

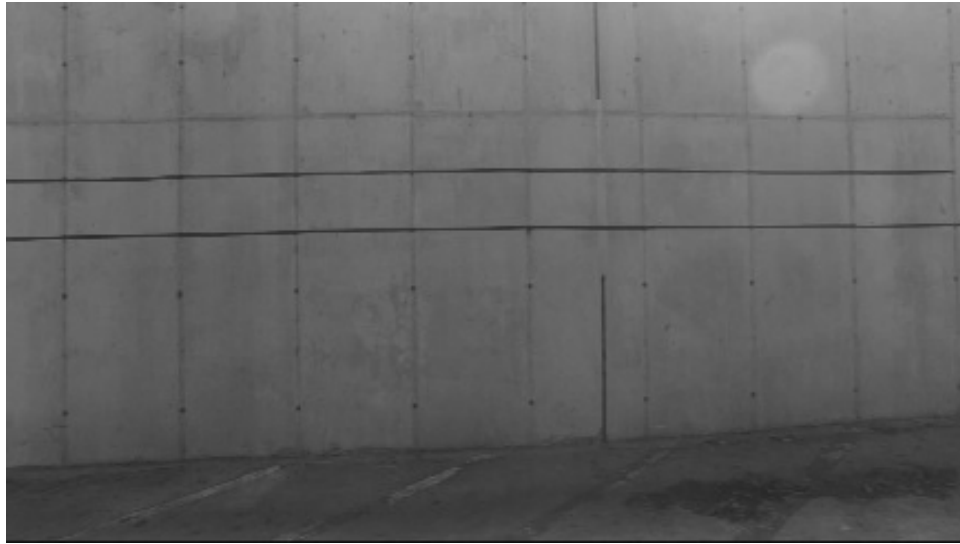
Figure 20: Horizontal 28 cm strip used for flight quality testing.

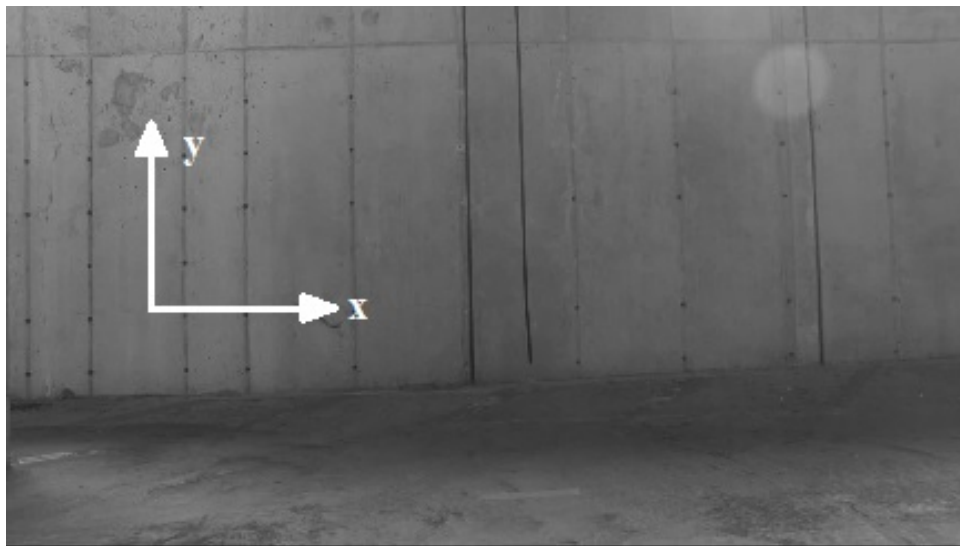
Figure 21: Horizontal 28 cm strip used for flight quality testing.

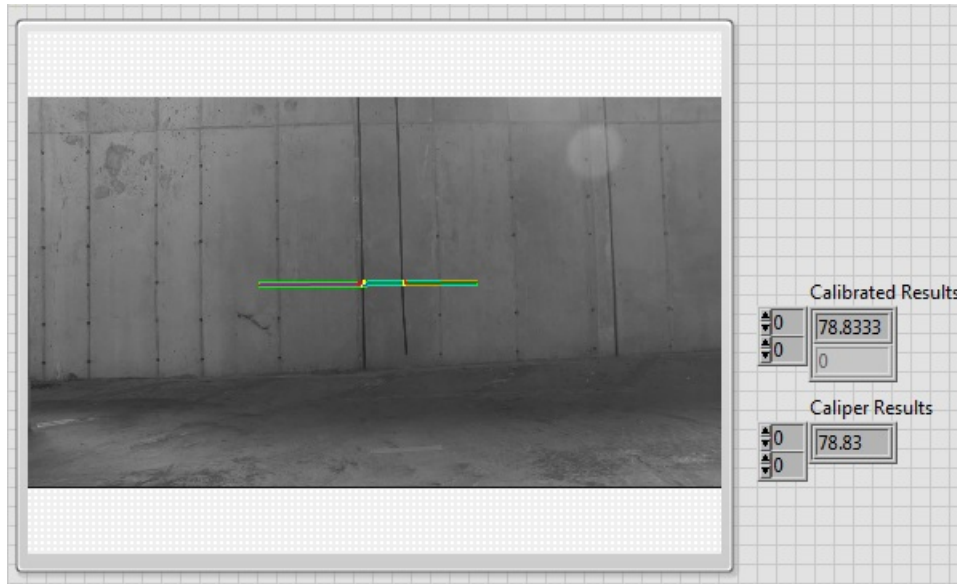
Post-flight image processing was completed using LabVIEW's Vision Assistant Virtual Instrument (VI). The VI was used to process video taken during Cooper-Harper scale testing. Video data was converted to grayscale permitting distinction between the strands of electric tap and the surrounding wall. The Vision Assistant (Figure 22) was used to calculate the strip's centroid relative to the camera's 960 x 650 pixel screen. The Vision Assistant was also used to monitor strip pixel width. Any deviation from the calibrated line was indicative of deviation from the predetermined distance set forth prior to flight testing and could indicate a lack of safe flight stability.

Figure 22: LabVIEW Vision Assistant screen shot.

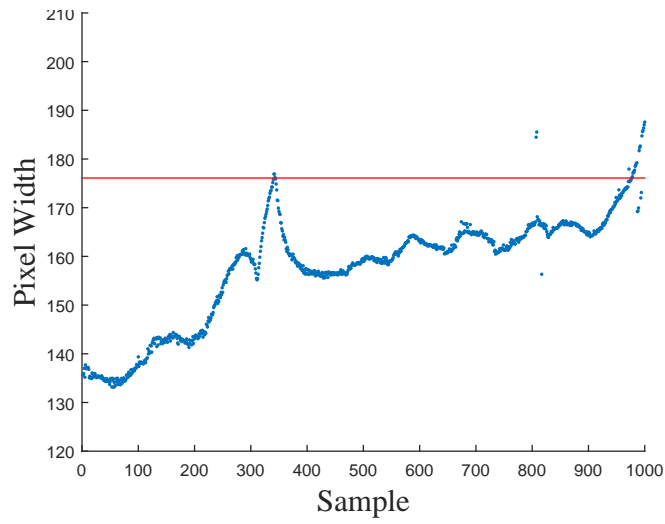
Figure 23: Vertical strip pixel width at 1.5 m: Trial 1.

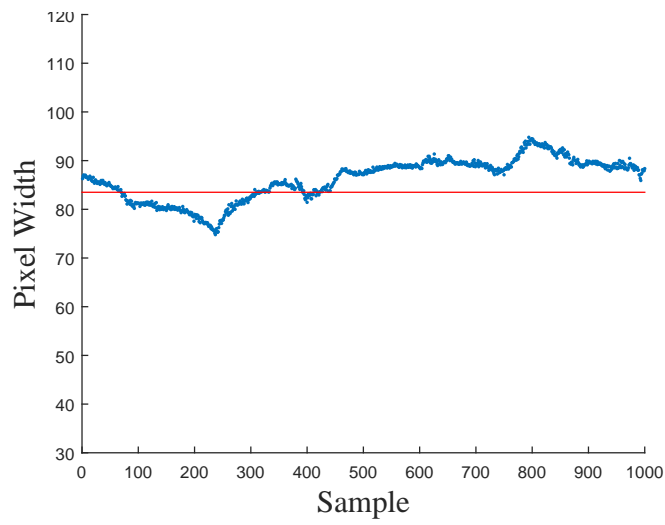
Figure 24: Vertical strip pixel width at 3.0 m: Trial 1.

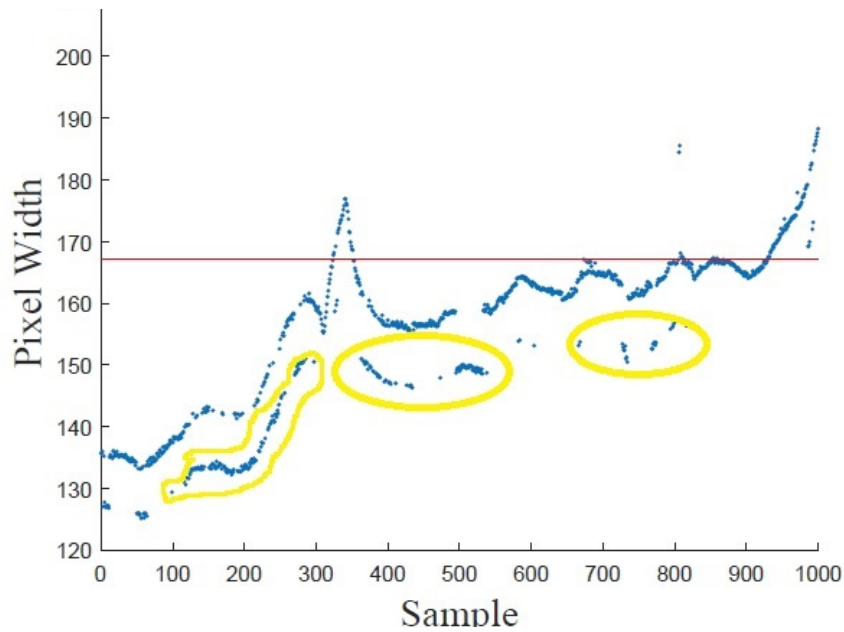
Figure 25: Pixel width data inconsistencies.

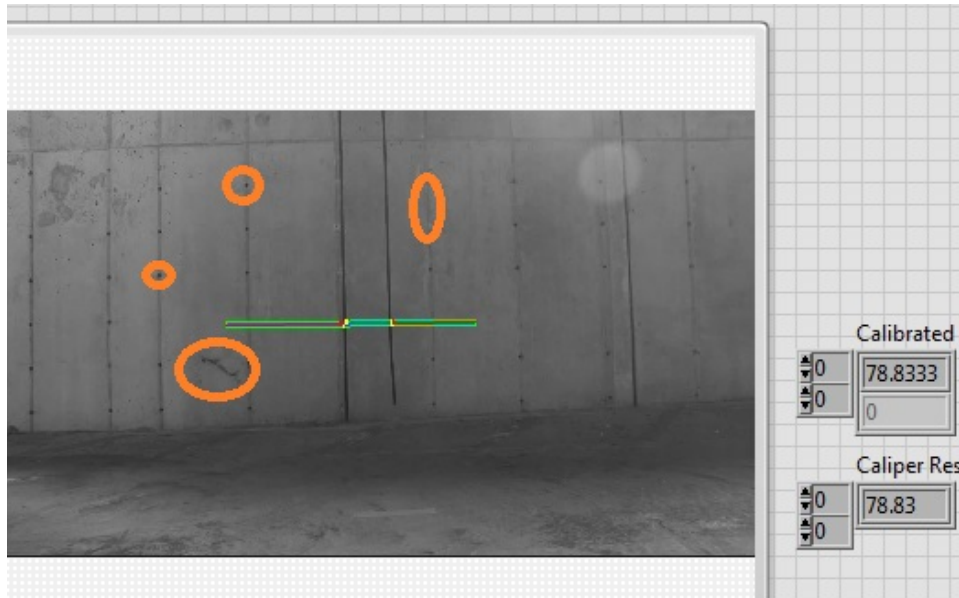
software unable to distinguish the two strips of tape in the flight video. Due to differences in lighting, wall imperfections such as dirt and debris as highlighted in Figure 26, the Vision Assistant had trouble properly identifying the strands of tape used to make the 28 cm strip. As a result, the Vision Assistant would over-measure the strip pixel width. Adjustments were made through the software to not pickup inconsistencies and although not all imperfections could be eliminated the most accurate configuration was achieved. All flight pixel width data was adjusted in order to eliminate the occasional “jumps” and converted from pixels to distance (m) using the baseline measurements from Table 7 and are presented in Appendix A. As can be seen in Figure 25 the inconsistencies follow the same pattern as the surrounding data and experiences similar shifts. Adjustments were made by either increasing or decreasing the data “jumps” along the pixel width axis so as to align it with the rest of the data. The adjusted data was used in calculations of mean and standard deviation. Data was converted from pixel width to distance in order to provide ease of visualization as to how far the aircraft was drifting from its intended target.

Figure 26: Parking structure wall imperfections.

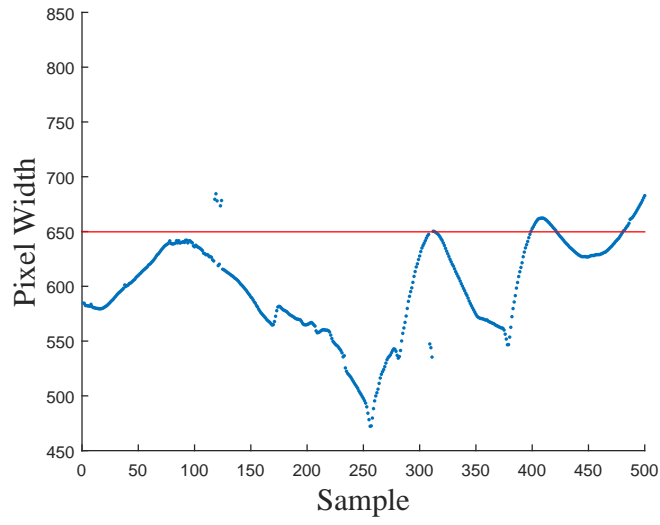
Figures 27 and 28 are representative results of the mid point deviation pixel data of the vertical flight test at a distance of 1.5 m and 3 m, respectively. In each plot a red marker is used to indicate the average pixel y coordinate. As with Figures 23 and 24 there is a noticeable deviation away from the average pixel coordinate when flying at a distance of 1.5 m. Figures 27 and 28 further support the intuitive notion that maintaining steady flight is harder to achieve at closer flying distances. Tables 12 and 13 show the average mid point deviation and standard deviation for each trail at each of the two distances. The pilot was able to complete the task although with significant deviations when flying at 1.5 m. There exists a stark difference between standard deviations for horizontal and vertical flight regardless of flight distance; standard deviations are higher for vertical flight signifying that the aircraft encountered significant sideways motion as it descended and

Figure 27: Vertical strip midpoint deviation at 1.5 m: Trial 1.

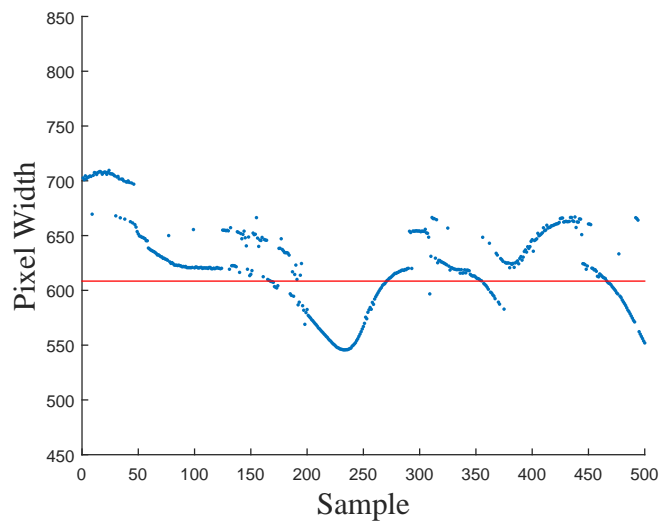
Figure 28: Vertical strip midpoint deviation at 3.0 m: Trial 1.

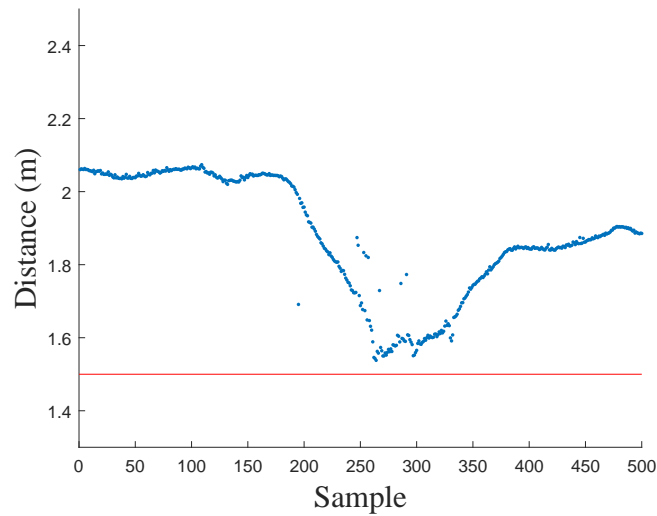
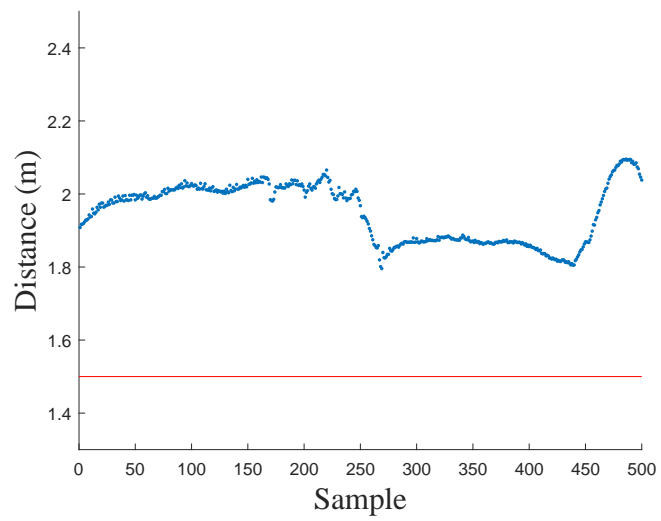
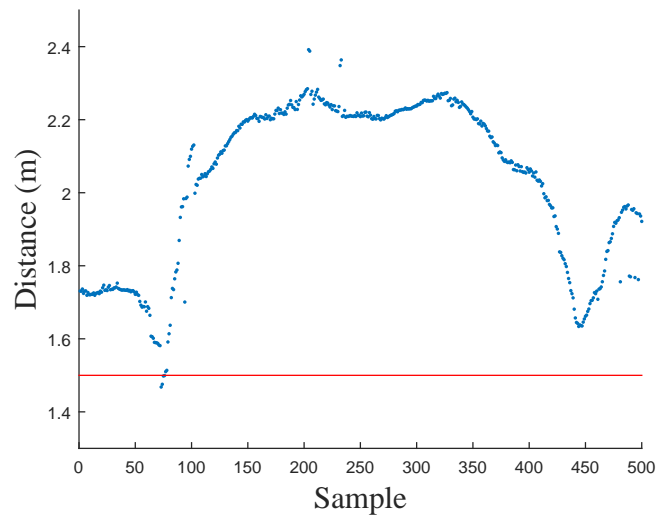
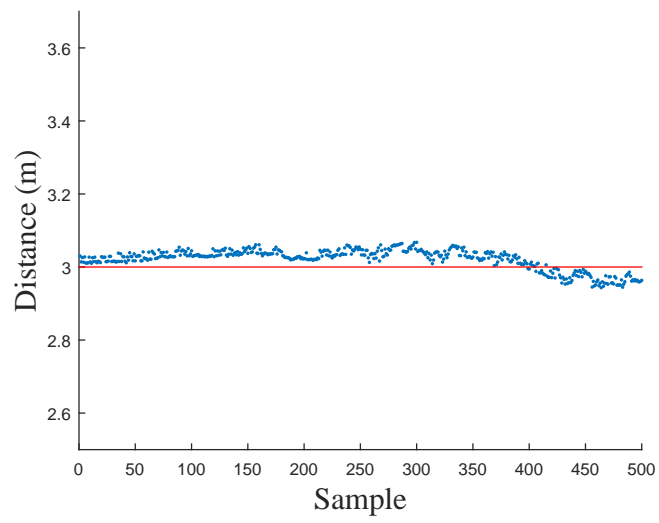
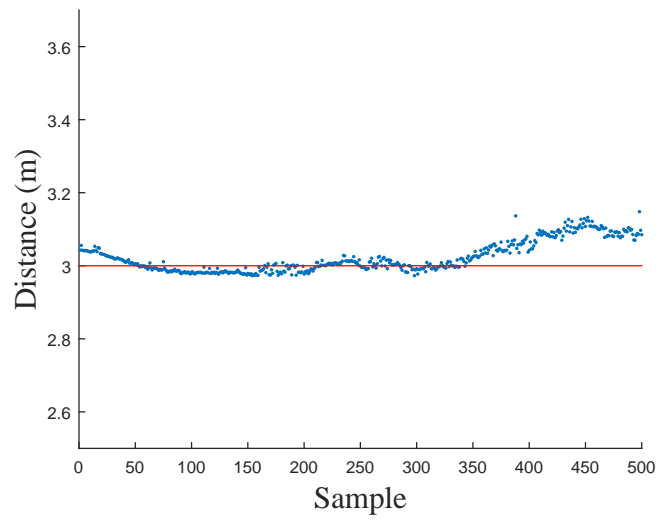
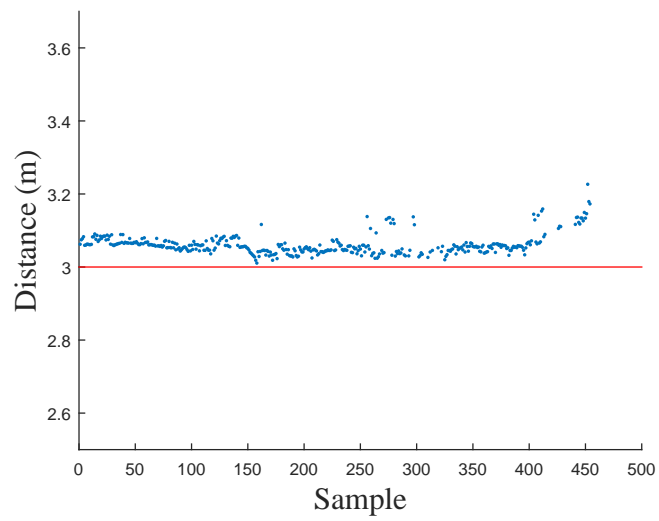
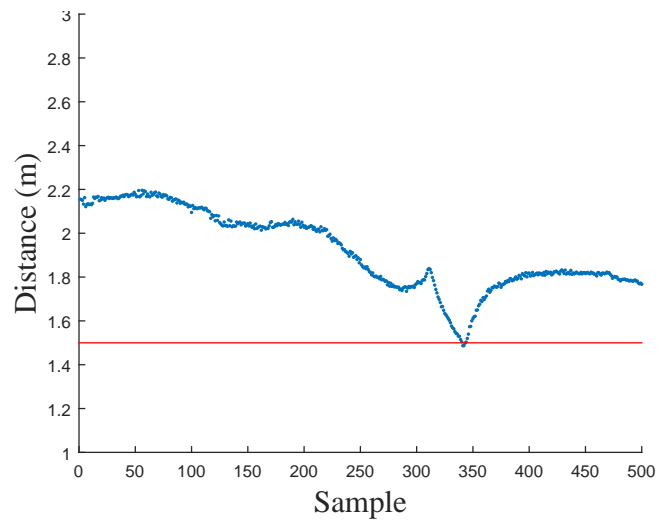
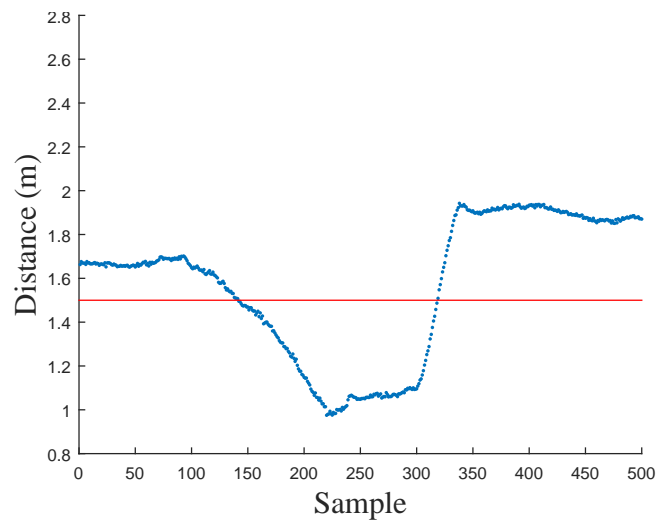
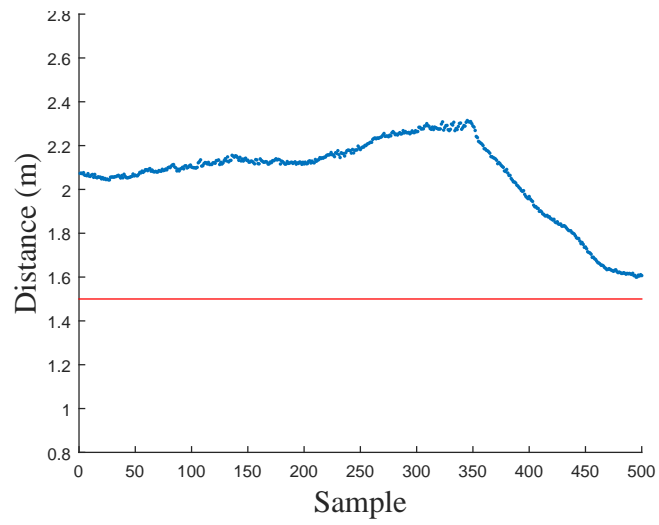
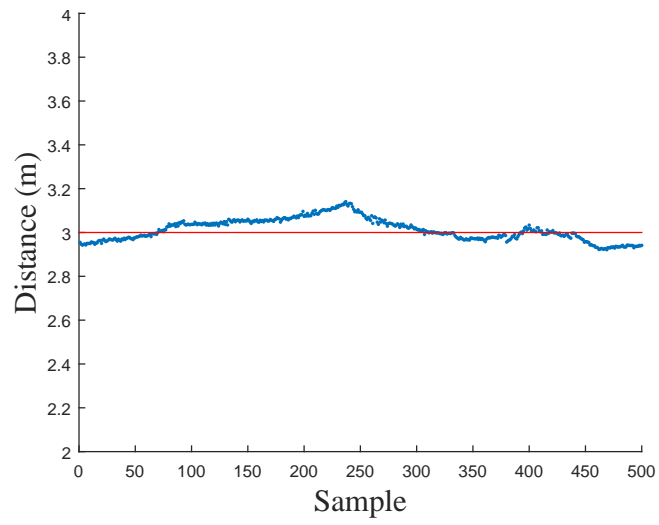
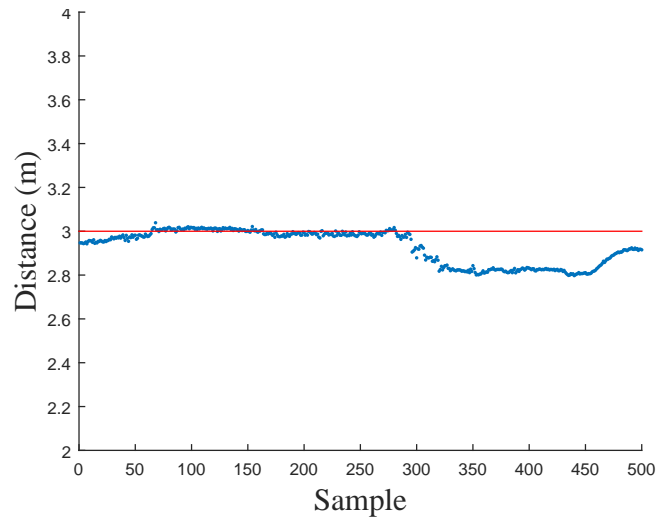
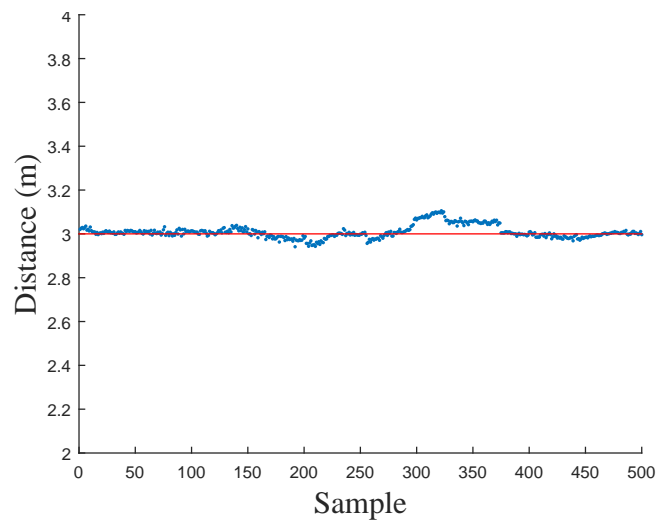
This appendix presents all flight pixel width data for vertical and horizontal flight tests at distances of 1.5 and 3 meters. Data is adjusted in order to eliminate the occasional “jumps” and inconsistencies and converted from pixels to distance (m) using the baseline measurements from Table 7 and are presented here. Adjustments were made by either increasing or decreasing the data “jumps” along the pixel width axis so as to align it with the rest of the data. Data was converted from pixel width to distance in order to provide ease of visualization as to how far the aircraft was drifting from its intended target. Red lines indicate the respective target flight distance.
