OVERCOMING THE CHALLENGES OF USING UNMANNED AIRCRAFT FOR
BRIDGE INSPECTIONS

A THESIS IN
Mechanical Engineering

MASTER OF SCIENCE

by
IGNACIO HERNANDEZ

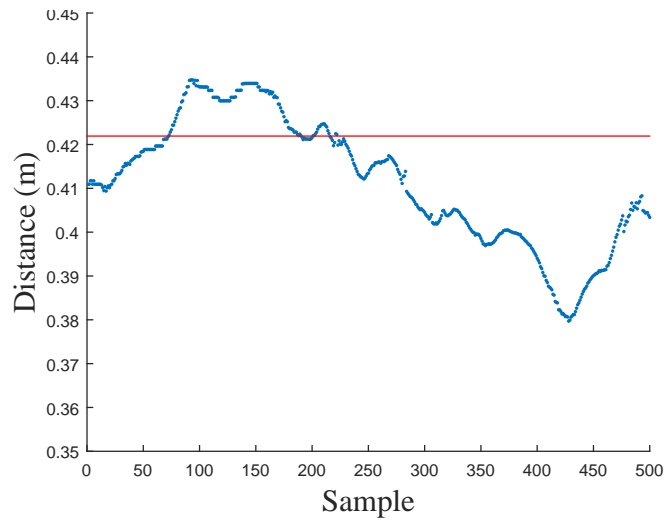
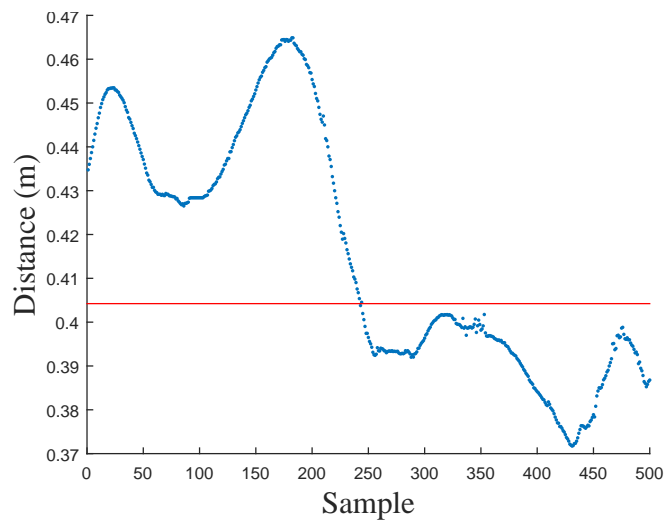
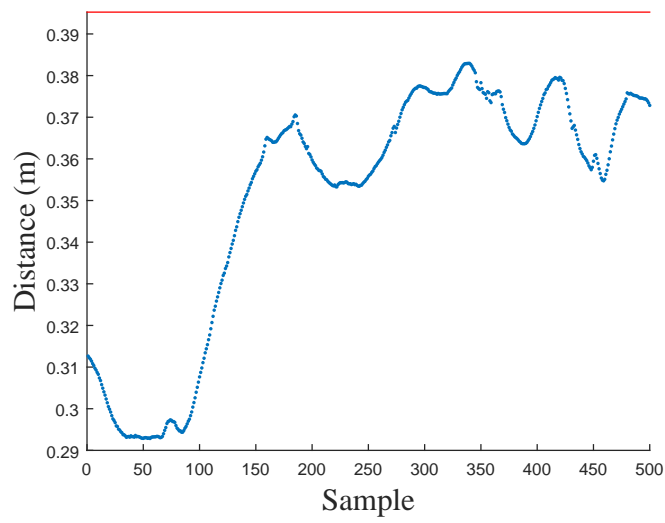
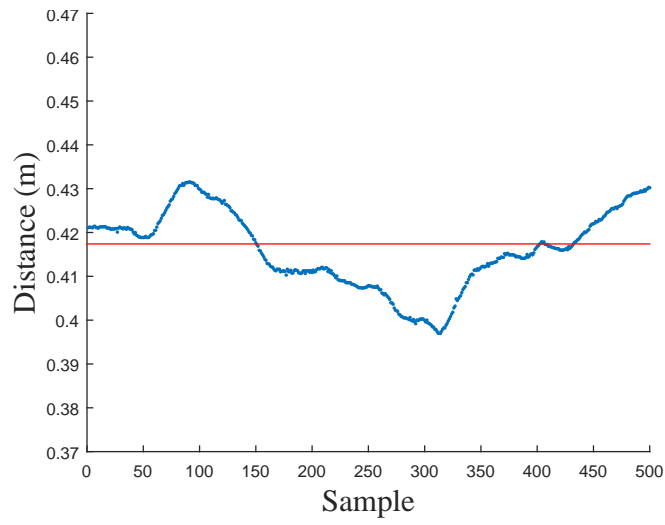
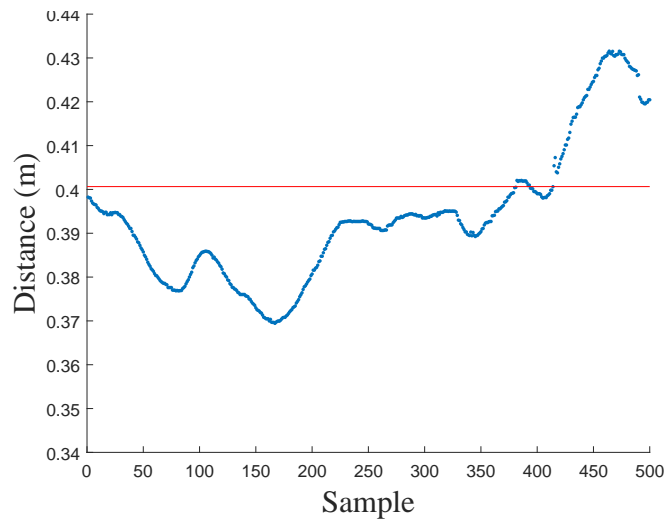
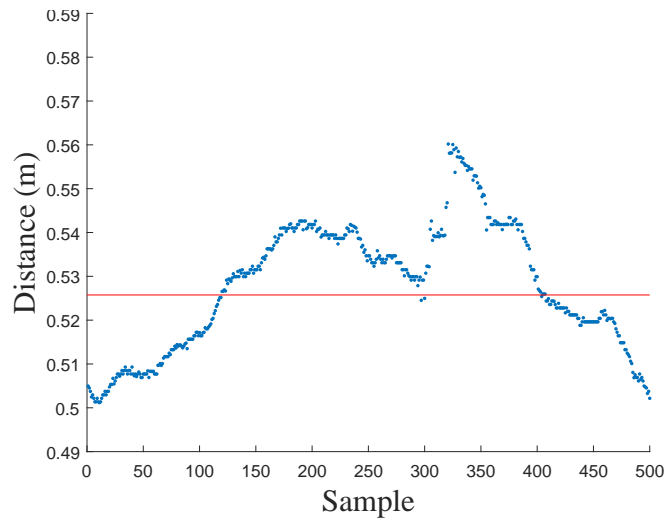
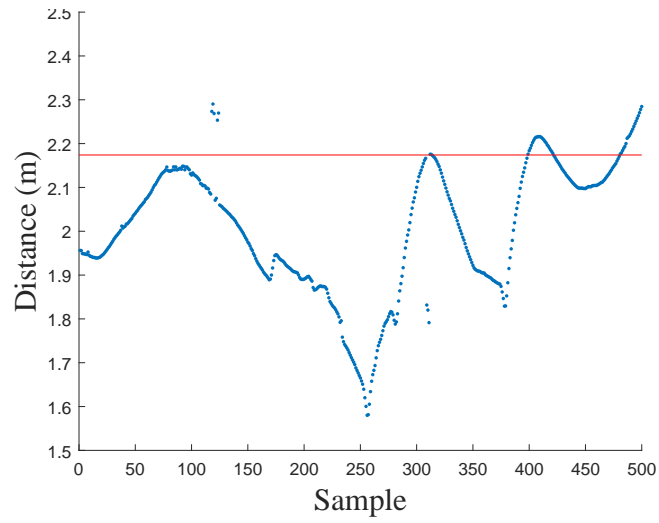
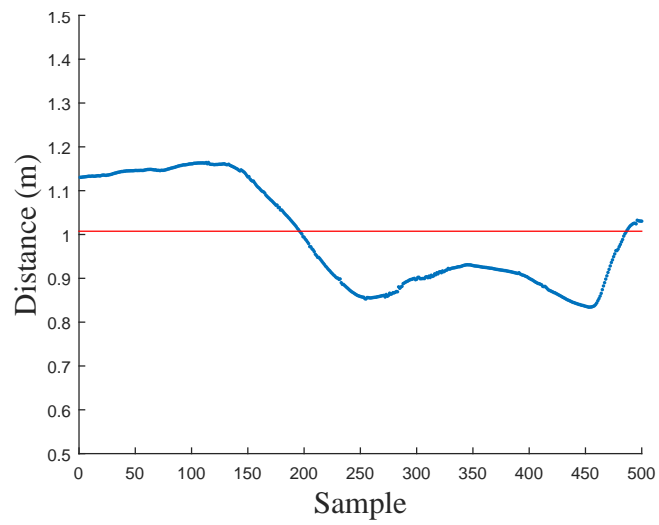
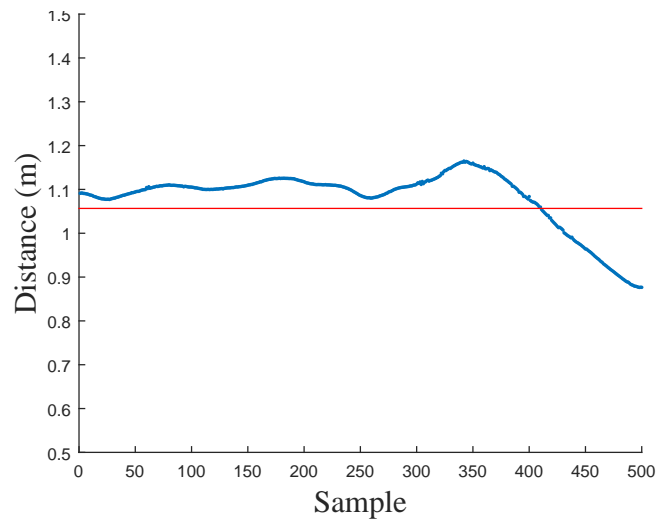
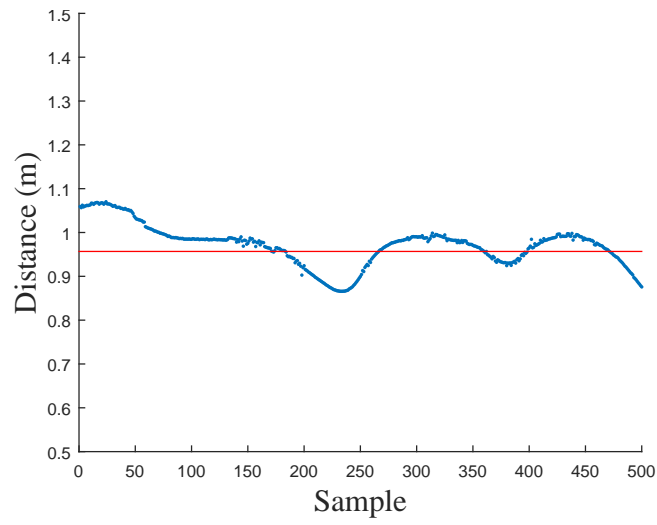
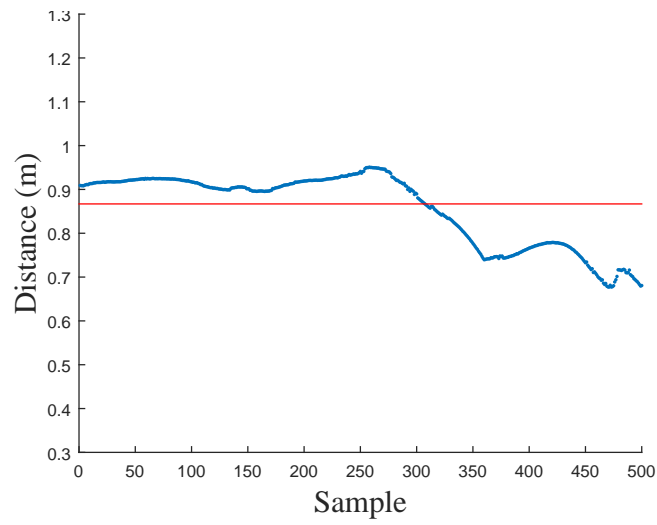
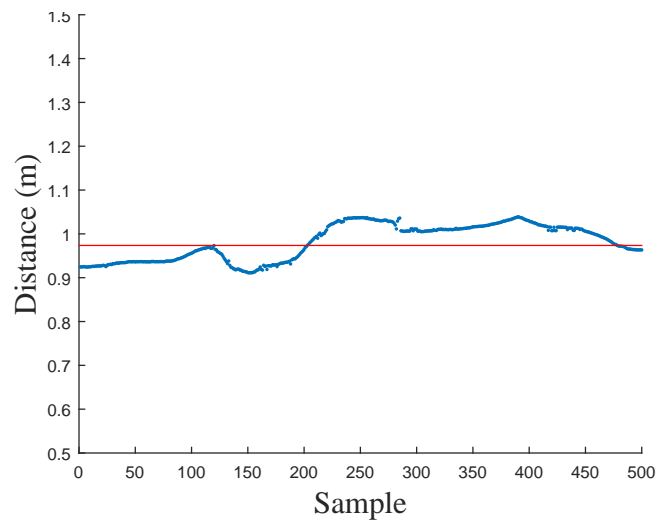
This appendix presents all flight midpoint pixel data for vertical and horizontal flight tests at distances of 1.5 and 3 meters. Data is adjusted in order to eliminate the occasional “jumps” and inconsistencies and converted from pixels to distance (m) using the baseline measurements from Table 7. Adjustments were made by either increasing or decreasing the data “jumps” along the pixel width axis so as to align it with the rest of the data. Data was converted from pixel width to distance in order to provide ease of visualization as to how far the aircraft was drifting from its intended target. Red lines indicate the average deviation distance from the 28 cm strip for the respective trial.
