THE UNIVERSITY OF MISSOURI BULLETIN  
VOLUME 29, NUMBER 37 (Bulletins 29 to 36 inclusive not issued.)

ENGINEERING EXPERIMENT STATION  
Series 28

# REINFORCED BRICKWORK

MASON VAUGH

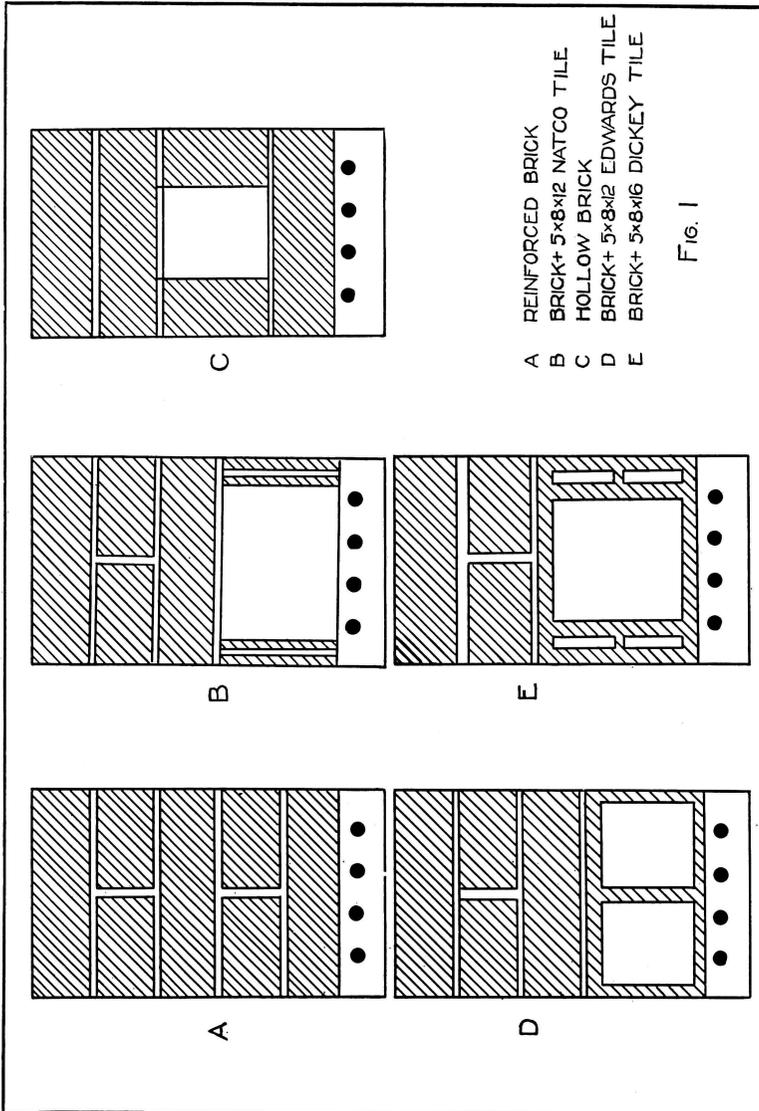
The first series of five beams were tentative and were designed to give information on two phases of the subject. In the first phase it was desired to get all the information possible as to the behavior of such beams as a guide to future design; to get some definite idea of the loads the beam could be expected to carry, the type of failure to be provided for, the magnitude of the deflections to be expected and, if possible, information on the modulus of elasticity of brickwork. Fig. I shows the

cross section of the five designs built. The beams were uniformly about thirteen feet long and were tested on twelve foot centers with the loads applied at third points by an Olsen beam testing machine of 50,000 pounds capacity.

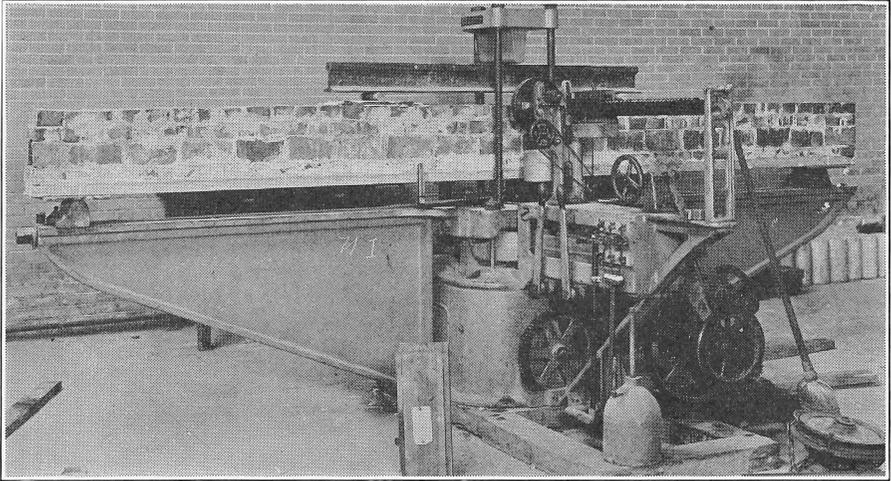
Fig. 2 shows the testing machine used with a beam in place. It was originally planned to use an Olsen beam apparatus but this was found to be impossible with the equipment available when the tests on the first series were made. Therefore, only loads and deflections were taken. The load was applied at one-third points as shown using the slowest speed of the machine. Fifteen to twenty minutes were required to apply the full load including the time the machine was stopped for readings.

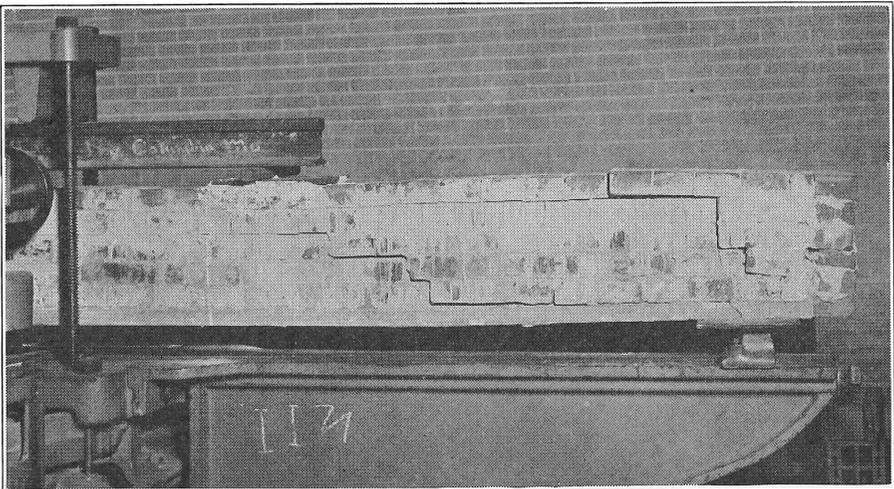
Fig. 3 shows the failure in the solid brick beam. It is a typical diagonal tension failure showing a greater tendency for the parts of the beam to separate vertically than for slip to take place horizontally. The tendency to push the end off should be noted. Later determinations show the load of 13,000 lbs. to be near that required to stress the steel to its elastic limit. The following table No. 1, gives the data as taken during the test.

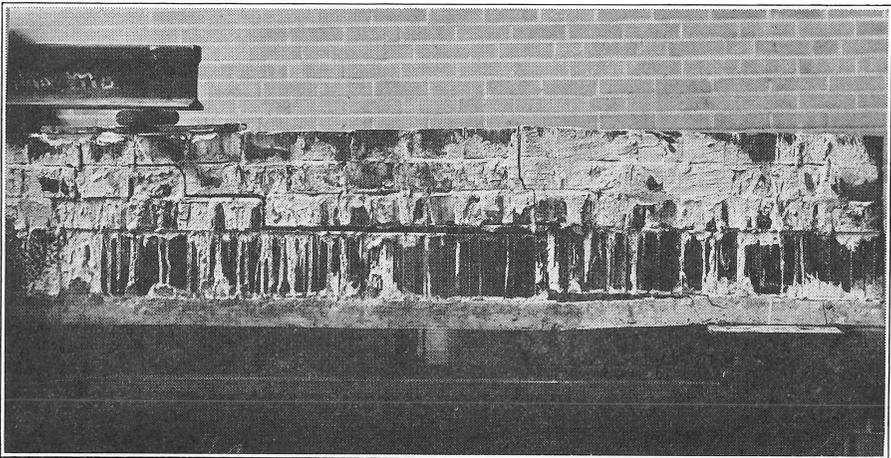
Beam No. 2 was made with Natco end-construction hollow tile in the lower part of the beam. Fig. 5 shows quite clearly construction of the beam and the type of

failure. Unfortunately, the dead weight of the beam was not recorded, but table No. 2 shows the data secured and Fig. 6 shows the deflections plotted against the loads.

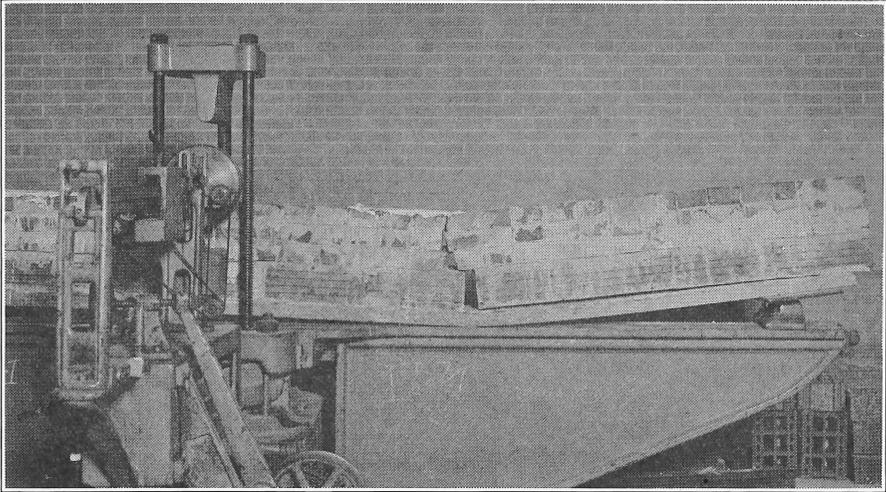
Fig. 10

Beam No. 4 was made with a two cell tile in the lower half. This tile was good in that it laid up quickly but the adhesion to the mortar seemed poor and failure was sudden as shown in Fig. 10. Table No. 4 gives the data.

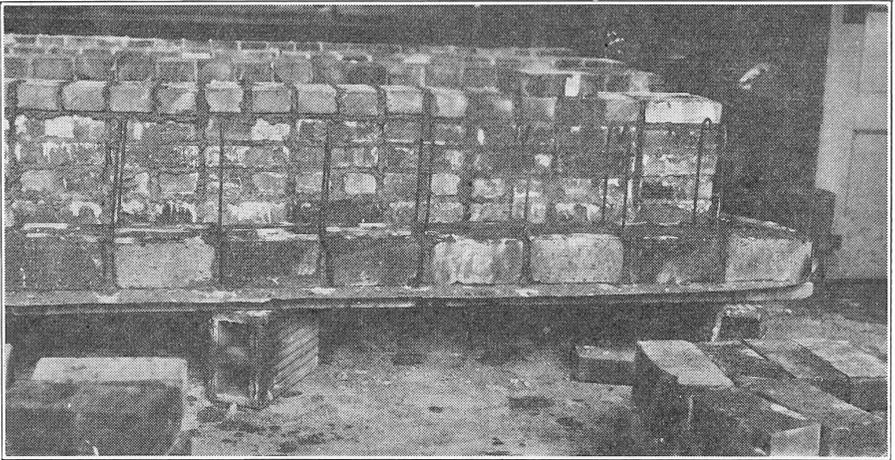
Fig. 14

during testing, the mortar was not injured by excessive absorption. Though compressive stresses reached comparatively high figures, there was no single case of crushing either brick or mortar in compression. A few bricks broke across due to transverse stress. Figs. 14 to 20 show various aspects of the construction and are clear enough without further explanation.

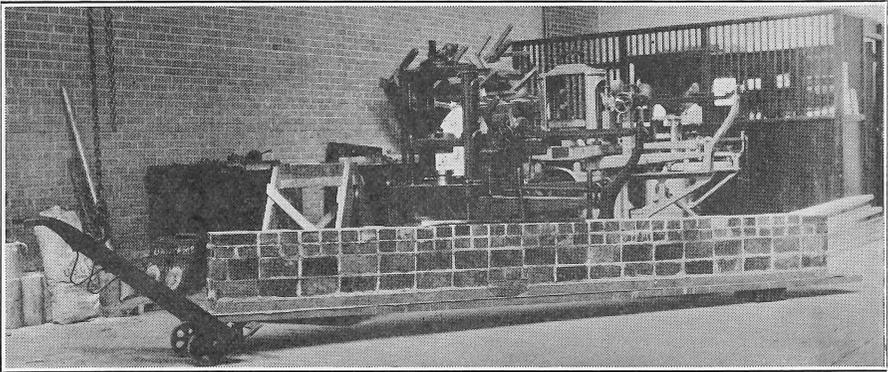
Fig. 21 shows the method of transporting the specimens from the room where they were built to the testing machine and Fig. 22 shows the manner of placing the beams on the table of the machine. In this way, two men could handle a beam fairly easily. The same small iron dolly was used under the rear end of the beam when moving it on the floor and under the front end when putting it on the machine. The hoist not shown in the picture was an ordinary triplex chain block. Contrary to ordinary expectation, no particular difficulty was experienced in handling these beams in spite of the comparatively crude apparatus available. Only two were damaged in handling. One was dropped about a foot in getting it onto the trucks and cracked through a vertical mortar joint near one end. When put on the machine, this point was reinforced by wrapping some wire around the beam parallel to the crack. Failure occurred at the other end and in a similar way and under similar loads

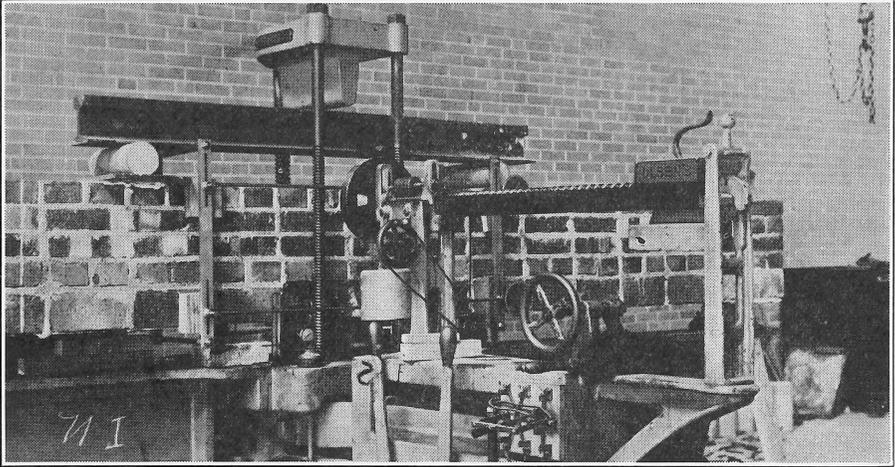
Fig. 23

flection. All measurements were made on both sides of the beam and averaged. The steel deformation was measured with a Berry strain gauge registering on an Ames' dial reading to 0.0002 of an inch direct. The masonry deformations were measured by an Olsen Beam Apparatus over a distance of 40 inches. The deflections were measured by Riehle lever type deflectometers reading by vernier 0.001 inches. The deflectometers were mounted on the bed of the testing machine and would really record not only the deflection of the beam but any tendency of the machine bed to give under the load. Therefore the deflections recorded are rather in excess than otherwise. In one or two tables where a column of data is omitted, the apparatus, failed to function for some reason. In one or two cases, the beam apparatus was accidentally struck and thrown off so that it was impossible to get readings for one or two of the last loads. Figs. 23 and 24 show the apparatus in place for tests.

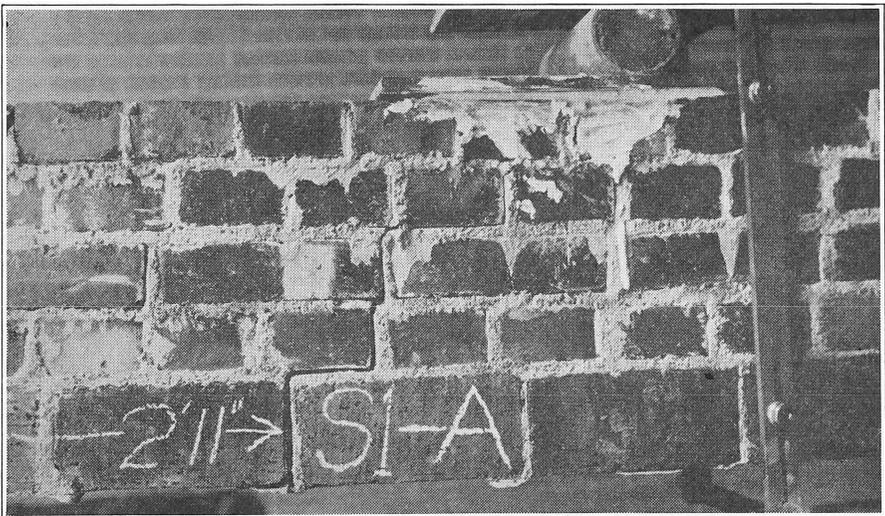
Beam S1-A, built March 6, 1928 and tested April 24th, gave the data shown in Table No. 7. The steel was not hooked on the ends and the mortar was not too well packed around it so failure occurred by slipping of the steel. Fig. 25 shows the crack which opened up after the steel had slipped about  $\frac{3}{8}$ ". Even after this much slipping, the beam carried over 6,000 lbs.

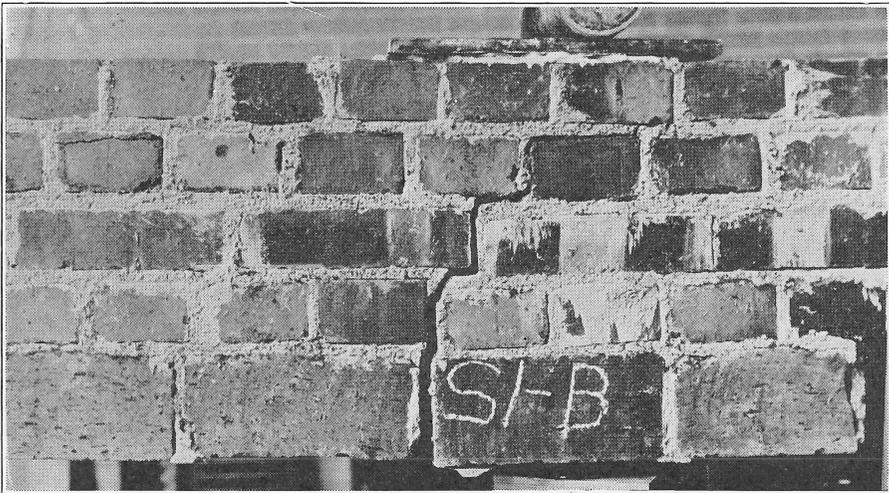
around the rod. Fig. 26 shows the type of failure at the north load point and Figure 27 shows the poor filling around the rod at the hook. Fig. 28 shows the poor filling around the middle part of the rod showing that the mortar was not in contact with the rod at all below for some distance and the sides of the rod also were not covered. Table No. 8 gives the data which is applicable to neutral axis and other calculations as slipping apparently did not take place until about the time it failed completely.

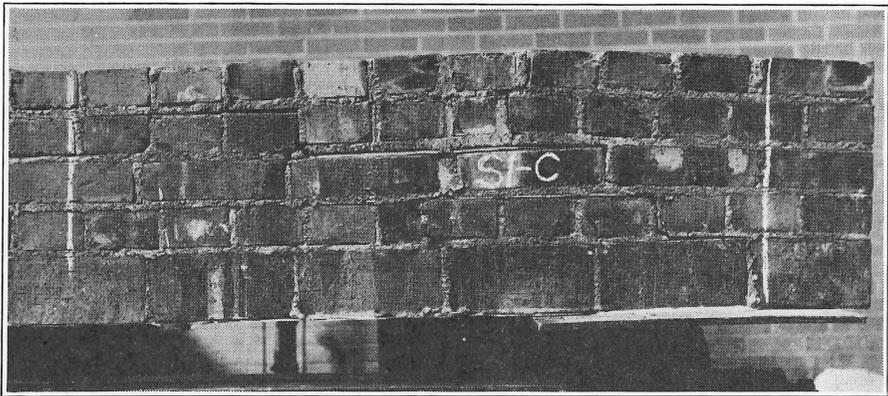
Fig. 29 shows the type of failure of beam S1-C, due to shear or diagonal tension. It is typical of many of the later failures. Note how the end seems to be shoved off. This beam was made March 7th and tested April 18th. Table 9 gives the data for this beam. Fig. 30 shows the deflections of all three S1 beams plotted on one sheet and an average curve drawn. Figure 31 shows the steel deformations plotted against loads.

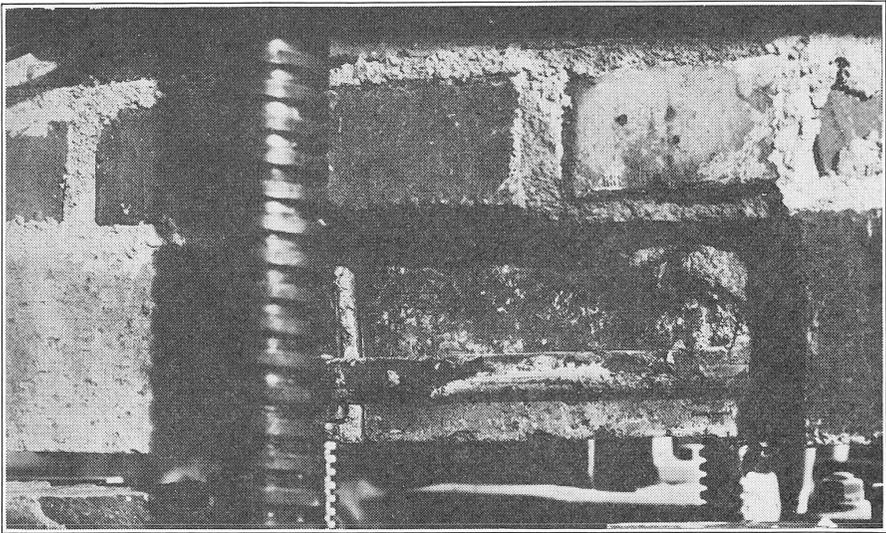
Fig. 32 shows the steel in beam S2-B after failure and also the single-vertical crack that opened in the mortar joint just behind the screw. Failure in this beam was also by tension in the longitudinal steel. Unfortunately, struts placed to prevent displacing the table of the testing machine when putting the beam in place were not removed until the test had stressed the steel to its elastic limit. The loads as originally observed were not therefore the true loads as the steel began to stretch at an observed load of 11,000 lbs. which was obviously wrong.

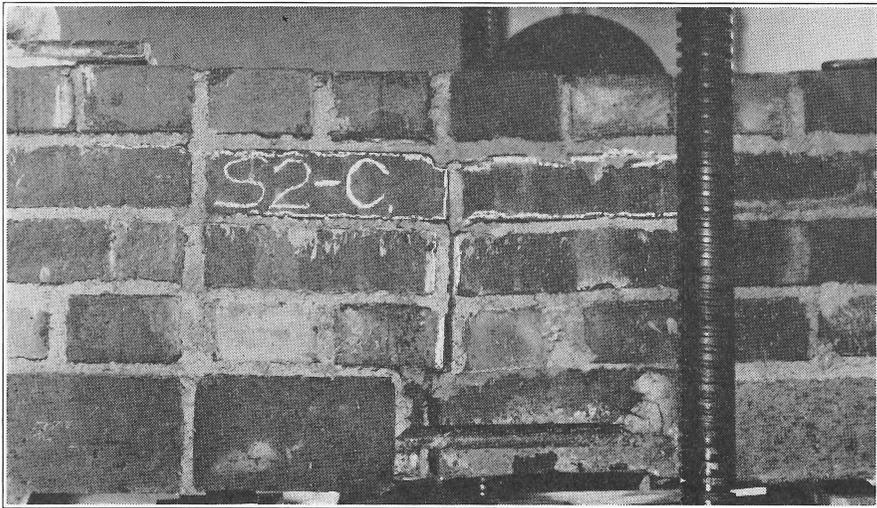
Fig. 33 shows the failure of beam S2-C after the longitudinal steel had been stretched enough to open the crack near the center of the beam to about  $\frac{3}{8}$  inch. This beam was loaded repeatedly before failure. The load was applied in increments of 1,000 lbs. up to 12,000 lbs. and then released with the faster speeds of the machine.

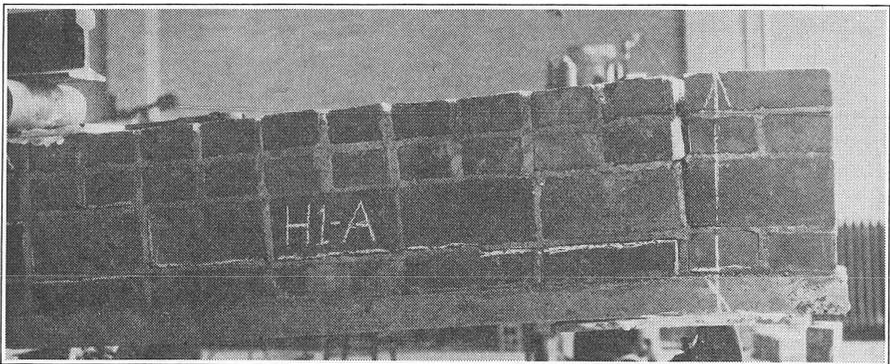
Fig. 36

The H1 series were reinforced with the 1/2 inch rods and so no measurements were taken of the strain in the steel. Figure 36 shows the failure of H1-A by horizontal shear. Note the vertical crack at the first vertical mortar joint. Table No. 13 gives the detail data for this beam. Unfortunately, the beam apparatus was accidentally disturbed so that the last few West readings could not be taken accurately so they were omitted. The west deflection ran off the scale of the deflectometer and so could not be recorded. It should be noted that the load carried by this beam was 2,000 lbs. higher than that carried by the best of the S1 series in spite of the fact that it was 200 lbs. lighter. H1-A was made March 12 and tested April 25.

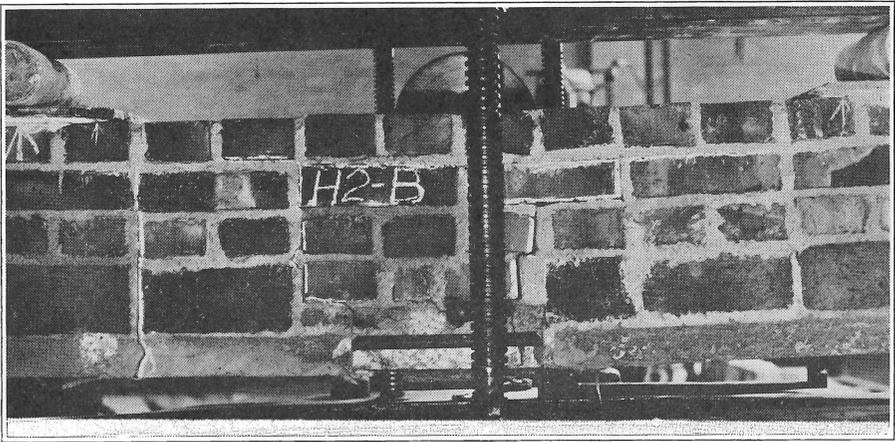
While H2-A failed primarily in tension in longitudinal steel, the diagonal tension failure is the most prominent feature in the picture. Fig. 40 shows quite definitely that failure in H2-B was from tension in the longitudinal steel. There were very fine diagonal tension cracks in the mortar joints of the north end, indicating that possibly the diagonal tension failures were partly the result of incipient failure in the

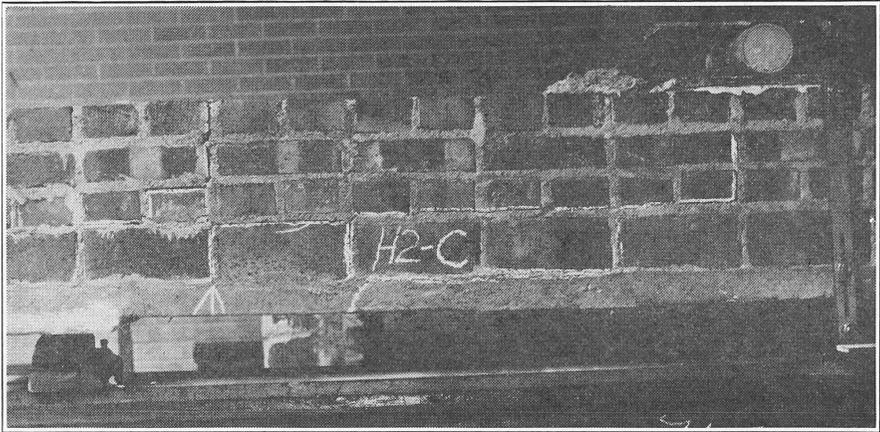
Fig. 41 again shows a failure in diagonal tension very similar to that of H2-A and other beams but again not until near the yield point of the longitudinal steel. This was the beam which was dropped about one foot in loading it onto the truck at which time the crack over the arrow point was made. Apparently this crack did not affect the strength of the beam until near 13,000 lbs. load when it began to open slightly. Just as the load reached 14,000 but before readings could be taken, slipping occurred longitudinally and the beam failed. Had there been one longitudinal bar bent up to take the stress that opened the vertical joint, perhaps the load carried would have been increased. Table No. 18 gives the detailed data on this test, and Fig. 42 gives the steel deformation in the three beams separately. H2-C was made on

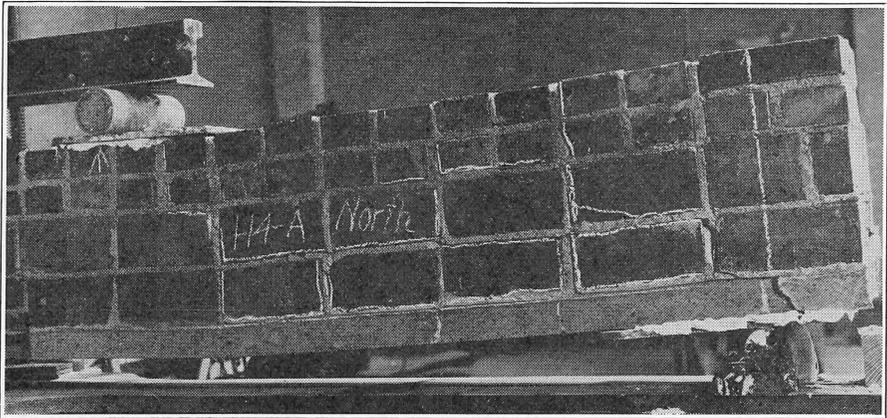
The H4 series again gave very consistent results, two of the series failing above 16,000 lbs. and the third above 14,000 lbs. H4-A was made with two courses of brick on edge forming the hollow part as shown in Fig. 47 which also shows the failure,

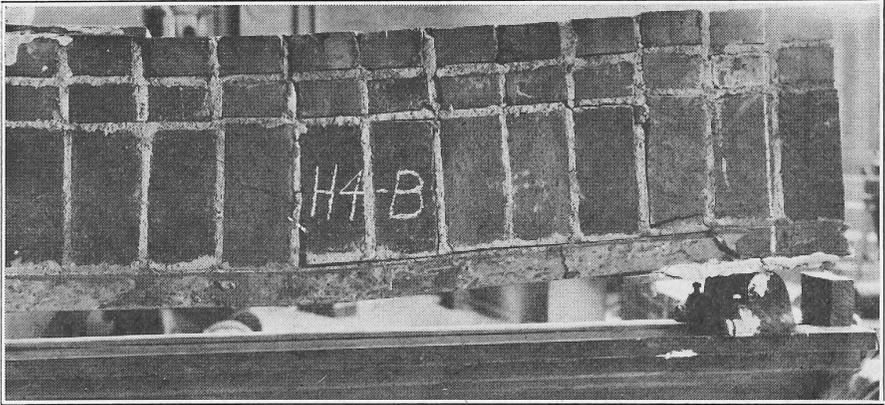
Fig. 48 and Table No. 23 give the essential information on beam H4-B. There was nothing strikingly different about the test to need noticing. Also the same information for H4-C is given in Fig. 49 and Table No. 24. Fig. 50 gives the same curves as given for the other series. H4-A was made on March 10 and the other two were made on March 12. B and C were tested on April 26 and A was tested on April 27.

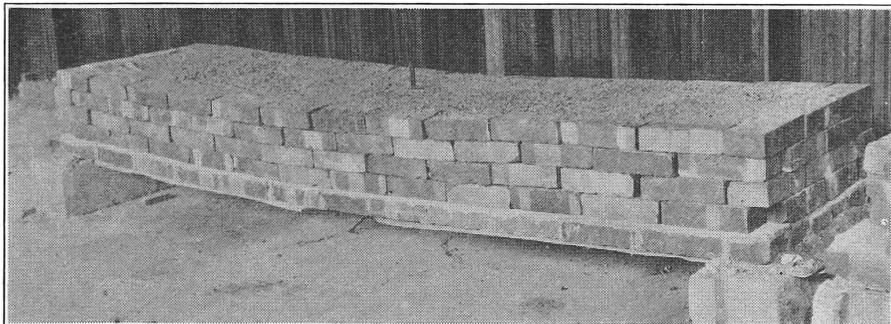
Fig. 60 shows the failure of flat brick slab No. 2 and Table No. 26 gives the corresponding data.

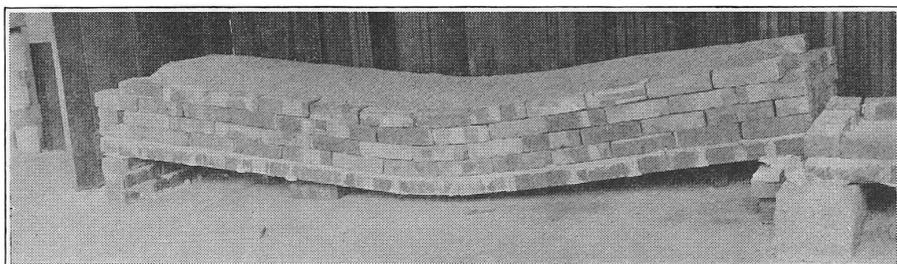
Fig. 61 shows the failure of flat brick slab No. 3, and Table No. 27 gives the data for it. This slab went down practically to the floor under the load but on removal of the load it, recovered somewhat and the three men shown in Fig. 62 were not sufficient to materially deflect it. It is unsupported except for the end supports in this picture and shows how even in cases of rather complete and extreme failure, these slabs do not collapse. Due to cramped space, the supports under this slab were not as good as

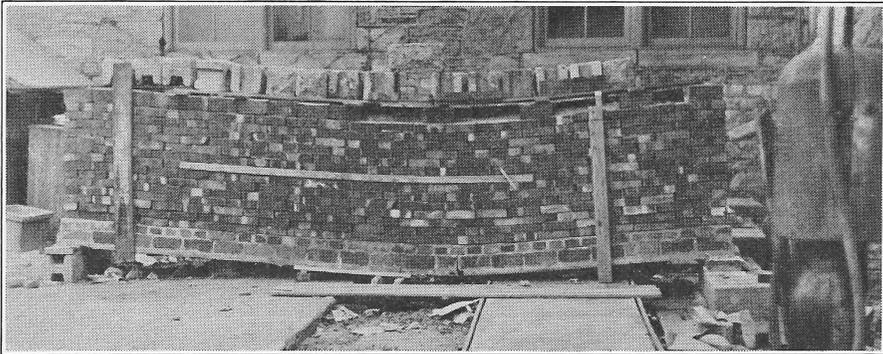
Fig 67

The ribbed slab, shown under the failure load in Fig. 67 was loaded over a period of twenty-four hours. It was over reinforced somewhat. The load was applied as rapidly as the men working at it could conveniently handle the material. The load of 36 inch sand exhausted the sand available and was applied just before noon. About one o'clock the deflections had increased as shown in the last reading in Table No. 31
