EVALUATION OF THE SERVICE PERFORMANCE OF AN INNOVATIVE PRECAST PRESTRESSED CONCRETE PAVEMENT

A Thesis
presented to
the Faculty of the Graduate School
University of Missouri – Columbia

July 2009

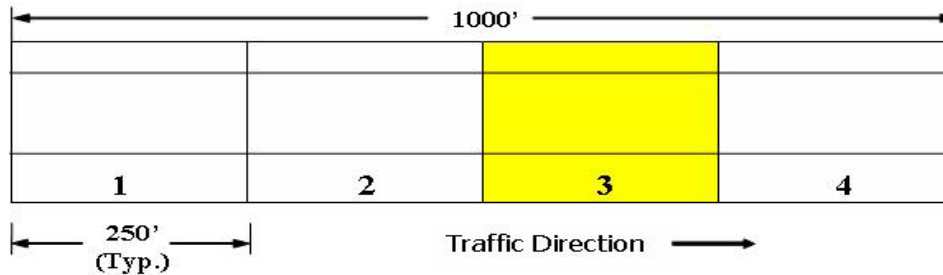
Figure 1.1 – Overall PPCP section layout with driving lanes shown (25 panels per section; Section 3 is heavily instrumented)

A 1,010 ft section of conventional cast-in-place pavement was replaced with four sections of post-tensioned precast pavement panels. A typical section consisted of an anchor panel near the middle with eleven or twelve base panels on each side with a joint panel at both ends. These joint panels were heavily reinforced since they contained the post-tensioning blockouts and served to accommodate thermal expansion/contraction of the 250 ft section. Figure 1.1 shows the layout of the four sections of pavement (the highlighted section is heavily instrumented and will be discussed later in detail). Figure 1.2 shows the layout of panels within each individual section.

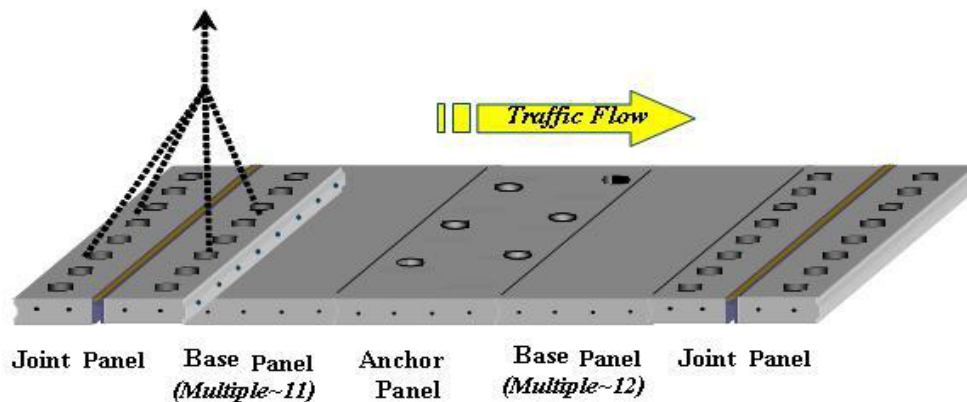
Figure 1.2 – Typical section of PPCP panel assembly and layout modified to reflect Missouri Project (Merritt, McCullough et al. 2000)

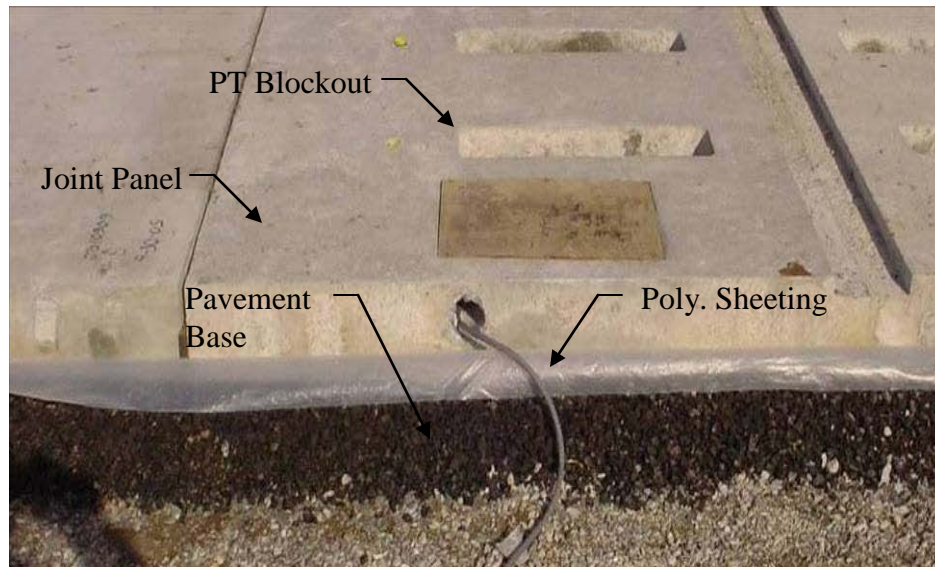
Figure 1.3 – Joint panel on polypropylene over asphalt, and aggregate base (Missouri project) (Note: Instrumentation data cable exiting the end of the panel)

The construction of the PPCP section was performed by Gaines Construction from Wentzville, MO. Typical panel placement rates were between 8 – 25 panels per day. The base, a very critical component of pavement construction, was made up of a 4” asphalt treated base over a 4” permeable crushed stone filter layer. A layer of polypropylene was used as a friction reduction layer and to ease the construction of the pavement. This friction reduction layer is critical in post-tensioned pavement where sub-grade friction reduces the efficiency of prestressing. Figure 1.3 shows an instrumented joint panel on top of the prepared asphalt base with polypropylene sheet clearly visible.

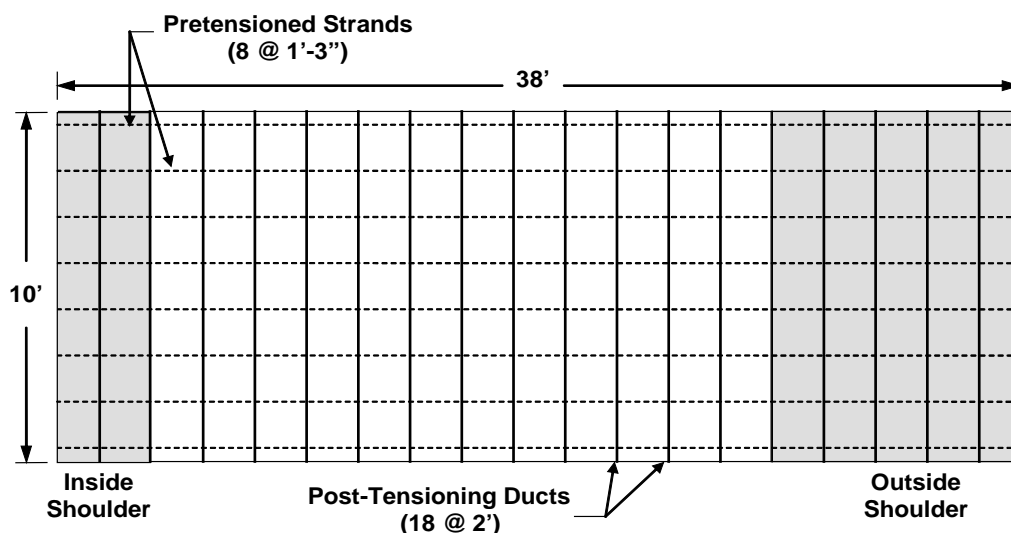
Figure 1.4 – Plan view of typical base panel

Standard 60 ksi epoxy coated rebar bordered the edges of each base panel and is not shown on the schematics. Its role was to provide typical edge reinforcement to curb cracking and fragmentation of the corners. Each base panel contained eight pre-tensioning strands as shown in Figure 1.4 and Figure 1.5. The pre-tensioning strands located in the top half of the panel were draped to follow the slope of the crown and meet cover requirements at the shoulders. Draping was accomplished by placing varying heights of galvanized chairs under the strands at key locations (see Figure 1.6).

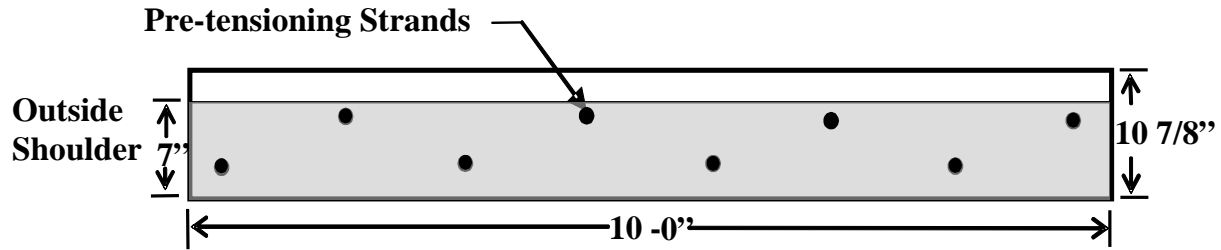
Figure 1.5 – Section of base panel looking perpendicular to traffic direction

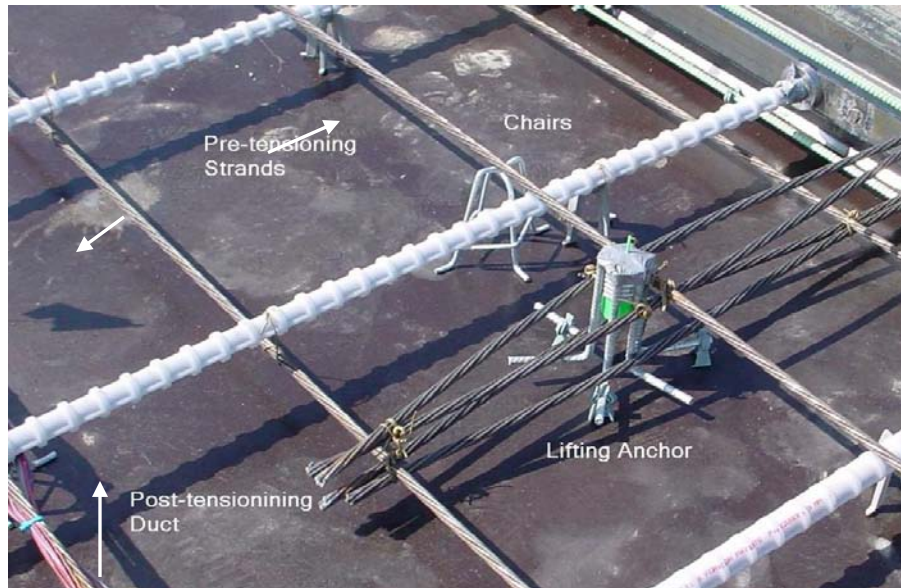
Figure 1.6 –Lifting anchor, chairs, and prestressing strands

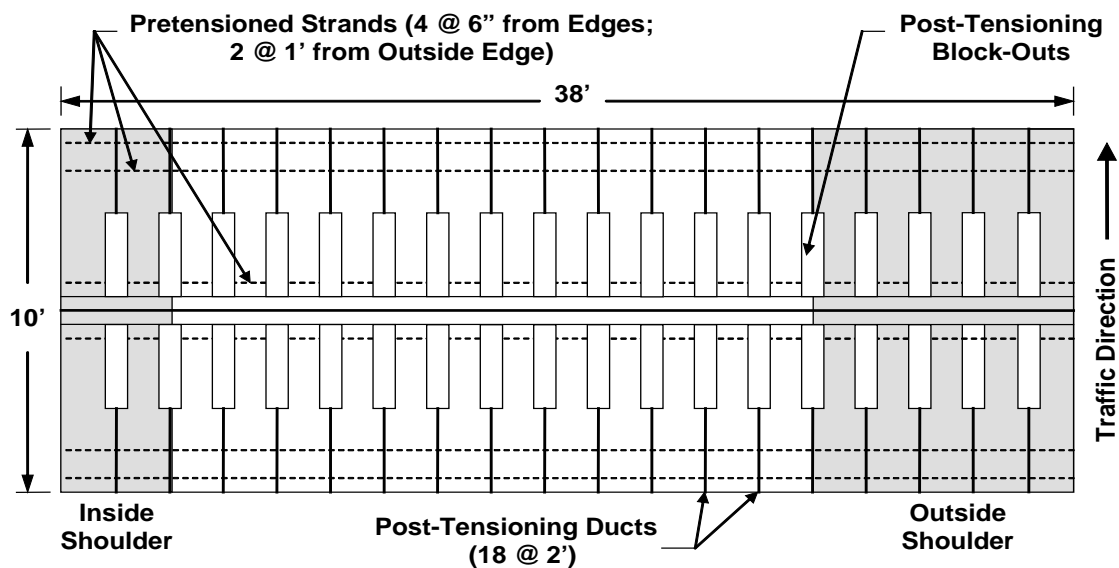
Figure 1.7 – Plan view of typical joint panel

panel required to be cast in two separate halves. Figure 1.7 shows a plan view of a typical joint panel. Block-outs toward the center of the panel allow access to the post-tensioning ducts, which were filled with grout after post-tensioning. Joint panels have 12 pre-tensioned strands instead of 8 (see Figure 1.8). The top strands are draped with the slope of the crown while the bottom strands are straight. Each half is connected by smooth dowels that provide shear transfer between sections (not shown in schematic). A cold-joint between sections was accomplished by using temporary bulkhead that fastened to the bottom of the bed. The cold-joint was needed to ensure that the joint panel “opened up” during post-tensioning operations. Figure 1.9 shows two halves of a joint panel, one side has cured for one night and the other is ready for casting the following afternoon. Five total joint panels were fabricated for the 1,010 stretch of pavement. The panels at the ends of the PPCP section were cast without post-tensioning block-outs on one half. The side of the panels adjoining to cast-in-place concrete pavement was dowelled in with conventional rebar reinforcement.

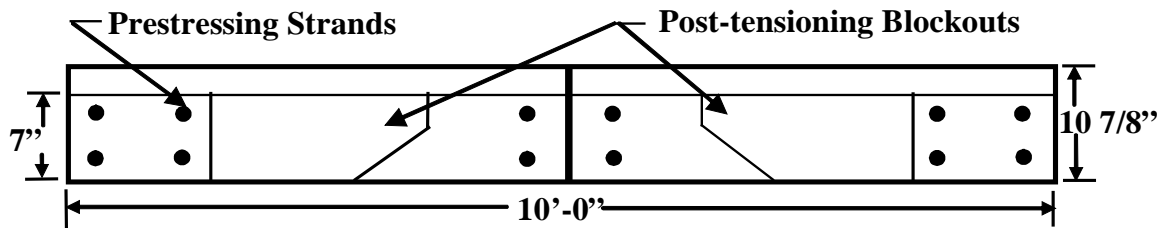
Figure 1.8 – Section of joint panel looking perpendicular to traffic

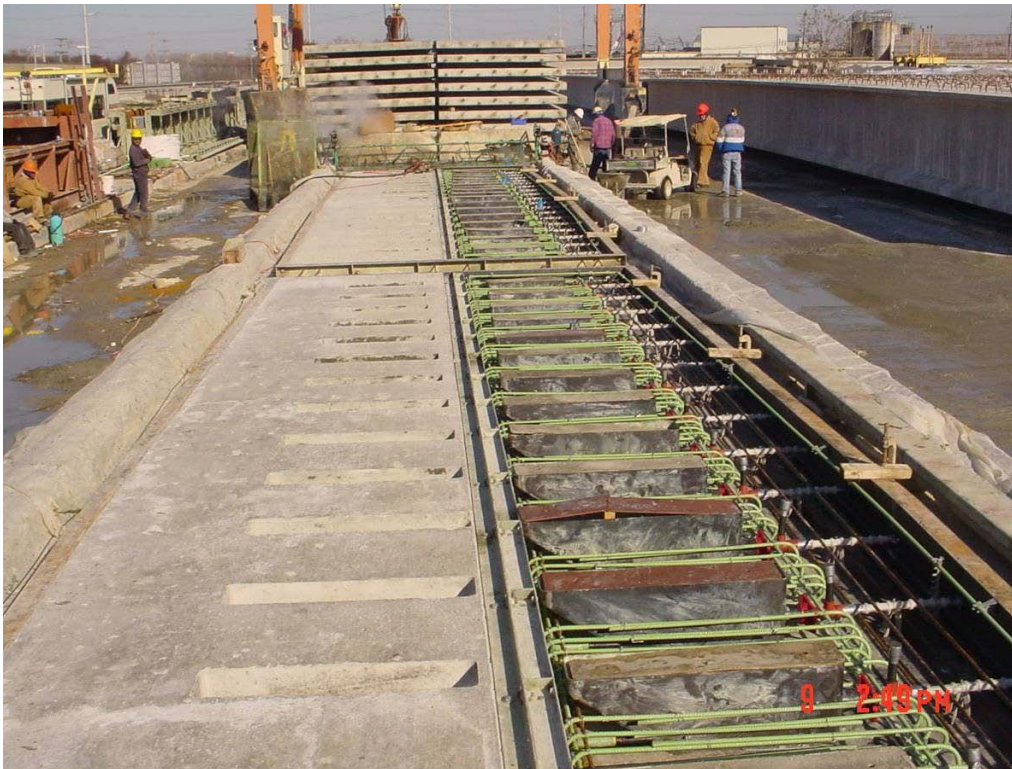
Figure 1.9 – Joint panel casting (left side cured for 1 night, right side ready for casting on 2nd day)

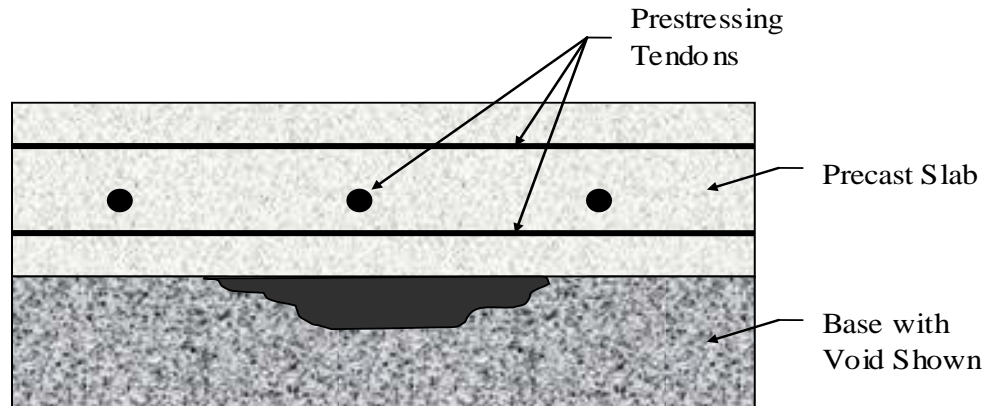
Figure 2.1 – Illustration of pavement section spanning over void in base material

increasing the prestressing force will help the panel act like a thicker pavement (Merritt, McCullough et al. 2000).

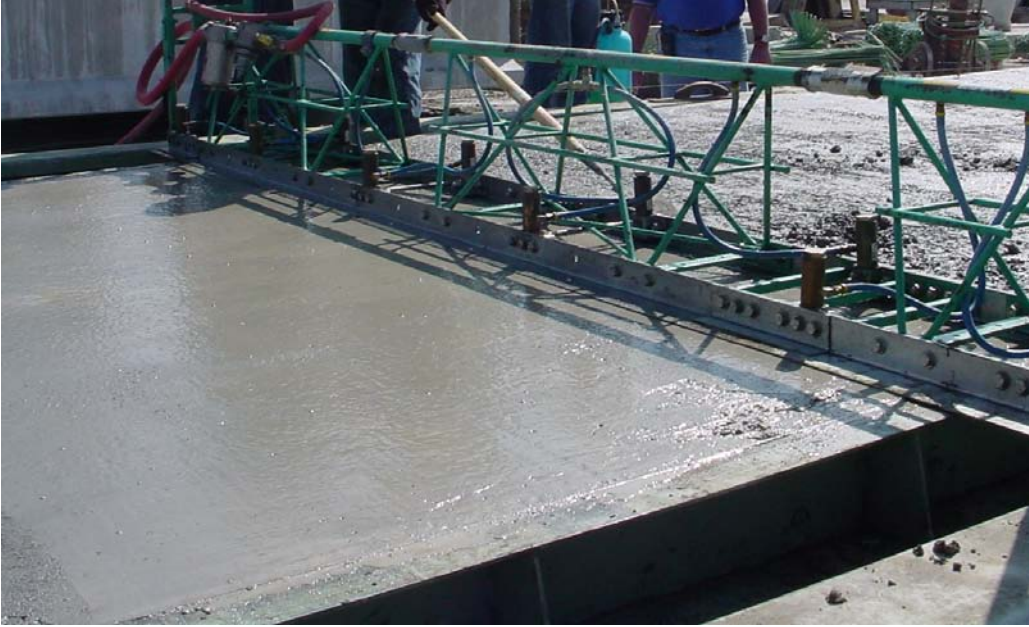
Figure 2.2 – Surface finishing of a typical base panel at the precasting yard

Another inherent benefit from precast pavement is the ability to control the quality of the finished product. Timeliness is held paramount most often when placing conventional pavement due to traffic, workers, and high equipment costs and other constraints. These influences can weigh heavily on builders and can compromise the quality of a finished product. When the pavement is fabricated in advance, more effective quality control, lower tolerances in size and shape, and selective production schedules can be used under controlled conditions since fabricators are not under these constraints (See Figure 2.2).

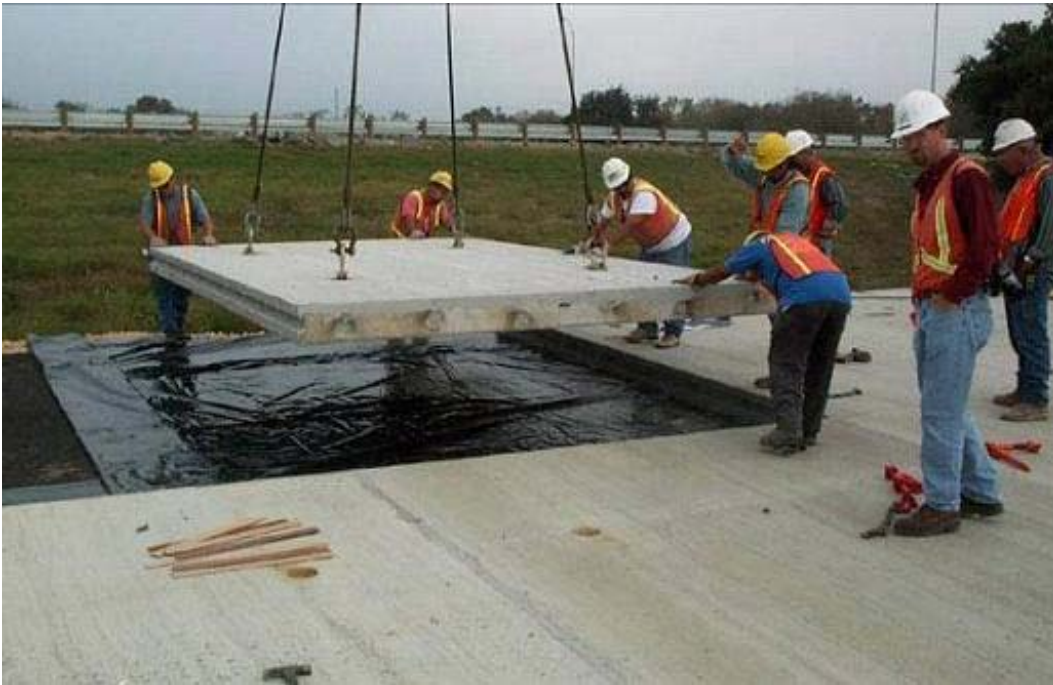
Figure 2.3 – Partial width panel placement on Georgetown Frontage Road, TX PPCP (Merritt 2002)

panels were wide enough to accommodate two twelve foot lanes an eight foot outside shoulder and a four foot inside shoulder. The partial width panels were 16 feet and 20 feet in width respectively. When placed, the centerline of the roadway matched with the joint between the two panels. The Georgetown pilot project presented many challenges for precast pavement implementation (Merritt 2001). Among the successes were demonstrating that the match-casting is not necessary due to the rugged formwork used in fabrication and geometric mechanisms such as the mating connections cast into each panel that provide for alignment of the post-tensioning ducts in the field. Successful implementation of PPCP technology is dependent on the constructability and flexibility of contractors to develop new practices where standard details have not been developed.

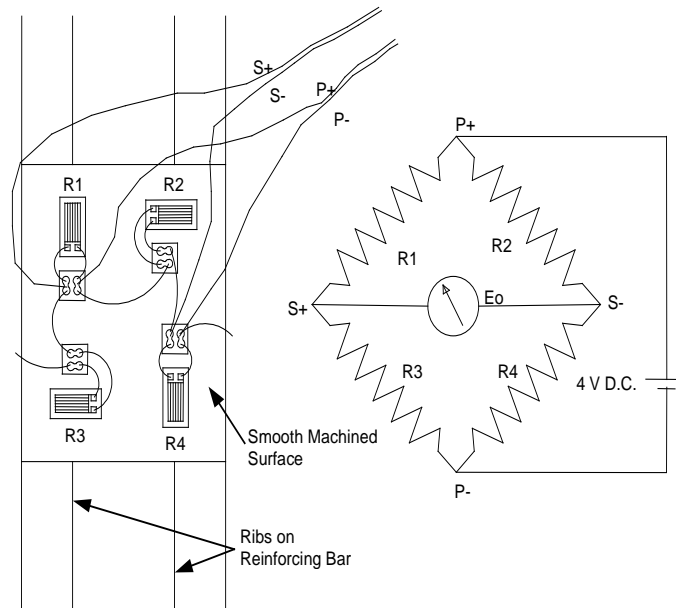
Figure 3.1 – Schematic of the strain gage configuration on the strain gage rebar (Eatherton 1999)

used is illustrated in Figure 3.1. The ends of the strain gage rebars were threaded to accommodate gripping for calibration. A completed strain gage rebar is shown in Figure 3.2. Strain gage instrumented rebars are capable of measuring very dynamic events such as stress transfer from strand cutting and traffic loads while in-service. The instruments are also very robust and have a good track record from previous projects completed at the University of Missouri – Columbia.

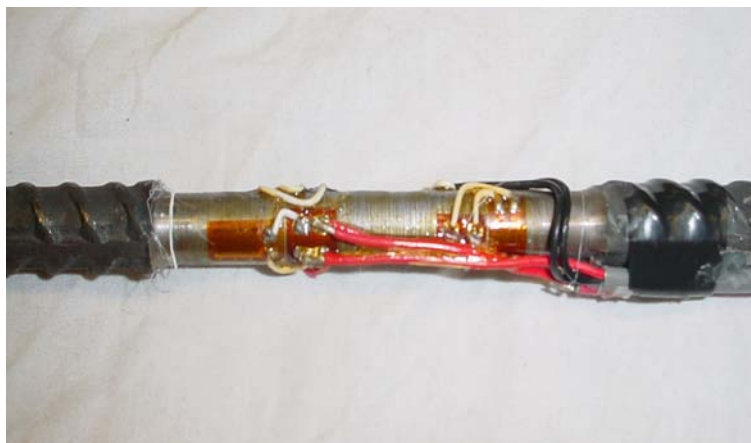
Figure 3.2 – Instrumented Rebar showing installed strain gages

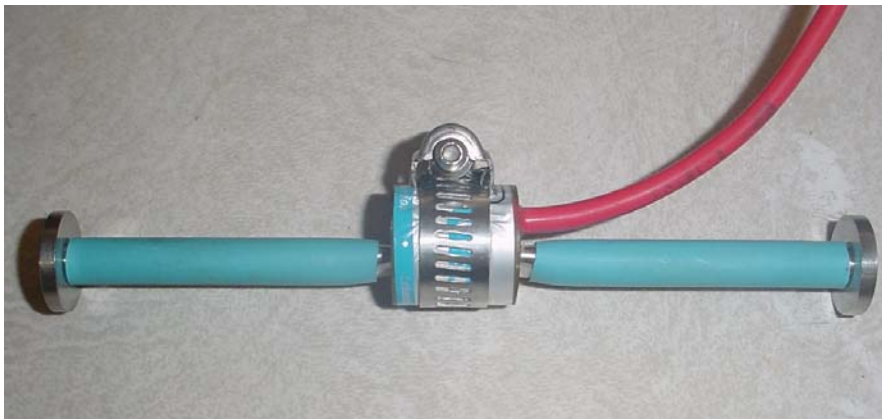
Figure 3.3 – Model 4200 vibrating wire gage from Geokon Incorporated

The vibrating wire gages are very useful for long-term strain measurements; however, dynamic events cannot be measured due to settling time of the stretched wire. After embedding the gage in concrete, a zero reading can be taken. At any time the zero reading can be referenced, and the state of strain of the concrete can be determined based on changes in frequency from the base state (zero reading).

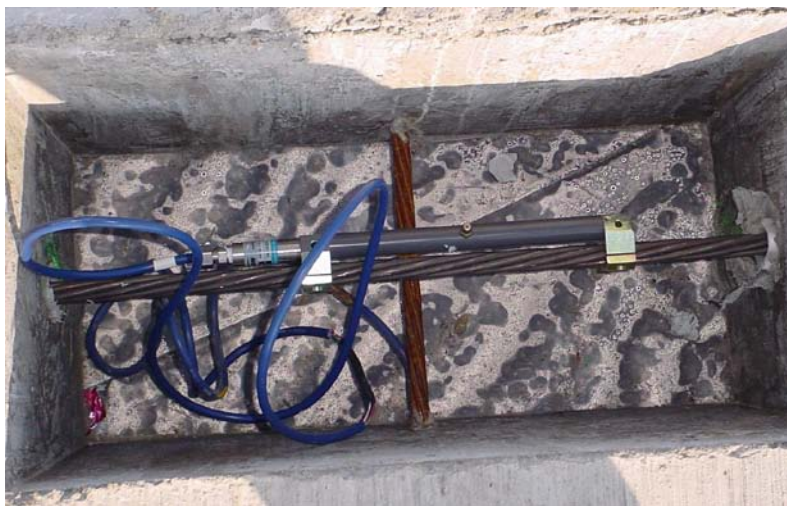
Figure 3.4 – Model 4410 vibrating wire Strandmeter, unsheathed

The strandmeters primary function was to measure the strain of the post-tensioning strands during the stressing operations as well as maintain a record of strand behavior during service. Strand stresses can be correlated with frictional and time-dependent concrete losses to characterize pavement behavior and validate intended design.

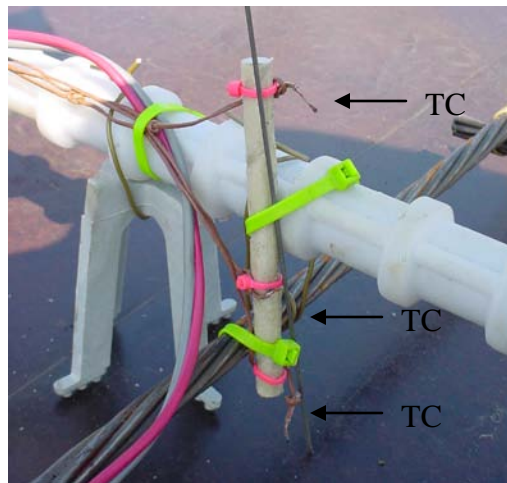
Figure 3.5 – Three thermocouples attached to fiber rebar coupled to post-tensioning and pre-tensioning strands

Type T thermocouples utilizing a copper-constantan connection were used for concrete temperature measurement. The specified temperature range was -328° to 663° F (-200° to 900° C). The thermocouples were cut to length, welded using thermocouple welders, and coated in epoxy at the University of Missouri – Columbia. This type of temperature measuring device is very advantageous due to its robustness, ease of use, and accuracy ($\pm 0.1^{\circ}$ C). Gages were positioned throughout the cross sectional depth, as shown in Figure 3.5, and at various locations across the panel width and length.

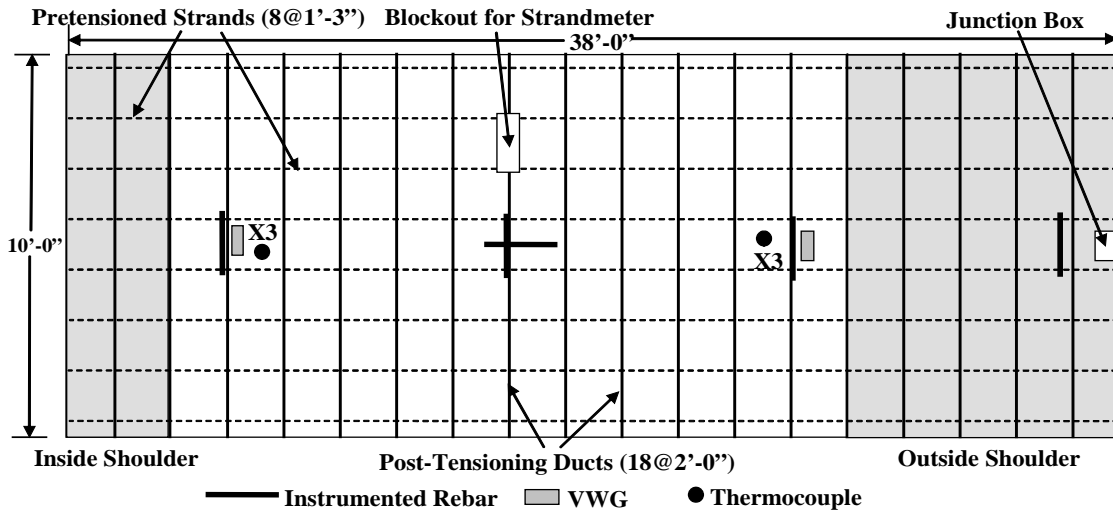
Figure 3.6 – Typical instrumented base or anchor panel

along with strain in the post-tensioning strands. Figure 3.6 depicts typical instrumentation in a base or anchor panel and Figure 3.7 shows the instrumentation locations in joint panel A32. Concrete strain was monitored using the strain gage rebars and vibrating wire gages mentioned previously. Post-tensioning strand strain history was measured by vibrating wire strandmeters. Temperature measurements were observed by thermocouples and iButtons (Maxim) embedded in the concrete along with thermistors incorporated inside of the vibrating wire gages.

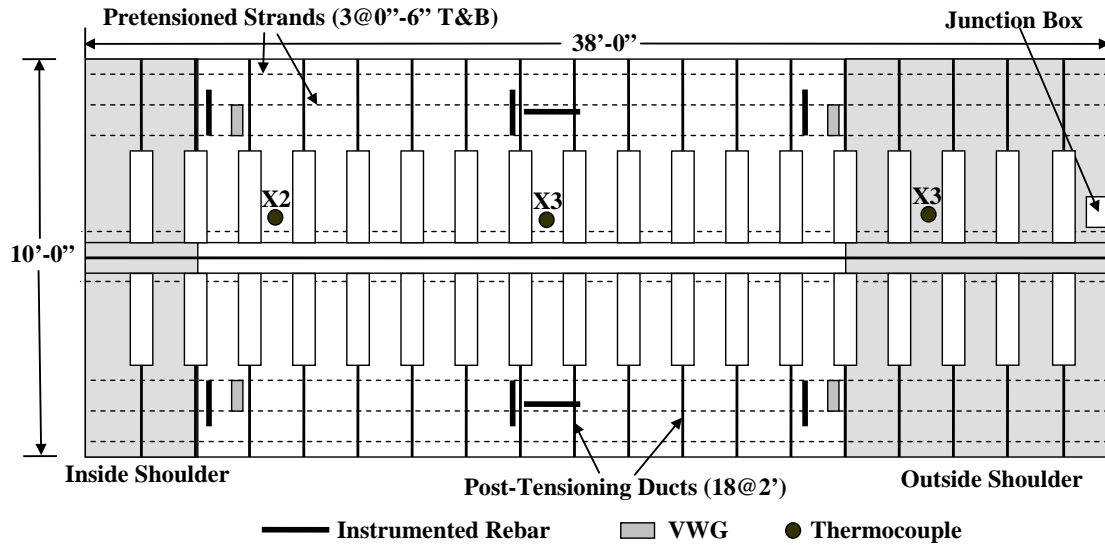
Figure 3.7 – Instrumented joint panel A32

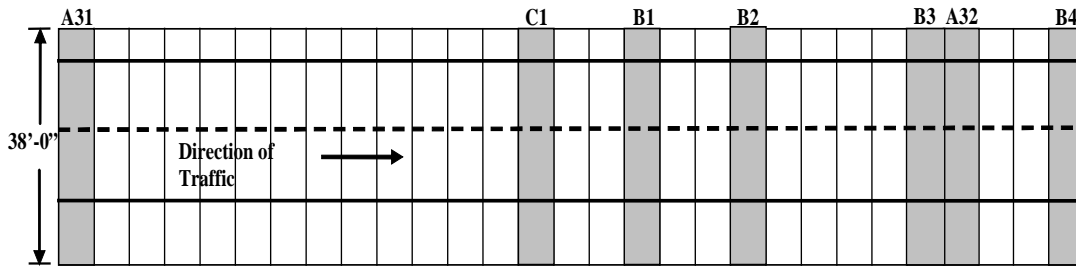
Figure 3.8 – Overall view of test-section and location of instrumented panels (A refers to a joint panel, B refers to a base panel, and C refers to a anchor panel)

The pilot project encompassed 1,000 feet of roadway rehabilitation and consisted of four, 250 ft long post-tensioned sections. The primary goal of the research program was evaluate the performance of the PPCP with regard to temperature, loading, local strains, and joint displacements. To accomplish this, the research team decided to focus on a single 250 ft section and instrument panels within this section. Section 3 of the 4 sections along the traffic direction was chosen. It was selected based on its proximity to an AC power source and to limit possible transition effects from conventional concrete pavements adjacent to the PPCP. Four base panels, two joint panels, and one anchor panel were instrumented to characterize the performance of the pavement system under environmental and vehicle loading. Figure 3.8 shows the location of the instrumented panels within the chosen section. The panel marked B4 in Figure 3.8 lies outside the third section and was instrumented for redundancy purposes.

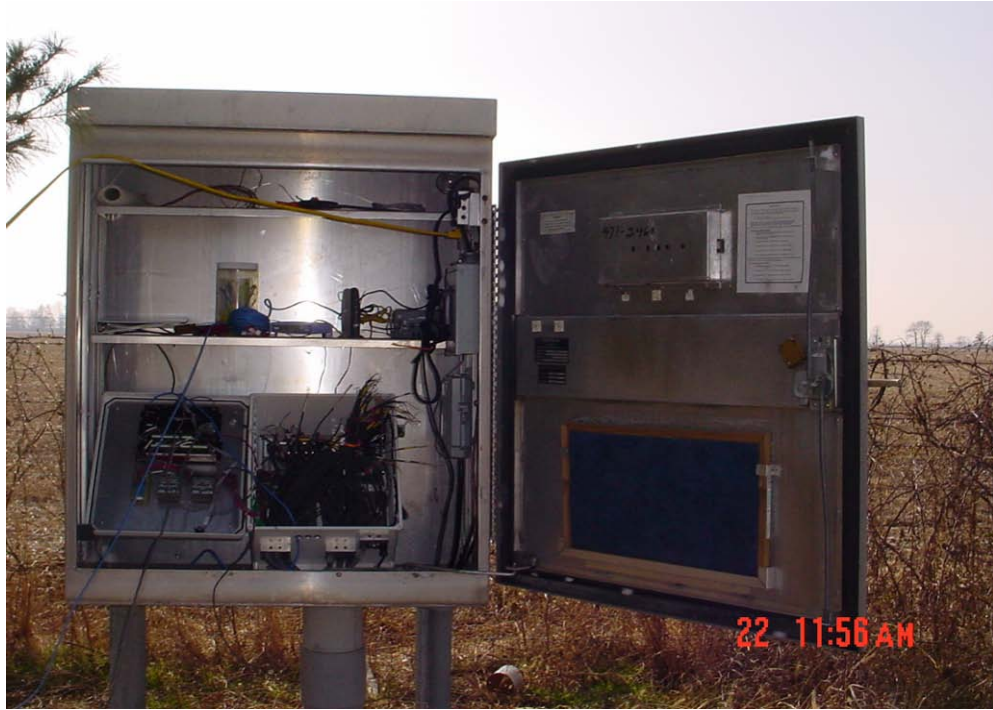
Figure 3.9 - Signal cabinet with main data-acquisition equipment installed at the edge of right of way

A custom data-acquisition system was assembled and used for the monitoring of embedded instrumentation. The data acquisition system consisted of a Campbell Scientific CR10X data logger, (3)-32 differential AM416 relay multiplexers, 110V AC to 12V DC power supply, two AVW1 vibrating wire interfaces, and an NL100 network link interface for remote communication. A centralized location at the test site was chosen to minimize cable lengths and power requirements where the system was housed in an all-weather signal cabinet typically used to house electronics at traffic signals (Figure 3.9).

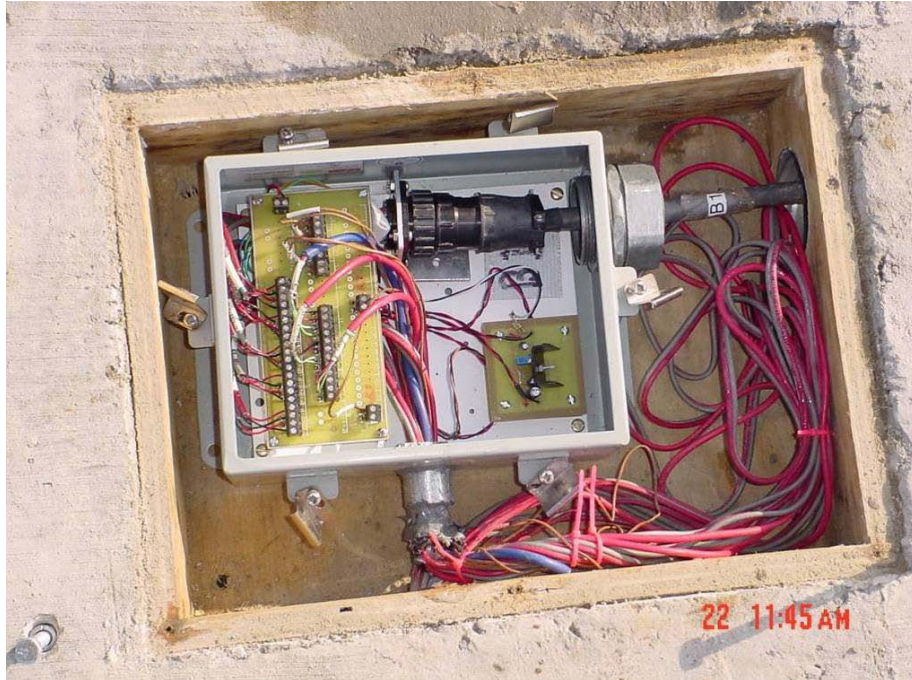
Figure 3.10 - Junction box installed in blockout cast in outside shoulder of precast pavement panels

Junction boxes were cast into the shoulder of instrumented panels to provide quick-connect after panel shipment, house a cold-junction compensation circuit needed for thermocouples and voltage regulation circuit for regulating power used by instrumented rebars (Figure 3.10). Voltage regulation at the pavement was necessary due to the voltage loss in the long lengths of cabling to connect instrumentation required due to the large foot print of the project. Multi-pair, stranded wires were run from the junction boxes of each panel back to the data acquisition system for signal transmission.

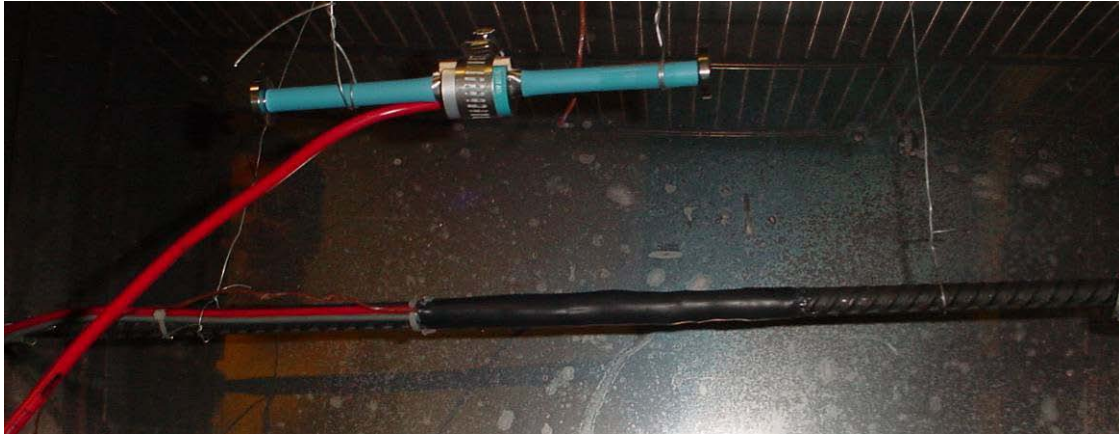
Figure 3.11 – Unrestrained instrumented rebar and vibrating wire gage in temperature controlled oven

In an effort to minimize temperature dependent effects, self temperature compensating full bridge circuits were used on the instrumented rebars. In order to understand how the embedded instrumented rebar system responds to thermal and mechanical loads from restraint, laboratory experiments were performed using both unrestrained instrumented rebars as well as instrumented rebars embedded in concrete. One instrumented rebar and one vibrating wire gage were cast into a 6 inch x 6 inch x 24 inch (15.24cm x 15.24cm x 60.96 cm) long concrete specimen in order to duplicate the response of an instrumented rebar embedded in the pavement. Another set of similar instrumentation was supported by metal wires so as to eliminate any restraint to their free movement. Both sets (embedded and unrestrained) of instrumentation were put in an oven and subjected to programmed temperature histories. Figure 3.11 shows the unrestrained instruments suspended by thin wire in the oven.

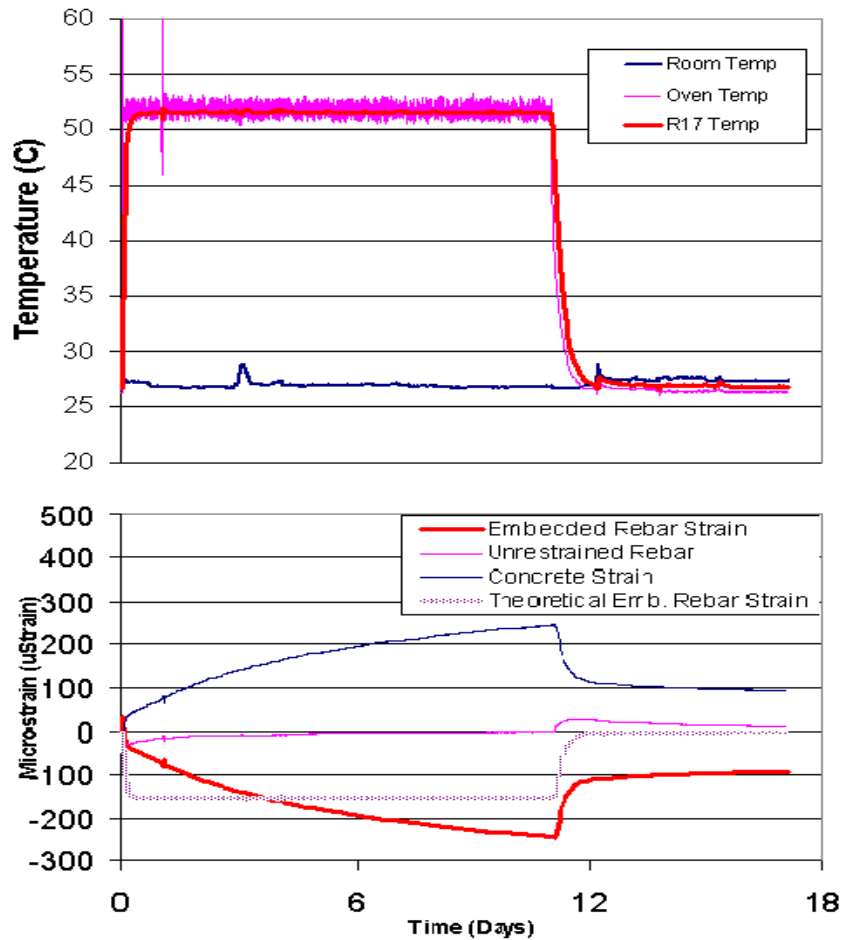
Figure 3.12 – (a) Temperature history (b) Strain history of embedded and unrestrained rebar instruments

temperatures in the oven (for a relatively green concrete, 14 days old when experimented was started). This was confirmed after the heat had been turned off. The resulting magnitude of residual strain measured by the embedded rebar was equal to the difference between the theoretical embedded rebar strain and actual embedded rebar strain (approximately 100 μ strain of drying shrinkage strain). Concrete strain was calculated by multiplying the scalar $(-6 / 6.2)$, which was calculated from the difference in CTE's of concrete and the rebar. It can be seen in Figure 3.12 that after 11 days, the temperature measured by the thermocouple (wrapped up with the embedded rebar, R17), had reached room temperature rather quickly yet there was still strain recovery over the following days that mimicked the unrestrained rebar signal.

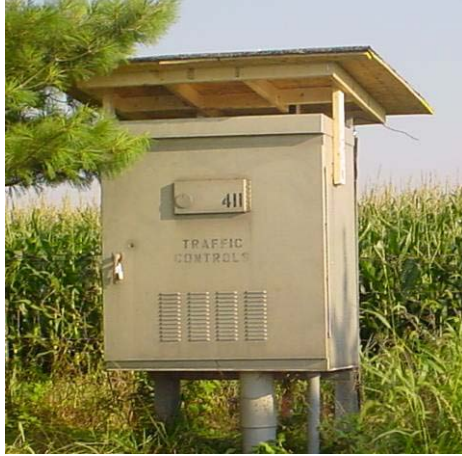
Figure 3.14 – Signal cabinet protected during the heat of the day by a shade roof

The signal cabinet that housed the power supply, communications and data acquisition system was located in a field just beyond the shoulder alongside the instrumented pavement section. This box was exposed to fairly high ambient temperatures (build-up of temperature in excess of 160°F during peak summer days was measured). These excessive ambient temperatures and resistive heat build up in the voltage regulators resulted in malfunctioning of the voltage regulation circuitry that supplied DC power to the instrumented rebars. A “belt-and-suspenders” approach helped alleviate this problem. First a roof was built to protect the signal box from direct sun exposure (Figure 3.14). Secondly, two heavy-duty equipment fans were installed in the signal cabinet that were on at all times and allowed flow of air through the cabinet. Third, all the voltage regulators were replaced with military grade regulators that were specified for higher operating temperatures. And fourth, all the regulators (those in the signal cabinet as well as the individual panel terminal boxes) were provided with larger aluminum heat dissipation fins. Collectively all of these four upgrades essentially eliminated problems associated with excessive heat build-up and associated electronic instabilities.

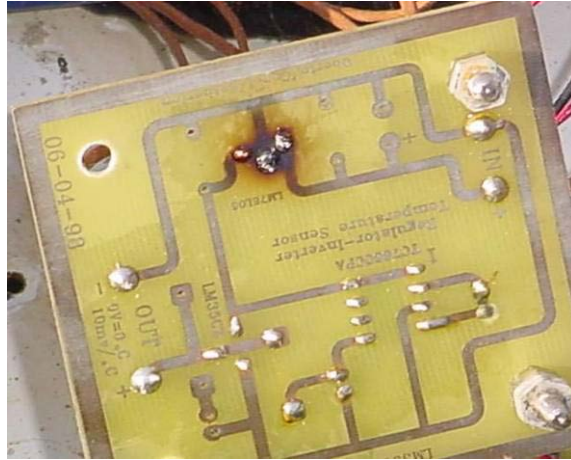
Figure 3.15 – Close-up of CJC damaged by lightning

Even while all cables were well shielded and grounded, lightning strikes tripped the protective circuit breakers, damaged the uninterruptible power supply (UPS), several voltage regulators and cold junction compensation (CJC) circuitry. While studying the “as-implemented” circuitry to fix the problem, it came to light that while the circuit was well protected against a lightning strike on the power pole side of the system, there was little protection against voltage surges on the instrumentation side of the circuitry. Close-up of a CJC circuit board damaged by a lightning strike is shown in Figure 3.15. Diodes, which prevent the reverse flow of electricity, were employed in all of the instrumentation lines and across all of the voltage regulators to ensure that any electrical surge would be discharged to the earth ground. After observing that the most viable method to properly ground the system for lightning affected the magnitudes of the outputs from the instruments due to a ground loop differential, a spark gap was employed to prevent adversely affecting the system during normal operating conditions and still provide lightning protection when needed.

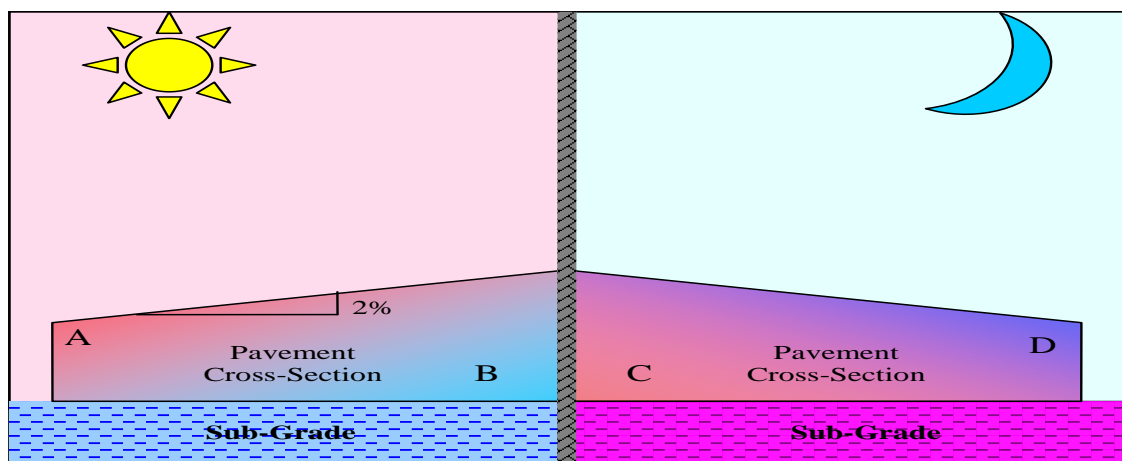
Figure 4.1 – Day and Night Cooling Trends

and ground work as heat sources and sinks. This enables the thinner sections to heat and cool more quickly than the thicker section around the crown. Figure 4.1 highlights the potential for differential heating and cooling using a typical summer day and night. Point A on the pavement panel is at the outer edge of the thinner section, and during the daytime it heats quicker than the rest of the panel that is exposed to the air due to the thicker cross section and proximity to exposed surfaces. Point B is the last portion of the concrete section to heat up during the day, and during the night is the last section to cool down (Point C). Similar trends in reverse are anticipated during cooling cycles during nights or winter related seasonal cold fronts.

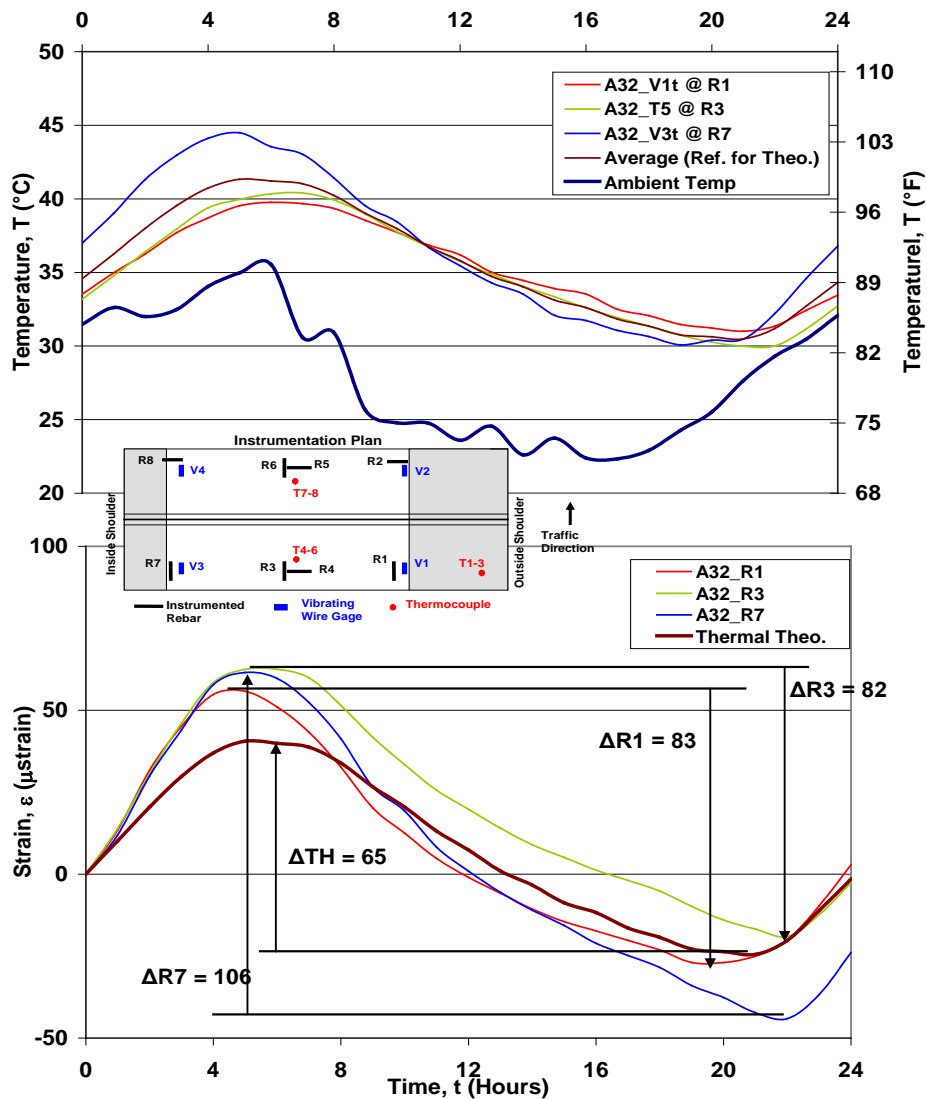
Figure 4.2 – One day window from July 13, 2006 for Panel A32 (a) temperature history (b) strain history

The duration that the strain level is sustained at peak levels during temperature extremes is correlated well with pavement thickness at the location. In Figure 4.2 , R1 peaks at 5 hours and starts to indicate less tension faster than R3 and R7. R3 and R7 exhibit similar thickness dependent strain response.

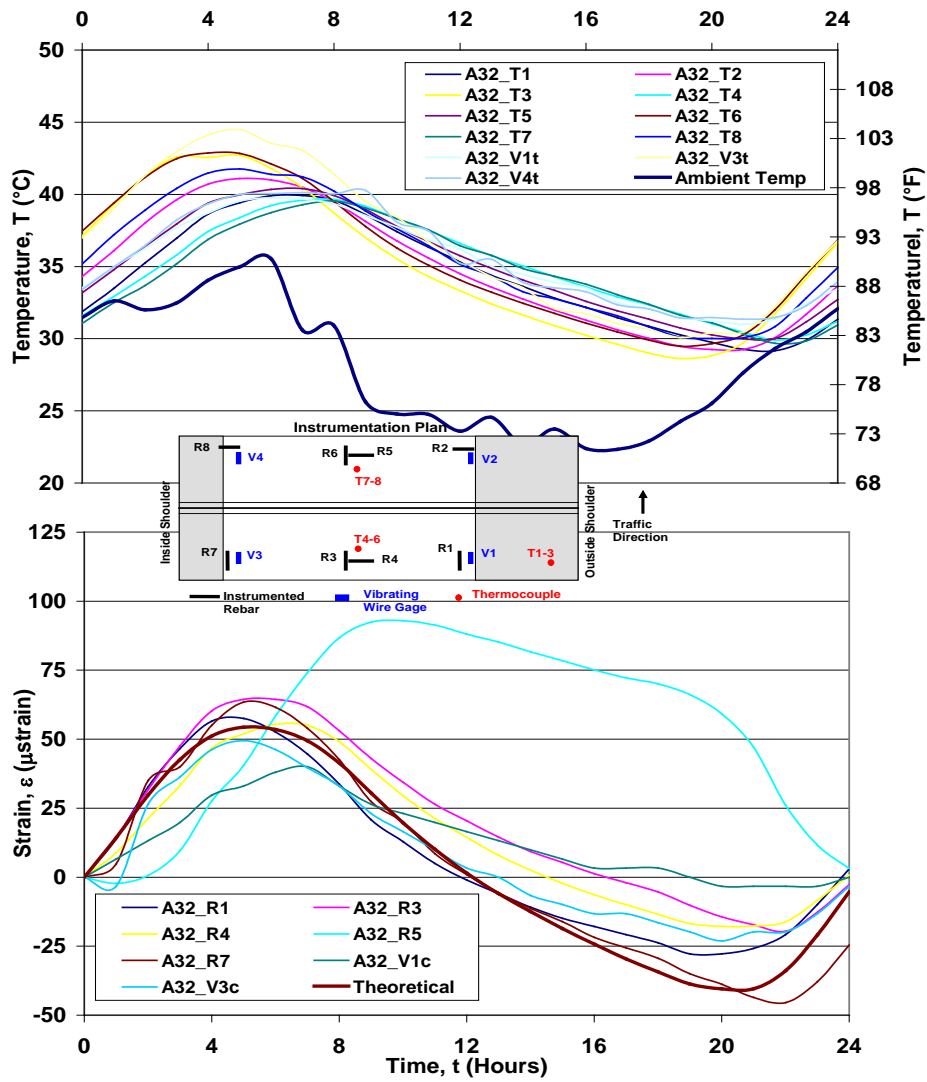
Figure 4.3 – One day window from July 13, 2006 showing all instruments for Panel A32 (a) temperature history (b) strain history

The relative strain response from longitudinal and transverse concrete strains was also studied in relation to the daily thermal history. Figure 4.3a and Figure 4.3b shows the response from instrumented rebars during a 24-hour window for a typical summer day. Strains proportional to the local temperatures of 35 to 60 μstrain can be observed for the rebars aligned along the traffic direction (longitudinal rebars R1, R3, and R7). R5

which is located transverse to traffic indicates much larger tensile strains on the order of 90 μ strain. The tensile strains of R5 in Figure 4.3b are also sustained at the high magnitudes of strain for much longer than peak strains sustained by the longitudinal rebars. The higher tensile strains and durations are also illustrated for the transverse rebar, R3 in panel B3 (Figure 4.4b). Similar responses for the transverse strain behavior were recorded for a typical winter day and presented in Appendix A (See Figure A.1), highlighting the fact that this behavior is not unique to significantly different average ambient temperatures (30°C for the summer day shown versus 8°C for the winter day).

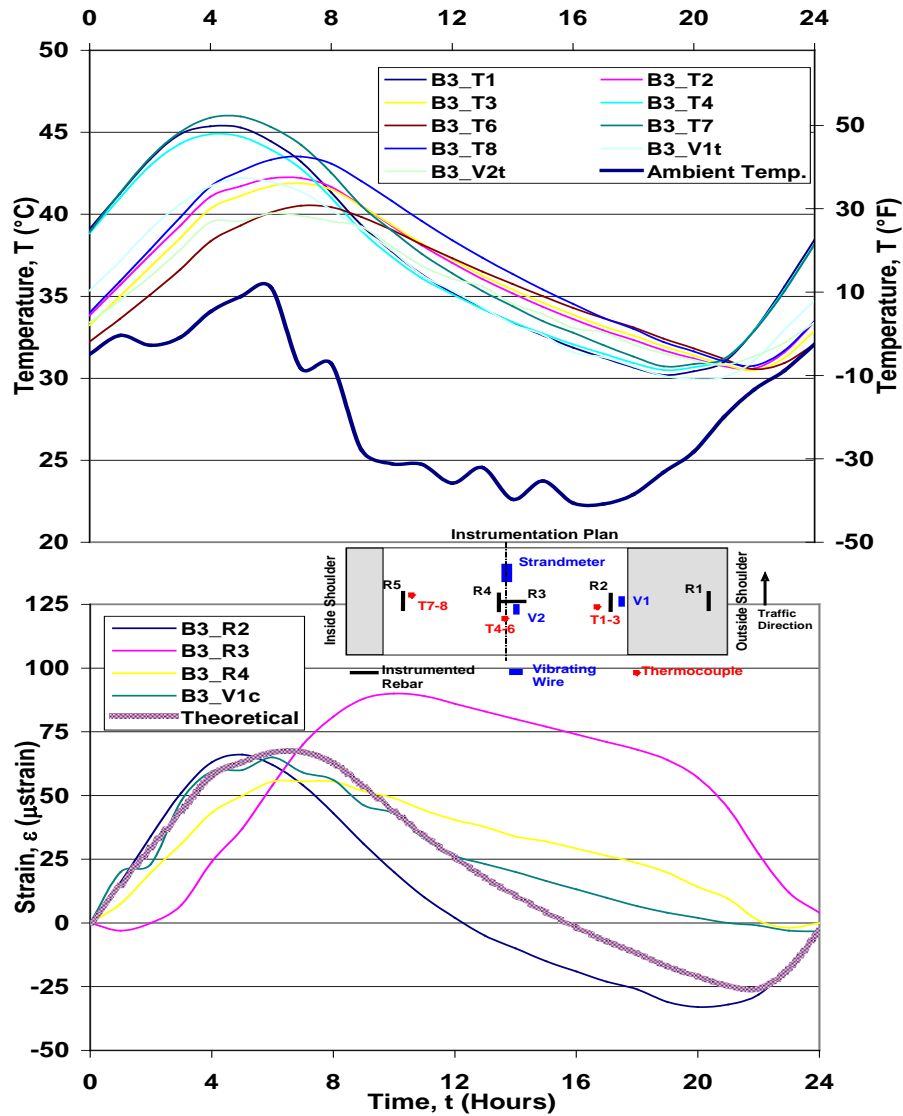
Figure 4.4 – One day window from July 13, 2006 for Panel B3 (a) temperature history (b) strain history

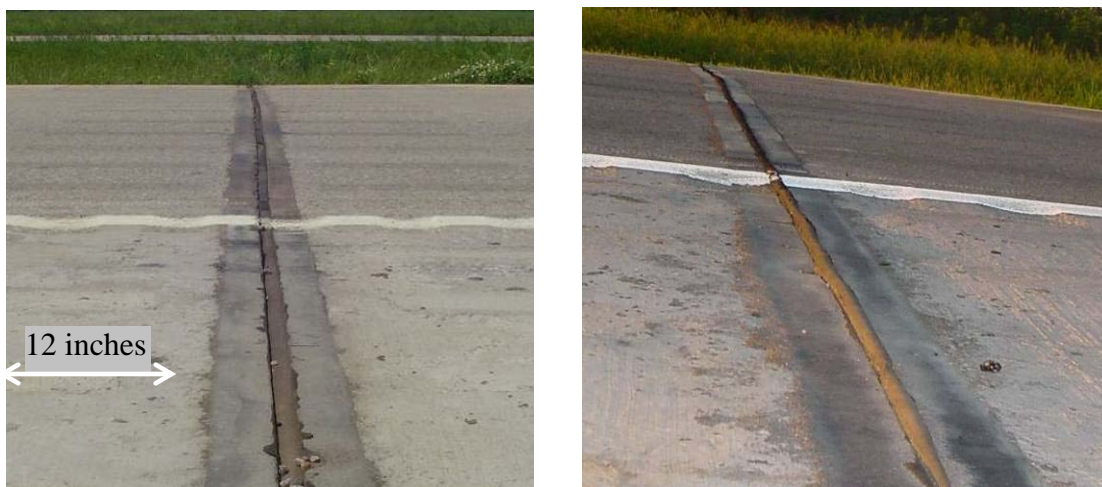
Figure 4.5 – Joint Panel A31 during mild temperatures (Left) and hot temperatures (Right)

The effect of daily temperature excursions can also be observed by looking at the performance of a typical joint panel during the day. Figure 4.5 (Left) shows the silicone based joint compound receding below the pavement surface during lower temperatures. During the hottest times of the day the joint compound squeezes above the pavement surface and appears to be damaged by vehicles passing over it (Right).
