EVALUATION OF THE SERVICE PERFORMANCE OF AN INNOVATIVE PRECAST PRESTRESSED CONCRETE PAVEMENT

A Thesis
presented to
the Faculty of the Graduate School
University of Missouri – Columbia

July 2009

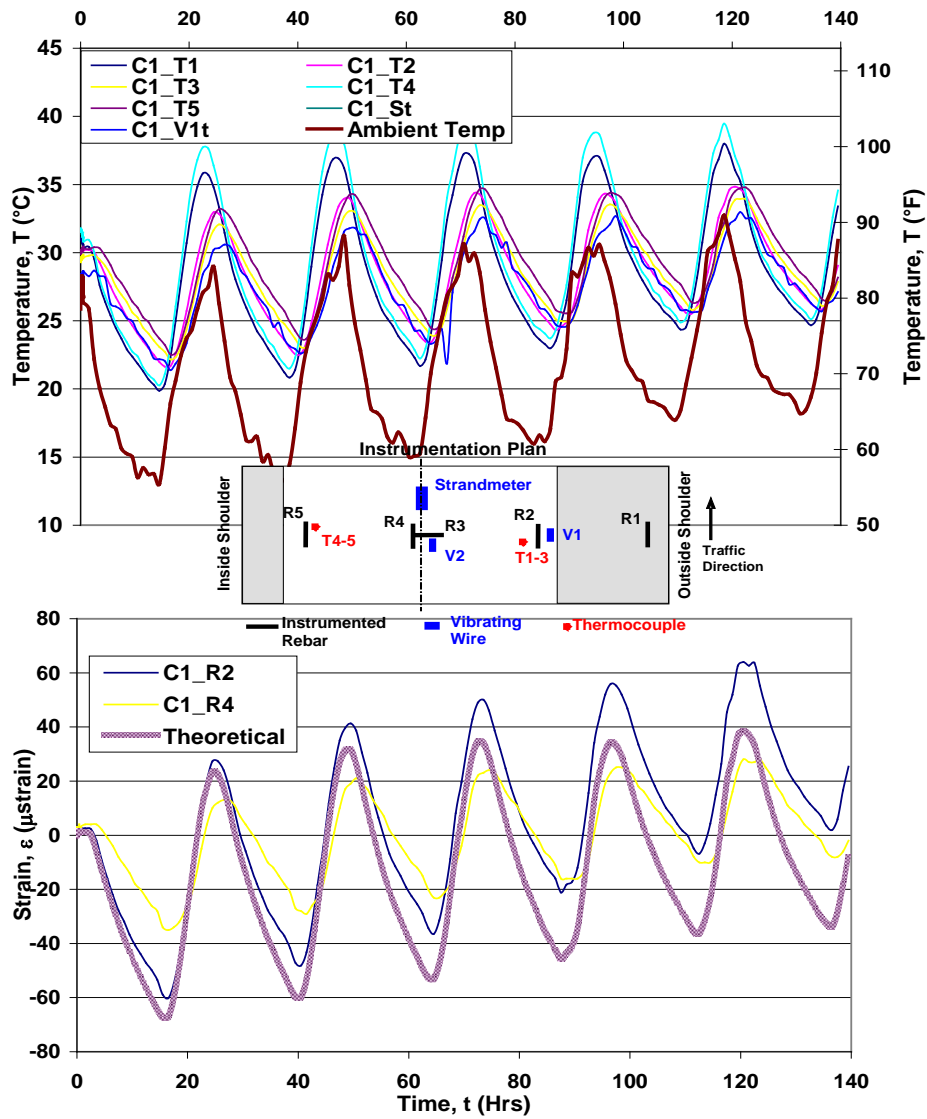
Figure 4.6 – Measured concrete strains in pavement at a short-termed window (a) temperature history (b) strain history

The rate at which the temperature in the pavement increased or decreased was observed to largely be a function of the proximity of the specific location to an exposed surface and location-specific thickness of the pavement, as seen in Figure 4.6a. Thermocouples 1 and 4 (T1 & T4) had a faster rate of heating and cooling since they were located approximately 2 inches from the top surface of the pavement. It is for this reason that they measured the hottest and most cool temperatures from day to day. The rest of the thermocouples were located at mid-depth or at the bottom 1/3 of the cross-section. As the location of the temperature measurement gets closer to the crown and deeper in the pavement, smaller magnitudes of changes in temperature were observed as

shown in Figure 4.6a. The convention used was as follows: T1 closest to the top surface, T2 in the middle, T3 at the bottom, T4 at top, T5 close to bottom. The exact locations and thicknesses of the pavement at specific instrument locations are presented in Appendix B. Concrete strain, as denoted by the individual devices (R2, R4) is largely proportional to the magnitude of temperature at that cross-section of pavement.

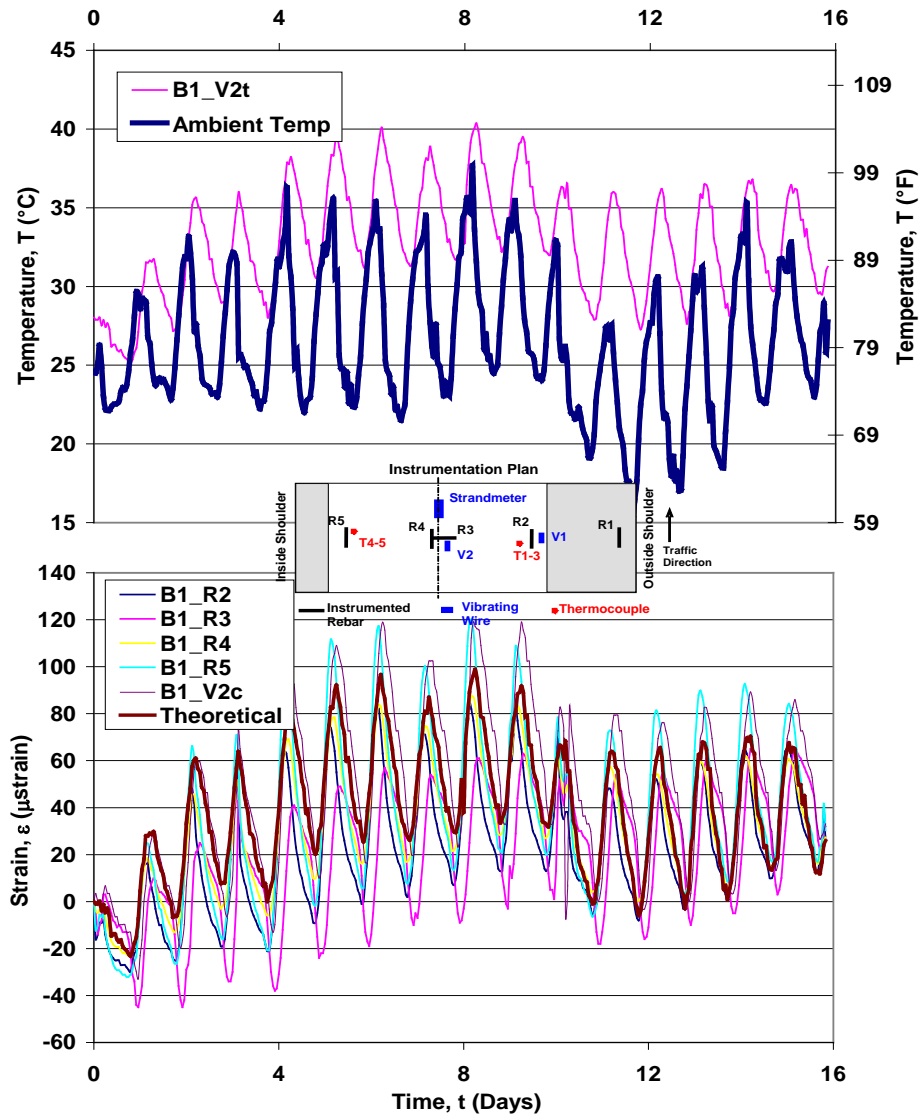
Figure 4.7 – Medium window indicating weekly heating and drastic cold front with associated concrete strains (a) temperature history (b) strain history

Analysis of results using time windows of different lengths facilitated study of seasonal variations and associated performance of the pavement section. Figure 4.7a shows a moderate heating trend in mid July, including the movement of a cooling front on Day 11 where the mean temperature drops approximately 5°C (9°F). It is readily apparent in Figure 4.7a that the pavement temperatures are higher than the ambient air temperature. The temperature in the pavement stays well above the low temperature at night due to the ground retaining much of its heat. This effect is clearly noted on Day 11 in Figure 4.7 due to the cold front moving and the lowest temperature in the pavement was still above the hottest air temperature of the previous day. Much larger strains were measured by the instrumented rebars compared to the theoretical values, which were validated by comparing with the strain response from the vibrating wire instruments. This is in part due to the only location that temperature was measured in the panel was located near the thickest portion, where the change in temperature is the lowest throughout the day. It was from this temperature measurement the theoretical response was predicted. Larger temperature variations are prevalent in the thinner sections which resulted in larger changes in strain over the individual days. This relationship is indicated in Figure 4.8.

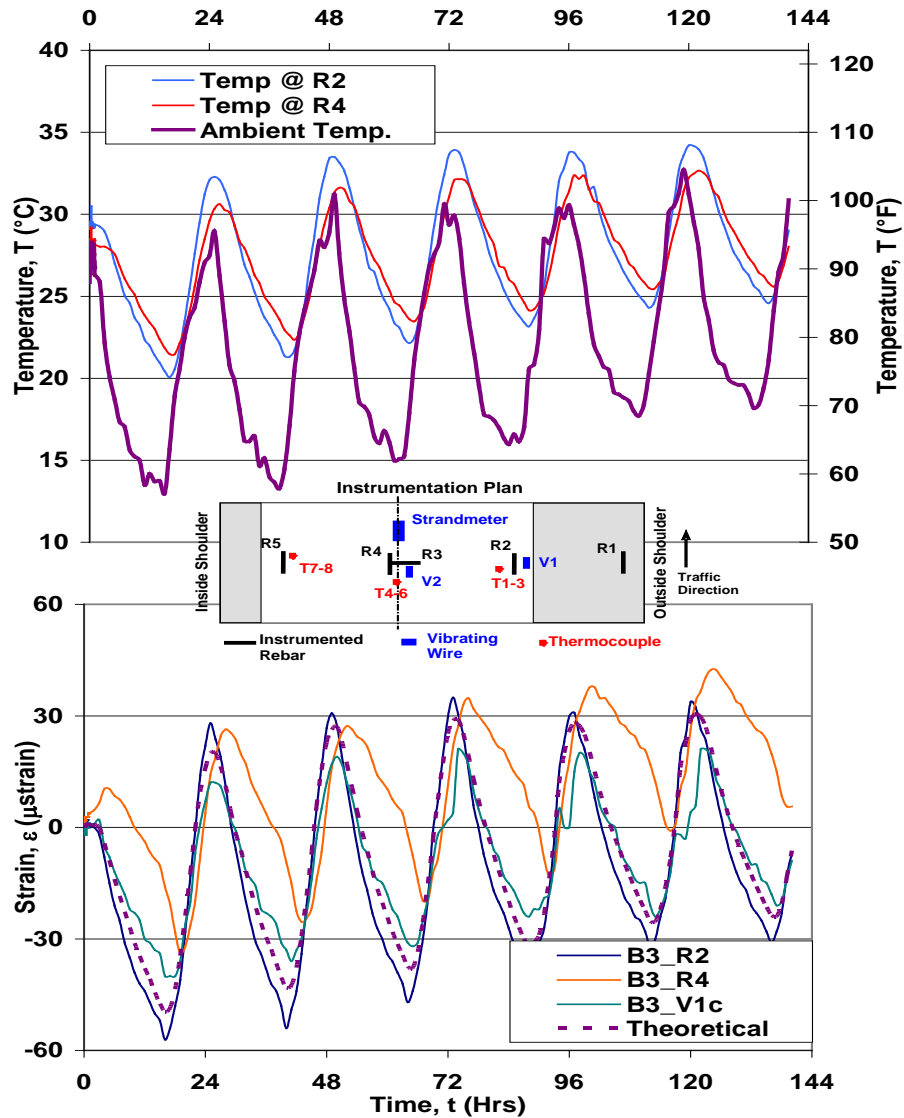
Figure 4.8 – Weekly instrument history for Panel B3 (a) temperature history (b) strain history

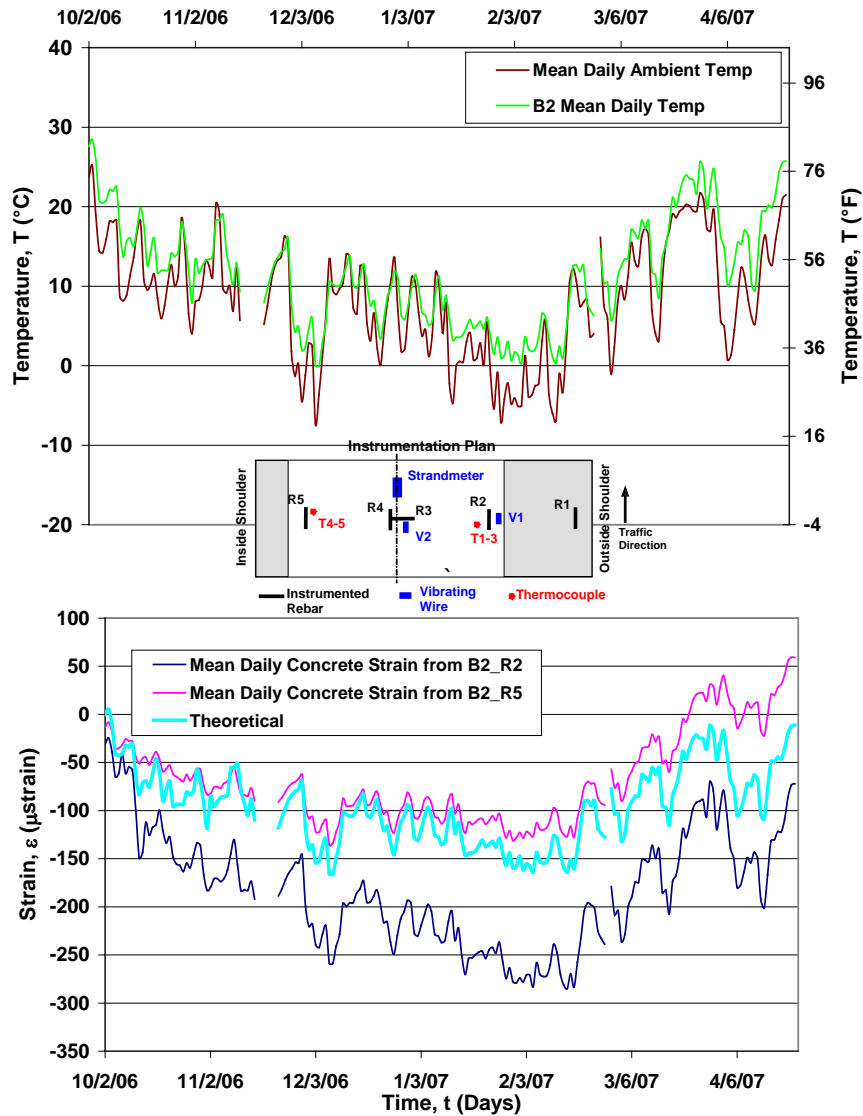
Figure 4.9 – Six month window showing longitudinal concrete strains in Panel B2 at different locations (R2 and R5) (a) temperature histories (b) strain histories

In Figure 4.9 an overall compressive trend (reducing strain magnitude) can be observed as the mean daily temperature drops during winter and similarly a tensile trend (reduced compression) can be observed when the mean temperatures rise during spring. The theoretical concrete strain ($\alpha\Delta T$) is calculated assuming a CTE of $6 \mu\text{strain}/^\circ\text{C}$ (using the average change in temperature recorded by all thermocouples in the panel).

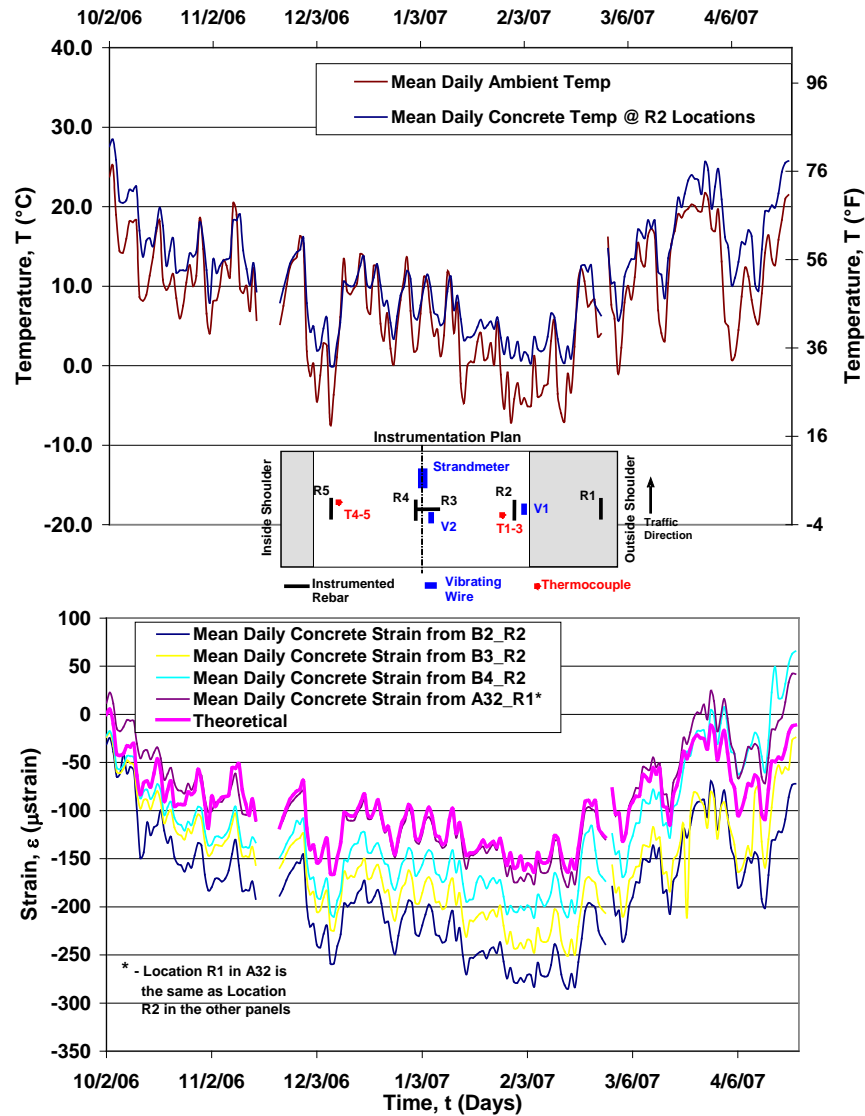
Figure 4.10 – Six month window showing longitudinal concrete strains at identical panel location (R2) in different instrumented panels (a) temperature histories (b) strain histories

While simplistic and idealized this prediction captures the essence of trends in strains from thermal loads. However magnitudes of strains are predicted inadequately. It should be noted that in addition to thermal loads, the strain histories in plots like that shown in Figure 4.9 are also influenced, in a location specific manner, by several other factors including: elastic (modulus) and thermal (CTE) mismatch between pavement and sub-grade and resultant sub-grade friction, restraint due to an improperly performing joint, local thermal variations (differential thermal gradients due to differences in local exposure/dissipation conditions and due to different pavement thicknesses) and changes in prestressing force due to thermal effects. Relatively negligible influences can also be attributed to creep and shrinkage of concrete, relaxation of prestressing steel, traffic loads and strain gradients from bending. Figure 4.10 shows longitudinal strain histories measured from different instrumented panels using instrumented rebars along the passenger side wheel path of the right lane (see inset showing measurement location R2).

It should be noted that location R1 in joint panel A32 is identical to location R2 in all base panels (B2, B3, and B4). It is interesting to observe that strain magnitudes monitored in Figure 4.10b progressively decrease from panel B2 to B3 to B4 and to A32 (from the base panels in the middle of the test section to the joint panel at the end of the test section). While not conclusive, the consistent and progressive reduction of peak

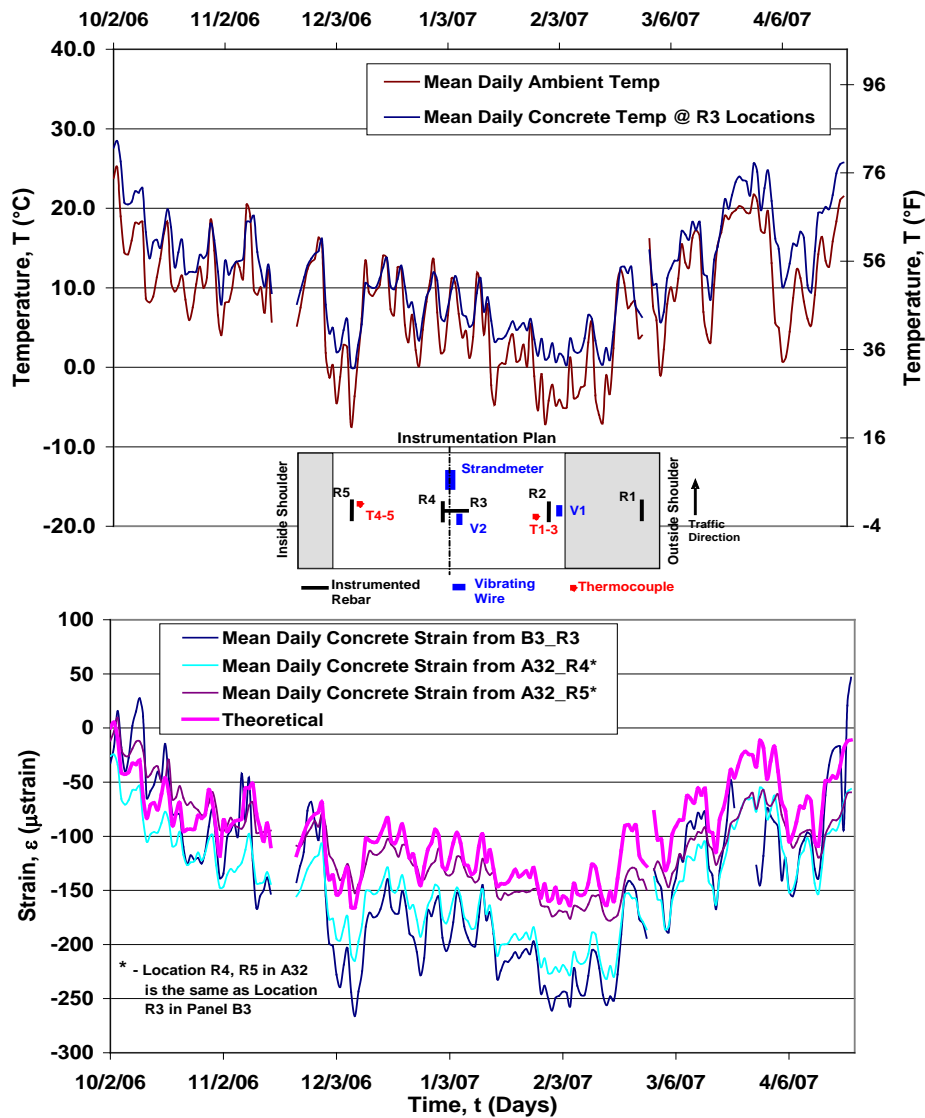
Figure 4.11 – Six month window showing transverse concrete strains at identical panel location (R3) in different instrumented panels (a) temperature histories (b) strain histories

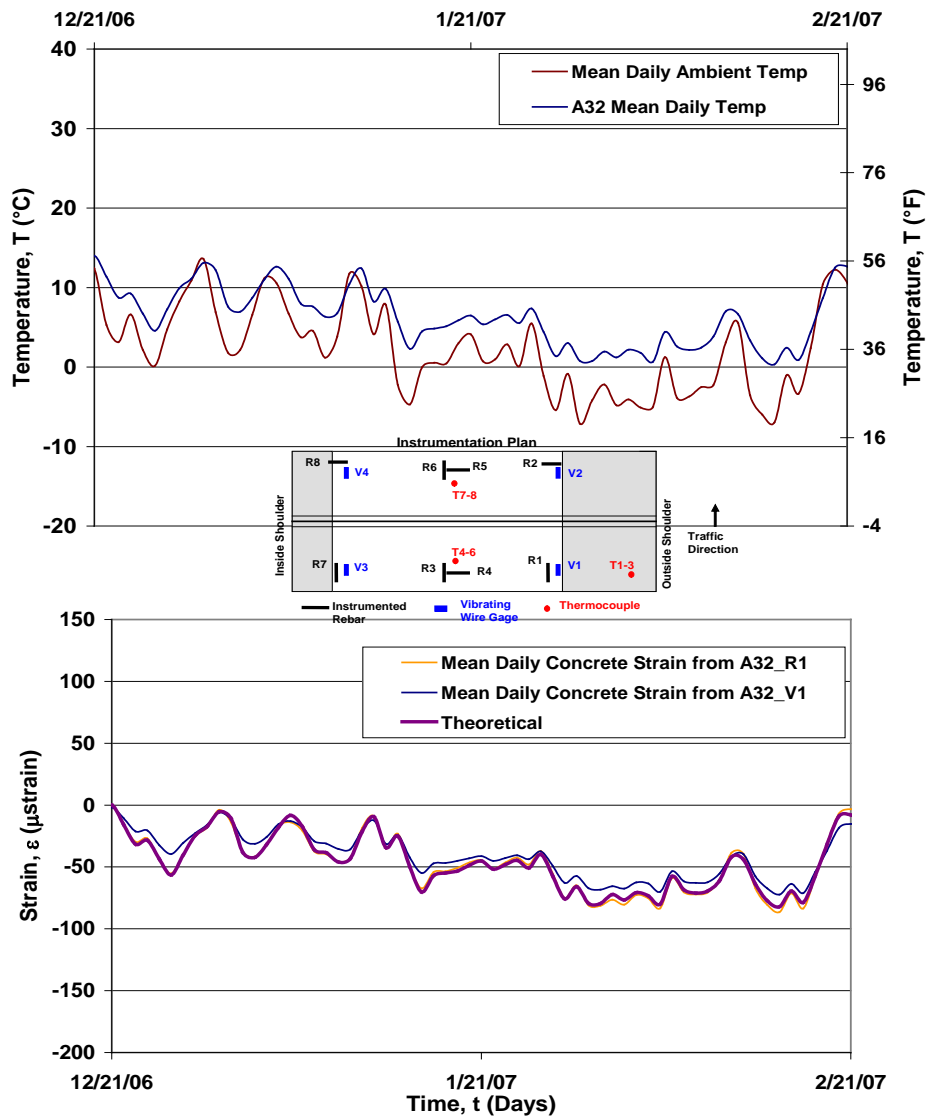
Figure 4.12 – Two month window showing longitudinal concrete strains at identical panel location (R1-V1) measured using instrumented rebar R1 and vibrating wire gage (V1) (a) temperature history (b) strain history

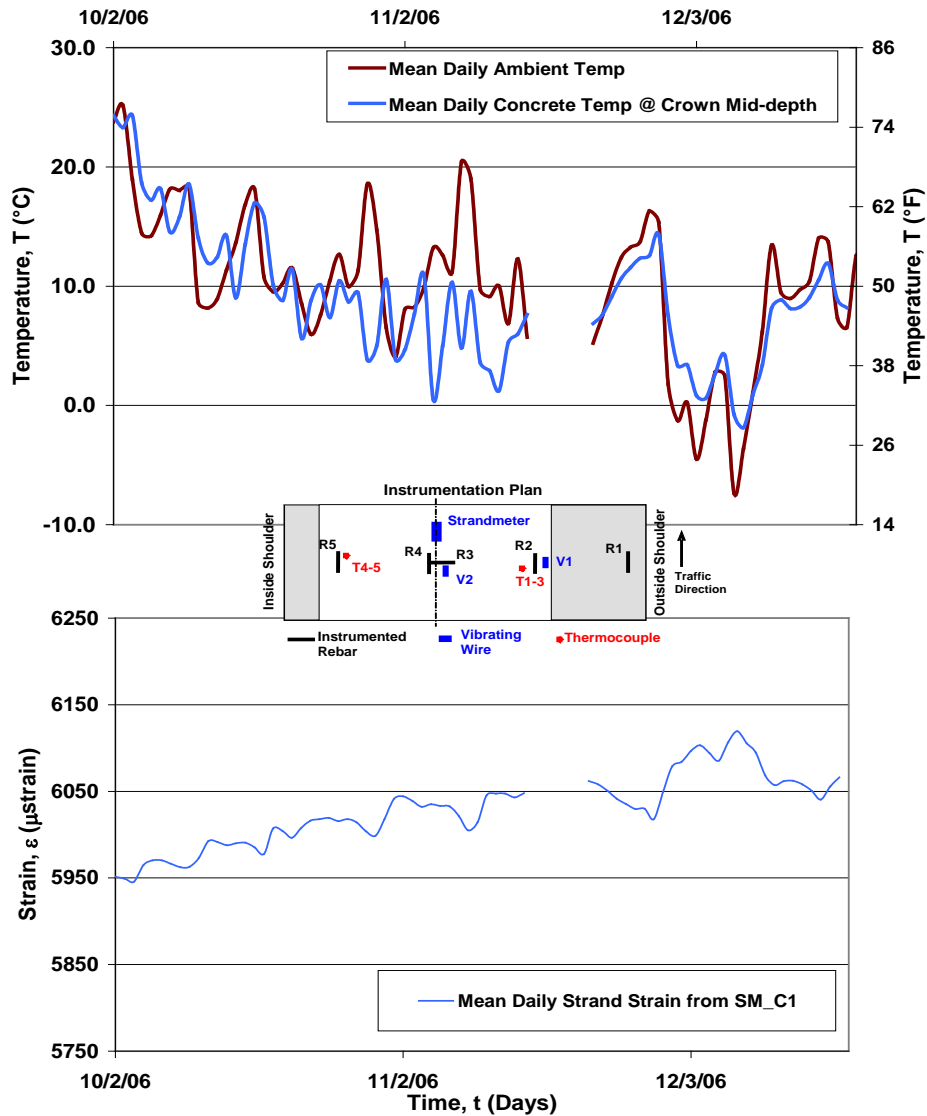
Figure 4.13 – Strandmeter response at center of 250’ test section during typical winter-time temperature excursion (a) temperature histories (b) strain histories

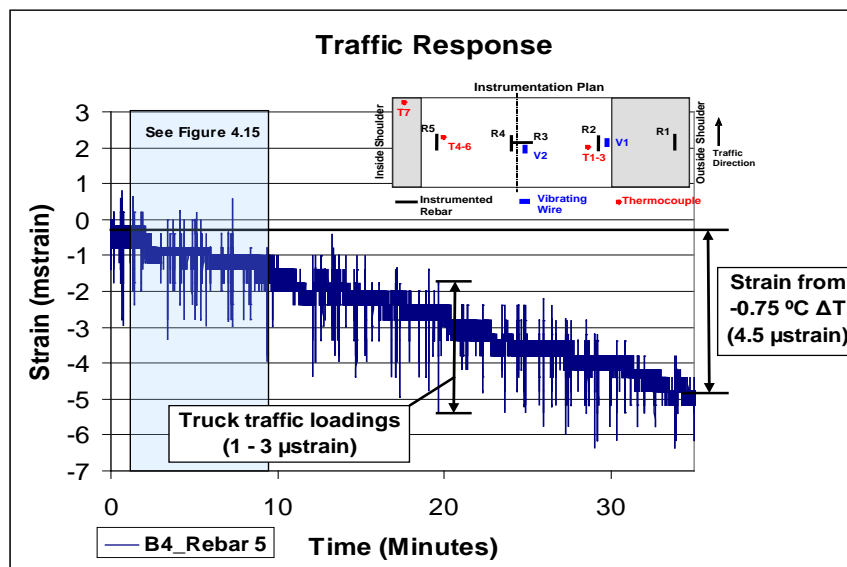
Figure 4.14 - Traffic strain (rebar response) in the pavement at crown

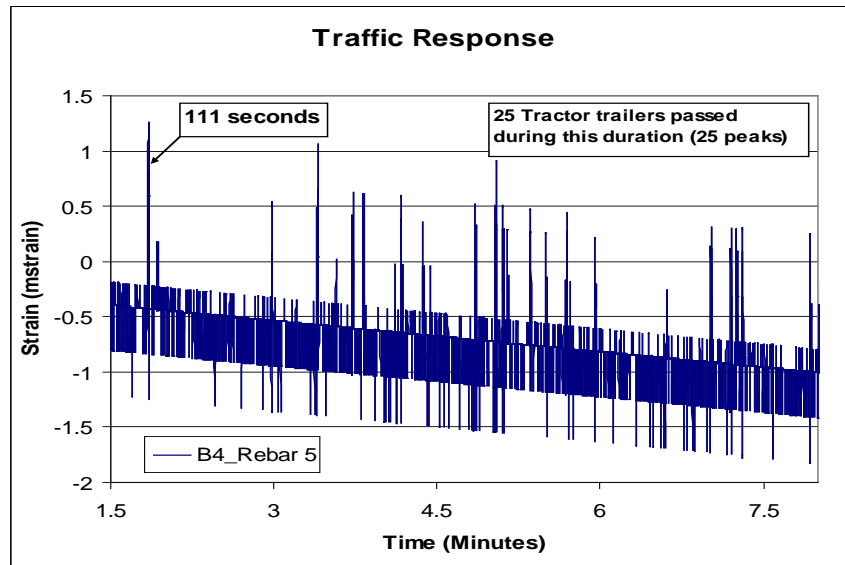
Figure 4.15 – Duration of traffic response that was verified visually

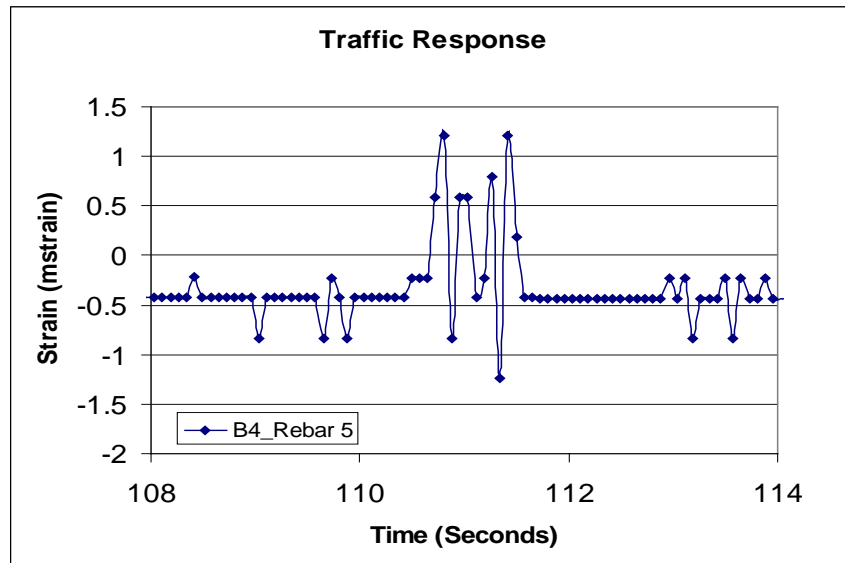
Figure 4.16 – Resulting concrete response from a tractor trailer passing over

strains (extreme fiber) caused by traffic loading are likely less than 25 μ strain which is a small portion of the total daily strain behavior characterized largely by thermal expansion/contraction.

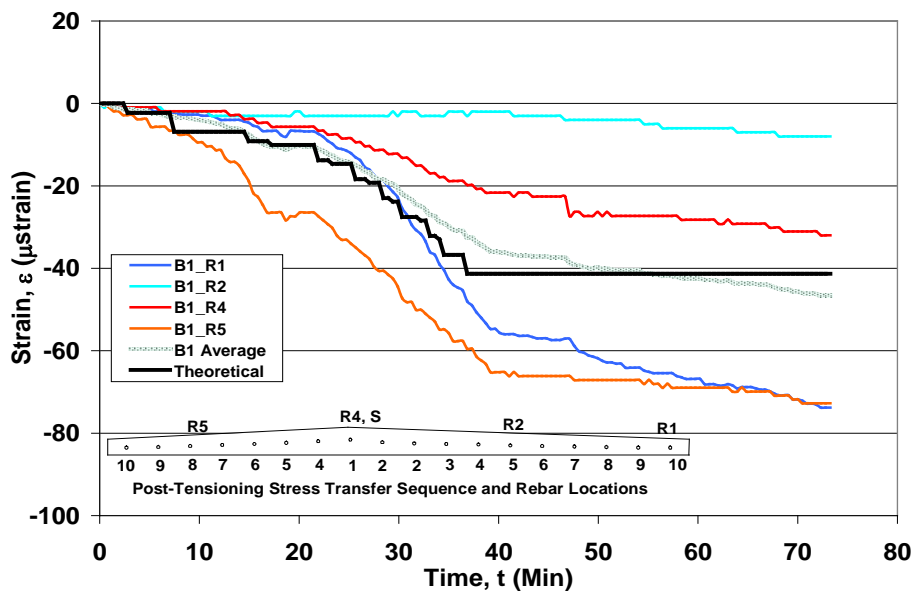
Figure 4.17 – Concrete strain for a typical base panel during post-tensioning operations

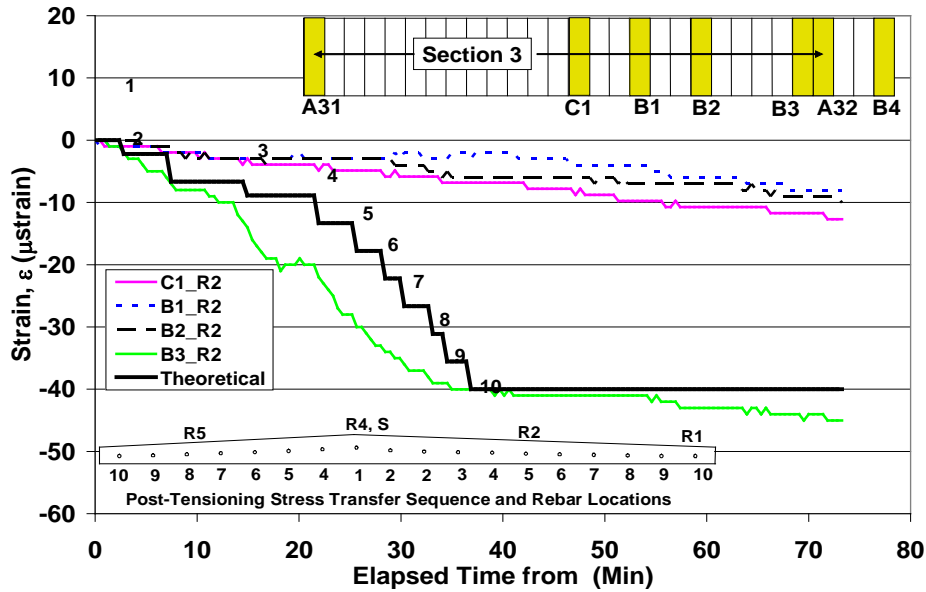
Figure 4.18 – Concrete strain measured at the R2 location (beginning of outside shoulder)

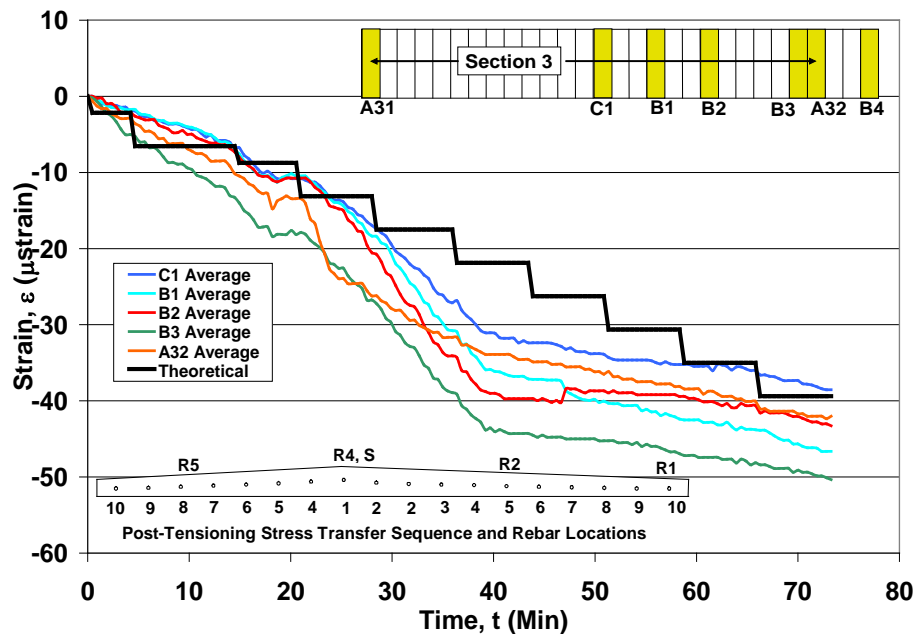
Figure 4.19 – Average Post-tensioning concrete strain histories for instrumented panels

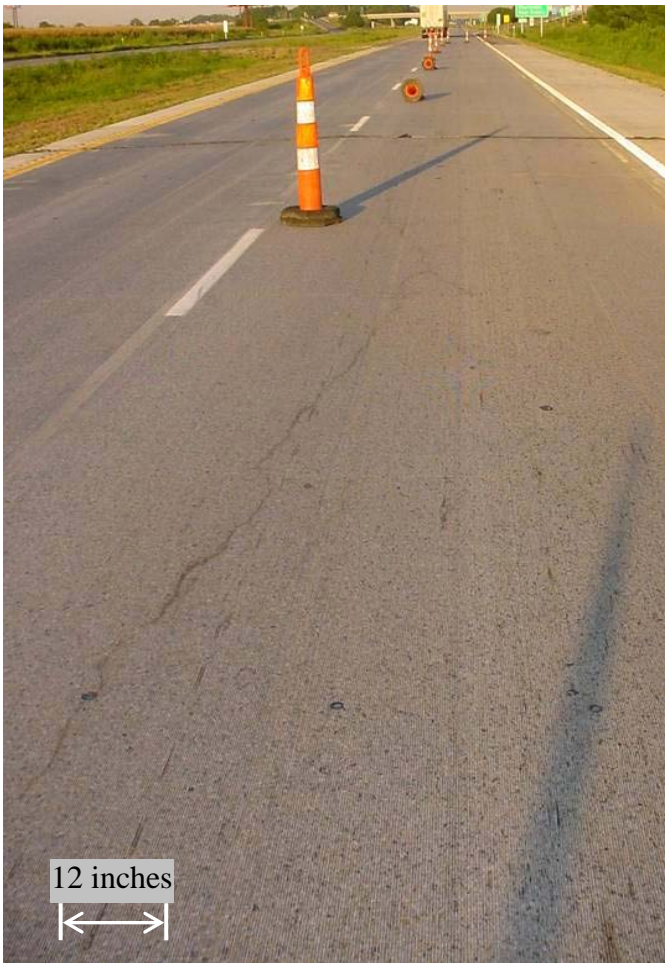
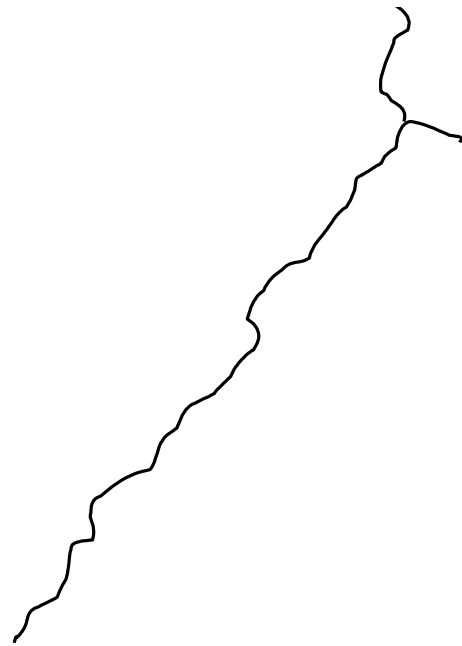
Path of the longitudinal crack

Figure 4.20 - Longitudinal crack in driver side wheel lane

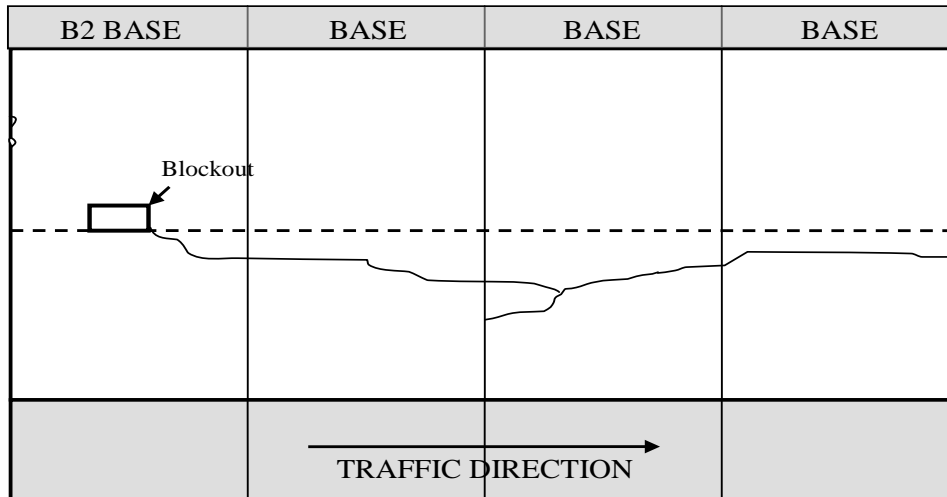
Figure 4.21 - Schematic of one longitudinal crack

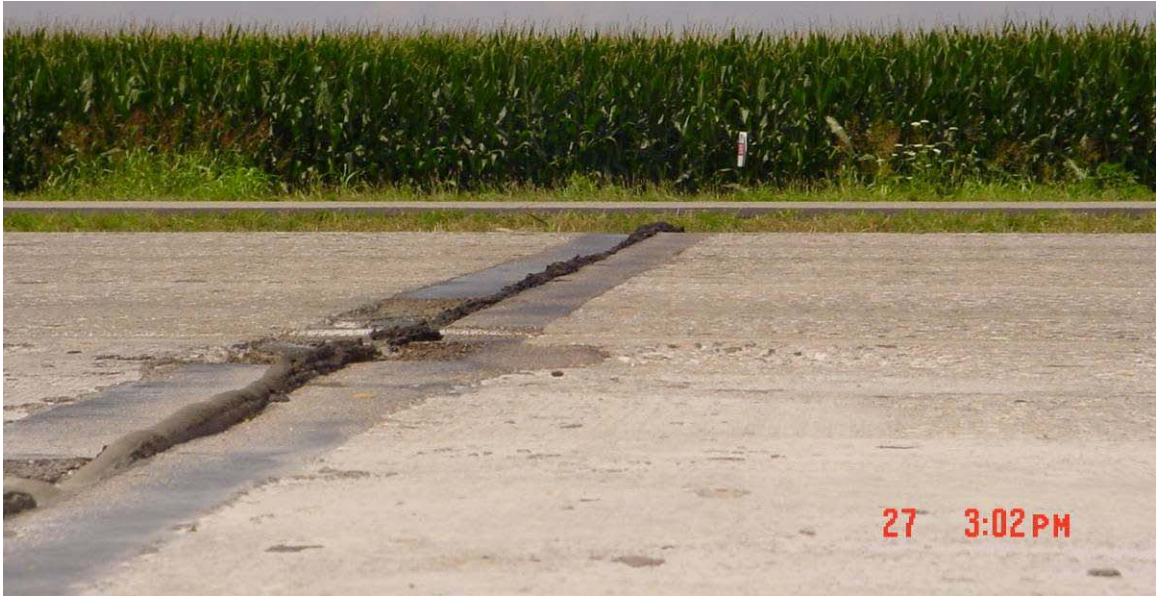
Figure 4.23 – Flexible joint compound squeezing out on a hot day with minor amount of chipping of rigid compound, Joint Panel A32 (June 27, 2006)

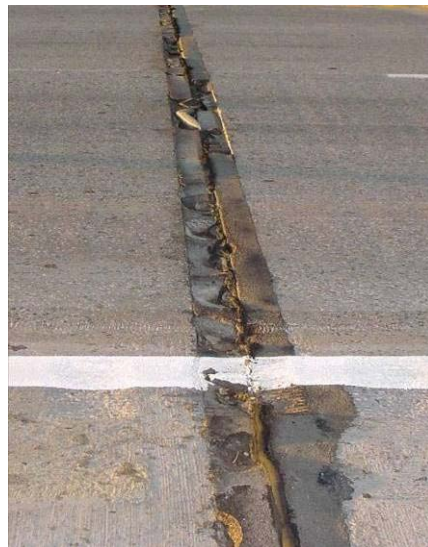
Figure 4.24 – Rigid joint compound chipped away more extensively, Joint Panel A32 (August 16, 2006)

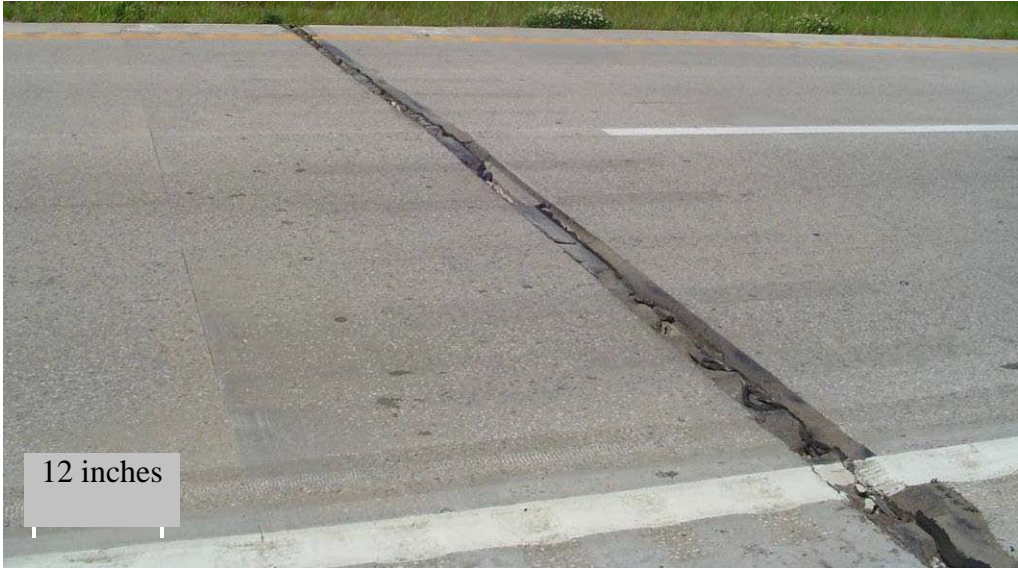
Figure 4.25 – Moderate degradation to rigid joint compound, Joint Panel A32 (May 9, 2007)

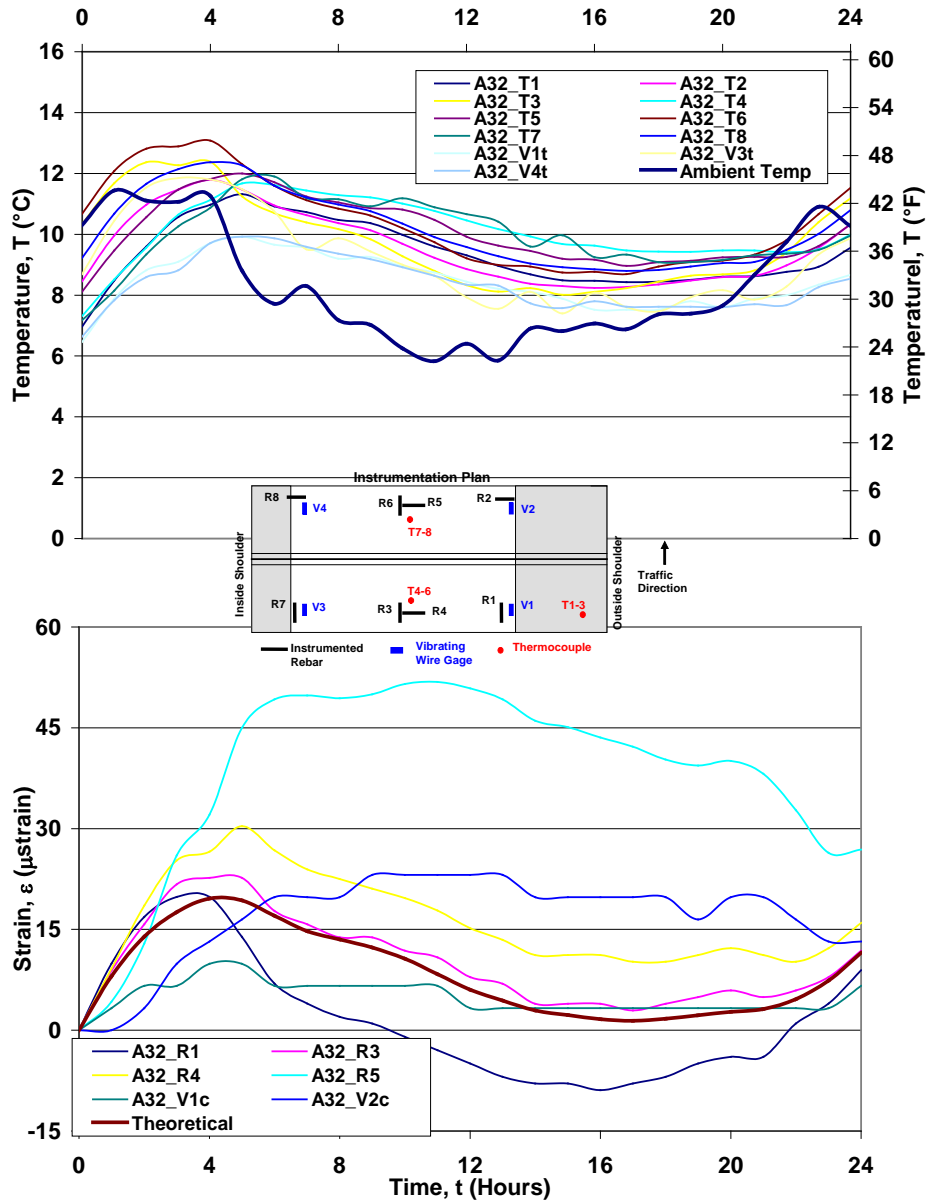
Figure A.1 – One day window from 12/27/2006 for Panel A32 (a) temperature history (b) strain history

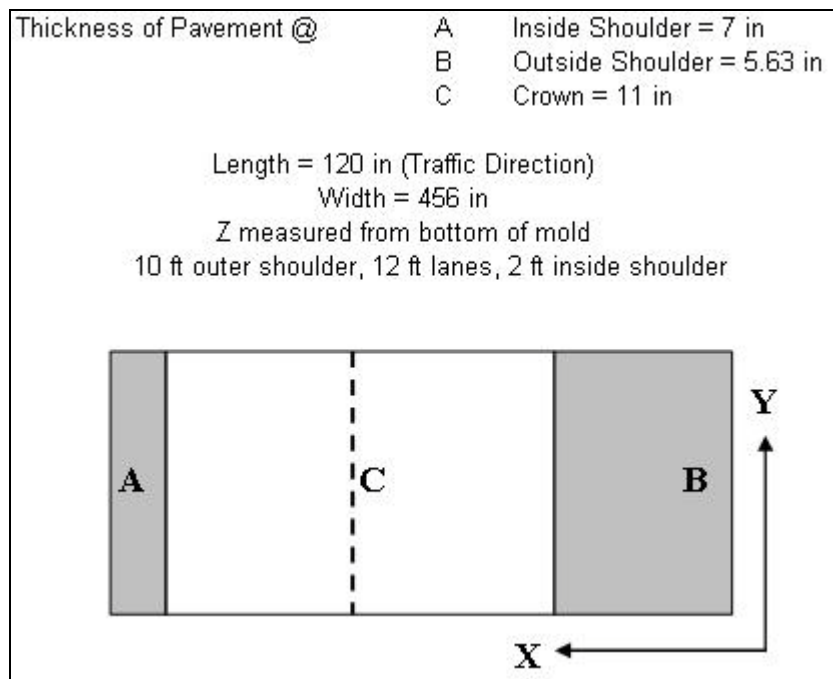
Figure B.1 – Convention for gage locations
