REMOTE HEALTH MONITORING FOR ASSET MANAGEMENT

A Thesis presented to the Faculty of the Graduate School of the
University of Missouri - Columbia

MAY 2009

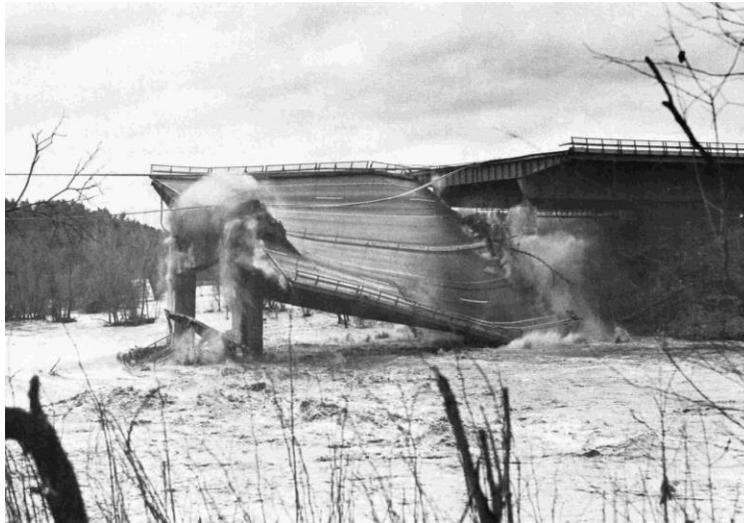
Figure 2-1. Photograph of the Schoharie Creek Bridge collapse, 1987.

The collapse of the Schoharie Creek Bridge in 1987 (shown in Figure 2-1) introduced a new era of concern regarding the structural stability of highway bridges and the stability of the substructure systems supporting them. The tragic collapse and others that followed have focused attention on the need for dependable methods of monitoring the structural stability of highway structures. Bridge scour that results in a loss of structural stability is the most common reason for the collapse of highway bridges, and innovative, cost-effective monitoring methods are urgently needed. Presently there are more than 26,000 bridges in the U.S. identified as scour critical [1, 2]. More than 3,700 bridges were damaged by scour during the period of 1985 to 1995[2].

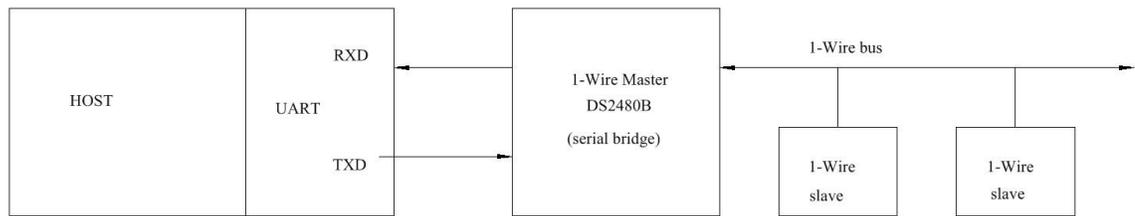
Figure 3-1. DS2480B usage layout.

The DS2480B is used as a microcontroller for 1-Wire applications. It is described as a “serial bridge to the 1-Wire network protocol.” A simplified schematic diagram of the usage of a DS2480B is shown below in Figure 3.1 with two slave devices (DS18S20) attached in a daisy-chain configuration.

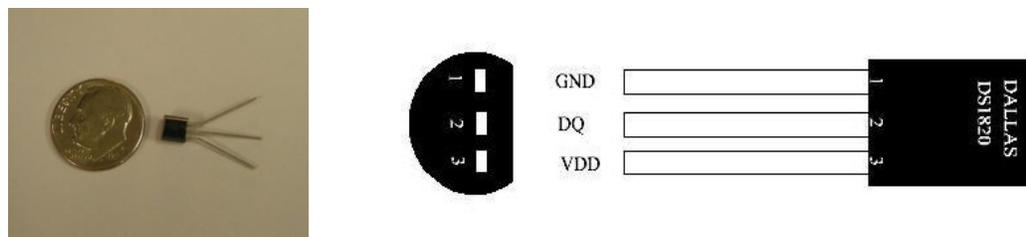
Figure 3-2. Photograph of sensor and pin layout of DS18S20.

The DS18S20 operating temperature ranges from -55°C to $+125^{\circ}\text{C}$ with an accuracy of $\pm 0.5^{\circ}\text{C}$ between -10°C and $+85^{\circ}\text{C}$. One microcontroller can regulate many DS18S20 sensors due to the 64-bit serial code given to each sensor during production. The main advantage of the DS18S20 over a basic thermocouple is its direct-to-digital temperature sensor. This reduces the effect of noise on temperature readouts and improves the sensor accuracy. Figure 3.2 below shows a photograph of a DS18S20 and the pin layout.

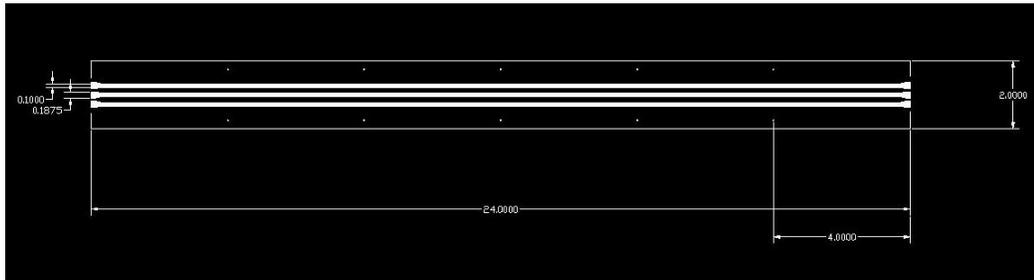
Figure 3-3. AutoCAD drawing used for printing circuit boards.

The AutoCAD drawing of the trunk line design is shown in Figure 3-3. The trunkline design consisted of three conductor lines that run the length of a 24 in. board, a commonly available size for the circuit board materials. Solder tabs are etched at either end of the trunklines to enable the board to be connected by short wires, such that 24 in. modules could be manufactured and then several boards could be connected to create the appropriate length sensor array. The sensors themselves can be soldered to the trunk lines at any spacing interval; a sensor every three or four inches was selected as a suitable spacing for this project. This allows for up to four measurements per foot of pile, adequate for estimating the soil line depth along the pile. This spacing was based on discussions with bridge maintenance engineers that indicated that information on the depth of scour holes to the nearest one foot was adequate for effective decision making and asset management. By placing four sensors per foot, measurement redundancy would exist to provide improved reliability in field applications, and ensure that system resolution met the requirement of determining the depth of a scour hole to the nearest foot.

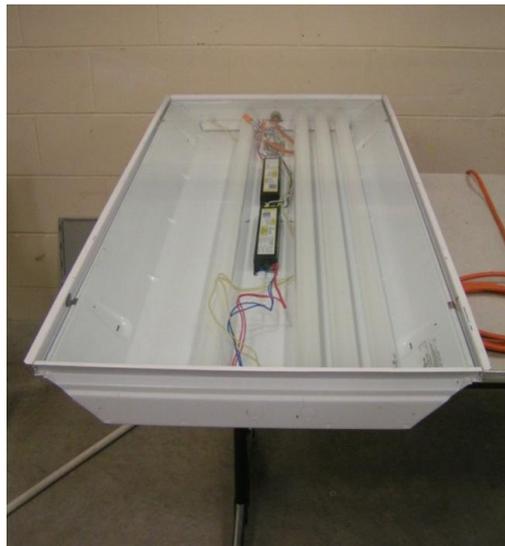
Figure 3-4. Setup for exposing circuit boards.

Figure 3-4 shows the setup used for exposing the circuit boards to UV light. Four fluorescent UV lights were used to maximize the amount of UV light along the entire length of the circuit boards. The large (24 in. long) circuit boards that were required for this project exceeded the size of the exposure beds that were available, and as such a new exposure bed needed to be developed. The exposure bed consisted of a common, 48"

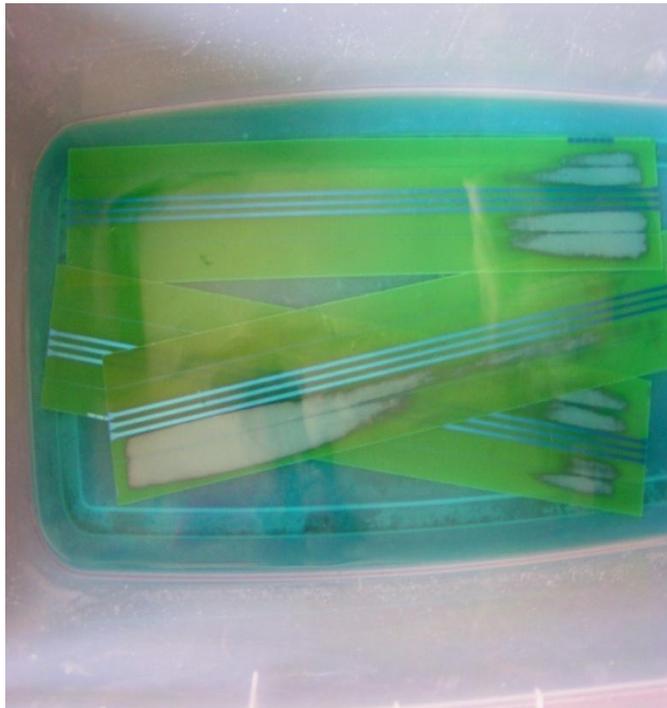
Figure 3-7. Excess copper being removed from the printed circuit boards.

the boards are washed to remove the acid. This manufacturing process was developed through an iterative procedure that improved the consistency of the process and ensured that the copper trunk lines remaining on the board had clear edges to improve long term reliability.

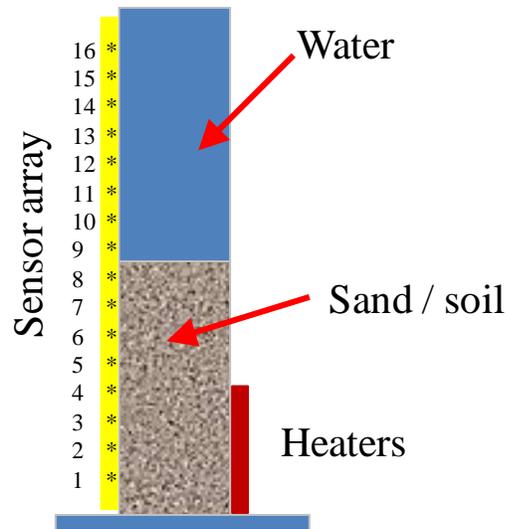
Figure 4-1. Schematic diagram of test set-up showing heaters, sensor array and sand/water interface.

The laboratory set-up included a 6 in. x 6 in. x ½ in. HSS member 48 inches in length to provide a model test pile as shown in Figure 4-1. This test pile was mounted on a 18 in. x 24 in. steel plate by angle clips. A rubber gasket was used to ensure that the HSS would hold water without leaking. The 48” sensor array was attached to the outside of the pile. Inside the test pile, sand was placed in the pile up to a height of approximately 24 inches, then the pile was filled to the top with water. During subsequent testing, the sand was replaced with soil. The test setup was intended to model the installation of the pile in the field, with the array and soil/water interface on opposite sides of the pile. In a field installation, the water and soil would be outside the pile and the sensor array would be

installed within the pile, to measure the thermal behavior of the pile by attachment to the surface of the steel. This configuration was reversed in laboratory testing for convenience. This enabled the evaluation and testing of the effect of changing the temperature of the soil and water, and measuring these changes through the ½ in. steel pile wall.

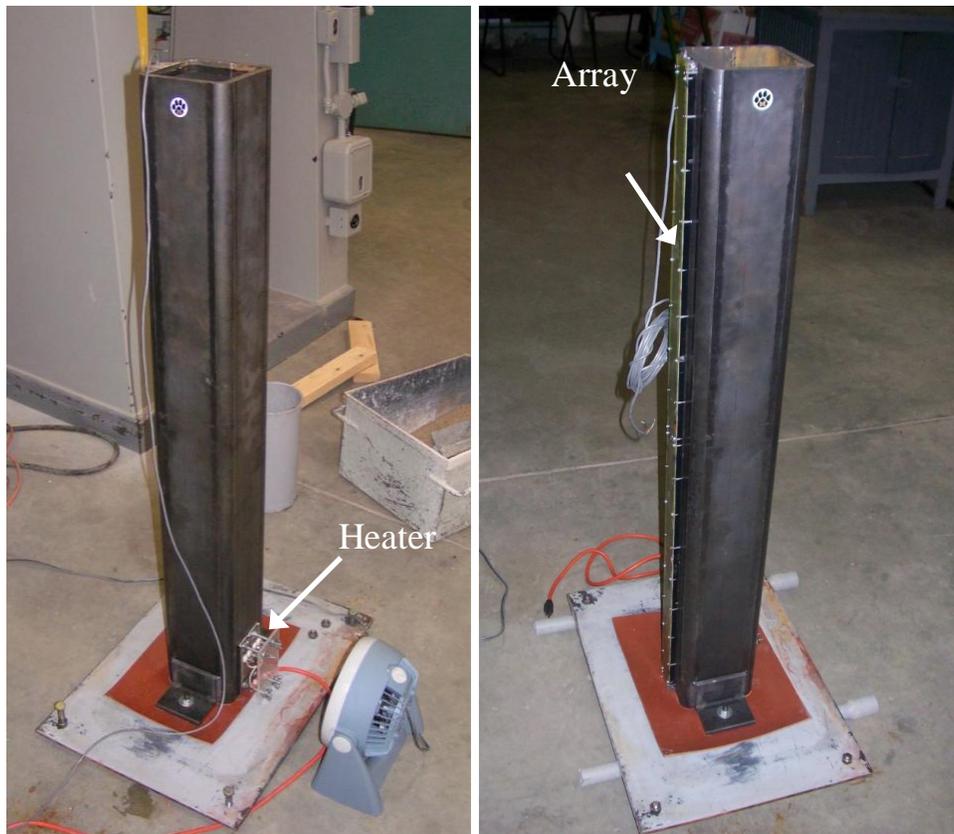
Figure 4-2. Both sides of large test pile, showing heater and array locations.

Figure 4-2 shows a photograph of the test pile from two angles. The 16-sensor temperature array is attached to the side of the pile, extending from the base to the top of the test pile as shown in the Figure. A single 3-conductor wire is used to connect the array to the data acquisition computer. The ceramic heaters, attached near the base plate of the test pile, were concealed by a polycarbonate plate to ensure that the heater connections were not inadvertently contacted during the testing. A fan was also used during the testing to speed the cooling of the pile by convection.

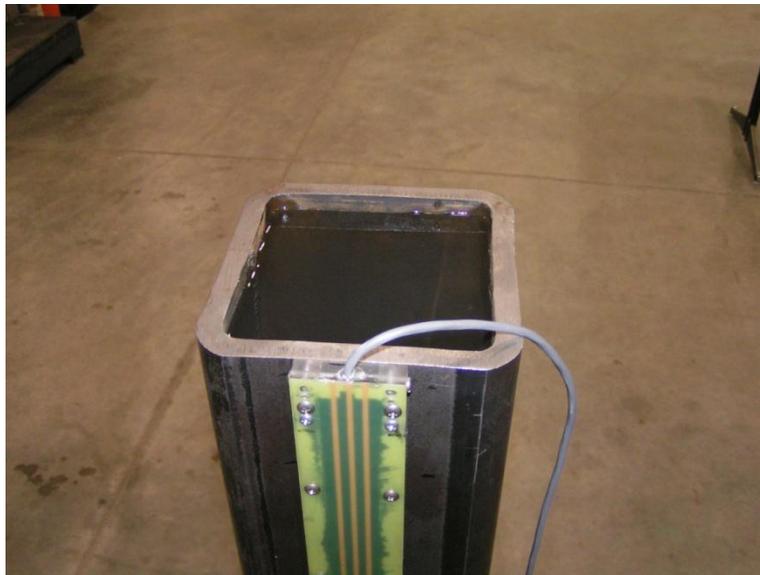
Figure 4-3. Image of sensor array and water filled test pile.

A closer photograph of the test pile is shown in Figure 4-3. The outside of the 16-sensor array can be seen. The three copper trunk lines are visible through the back of the circuit board, along with the black epoxy. The gray 3-conductor wire attaches all of the sensors to the serial port of the test computer through an adapter. Also, the water that fills the inside of the pile can be seen. The combination of water and sand/soil within the test pile was expected to allow for thermal gradient changes such as would be expected in the field.

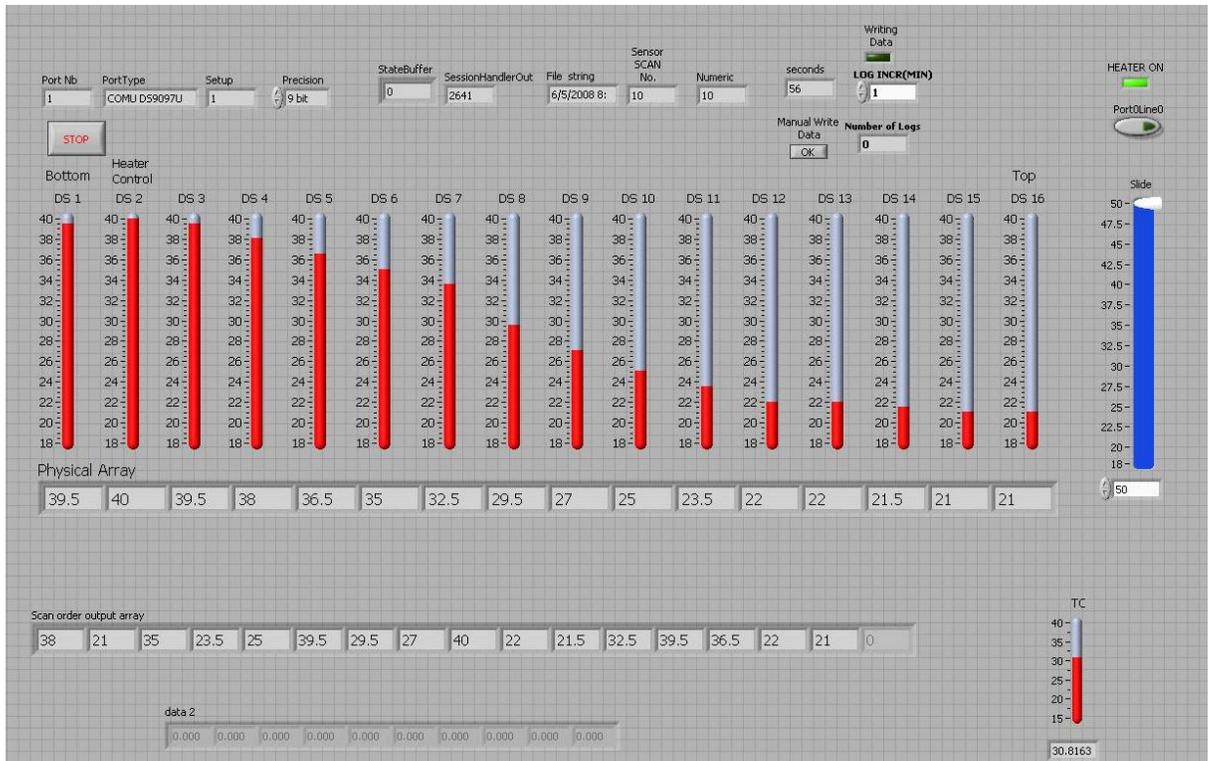
Figure 4-4. Front panel of Labview program.

The software suite that was developed was capable of detecting and measuring the outputs from the 16 temperature sensors and controlling the heating circuit. A screen shot of the software front panel is shown in Figure 4-4. This front panel displays the temperature measurements from each of the sensors in the array, provides a bar-type graphic of the sensor temperatures, and stores the data at a specified rate. A slide control on the front panel allows the user to set the target temperature for the heaters.

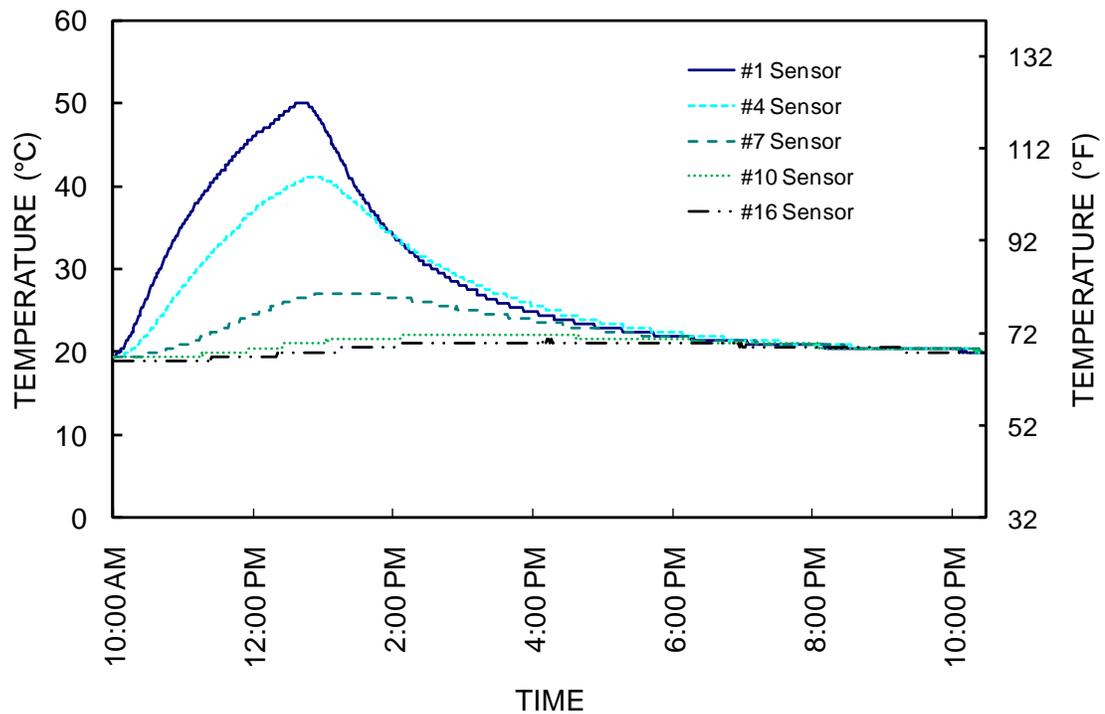
Figure 4-5. Sensor array measurement during heating to 50°C and cooling.

The testing of the 48 in. sensor array demonstrated the effectiveness of the new measurement technology. Figure 4-5 shows the results of one test where the pile started at room temperature and was heated. When the sensors nearest the heater reached 50 degrees Celsius the heater was turned off. From the start of the test to the peak temperature took about three hours, and from there back to equilibrium took about seven hours. The seventh sensor, which was just less than two feet from the heater, was the furthest away from the heat source that registered a significant differential from the adjacent sensor. The test illustrated that the gradient measured along the pile was detected by the sensors in their complete array configuration, and the data was successfully stored for later processing. The test also illustrated that the sensor array responded in a timely manner to impressed thermal changes.

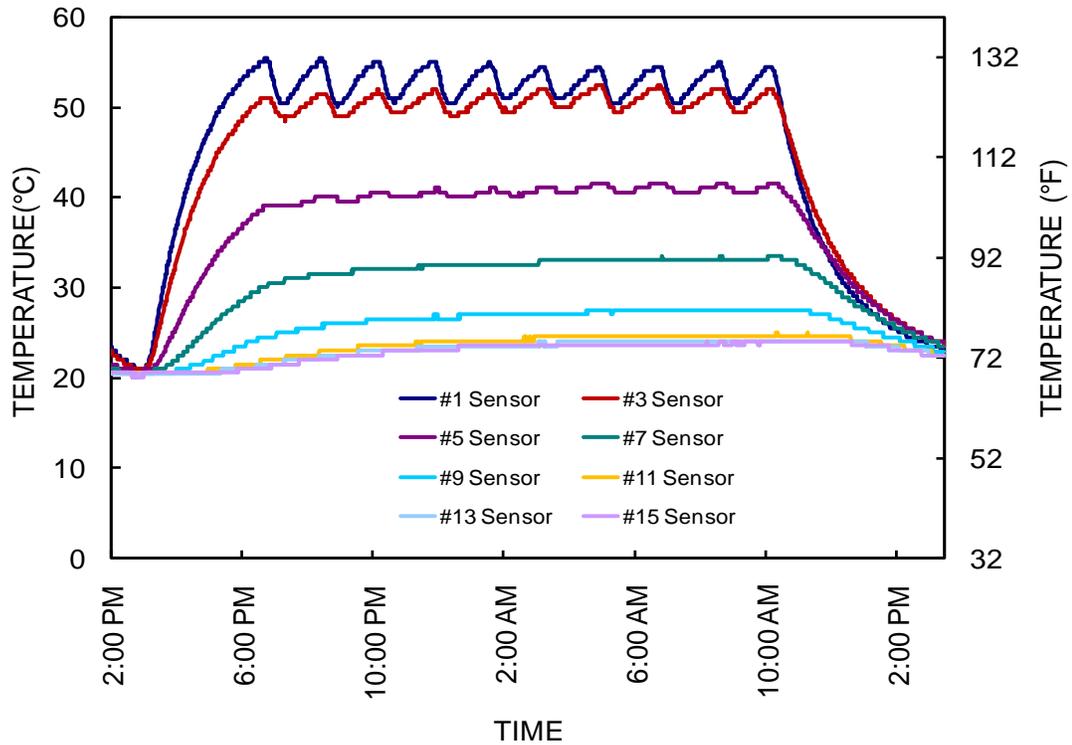
Figure 4-6. Sensor array output during 1-day, 55 degree Celsius test.

a delay in the response of the system to applied heat. This delay manifests in the variations in the temperature measurements (cycles) in time shown in the Figure.

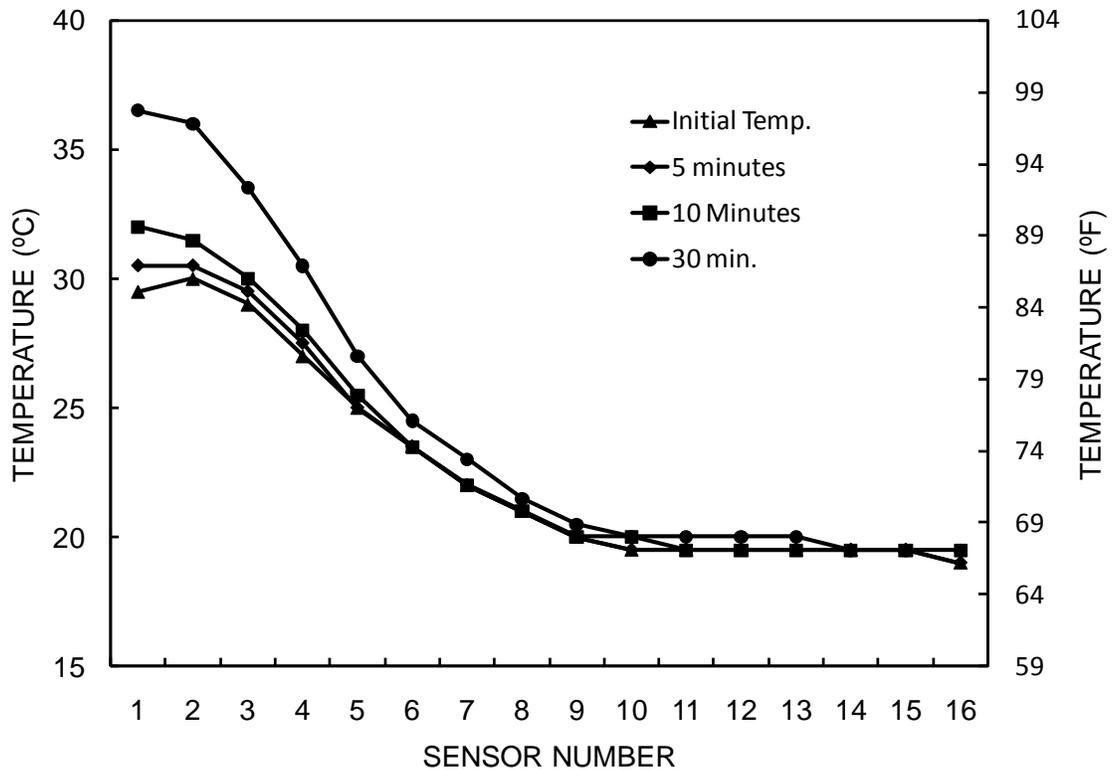
Figure 4-7. Temperature gradient in the test pile during heating.

developed in the pile as intended. Sensors farthest from the pile do not respond to the applied heat. The change in temperature during the test for each sensor can be observed in the Figure, for example the output of sensor 1 changes significantly in the final 20 minutes of the test. Graphing data as the gradient or profile along the length of the pile is expected to improve the ability to identify where the soil/water interface exists and how this interface changes over time.

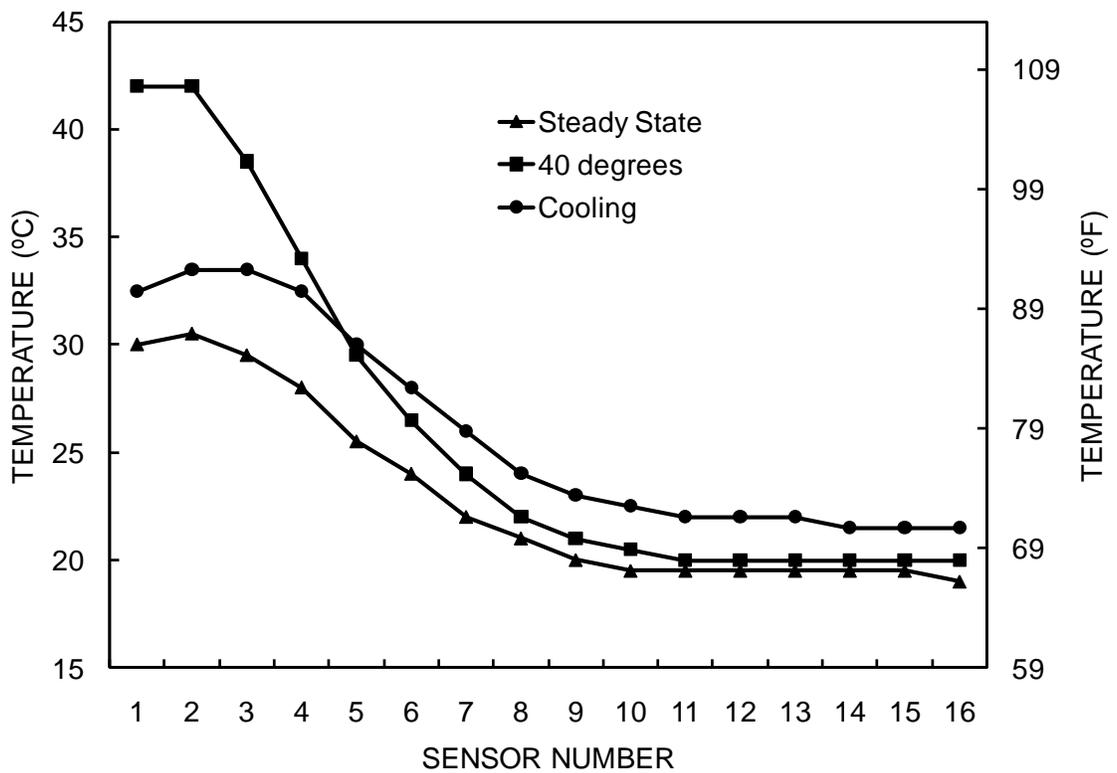
Figure 4-8. Temperature gradient in the test pile during heating and cooling.

Figure 4-8 shows the thermal gradient along the length of the pile for three conditions. The steady-state condition is the thermal gradient in the pile after a test temperature of 30°C has been established and maintained for several days. This is an established, steady thermal gradient along the length of the pile. The test temperature was then raised to

40°C, resulting in the increased thermal gradient along the length of the pile as expected. The test temperature was subsequently adjusted to 20°C. During the cooling of the pile, the thermal gradient is reduced as sensors respond to the pile reaching toward thermal equilibrium. This is illustrated by the increased temperatures of sensors 5-16 during the cooling phase, as the thermal wave resulting from the increased test temperature propagates through the pile. This testing illustrated that the sensor array was sensitive to changing thermal conditions and was capable of determining the thermal profile along the test pile under a variety of thermal conditions.

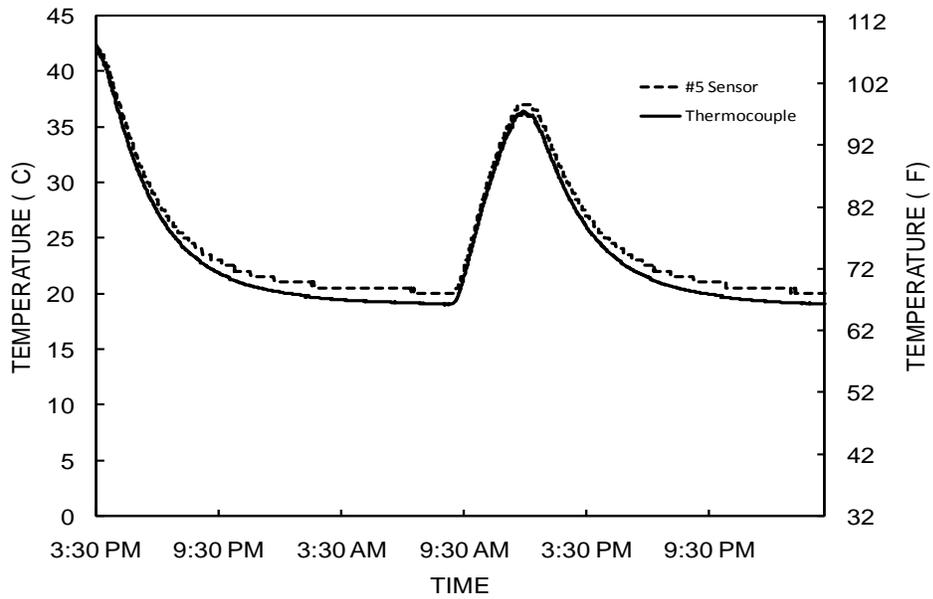
Figure 4-9. Thermocouple and DS18S20 readings during cooling and heating.

be negatively impacted by the array design. Because the sensors are embedded in epoxy, it is expected that some delay will exist between changing thermal conditions outside the array and the actual array response. Figure 4-9 shows the results of testing to determine how much lag exists from the sensor array relative to a basic K type thermocouple. The thermocouple was placed directly along the side of the large array in-line with sensor 5. All other sensors have been removed from the graph for simplicity. At the outset of the test, the thermocouple read 42.4 degrees Celsius, while the DS18S20 was reading 41.5 degrees. They both cooled for almost 18 hours, after which the thermocouple read 19 degrees and the DS18S20 read 20. The heater was turned on, and the thermocouple first showed a temperature increase at 8:57am. The DS18S20 showed its first increase at 9:03am, 6 minutes later. Note that the DS18S20 only has a resolution of 0.5°C; such that the output will not change until 0.5°C temperature variation is experienced. At 12:15 the sensors reached the highest temperature in the test, the thermocouple read 36.5 degrees while the DS18S20 on the array read 37. Finally, at the end of cooling, the thermocouple showed 19.1 degrees while the DS18S20 was at 20 degrees Celsius. In this test, the sensor array and the thermocouple reacted very similarly to the heating being applied, and there was only a small lag (<6 minutes) in the response of the sensor array relative to a thermocouple device. The DS18S20 sensor also registered a slightly higher temperature than the thermocouple throughout the test, possibly due to calibration differences between the sensors.

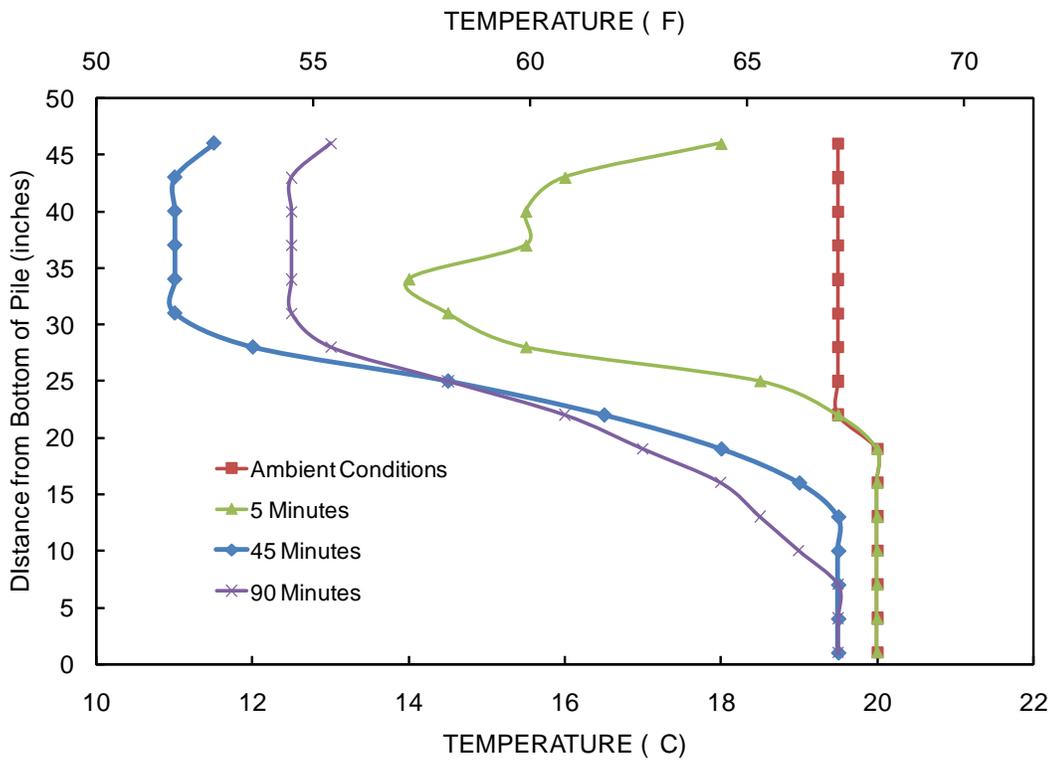
Figure 4-10. Thermal gradient along the length of the test pile during cold water test.

it was necessary to fill the test pile with cool water during the testing to model the behavior of running water in a streambed. This was done by using two siphons, one deep in the pile to remove the ambient temperature water and another pouring cool water into the pile. The results of this test are shown in Figure 4-10, which shows a number of thermal profiles of the pile at different times after the initiation of the water exchange in the test pile. The Figure shows the thermal profile in the pile at the initiation of the test (existing conditions), and 5, 45 and 90 minutes after the test initiation. The large difference in temperature of the water and dirt created results that clearly showed the transition area to be between the 5th and the 11th sensor, corresponding to 13 and 31 inches from the bottom of the test pile. The actual interface is locating at approximately 24 inches from the bottom of the pile. As illustrated in the figure, the interface results in a significant change in the thermal gradient along the pile. By the 90th minute, the ice had melted, which is why there was an increase in temperature between the 45th and 90th minutes. This test illustrates that the sensor array prototype is capable of making the desired measurements to monitor changes in thermal profile along the length of the pile. A total temperature difference of 8.5°C existed between the hottest and coldest sensor.

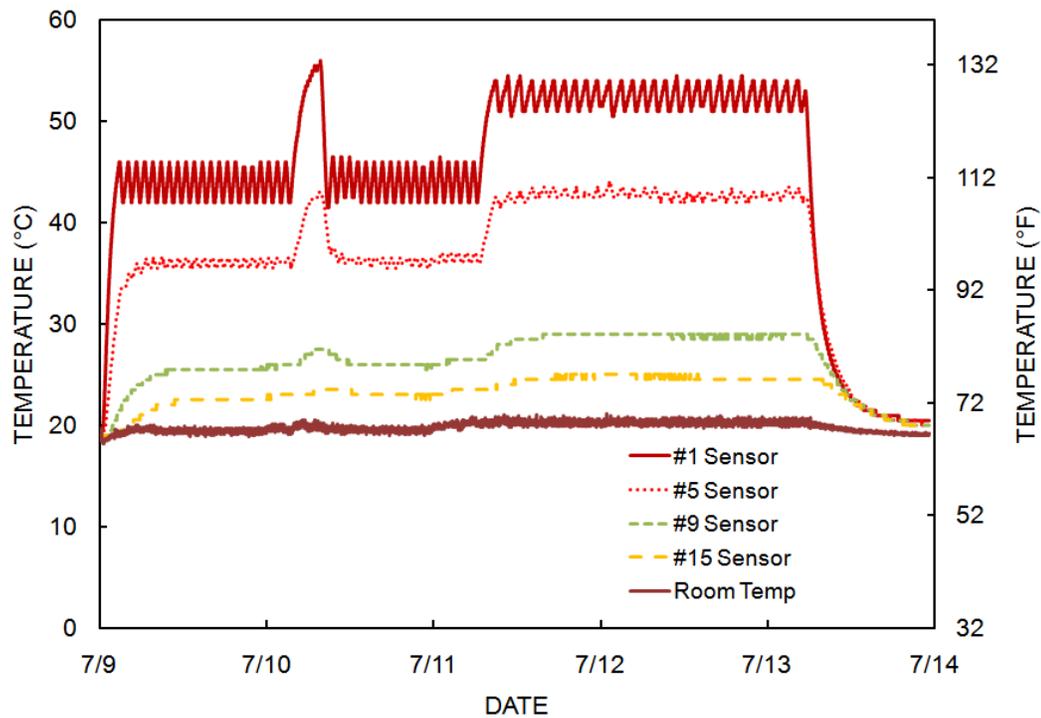
Figure 4-11. Results of monitoring the sensor array over a 5 day period.

Figure 4-11 shows the output of the sensor array mounted on the test pile over a time period of 5 days. Several changes in thermal conditions were impressed on the pile by the ceramic heaters. During this particular test, the temperatures ranged from 18.5 to 56.5°C. Room temperature remained just below 20 degrees for the duration. When the test began, the whole pile was at room temperature. The heater control temperature was set to 45 degrees for over 24 hours. The control temperature was then raised to 60 degrees and returned back to 45 degrees as it approached this control temperature. The control temperature was again raised to 55 degrees and allowed to stay there for almost 48 hours. The heater was then shut off to allow the pile to return to room temperature. This test and previous tests run in the lab illustrate that the software developed is capable of storing data over long time periods and that the sensor array performs as expected. The array responded effectively to temperature changes, illustrated very little noise, exhibited no electronic drift over time, and consistently registered data.

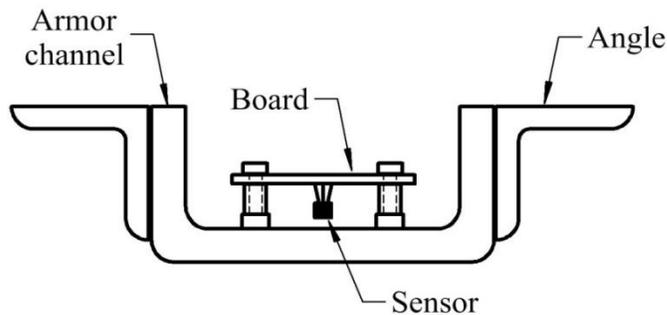
Figure 5-1. Schematic diagram of sensor configuration in armor channel.

The field test pile consisted of 64 DS18S20 one-wire sensors mounted along the length of a 20 ft. H-pile. To effectively implement the sensors in the field, the sensor array needed to be armored and mounted in such a fashion that it could be driven into the ground, operate over a long time period while submerged in water, and survive in the rugged environment of a bridge. To support these goals, a design was developed in which the sensors were mounted on the rigid circuit board material, and this rigid circuit board was then mounted onto stand-offs welded onto a 3/8 in. steel channel. The final configuration of the sensor within the armor channel is shown in Figure 5-1. Angles welded periodically onto the sides of the armor channel provide a positive mechanical connection for the completed thermal array for installation onto the web of the pile.

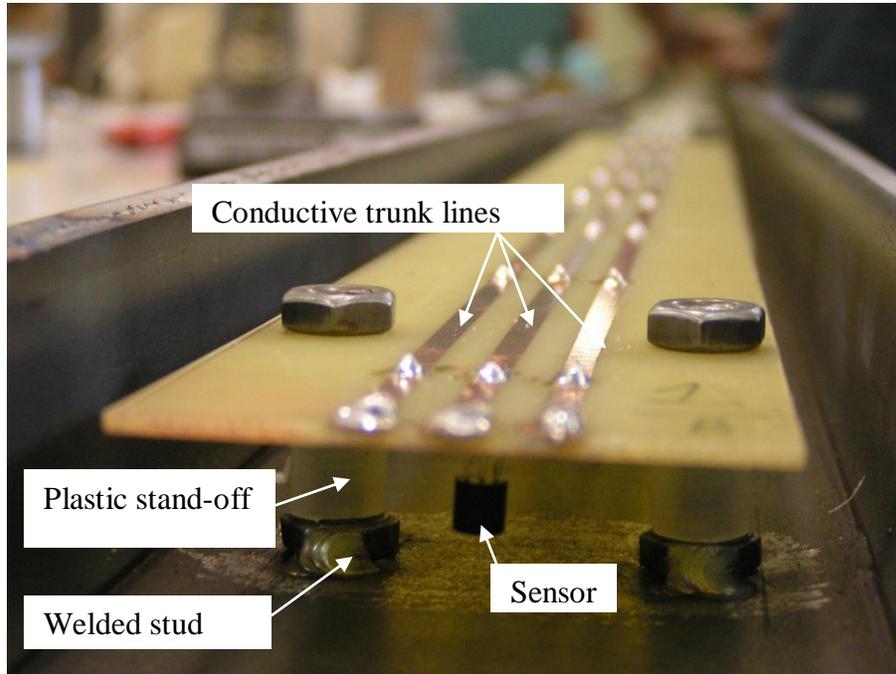
Figure 5-2. Photograph of the assembled sensor array showing plastic stand-offs, welded studs, sensors and conductive trunk lines.

The rigid circuit boards were produced in the laboratory at MU to have three conductive trunk lines extending over the 24 in. length of the board. Each 24 in. board had 8 sensors mounted on the board, at a separation of 3 inches. Each sensor was mounted in a through-hole fashion on the rigid circuit board to provide some mechanical support to the soldered joint between the sensor and the circuit board. When mounted in this fashion, the sensors are mounted on the opposite side of the circuit board from the conductive trunk line. Once this board and associated sensors are potted in the epoxy, the sensors are fixed and will not move. The sensors were placed such that they are close to the armor channel in which the array is mounted. Figure 5-2 shows the armored sensor housing during the construction of the sensor array. The Figure shows the threaded studs that are welded to the steel channel, plastic stand-offs used to set the sensor array at a constant elevation in the cross-section, and the rigid circuit board with the sensors attached. As noted earlier, the sensors are mounted in a through-hole fashion such that the sensor leads project through the circuit board and are actually soldered to the board on the opposite side of the circuit board.

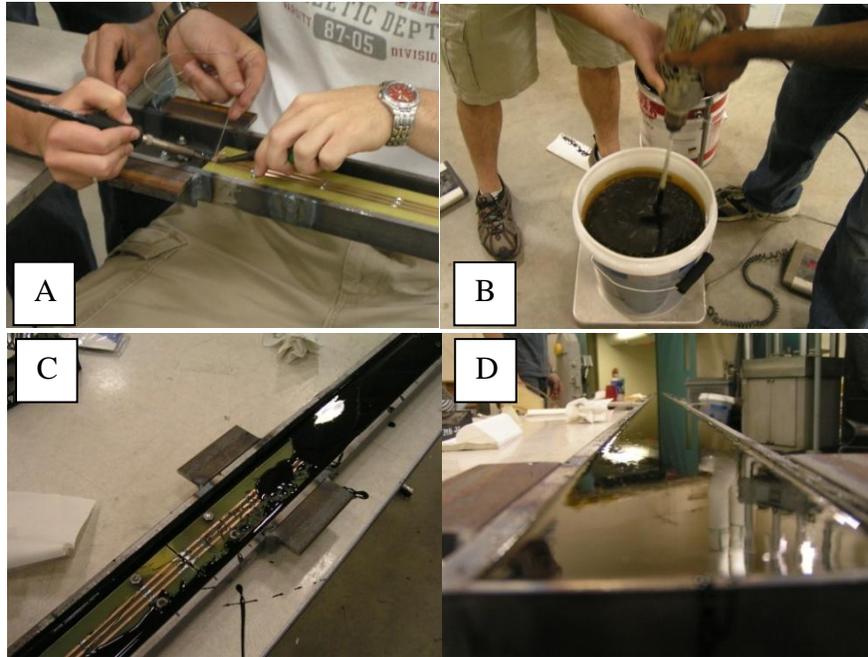
Figure 5-3. Photographs of the array construction showing A) soldering connections in the armored channel, B) mixing the epoxy, C) placing the epoxy in armored channel and D) completed array.

channel. Figure 5-3C shows a photograph of the epoxy placement in the armored channel with part of the board already submerged in epoxy. Figure 5-3D show a photograph of the array after the epoxy has been placed, showing a view from one end of the 18 ft. armored channel.

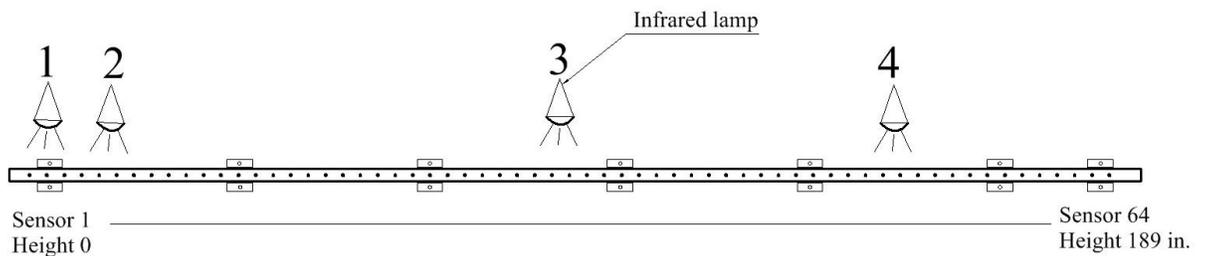
Figure 5-4. Schematic diagram of laboratory test set-up.

An infrared lamp was utilized to impose a thermal gradient in the sensor array. The lamp provides an intense heat source that performs consistently and can be easily moved to different portions of the array to establish the operation of all 64 sensors. Numerous tests were conducted during the development of the software needed to read and log the output of all 64 sensors. The results of two tests are focused on here: first, the response time of the array was evaluated by placing the lamp at one end of the pile and collecting sensor outputs over several hours, shown as location 1 in Figure 5-4. Second, the lamp was placed at different locations along the test pile to establish that all of the sensors were operational, and that the sensor locations were correctly identified (locations 2 – 4). The test setup is shown schematically in Figure 5-4. The sensor array was mounted horizontally in the laboratory with the infrared lamp directed at the array from a distance of approximately 18 inches for a typical test.

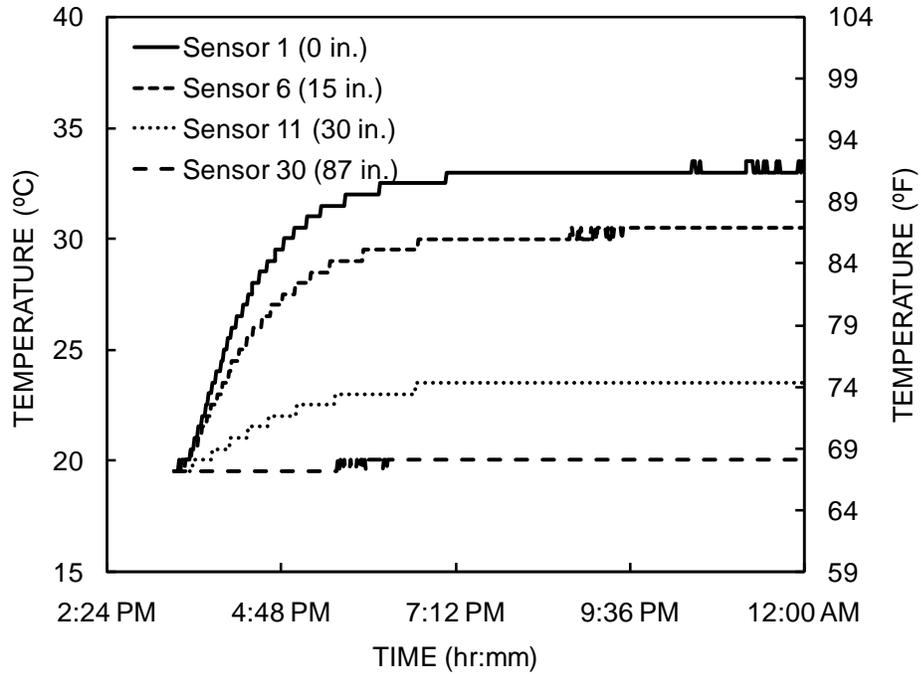
Figure 5-6. Response of sensor 1, 6, 11, and 30 to applied heat from an infrared heater at location 1.

Figure 5-6 shows the performance of sensors 1, 6, 11 and 30 during the test. As shown in the figure, when the test is initiated (the heating lamp is turned on) the sensor responds to the external heat application and measures the heating of the sensor array up to a maximum temperature of 33.0°C approximately 4 hrs later. The temperature distribution along the length of the pile measured by the remaining sensors in the array was expected to show a thermal gradient as the distance from the heat source to the individual sensor increased. Figure 5-6 shows that a sensor located 87 inches from the heat source (sensor 30) showed no reaction to the application of heat at the end of the pile, while sensor 6 (15 in. from the heat source) and sensor 11 (30 in. from the heat source) responded to the application of heat in an expected manner, increasing less rapidly over the course of the testing.

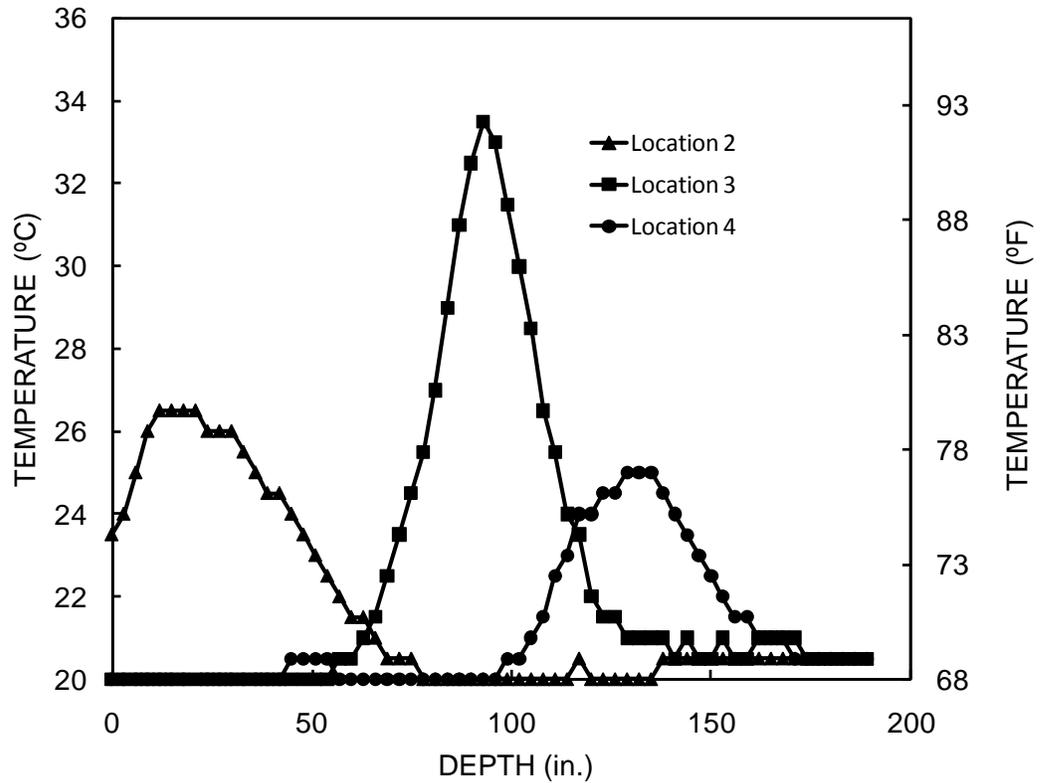
Figure 5-7. Temperature distribution along the length of the array during laboratory testing.

To evaluate the functionality of all sensors in the array, and evaluate and develop the necessary software to scan the sensor array and store the data, the infrared lamp was relocated to different locations on the array. For this test, the infrared lamp was located at three different locations as shown in Figure 5-4, locations 2-4. The heat lamp was initially placed at location 4, then location 2 and finally placed at location 3. Heating was applied in location 4 for approximately 45 minutes, location 2 for approximately 60 minutes, and left at location 3 for 21 hours at a distance of 24 inches, relocated to 18 in. from the array for 47 hours, and then shut off. This allowed for the heating of the array in different sections, and to evaluate the response of the array. The distribution of heat along the length of the array during the testing is shown in Figure 5-7. This Figure shows time intervals of maximum temperatures at each location for the array. This test demonstrated that all of the sensors were operational, had approximately equivalent response to external stimuli, and there were no latent effects on the sensors.

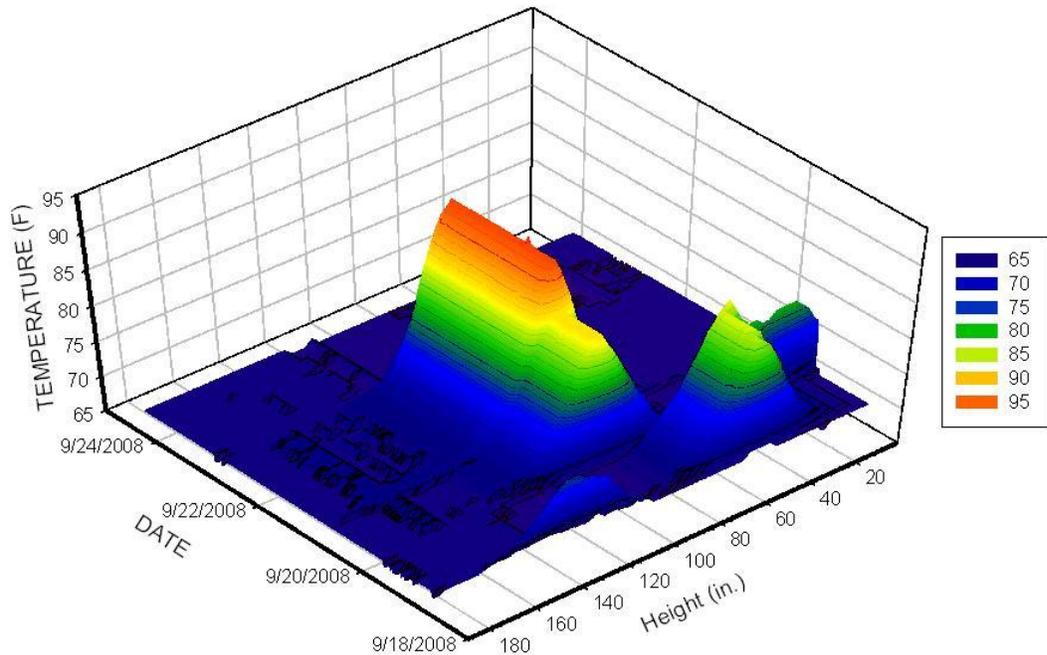
Figure 5-8. 3-D graph showing sensor array behavior in the laboratory.

interpretation of the data. Such a graphing approach was utilized in the installed pile to evaluate if changes in the thermal behavior of the pile have occurred.

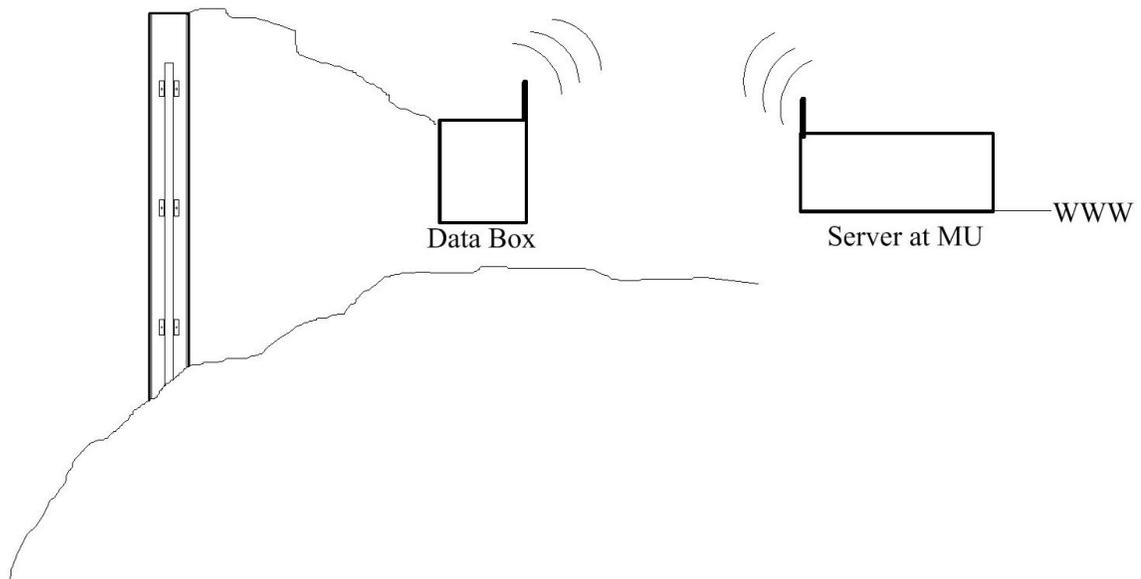
Figure 5-10. Schematic diagram of wireless data connection for remote monitoring of test pile.

A separate program operates a cell-phone based link to a server in the engineering building at MU. This program uses a Sprint cell phone modem to transmit data to the server at the set time interval. A time interval of 15 minutes between data transmission was selected, to couple with the scan interval for the temperature sensors. This software is embedded in the system, and does not interact with the user. The wireless connection is shown schematically in Figure 5-10. Data is collected on-site, transmitted over the cellular modem to a server at MU, and subsequently made available over the World Wide Web.

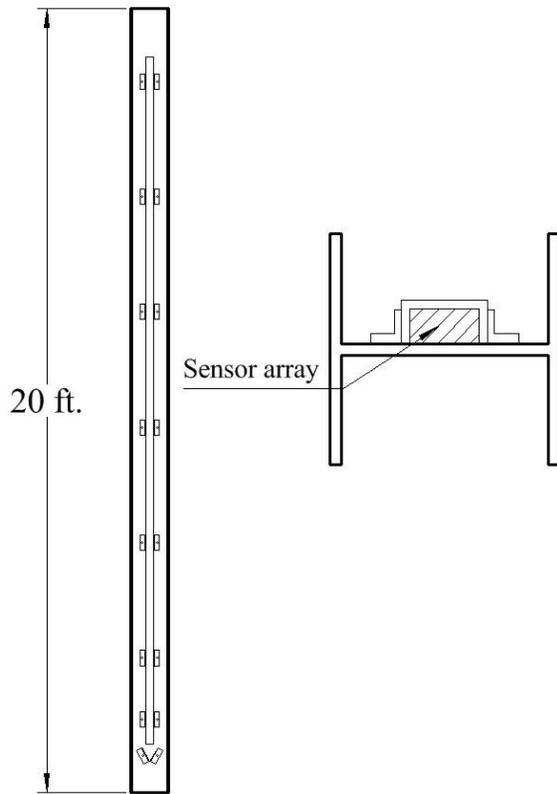
Figure 5-11. Schematic diagram of prototype test pile.

This section describes the final construction and installation of the test pile. The final construction of the test pile included affixing the sensor array to the web of the test pile, installing the test pile adjacent to the creek bed, and establishing an on-site data acquisition system to collect sensor array data. The H-pile selected for the prototype pile was an H10 steel pile with yield strength of 50 ksi. This pile was selected as a typical, representative full-scale pile for demonstration of the technology. The pile was delivered to the test location from the steel fabricator, such that the installation of the sensor array onto the web of the pile was completed in the field. The thermal array was positively connected to the web of the pile using ½” steel bolts, bolted through the angles on the sensor array to the web, as shown schematically in Figure 5-11. A coating of epoxy was applied to the sensor array immediately prior to installing the array onto the web of the pile, such that there was effective thermal coupling and the connection would be waterproof. All web holes needed to support the installation of the thermal array were made in the field using a common magnetic drill. Two angles were connected to the web in front of the array to deflect debris during the installation of the pile and to protect the array from direct impact on the nose of the array during the driving procedure.

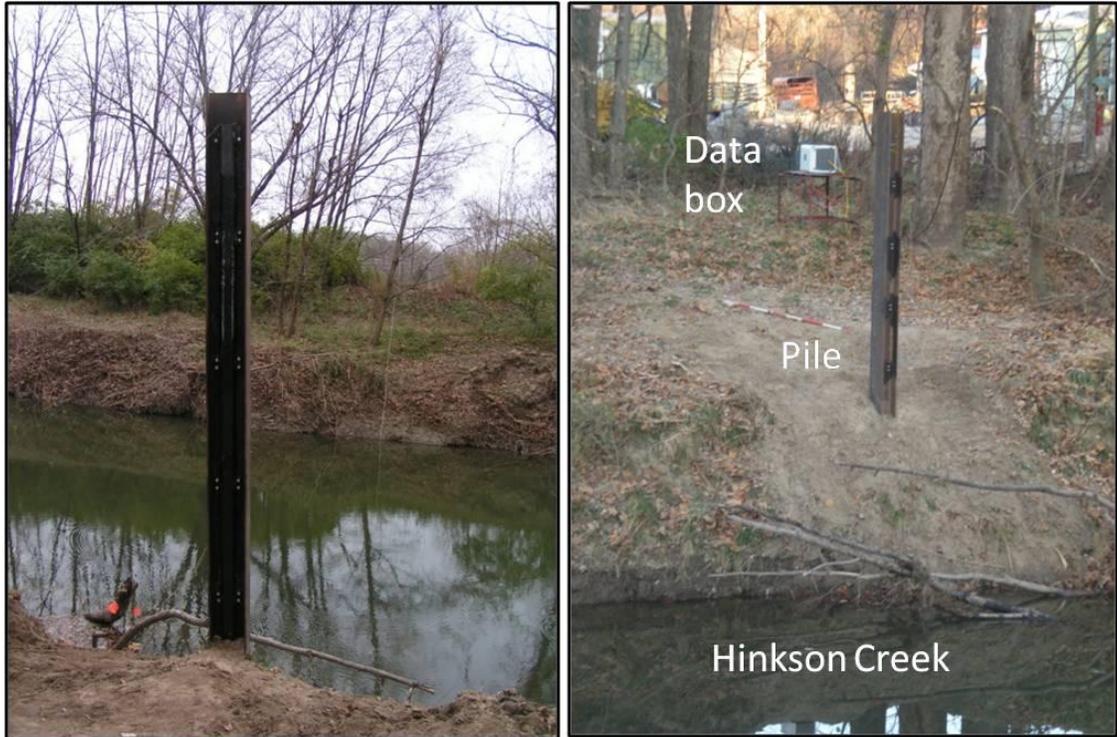
Figure 5-13. Photograph of the test pile installation at Hinkson Creek.

The pile was driven to refusal at this location. Approximately 18 in. of loose soil was placed around the top of the pile to level the bank and extend the portion of the test pile installed in the soil. This area of the creek is expected to flood regularly during high water events because the creek has steep, narrow banks, such that high water will occur with modest amounts of rainfall. The test pile was connected to the computer in the data box, and data stored on site as well as at a server on the MU campus.
