REMOTE HEALTH MONITORING FOR ASSET MANAGEMENT

A Thesis presented to the Faculty of the Graduate School of the
University of Missouri - Columbia

MAY 2009

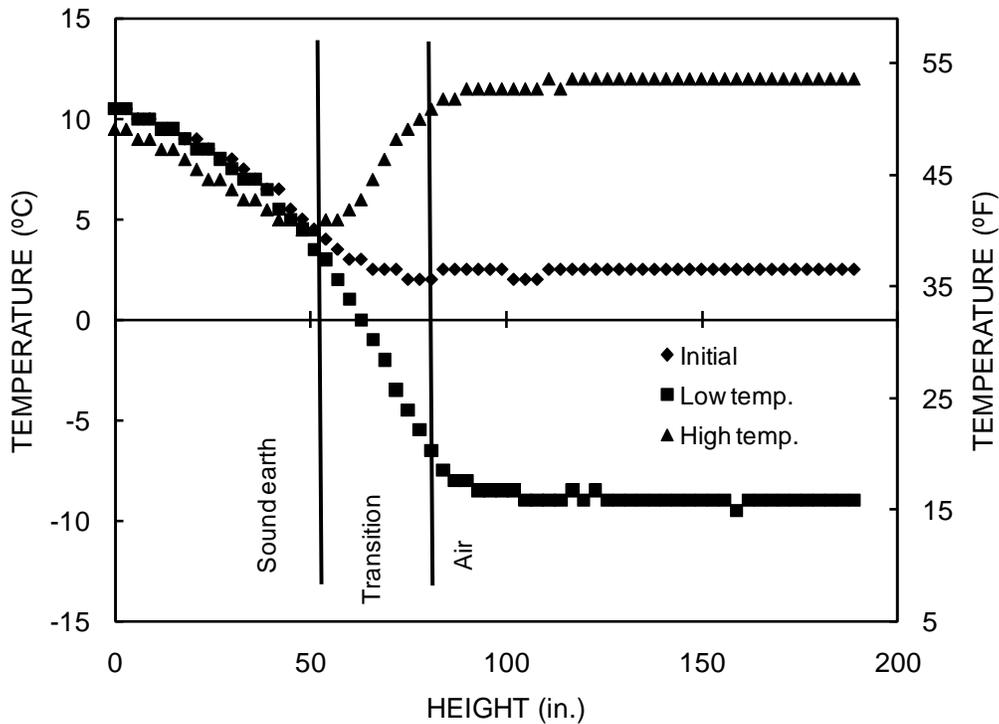
Figure 5-14. Temperature profile along the test pile for high, low and initial air temperatures.

when data collection was started. The Figure shows that there is an area of transition from the air temperature to the sound soil temperature. In this transition area, the temperatures measured along the pile are in transition from the external air temperatures to the sound soil temperature. This transition area includes the loose soil that was placed along the pile at the time of pile installation which has a low density relative to the soil that was intact at the time of installation. As shown in the Figure, there is a consistent height along the pile at which the temperatures remain the same, regardless of the external air temperature. The movement of this sound earth point along the pile would be indicative of scour occurring at the pile. This height (~52 in., or between sensors 17 and 18) along the pile has remained consistent throughout the initial testing, with the exception of the some slight changes (+/- 2 °C) that occur over long time periods of several days. Temperatures increase slightly into the sound soil, as the pile is not driven very deep due to the bedrock present at the site.

It was previously shown in Figure 5-14 that the sound earth line was nearest to sensor 17, at a height of 52 inches. In addition, from the earth line exploration test (Figure 5-15) the ground level of the loose soil surrounding the pile was nearest to sensor 24 on the creek side, and sensor 27 on the bank side. Due to those important locations, the data analysis was focused on the sensors near that range.

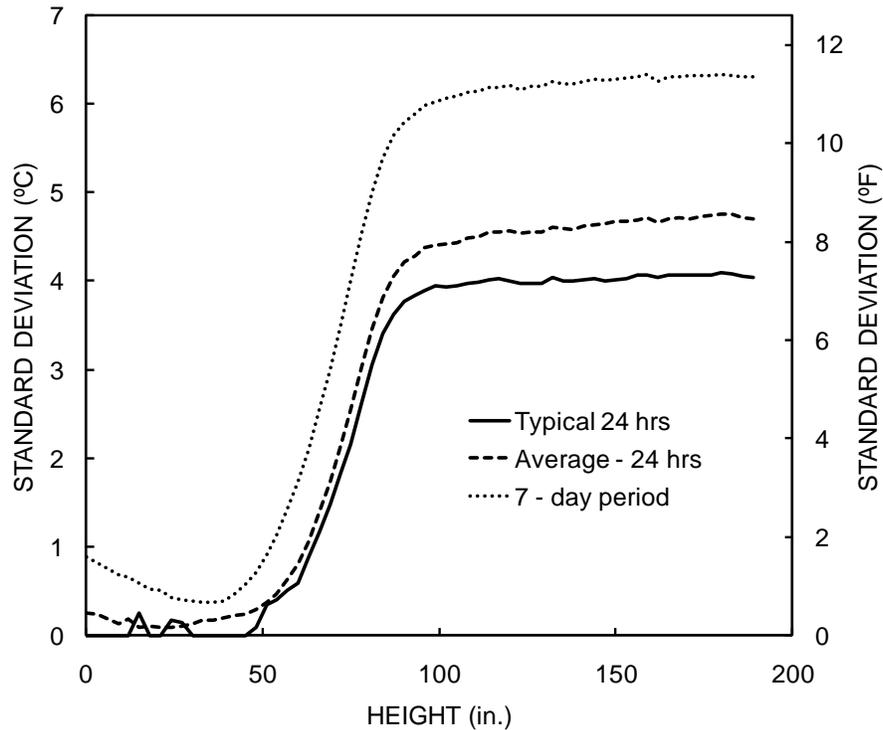
Figure 5-16. Standard deviation of temperature outputs for three time intervals: 24 hr. period, average of 24 hr. periods for 7 days, and standard deviation over a 7 day period.

Where \bar{x} is the sample mean and n is the sample size. The standard deviation is a measure of how widely dispersed values are from the average. For sensors exposed to air, the measurements vary with the diurnal temperature variations, and as such the standard deviation is high. For sensors in sound earth, the temperature varies very little over time, such that the standard deviation would be expected to be low. To evaluate the behavior of the sensor array, data was examined under three conditions; the standard deviation over a 24 hour period, the average of 24 hr standard deviations over 1 week, and the standard deviations for 1 week of data. Figure 5-16 shows the standard deviation from the sensor array under each of the three conditions. Analysis of data in this manner reveals if such data analysis would be adequate over a short time period (24 hours), when ambient temperature variations may be small, as well as over a longer time period (1 week) when ambient temperature variations would be expected to be larger. For evaluation of the effects of scour, a shorter time period is desired, such that rapid

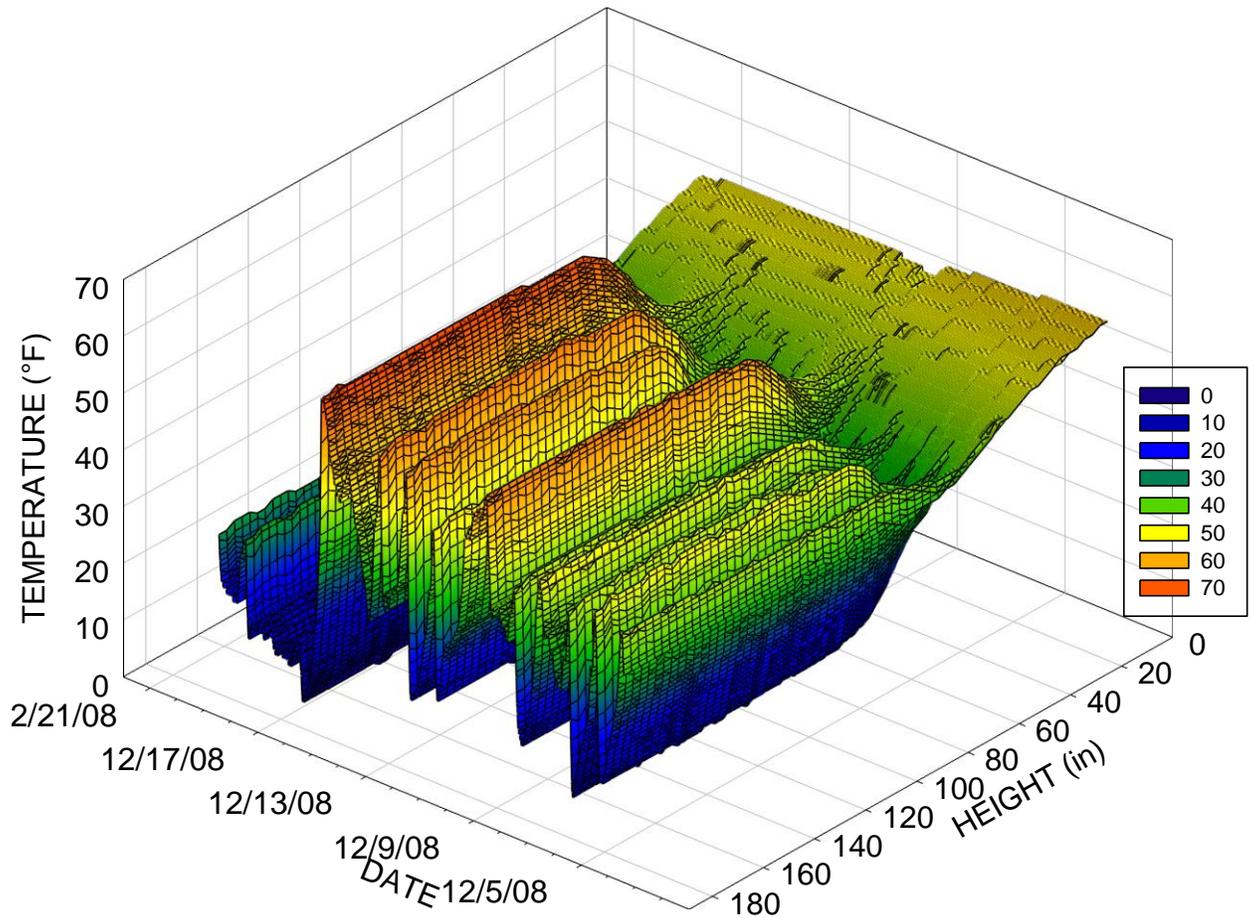
Figure 5-18. Plot showing temperature variations along the pile as a function of time over 15 days.

The data can also be observed as a three-dimensional plot that shows the daily variation in air temperatures, and the consistent behavior of the sensors that are embedded in sound soil. Such a plot is shown in Figure 5-18, which shows a color-coded plot of the sensor response over a 15 day period (Dec. 3 – 21, 2008). In this Figure, the temperature measurements are shown on the vertical axis, and the height along the pile and time of measurements shown on the base plane. Such a presentation of data provides a visual representation of where the sound earth exists along the pile, as well as showing the transition range and the sensor in air, which vary significantly over the course of each day. As shown in the Figure, the sound earth sensors are very stable over the two-week period. The data also shows that there is a slight increase in the temperatures as the embedment of the pile increases. This result is consistent with previous research results by Camp [10].

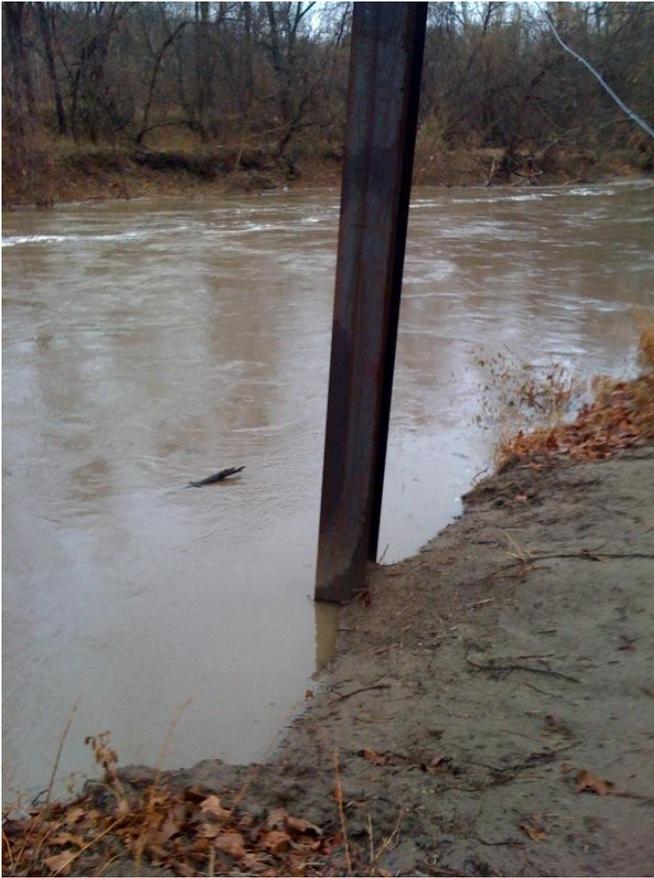
Figure 5-20. Photo of Pile during High Water Event, December 27, 2008.

This section describes the response of the prototype pile to flooding conditions that occurred. During this flood, the flow level of Hinkson Creek increased to the level of the ground/pile interface on December 27, 2008, as shown in Figure 5-20. Using the data measured before, during, and after this flood event, an investigation was conducted to determine if scour was detected in the area of the pile. No significant scour was observed as a result of the flood. The data analysis described in this section indicated there was not clear evidence of a change in earth level, though there was some evidence that suggest the earth line may have moved.
