# EXPERIMENTAL ASSESSMENT OF ADVANCED THERMAL IMAGING FOR DETECTING VOIDS IN DUCTS

A Thesis

the Faculty of the Graduate School  
at the University of Missouri–Columbia

DECEMBER 2017

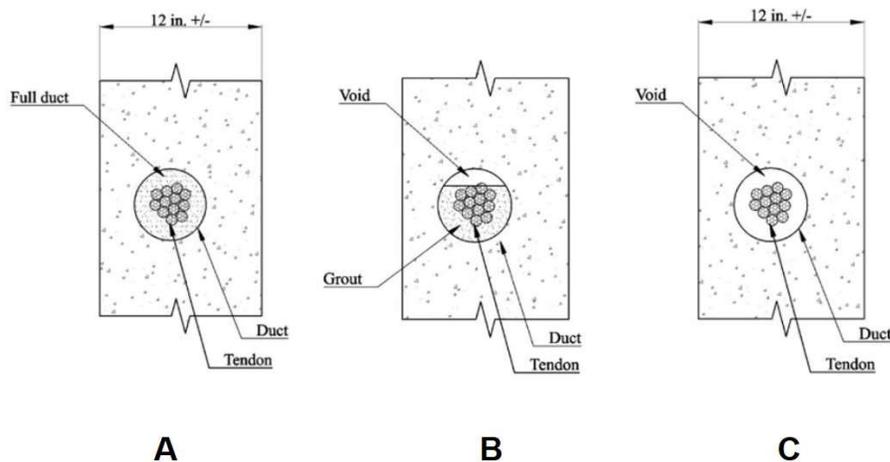
**Figure 1 – Cross-sections displaying a filled duct (A), a partially filled duct (B) and an empty duct (C)**

In recent years, there has been an increasing number of bridges in the National Bridge Inventory (NBI) constructed using PT concrete design. Post Tensioning is a design concept in which steel tendons are placed inside plastic or galvanized steel ducts that are embedded within the concrete itself. A typical PT cross-section is shown in Figure 1.

Figure 1 gives a visual representation of common grouting conditions that occur within bonded PT ducts. The duct cross-sectional area is required to be at least two and a half times the total cross sectional area of the strand bundle [3]. The ducts are either galvanized steel or high-density polyethylene (HDPE) piping. As shown in Figure 1, grout in the duct may completely fill the duct and surround the steel tendons (Figure 1A), partially fill the duct (Figure 1B), or the duct may be completely empty (Figure 1C). Partially filled or empty ducts are voids that allow water and chlorides to congregate and create a localized corrosive environment that is difficult to detect. These voids can create critical defects in the high-strength steel strands that need to be detected and repaired to ensure the safety of the structure. Detection problems arise because the voids are embedded within the duct which is embedded within the concrete. Therefore, there are few practical NDE technologies that could be used in detecting these critical voids.

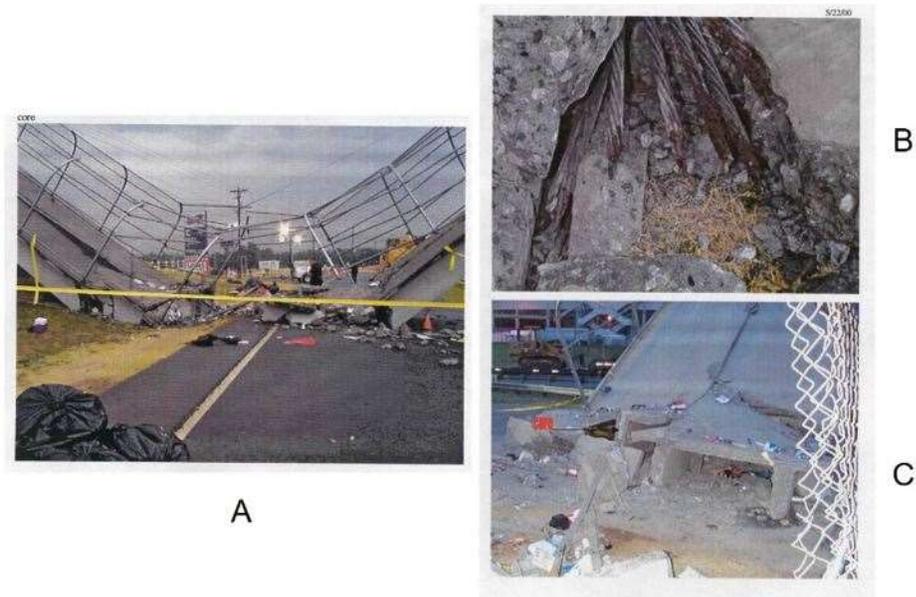
**Figure 2 – Images of the pedestrian bridge failure at Lowe’s Motor Speedway in 2000.**

Figure 2 provides a visual representation of the danger associated with corrosion in steel tendons from the collapse of a pedestrian bridge at Lowe's Motor Speedway in 2000. The bridge was constructed in 1995, but poor-quality grout resulted in rapid corrosion of the tendons in the bridge. The corrosion weakened the steel tendons; this caused the tendons to fracture (Figure 2B) and the bridge to collapse under the weight of the pedestrians. More than 100 pedestrians were injured when an 80-foot section of the bridge fell to the ground below.

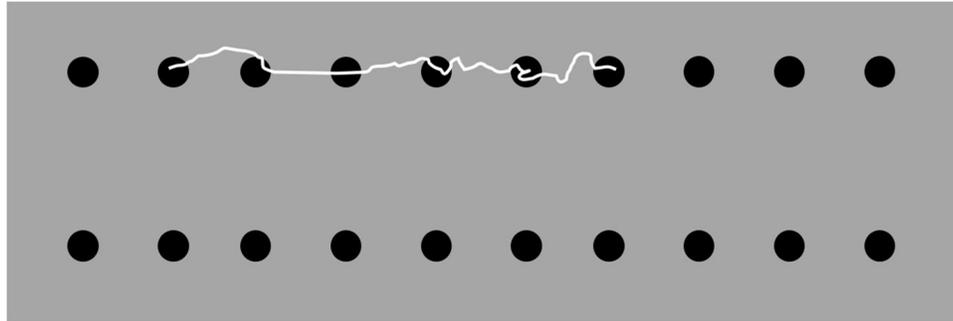
**Figure 4 – Image visualizing the cracking and deterioration of reinforced concrete members.**

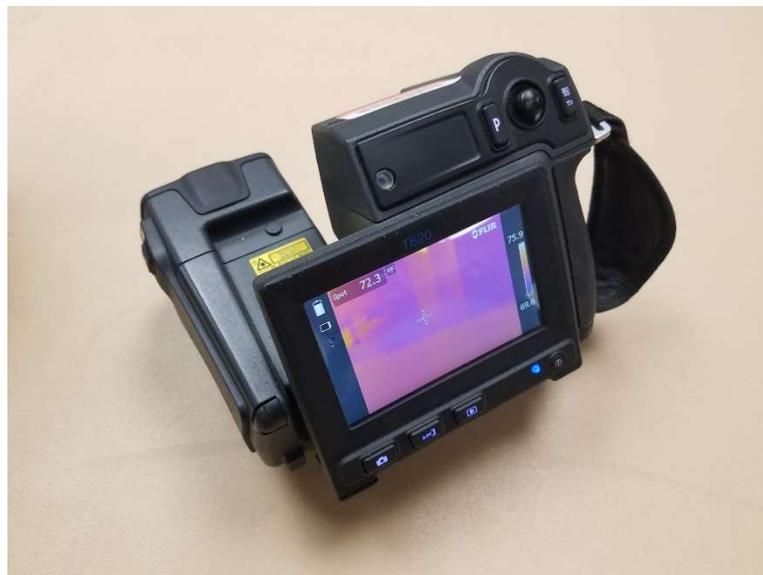
**Figure 6 – FLIR T620 hand-held infrared camera.**

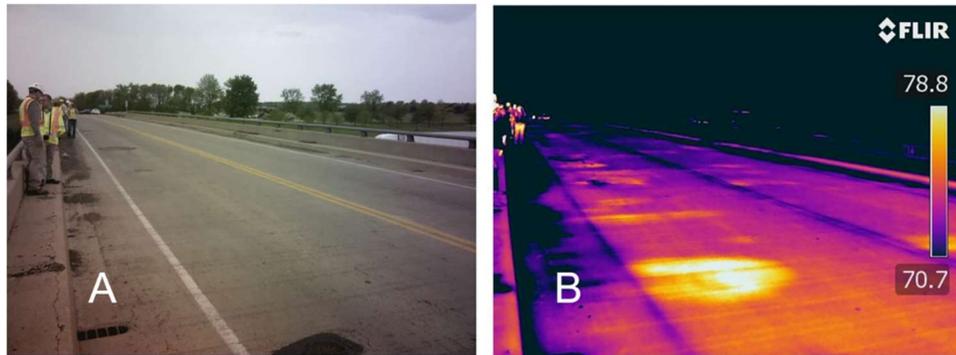
**Figure 7 – Image of a bridge deck (A) and an IR image (B) of the same bridge deck area showing a subsurface defect.**

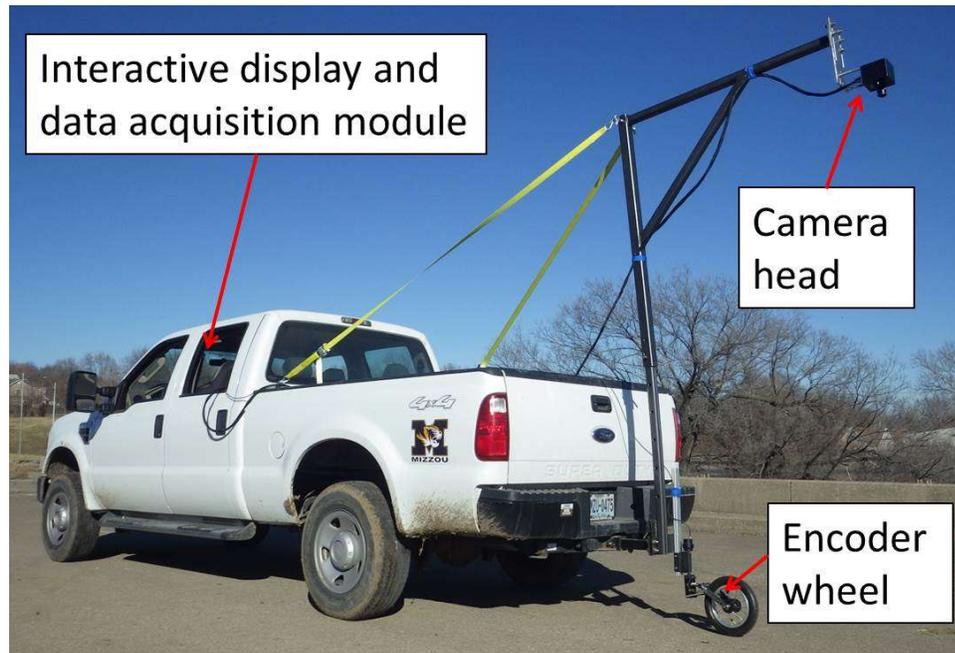
**Figure 8 – Setup of the IR-DSS system on a truck.**

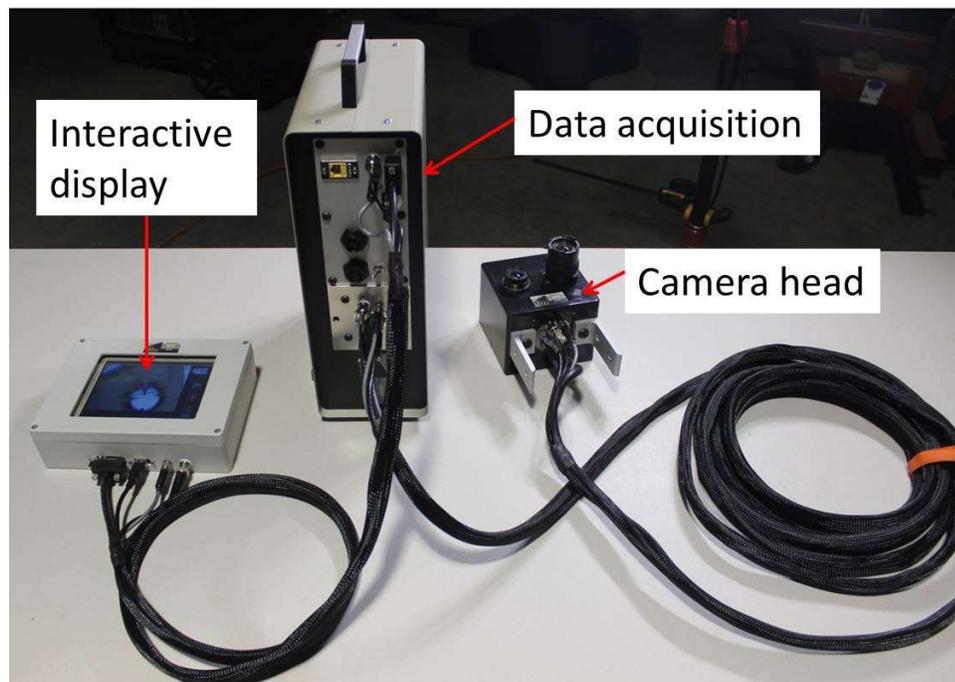
**Figure 10 – All of the base parts that make up the IR-UTD system.**

The Infrared Ultra Time Domain (IR-UTD) system has been designed to be operable on several field testing setups according to available space and restrictions. The IR-UTD camera can be bolted to a pole that is then attached to a bridge parapet; the camera can be hoisted into the air to collect data without interfering with traffic. Figure 10 shows all the various parts that make up the IR-UTD system.

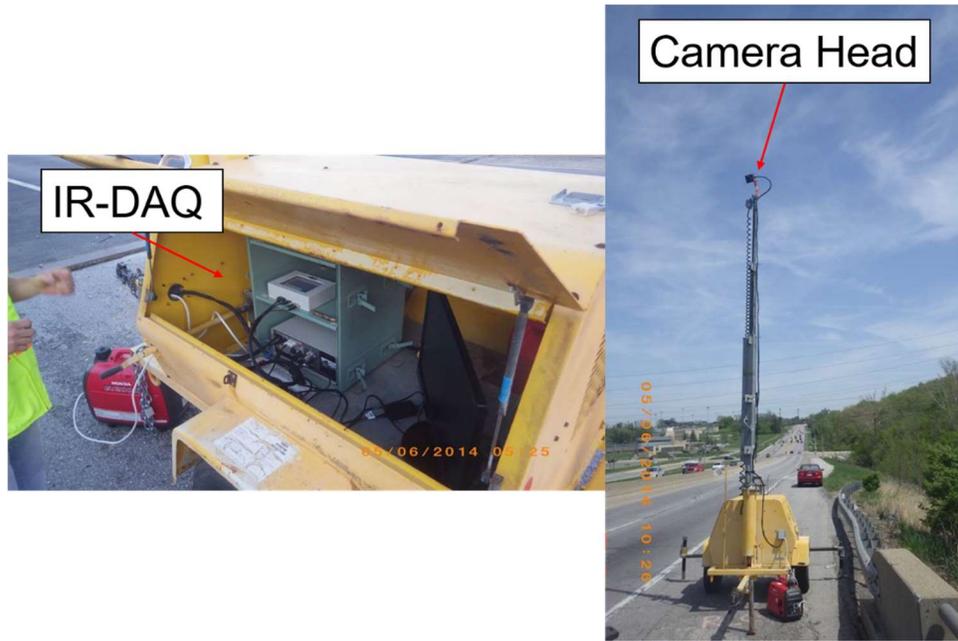
**Figure 12 – IR-UTD system set up in a portable DAQ system alongside the roadway.**

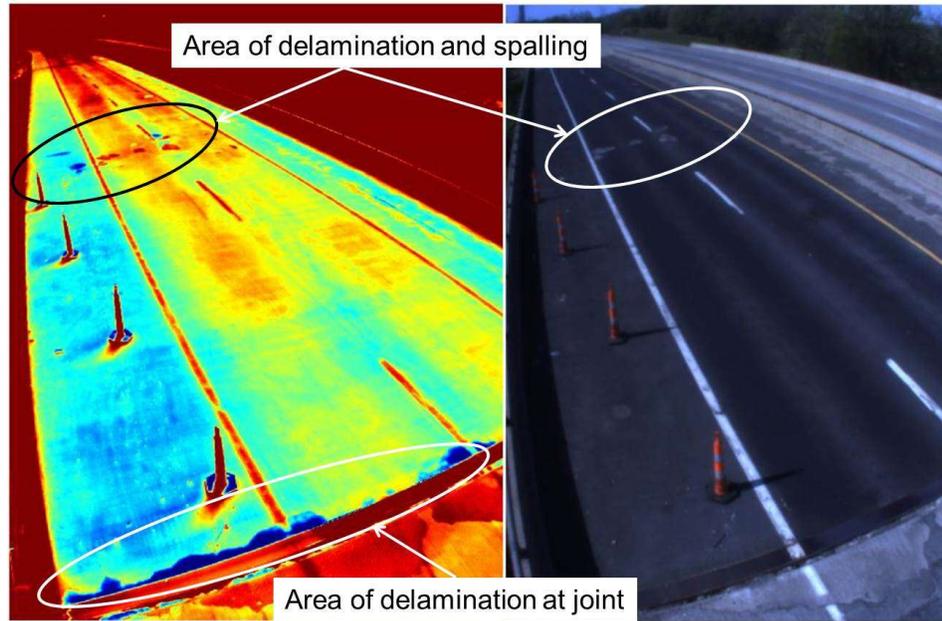
**Figure 13 – Side by side infrared (left) and visual image (right) taken during testing.**

Figure 13 shows how large areas (or full bridge decks) can be analyzed with relative ease. Once the images are collected, they are analyzed using a proprietary program to identify differences in the thermal behavior of the concrete. The differences are then analyzed more closely with the visual images to determine if they were caused by subsurface defects, moisture, loose materials, or other anomalies which would cause these results. Perceived subsurface defects can be verified through additional void detection technologies. Since the IR-UTD is a thermal gradient based system, it has seemingly endless applications and will be the technology featured in the remainder of this report.

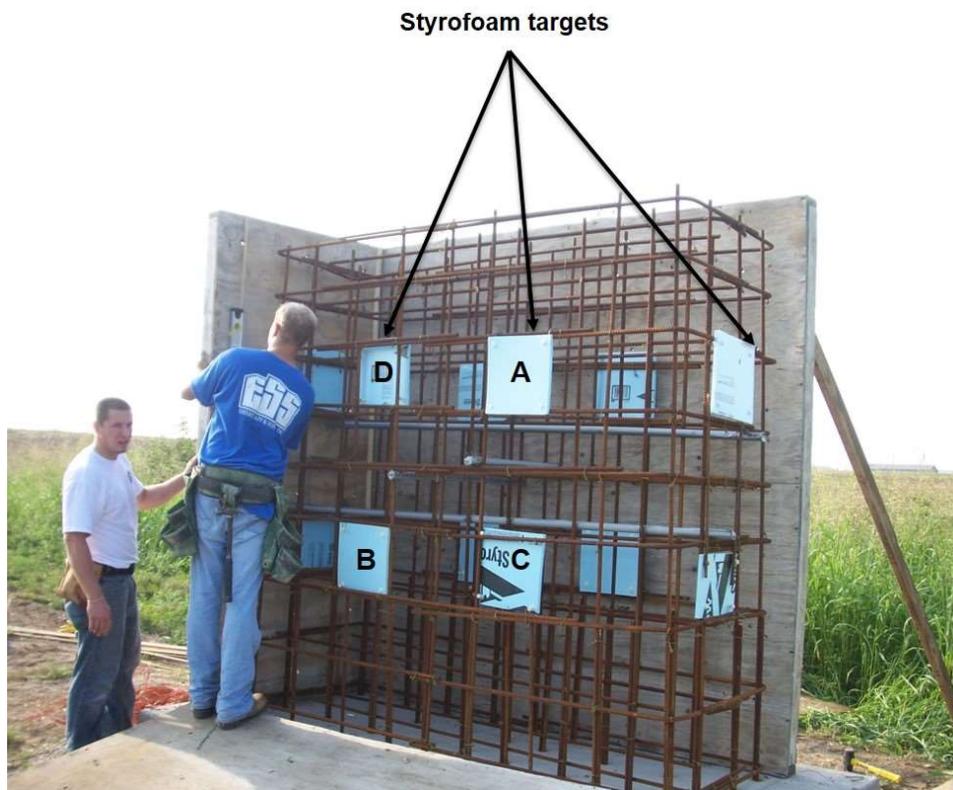
**Figure 14 – Midway test block before the concrete is poured.**

The purpose of the construction and testing of the Midway Test Block was to observe the depth measurement effects of the IR-UTD camera against a known condition. Subsequently, the IR-UTD system was used to compare the IR-UTD systems result to that of traditional infrared camera results. Styrofoam targets at known depths were placed into a concrete block for testing. Figure 14 shows the Styrofoam target locations before the concrete was poured.

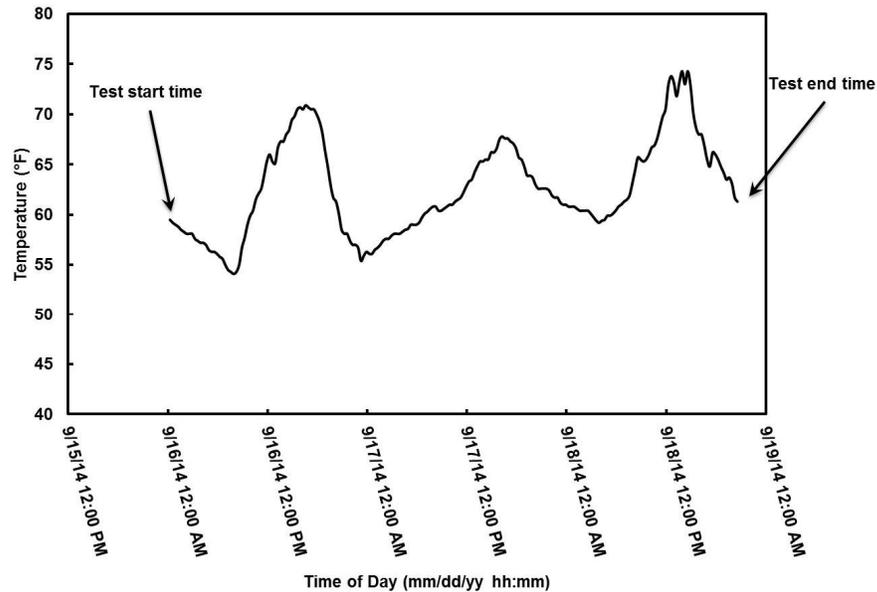
**Figure 15 - Midway Test Block weather data from September 16, 2014 to September 19th, 2014.**

The test was conducted over a period of three days, from September 16<sup>th</sup>, 2014 until September 19<sup>th</sup>, 2014. Figure 15 represents the ambient weather changes during the three-day testing period.

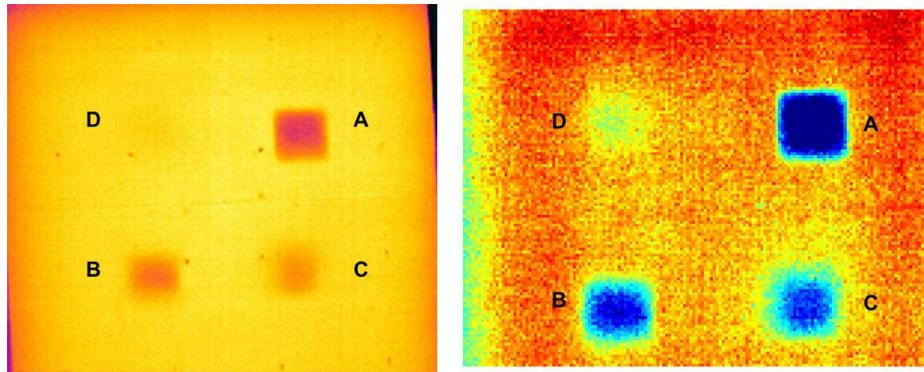
**Figure 16 - Results from both the handheld infrared camera (left side) and the IR-UTD system (right side)**

“D” (5”) observable in the IR-UTD image, but all of the other defect indications are more pronounced than the indications in the handheld infrared camera image.

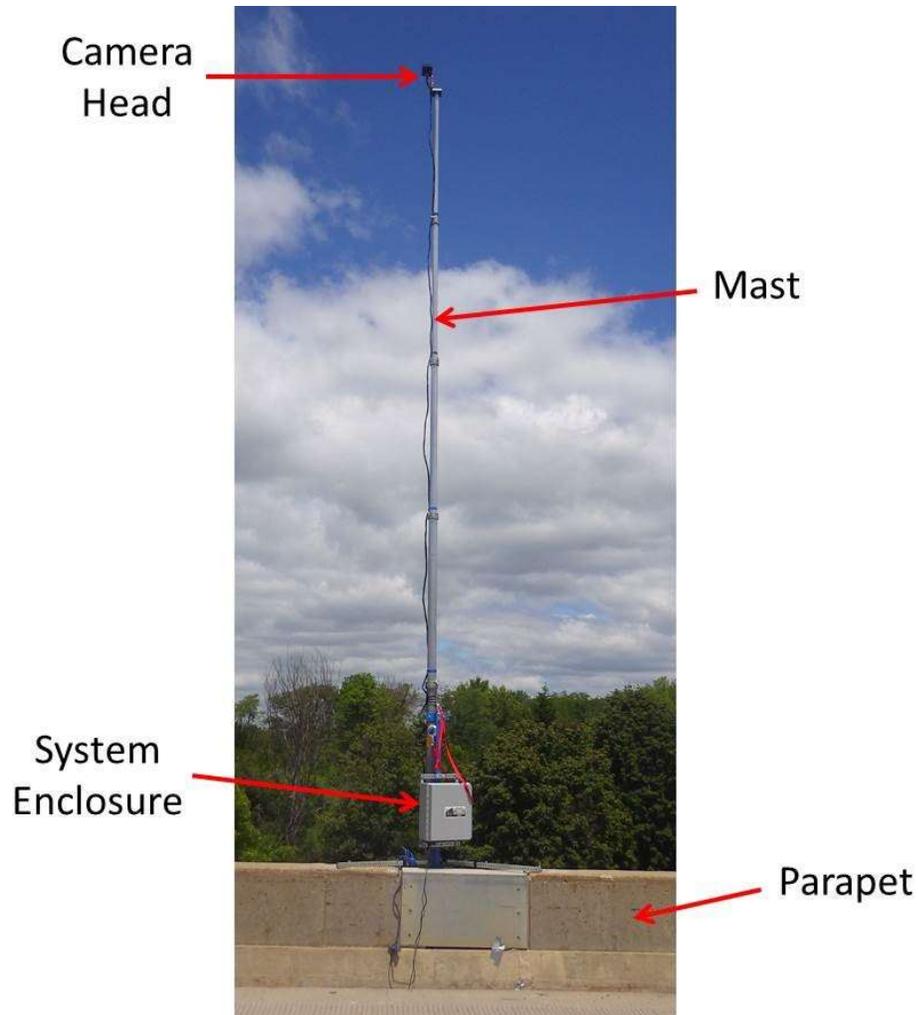
**Figure 17 – IR-UTD system mounted on a light pole base on Iowa Bridge.**

The testing on the Iowa Bridge started at 11:54 AM on September 8th, 2014. The IR-UTD system was mounted to the side of the bridge as shown in Figure 17, and was hoisted into the air, imaging approximately 3200 square feet of the bridge deck. Figure 18 shows the bridge deck area imaged by the IR-UTD system when hoisted into the air. Infrared data was collected and compared against data from the inspector. From these data, defect locations were determined, as well as general defect depth.

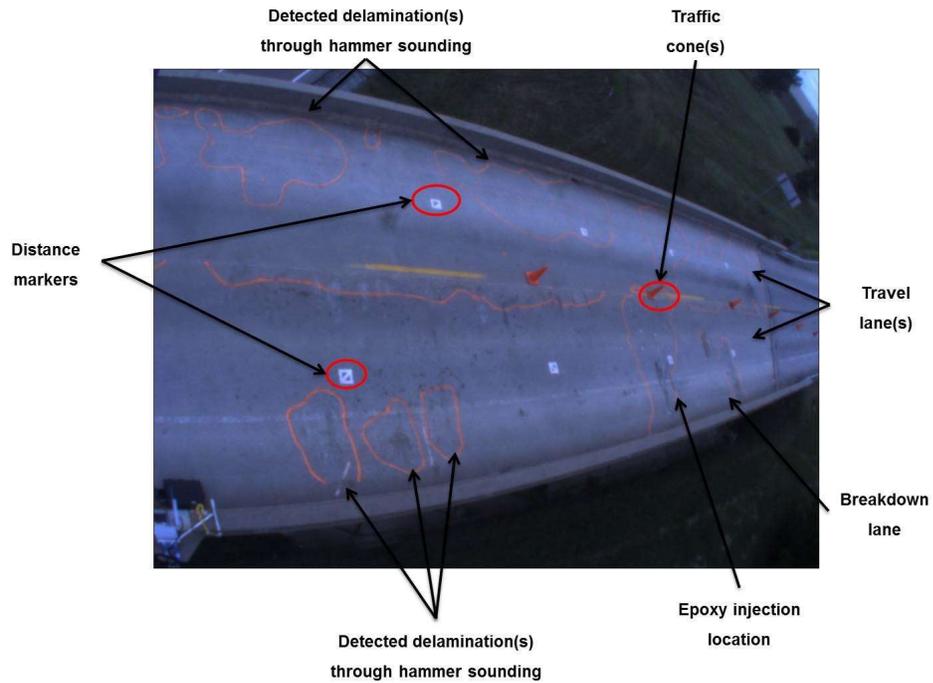
**Figure 18 – View of the IowA bridge deck from the IR-UTD system camera.**

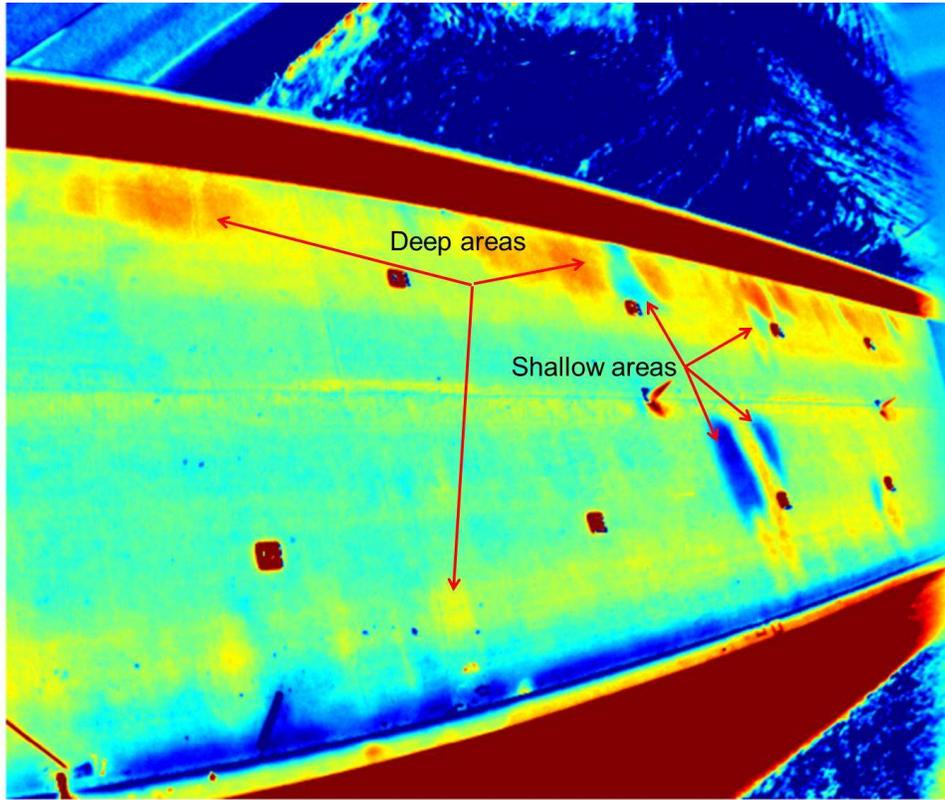
Figure 19 – Initial test results of the Iowa Bridge.

Figure 19 displays the location of the delaminations determined by the IR-UTD system. Drilling was also conducted on a specific defect on the bridge deck. Drilling was conducted to measure the depth of delaminations at this location. The drilling location and measured depths of each delamination can be seen in Figure 20 and Figure 21. In Figure 20, the infrared color data is compared to the depth of delamination at each drilling point. Figure 19 demonstrates the ability of the IR-UTD to indicate the general depth of delaminations based on color; red being deeper and blue being more shallow under the color spectrum used.

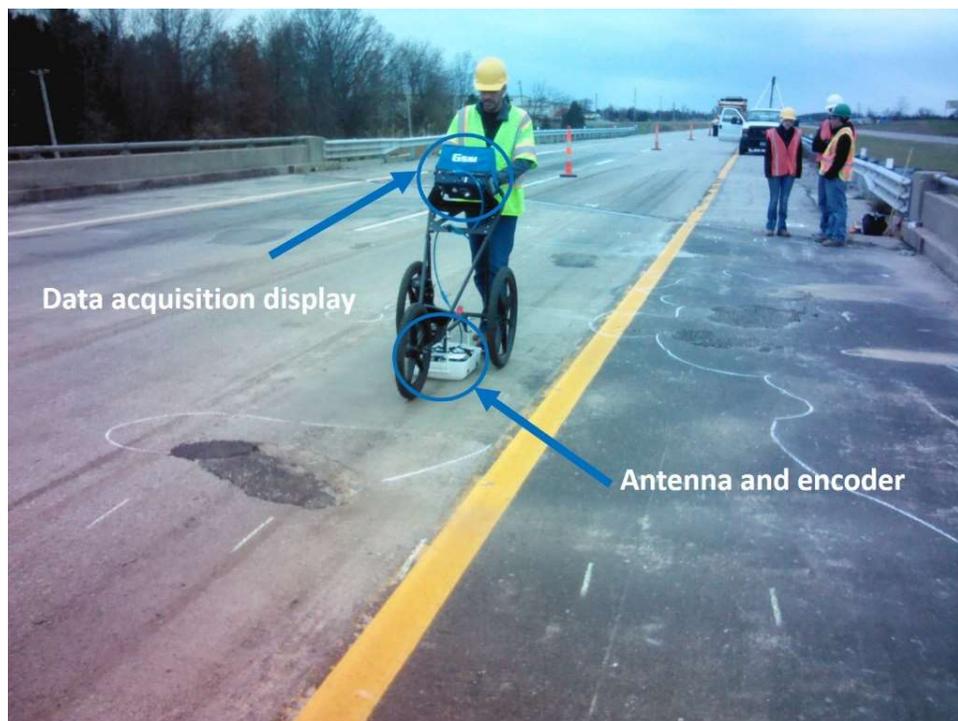
Figure 23 – Image of a ground-coupled GPR system inspecting a RC bridge deck.

Ground Penetrating Radar is a commonly used technique for varying reinforced concrete applications. Figure 23 shows a ground-coupled GPR system consisting of an SIR-3000 data acquisition controller device, a 16000 Hz antenna and encoder to measure distance traveled. This instrument is being used to inspect a reinforced concrete bridge deck.

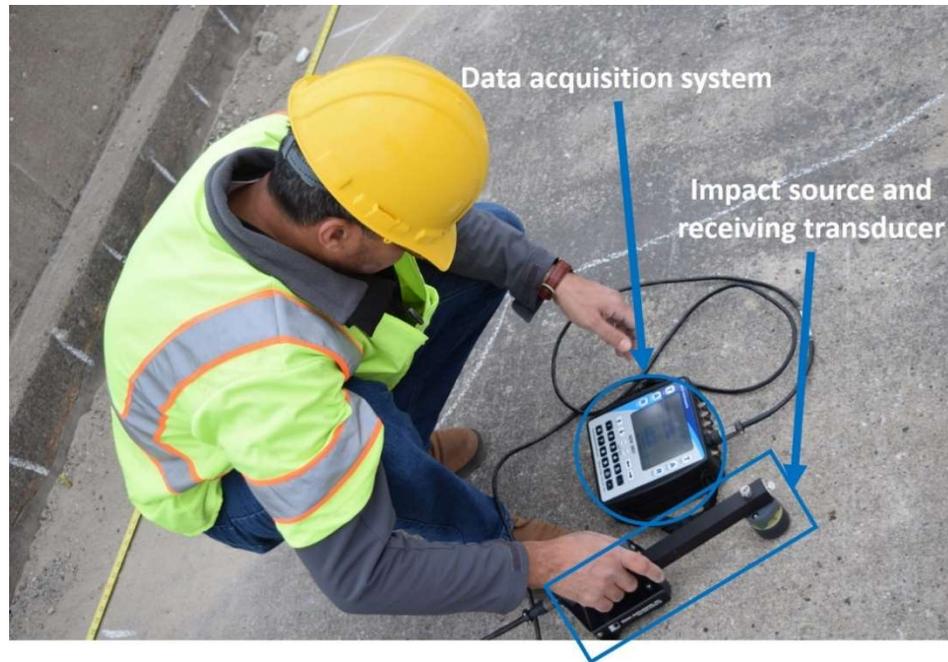
**Figure 24 – Image of IE being used to confirm a subsurface delamination in a reinforced concrete bridge deck.**

Impact Echo (IE) is a very commonly used stress wave propagation method [18]. Figure 24 shows an IE machine being used to detect subsurface delaminations in a reinforced concrete bridge deck.

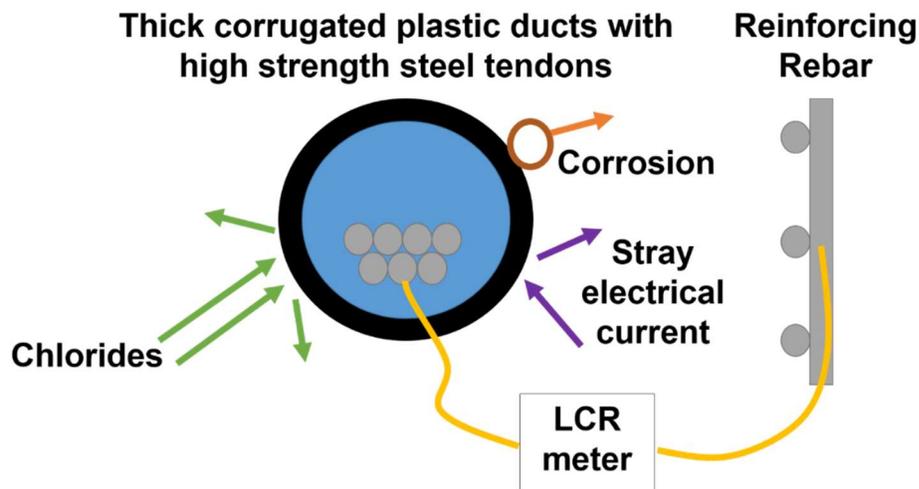
Figure 25 – Image displaying a general concept behind how the impedance measurements would be collected when using Electrically Isolated Tendons.

Electrically Isolated Tendons refers to a monitoring system that improves and tracks the corrosion protection of the high-strength steel tendons during the service life of the structure. The corrosion protection is improved by using thick corrugated plastic ducts, as opposed to galvanized steel ducts. This creates a tight envelope that helps to avoid chloride ingress to the high strength steel and avoid stray electrical current on the tendon steel [22]. Corrosion protection monitoring is achieved by recording the impedance between the tendons and the concrete-reinforcing rebar. This monitoring can be accomplished by use of an LCR meter, which measures the inductance (L), capacitance (C), and resistance (R) between two metallic materials. Figure 25 shows the general principle behind measuring the electrical impedance of a PT tendon with an LCR meter.

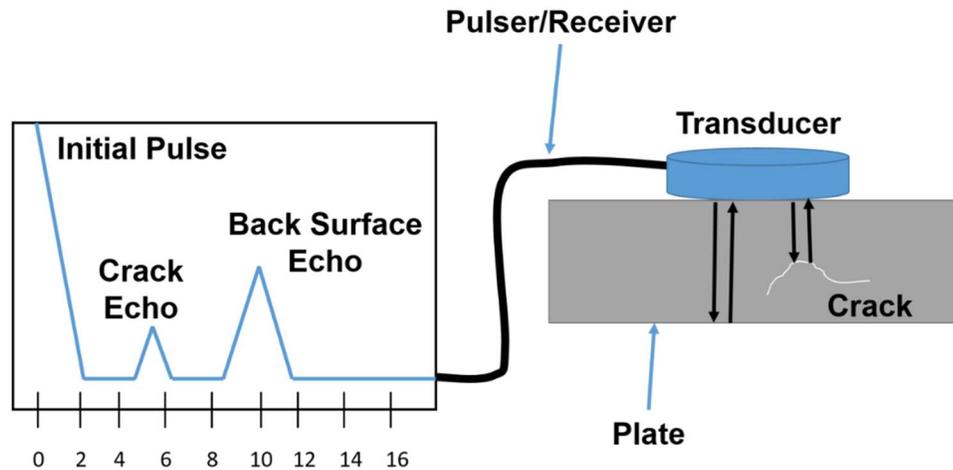
**Figure 26 – Image displaying how the UT system sends a wave into a material as well as the amplitude upon returning**

would have a lesser reflected amplitude due to the scatter of the wave encountering the defect. Figure 26 also illustrates an example of what the display might look like following a test. One limitation of UT is the need for access to the surface of the object under evaluation.

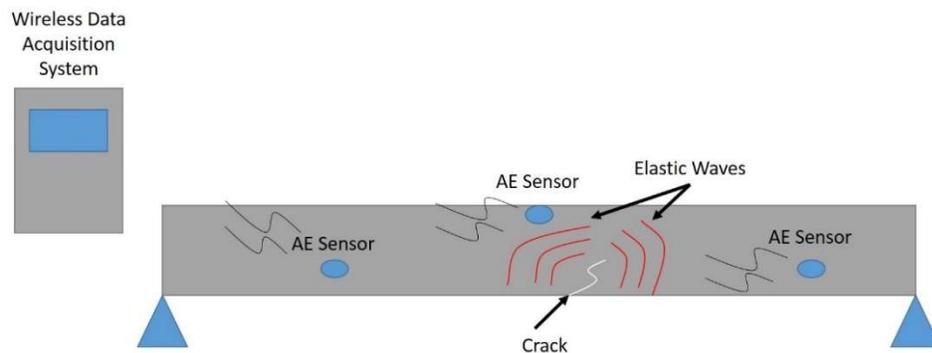
**Figure 27 –Acoustic Emission monitoring system visualization.**

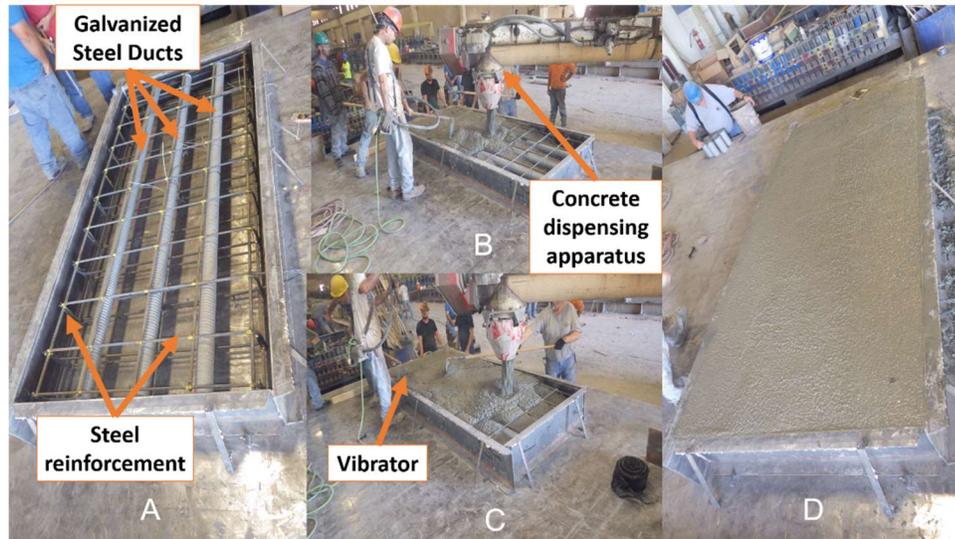
**Figure 29 – Specimen construction process at Coreslab in Marshall, MO.**

display two separate stages in the pouring process. Image D is the specimen after the pouring is finished and the smoothing of the surface has been completed.

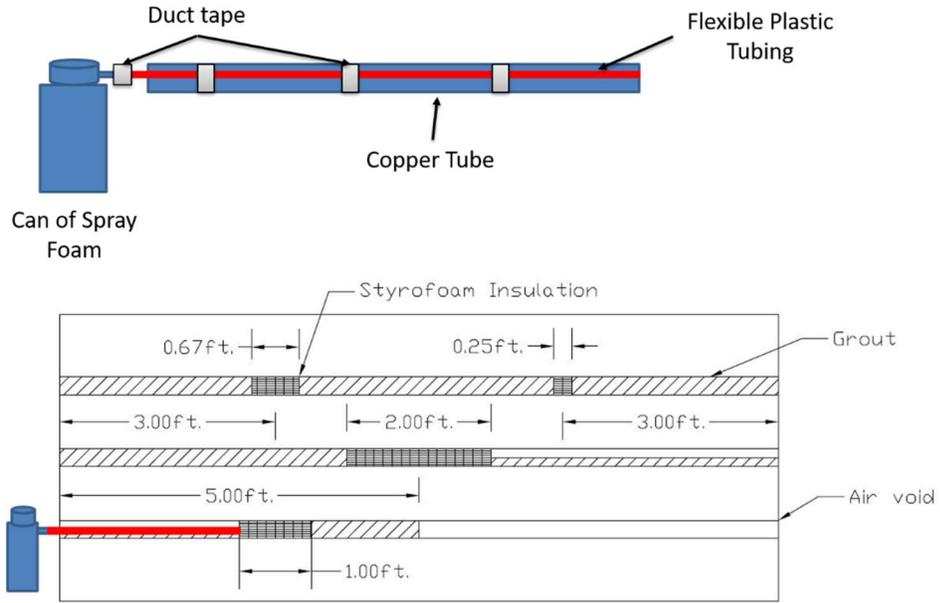
**Figure 30 – Image displaying how spray foam was inserted into the ducts.**

Before the placement of foam began, several tests were run to determine what the expansion rate was in terms of the linear length along the beam (i.e. if 1 linear inch of foam was sprayed inside the 3-inch diameter duct, how much would it expand linearly along the length of the duct). Testing on a spare 3-inch galvanized duct concluded that the foam expanded at approximately a rate of 4:1 (i.e. if 1 linear inch of foam was sprayed inside the 3-inch diameter duct, the ending result will fill the duct 4 linear inches). These tactics were used to accurately place spray foam defects along the length of the duct at the locations and sizes called out in Figure 30.

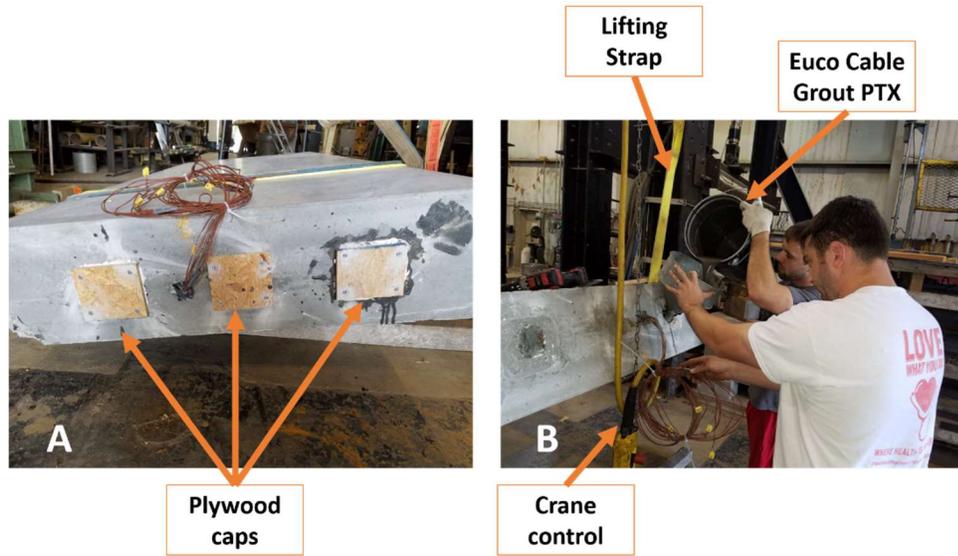
Figure 31 – Image A (left) displays plywood caps protecting the ducts while image B (right) shows grout being poured into the ducts.

The ducts were grouted using Euco Cable Grout PTX, a type of commonly used grout in the state of Florida for PT ducts. The grout was donated by the Euclid Chemical Company. The grout was placed using a gravity feed, which required that the specimen be positioned differently for each defect. Maneuvering of the specimen was completed multiple time until the final layout was nearly identical to that in Figure 30. Image A of Figure 31 shows a plywood cap placed on top of the ducts to seal the compartment for curing while image B displays grout being placed inside of the ducts prior to capping. Figure 32 displays what ducts look like when they are filled with grout, partially filled with grout, or completely empty.

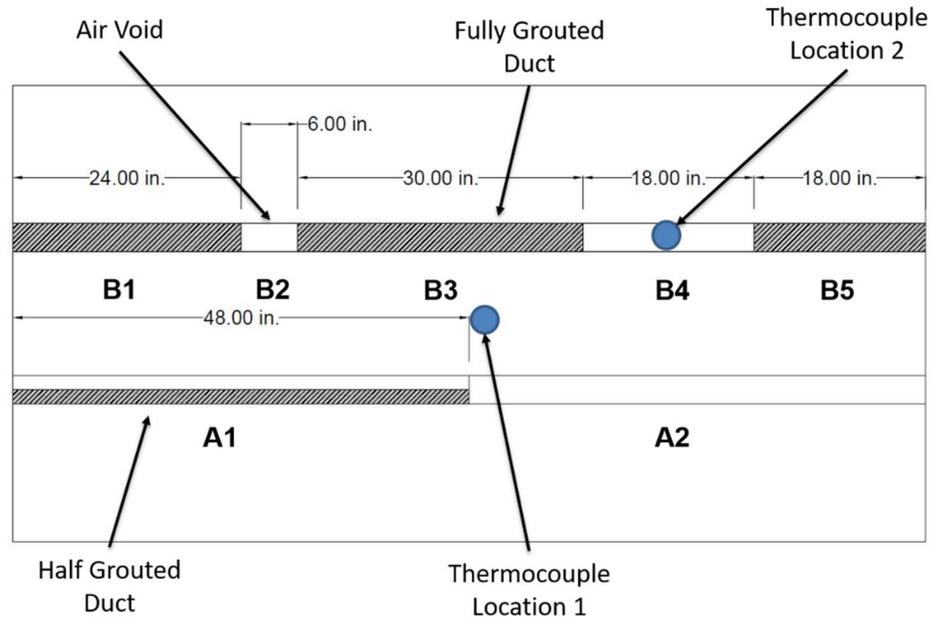
**Figure 34 - Defect and Thermocouple layout for Post Tensioned Specimen 2.**

compartments. Each compartment of each duct had a number associated with it; B1, B2, etc. Figure 34 shows the numbering of each compartment for both ducts.

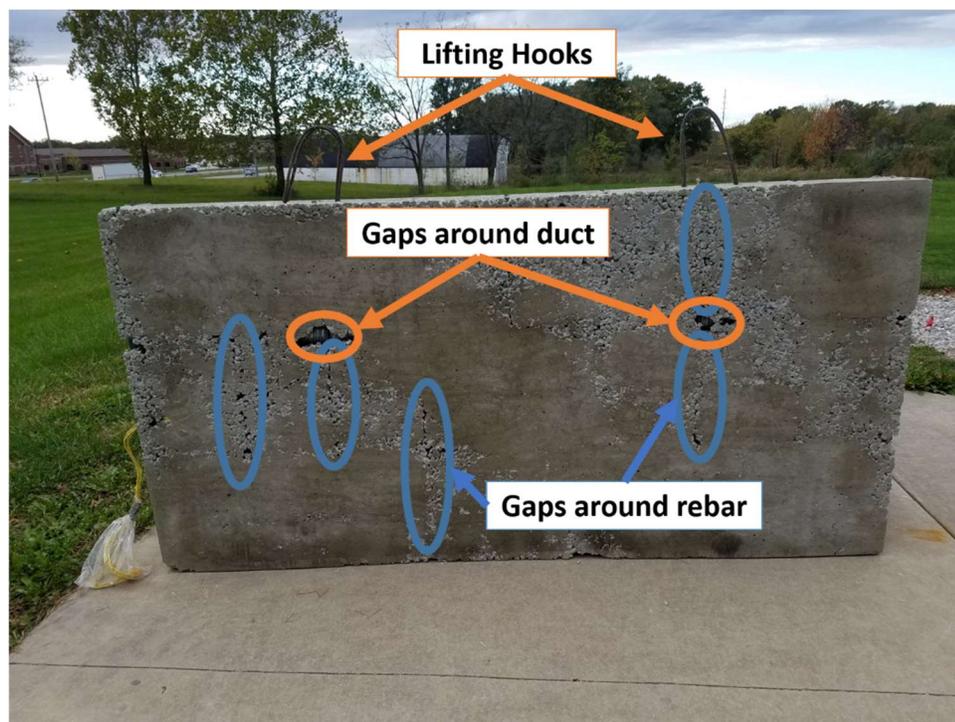
**Figure 40 – Gaps around the embedded ducts and rebar post pouring.**

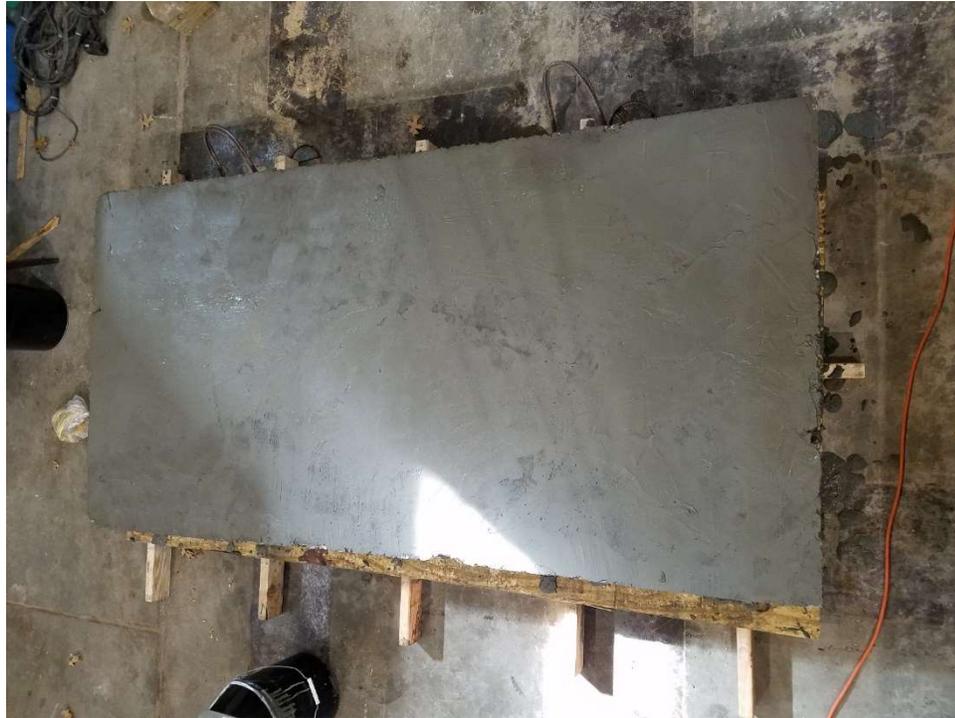
**Figure 41 – Damaged side of Specimen 2 after resurfacing.**

refinishing of the surface. Due to the voids that were present prior to repair, the refinished side of the specimen was not imaged during testing.

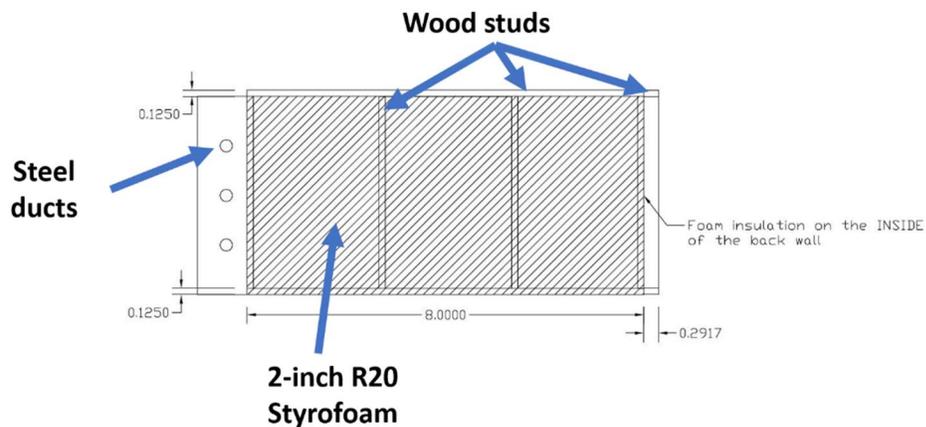
**Figure 42 - Side wall drawing for the insulated structure.**

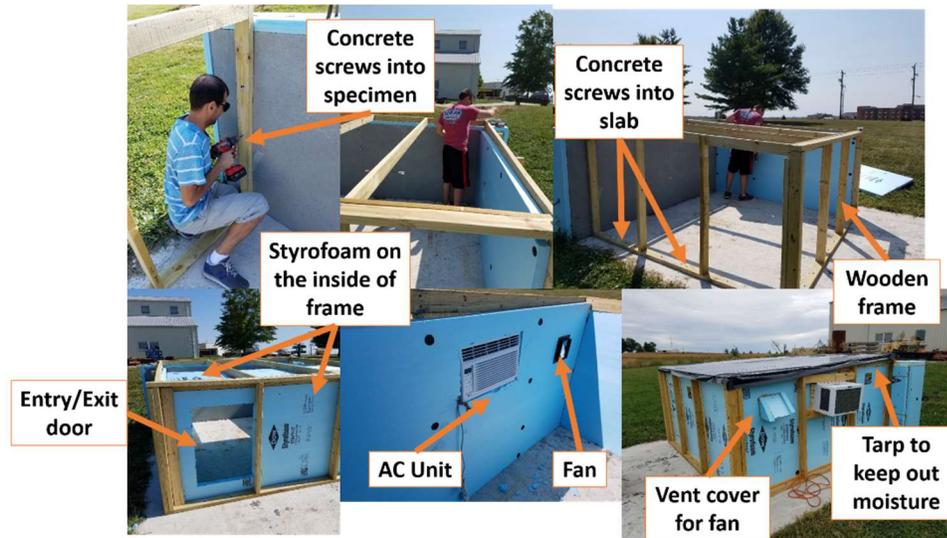
**Figure 43 - Multiple stages of construction for the insulated structure.**

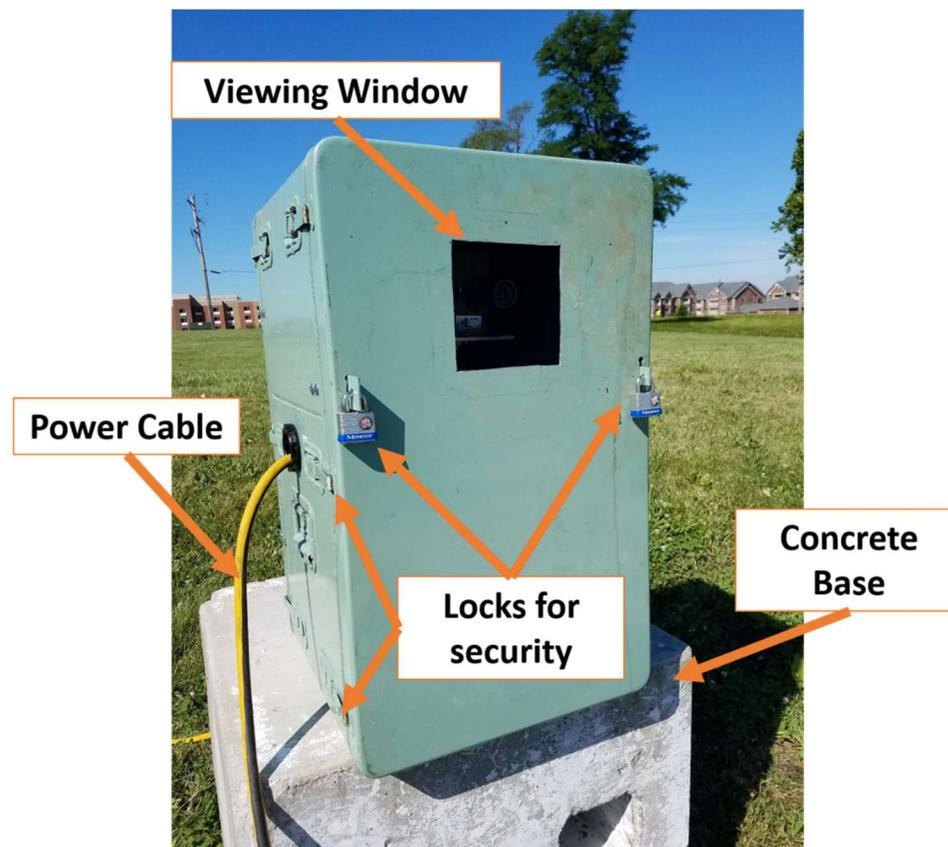
Figure 44 – Aluminum DAQ system for secured viewing.

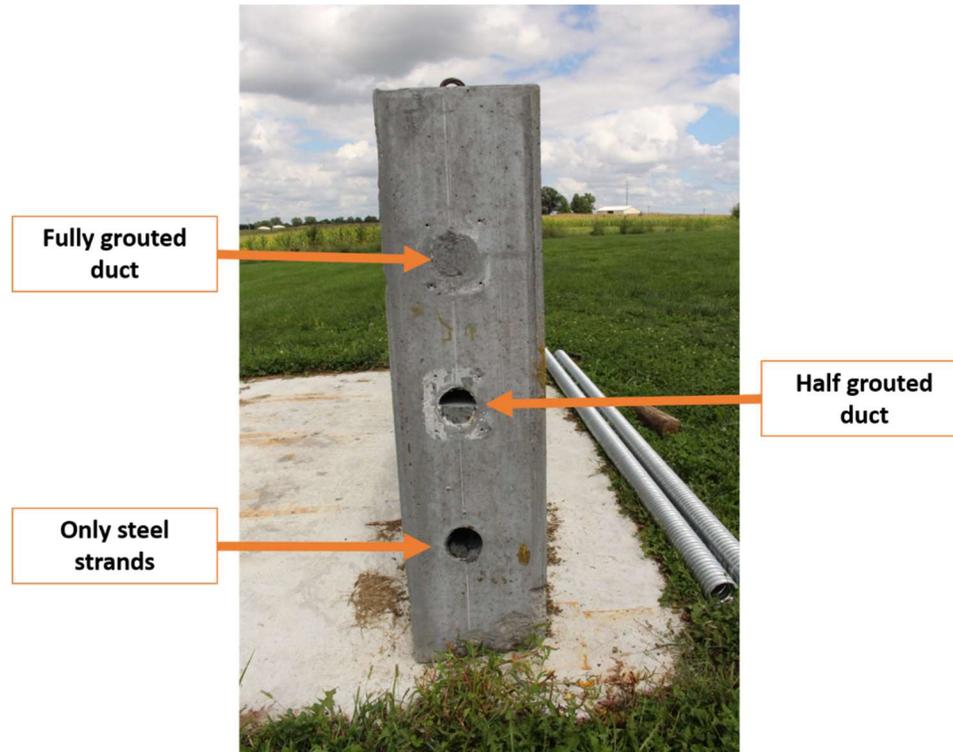
**Figure 46 – Grouting profile for test 2 on specimen 1.**

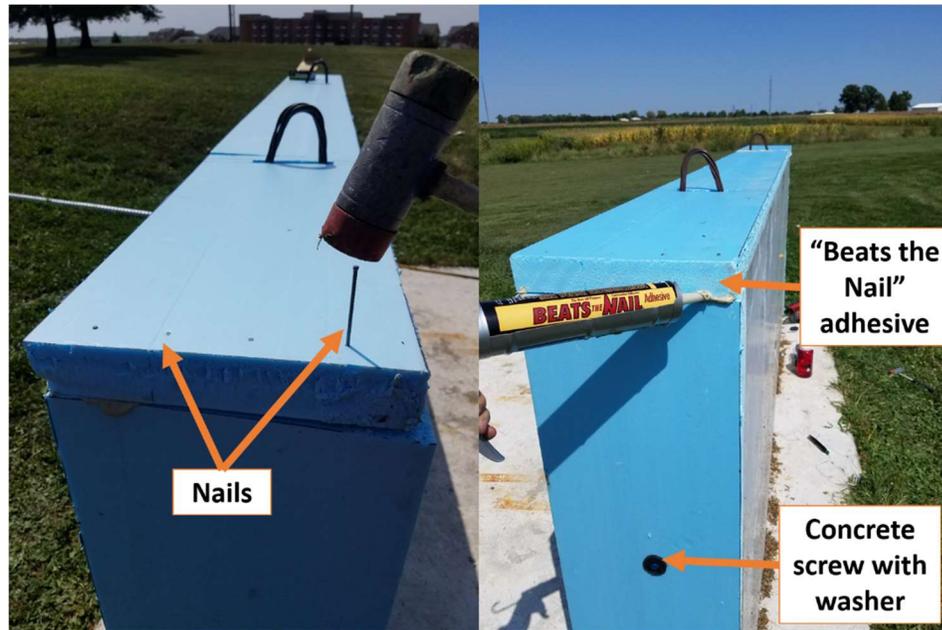
**Figure 47 – How Styrofoam insulation was attached to the side of Specimen 1.**

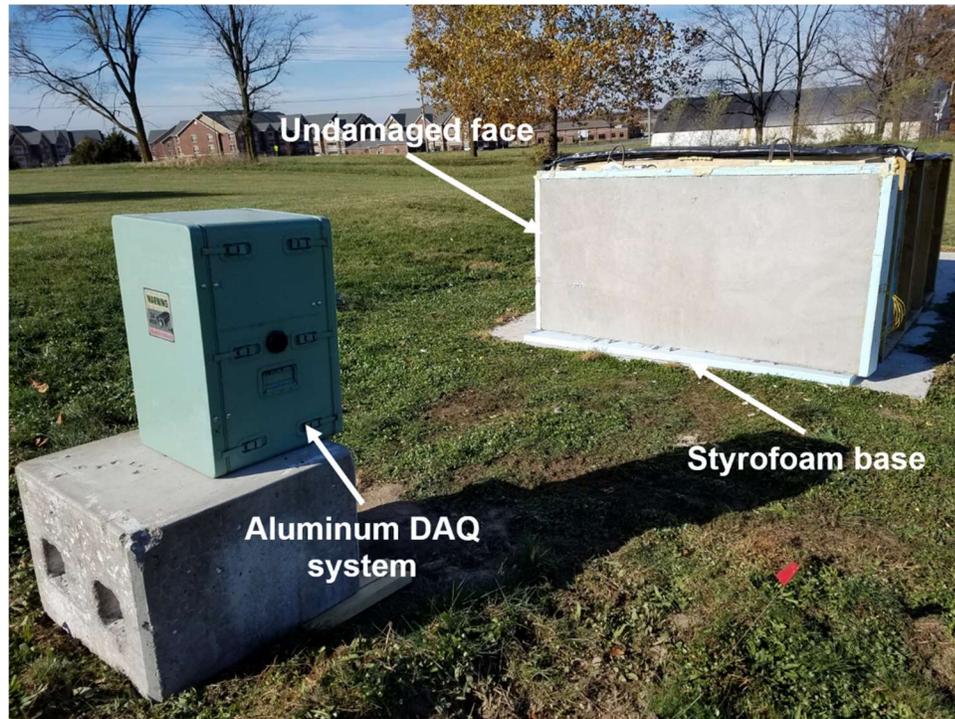
**Figure 52 – Test setup used during test 3 on specimen 2.**

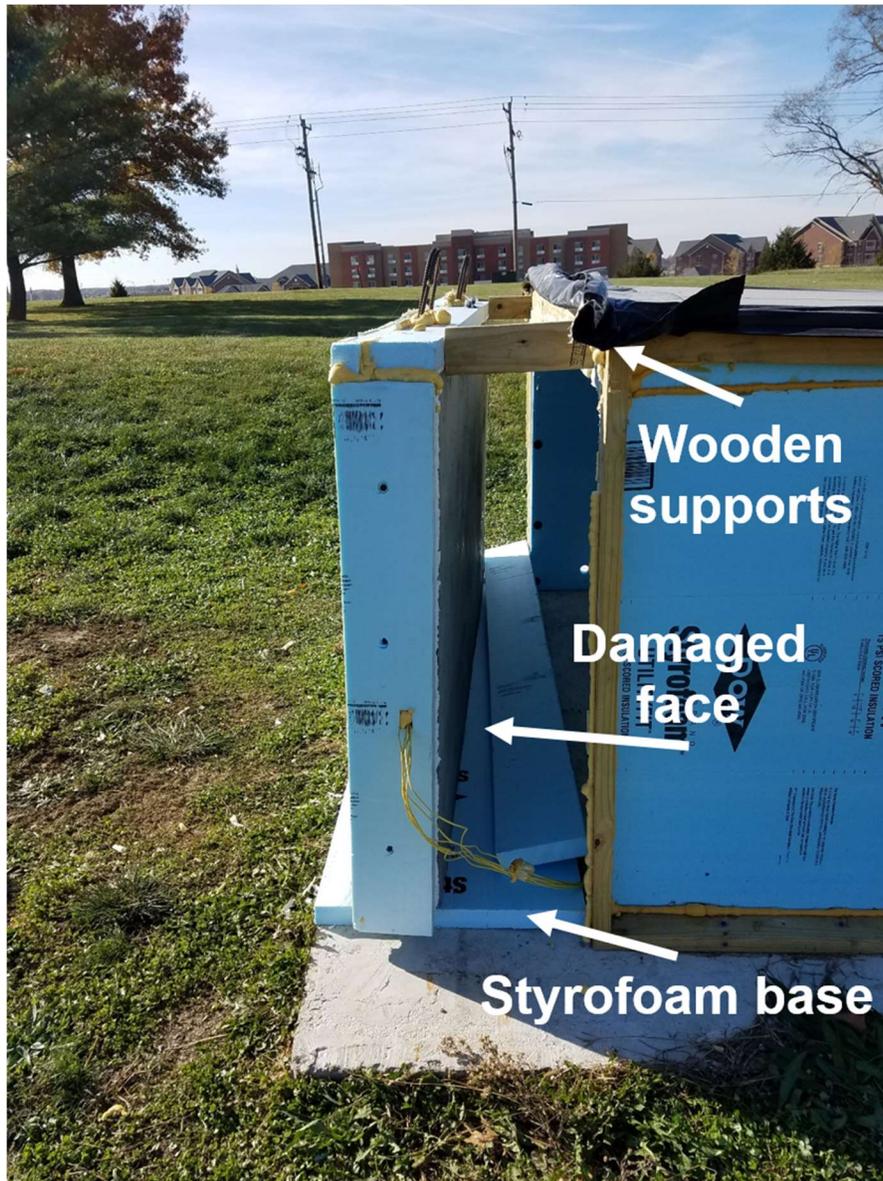
**Figure 53 – Test setup for test 3 on specimen 2.**
