# EXPERIMENTAL ASSESSMENT OF ADVANCED THERMAL IMAGING FOR DETECTING VOIDS IN DUCTS

A Thesis

the Faculty of the Graduate School  
at the University of Missouri–Columbia

DECEMBER 2017

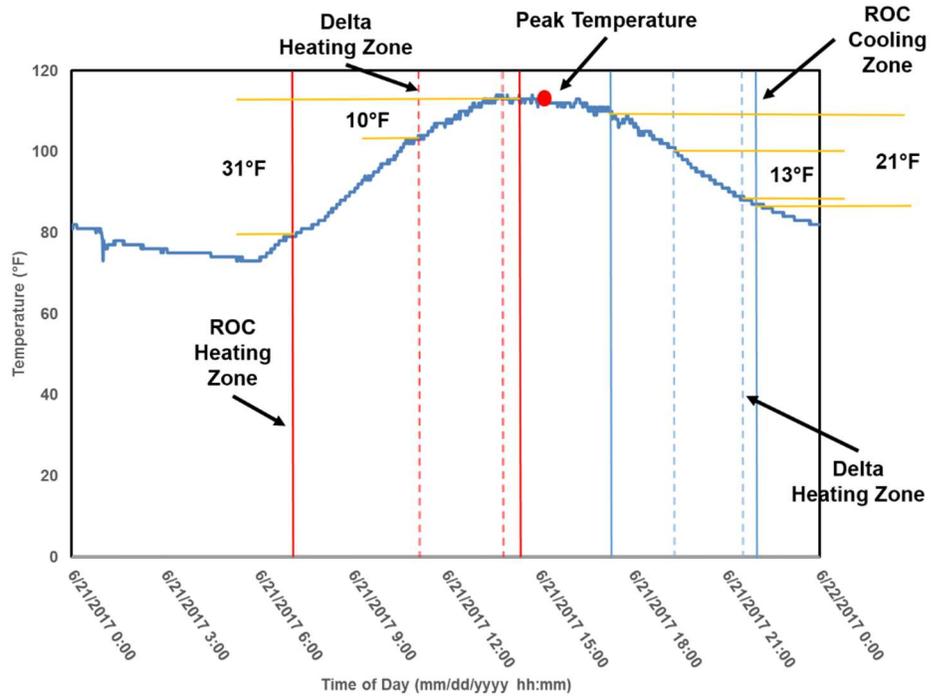
Figure 54 – Surface thermocouple data for PT Specimen 1 – Test 1 on June 21<sup>st</sup>.

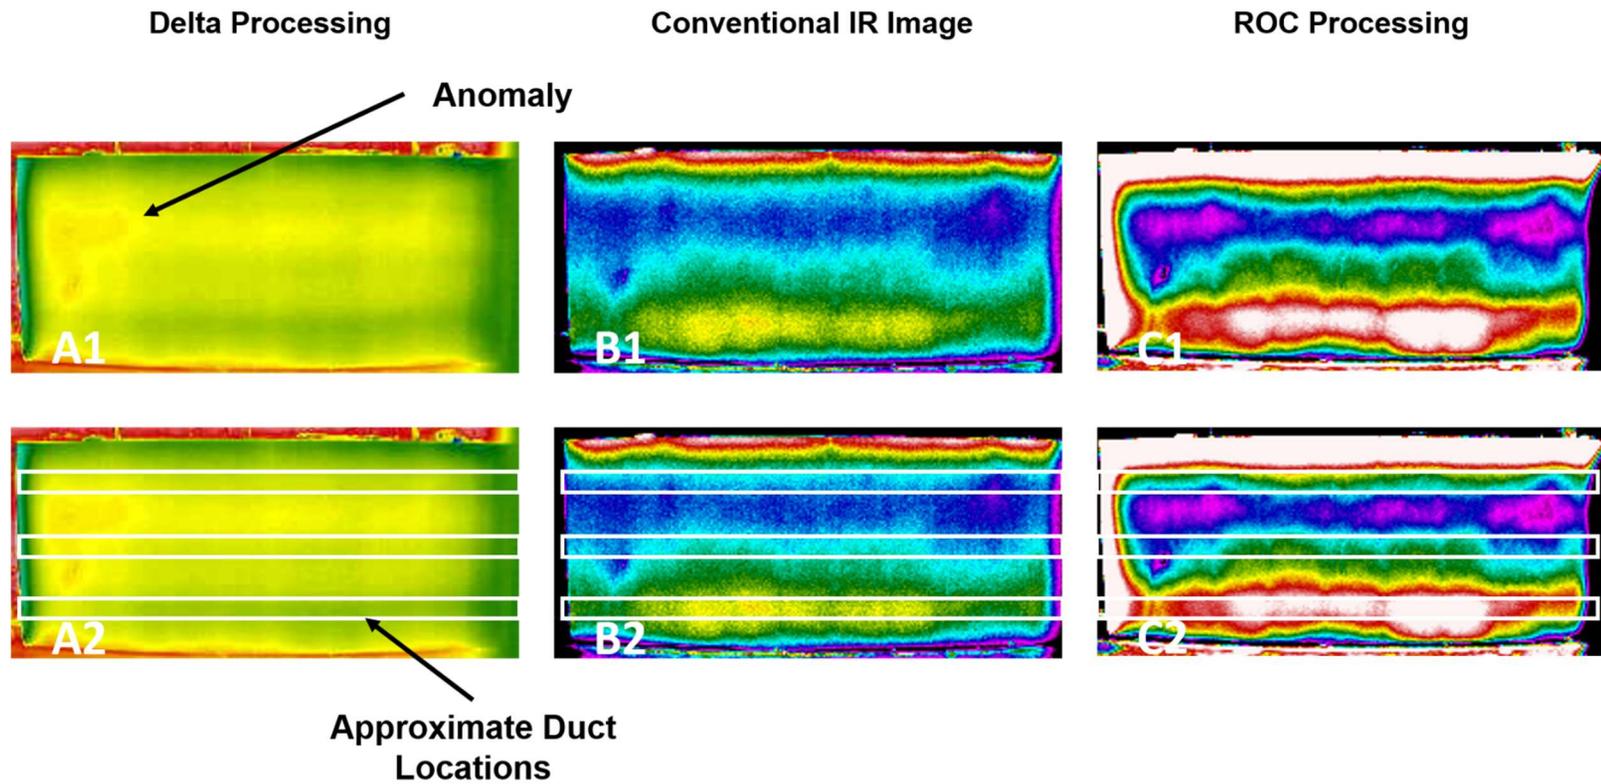
Figure 55 – Results after data processing on June 21<sup>st</sup>, 2017.

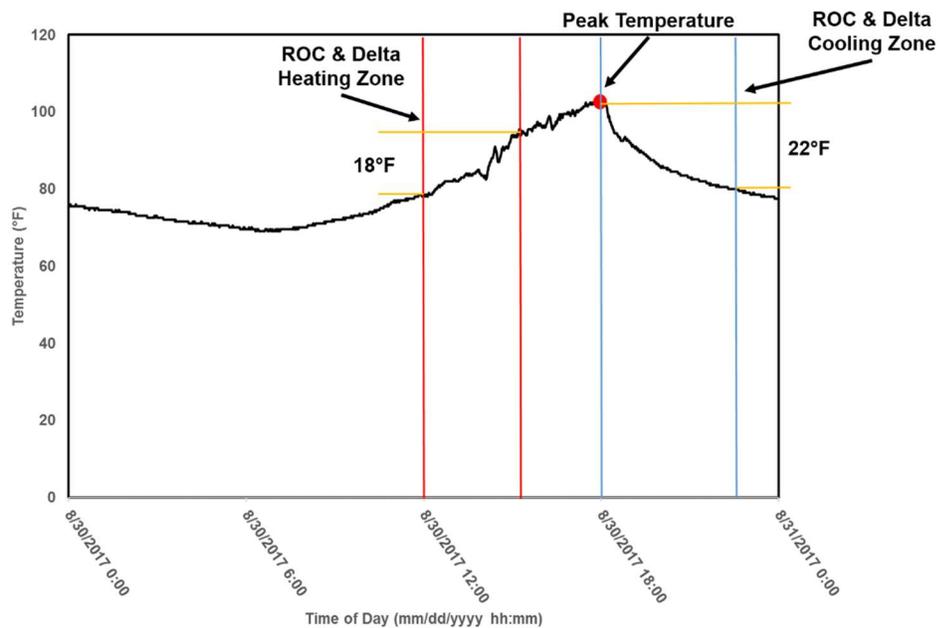
**Figure 56 – Thermocouple data collected during Test 2 on August 30<sup>th</sup>, 2017.**

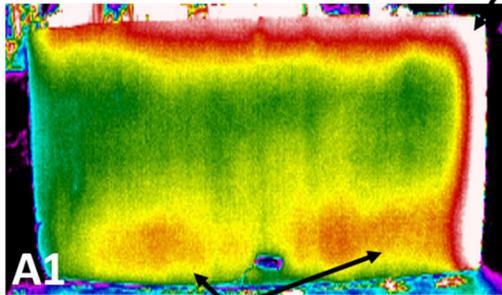
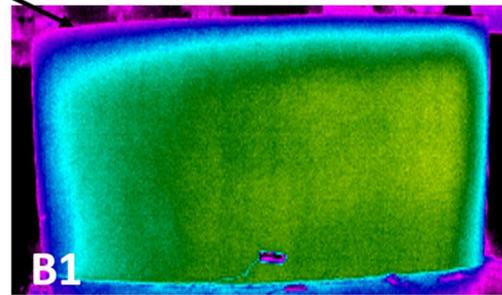
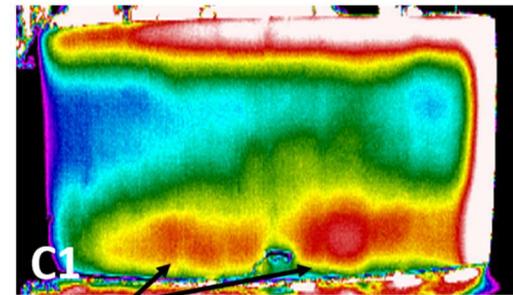
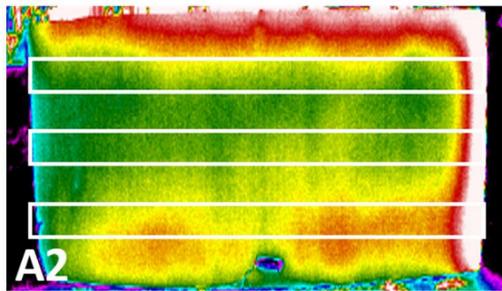
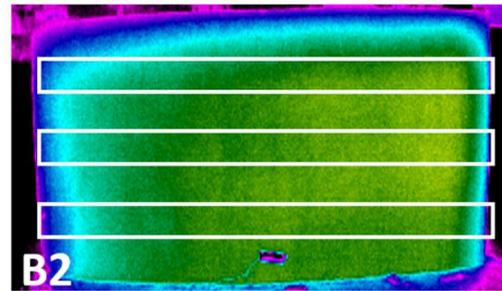
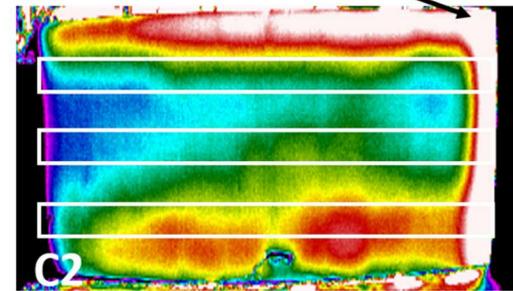
Edge Effect

Defects

Figure 57 – Image produced from processing thermal data on August 30<sup>th</sup>, 2017.

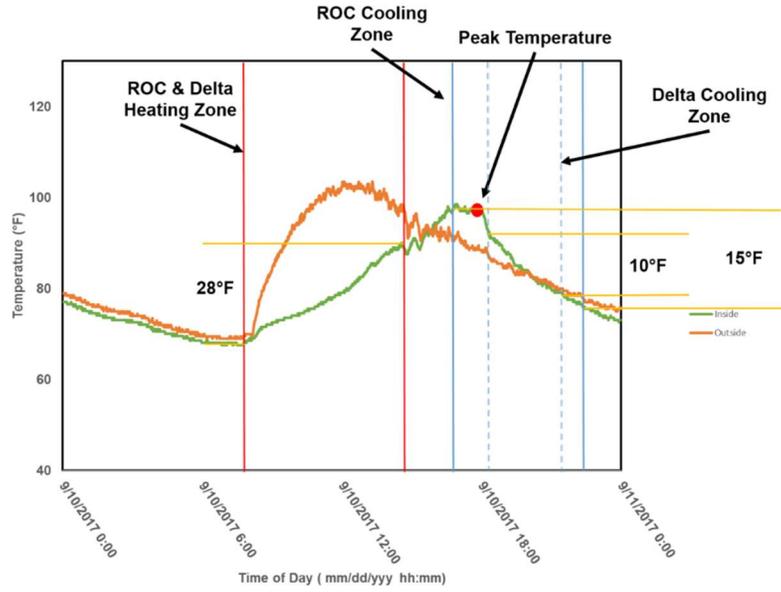
Figure 58 – Thermocouple data collected on PT Specimen 1 on September 10<sup>th</sup>.

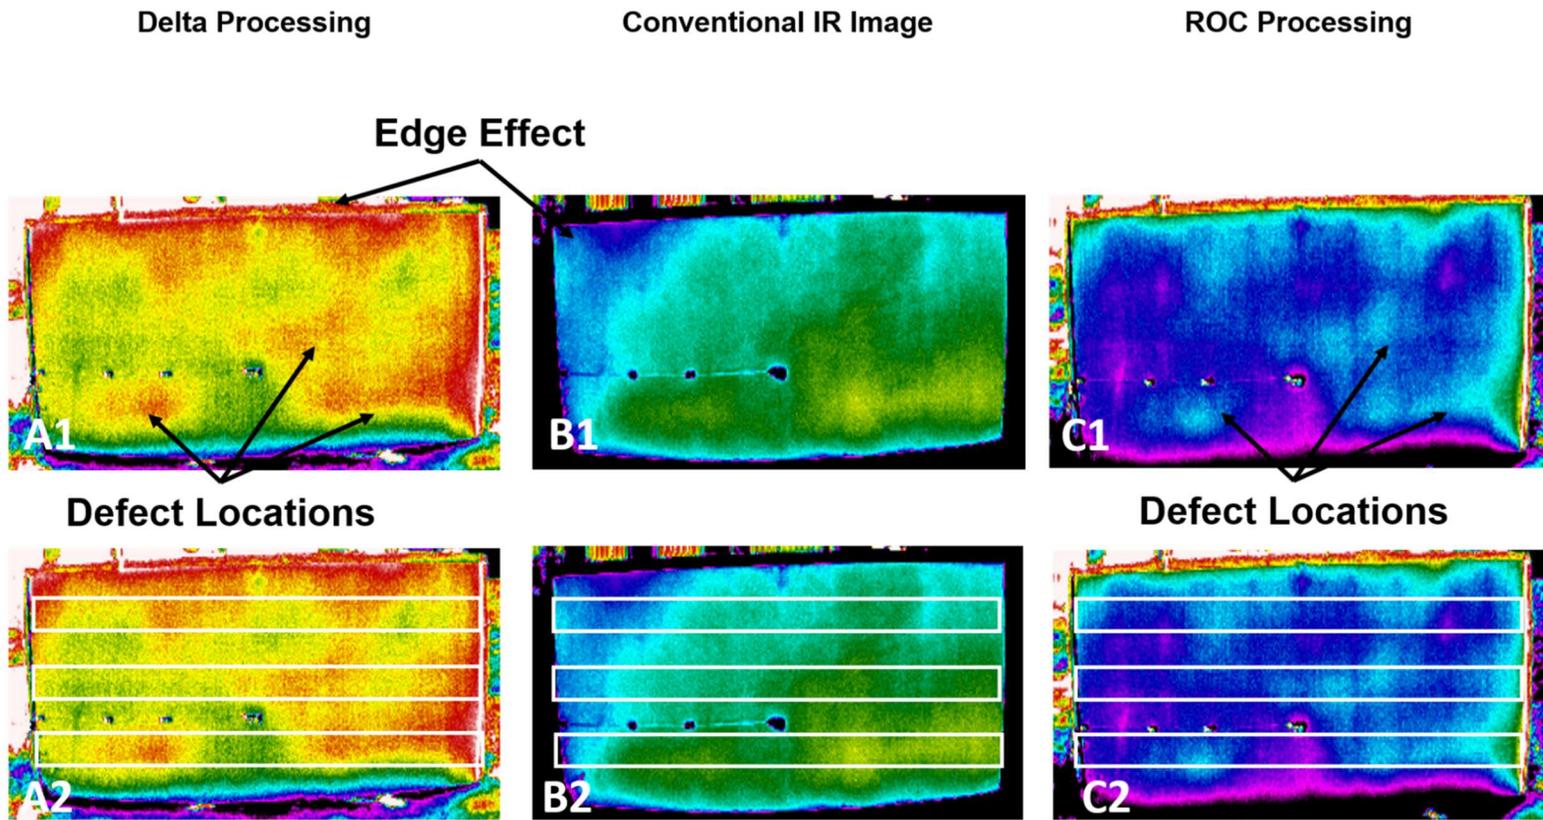
Figure 59 – Processed image from data collected on September 10<sup>th</sup>, 2017.

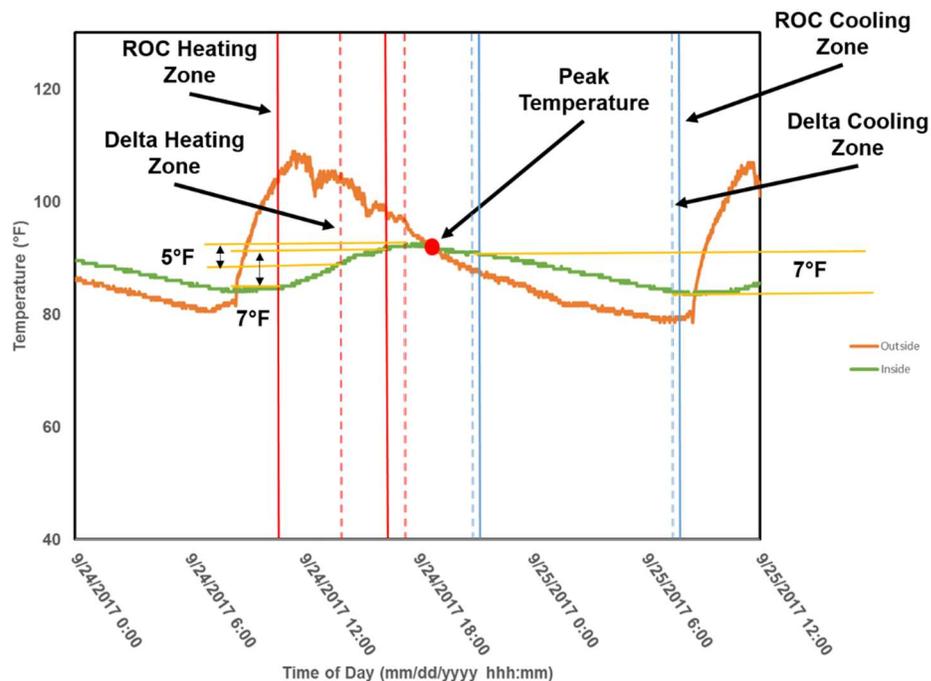
**Figure 60 – Thermocouple data from testing conducted on September 24<sup>th</sup>-September 25<sup>th</sup>, 2017.**

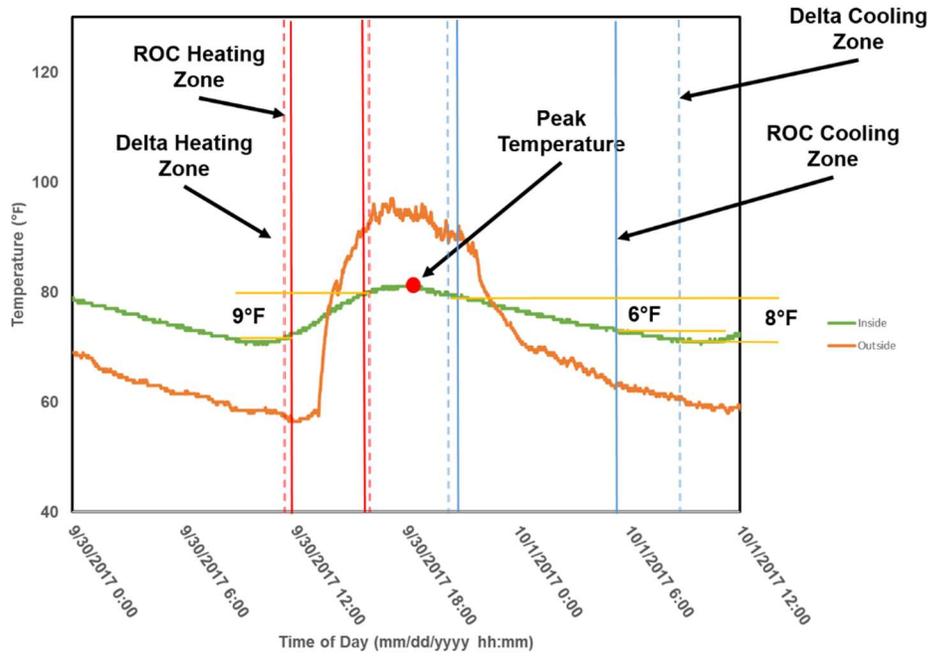
Figure 62 – Thermocouple data collected from September 30<sup>th</sup> to October 1<sup>st</sup>.

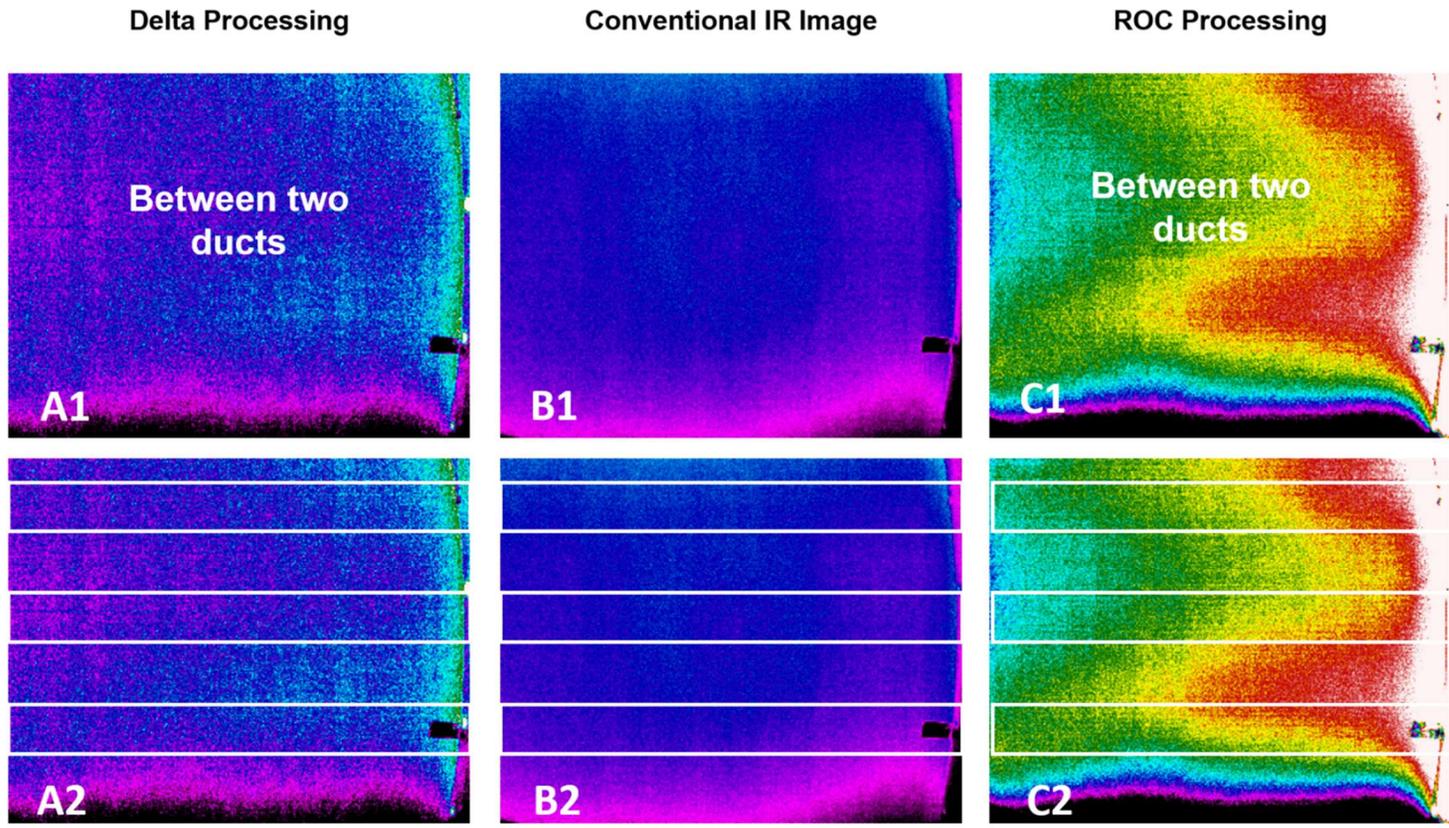
Figure 63 – Infrared results from processing thermal data collected on September 30<sup>th</sup> and October 1<sup>st</sup>.

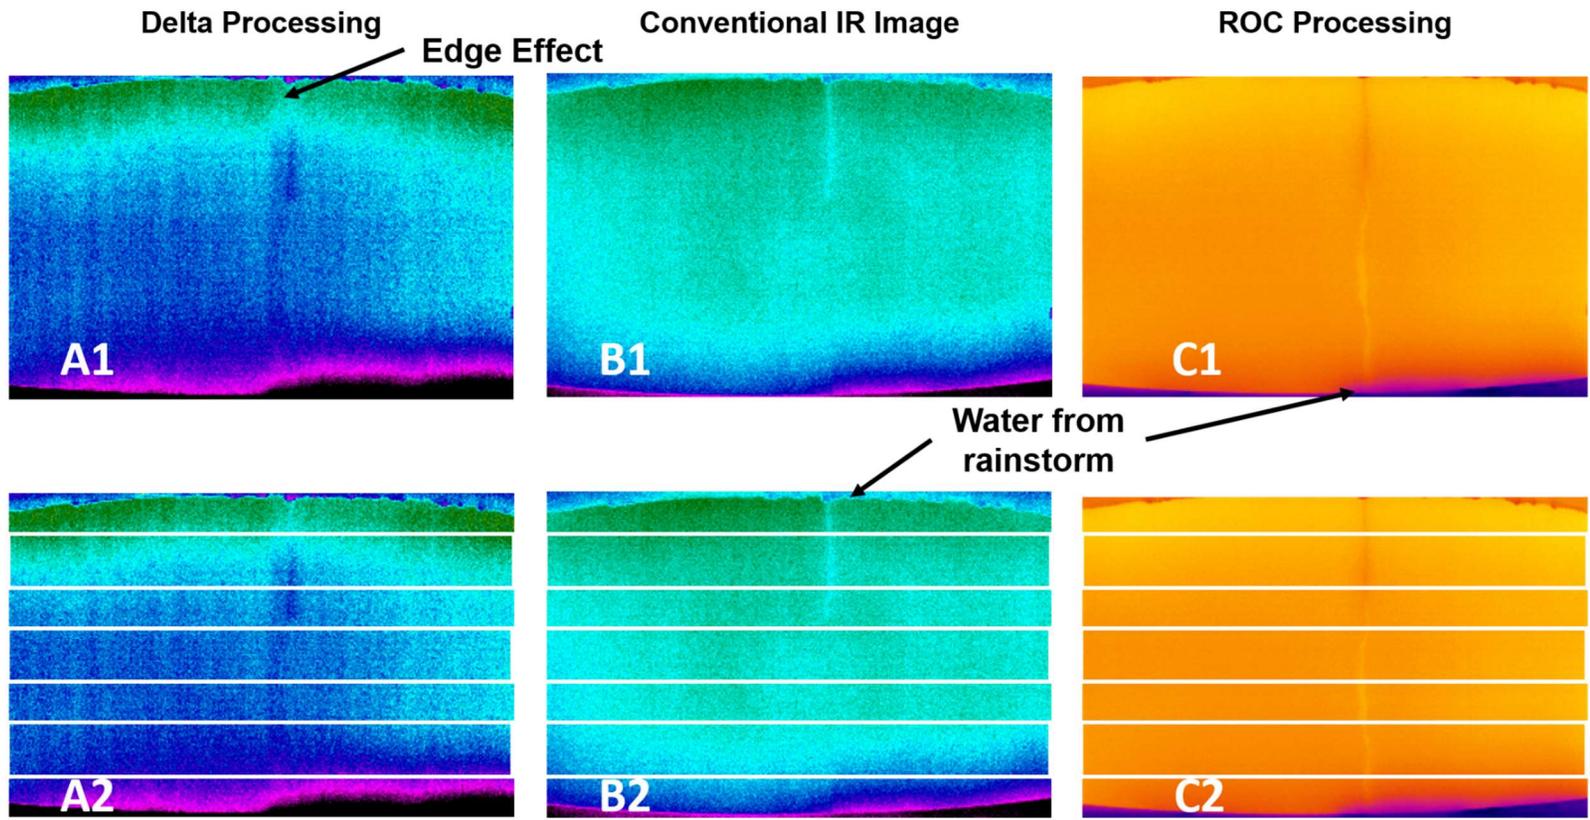
Figure 65 – Processed infrared image from data collected on October 16<sup>th</sup> and 17<sup>th</sup>.

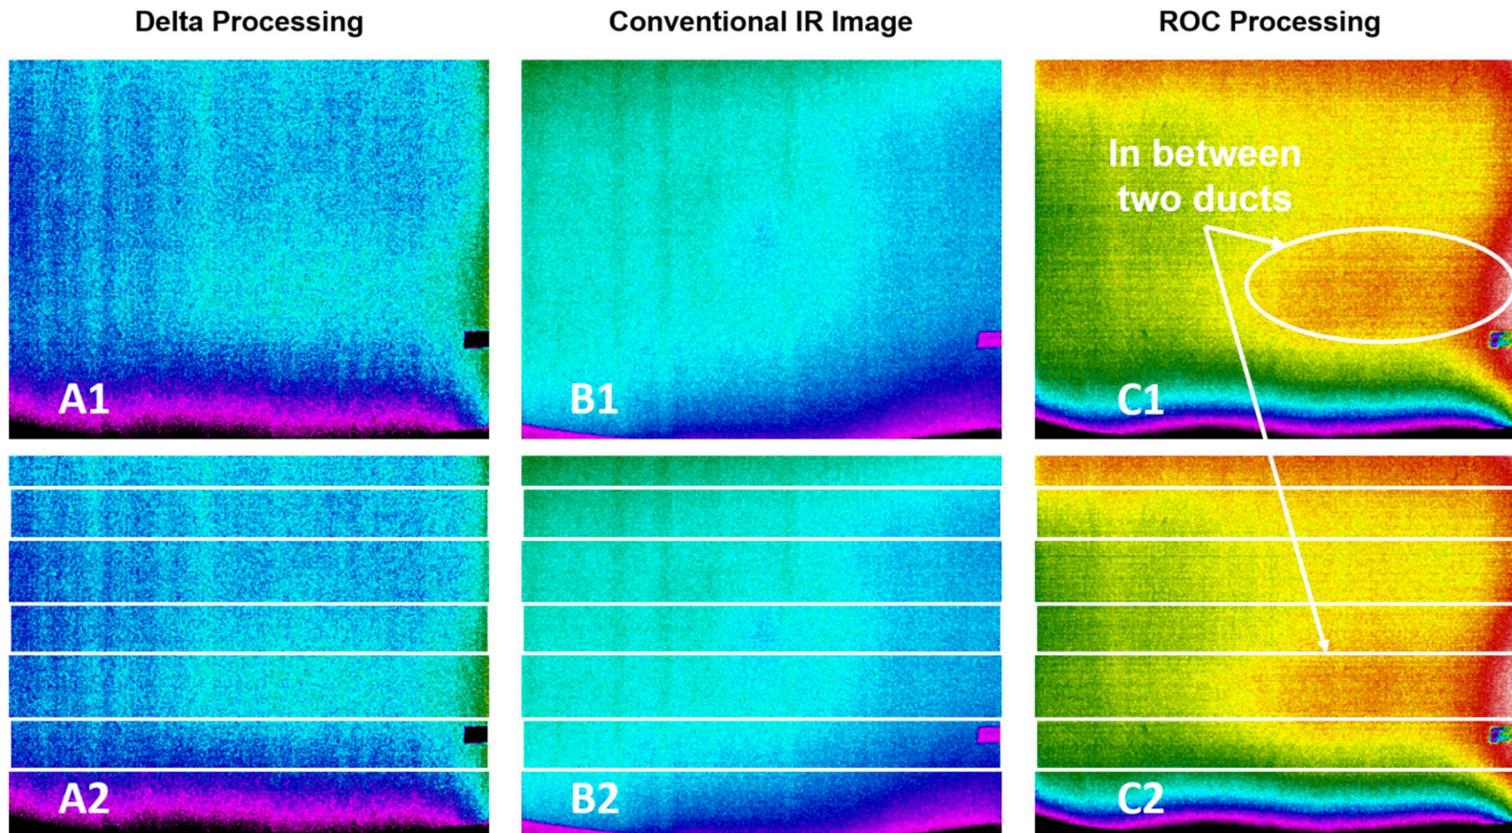
Figure 67 –Processed infrared image collected on October 18<sup>th</sup> and 19<sup>th</sup> for test 5.

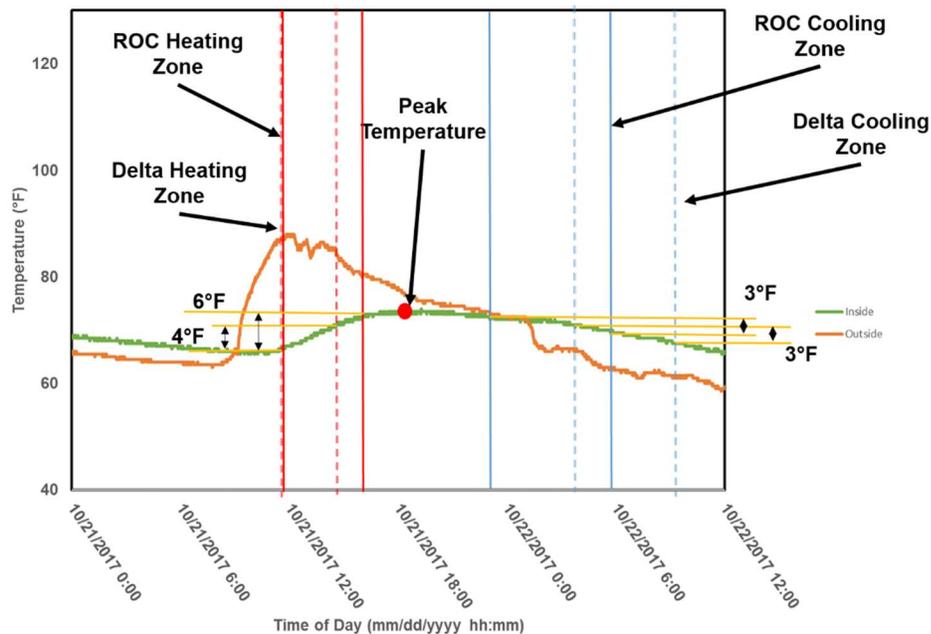
Figure 68 – Thermocouple data collected during test 6 on October 21<sup>st</sup> and 22<sup>nd</sup>.

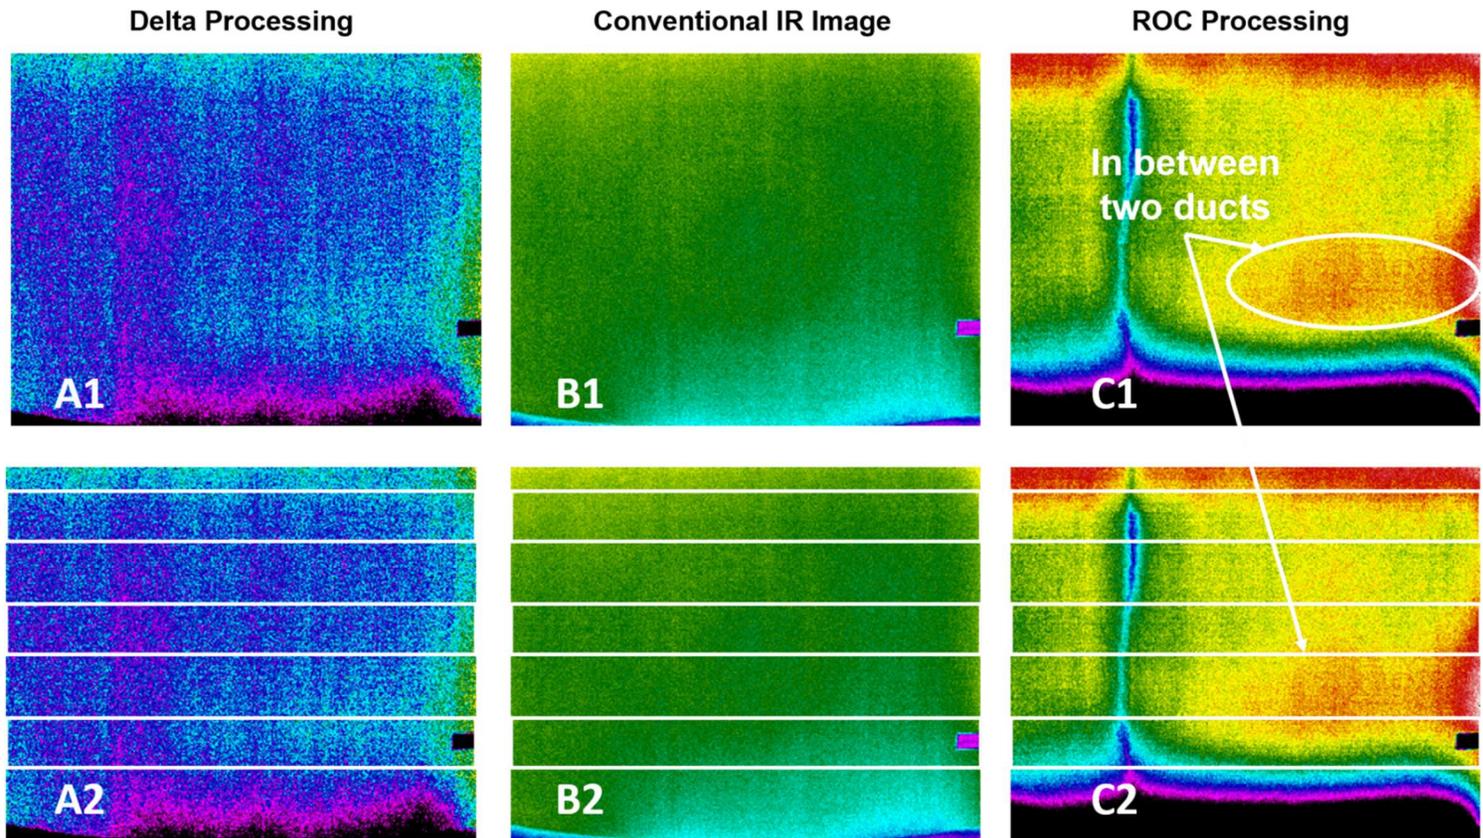
Figure 69 – Processed infrared image from testing on October 21<sup>st</sup> and 22<sup>nd</sup>.

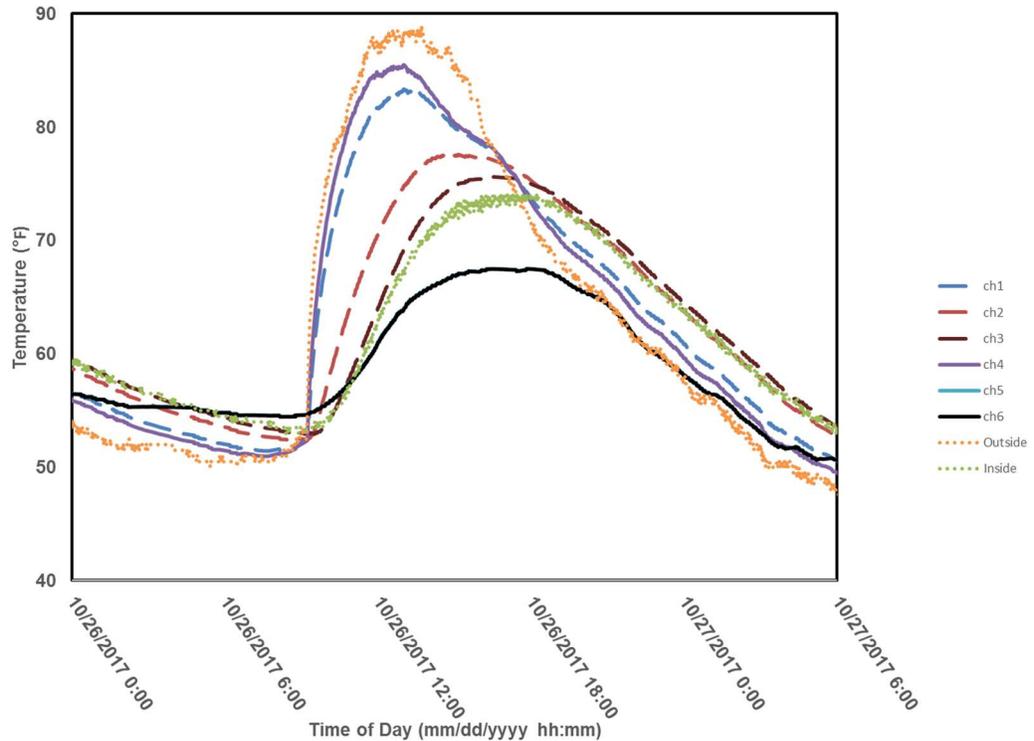
**Figure 70 – All thermocouple data collected during test 1 on October 26<sup>th</sup> and 27<sup>th</sup>.**

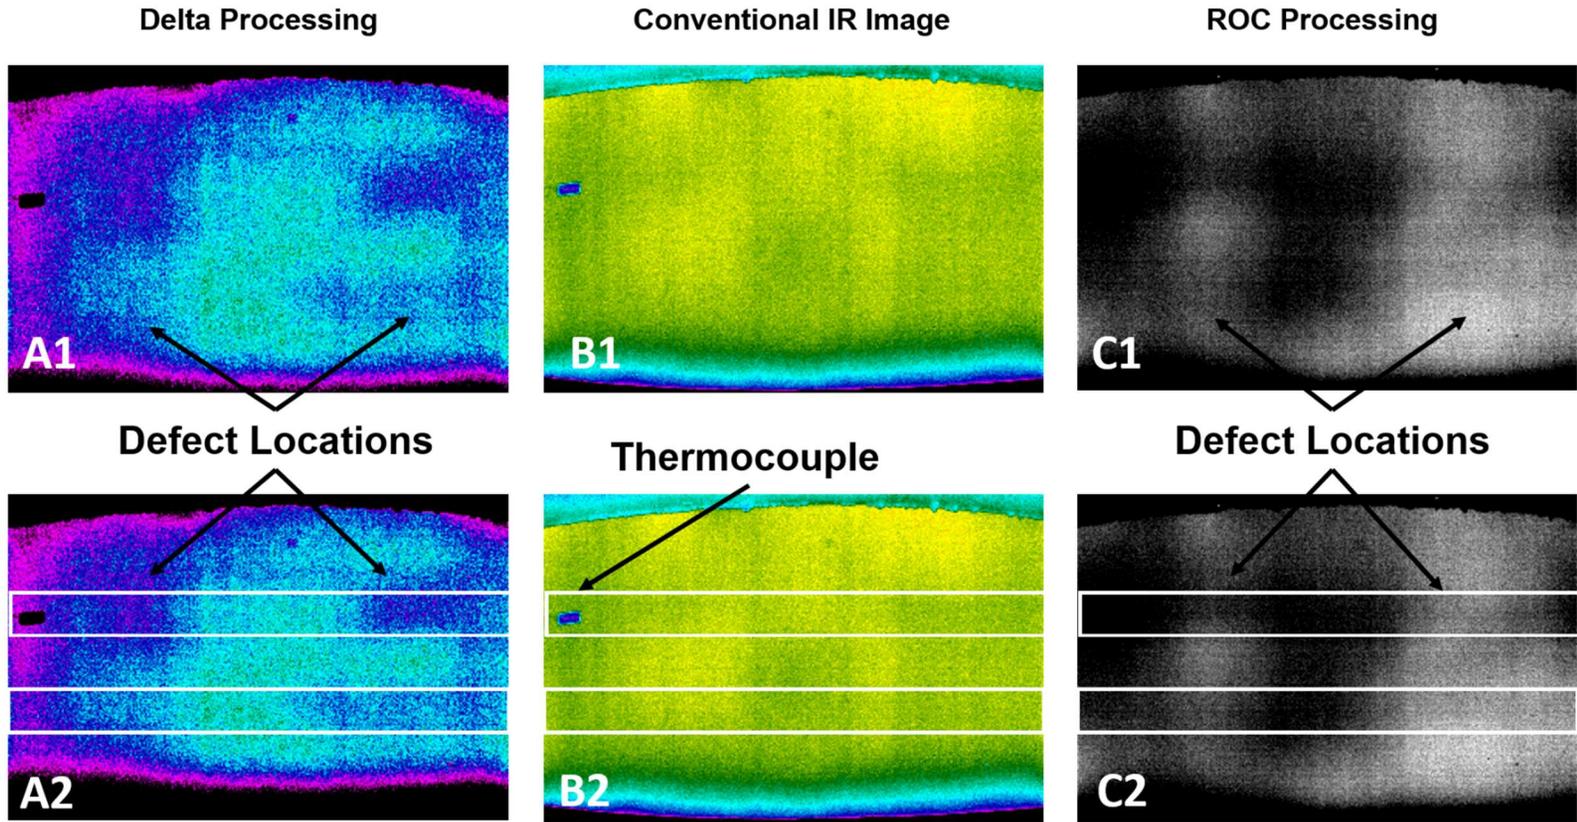
Figure 71 – Processed infrared image for PT specimen 2 on October 26<sup>th</sup> and 27<sup>th</sup>.

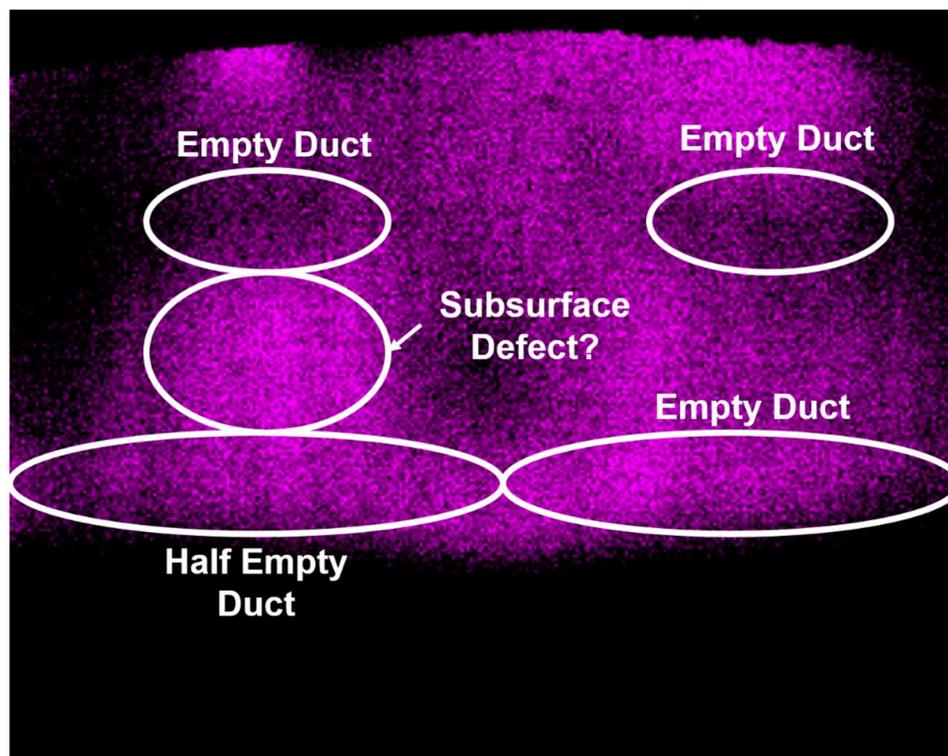
**Figure 72 – Infrared image collected at the max difference between thermocouple 6 and thermocouple 3.**

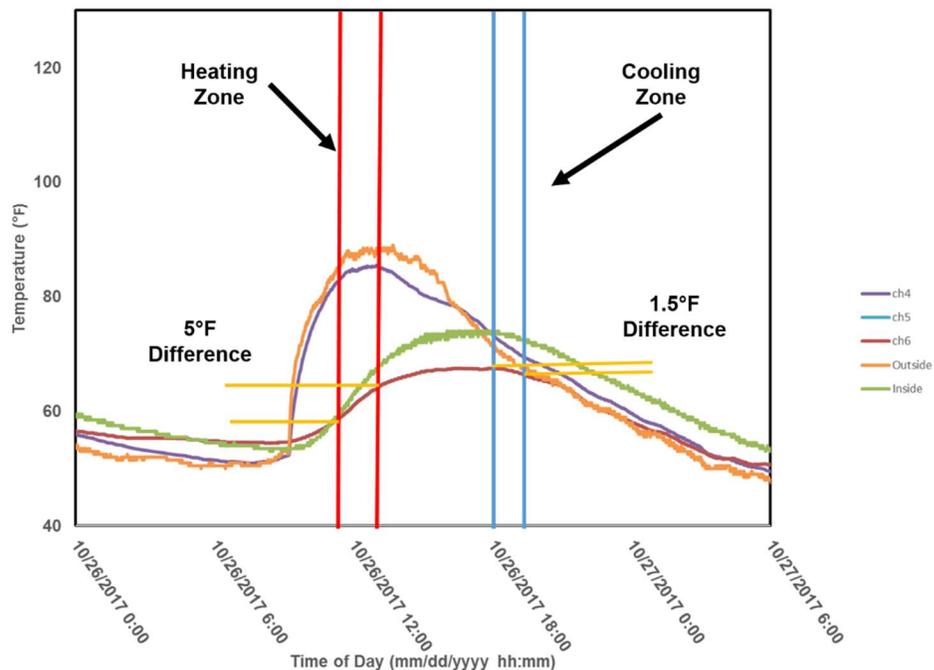
**Figure 73 – Collected thermocouple data along with the processing period used to detect the half empty ducts.**

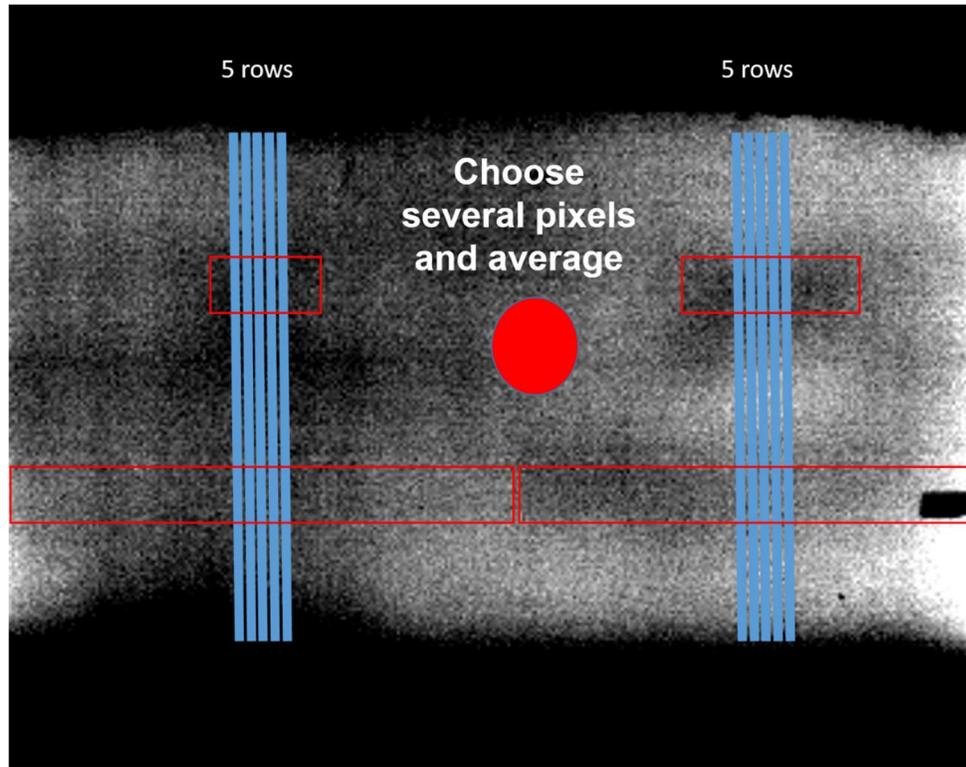
Figure 75 – Infrared image showing how to quantitatively show defective areas.

Figure 76 – Normalized and averaged pixel values for the two sets of five rows outlined in Figure 75.

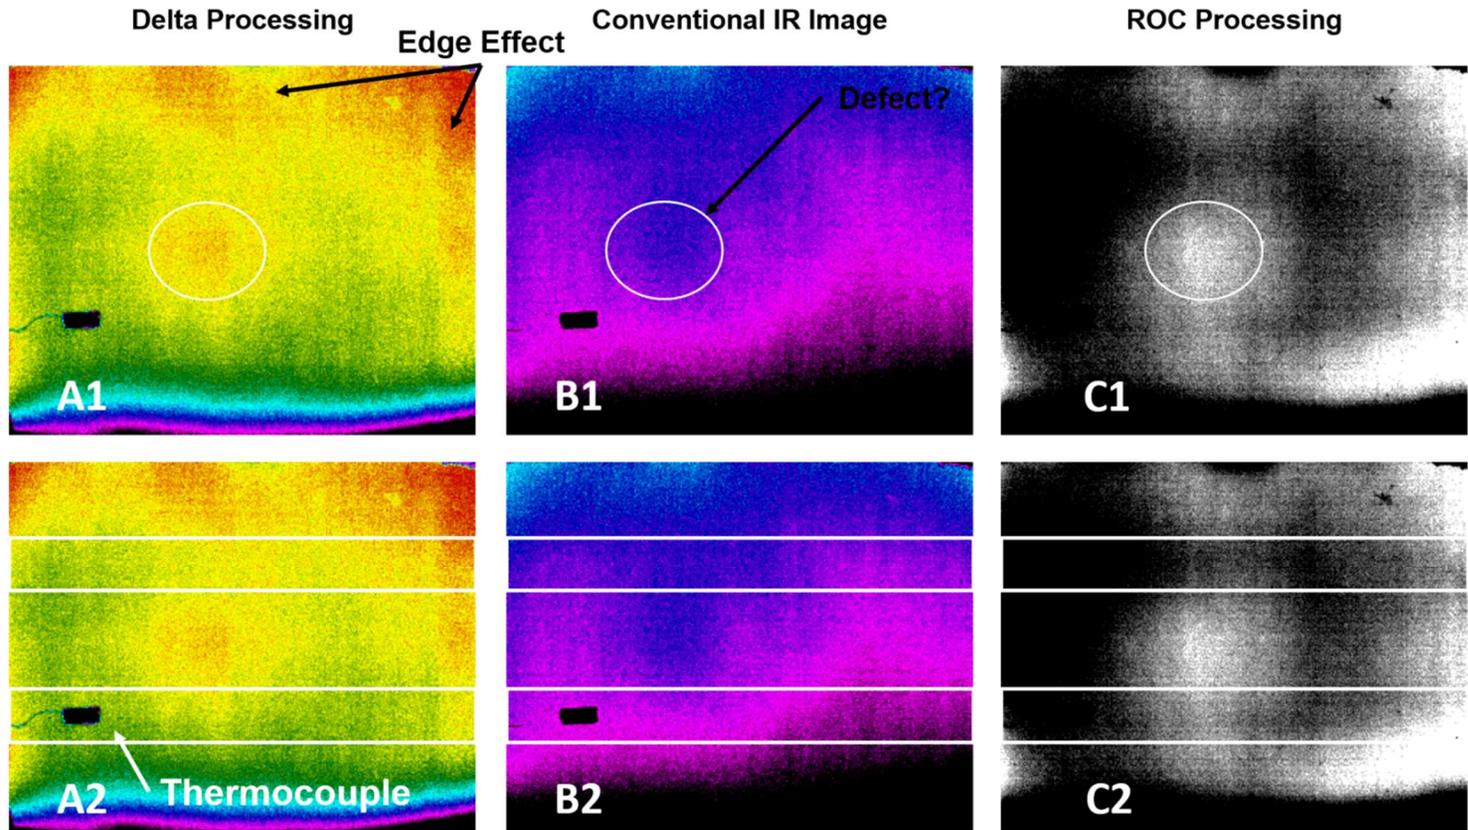
Figure 78 – Infrared images produced from processing conducted on infrared and thermocouple data collected on October 2<sup>nd</sup> and 3<sup>rd</sup>.

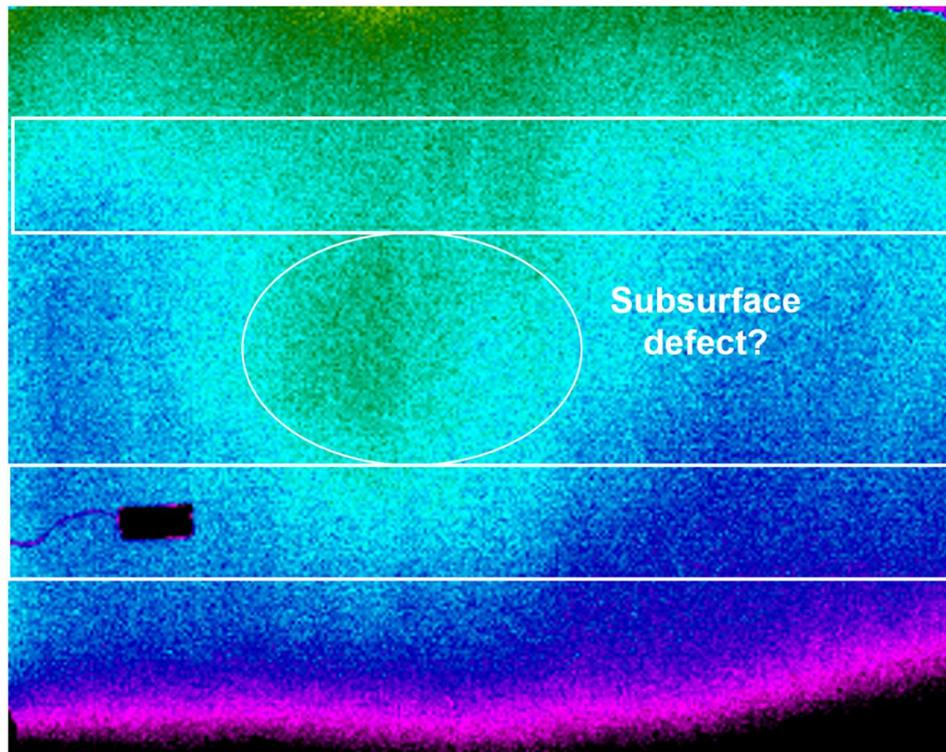
**Figure 79 – Singular infrared image collected during the peak difference at 3:27 PM on October 2<sup>nd</sup>, 2017.**

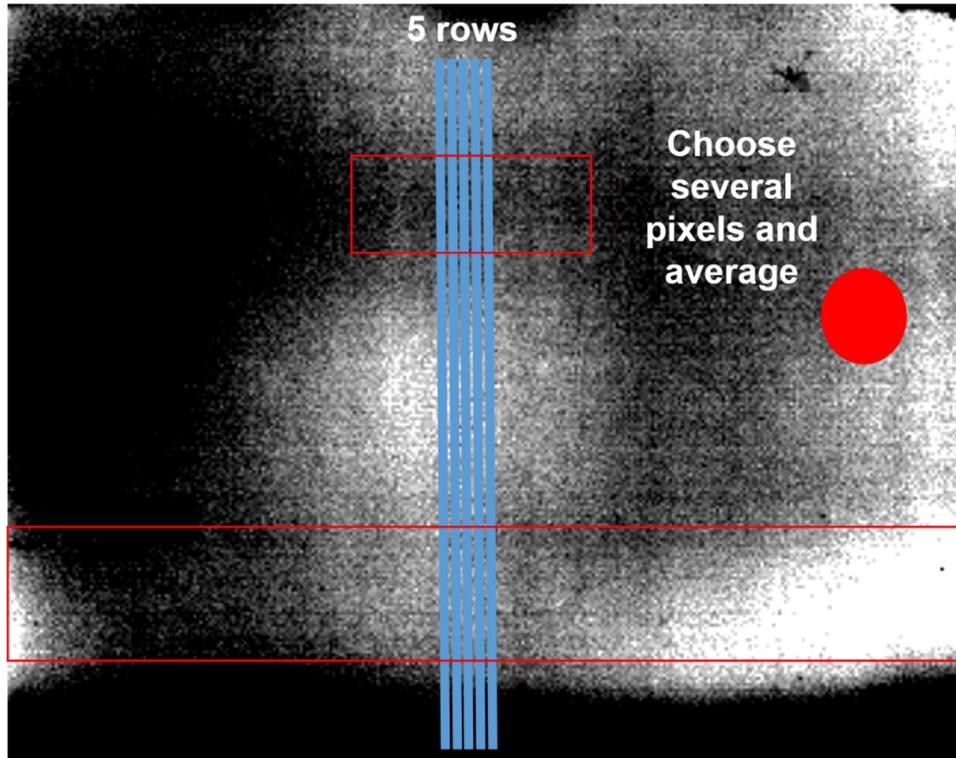
**Figure 80 – Image used for quantitative processing to detect the half empty duct.**

**Figure 81 – Averaged and normalized values of the five rows of pixel data called out in Figure 80.**

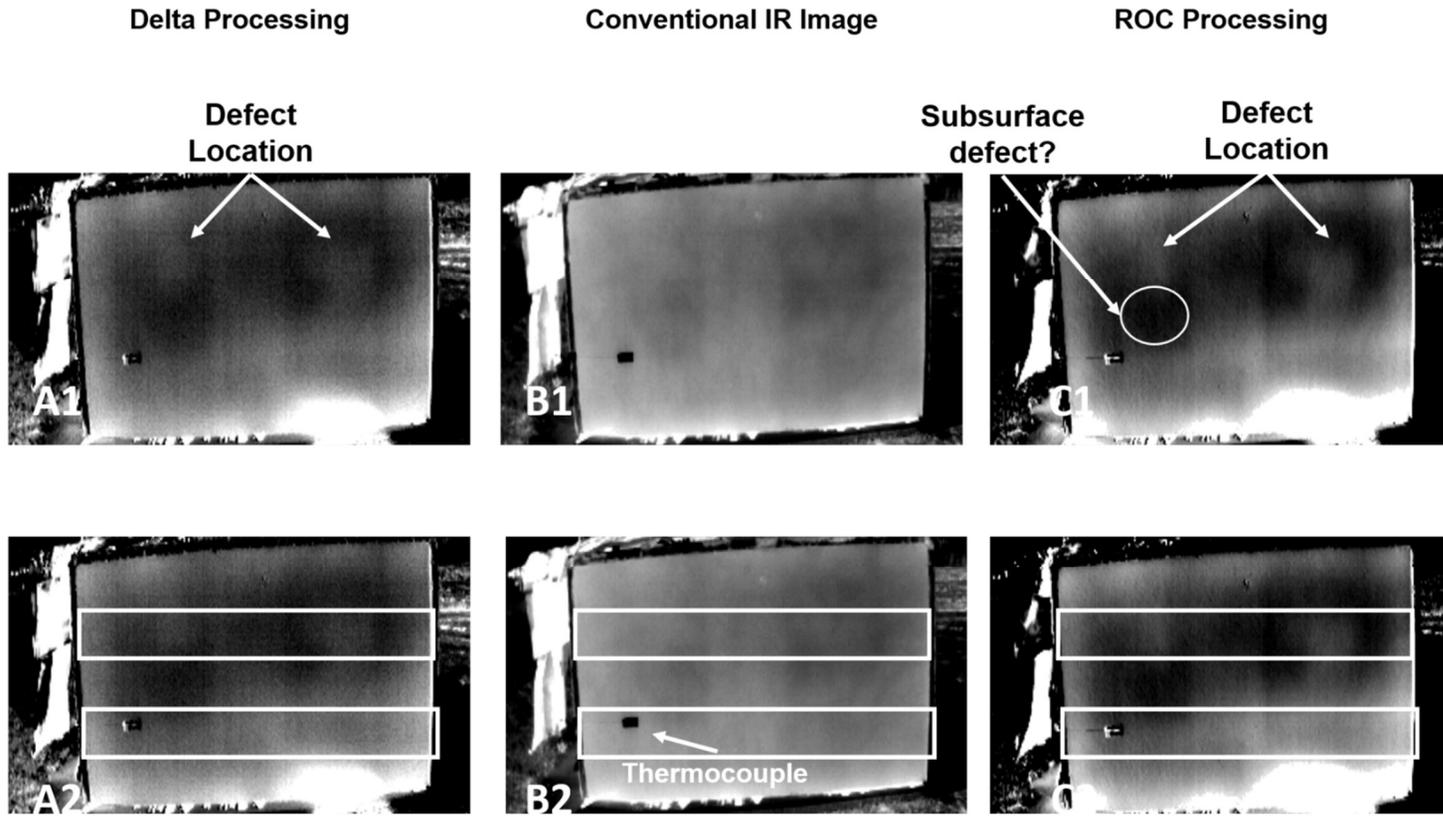
Figure 83 – Infrared processing results for the baseline test on specimen 2.

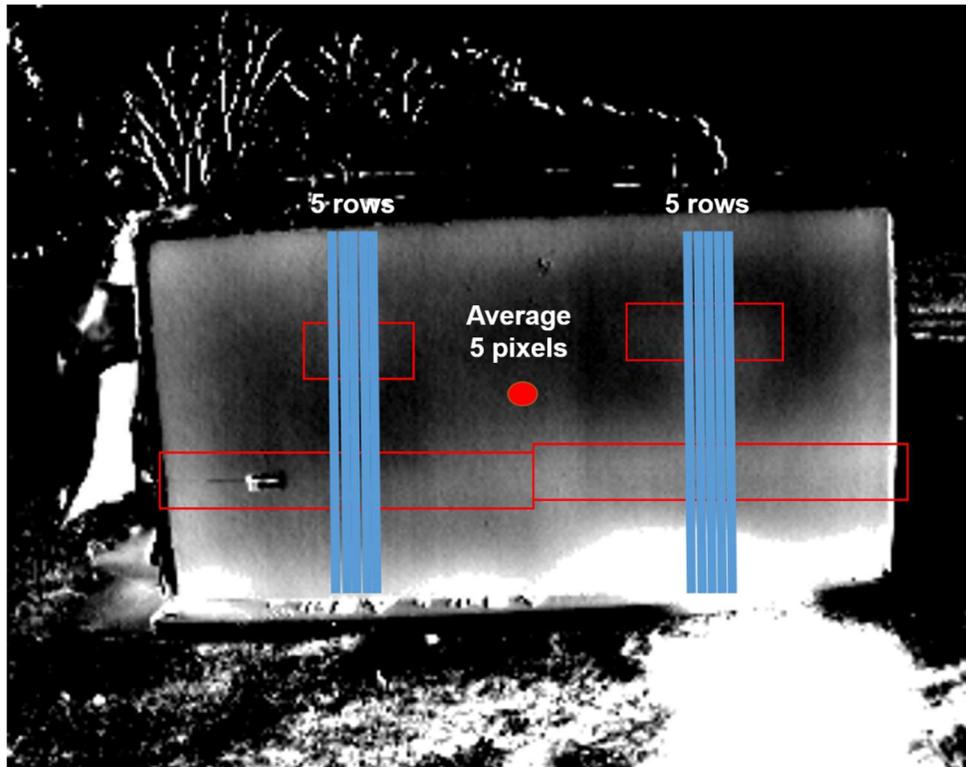
Figure 84 – Quantitative outline for processing of ROC results.

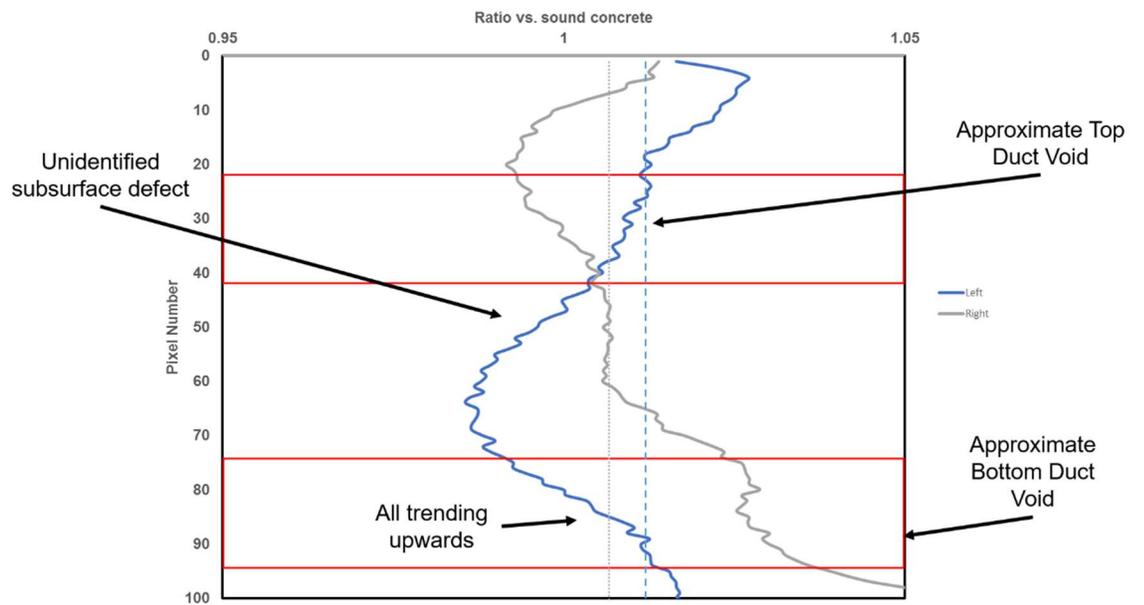
Figure 85 – Quantitative results for the baseline test of specimen 2.
