MIROBRIGA
INVENTORY

Objectos no Museu Municipal, Santiago para exposição na Sala de Mirobriga

Missouri Portugal Project

Object Registry

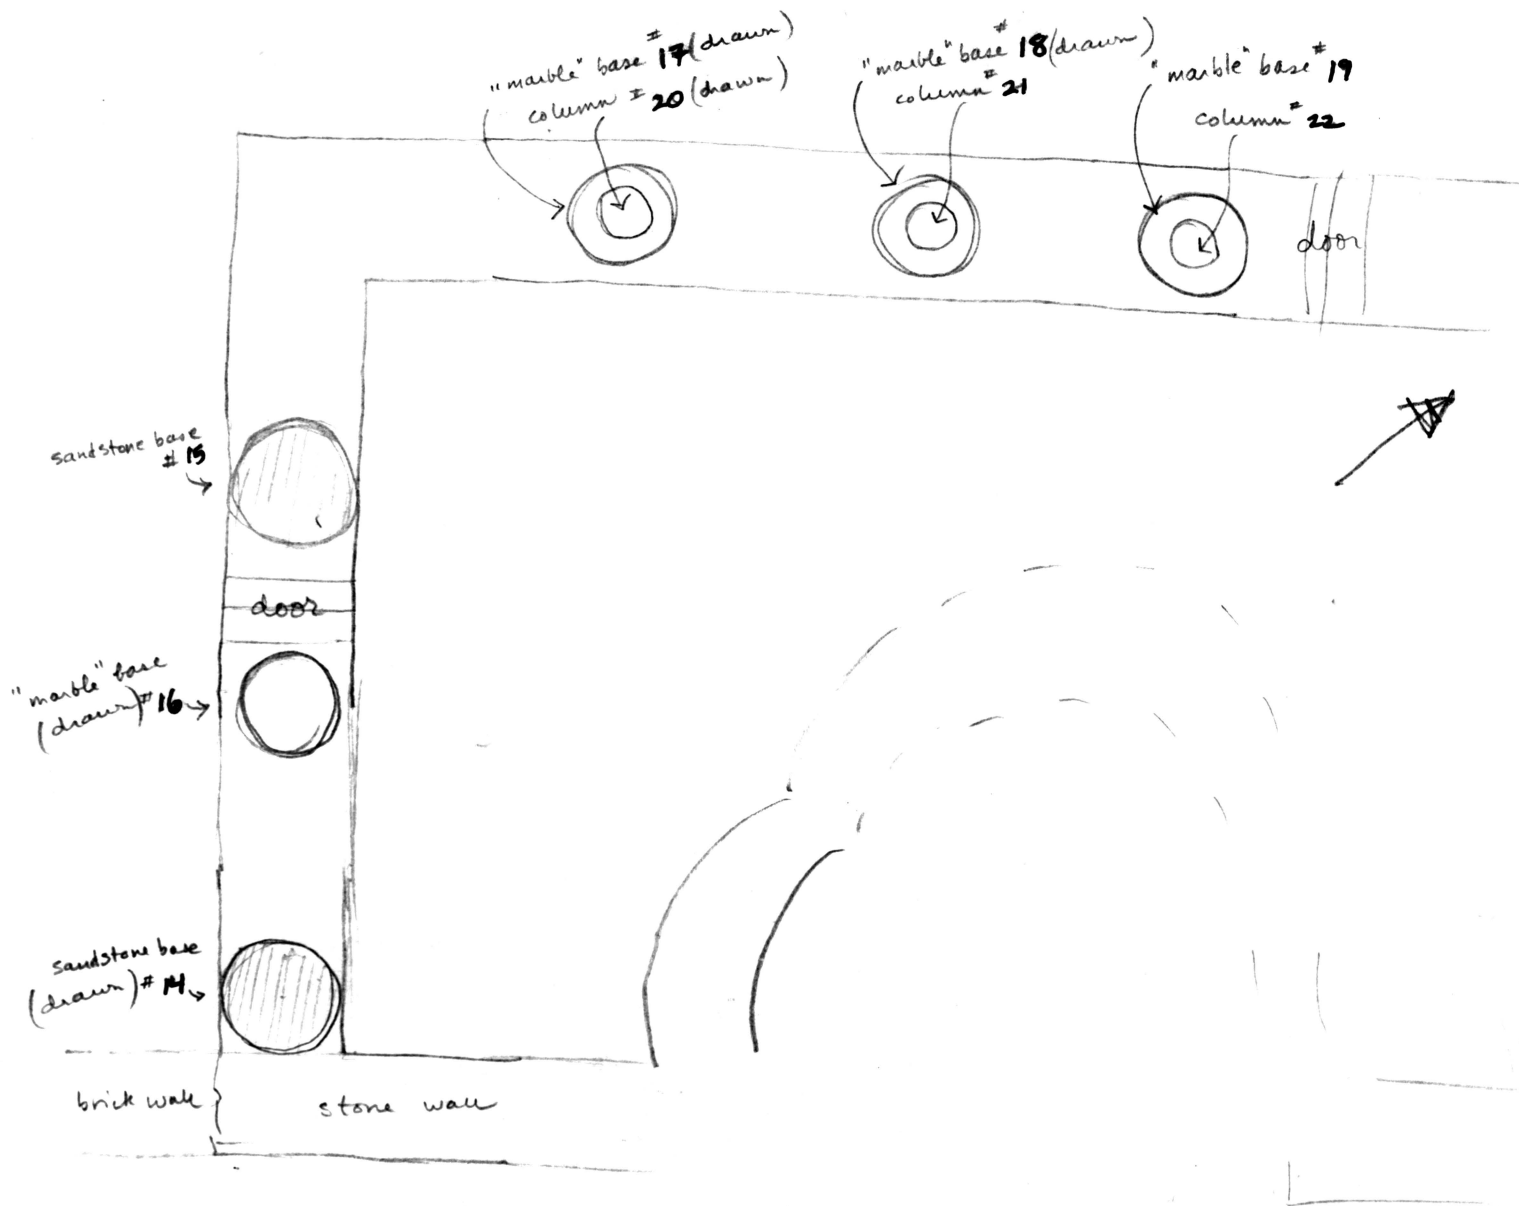
#s 14-22:

2 bases of yellow sandstone in south wall: ^{square} plinth supporting ^{Plinth} two torus moldings, carved in one piece. One base missing entire top half. ^{#15} Badly worn on all edges. ^{Built} ~~Cemented~~ into ^{Portico} wall [by de Almeida] so parts of two sides obscured.

#16-19 4 badly worn bases preserved in two walls. ^{square} Plinth supporting ^{(Attic) Ionic base} ~~two torus moldings~~, carved in one piece. Plinth and torus sizes vary by several cms. from base to base. One is missing its upper half; ^{#16} the rest have been cemented-over in places. Drawing is a composite from 16, 17, & 18.

composite drawing made of 16-18
 "marble" column base

drawing of sandstone base 14

Columns 21-22 larger than 20, broken,
 not drawn.
 Bases 15 and 19 not drawn
