ENGINEERING EXPERIMENT STATION -- BULLETIN NO. 31 - 1942

CROSS-CONNECTION SURVEY
IN CALHOUN COUNTY,
MICHIGAN

A Special Study
Submitted in Partial Fulfilment of the
Requirements for the Degree of
Master of Science in Civil Engineering
in the Graduate School of the
University of Missouri
June, 1942

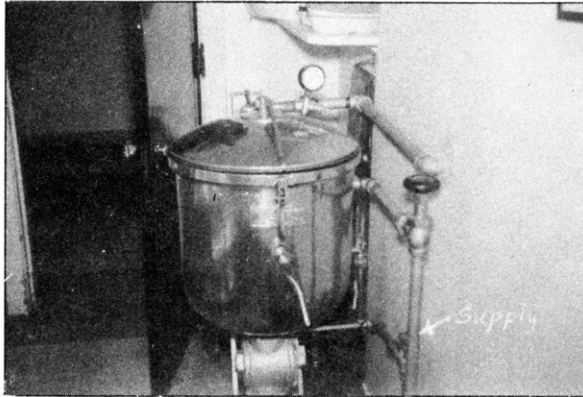
Fig. 28.—A bed pan washer at a hospital with submerged supply. These are always to be considered a definite hazard to the water supply when installed in a manner similar to that shown.

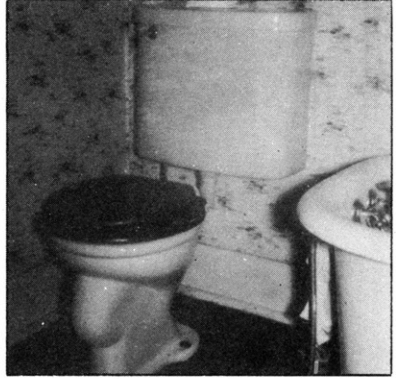
Fig. 36.—A water closet wall-supported, submerged valve supply. This is a common defect.

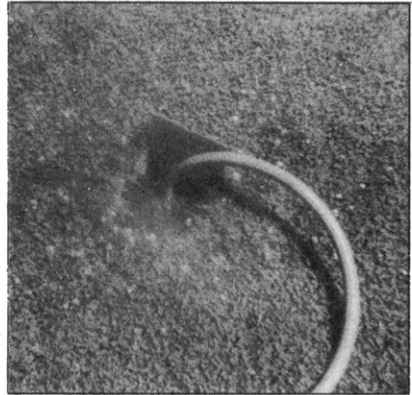
Fig. 79.—A yard hydrant that is filled with water around the leaking hose connection. The supply valve is entirely submerged in this contaminated water.
