ENGINEERING EXPERIMENT STATION -- BULLETIN NO. 32 - 1943

## CROSS - CONNECTION SURVEY IN CALHOUN COUNTY, MICHIGAN

(Revised Edition)

In Cooperation With The  
W. K. KELLOGG FOUNDATION  
BATTLE CREEK, MICHIGAN

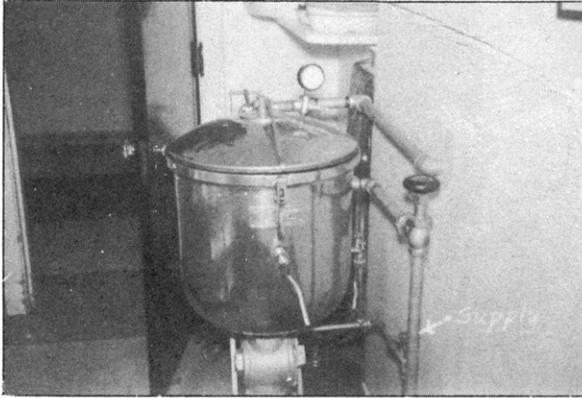
Fig. 28.—A bed pan washer at a hospital with submerged supply. These are always to be considered a definite hazard to the water supply when installed in a manner similar to that shown.

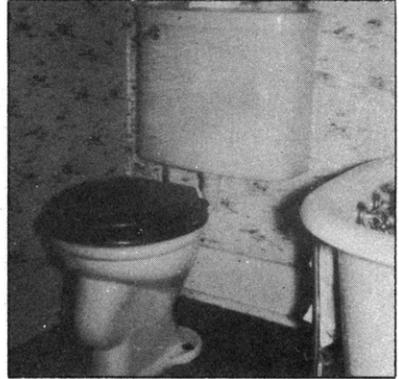
Fig. 36.—A water closet wall-supported, submerged valve supply. This is a common defect.

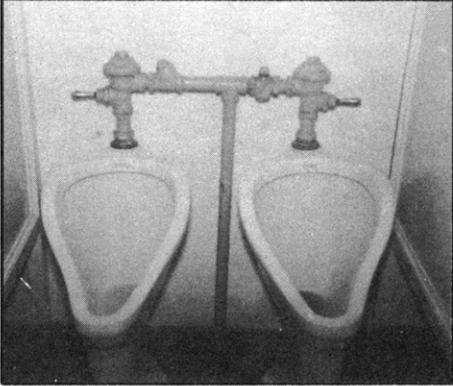
(Above) Fig. 39.—Flushometer valves with no vacuum breakers. This is a siphonic jet type of urinal and under the conditions of a negative pressure and leaking or open valve, the trapped wastes in the bottom could be siphoned into the water supply line. These fixtures were found in a hospital.

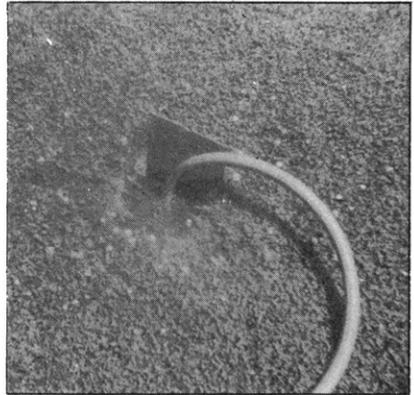
Fig. 79.—A yard hydrant that is filled with water around the leaking hose connection. The supply valve is entirely submerged in this contaminated water.
