Solar Domestic Water Heating: A Case Study

This is a first-year performance report on the operation of a domestic solar water heater. The system being reported on is installed in CEDAR RIDGE, the solar research house designed and built by the author near Mexico, Missouri.

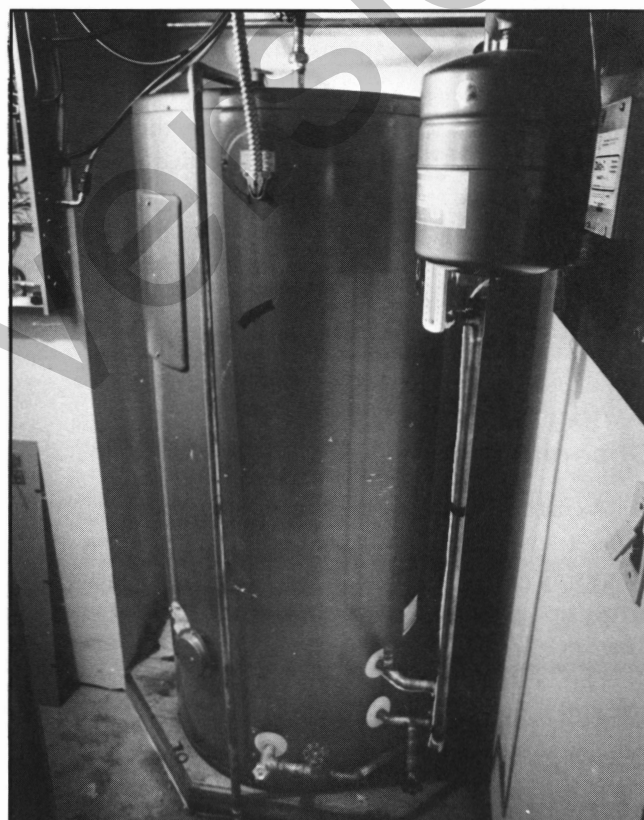
120 gallon storage tank weighs 1,500 pounds when full. Flexible conduit near top leads to single 4,500 watt back-up element.

Storage—storage for the system consists of a “stoned lined” steel tank of 120 gallon capacity. Located in the basement and designed especially for solar applications, this massive tank weighs 500 lbs. empty (approximately 1500 lbs. filled) and stands almost six feet tall. The tank is factory insulated with 2 inches of fiberglass insulation. Contained in the bottom of the tank is a corrugated, double walled, coiled copper heat exchanger. A single, 4500W, 220V electric element mounted in the upper 1/3 of the tank provides backup heat. The standard temperature/pressure relief valve adorns the top of the tank (see Fig. 2).

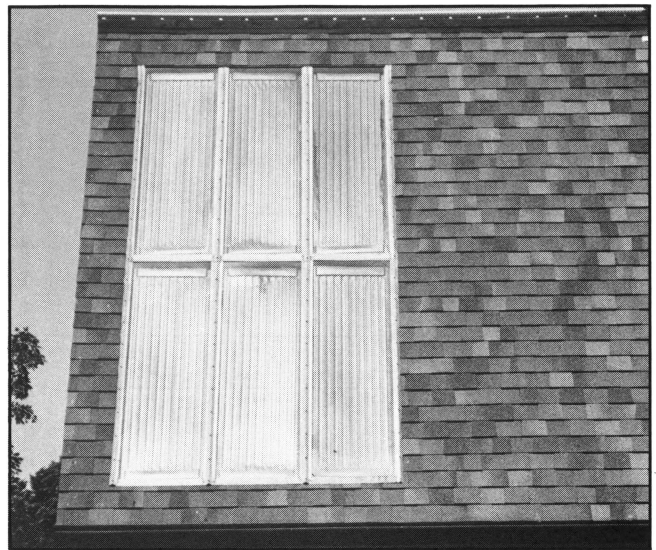
Six-panel array, 72 square feet net area, installed flush in the roof.

Collectors—(6) manufactured steel flat plate, liquid collectors, single glazed and mounted at a 53°* incline, with azimuth angle equal to 14° east of true south. The collector array is flush mounted in the roof and consists of 72 net square feet of absorber area. The absorber panels are interconnected through top and bottom manifolds plumbed from the back (attic) side. The absorbers are painted with a silicone-base flat black paint and back insulated with unbonded fiberglass to an R-16 level.
