# **FULL-SCALE CRASH TESTS on PLASTIC DRUMS with TYPE III OBJECT MARKERS**

Missouri Highway and Transportation Commission  
Report No. 87-2

April 1988

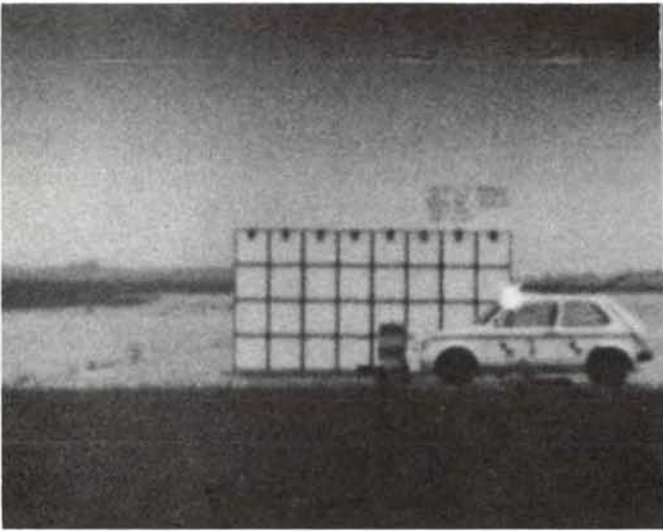
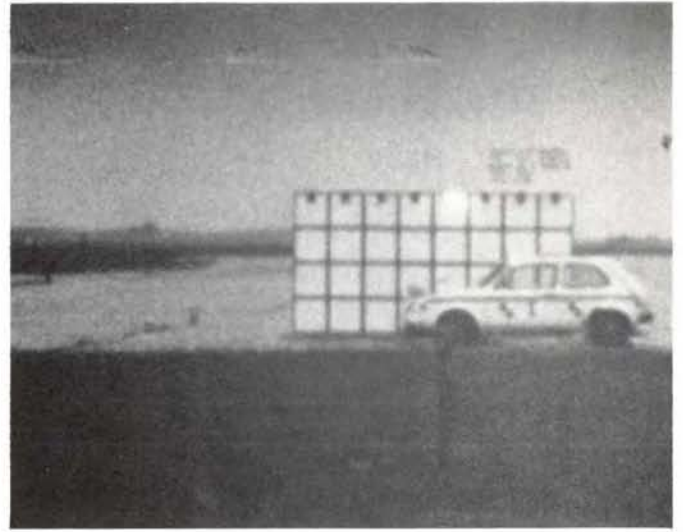
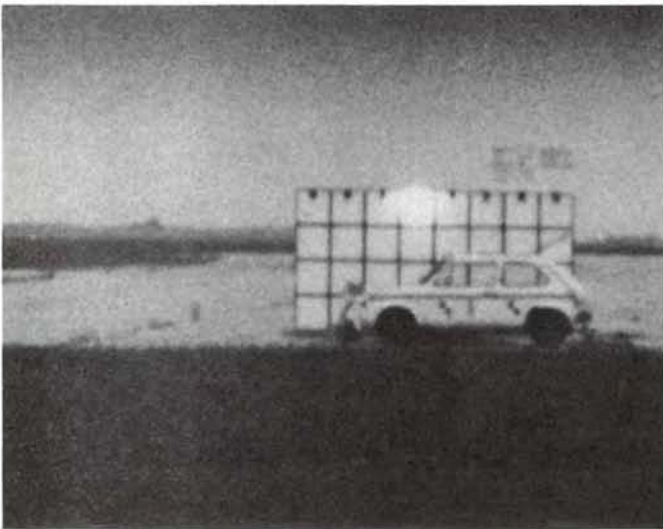
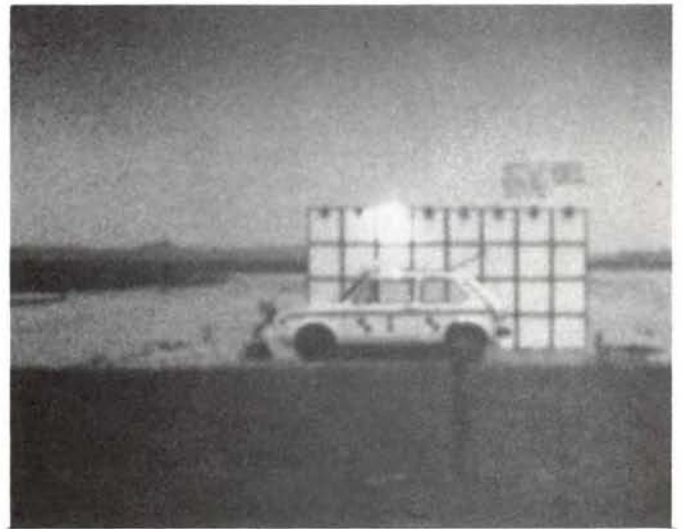
Figure 15. Sequential Photos, Test No. 1

Upon impact, the channelizer buckled but remained upright and in front of the vehicle. When the channelizer buckled, the object marker deflected down touching the hood momentarily and then rebounded back to a position very close to its original position. After close examination, there was no visible evidence of fracture in the polycarbonate connectors. There was no damage done to the test vehicle and the only damage done to the flexible reflective sheeting was some tearing due to impact. The sheeting conformed with the deformation of the channelizer without any evidence of cracking or peeling. Figures 17-19 show photos of the channelizer, object marker, and test vehicle after the test.

| TIME (SEC.) | EVENT |
|---|---|
| 0.070 | Object marker<br>touching hood |
| 0.127 | Plastic Drum being<br>pushed by vehicle.<br>Object marker off<br>hood |

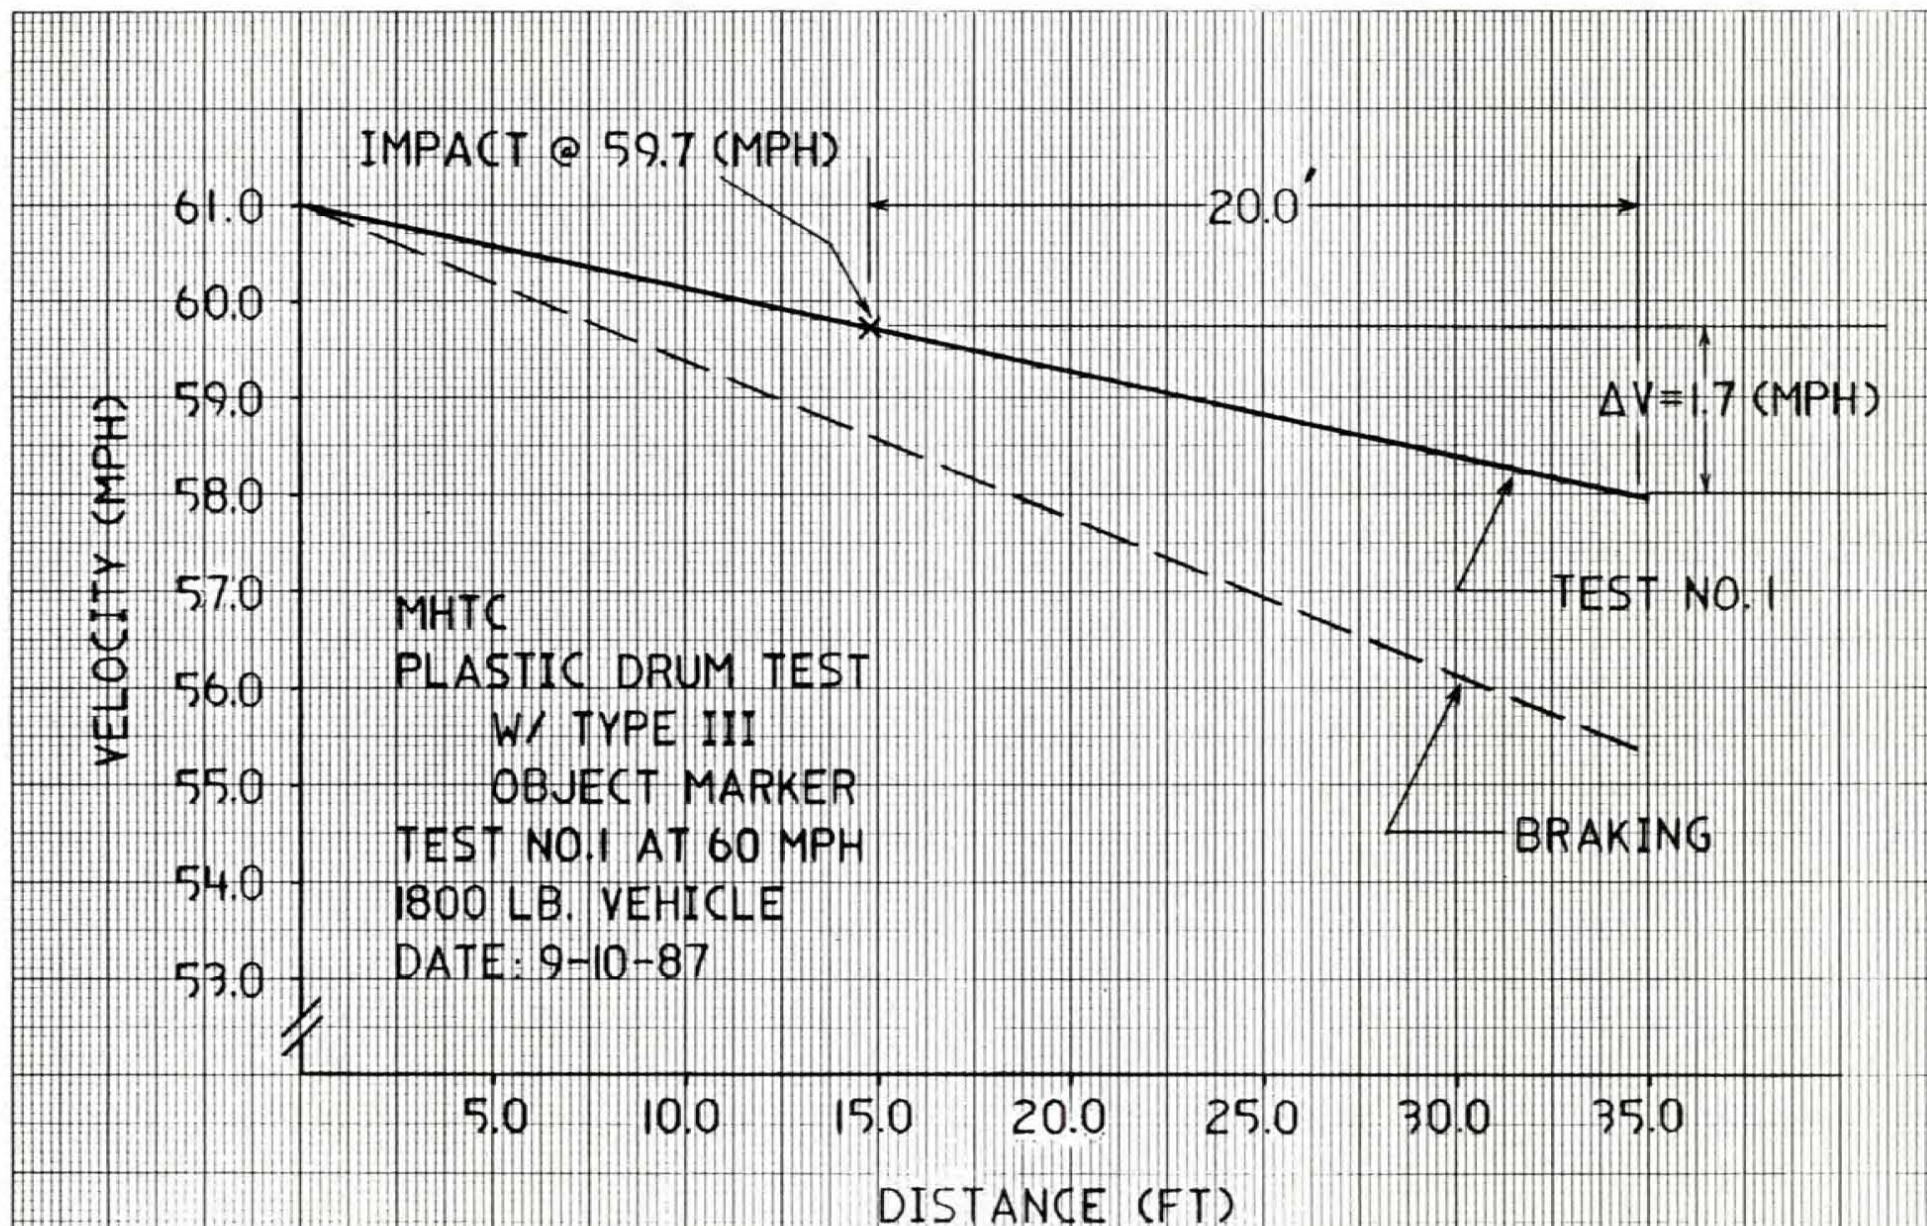
FIGURE 16. CHANGE IN VELOCITY, TEST NO. 1

The actual impact speed of the vehicle was 59.7, while the corresponding change in velocity after impact was 1.7 mph (2.5 fps) from the point of impact to a point 20 feet behind the channelizer. This is shown in Figure 16. After impact, the vehicle lost contact with the channelizer at approximately 84 milliseconds but regained contact at approximately 247 milliseconds. The vehicle then continued to push the channelizer approximately 500 feet until the vehicle stopped.

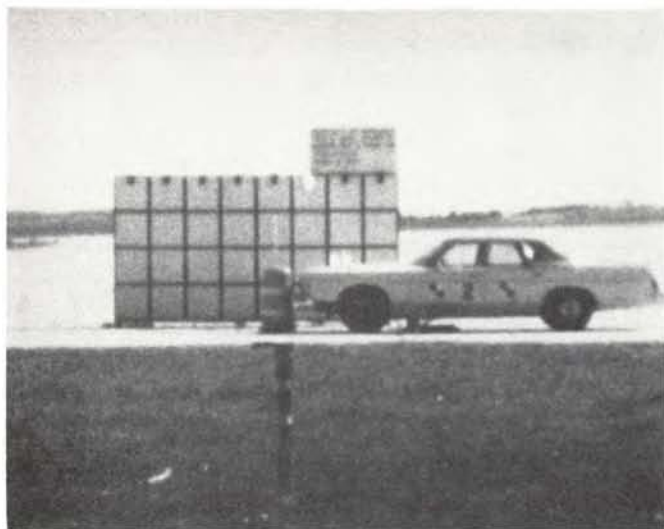
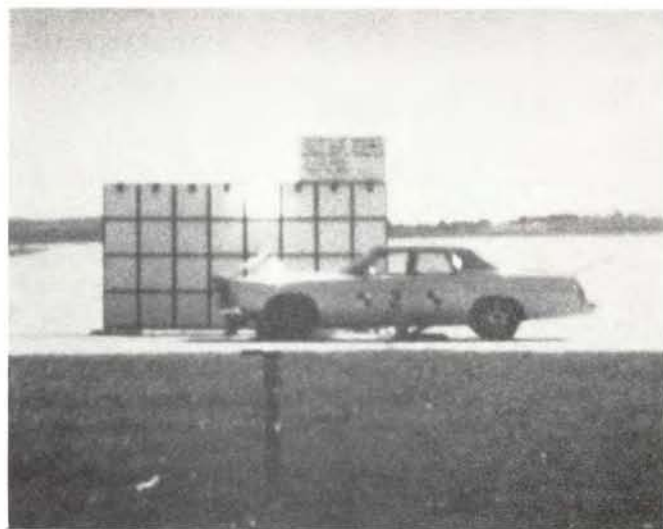
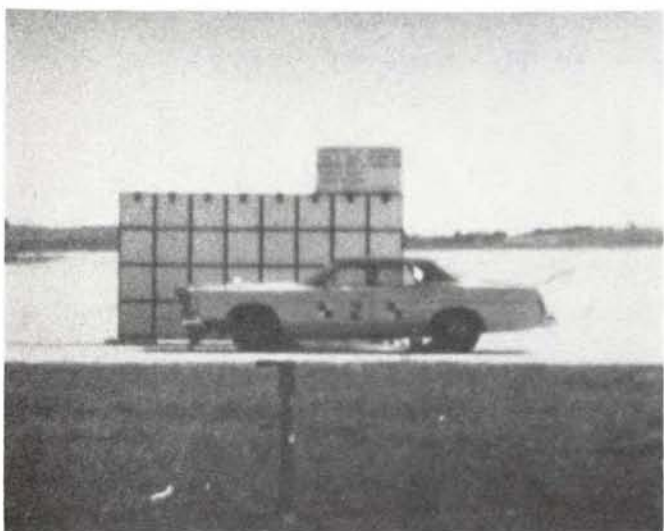
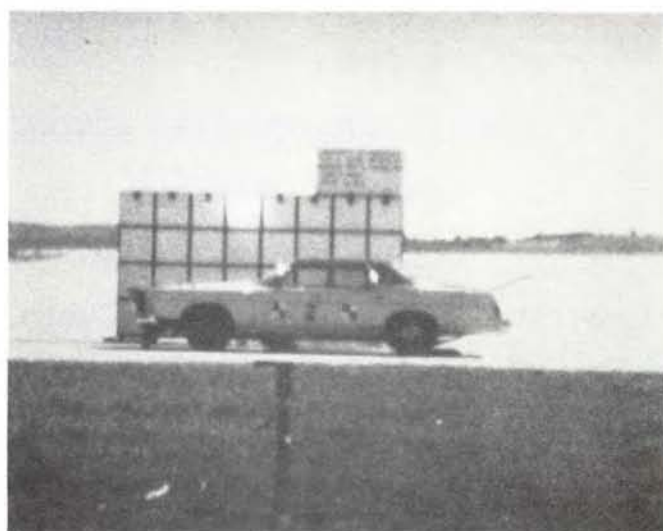
Figure 20. Sequential Photos, Test No. 2

| TIME (sec.) | EVENT |
|---|---|
| 0.068 | Object marker flat on<br>hood |
| 0.093 | Plastic drum in full com-<br>pression with object<br>marker coming off hood |

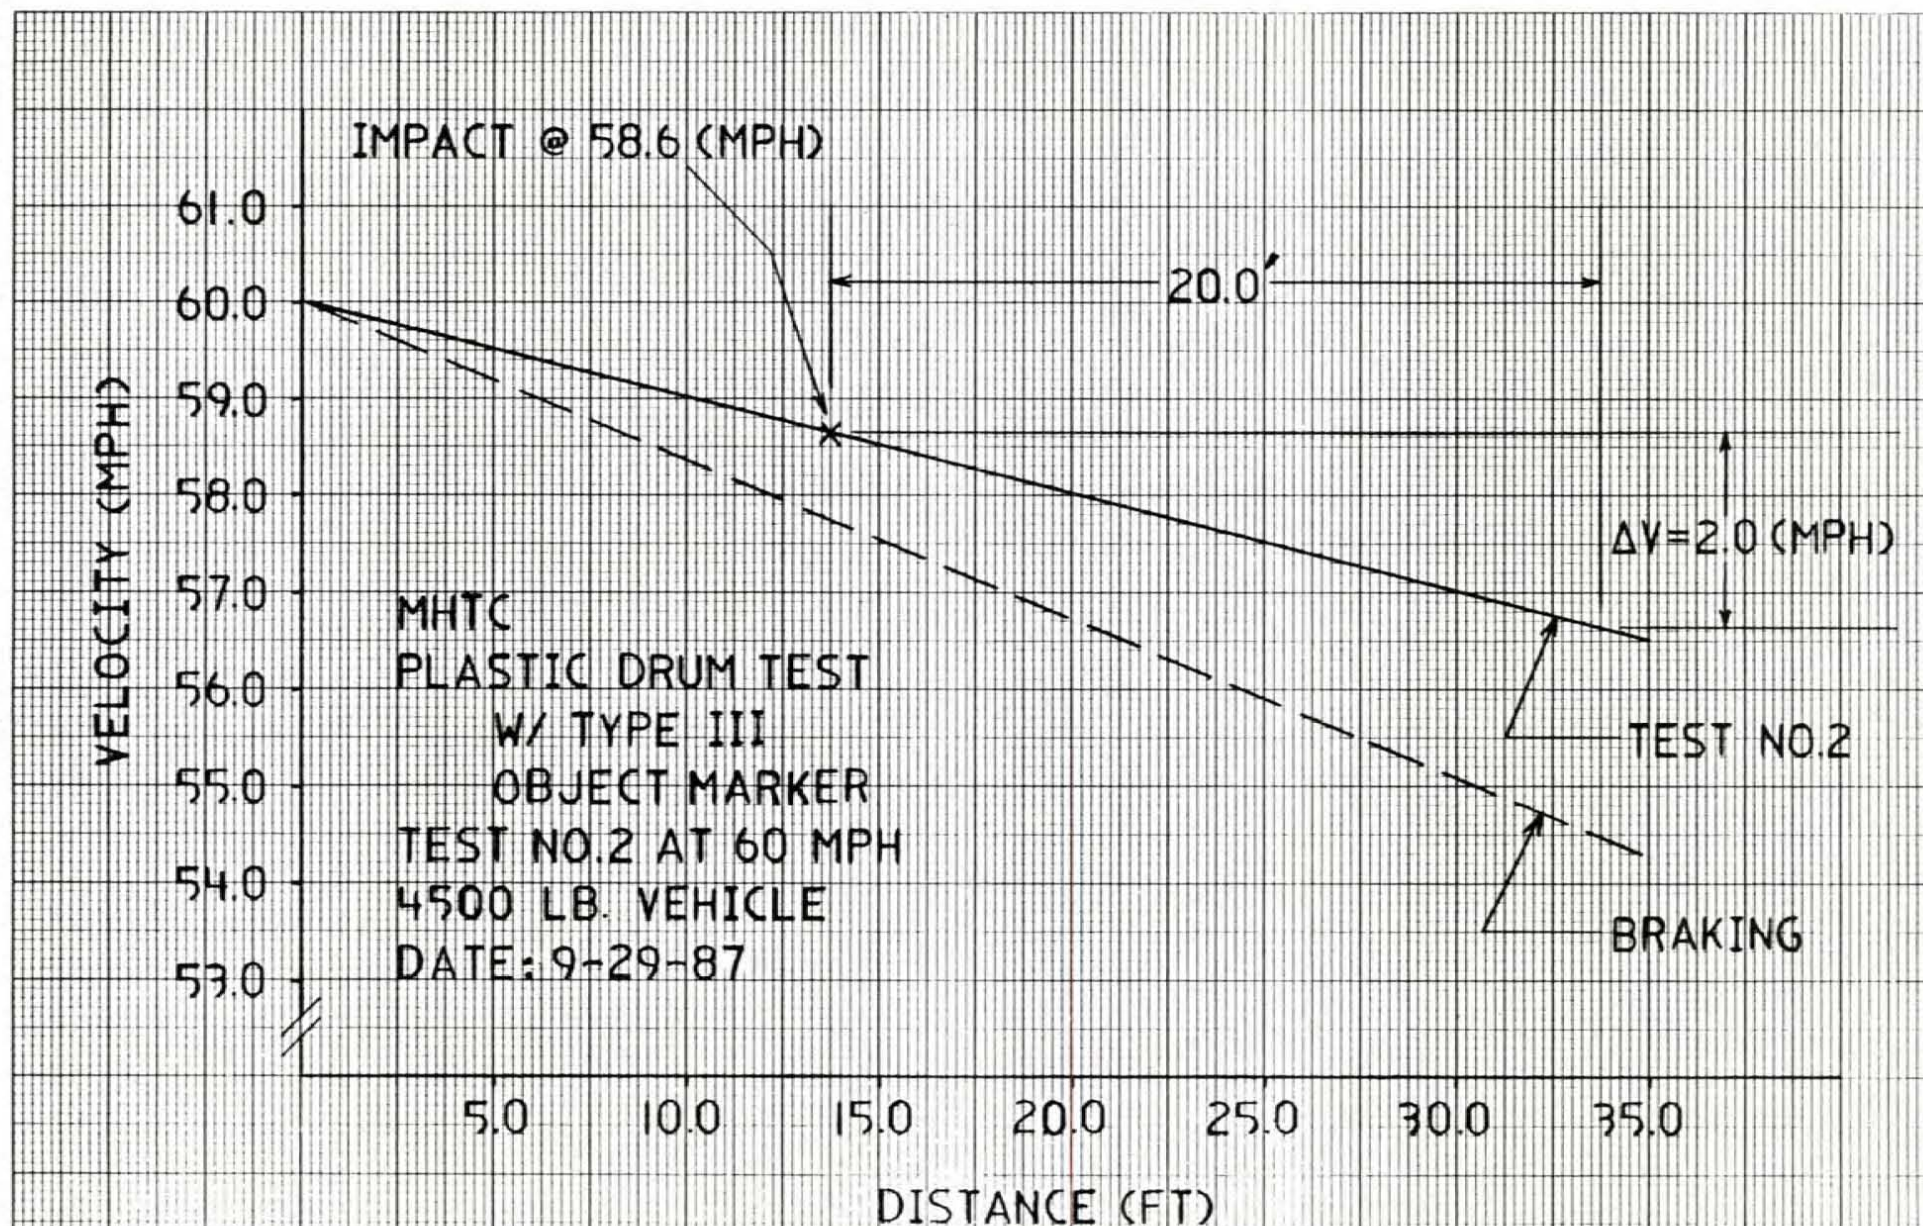
FIGURE 21. CHANGE IN VELOCITY, TEST NO. 2

The results of the second test were quite similar to those of the first test. The actual impact speed was 58.6 mph, and the change in velocity after impact was 2.0 mph (2.9 fps) over a distance of 20 feet as shown in Figure 21. After impact, the test vehicle never lost contact with the channelizer until the vehicle came to a stop.
