**VERIFICATION OF THERMOGRAPHIC BRIDGE
INSPECTION TECHNOLOGIES**

A Thesis presented to the Faculty of the Graduate School
at the University of Missouri - Columbia

Alan Michael Jungnitsch

MAY 2015

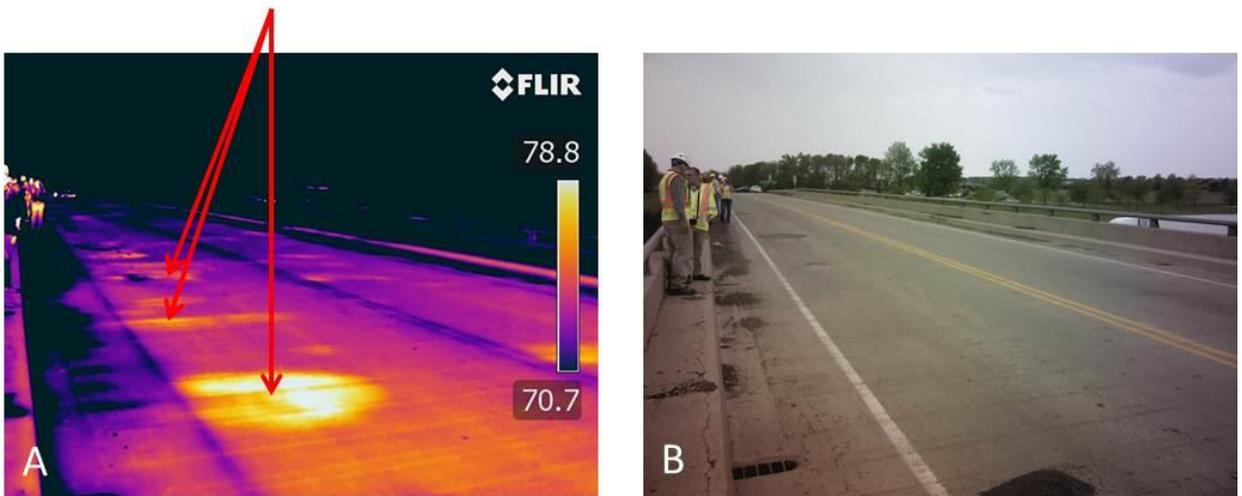
Figure 3-1: IR (A) and digital (B) images of deck delaminations captured during Ohio training

A training trip in Ohio was completed May 6-7, 2013. The training was conducted at a DOT location in northwestern Columbus near Ohio State University Airport. After the classroom session, inspectors were taken to a bridge 20 minutes north of the training facility. Due to rain, approximately one hour was spent in the field. Despite a relatively short amount of time spent inspecting the bridge, quality thermal images were captured of the deck. IR (A) and digital (B) images of the deck are shown in Figure 3-1.

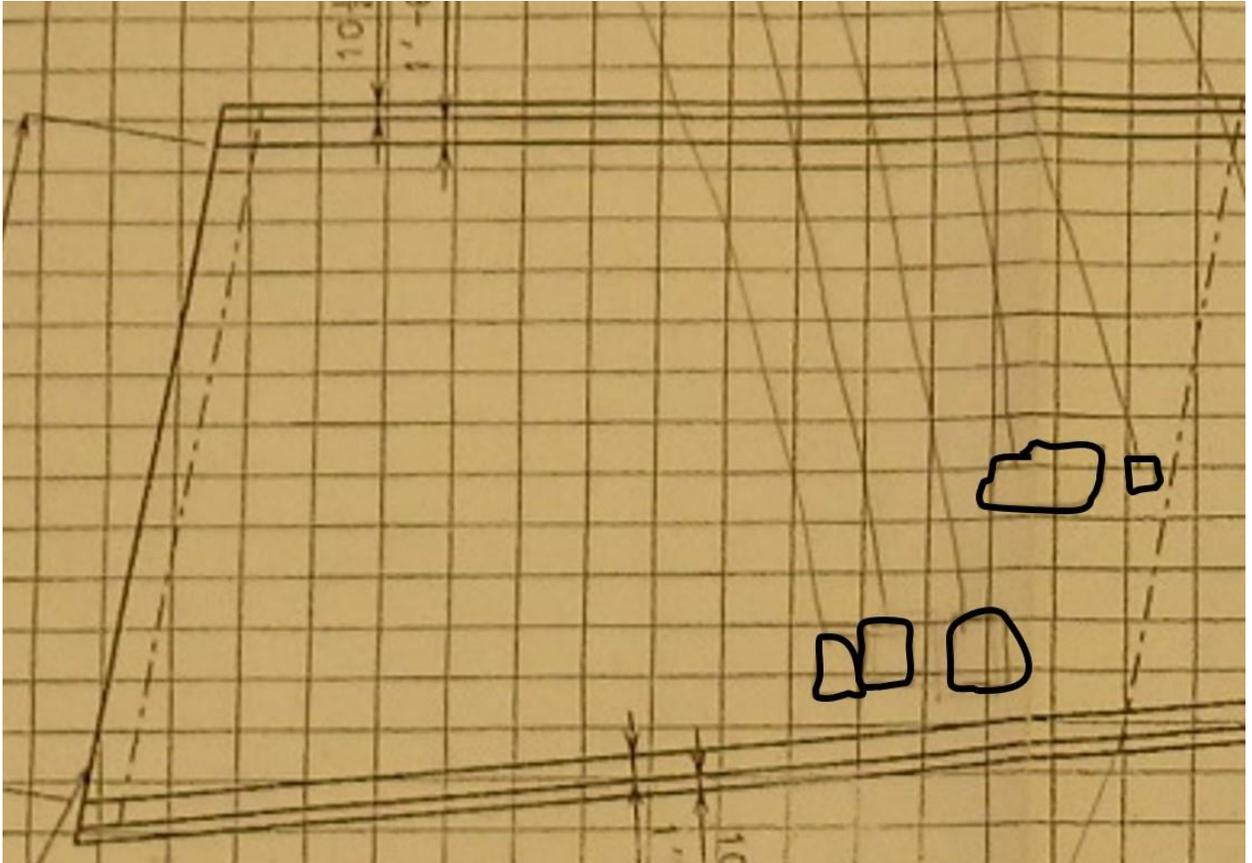
Figure 4-5: Chain drag results for the North span of Bridge A0295

Testing on this bridge was conducted so that the results achieved with the infrared camera could be compared to chain drag results. An infrared camera located and captured the delaminations. Chain dragging was performed by the Missouri Department of Transportation to verify the infrared results. Each delamination identified with the infrared camera was verified by the results of the chain dragging. The results of the chain drag are shown in Figure 4-5 below. Figures 4-6 and 4-7 show infrared images of these delaminations.

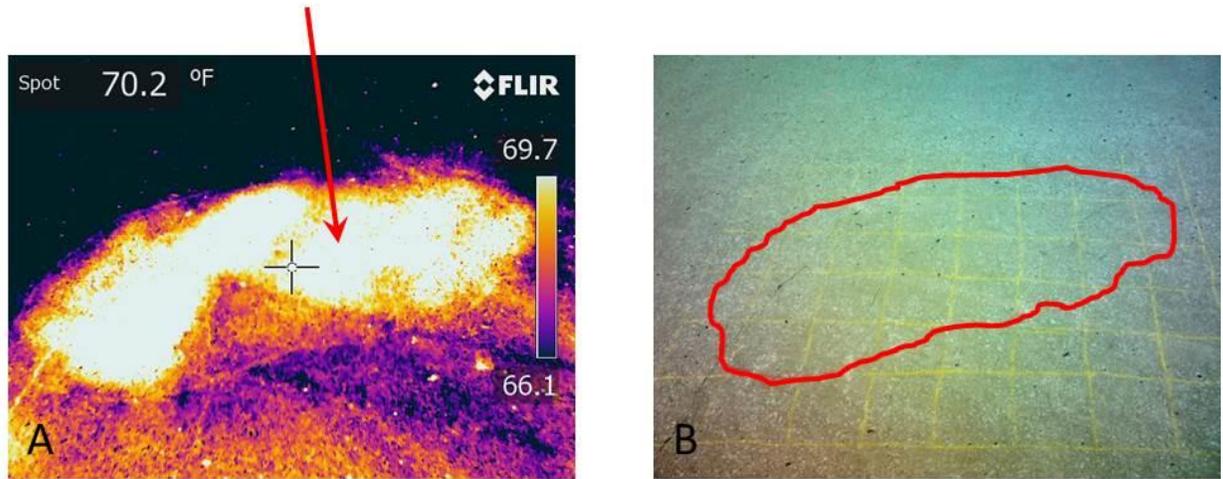
Figure 4-6: Infrared (A) and digital (B) images of a deck delamination in Kansas City

The delamination edges for one delamination were sounded; the hammer sounding results were compared to the infrared images. The accuracy of the infrared images are shown in Figure 4-6 below. The hammer sounding results are shown in the digital image as a red outline. It is important to note that hammer sounding can be subjective and is dependent on inspector training and experience.

The two images demonstrate that the accuracy of the hand held infrared camera is very high. The red outline marking can be seen in the infrared image indicating how accurate the infrared camera and the hammer sounding results really were. Another group of delaminations are shown in Figure 4-7.

Thirty delaminations including both infrared and hammer sounding results were included in the analysis. The delaminations from this chapter included in the analysis were from Figures 4-6, 4-11, 4-19, 4-20, 4-21, and 4-31. Delaminations not included in this paper, from the same inspections as the figures listed, were also included in the analysis. Statistics of the analysis are included in Table 4-2. The calculated values are based on the infrared areas relative to the hammer sounding areas. A value larger than 1 indicates that the infrared results occupied a larger area than the hammer sounding results.

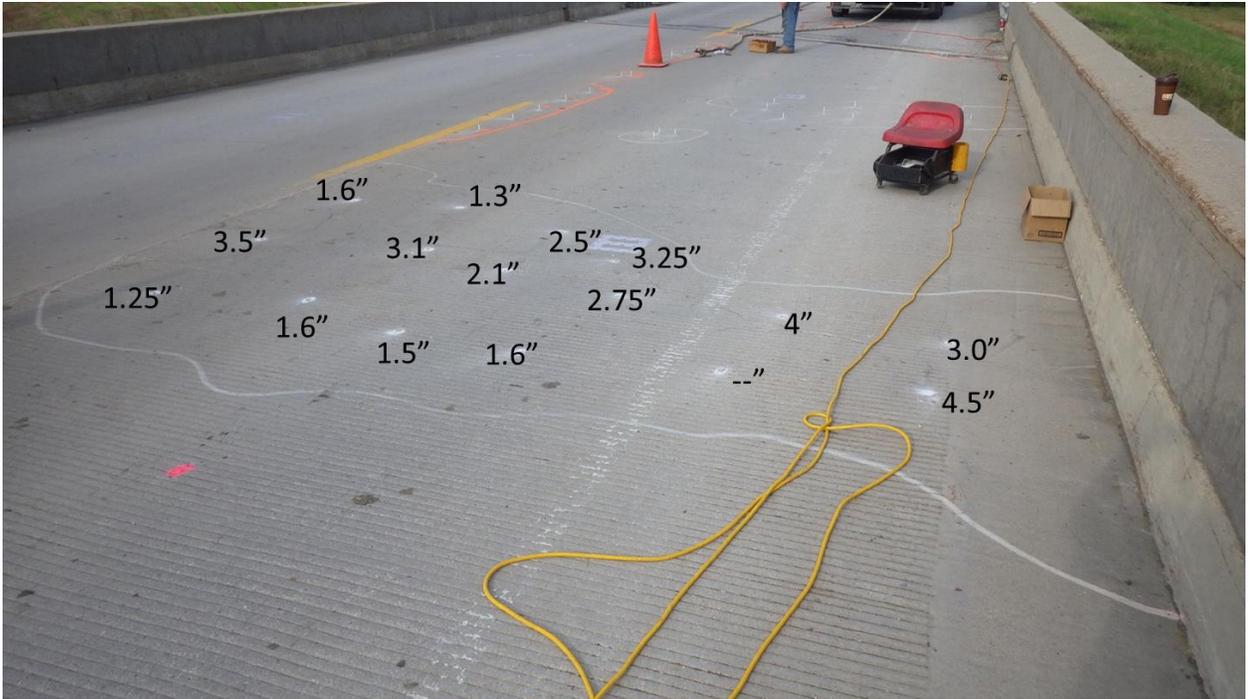
Figure 4-13: Drilled hole locations for borescope measurements

The borescope was also used to verify the depth of the delamination. Sixteen locations throughout the area of the delamination were measured. The depths and locations of each measurement are shown in Figure 4-13 below.

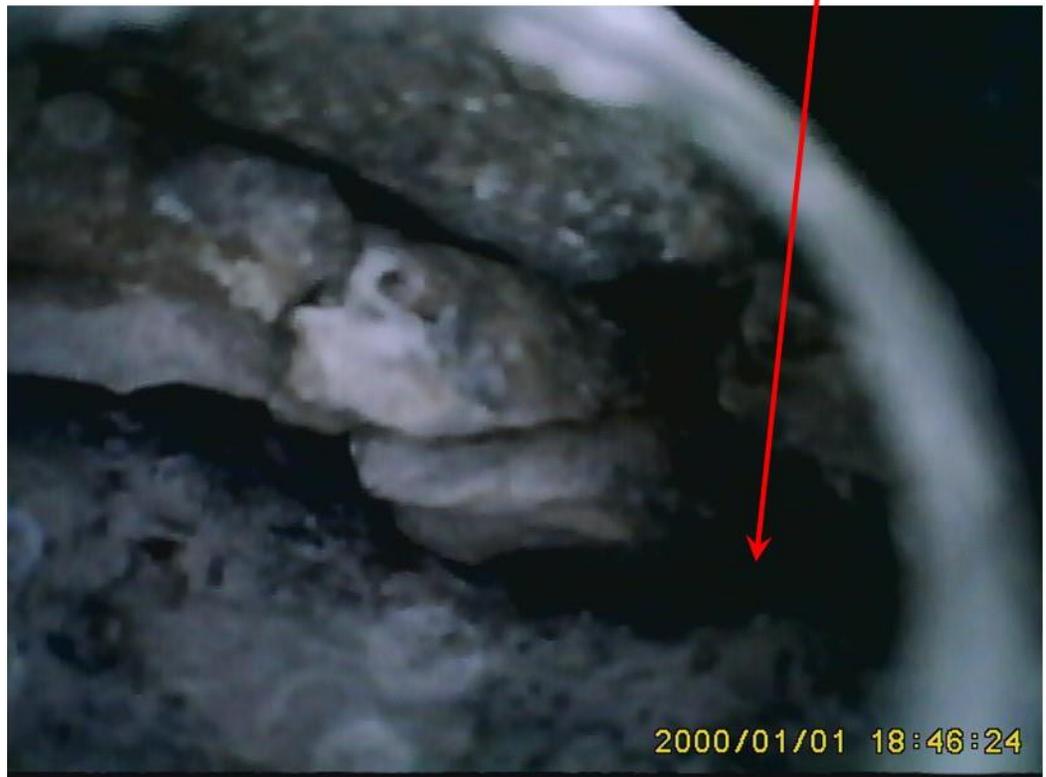
Figure 4-14: Borescope image of a deck delamination

In order to measure the depth of the delaminations, the borescope was inserted into the hole to the point where the crack could be seen and these measurements were recorded. Figure 4-14 shows an image captured with the borescope. Figure 4-15 shows a schematic diagram of how the borescope is used for inspection.

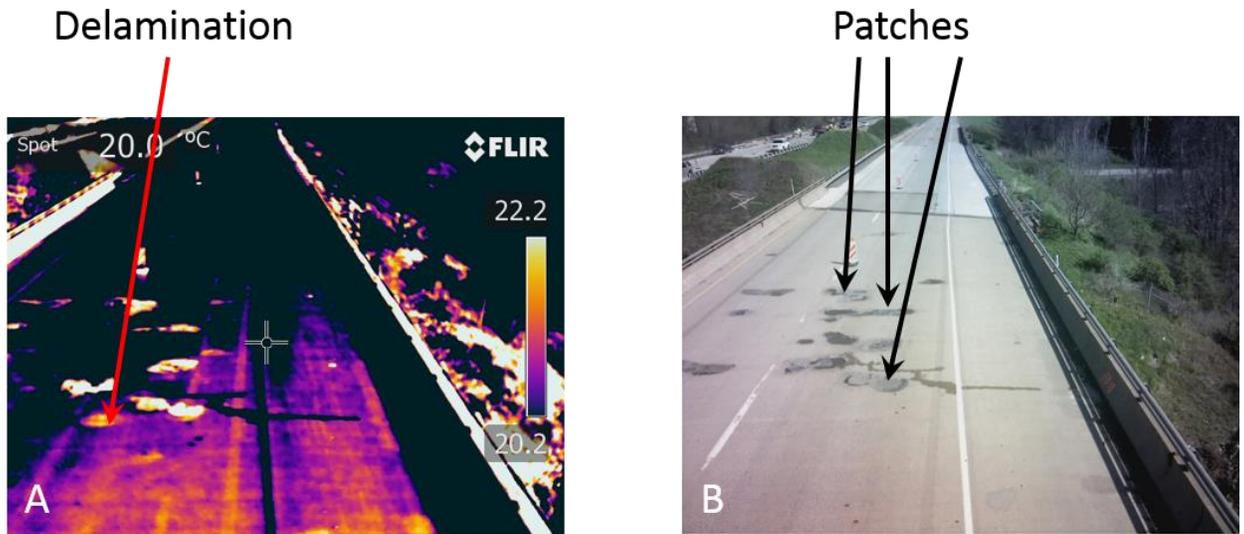
Figure 4-25: IR (A) and digital (B) images from a boom of a deck in Pennsylvania

Figure 4-25 illustrates the ability of infrared thermography to distinguish between delaminations and patches on the deck. Patches in the deck are easily identified in the digital image and can be paired with the infrared image. Delaminations are unlikely to be visible in the digital image.

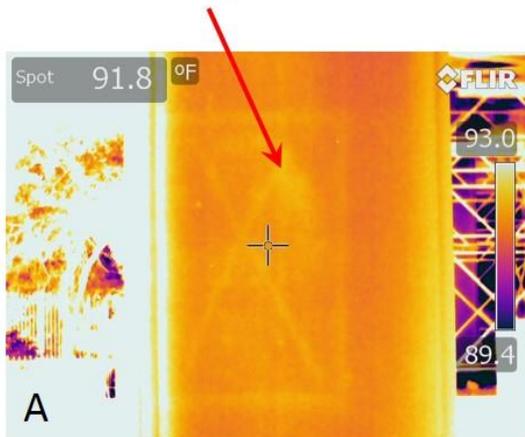
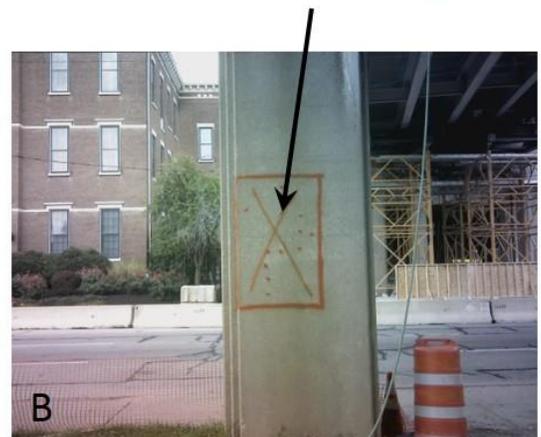
Figure 4-32: IR (A) and digital (B) images of hammer sounding results on a pier in Kentucky

Hammer Sounding Result

The comparison of the thermal and digital images show that some of the areas the inspectors did not mark are delaminated; this is consistent with additional images on the pooled fund shared data website. Since replacing

There was also a case where the inspectors hammer sounded a delamination that the infrared camera did not identify. Further analysis of the image was completed using a computer program called FLIR tools. The analysis showed that a 0.5° F contrast existed between the area in question and the surrounding concrete. It was determined that the delamination in question went undetected because a thermal contrast that small would not be readily apparent in the field.

concrete is typically done on per a square foot basis, minimizing the amount that needs to be replaced and ensuring that all the delaminated concrete is removed is a primary objective of repair. The infrared results and the hammer sounding may not always match. Hammer sounding is a subjective approach to inspection and may vary by inspector. The infrared camera has the capability to optimize the process and can be completed more efficiently. Instead of sounding the entire abutment wall, the camera can identify the areas of concern and sounding, along with other methods, can be used to verify delaminations.

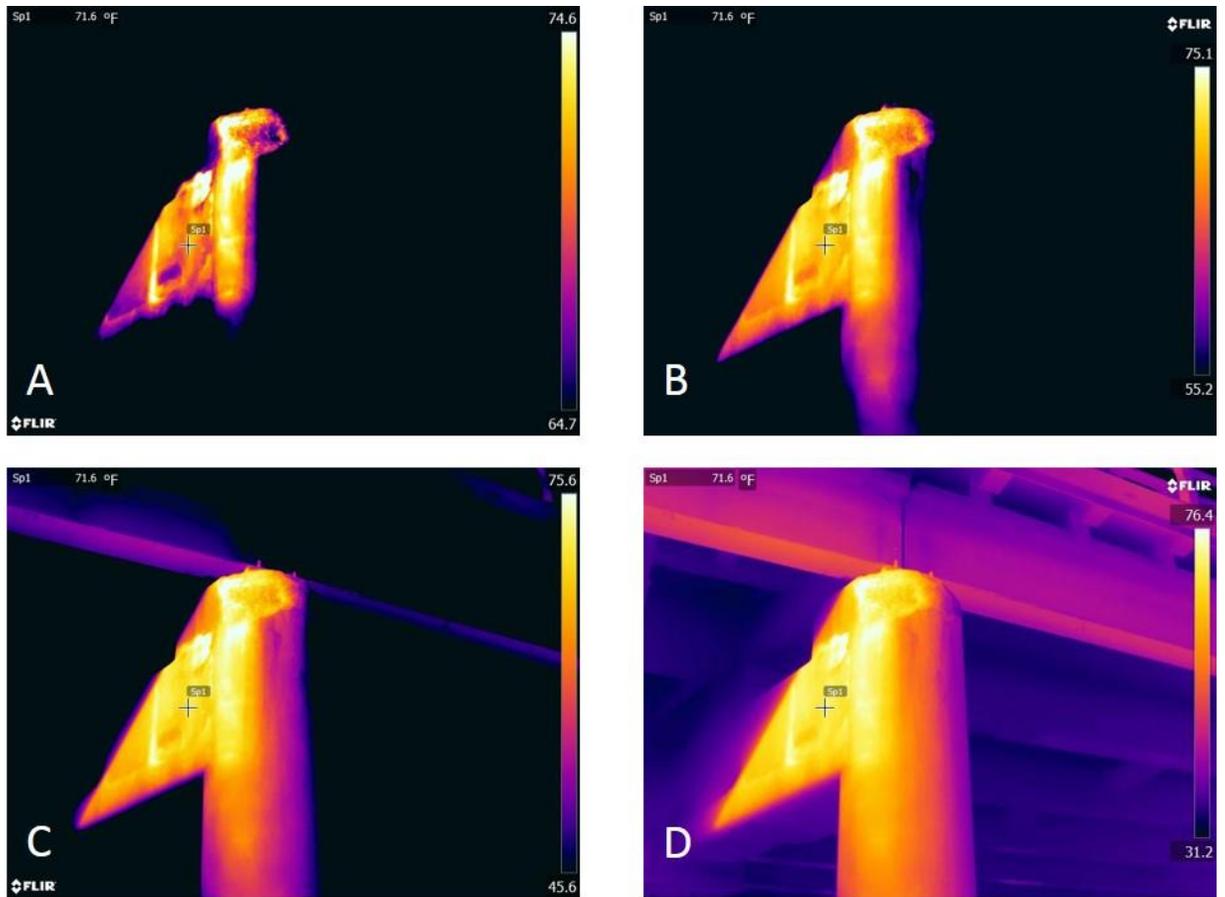
Figure 4-36: Illustration of how thermal gradient can affect an image

To further demonstrate the effect of a thermal gradient on an IR image, Figure 4-36 shows four of the same image with four separate temperature spans: 10°F (A), 20°F (B), 30°F (C) and 45°F (D). A typical span for capturing a good image in the field is approximately 4-8°F. For this example, a span of 40° F is required for everything in the infrared image to be visible.

The goal of the inspection for this bridge was to capture quality thermal images of delaminations that had been previously detected by the New York State Department of Transportation. The weather conditions for the day were sufficient enough for quality images to be captured. The thermal gradient of the transition from sun affected areas to non-sun affected made it difficult to capture quality images in some areas. However, there was a greater temperature contrast in the areas that the sun was affecting. An effective solution to the thermal gradient issue would be to capture images at night when there is no exposure to sunlight.

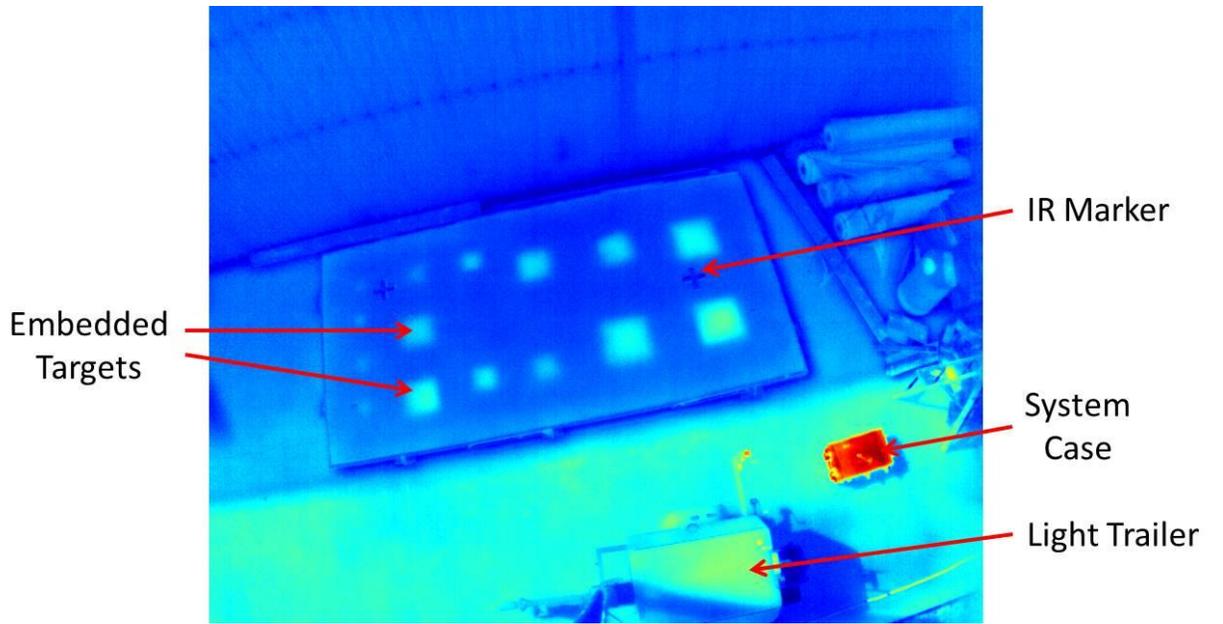
Figure 5-6: Processed results of IR-UTD test conducted on September 4, 2014

Environmental conditions for the test included an ambient temperature change of 11°F and an average wind speed of approximately 10 mph (Wunderground 2013-2015). Figure 5-6 shows an image of the results and Figure 5-7 shows the four 6" x 6" targets enlarged to demonstrate the spatial resolution of the camera.

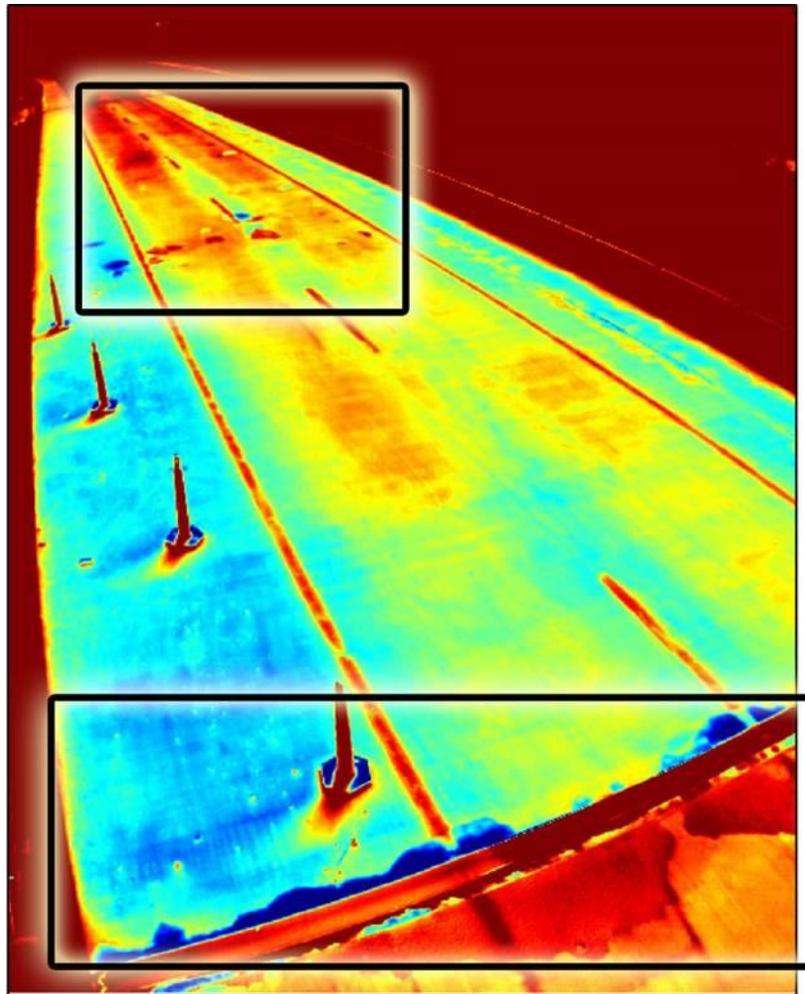
**Figure 5-9: Processed results of Providence Road test conducted on May 6,
2014**

The test parameters were set in order to capture images every two and a half minutes from 6:30 A.M. to 9:00 P.M. This testing duration allowed the technology to capture both a heating and cooling trend of the day. Weather conditions for the test included an ambient temperature change of 32°F for the first ten and a half hours and 11°F for the last four hours (Wunderground 2013-2015). Figure 5-9 shows the results of the test. The main areas of concern are those located inside the boxes.

The area of deck captured in this image is significantly more than those of later tests. However, it is difficult to determine accurately any delaminations on the far side of the image. As a result, a change was made after this test to orient the camera head so that the field of view was more normal to the deck surface.

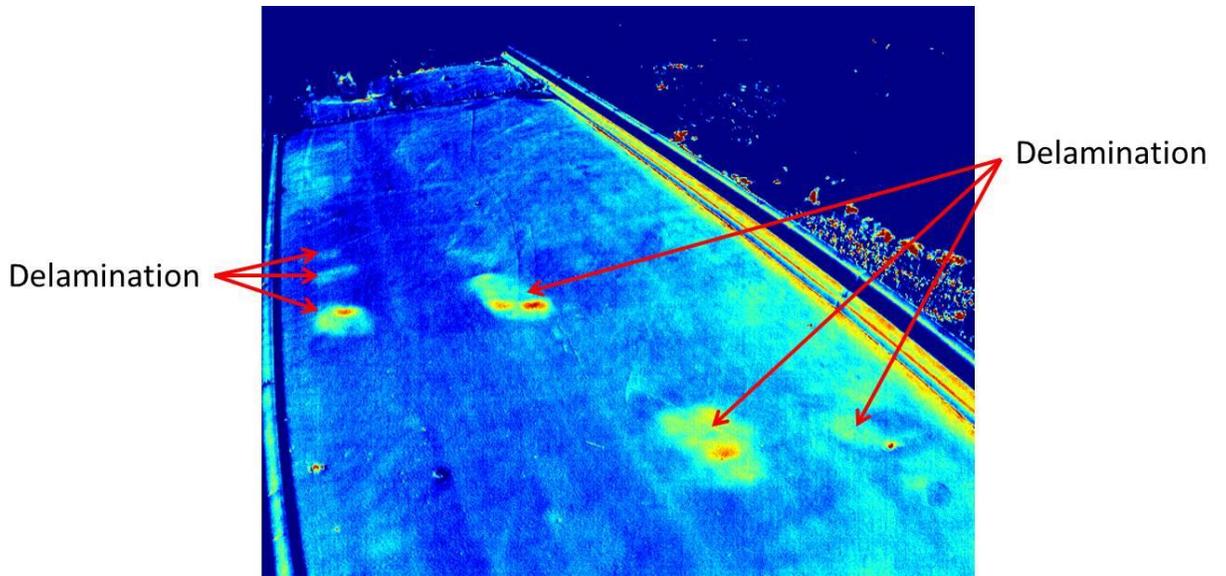
The parameters of the test were set to capture images every two and a half minutes for a duration of approximately six hours. An image of processed data from the test is shown in Figure 5-11 below. The image captures approximately 75 feet of the bridge deck length.

Figure 5-11: Processed results of IR-UTD test conducted on June 5, 2014

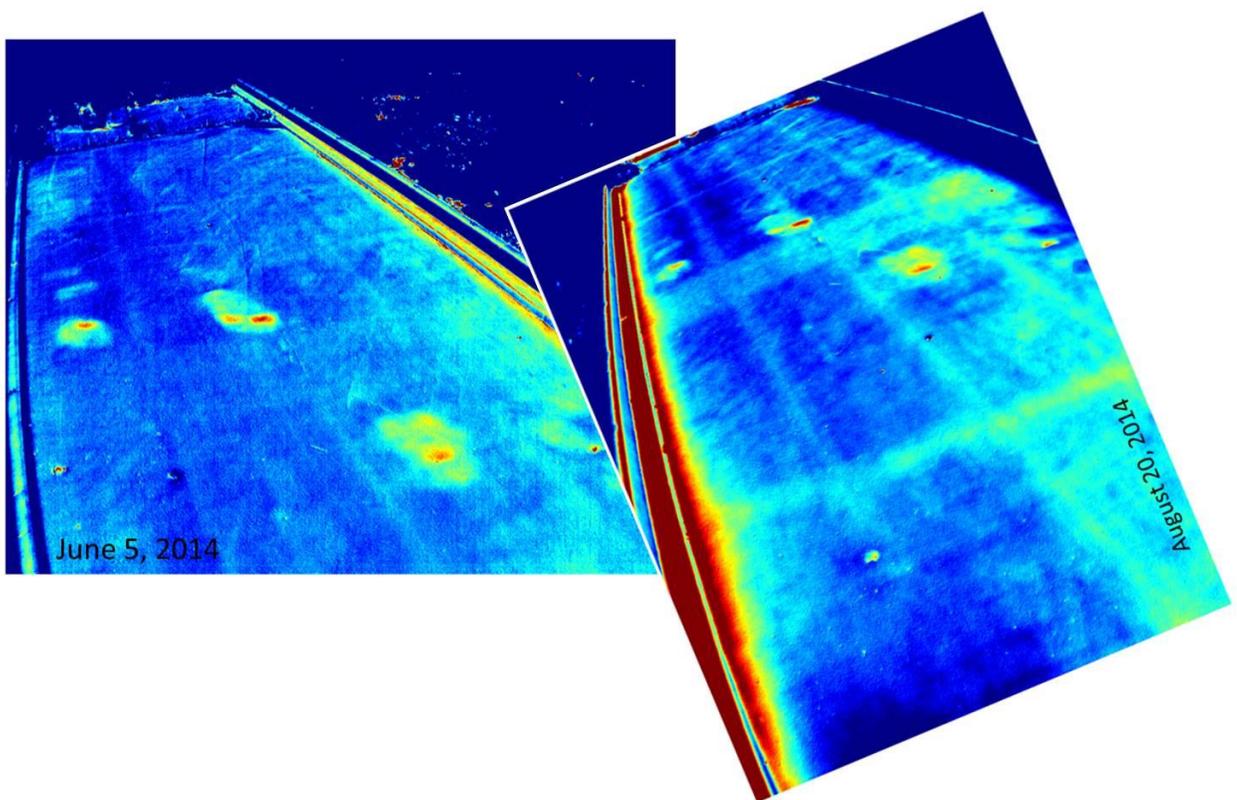
The left image was the result of a horizontal camera lens alignment while the image on the right is the result of a vertical lens alignment. It is clear that more of the bridge deck is visible in the image on the right. This shows that using a vertical alignment of the lenses is more useful for testing on narrow bridges (2-3 lanes wide). Edges of the bridge would not be visible if a vertical lens alignment were used on a wider bridge deck. Although the position and alignment of the camera head were different, the same delaminations can be observed in both images. Figure 5-14 shows that the delaminations are also consistent with the chain drag results produced by MoDOT inspectors.

Figure 5-14: Processed IR-UTD results of the June 5, 2014 (left) and August 20, 2014 (right) tests

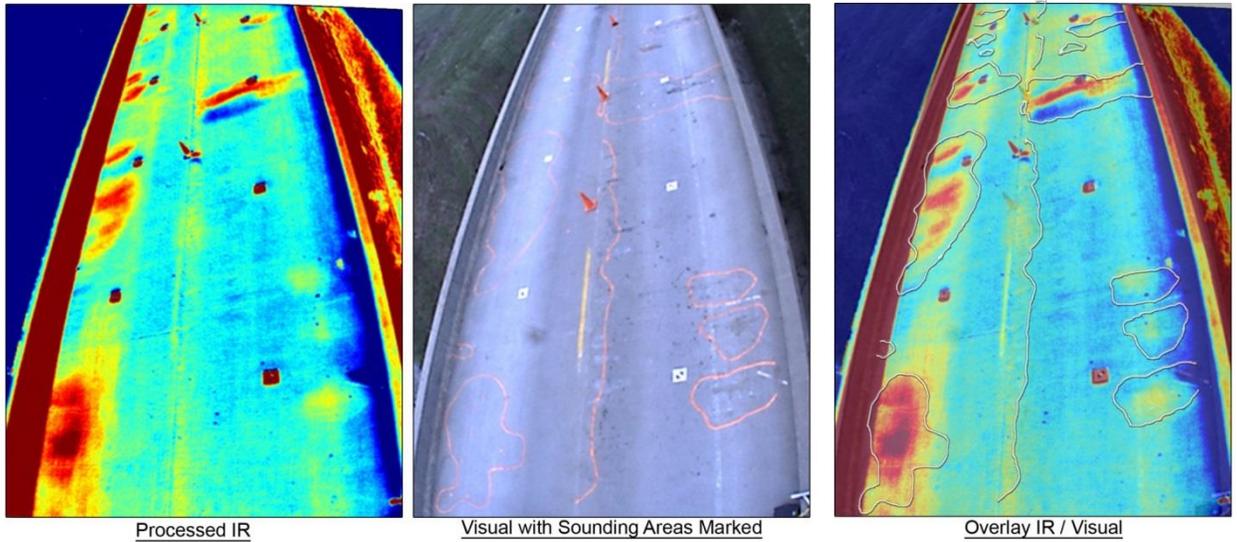
Figure 5-22: Processed IR-UTD results (left), hammer sounding results (middle) and overlay of the two (right) of the epoxy injection test

The accuracy of the technology is clear. The image showing the overlay of the IR and hammer sounding results depicts how well the results of each inspection coincide. Delaminated areas in the IR image can also be determined to be relatively deep or shallow. Determining relative depth of delamination will be further discussed in the analysis portion of this paper.

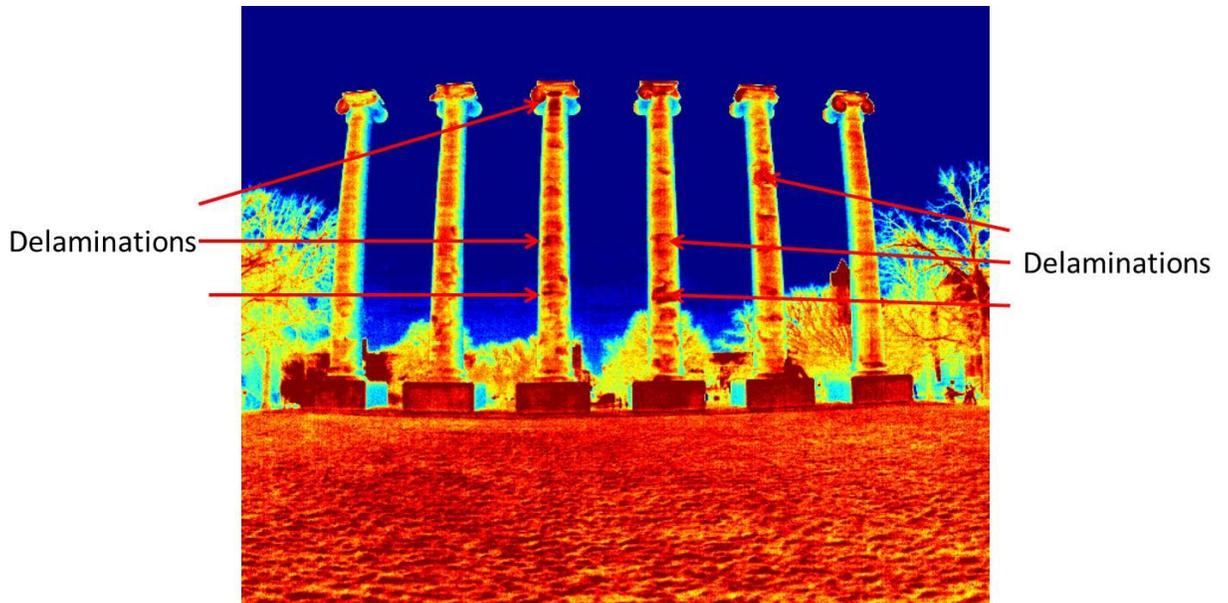
Figure 5-26: Processed results of the IR-UTD test on the south face of the Mizzou columns

Many areas on the south face of the columns were determined to be delaminated. Some of the heavily delaminated areas are indicated by arrows in the image above. There are more delaminated areas in the interior columns than the exterior columns; this was expected since the interior columns were exposed to a higher intensity of fire and the interior columns were located directly in front of the building center.

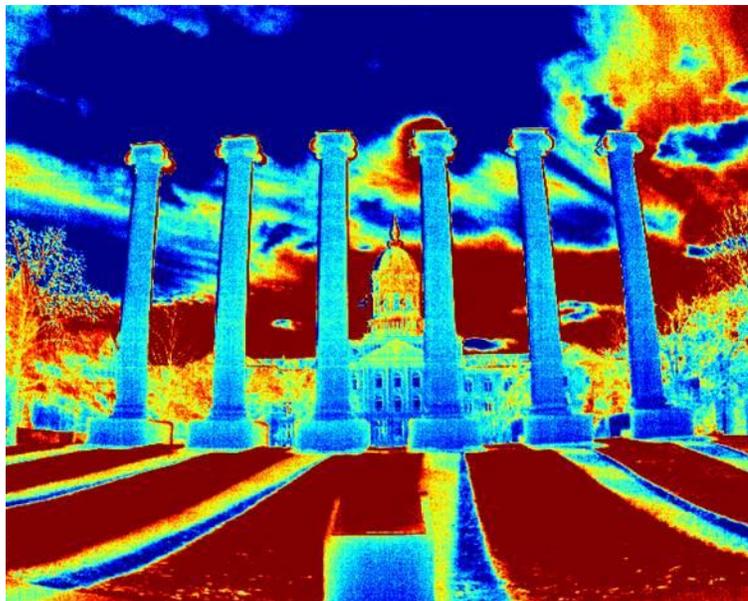
Figure 5-27: Processed results of the IR-UTD test on the north face of the Mizzou columns

No delaminated areas were detected on the north face of the columns, contrary to the delaminated areas detected on the south face. This result was expected due to the fact it was not exposed to fire. The image seems to be skewed a small amount. This is apparent with distinct difference along the left and right edges of the columns. It is assumed that the camera head may have been moved

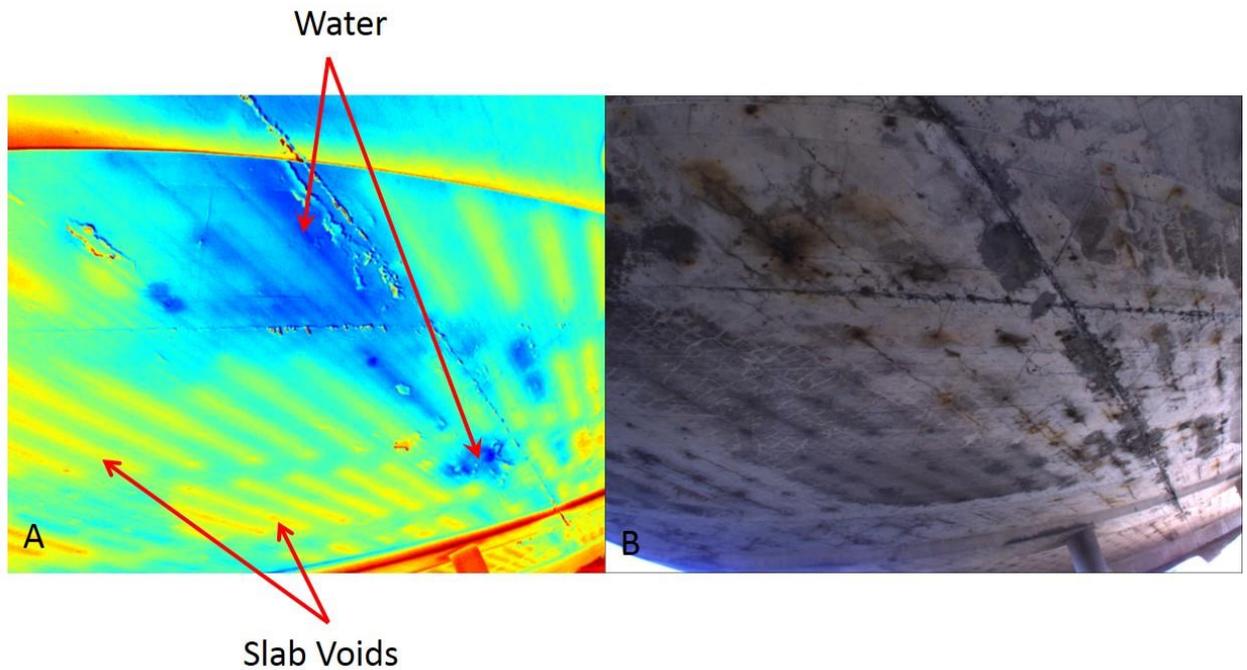
Figure 5-29: Result for West Blvd. soffit test

The slab voids are apparent in the processed results in image A. The slab voids heat up faster than the concrete around them because they act as an air void. However, the area in the center of the image appears to heat up at a slower rate than the sound concrete. Delaminations were expected to appear at higher rates of change of infrared radiation than the slab voids. Therefore, it was determined that the large, cool area in the center of the image was likely water from rain on a previous day.

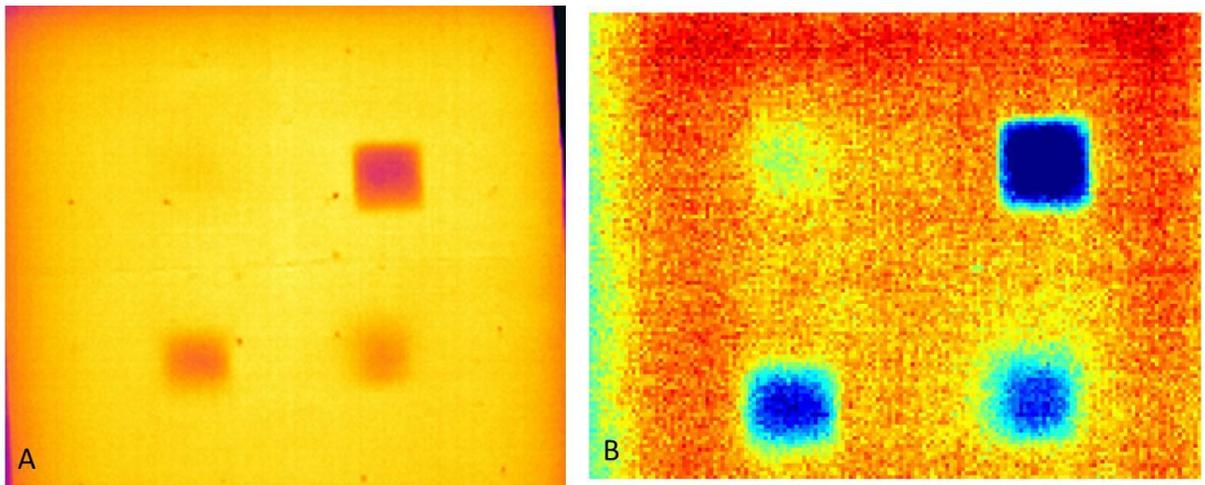
Figure 6-1: Hand held (A) and IR-UTD (B) results of the Phase I test block

The environmental conditions were conducive to thermographic testing in both situations. The 5 inch deep target is barely visible in the hand held image and would have a high probability of going undetected. The same target is more readily apparent in the processed image, which demonstrates the increased capability of the UTD technology.

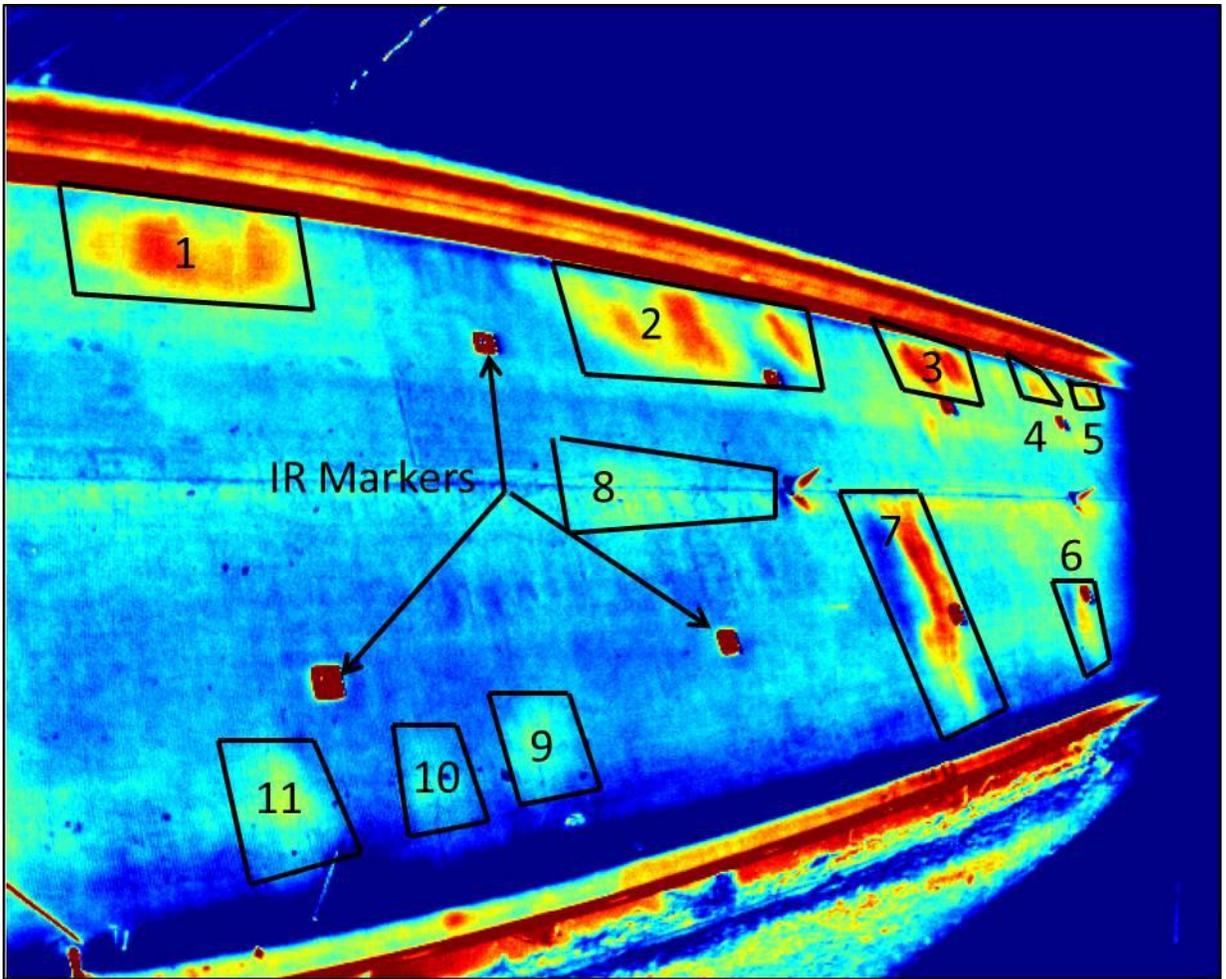
Figure 6-2: Areas used to calculate total delamination of the Lamoni, IA bridge deck

The processed image showed areas that appeared to be delaminated; these areas were estimated by the number of pixels they occupied. The approximate area of the deck was found using the same method. The number of pixels occupied by each delamination from Figure 6-2 are shown in Table 6-2.

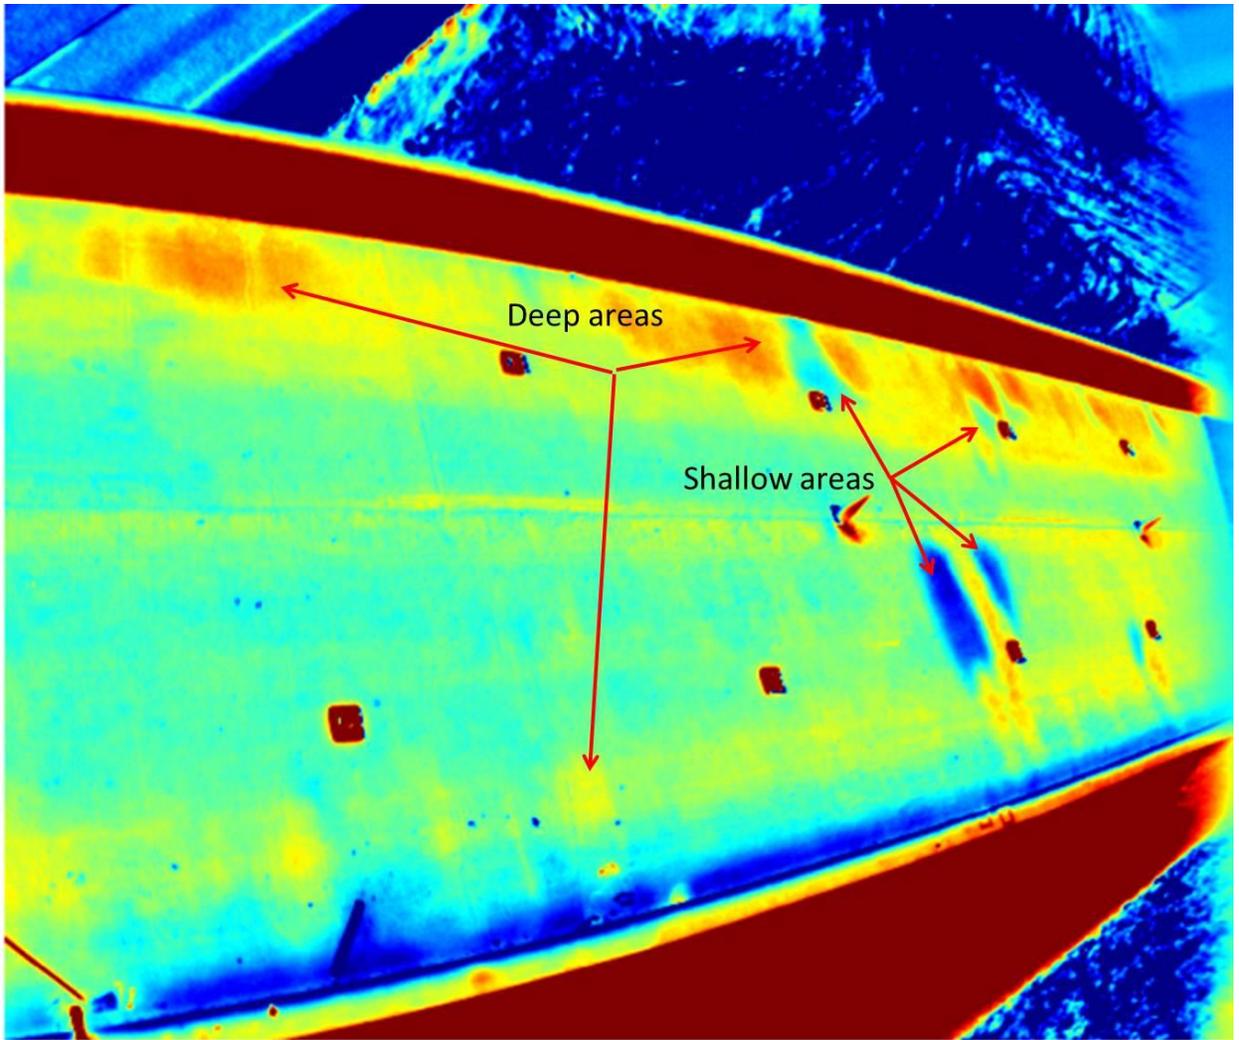
Figure 6-3: Processed image of Lamoni, IA bridge deck showing relative depths of delamination

The image above is a result of testing that included both a heating and cooling trend. Many images are produced from the data when processing is completed, but some contain better results than others. The best result produced depends on the heating cycle surrounding the test and the color scale set during post-processing. The best results for determining relative depth of delamination are achieved when testing experiences both heating and cooling cycles. This is
