University of Missouri-Columbia

RDT 03-010

University of Missouri-Rolla

Signal Mast Arm Failure Investigation

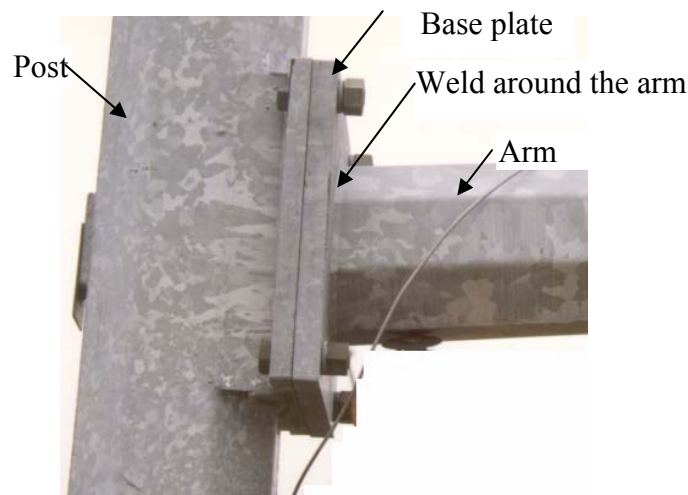
Figure 2.1 Arm-to-post connection

The cracks on all failed mast arms are located at the connection of arm to the base plate. They were observed to initiate on top of the arms and are primarily associated with the bending effect of the mast arms in the vertical plane.

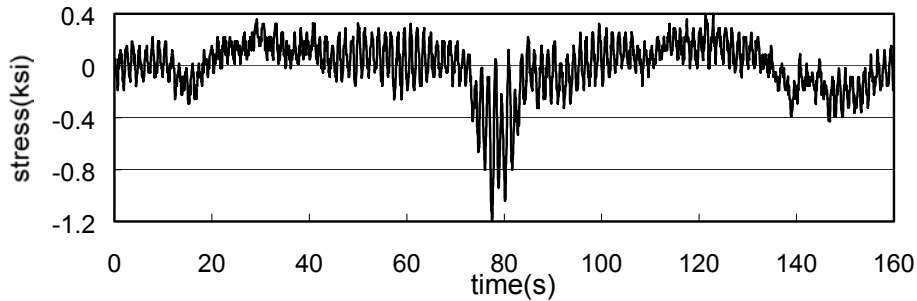
Figure 4.4 Stress time history at strain gage #3

As mentioned in the preceding section, only one record shows a significant gust effect. It represents the longitudinal strain on the front face of the arm-to-post connection at gage #3 as indicated in Figures 4.1 and 4.3(a). The strain response was converted to stress, which is plotted in Figure 4.4. Since the peak response occurs at approximately 80 s, the wind load from 60 s to 100 s is focused on below.

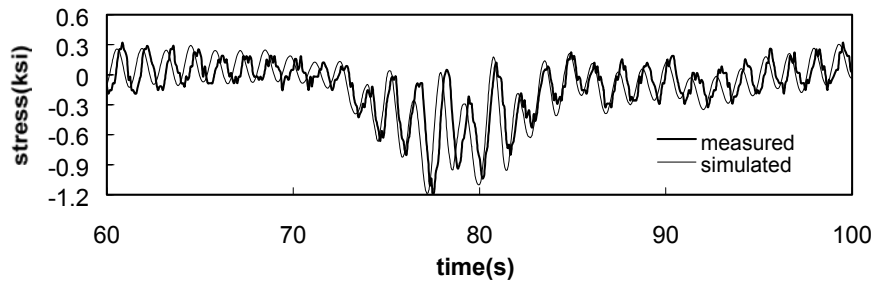
Figure 4.9 Measured and the simulated stress response at gage #3

The wind load can be regarded as the superposition of average wind and wind fluctuation. In this study, the average wind load was first extracted from the strain record measured at gage #3. Then, various pulse trains were used to simulate the wind fluctuation and truck-induced gust effect. The particular pulse train that leads to the structural responses in good agreement with the test data is referred to as the synthesized wind pressure and is shown in Figure 4.8. The stress history due to the synthesized wind load is compared in Figure 4.9 with the test results measured at gage #3. It can be observed from Figures 4.8 and 4.9 that the peak response from 70 to 90 sec was mainly caused by four wind gusts at approximately 74, 77, 80

and 82 sec due to natural wind or truck passage. Considering a speed limit of 45 mph on the highway/street, the distance between two trucks was roughly estimated as 150~200 ft, which is reasonable for the four-lane highway.

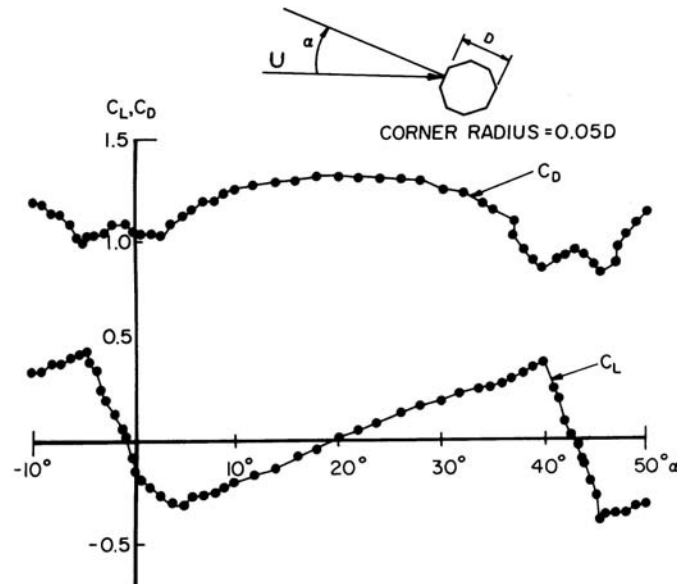
Figure 4.16 Force coefficients on an octagonal cylinder ($Re=1.2 \times 10^6$)

Galloping occurs when the total damping $d < 0$. To approximately evaluate the possibility of galloping, the lift and drag coefficients for an octagonal section from Simiu and Scanlan (1996) were used. They are reproduced in Figure 4.16. According to this figure, a slender octagonal mast arm could be susceptible to galloping in certain attack angle ranges ($-5^\circ < \alpha < 5^\circ$) because

When $\xi=4\%$ as used in Section 4.1.2, $U_g=48$ mph. This result indicates that the signal support structure could be vulnerable to galloping under wind gusts of 48 mph or higher.

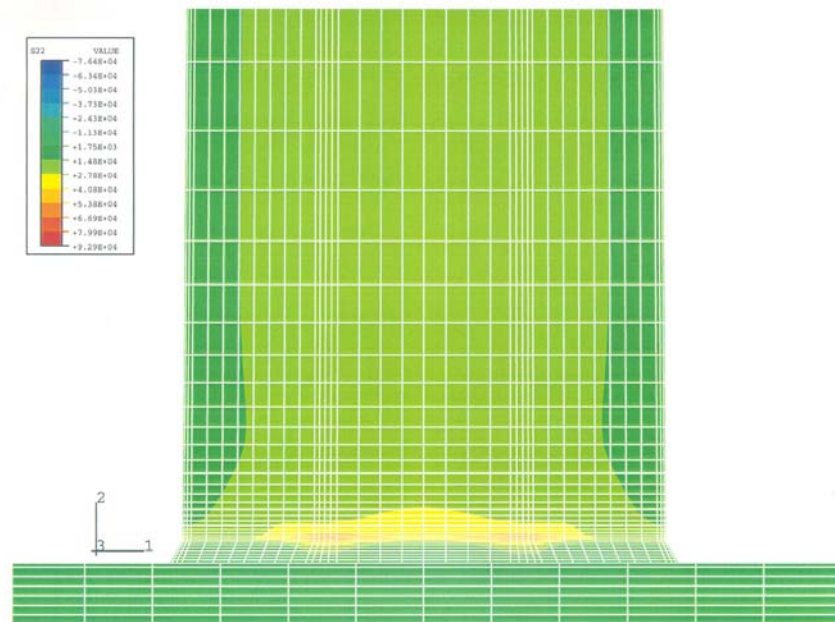
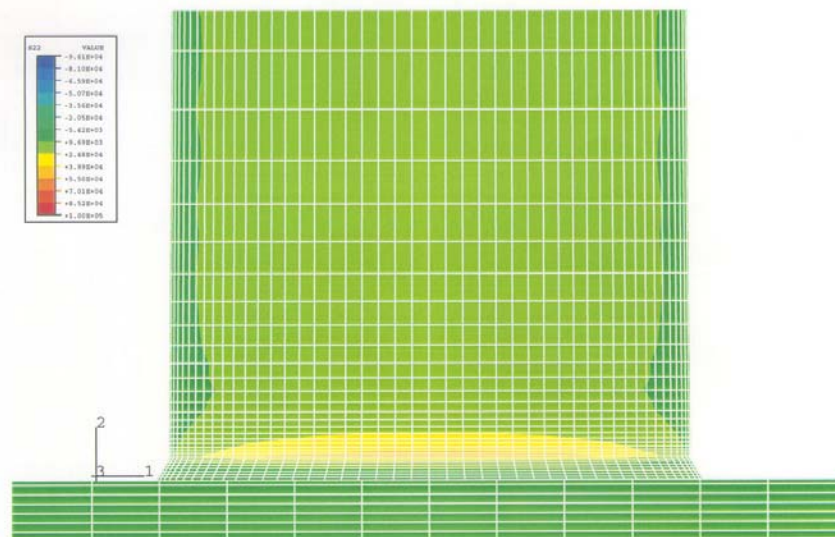
Figure 5.2 Stress contour around arm-post connection

The finite element analysis indicates that the longitudinal stress in the direction of the mast arm centerline is always dominant under wind loads from any direction. The maximum stress occurs near the toe of welding at the corner of the octagonal section and at the uppermost point of the circular section. To see this clearly, the contour of the longitudinal stress caused by the galloping load for octagonal and circular section-arm is shown in Figure 5.2, and the stress distribution along the centerline of the arm is given in Figure 5.3. It can be seen that the longitudinal stress is the maximum at the toe of the weld and rapidly drops to its asymptotic value in the area away from the weld connection. The stress concentration factor, the ratio of stresses at weld toe on the mast arm and at any point far away from the weld toe, can be determined from Figure 5.3 to be 2.88 for the octagonal arm and 2.63 for the circular arm. The longitudinal stress distribution for the galloping loads at the weld toe around the arm is shown in Figure 5.4 in which one can see the stress amplitude increases significantly at each corner of the octagonal cross-section arm, and at the uppermost point of the circular cross-section arm. The stress distribution induced by natural wind gust or truck-induced gust follows the same curve as that induced by galloping load and the stress concentration factor are the same for the above-mentioned three types of forces.

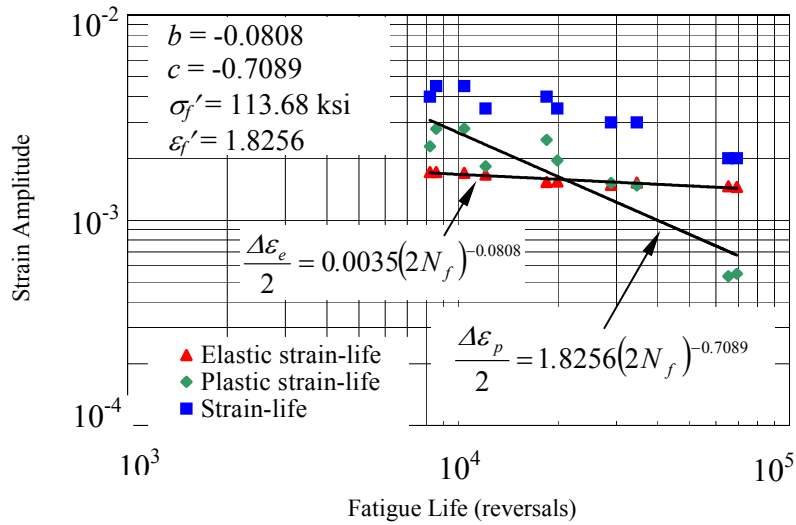
Figure 5.5 Parameters in the crack initiation prediction model

To determine the parameters in the above equations, ten flat-sheet specimens were made from the failed mast arm and tested on MTS810 machine according to the ASTM standard E606-92. The test results are presented in Figure 5.5. The parameters in Equation 5.1 and 5.2 are identified by curve fitting the plastic strain-stress and the strain-life model with the experimental data and they are listed in Table 5.1. The corresponding parameters of A-595A steel determined

(b) Strain and fatigue life relation

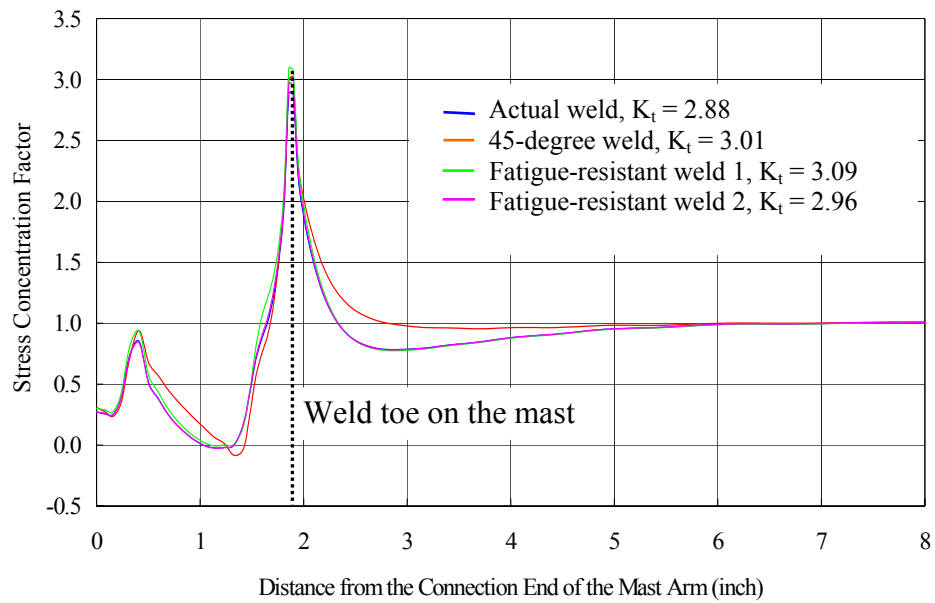
Figure 5.6 Stress concentration factors for various weld profiles

The Missouri Department of Transportation has recently introduced a so-called fatigue resistant weld profile with varying slopes. For this weld profile, the weld length on the mast arm is 1.83T, and that on the base plate is 1.57T, where T is the weld throat, i.e. the shortest distance between the root of the joint and the face of the weld. The maximum slope of the fatigue resistant weld is 30 degree. To understand the effects of weld profile on the stress concentration, four profiles for the octagonal mast arm are selected as shown in Figure 5.6(a). Profile (i) is the typical weld used in the current structure. Profile (ii) is a comparative weld, which possesses the same area as that of (i), but its slope on the mast arm is 45 degree. Profile (iii) is a fatigue-resistant weld with the weld throat equal to the thickness of the mast arm tube (0.1793 in). Profile (iv) is another fatigue-resistant weld. Its length on the mast arm is equal to that of Profile (i). Their effects on the stress concentration are presented in Figure 5.6(b). It can be observed that the actual weld yields the smallest concentration of stress with a factor of 2.88 at the weld toe even though its weld leg on the base plate is the shortest. This is mainly because the actual weld has the longest weld leg and the smallest slope on the mast arm wall. The stress concentration factor for the 45-degree weld is 3.01, although it has the same weld area as (i). The fatigue-resistant weld 1 has the largest stress concentration factor of 3.09, because its length on the mast arm is the shortest. Increasing the length of the fatigue-resistant weld to that of the actual weld, the stress concentration factor will be decreased to 2.96. Therefore, it is concluded that the stress concentration not only depends upon the slope of a weld profile but also depends on the weld length along the mast arm wall. The fatigue-resistant design could lessen the stress concentration if used to lengthen the weld leg on the arm wall.

(a) Weld profiles

(b) Stress concentration factors

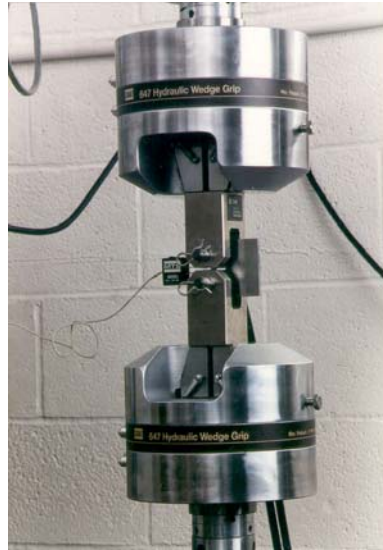
Figure 5.7 Determination of constants in the crack growth rate model

in which a is the crack length, N is the number of stress cycle applied to the structure, and C and m are two material constants. To determine these two constants, several compact tension specimens were made from the failed octagonal mast arm and tested in the MTS810 system according to ASTM standard E 647 - 95a. The test specimen and setup is shown in Figure 5.7(a). The material constants can be estimated as $C = 2.36 \times 10^{-10}$ in the units of a as inch and K as ksi $\sqrt{\text{in}}$ and $m=3.11$ from the test data shown in Figure 5.7(b).

(a) Test specimen and setup

(b) Crack growth rate vs. stress intensity factor range
