DEVELOPMENT OF SOLUTION TECHNIQUES AND DESIGN GUIDELINES FOR  
EQUESTRIAN TRAILS ON PUBLIC LANDS

A Thesis presented to  
the Faculty of the Graduate School  
at the University of Missouri-Columbia

a candidate for the degree of Master of Science Degree in Civil Engineering

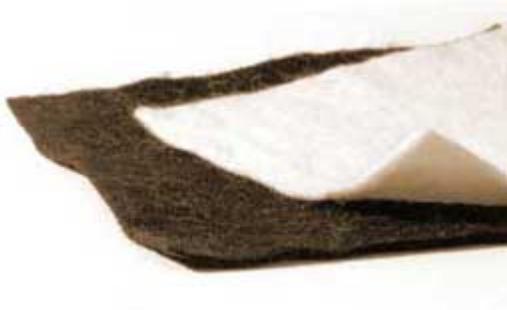
Geotextiles (Figure 2-3) are polypropylene fabrics that provide separation and reinforcement. The geotextiles recommended for use in trail applications are non-woven (long plastic fibers form a fabric by needle-punching and heat bonding). Non-woven

geotextiles allow water to flow through the fabric, but restrict soil particle from migrating upwards.

**Figure 2-3. Example of Non-Woven Geotextile Fabrics (Monlux et al., 2000).**

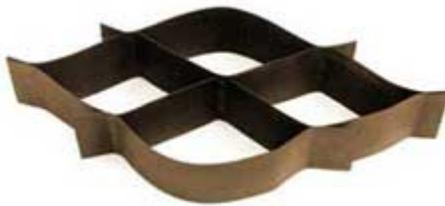
Geocells – Geocells (Figure 2-6) are plastic strips bonded together to create a honeycomb structure (Monlux et al., 2000). Geocells provide reinforcement over weak soils by spreading loads over a larger area. Construction involves filling the cell structure with free draining aggregate and covering the structure with surface aggregate. Geotextiles are applied to the surface below the cells to provide separation (Figure 2-7).

**Figure 2-6. Geocells have a Honeycomb Structure (Monlux et al., 2000).**

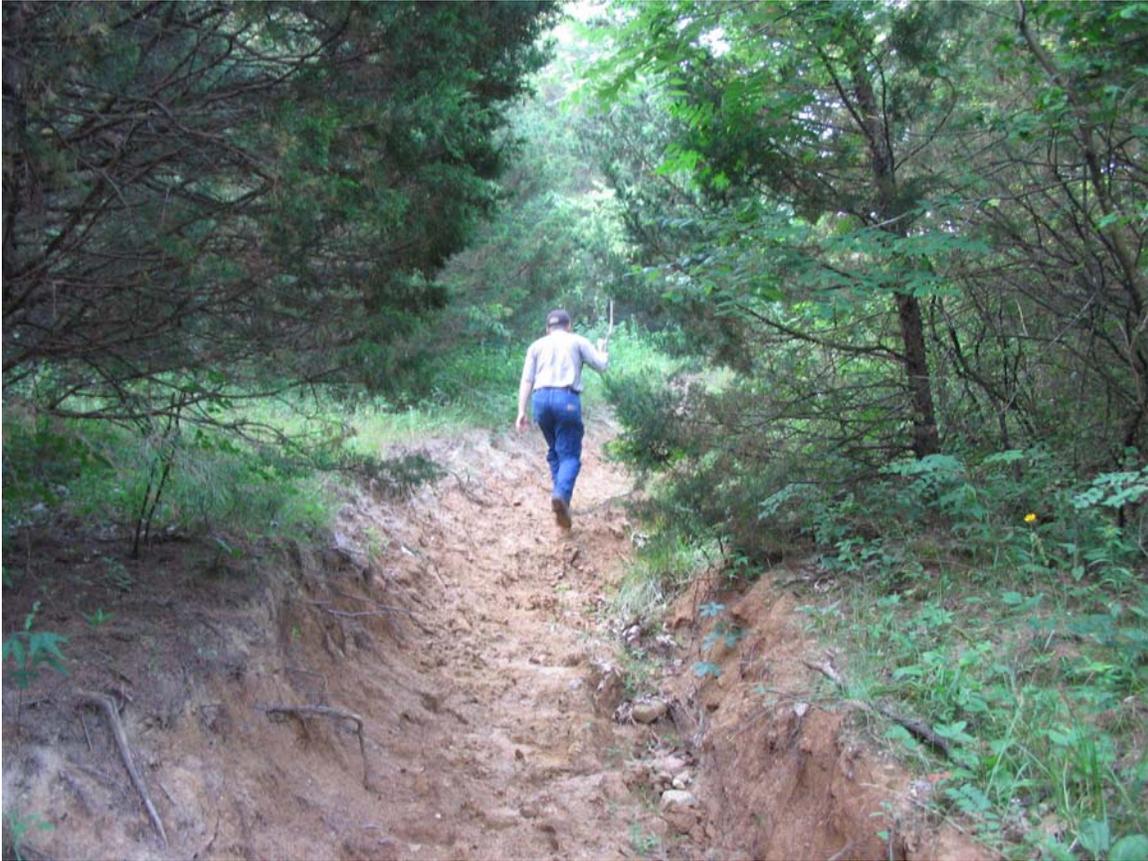
Between the ridge top and the stream crossing, the trail heads downhill. Gullies were observed ranging from one to four feet deep (Figure 4-3). The trail did not feature any methods for diverting water off the trail. All surface runoff from the upper portion of the trail was focused on the trail for several hundred feet.

**Figure 4-3. Gully Observed along Section 1.**

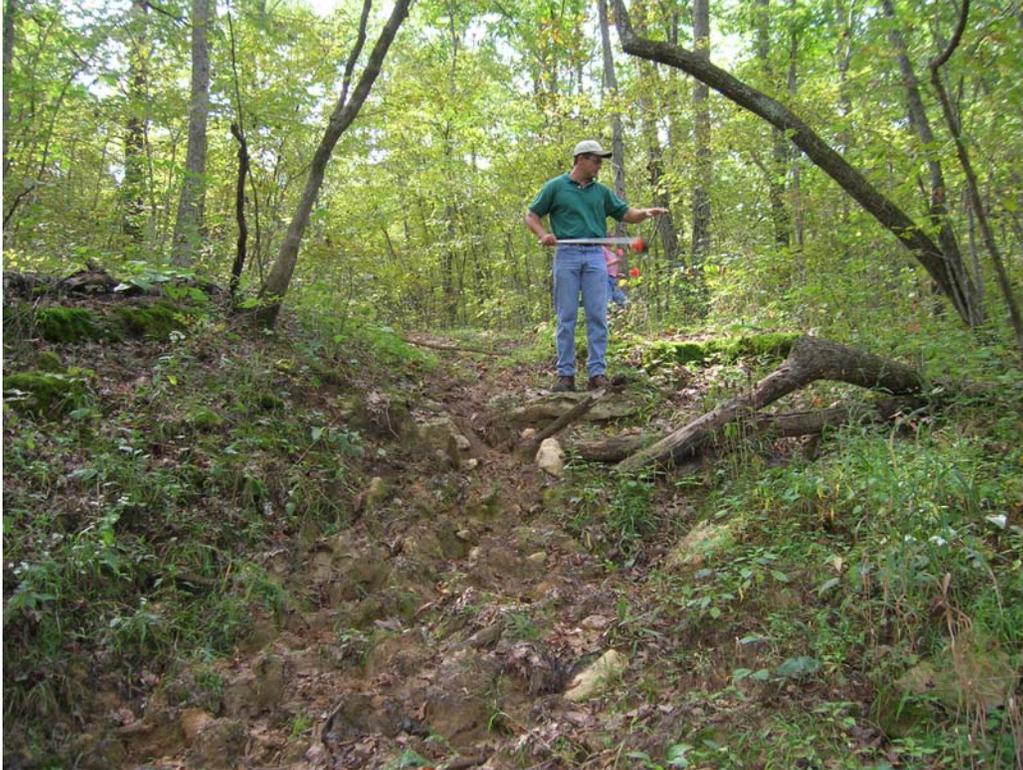
At the bottom of the hill, near the stream bed, the surface was muddy and saturated (Figure 4-4). The trail had widened to more than ten feet due to users trying to avoid muddy sections.

**Figure 4-4. Trail Widening near Stream Crossing on Section 1.**

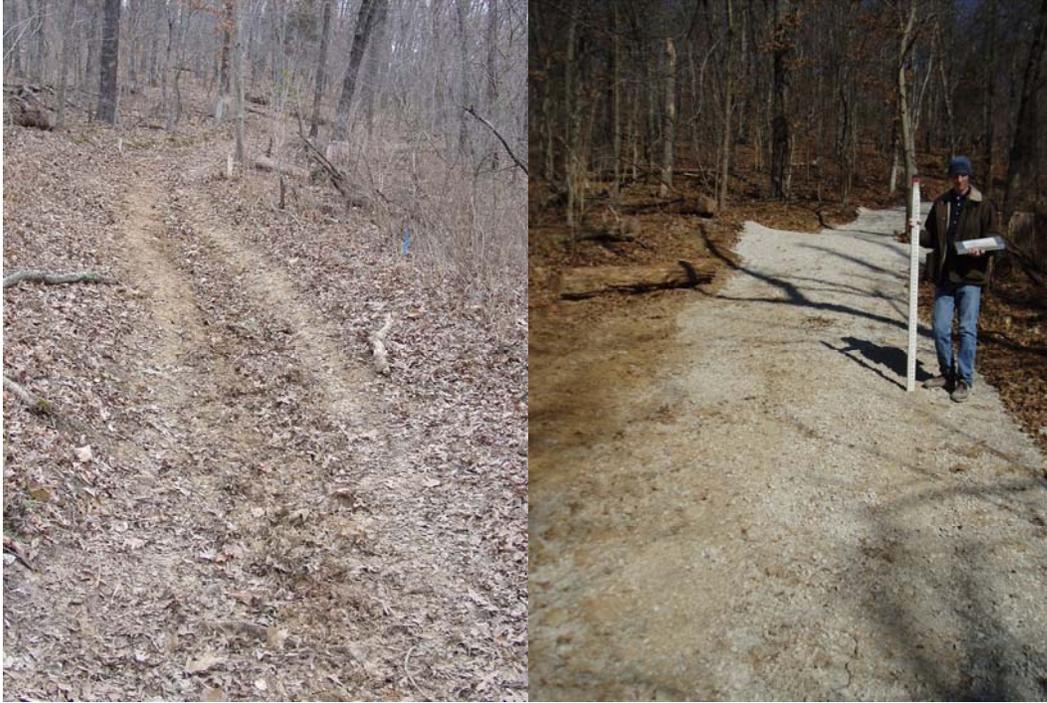
**Figure 4-9. Segments 16 through 18 Before and After Treatment.**

Segments 16 through 19 had geosynthetics applied to the surface. Because the surface was muddy during the reconnaissance visits, it was decided to improve the strength of the surface with geosynthetics. The solutions applied were two geotextiles segments (wrapped and non-wrapped) and two segments with four inch Geocells.

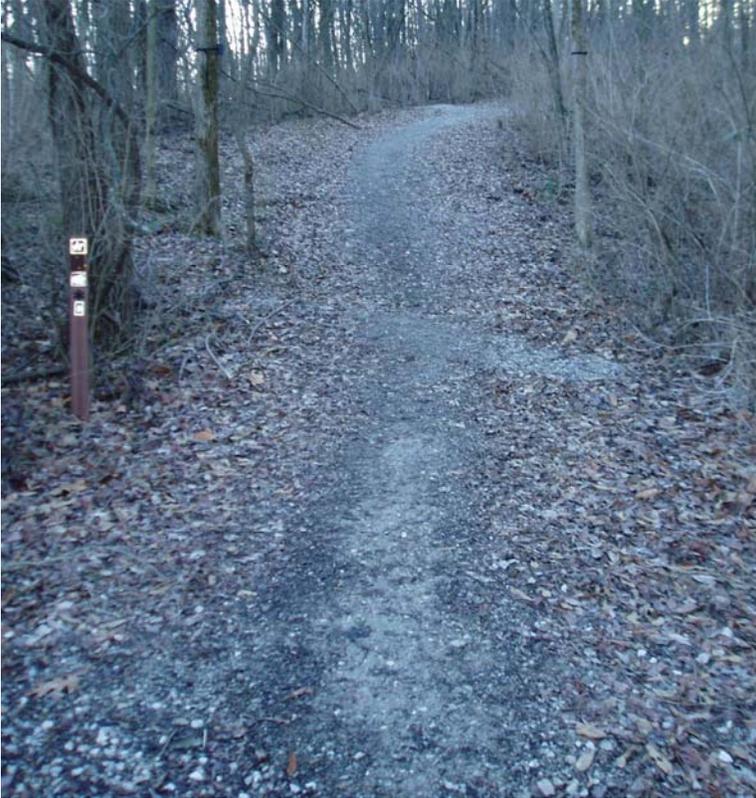
Figure 4-12. Segments 16 through 19 (Observed during January 2007).

During January 2007, the aggregate surface (within the path of use) appeared to have a significant amount of fines (Figure 4-12). Hoof prints could be seen ¼ inch deep in the aggregate surface.

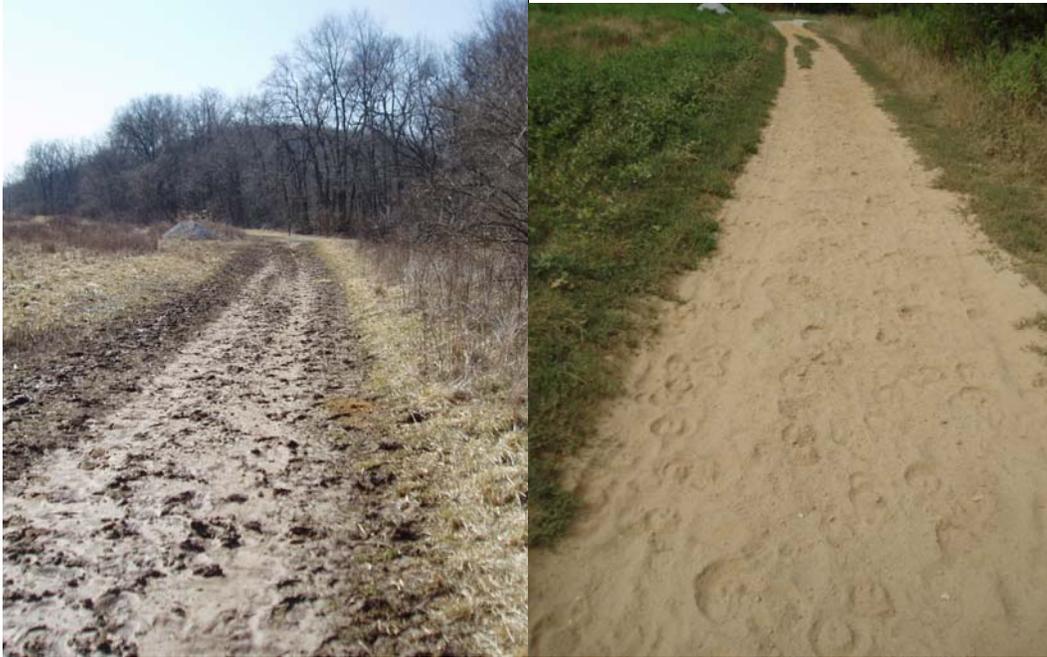
Post-Construction Observations - The natural soil segment (Segment 1) was muddy after rain events. When the surface was dry, disturbance broke up the soil to create a loose dust two inches deep (Figure 4-14).

**Figure 4-14. Forest 44 - Section 2 - Segment 1- Muddy and Dry.**

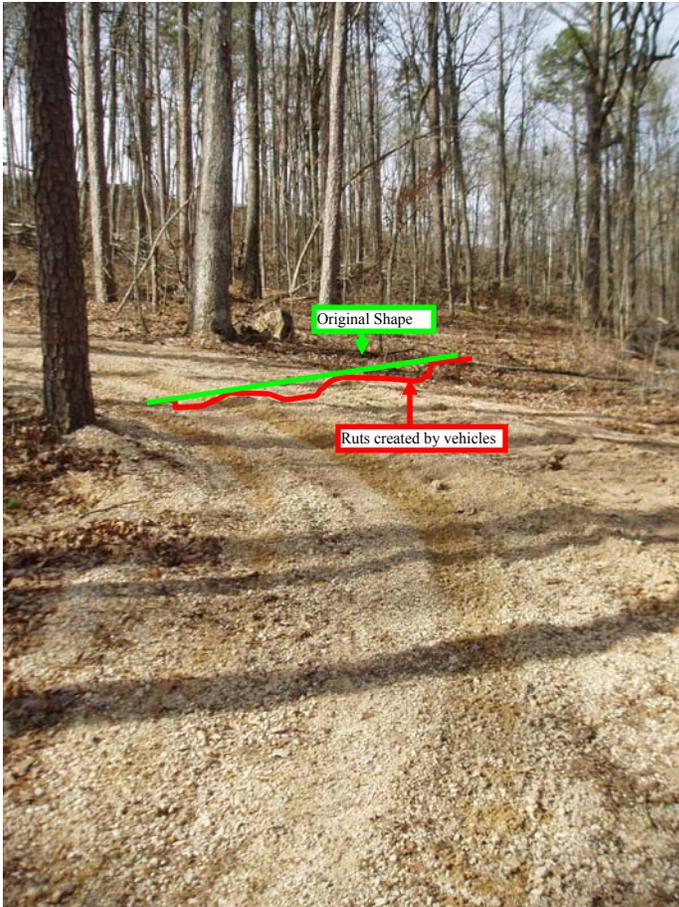
Ruts from wheeled vehicles were observed around sharp corners several times throughout the observation period (Figure 4-18). The ruts were most likely created by four wheel drive vehicles digging in while making sharp turns. While in four wheel drive, the wheels all turn at the same speed. When turning, the inside wheels turn the same number of revolutions, but travel a smaller distance than the outside wheels. The excess revolutions of the inside wheels can dig into the surface creating ruts. While ruts and disturbance could be seen due to flowing water and wheeled vehicles, no rutting or disturbance caused by horses was observed on Segments 1-21.

**Figure 4-18. Ruts from Wheeled Vehicles on Sharp Turns.**

Ruts created by four wheel drive vehicles on sharp corners were observed at the Angeline CA. The ruts were caused by the tires digging into the surface while taking sharp turns. The use of vehicles was not expected, and the trails were not designed for those users.

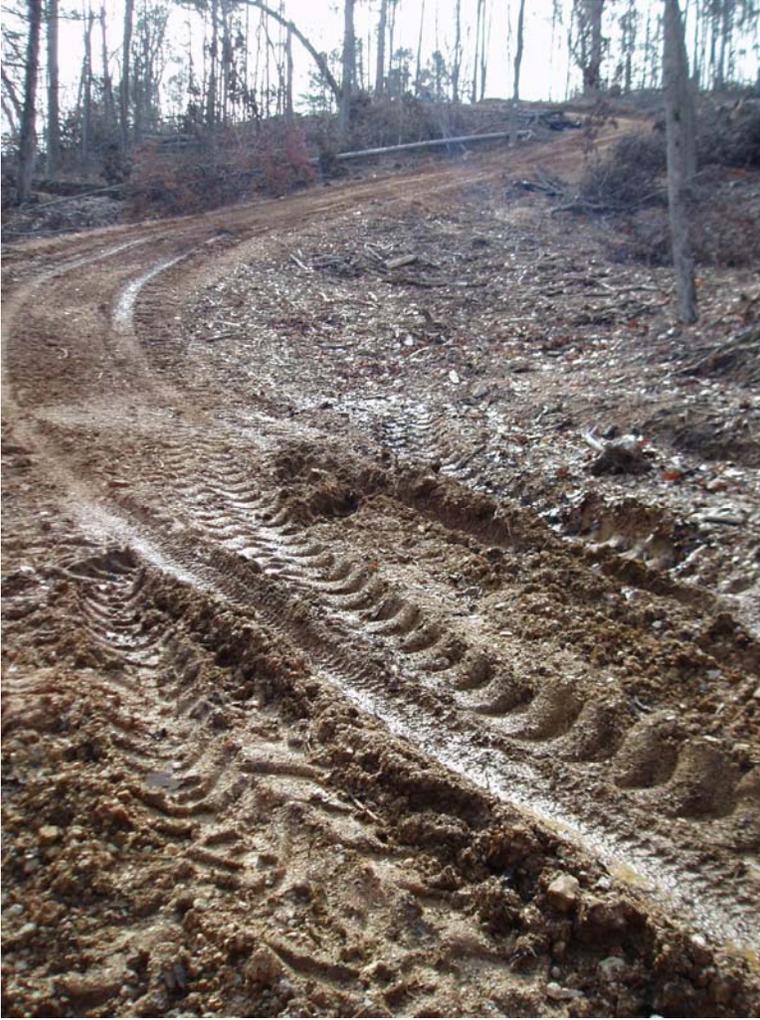
Segment 21 and 22 were observed to have ruts four to six inches deep from wheeled vehicles due to inadequate surface strength. Hoof prints were observed between the ruts from wheeled vehicles. Evidence of users sliding was observed by smearing on the surface. Both segments were muddy and water was ponded in the ruts (Figure 4-19). Geosynthetic separation was not installed on either segment. The surface aggregate had mixed with the underlying clay. The surface on Segment 22 was always observed to have a wet appearance. That segment crosses a large concave topographic shape that collects water from a large watershed drains onto the trail.

**Figure 4-19. Ruts and Muddiness Observed on Sections 21 and 22.**
