EVALUATING THE VARIABLES THAT IMPACT ULTRASONIC TESTING

A thesis presented to the Faculty of the Graduate School at the University
of Missouri – Columbia

DANIEL WAYNE LOOTEN

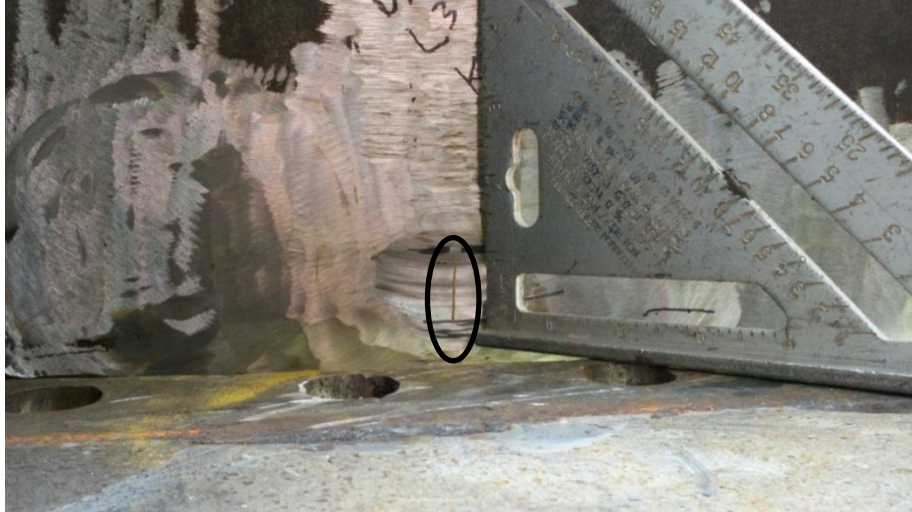
Figure 1-2: Vertical crack located in the SMB arch tie butt weld.

The Sherman Minton Bridge (SMB), shown in Figure 1-1, was opened in 1961 and carries I-64 traffic across the Ohio River from Kentucky to Indiana. The 5-span bridge includes two simple span steel tied arch trusses that are considered fracture critical. The SMB carries an average daily traffic of approximately 80,000 vehicles. The bridge was inspected using nondestructive evaluation (NDE) technologies between April 2011 and October 2011. The bridge was subsequently closed for 5 months, during which time the bridge was strengthened to mitigate the risk of fracture. (Gorrill 2011). On September 8, 2011, a significant vertical crack was identified in one of the fracture critical tie girders, shown in Figure 1-2.

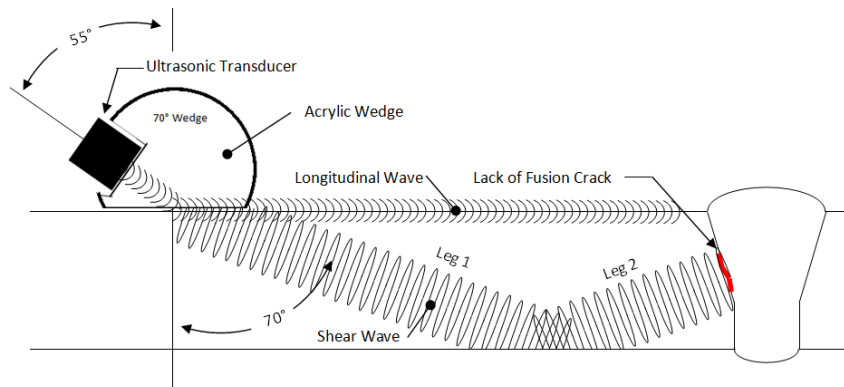
Figure 2-1: Wave path of a 70° angle beam wedge transducer

This research focuses on the pulse echo technique which requires a single probe that generates and receives the reflected wave (Firestone 1942, Desch, Sproule et al. 1946). Figure 2-1 illustrates the wave paths of the shear and longitudinal waves from a single ultrasonic transducer. The pulse echo technique is typically preferred for bridge inspection because it only requires access to a single weld side, unlike TOFD, which requires access to both sides.

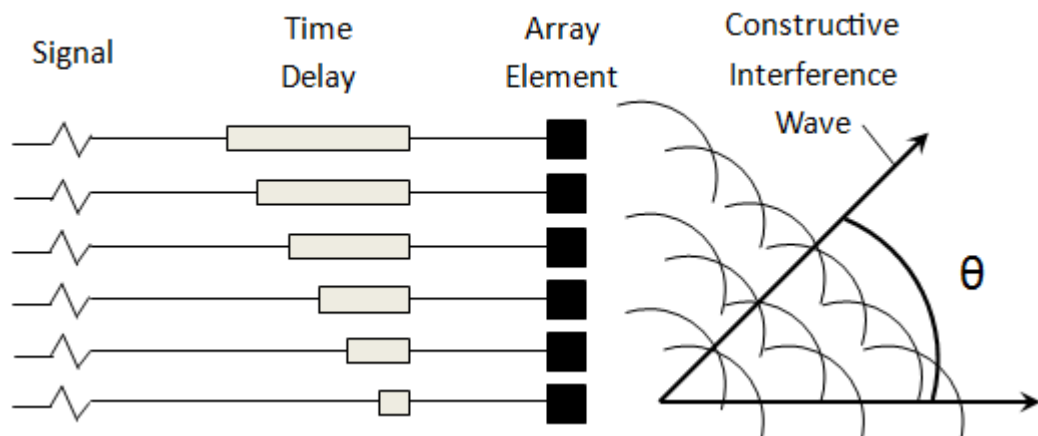
Figure 2-2: Phased array ultrasonic testing wave propagation

“steering.” Figure 2-2 shows a schematic diagram of beam steering using time delay. Each element is stimulated with a different time delay resulting in constructive interference. The resulting wave is used to inspect the weld. The steering angle, θ , is controlled using different time delays. This process is rapidly repeated, changing the steering angle to each angle in the desired range, such as 40° - 75° . The PAUT receiver stores information on the reflected amplitude to include time, angle and amplitude. This information is used to generate an S-Scan. This S-Scan displays the amplitude represented by a color located at a given reflection angle and reflection time. Figure 2-3 shows the constructive interference waves propagating from the phased array transducer to the defect. The phased array receiver is capable of generating A-Scans associated with each angle as described in Section 3.2. Using the PAUT, defects are much easier to detect, and multiple A-scans can be assessed in a single scan.

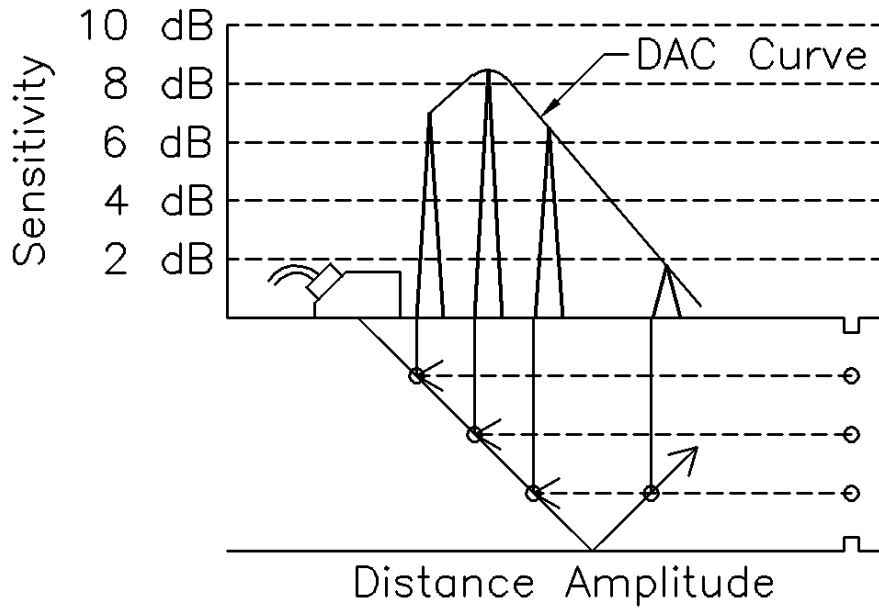
Figure 2-6: DAC curve construction

The ASME code uses a distance amplitude correction (DAC) curve to develop a reference level as seen in Figure 2-6. The DAC curve is developed using the maximum reflected amplitude from side drilled holes of similar diameter at different depths. The indications are of similar sized holes; however, the reflected amplitude decreases due to the material attenuation. These indications are used to develop a reference line used to determine a defect's acceptance or rejection. If any measured indication is larger than the DAC curve, the indication represents a defect larger than the side drilled hole at that depth. Any defect that is 20% of the DAC curve is further characterized and compared to the acceptance criteria. During the initial inspection, the ASME code requires that the sensitivity level is set 6 dB or higher than the reference level to ensure all possible defects are detected. These indications are then further evaluated to establish their severity.

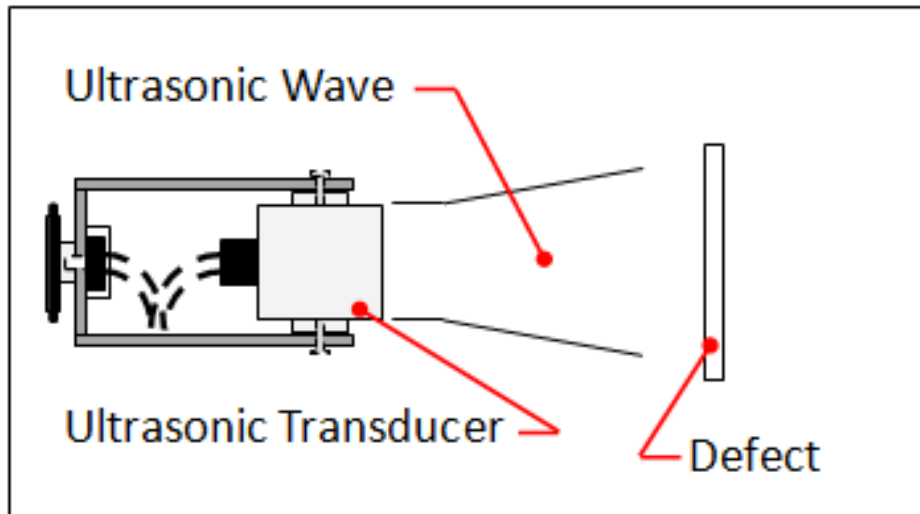
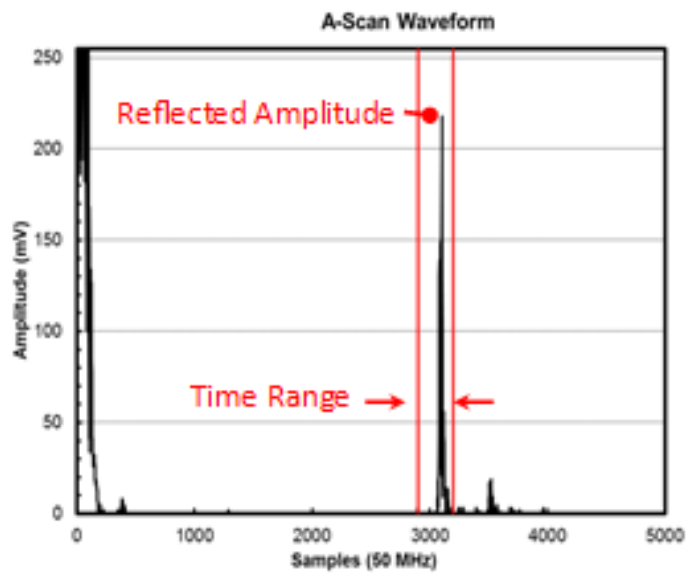
Figure 3-4: A-Scan waveform example indicating the B-Scan time range

Figure 3-4 and Figure 3-5 shows an example of both A-Scans and B-Scans of the same test. The two vertical lines in Figure 3-4 represent the time range calculated to analyze the defect indication. The maximum amplitude from each time segment is identified and associated to its location provided by the encoder. The B-Scan displays the maximum amplitudes found in the given time range versus the encoder locations as seen in Figure 3-5.

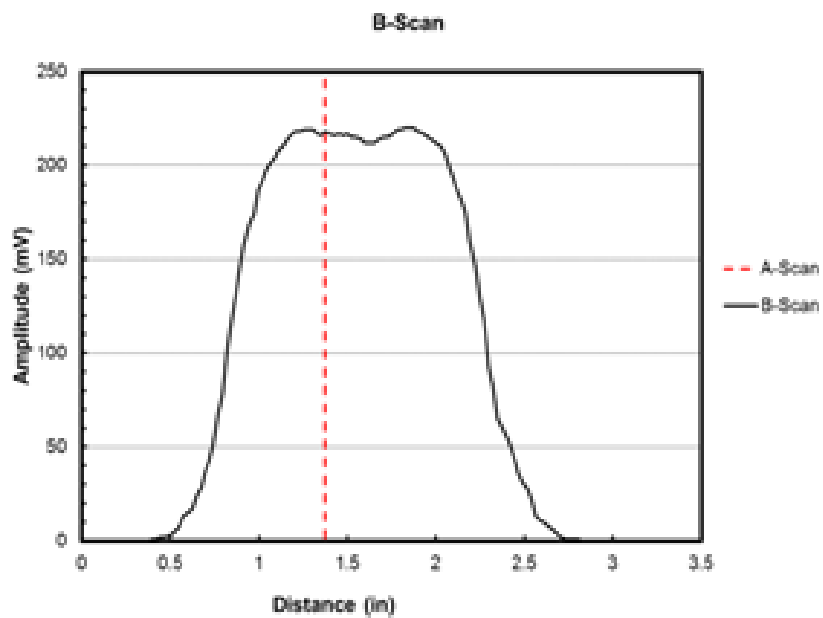
Figure 3-5: B-Scan showing location of the A-Scan measurement

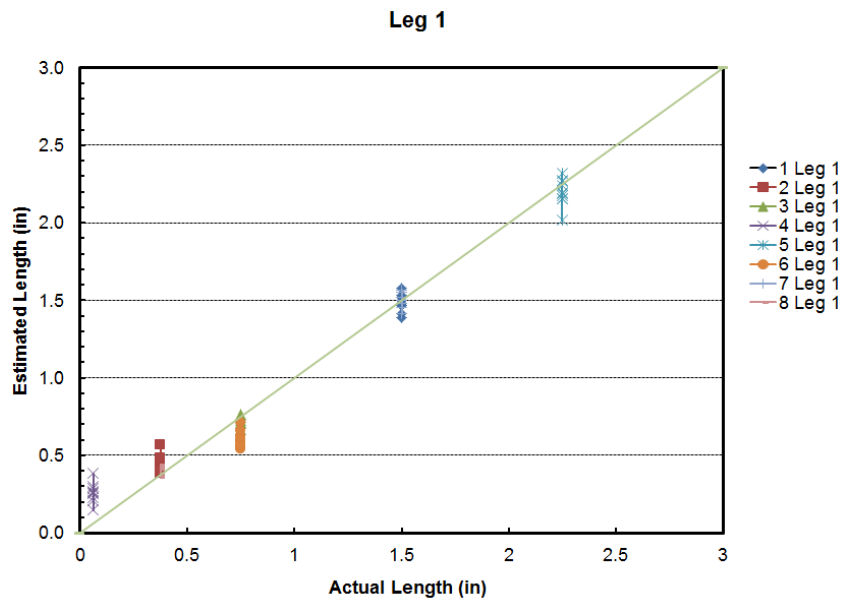
Figure 4-1: Length measurements vs actual length of all LA1 defects in Leg 1

Table 7 indicate that the length measurements are impacted by the defect length relative to the transducer length. Defects shorter than the 0.625” transducer length were affected by the beam spread and were initially oversized. Table 7 shows that the length measurements of the 1/16” and 3/8” slots increased from 0.257” to 0.286” and 0.391” to 0.5975”, or 11% and 53%, respectively. Defects larger than the transducer length were measured near or shorter than the defect.

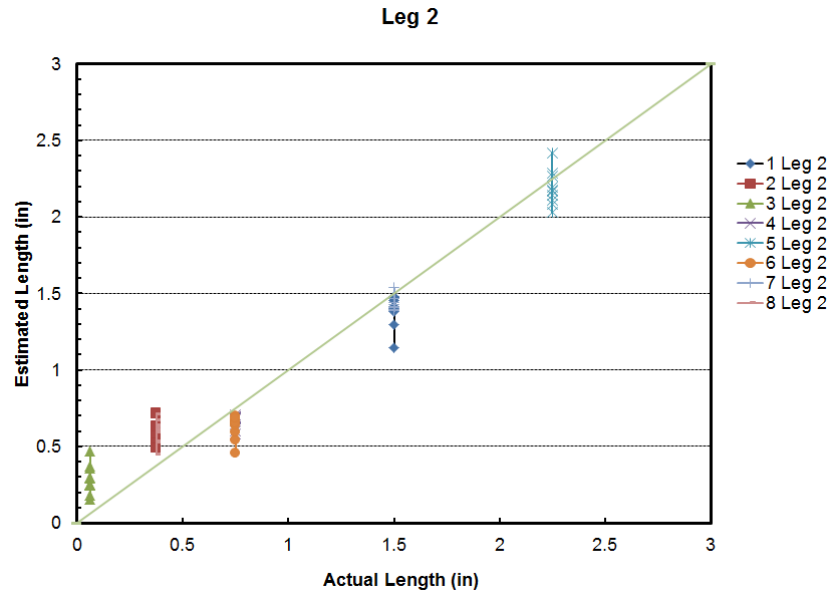
Figure 4-2: Length measurements vs actual length of all LA1 defects in Leg 2

same length. The loss in defect volume, caused the measured length to be undersized.

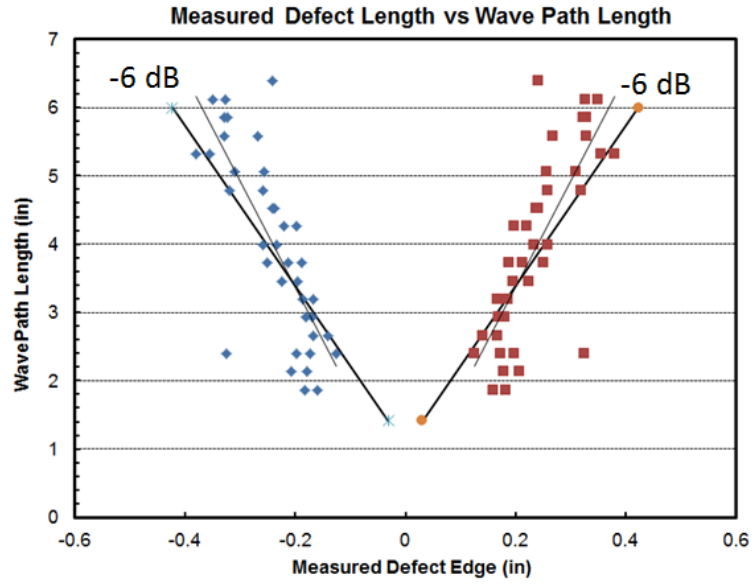
Figure 4-3: Beam spread test results of 1/16" diameter hole in LA1 plate

During this test, the transducer was placed on the steel specimen's surface at various surface distances away from the defect. Due to the near field interference calculated at 1.4 inches, the defect was initially inspected at a wave path length of 1.86" or a surface distance of 1.75" away. The wave path lengths are identified in Figure 4-3, Figure 4-4 and Figure 4-5. This process was repeated while moving the transducer away from the defect by 0.25" increments until a 6" surface distance was attained. Figure 4-3 to Figure 4-5 show two data point groups that represent the left and right measured edges of each length measurement. The thin slanted lines are trend lines representing the slope of each group of data points, and the thick slanted lines represent the calculated beam spread angle of the transducer.

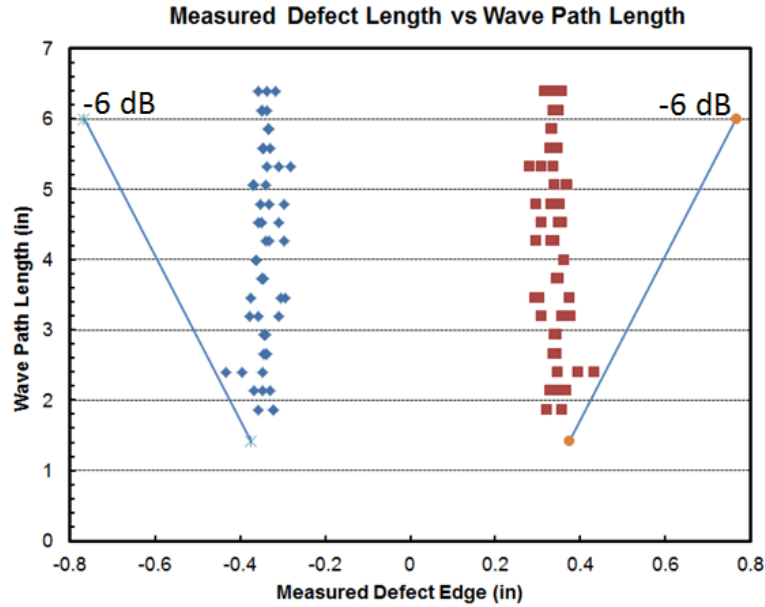
Figure 4-5: Beam spread test results of 3/4" slot in LA1 plate

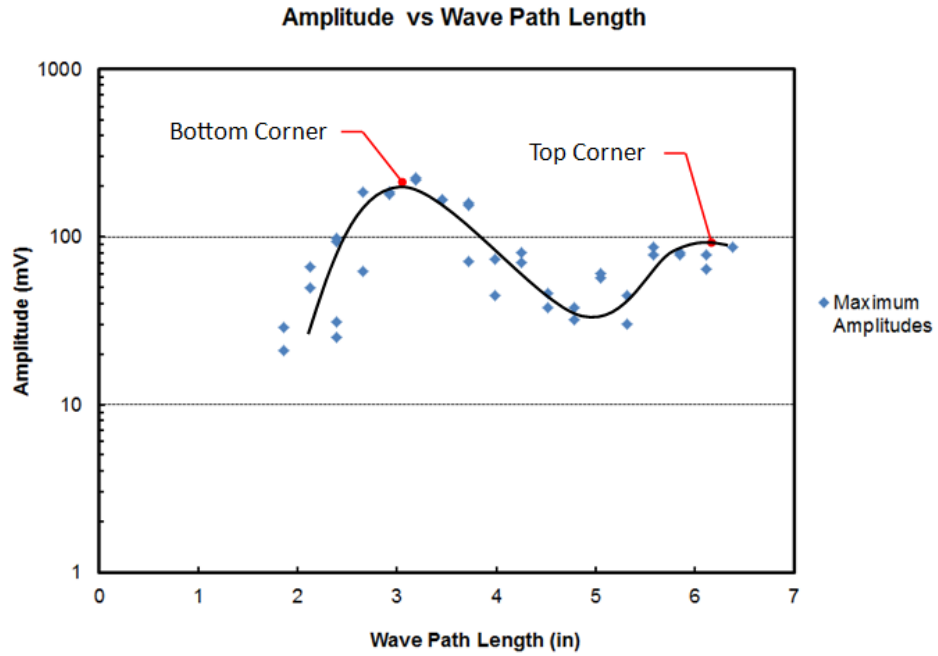
Figure 4-6: Attenuation of the 1/16" hole

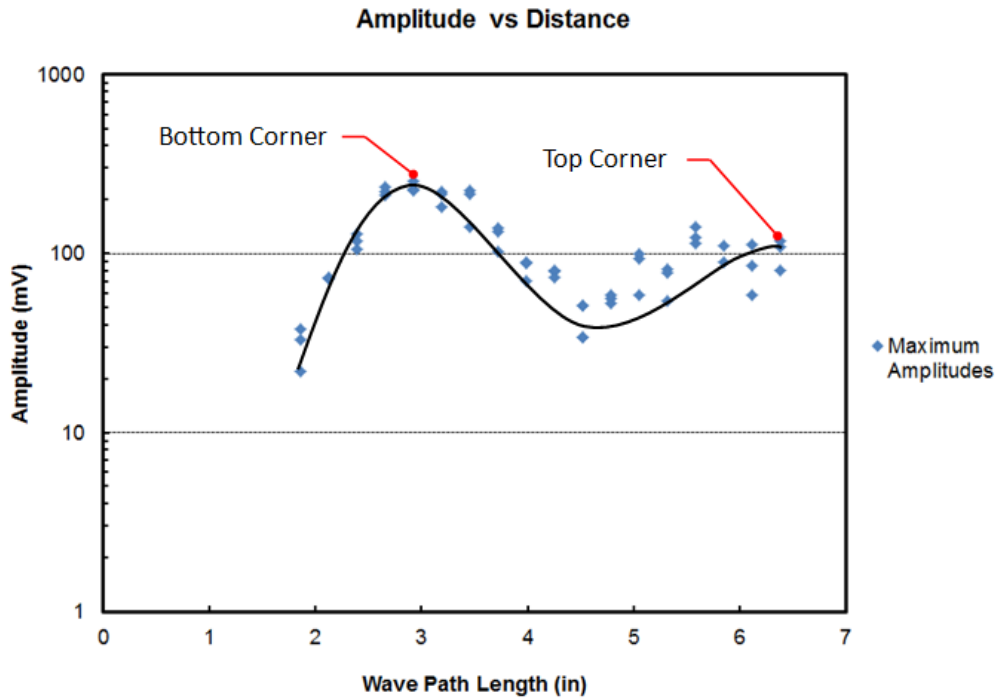
Figure 4-8: Attenuation of 3/4" slot

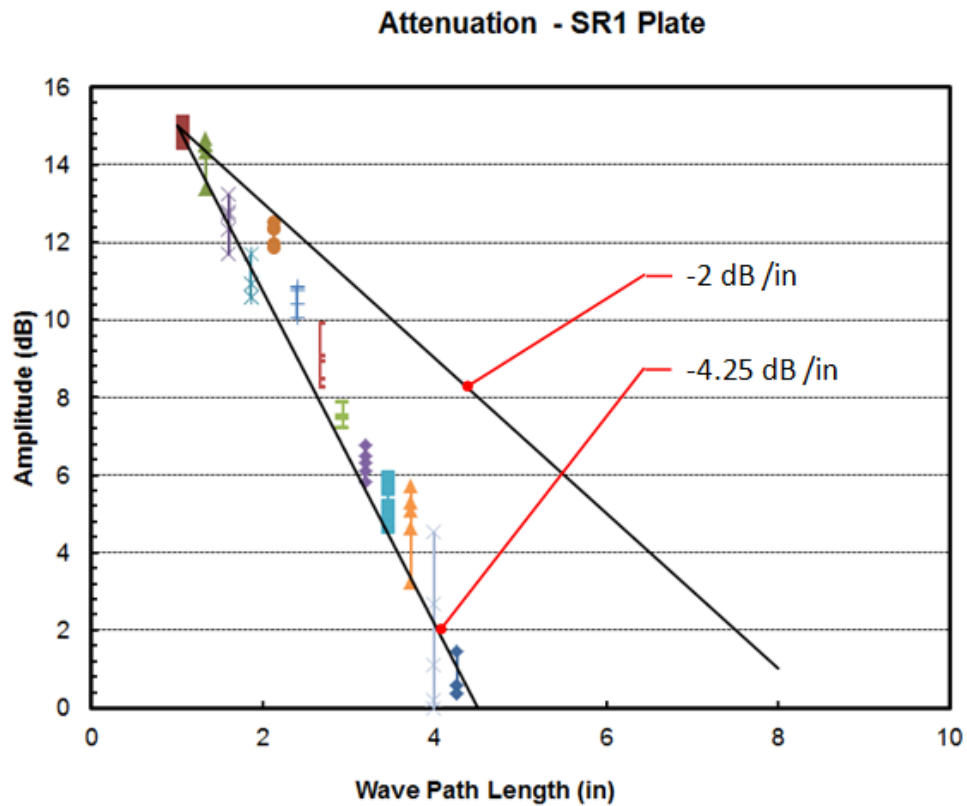
Figure 4-9: SR1, Side 7 attenuation results

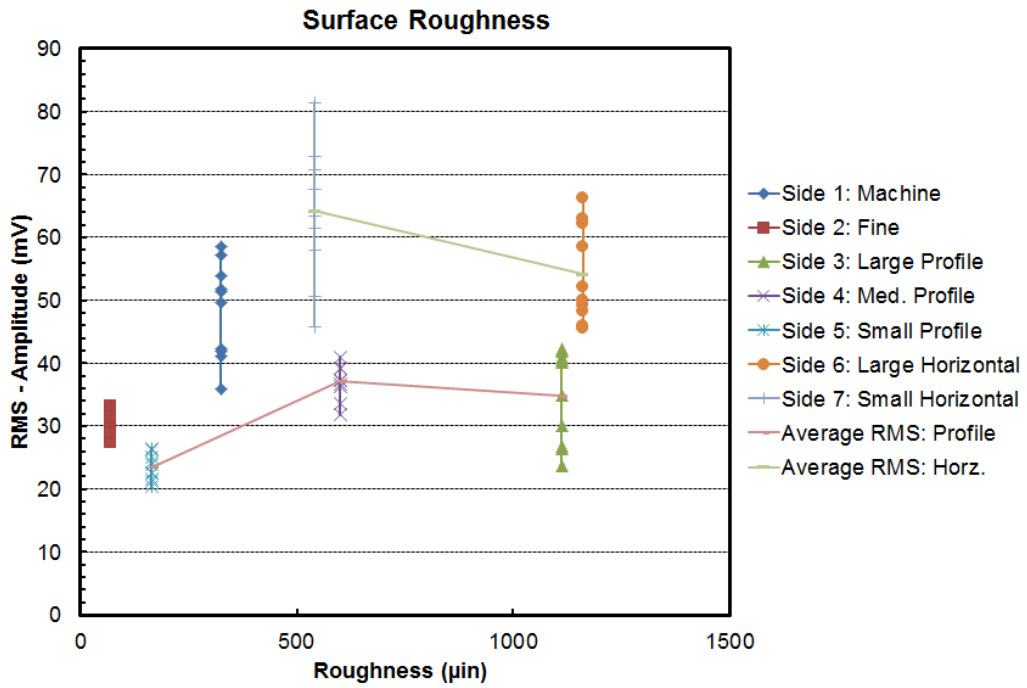
Figure 4-10: RMS values for each surface roughness B-Scan

Figure 4-10 and Figure 4-11 show the maximum reflected amplitude from each inspection vs the measured roughness. The data shown in Figure 4-10 indicates that the reflected amplitude was affected by the texture pattern as well as the texture roughness.

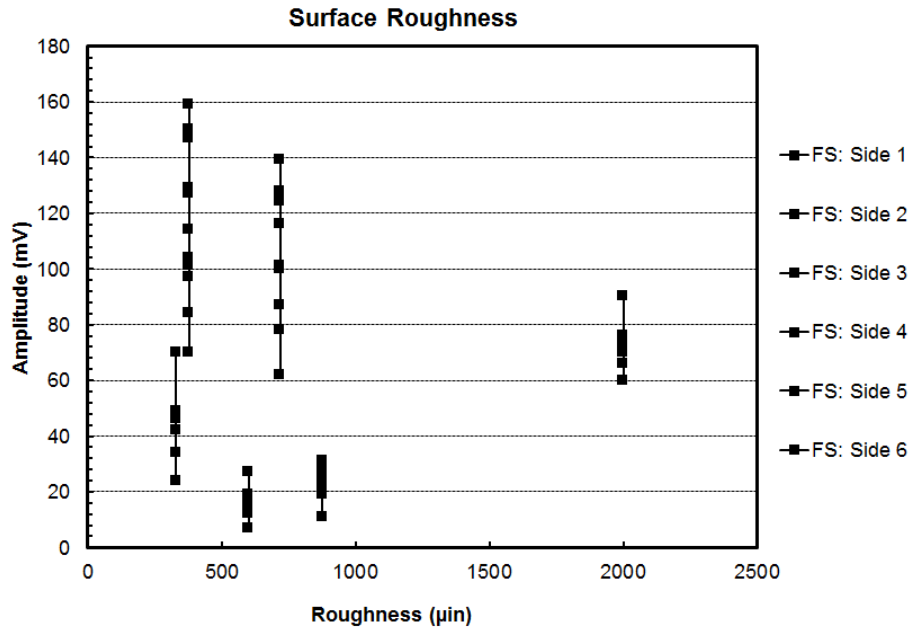
small amounts of the acoustic wave. As the roughness increased, the interference of the reflected wave also increased. Once the roughness increased to half wavelength, the reflected amplitude decreased.

Figure 4-11: Maximum reflected amplitudes for each fatigue specimen side

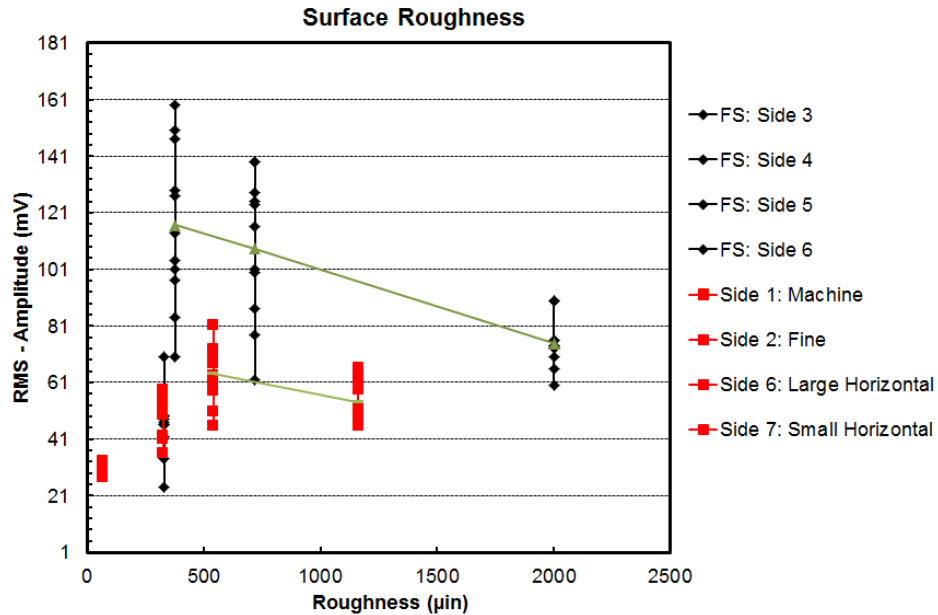
Figure 4-12: SR1 horizontal patterns results vs fatigued specimen results

textures and the fatigued specimens. The averages of both horizontal texture and fatigue crack walls increase in reflected amplitude as the roughness interferes with the reflected amplitude and decreases as the roughness interferes with the wave path reflection.

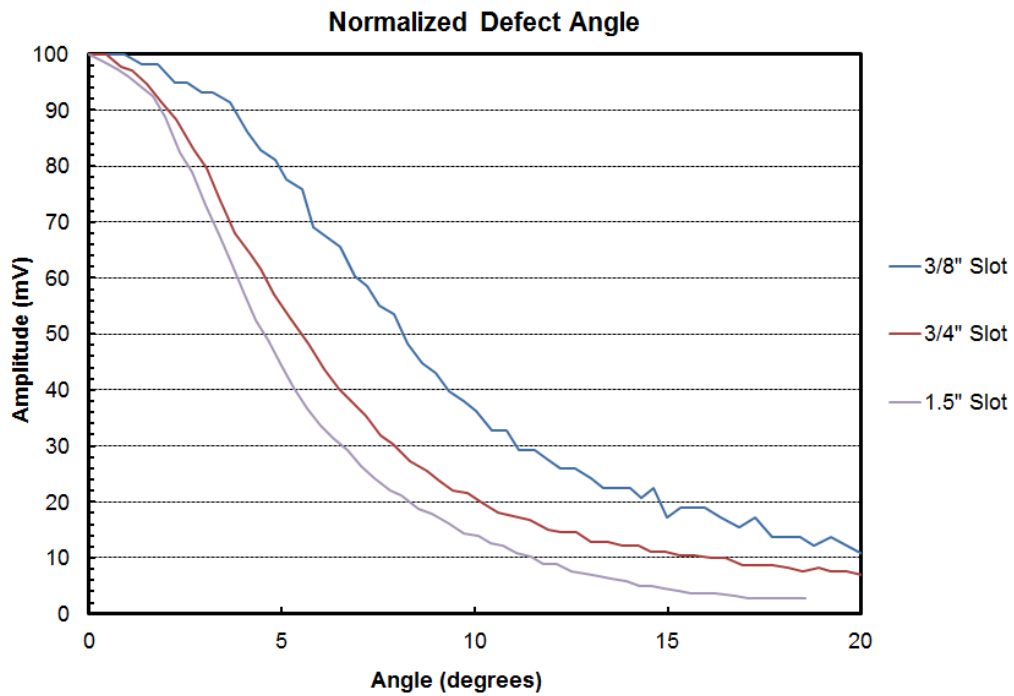
Figure 4-13: Normalized defect angle test B-Scans

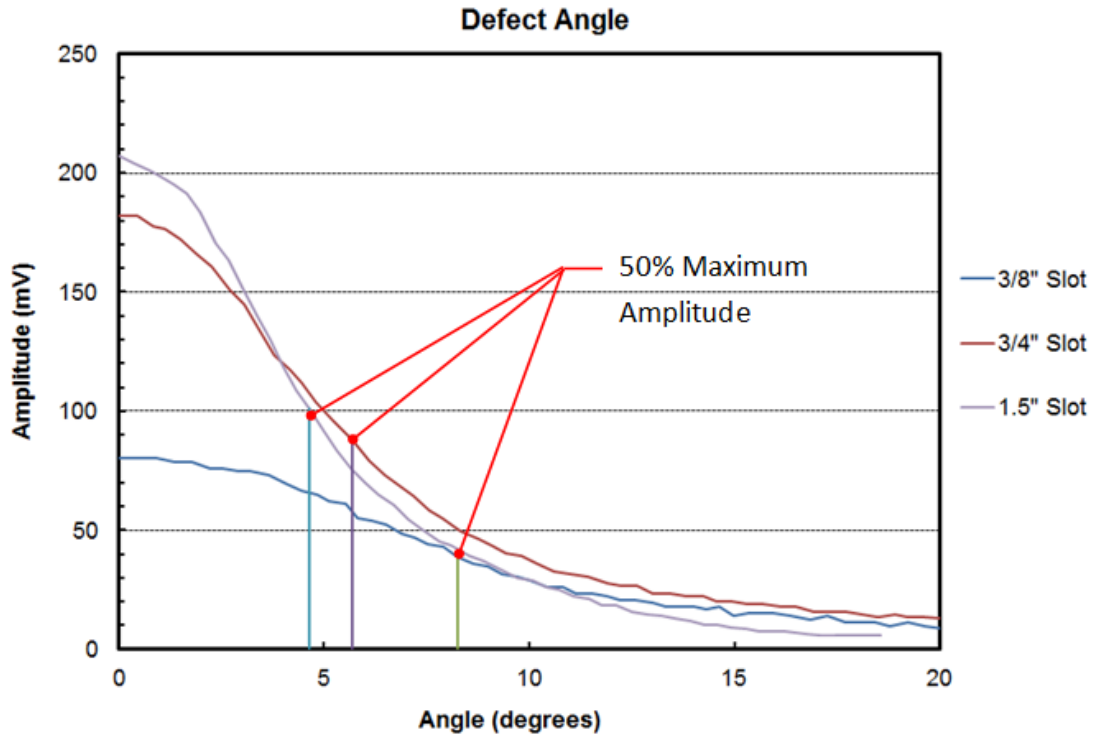
Figure 4-14: Reflected amplitude as the transducer is rotated about the defect

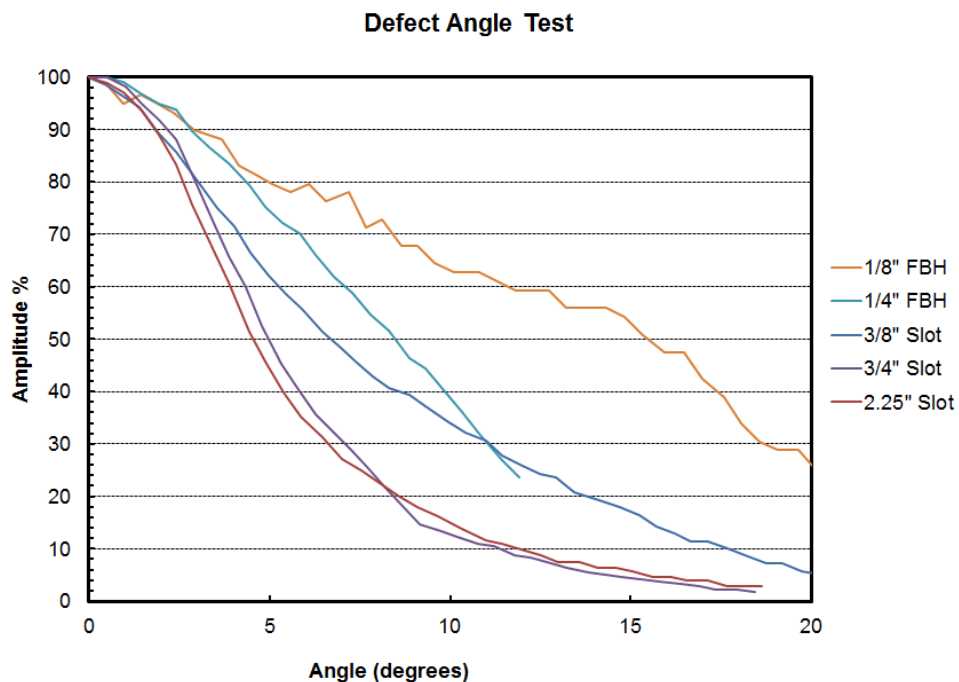
Figure 4-15: Normalized B-Scans relative to transducer rotation

In each of these inspections, the angle beam transducer was rotated while maintaining its location on the steel plate. An encoder was attached to the probe and was used to track the transducer's rotation. Each test yielded a B-Scan relating the reflected amplitude to the transducer angle. Figure 4-15 shows the normalized B-Scans of each inspection relative to the calculated transducer angle.

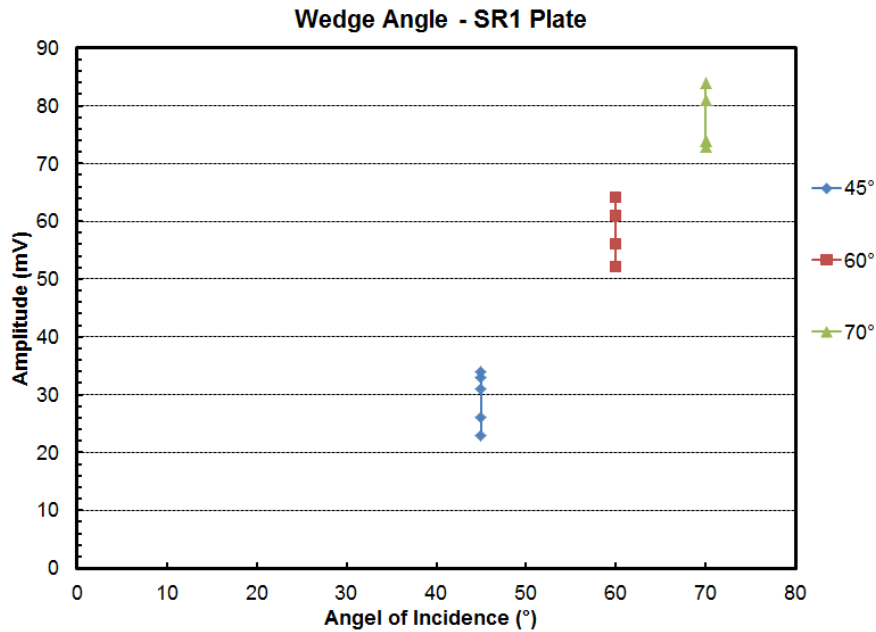
Figure 4-16: Maximum amplitudes from the SR1, Side 7 using the 45°, 60° and 70° wedges

this test indicate that 8.4 dB and 2.4 dB are required to adjust the 45° and 60° probe indications, respectively.

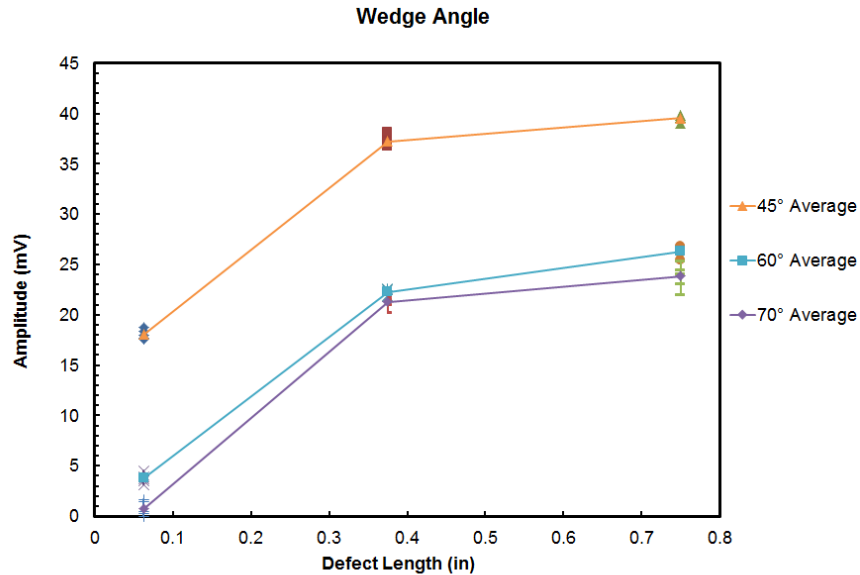
Figure 4-17 Wedge angle results relative to the smallest reflected amplitude

The second procedure inspected the bottom corners of the 1/16" diameter hole, the 3/8" slot and the 3/4" slot in the LA1 test specimen using each of the three angle beam probes. While the AWS assumes all cracks are vertically oriented, this is not always the case. The bottom corners were chosen to demonstrate the effect that the defect orientation has on all three transducer wedge results.

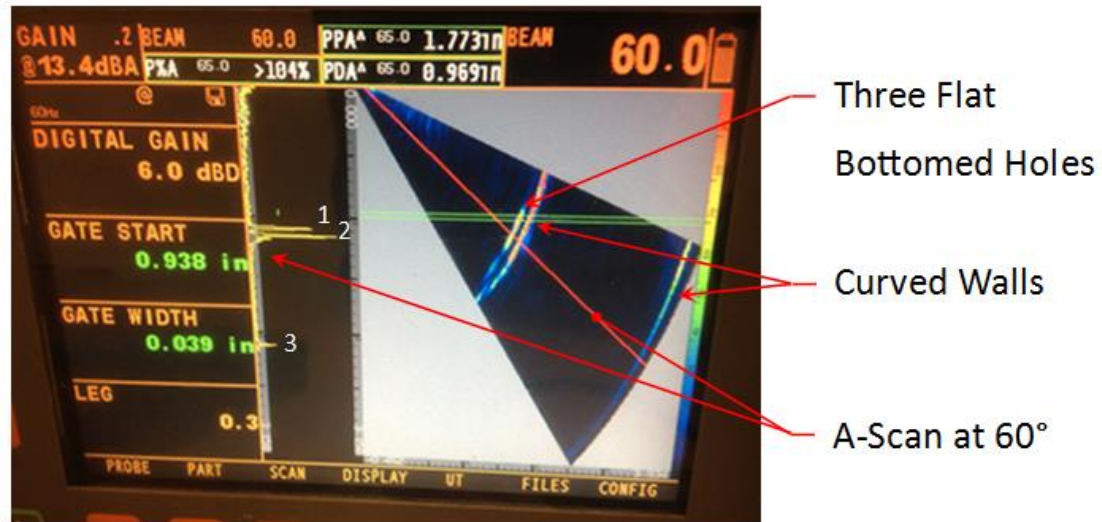
Figure 4-22: S-Scan of the PAUT IIW block

The Phasor XS receiver is capable of generating an A-Scan at any angle within the current angle range. The S-Scan in Figure 4-22 displays the A-Scan at 60° to the left of the S-Scan. The A-Scan angle is associated with the thin slanted line extending from the upper left-hand corner to the bottom right-hand corner of the S-Scan. The A-Scan at 60° shows three spikes in amplitude, the flat bottom hole (1), the first curved wall (2), and the second curved wall (3). Using the range of angles in a single inspection, each indication can be identified as a hole or a curved wall.
