RDT 03-001

# **Determination and Prioritization of Geotechnical Problems for Missouri DOT**

**Final Report**

**Determination and Prioritization of MoDOT Geotechnical Related Problems with  
Emphasis on Effectiveness of Designs for Bridge Approach Slabs and  
Pavement Edge Drains**

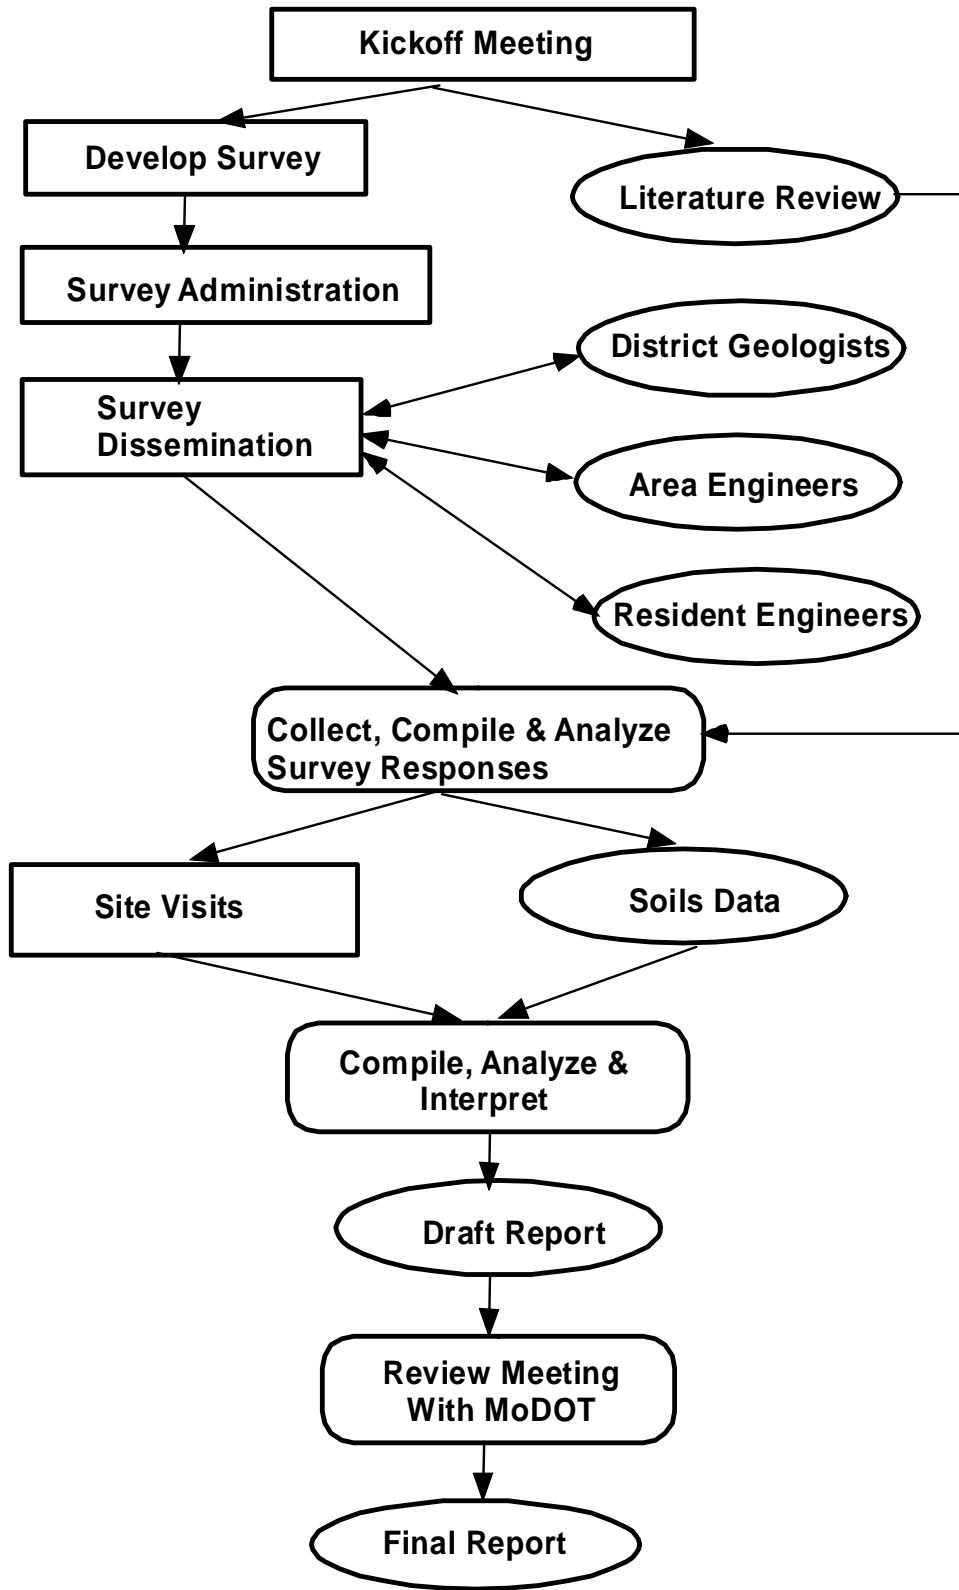
Figure 1 – Flowchart of the project showing major activities.

The aim of this project was to identify, observe, document, and prioritize geotechnical related problem situations that are present across the state. The “Kickoff” meeting was held at MoDOT in January 2000. Following dissemination, collection, and analysis of the survey, the principal investigators met to discuss findings from geographic areas across the state and develop a "consensus" report documenting the results of the survey and providing recommendations for future action. The program for arriving at the final consensus report is outlined in Figure 1.

The continuing program, shown in Figure 1, involved collection and compilation of the survey responses, visits to each of the Districts to assess some of the problems noted in the surveys and to examine field sites of the most recent designs for BAS and PED. As much information about the performance of BAS and PED was collected from MoDOT District personnel as practicable during the site visits and through subsequent communications.

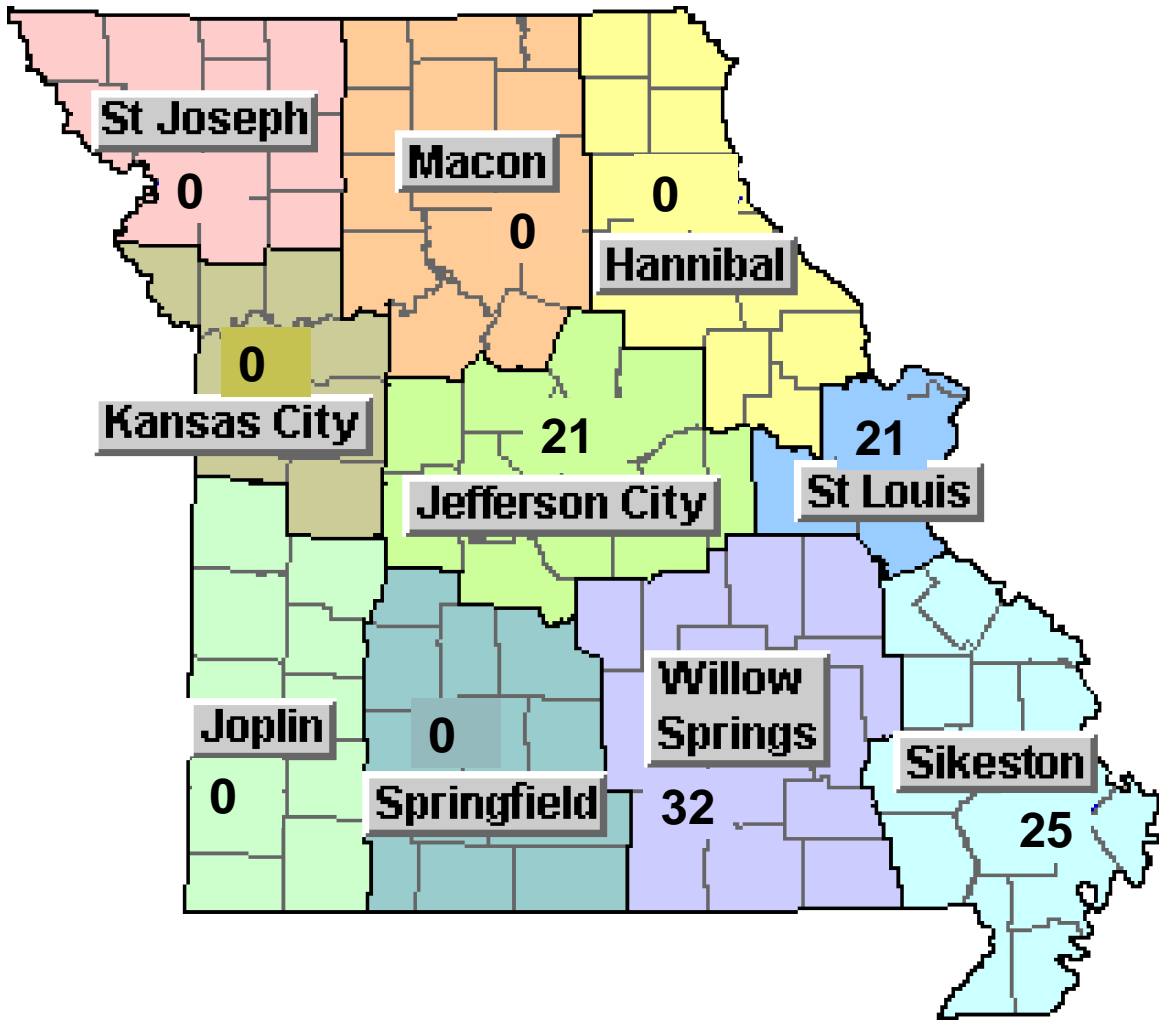
Figure 4. – Percentage of the Earthquake Foundation issues reported by District. Number is the percentage of statewide reported earthquake foundation issues lying within the specific District.

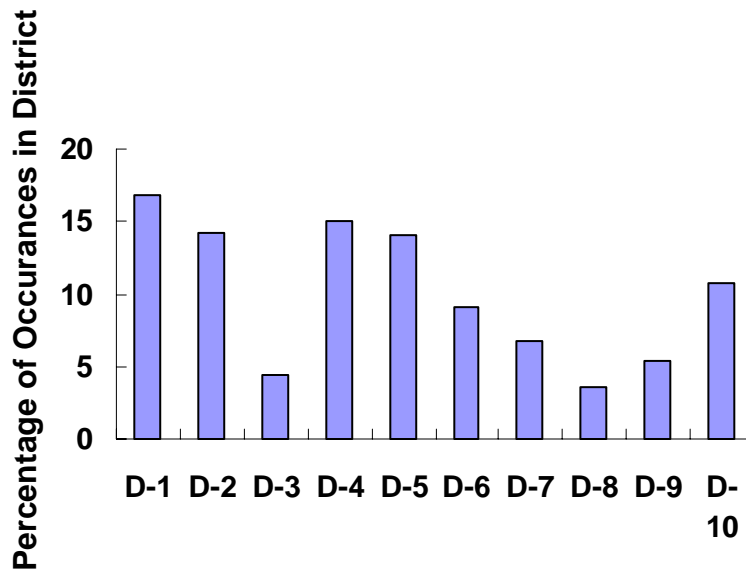
Figure 14 - Percentage of Occurrences of Scour Under Bridge and River Bank by District, normalized by the sum of the weights for all responders in the District. In this manner, each District receives the same weight although the number of responders is not the same in each District.

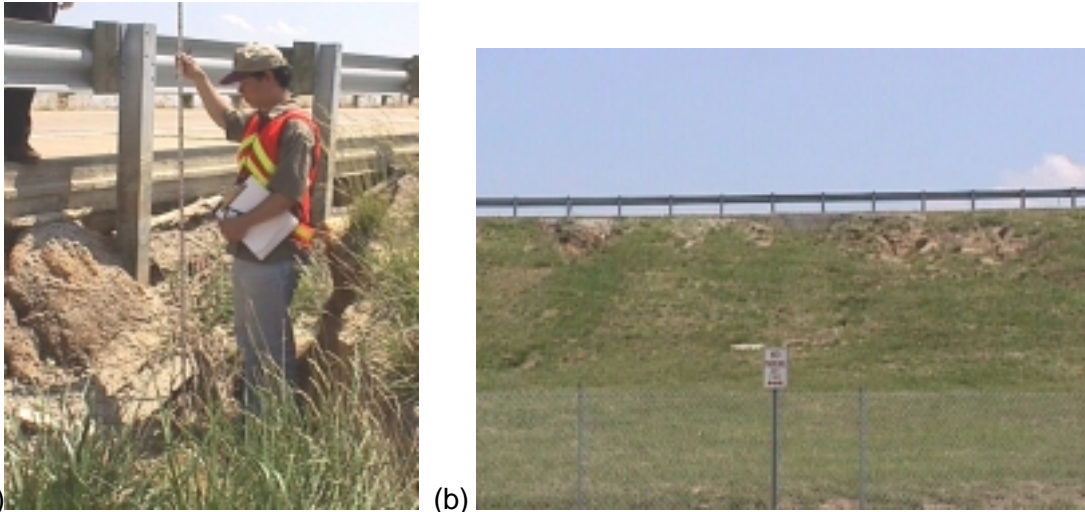
Figure 15 – (a) Erosion at the edge of shoulder concrete on Spencer road ramp on to Mo-370.  
(b) Erosion problem near I-170 and I-70 intersection.

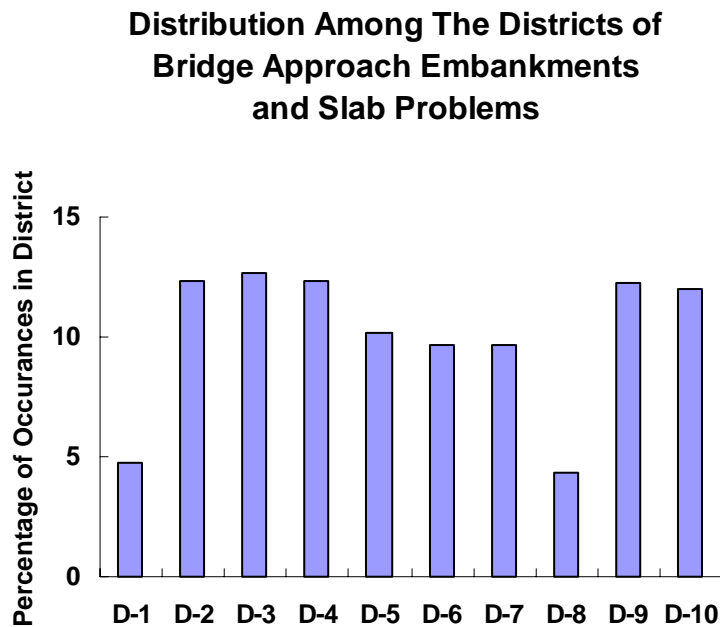
Figure 18 - Percentage of occurrences of Bridge Approach Embankment and Slab Problems by District, normalized by the sum of the weights for all responders in the District. In this manner, each District receives the same weight although the number of responders is not the same in each District.

All ten Districts reported bridge approach embankment and slab problems (Figure 18). Districts 2, 3, 4, 9 and 10 reported the highest occurrences and were about the same among these Districts. Districts 1 and 8 were the lowest among the Districts. The frequency and severity of bridge approach embankments and slab issues are listed in Table 10. Districts 3, 9 and 10 indicated the highest frequency and severity. District 1 indicated the lowest frequency and severity.

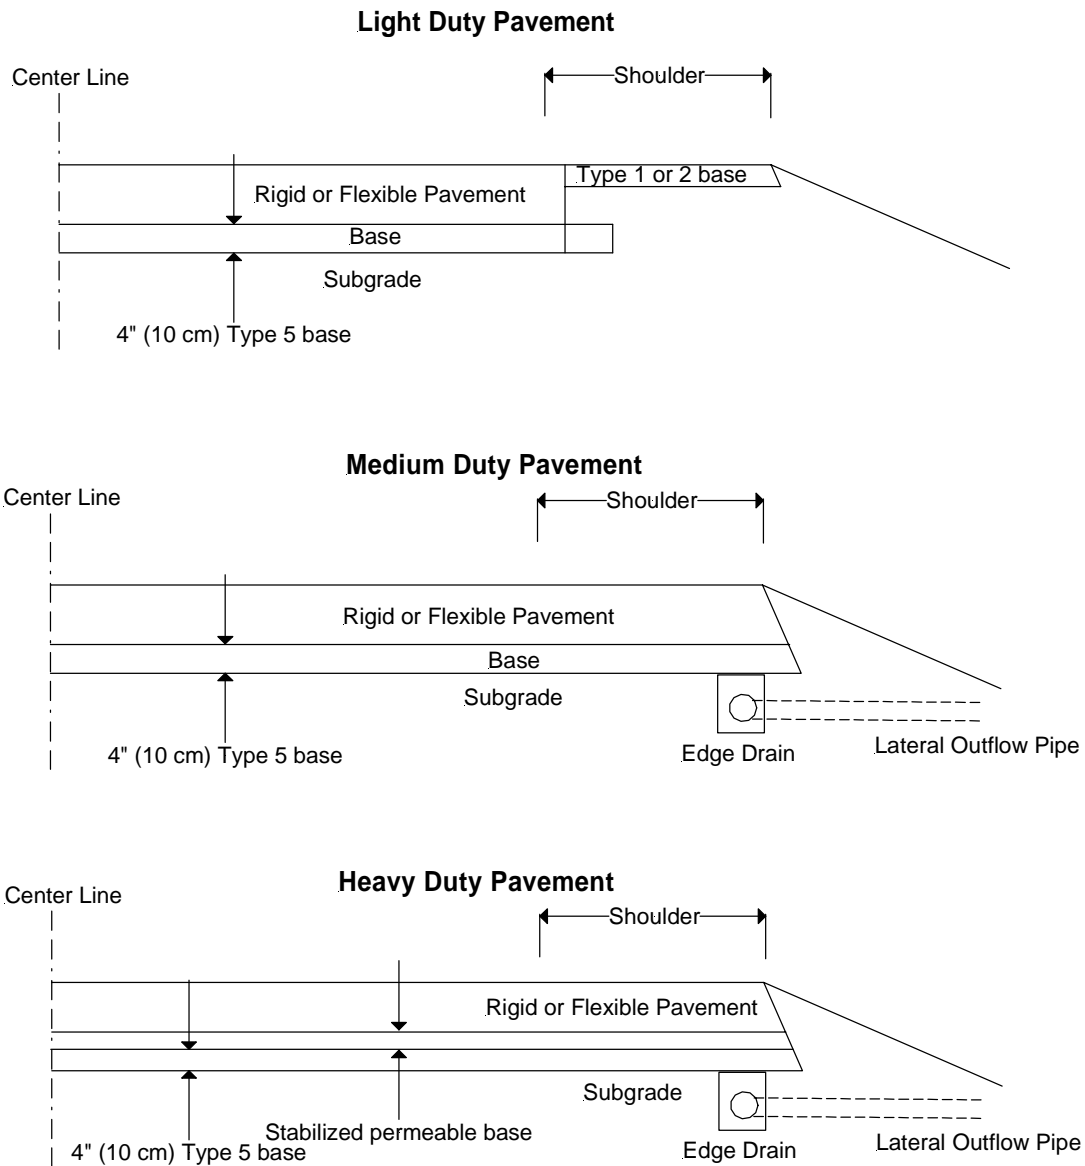
Figure 19 – The three pavement design cross sections used in MoDOT system (a) Heavy-duty, (b) Medium-duty, (3) Light-duty.

In Missouri, subsurface drainage of pavements is accomplished through use of drainable base courses and pavement edge drains (PED). Missouri DOT uses three standard pavement designs. These include light, medium and heavy-duty pavements (Figure 19). No subsurface drainage is supplied in light-duty pavements. Medium-duty pavements include a Type 5 base with edge drains, and heavy-duty pavements include an asphalt stabilized drainable layer with edge drains. Subsurface drainage is only provided for medium and heavy-duty pavements in the Missouri DOT system.

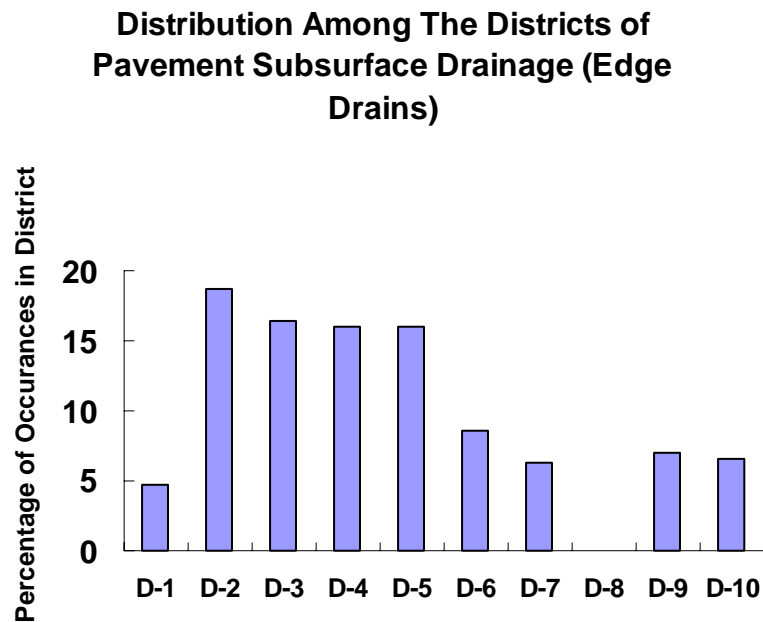
Figure 20 – Percentage of occurrences of Pavement Subsurface Drainage Problems by District, normalized by the sum of the weights for all responders in the District. In this manner, each District receives the same weight although the number of responders is not the same in each District.

All Districts reported some occurrence of subsurface drainage issues; however, District 8 did not specifically note this issue on Question 1 of the survey. Districts 2, 3, 4 and 5 reported similar occurrences and were the highest of the Districts. The frequency and severity of pavement subsurface drainage issues for each District are listed in Table 11. Districts 4 and 5 report higher frequency and severity for drainage issues than the other Districts. District 10 reports the lowest frequency and severity.

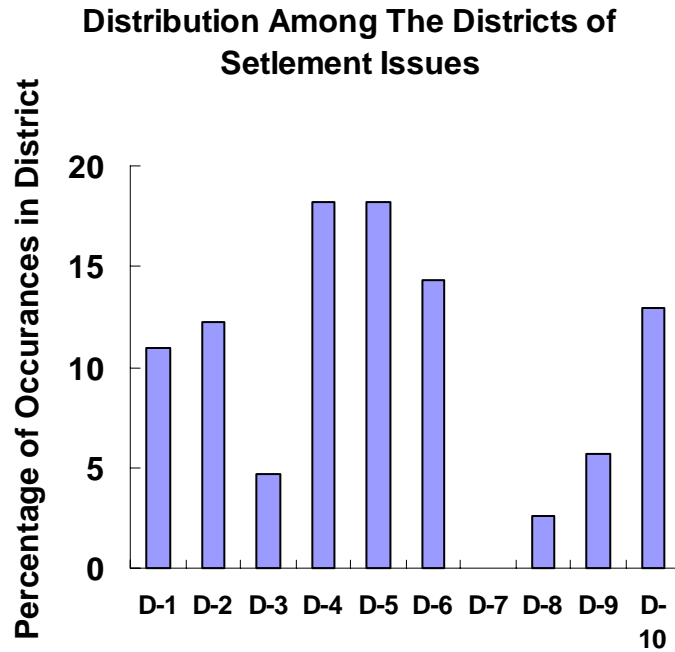
Figure 23 – Percentage of occurrences of Settlement Problems by District, normalized by the sum of the weights for all responders in the District. In this manner, each District receives the same weight although the number of responders is not the same in each District.

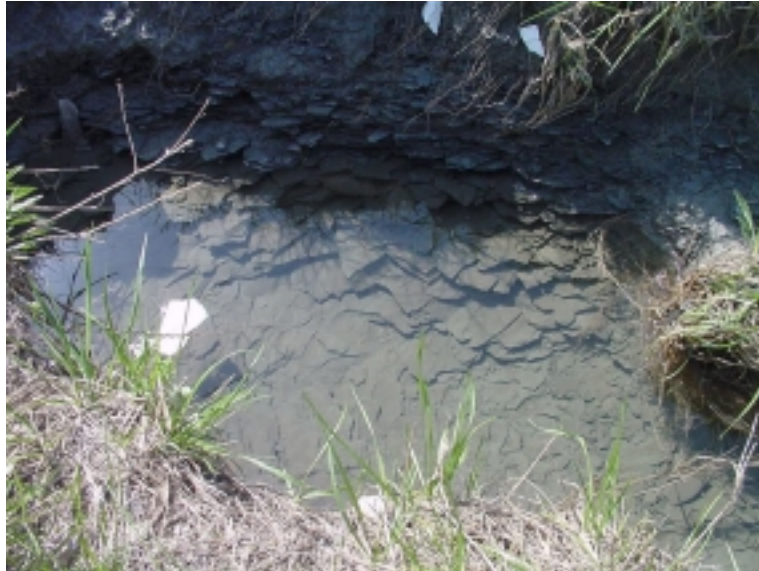
Figure 26 – Exposed area showing shale that is underlying highway in District 4.

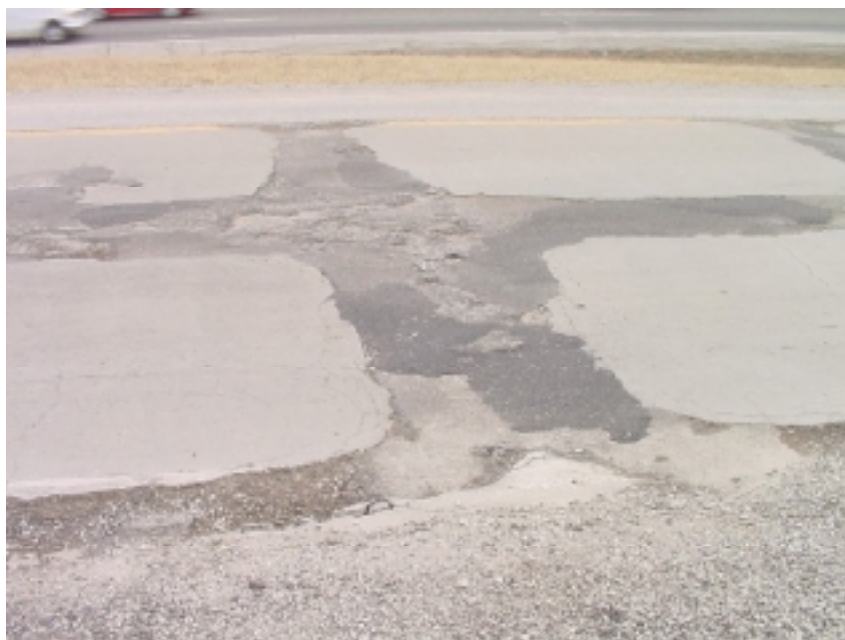
Figure 27 – Heave in I-435 due to underlying expansive shales.
